Project **FORTH REPLACEMENT CROSSING**

VIBRATION MONITORING REPORT
AUGUST 2016

Document number	Rev
REP-00290	00

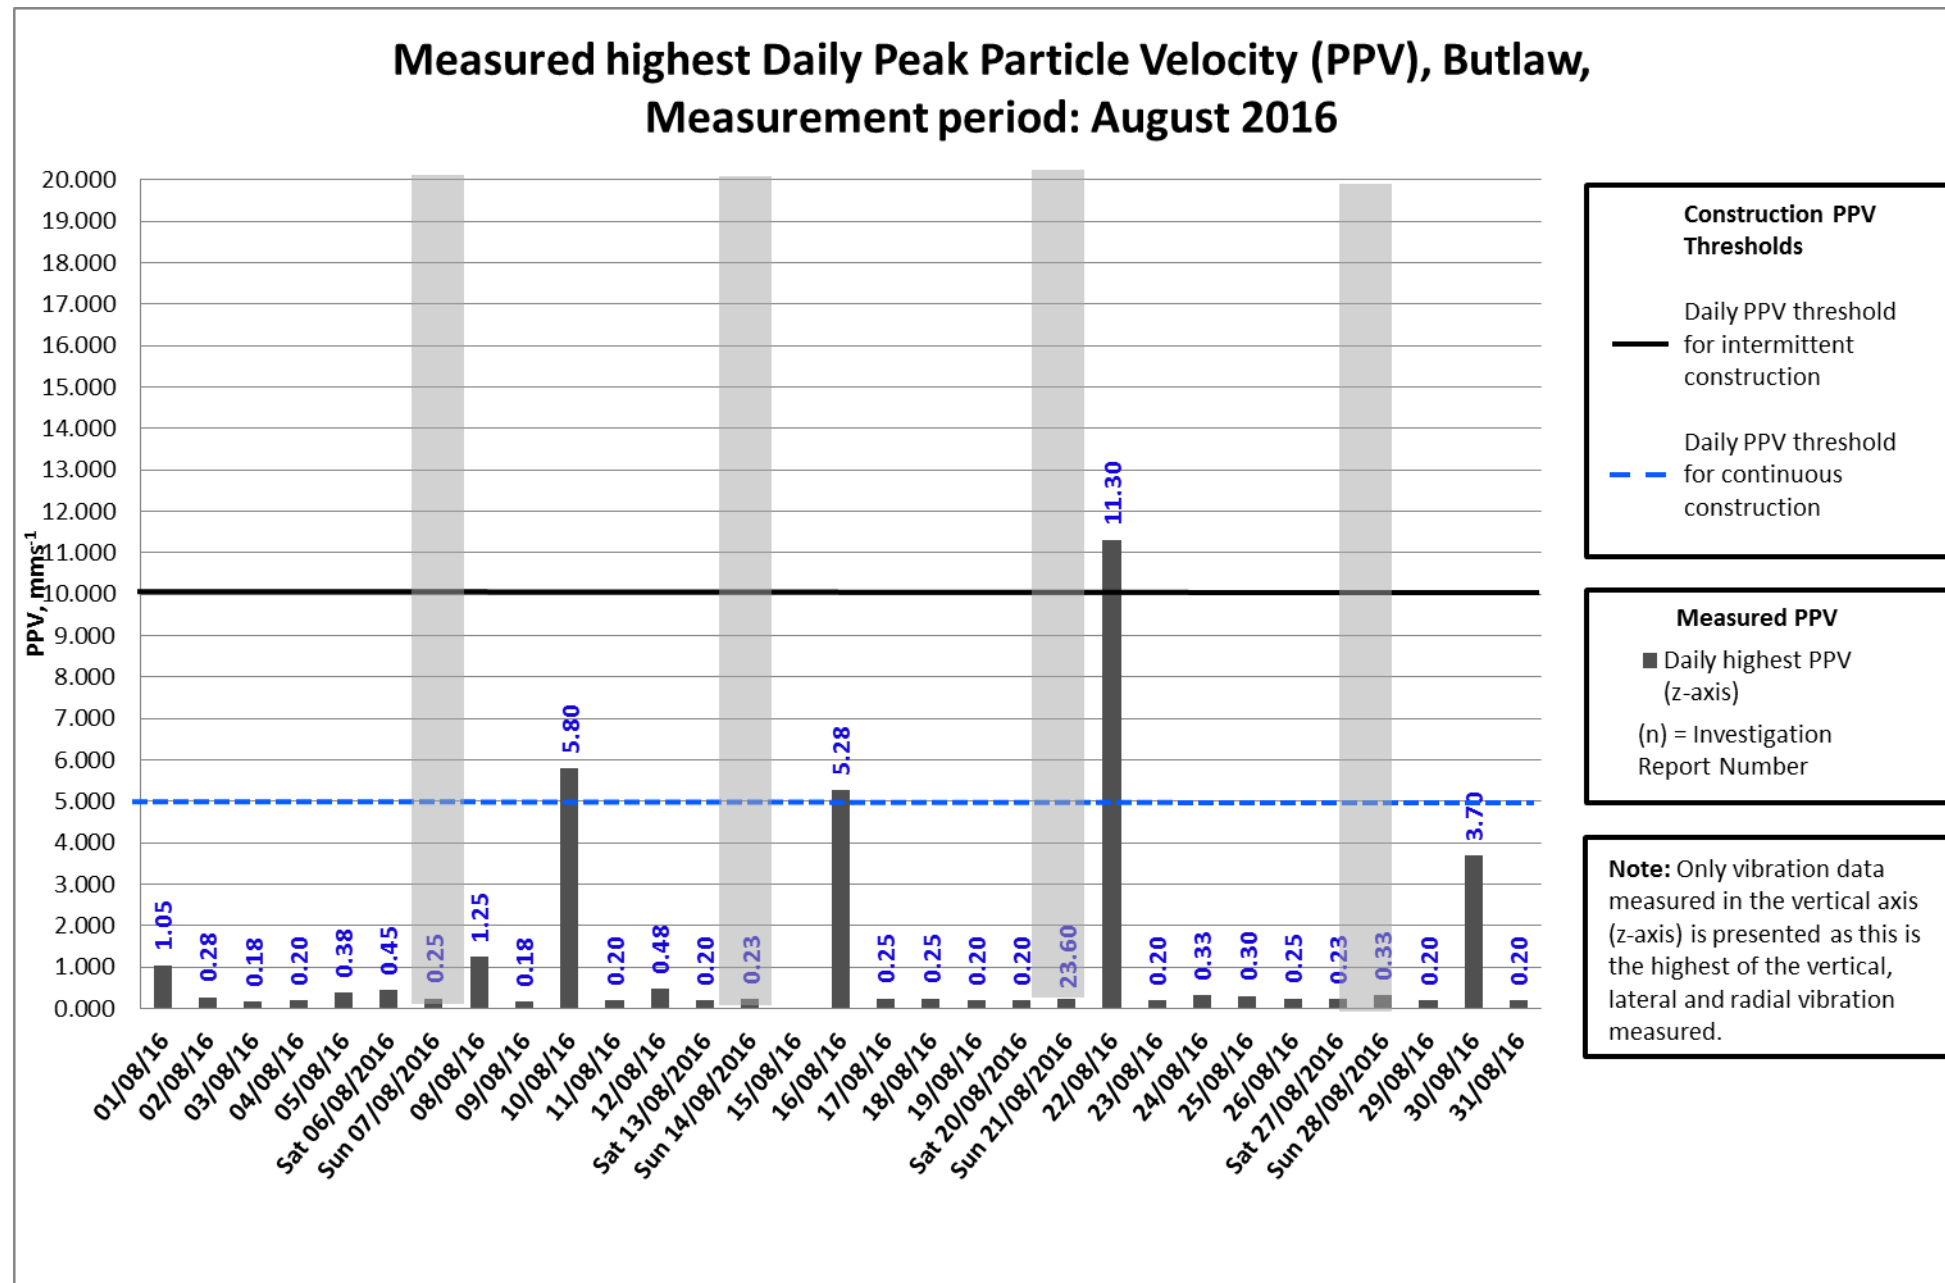
Exceedances on the 10th and 16th of August have been investigated and were found to be caused by the environmental department carrying out calibration/ maintenance on the noise and vibration monitors.

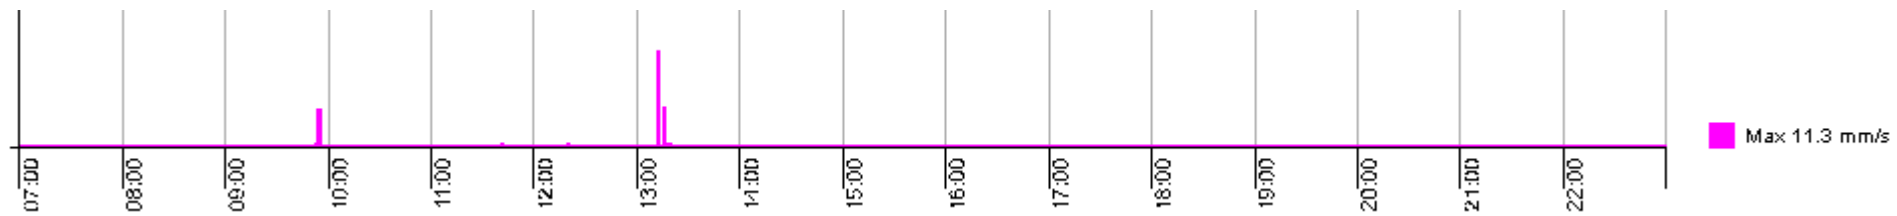
Exceedance on the 22nd August has been investigated and found to be caused by the resident cutting the grass where the vibration is situated at approximately 1320. Exceedance at approximately 0950 has been investigated and found to be caused by the environmental department carrying out maintenance on the noise monitor.

Data missing on the 15th August was caused by the annual calibration of the vibration monitor.

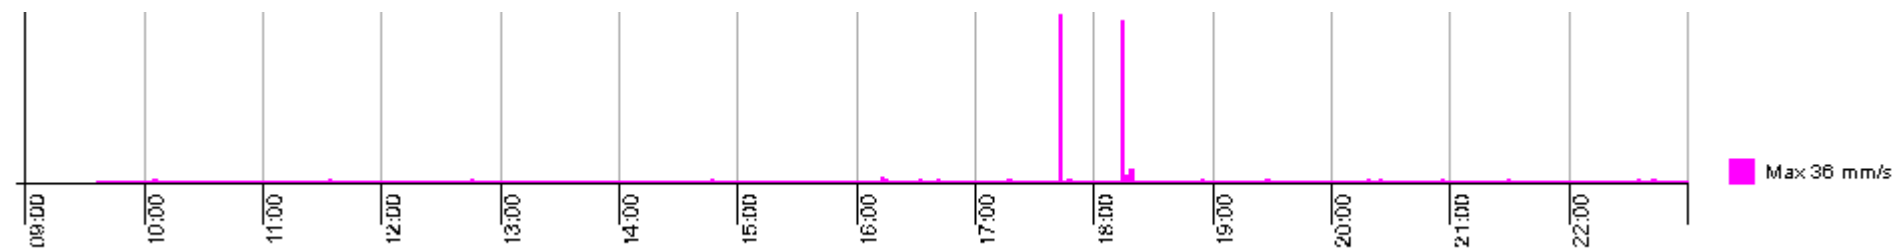
Exceedances on the 1st and 6th of August have been investigated and found to have been caused by the resident cutting the grass close to where the monitor was situated.

Data missing on the 16th of August was caused by the annual calibration of the vibration monitor.

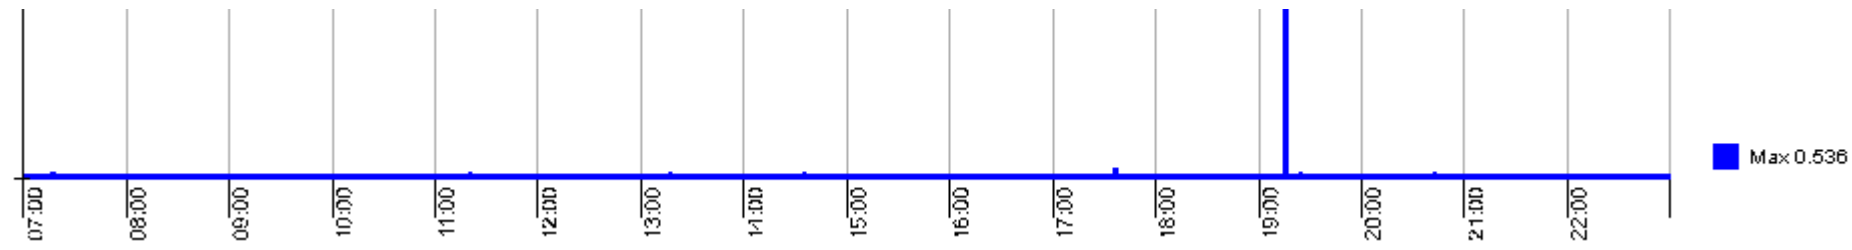
Exceedance 30th of August has been investigated and found to be caused out with construction working hours and therefore it is unlikely that construction related activities were the cause of this event (graph above from the 30/08/2016).

Data missing on the 16th of August was caused by the annual calibration of the vibration monitor.

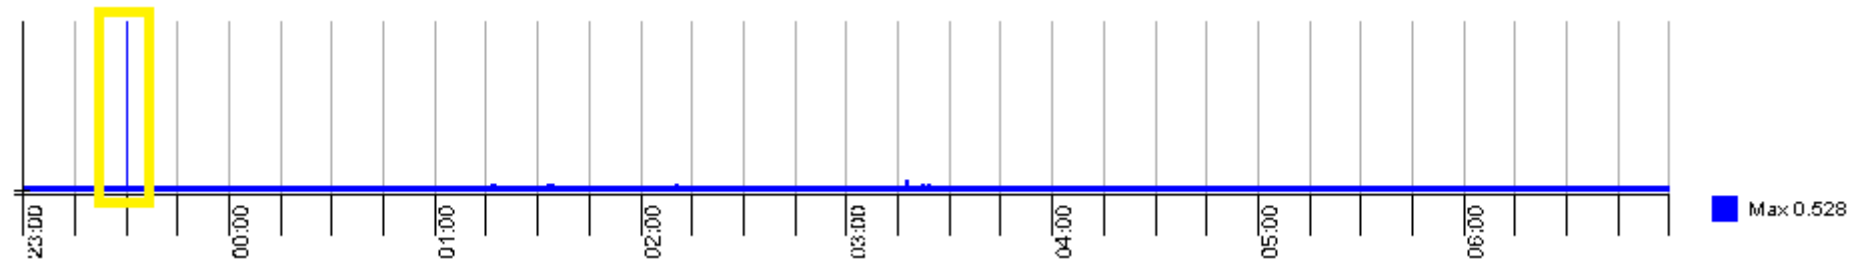
Exceedance on the 20th has been investigated and found to be caused out with construction working hours and therefore it is unlikely that construction related activities was the cause for this event (graph above from the 20/08/2016).

Data missing on the 16th of August was caused by the annual calibration of the vibration monitor.

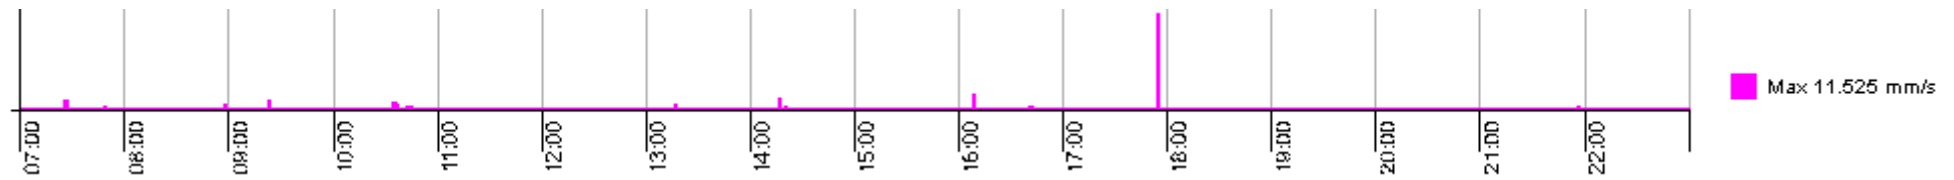
Exceedances on the 1st, 2nd, 4th, 5th, 8th, 10th, 11th, 12th, 15th, 18th, 19th, 20th, 22nd, 23rd, 24th, 25th, 26th, 30th and 31st of August have been investigated and found to have been caused by individual isolated events that are unlikely to have been construction related activities (graph above from the 12/08/2016). The closest works were located approximately 260m away which consists mainly of road surfacing. Due to the distance to the nearest works it is unlikely the exceedances stated above were caused by the Forth Crossing works.

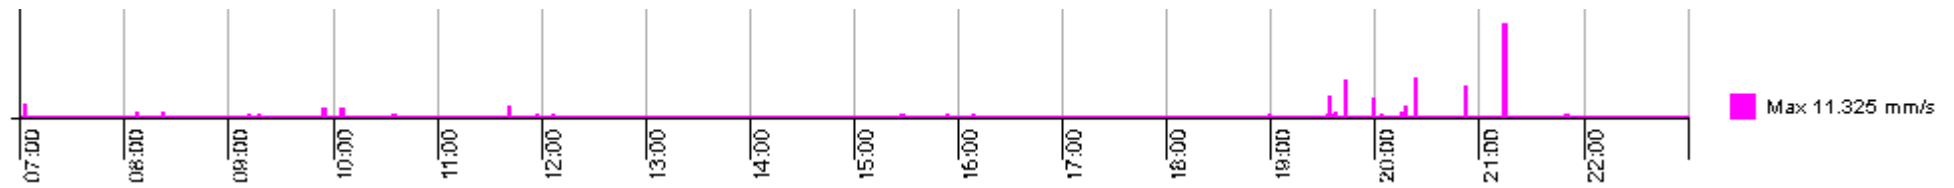
Exceedances on the 6th, 7th, 9th, 16th, 17th, 21st, 27th, 28th and 29th of August have been investigated and found to be caused out with construction working hours and therefore it is unlikely that construction related activities were the cause for these exceedances (graph above from the 27/08/2016).

Data missing on the 15th of August was caused by the annual calibration of the vibration monitor.
