Queensferry
Crossing

Project FORTH REPLACEMENT CROSSING

VIBRATION MONITORING REPORT
NOVEMBER 2016

Document number	Rev
REP-00300	00

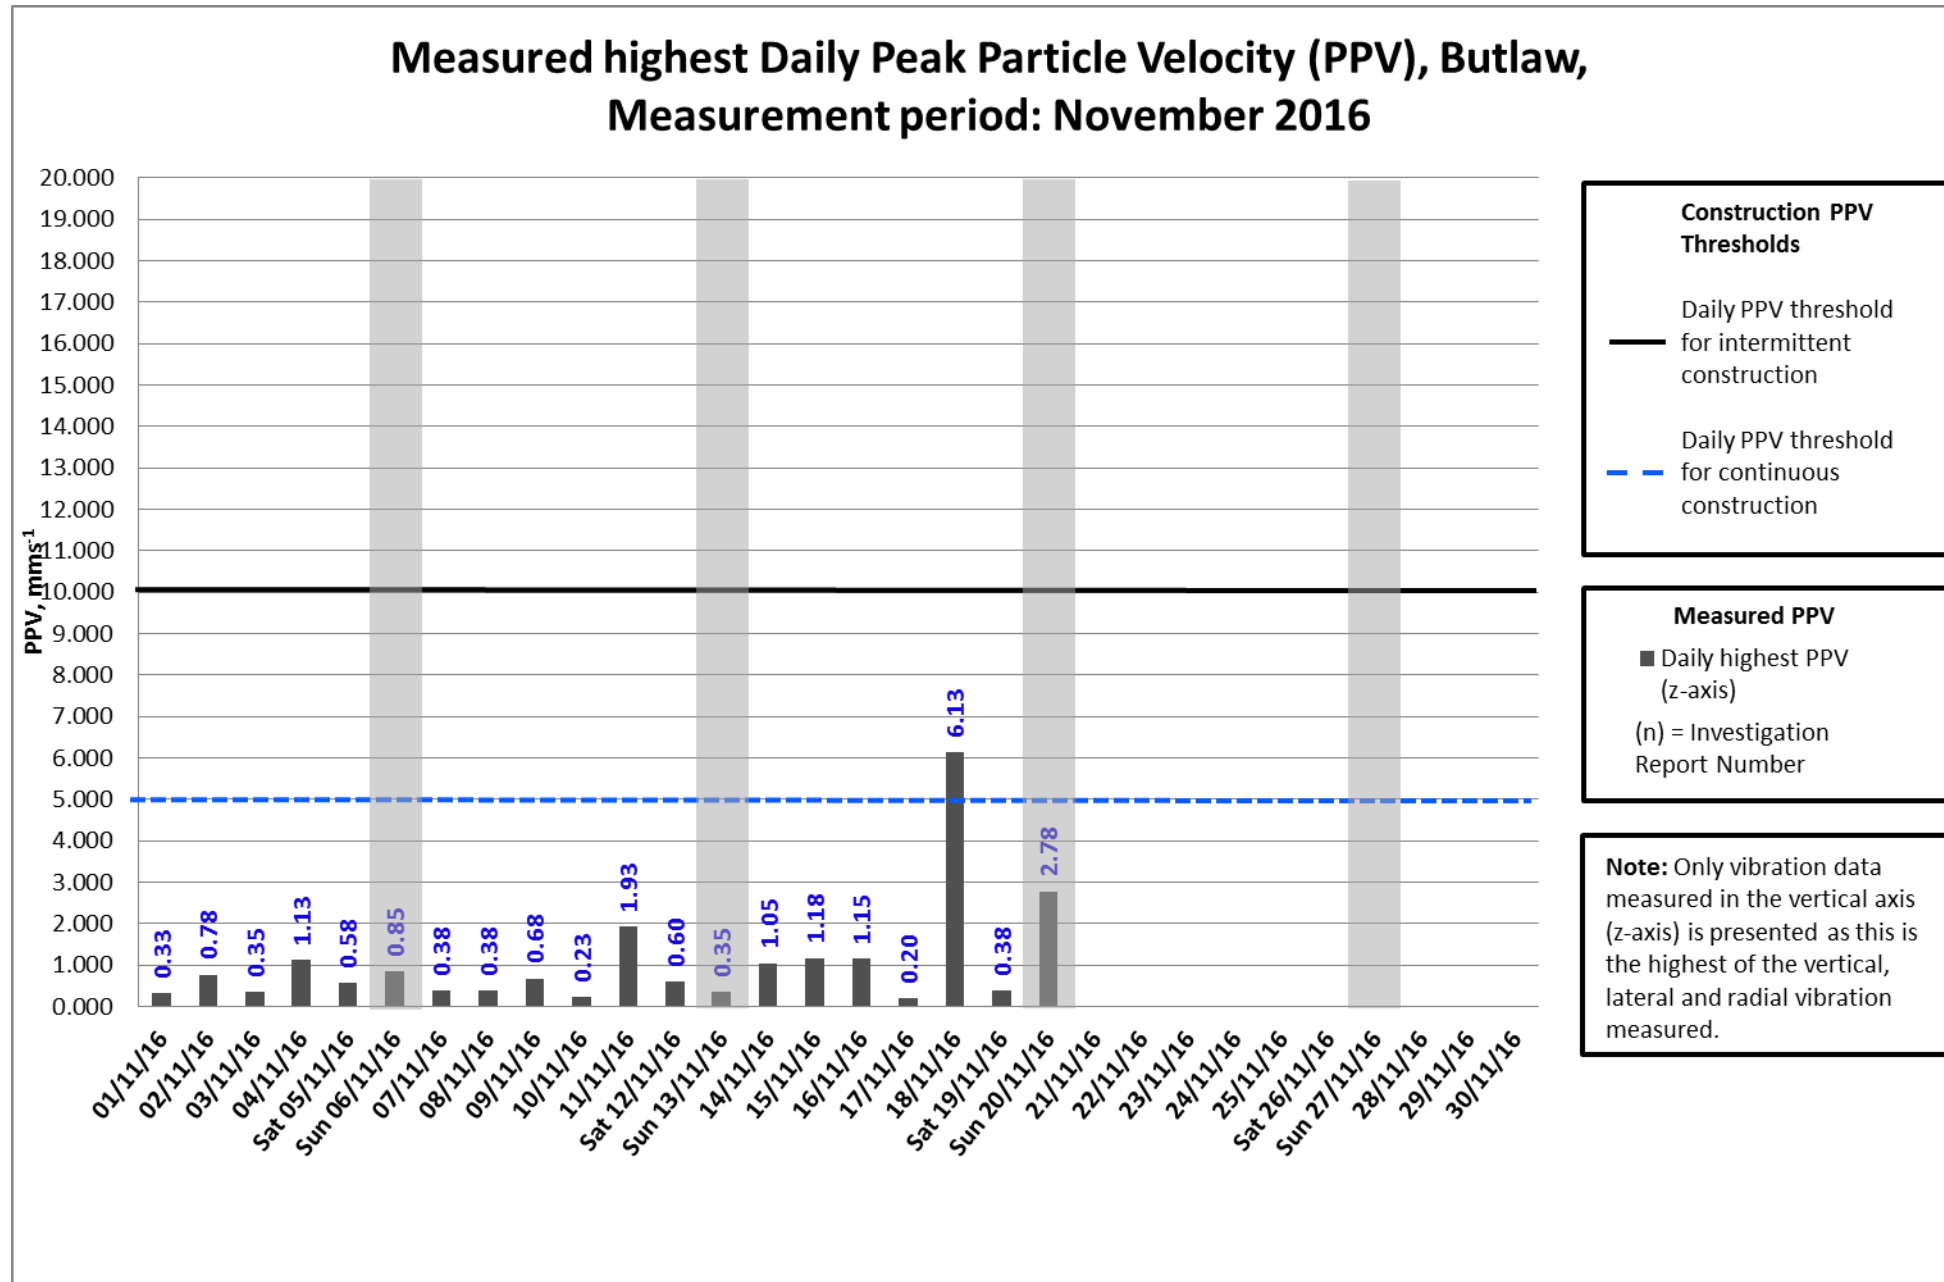
Data missing on the 21st – 30th November was caused by electrical issue with monitor.

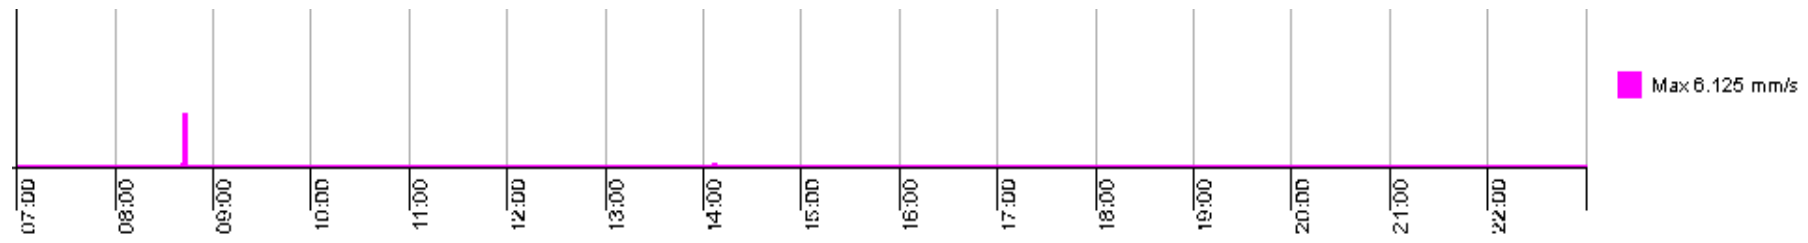
Exceedance on the 18th of November has been investigated and found to have been caused by an isolated event that is unlikely to have been due to a construction related activity.

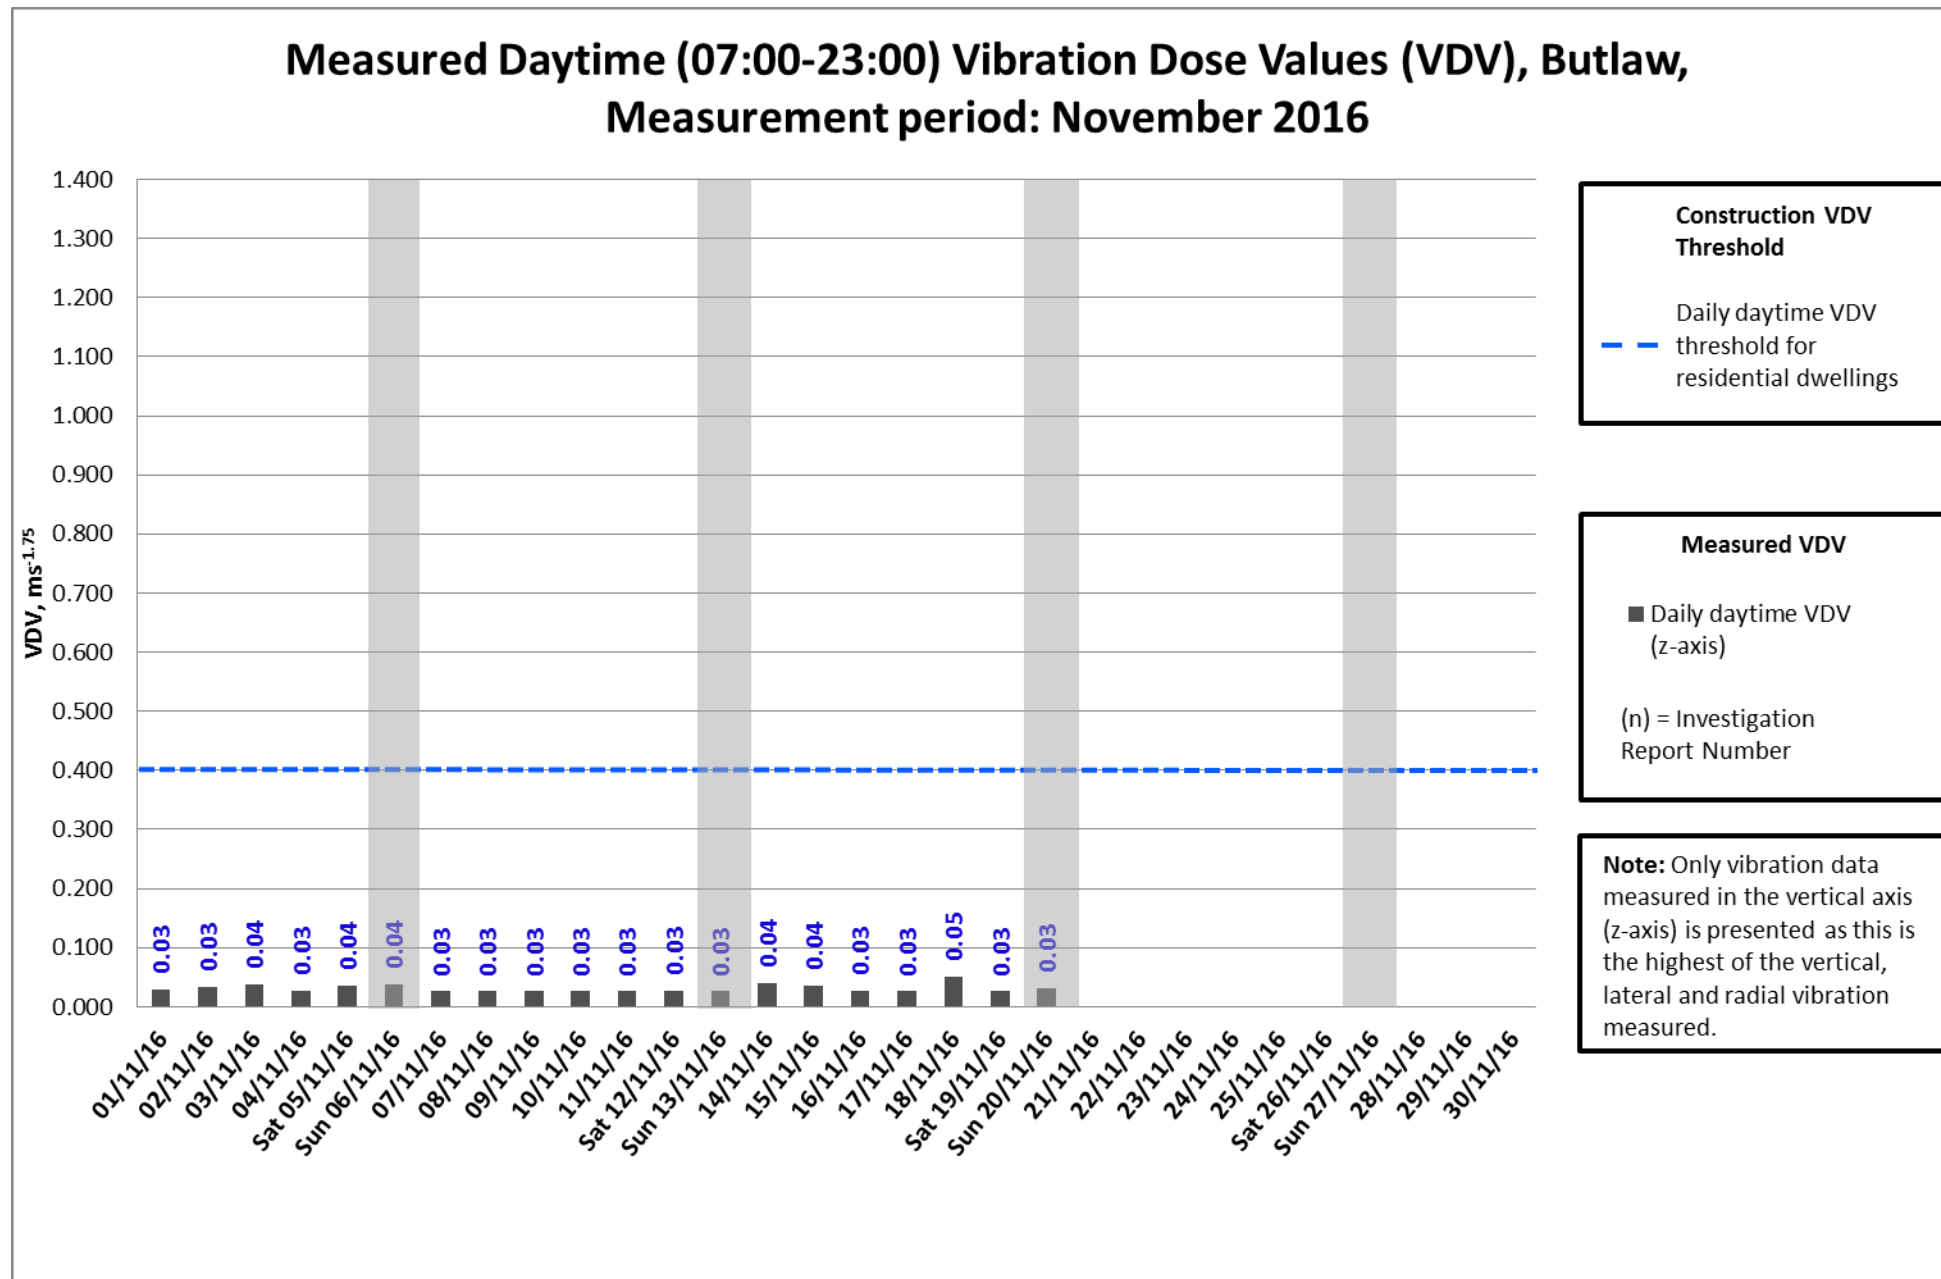
Data missing on the 21st – 30th November was caused by electrical issue with monitor.

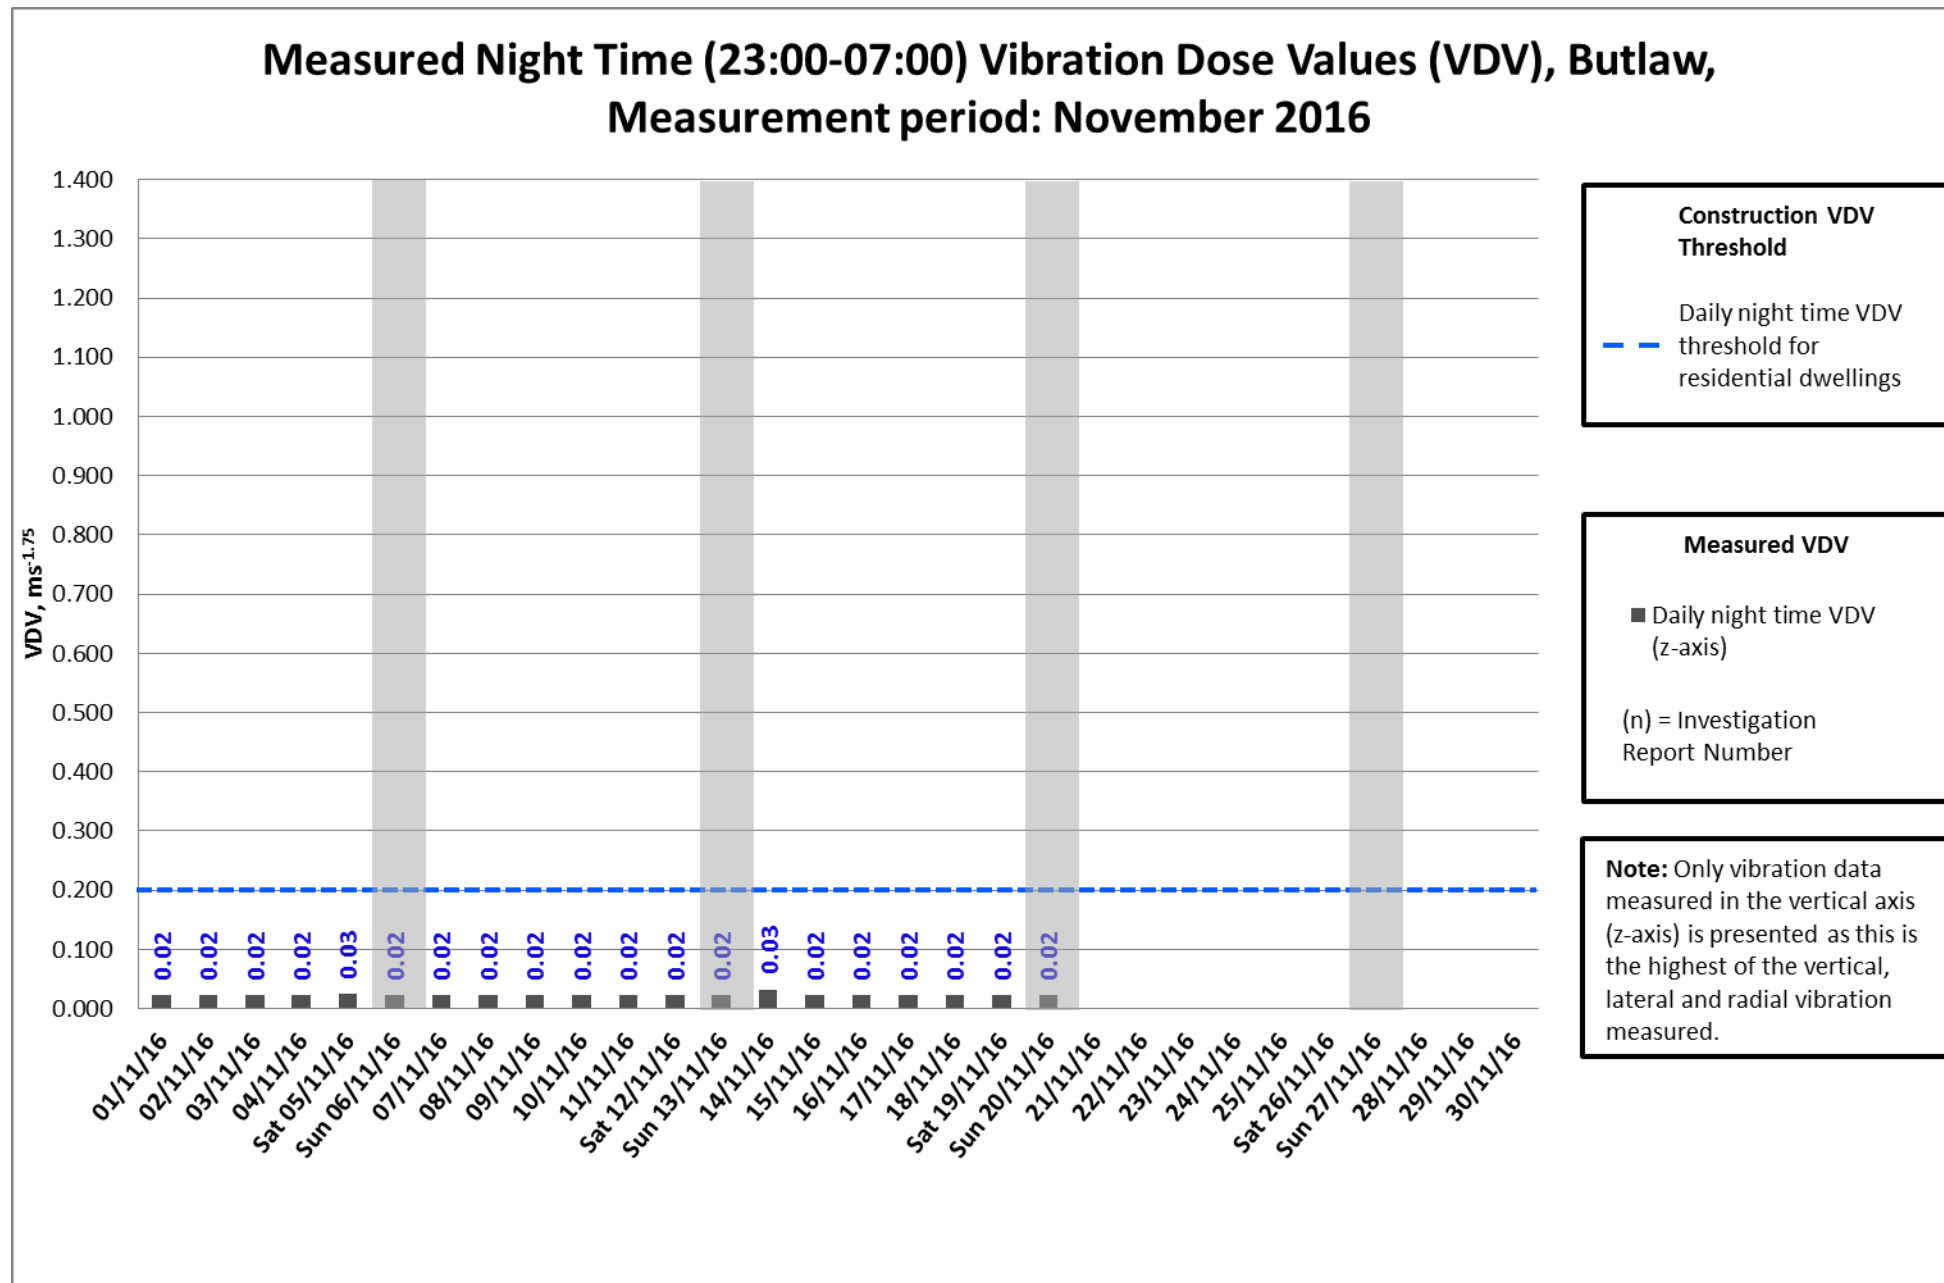
Data missing on the 21st – 30th November was caused by electrical issue with monitor.

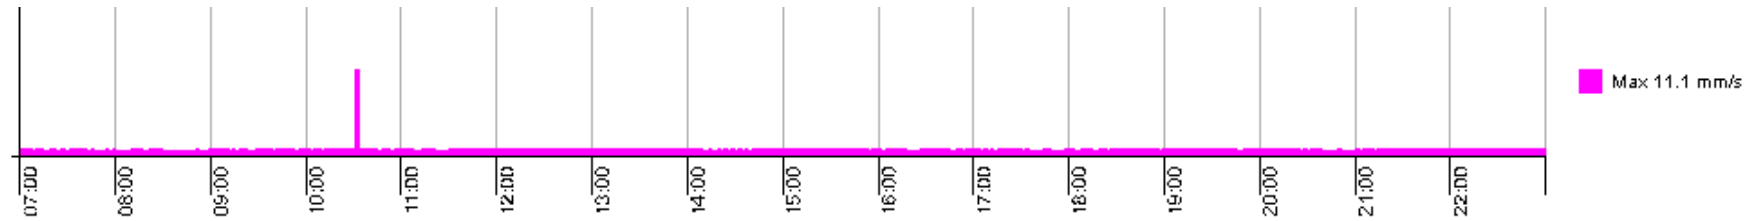
Exceedances on the 1st, 2nd, 6th, 8th, 11th, 12th, 13th, 14th, 15th and 18th of November have been investigated and found to be caused by individual isolated events (graph above from the 11/11/2016). With the monitor being located in a public amenity area there is a likelihood that the exceedances seen above might have been caused by pedestrians using this area. However it is worth noting that during this period, there have been works ongoing at the Suds pond east of the south abutment, approximately 30m away. Due to this and the fact that there isn't any supporting evidence to state otherwise, these exceedances may have been caused by construction activities.

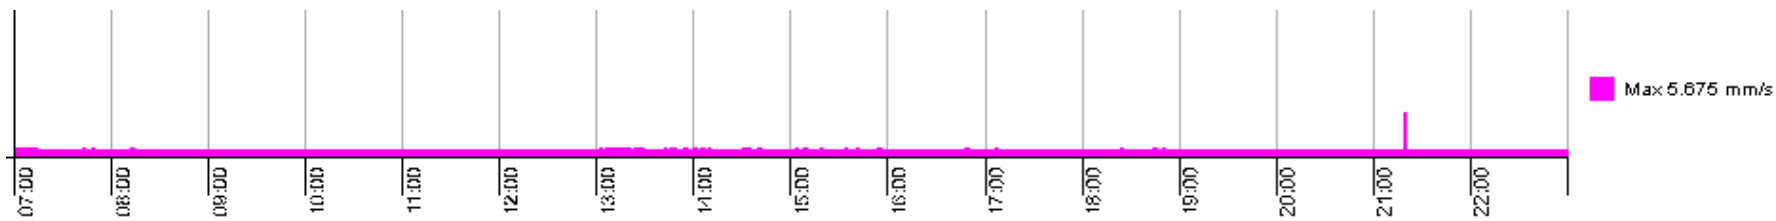
Exceedances on the 4th and 19th of November have been investigated and found to be caused out with construction working hours and therefore it is unlikely that construction related activity was the cause of these events (graph above from the 19/11/2016).

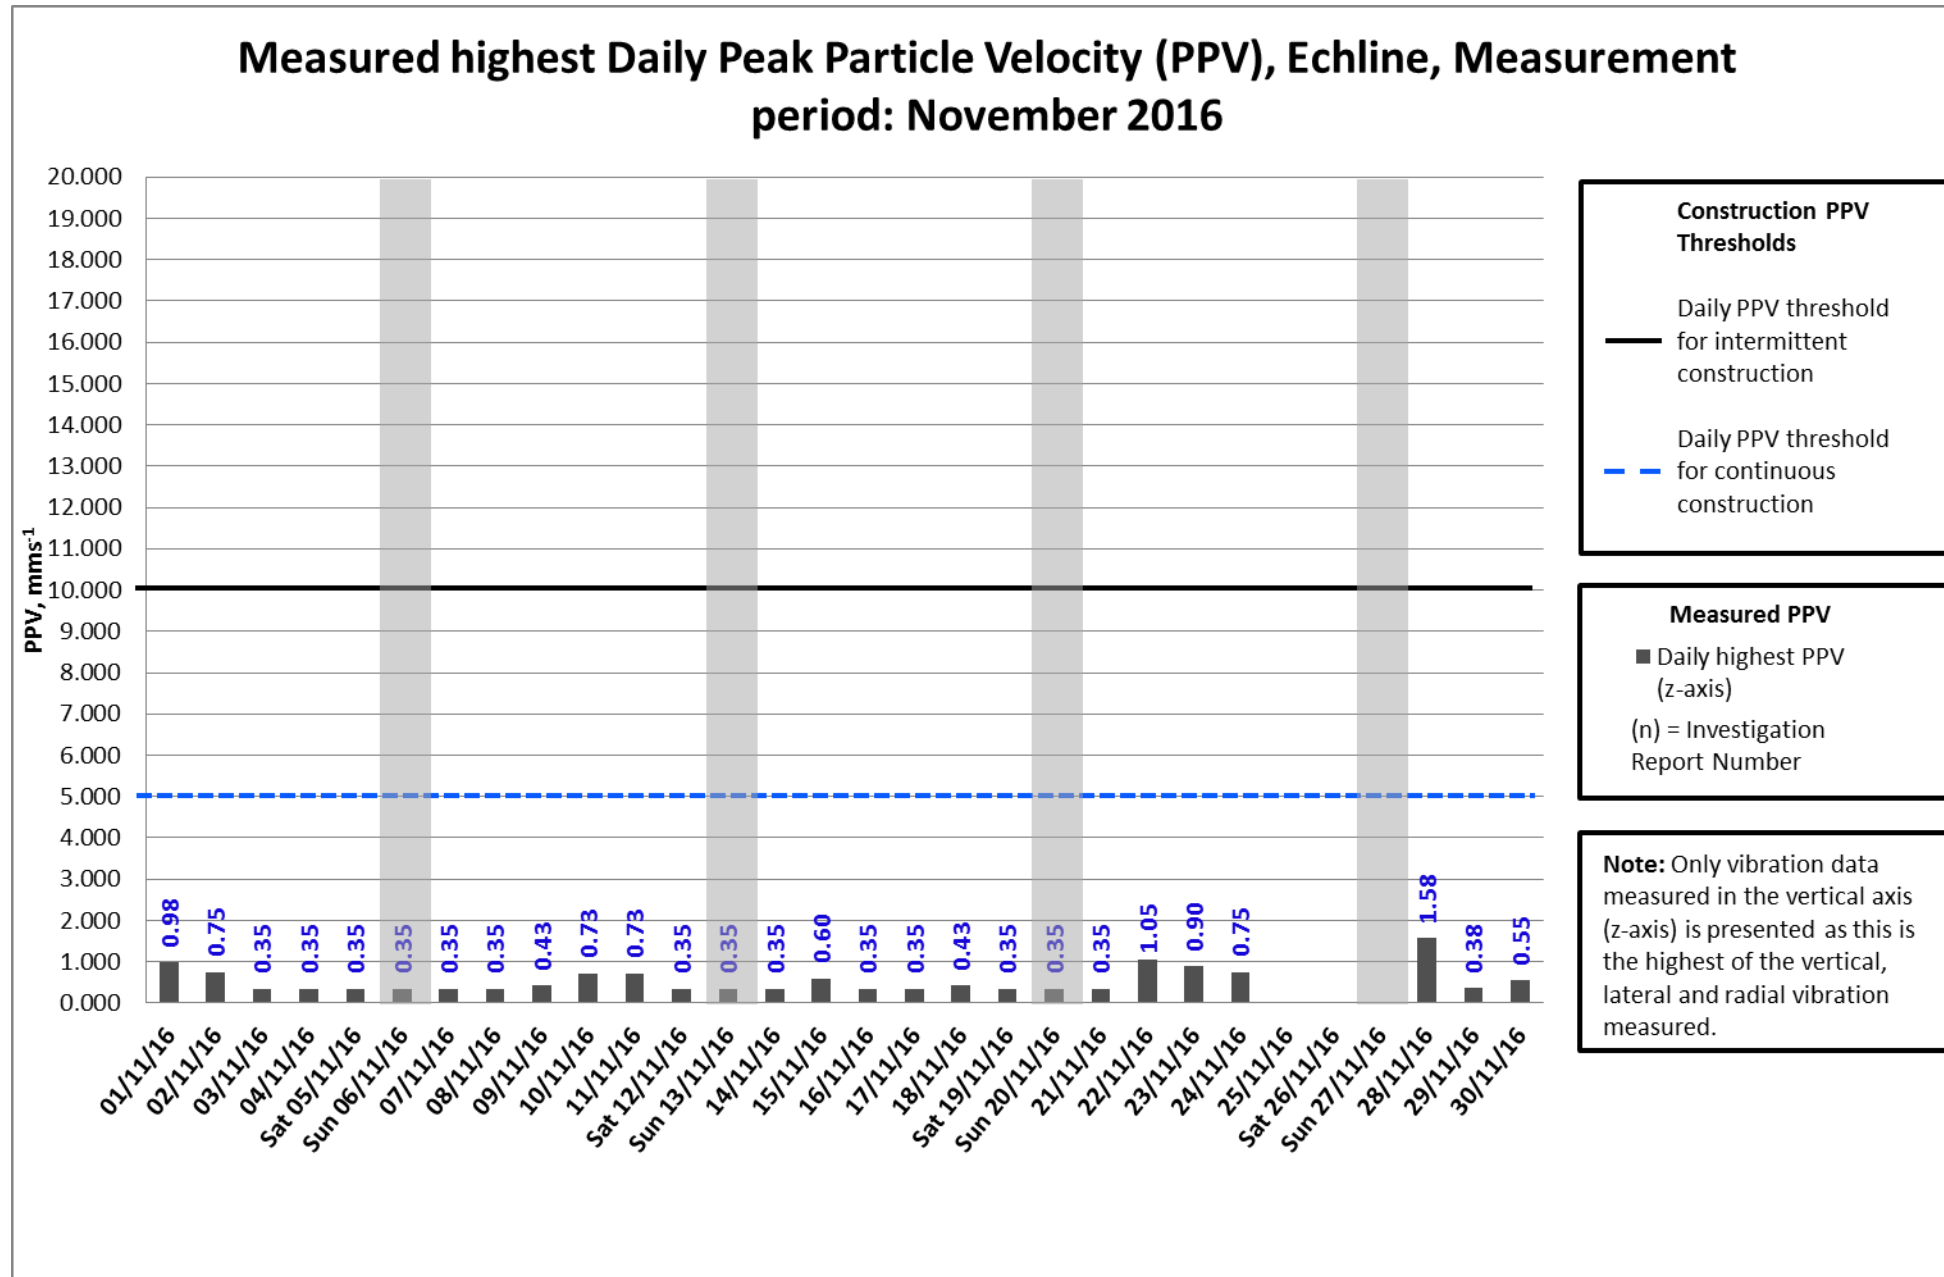
Data missing on the 25th - 27th November was caused by electrical issue with monitor.

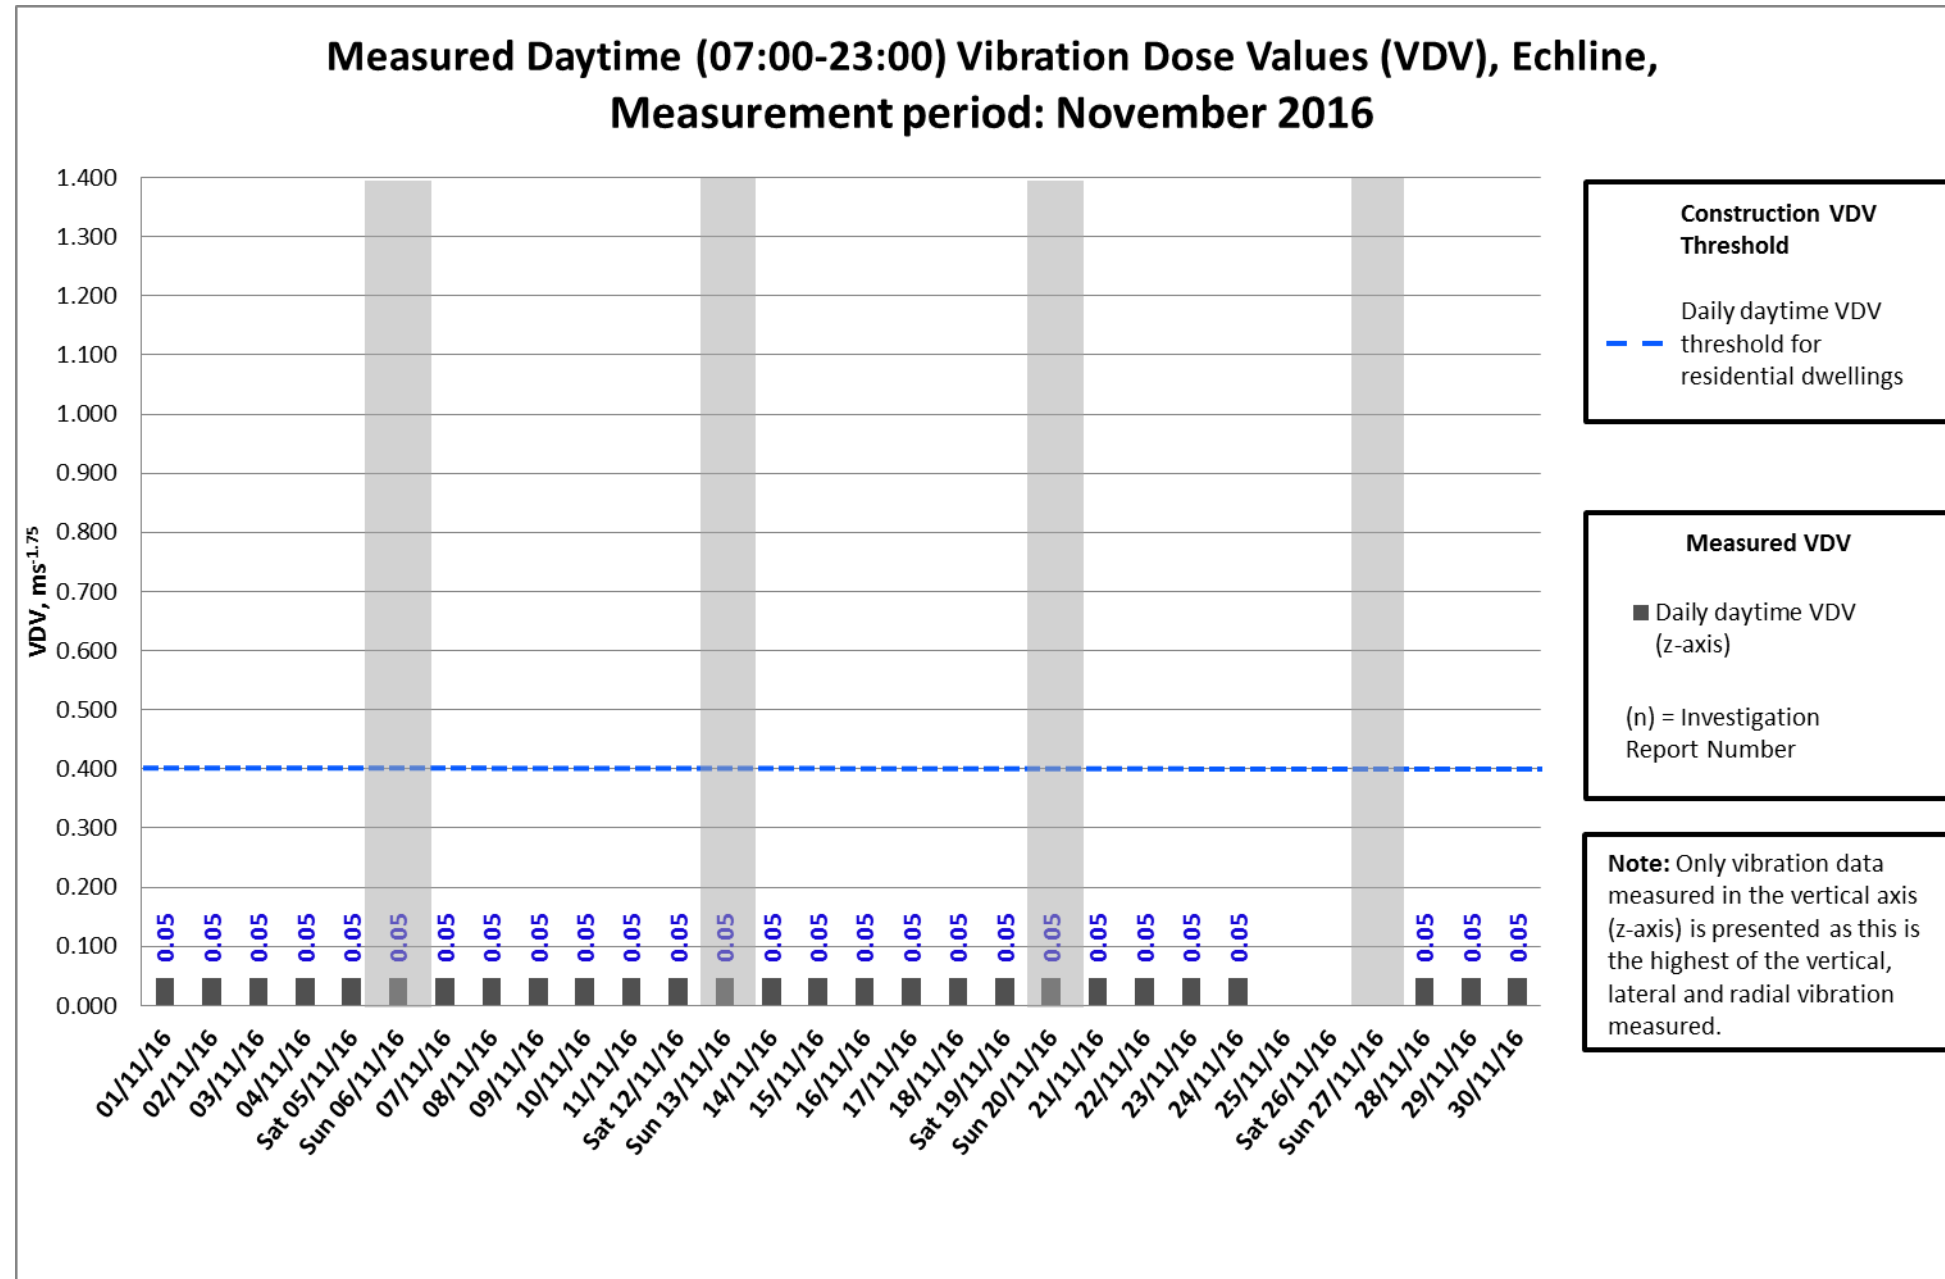
Data missing on the 25th - 27th November was caused by electrical issue with monitor.

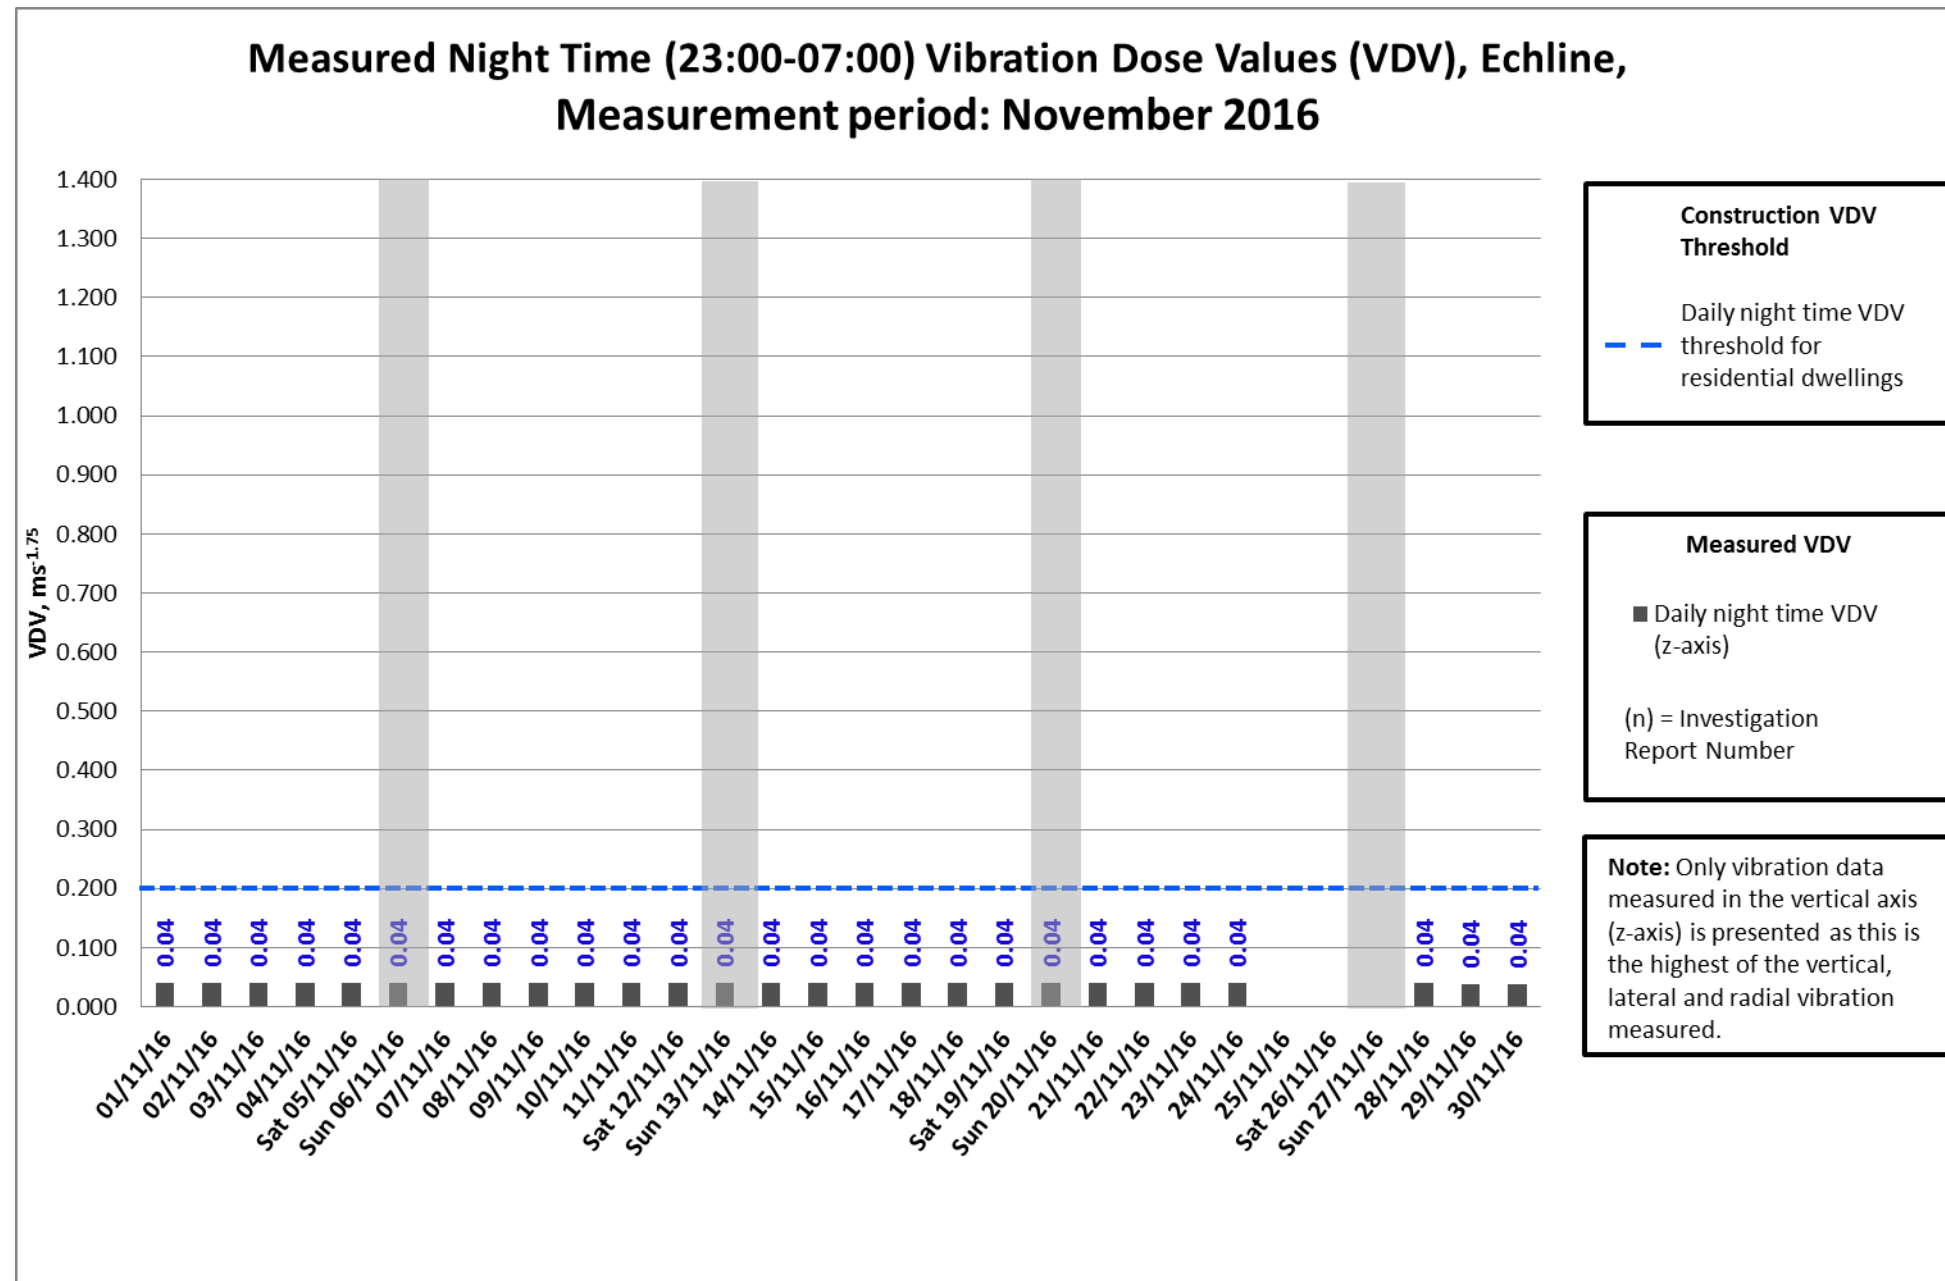
Data missing on the 25th - 27th November was caused by electrical issue with monitor.

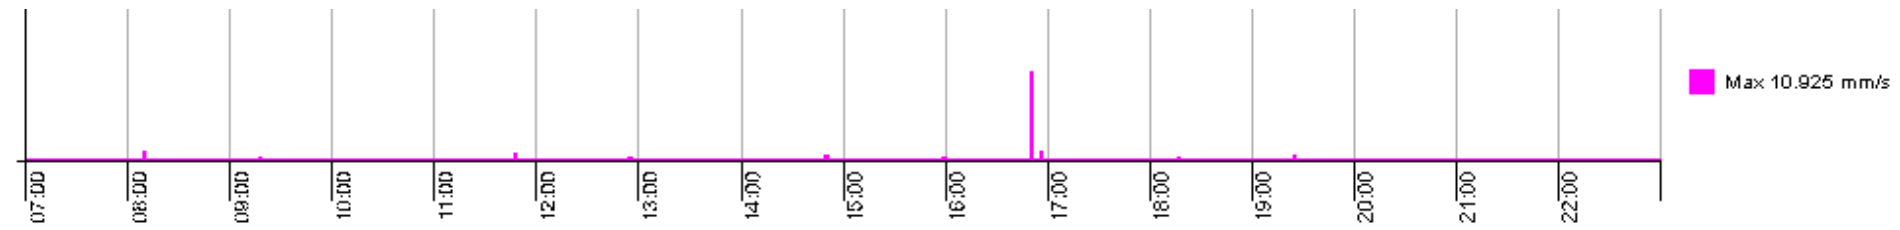
Exceedances on the 2nd, 5th, 9th, 10th, 11th, 12th, 18th, 24th, 25th, 26th, 29th and 30th of November have been investigated and found to be caused by individual isolated events that are unlikely to have been construction related activities (graph above from the 09/11/2016). The vibration monitor is located in the residents back garden, therefore resident's activity may have caused these exceedances.

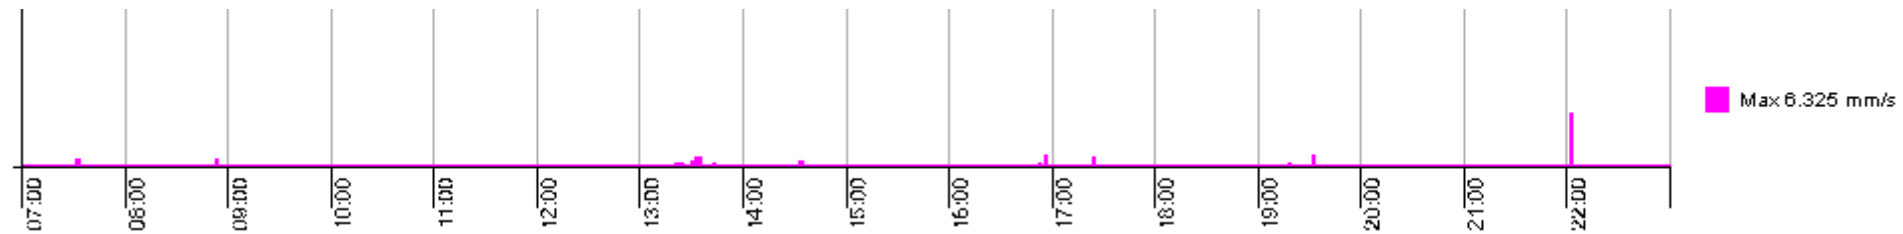
Exceedances on the 6th, 8th, 13th, 14th, 21st, 23rd, 27th and 28th of November have been investigated and found to be caused out with construction working hours and therefore it is unlikely that construction related activity was the cause of these events (graph above from the 06/11/2016).

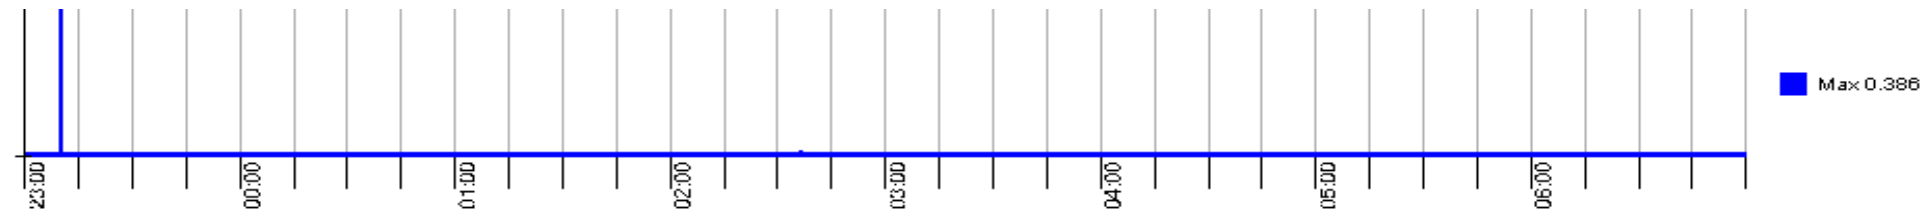
Exceedance on the 23rd of November has been investigated and found to have been caused by an isolated event that is unlikely to have been due to a construction related activity.

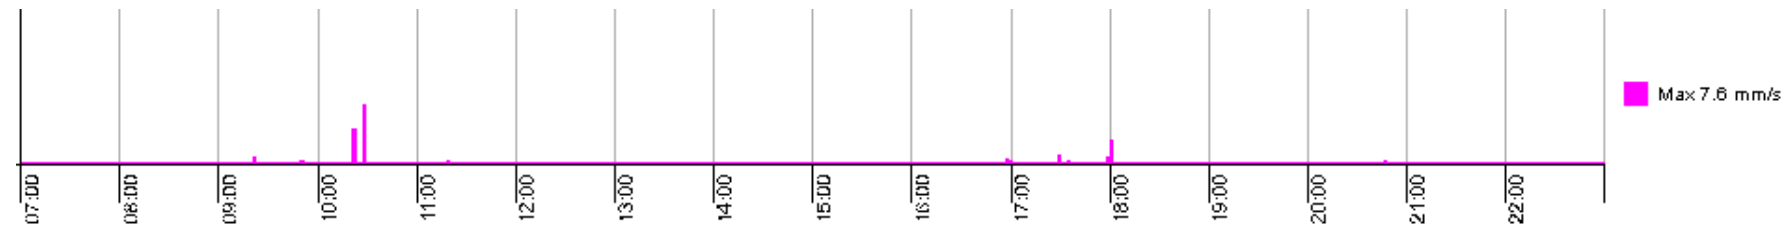
Exceedances on the 2nd, 6th, 7th, 8th, 10th, 11th, 14th, 16th, 18th, 19th, 20th, 21st, 22nd, 24th, 25th and 30th of November have been investigated and found to have been caused by isolated events that are unlikely to have been construction related activities (graph above from the 20/11/2016). The monitor is situated in close proximity to the residents outdoor log store situated in the back garden. It is possible that these high readings were due to the residents fetching logs from this store area.

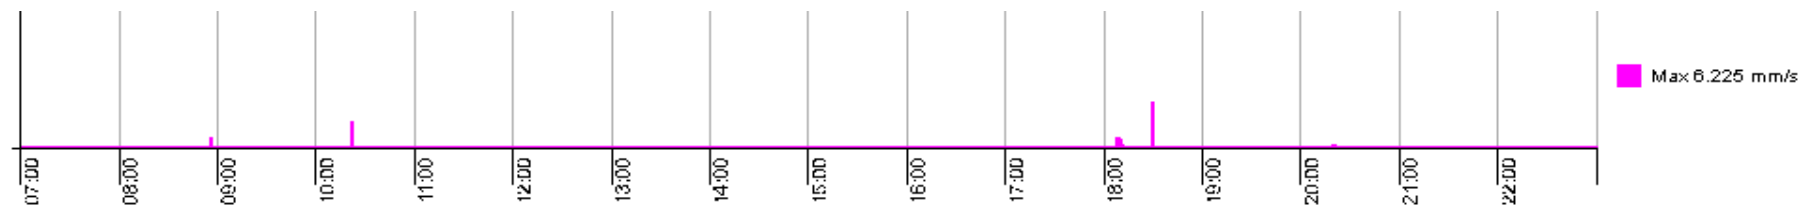
Exceedances on the 4th, 17th and 28th of November have been investigated and found to have been caused out with construction working hours and therefore it is unlikely that construction related activity was the cause of these events (graph above from the 04/11/2016).

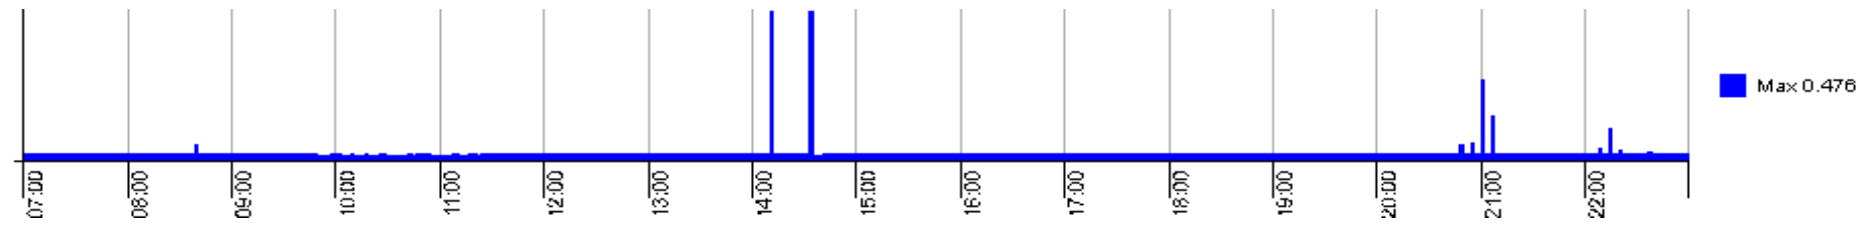
Exceedance on the 14th of November has been investigated and found to have been caused by several isolated events that are unlikely to have been construction related activities.

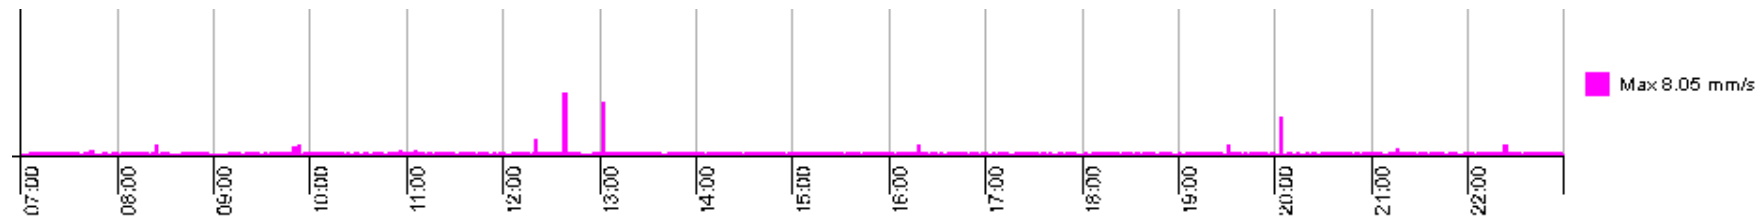
Exceedances on the 2nd, 4th, 6th, 9th, 11th, 12th, 13th, 14th, 15th, 16th, 18th, 19th, 20th, 21st, 22nd, 23rd, 24th, 25th, 26th, 27th, 29th and 30th of November have been investigated and found to be caused by individual isolated events that are unlikely to have been construction related activities (graph above from the 04/11/2016). The vibration monitor is located in the residents back garden, therefore resident's activity may have caused these exceedances.

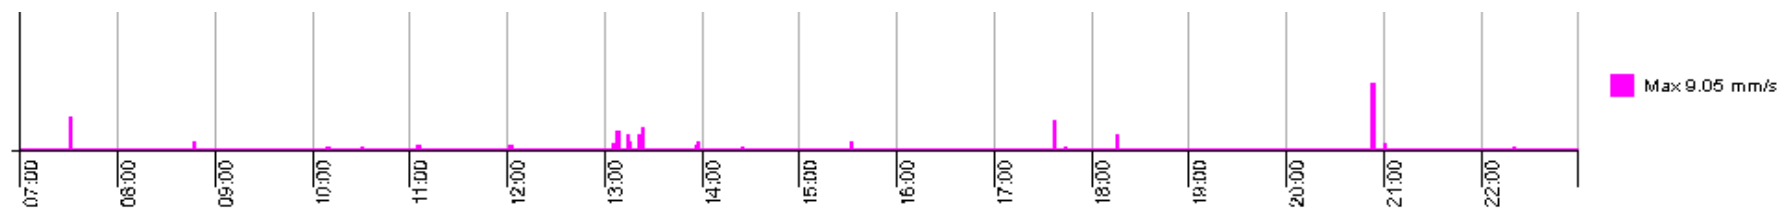
Exceedances on the 1st, 3rd, 5th, 7th, 8th, 10th and 17th of November have been investigated and found to have been caused out with construction working hours therefore it is unlikely that construction related activities were the cause of these events (graph above from the 17/11/2016).
