Project **FORTH REPLACEMENT CROSSING**

AIR QUALITY MONITORING REPORT
AUGUST 2012

Document number
REP-00060

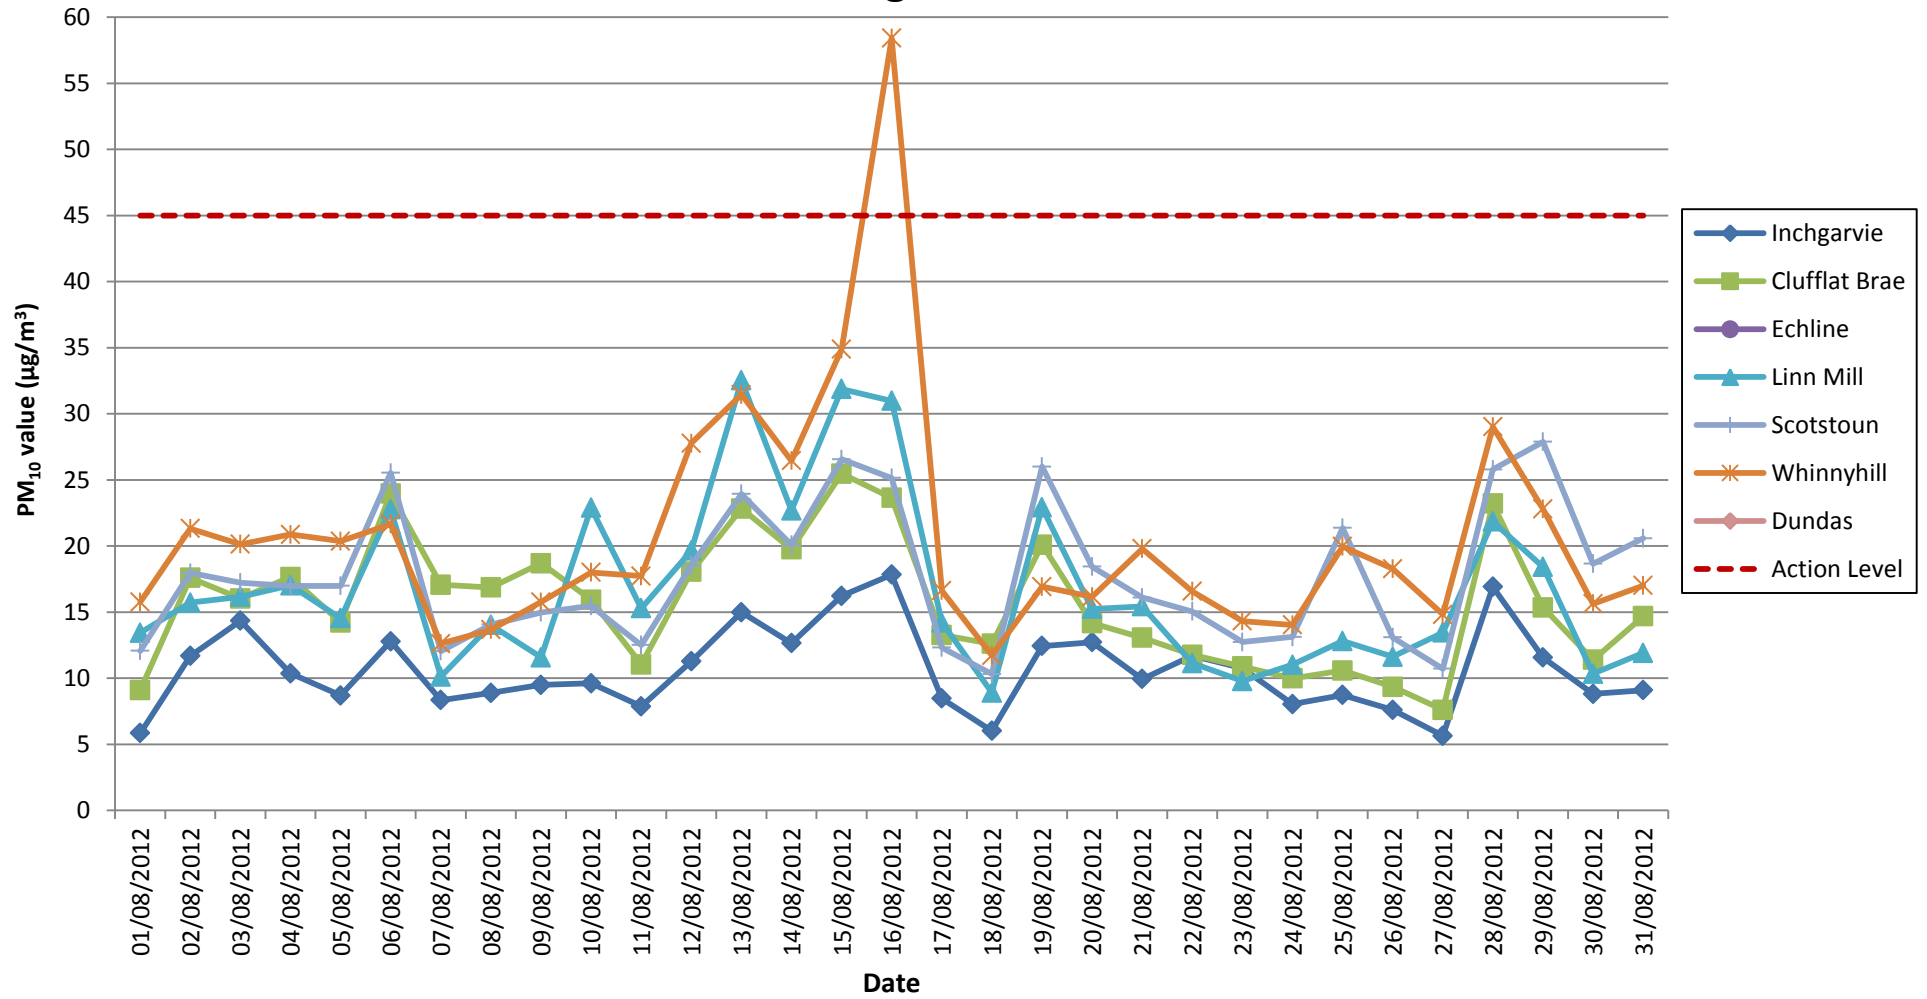
Particulate Matter (PM₁₀) Results for all Monitoring Locations

3.1.1. Light scatter results for August 2012 have been presented in a monthly chart; this can be found in Appendix A. Results show that generally PM₁₀ levels were low and largely followed the same pattern across the site. There was a single exceedance of the PM₁₀ threshold during August; this occurred at Whinny Hill on 16 August, where a level of 58.41µg/m³ was recorded. Real time triggers were received by the Environmental Team during this day and were investigated immediately. Drilling works were on-going in the Whinny Hill area on this day and it was found that these works were causing increased dust levels in this vicinity. The north networks section engineer was contacted and works were immediately stopped. It was found that a fault associated with the dust extraction system on the drilling rig was causing the increased dust levels. As a result of this, the drilling rig was changed, arriving on site on 17 August, when the works were restarted.

Note: Due to a power failure at Echline, no PM₁₀ data is available for this location. Due to an error associated with the Dundas device the results for this location have been excluded.

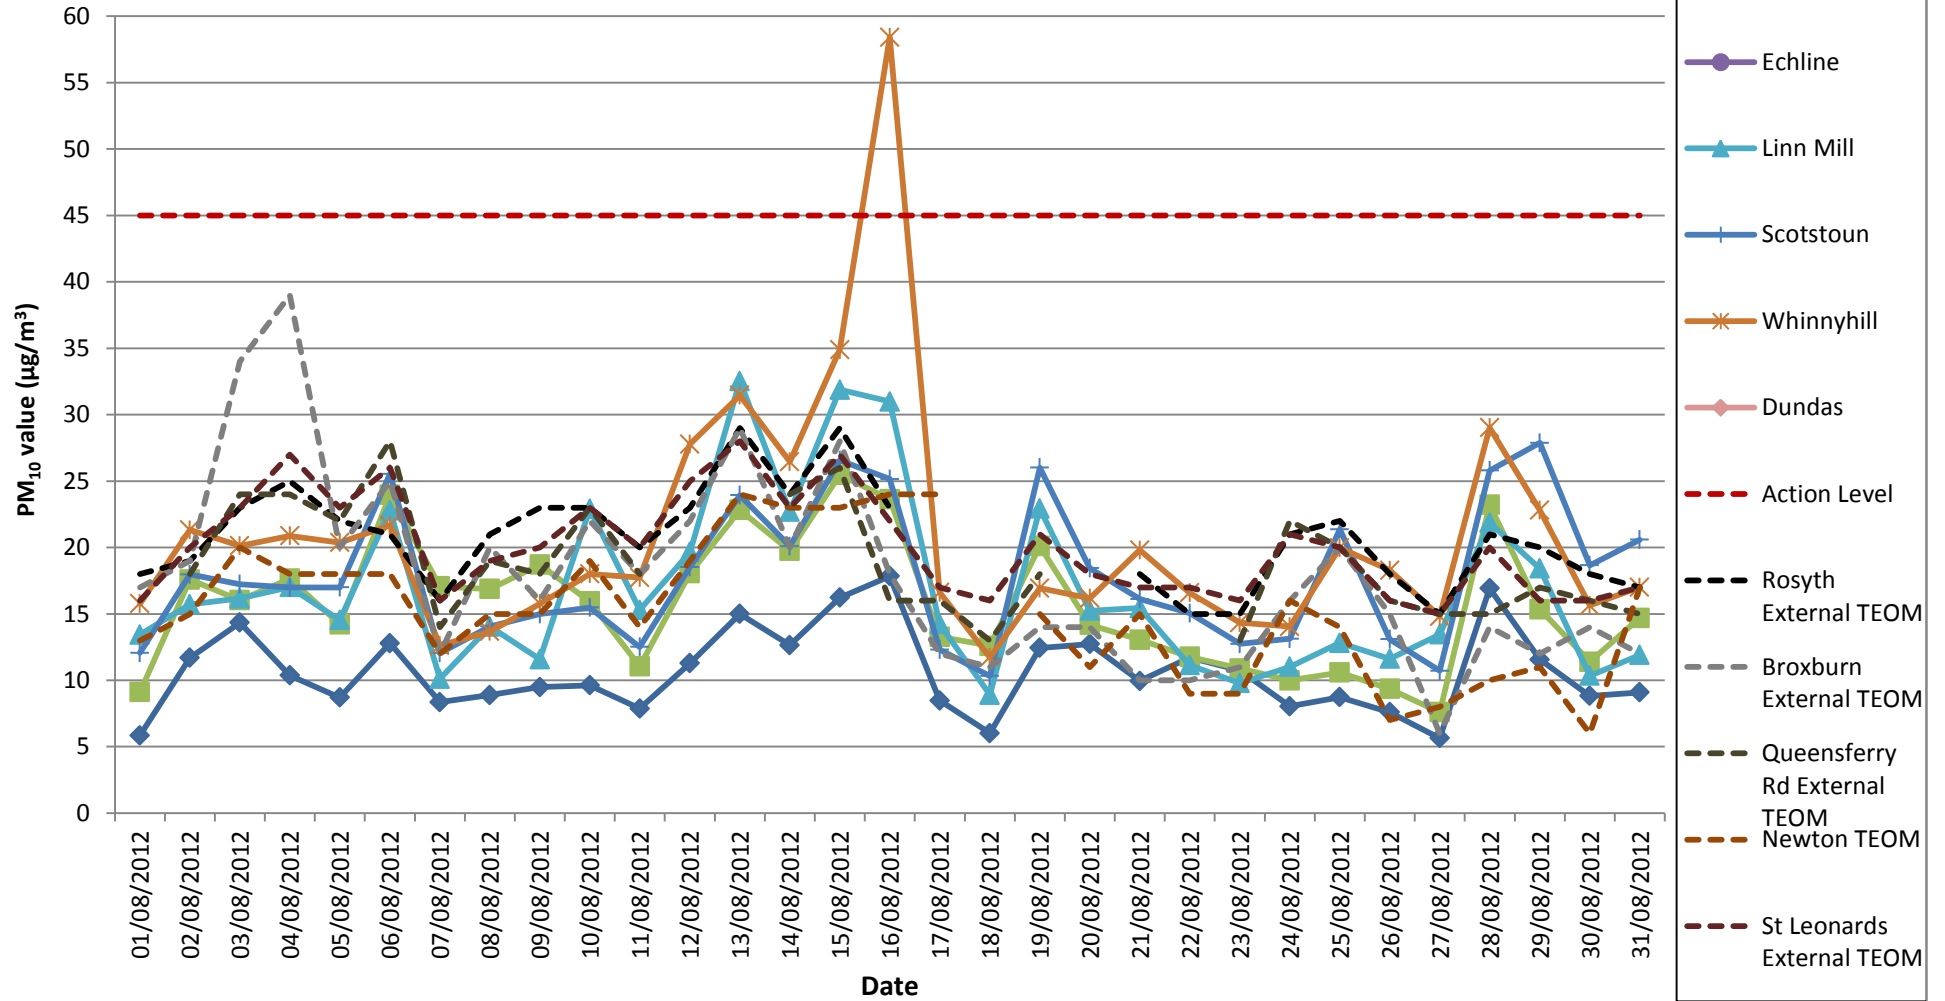
Particulate Matter (PM10) Results (with TEOM Results)

August was largely due to regional changes in air quality. The increased PM₁₀ levels at Whinny Hill on 16 August were not reflected in the TEOM results, further indicating that this was due to construction works and the fault with the drilling rig detailed above (paragraph 3.1.1.).

Note: Due to a power failure at Echline, no PM₁₀ data is available for this location

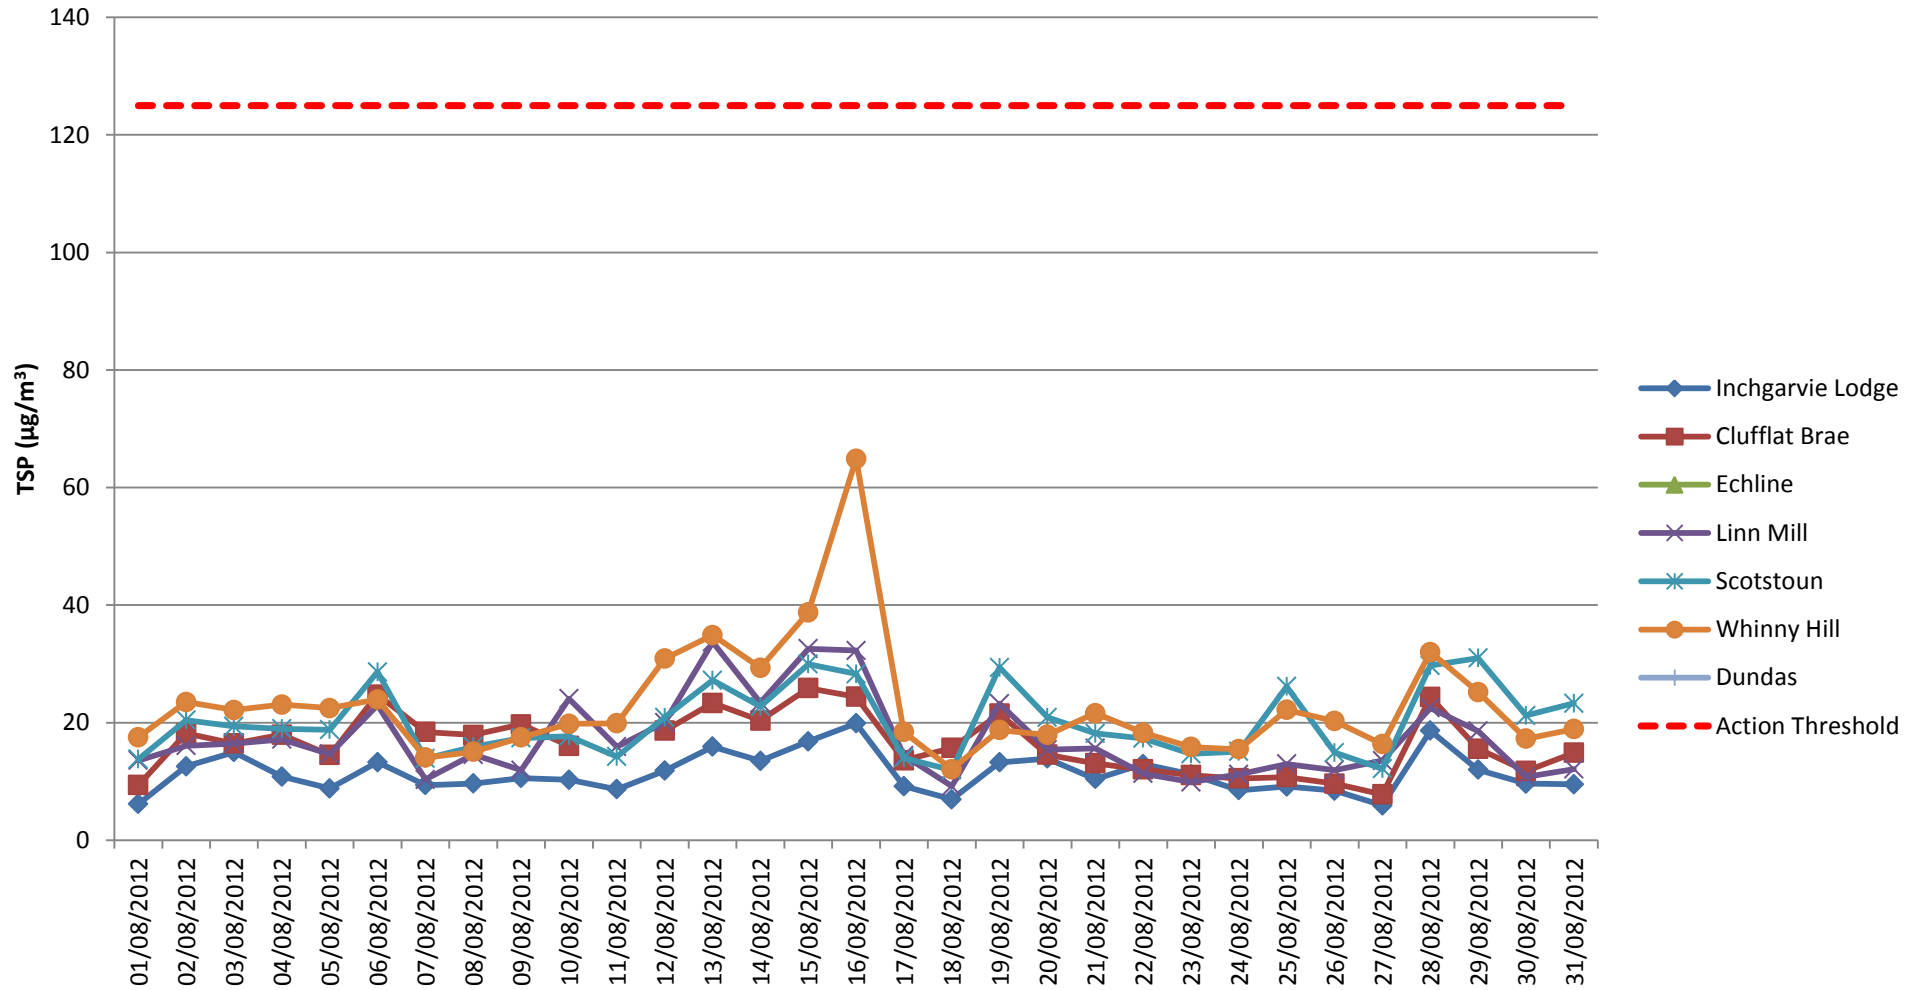
Total Suspended Particles (TSP) Results August 2012

3.2.1. The TSP results for August 2012 have been presented in a monthly chart; this can be found in Appendix B. TSP levels at all monitoring locations throughout August were low and generally found to follow a similar pattern across the site, demonstrating that the levels are influenced by regional changes in TSP levels, rather than construction works. One slight elevation in the results did occur at Whinny Hill on the 16 August, corresponding with the date on which high PM₁₀ results were recorded (see paragraph. 3.1.1. for further information); results were, however, significantly below the action threshold.

3.2.2. Due to a device error associated with the measurement of TSP at Dundas, the results for this location have been excluded from the graph. Measurements of TSP throughout August continued to be unrealistically low. FCBC have consulted with the supplier and an engineer will be visiting the site during September to resolve the issue. Data is also missing for Echline due to the loss of power, as noted in paragraph 3.1.3.

Note: Due to a loss of power at Echline, no TSP results are available for this location throughout June. Due to errors associated with the TSP results for Dundas, these results have been excluded.

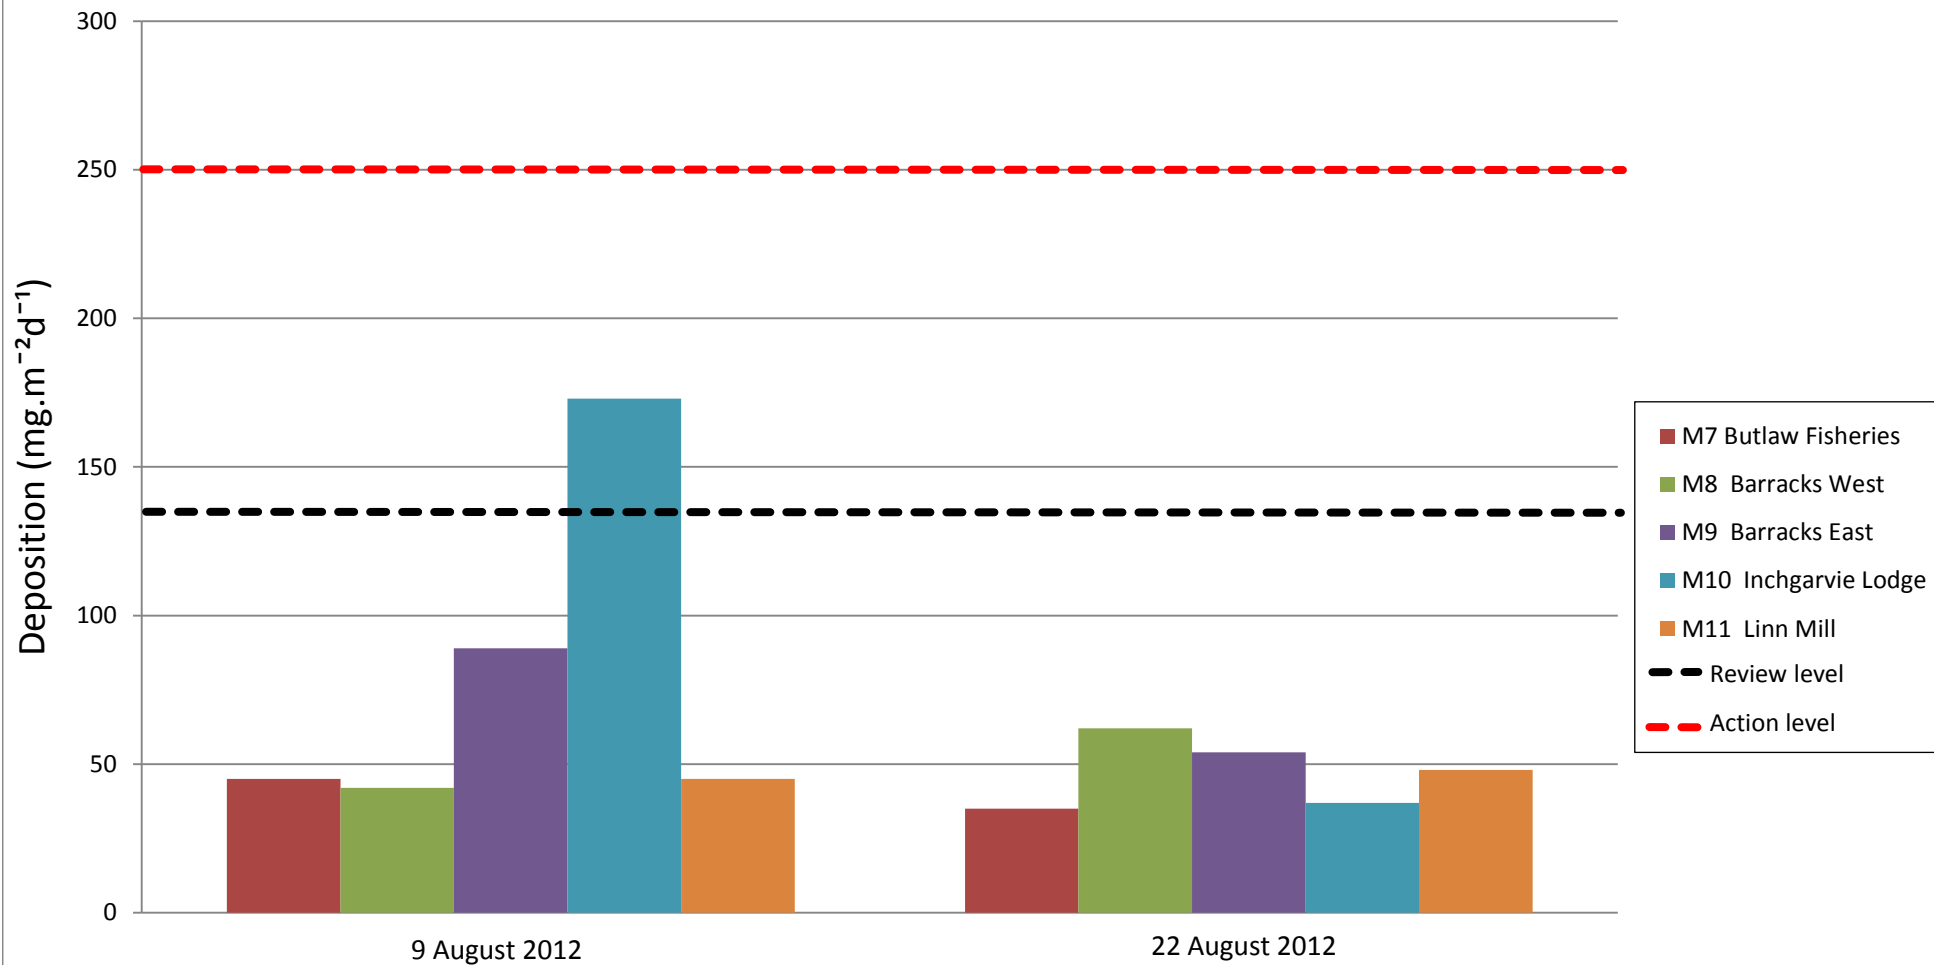
Frisbee Dust Deposition Results: Group 1

3.3.4. Throughout August the dust deposition rates for Groups 3, 4 and 5 were within the threshold levels. For Group 1, results for all locations were within the threshold dust deposition levels for the period ending on 22 August. However, there was an exceedance of the site review level at Inchgarvie Lodge (173 mg.m⁻²d⁻¹) for the period ending on the 9 August. The results for Group 2 show that results for all locations were also within the threshold levels for the period ending on the 22 August,

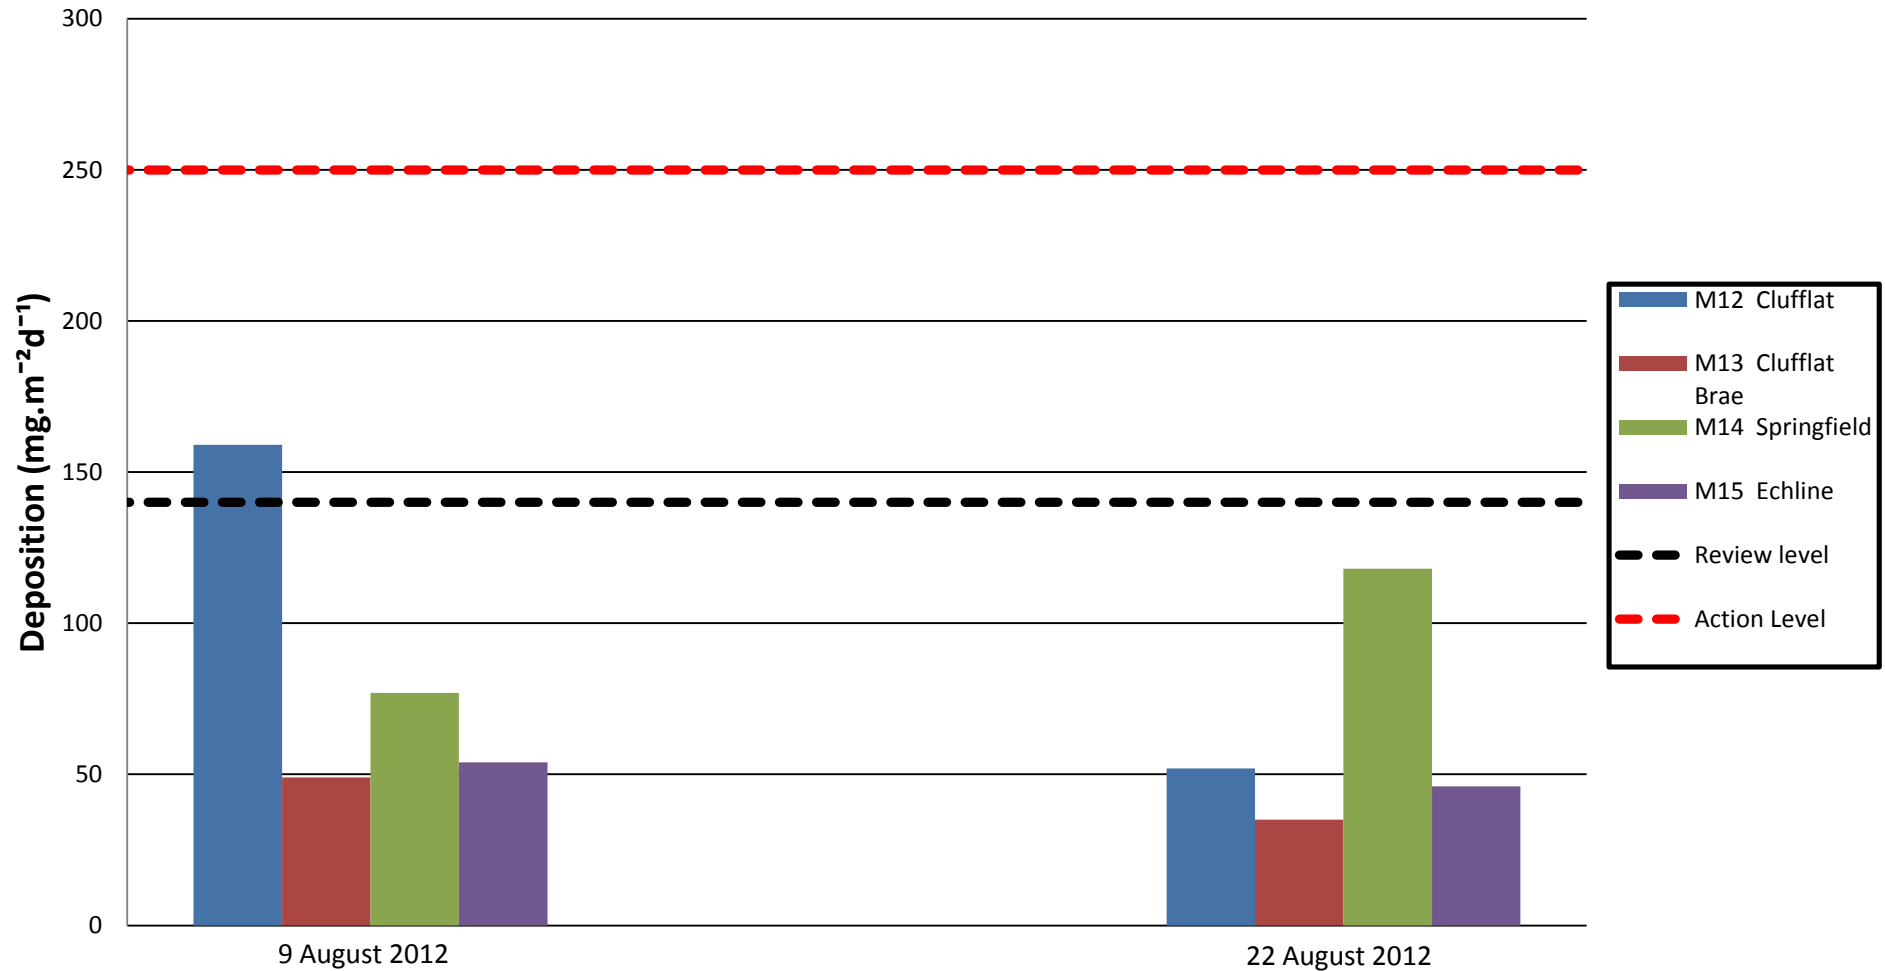
Frisbee Dust Deposition Results: Group 2

although there was an exceedance of the review level for the period ending on 9 August for Clufflat ($159 \text{ mg.m}^{-2}\text{d}^{-1}$). There were no exceedances of the site action level throughout August.

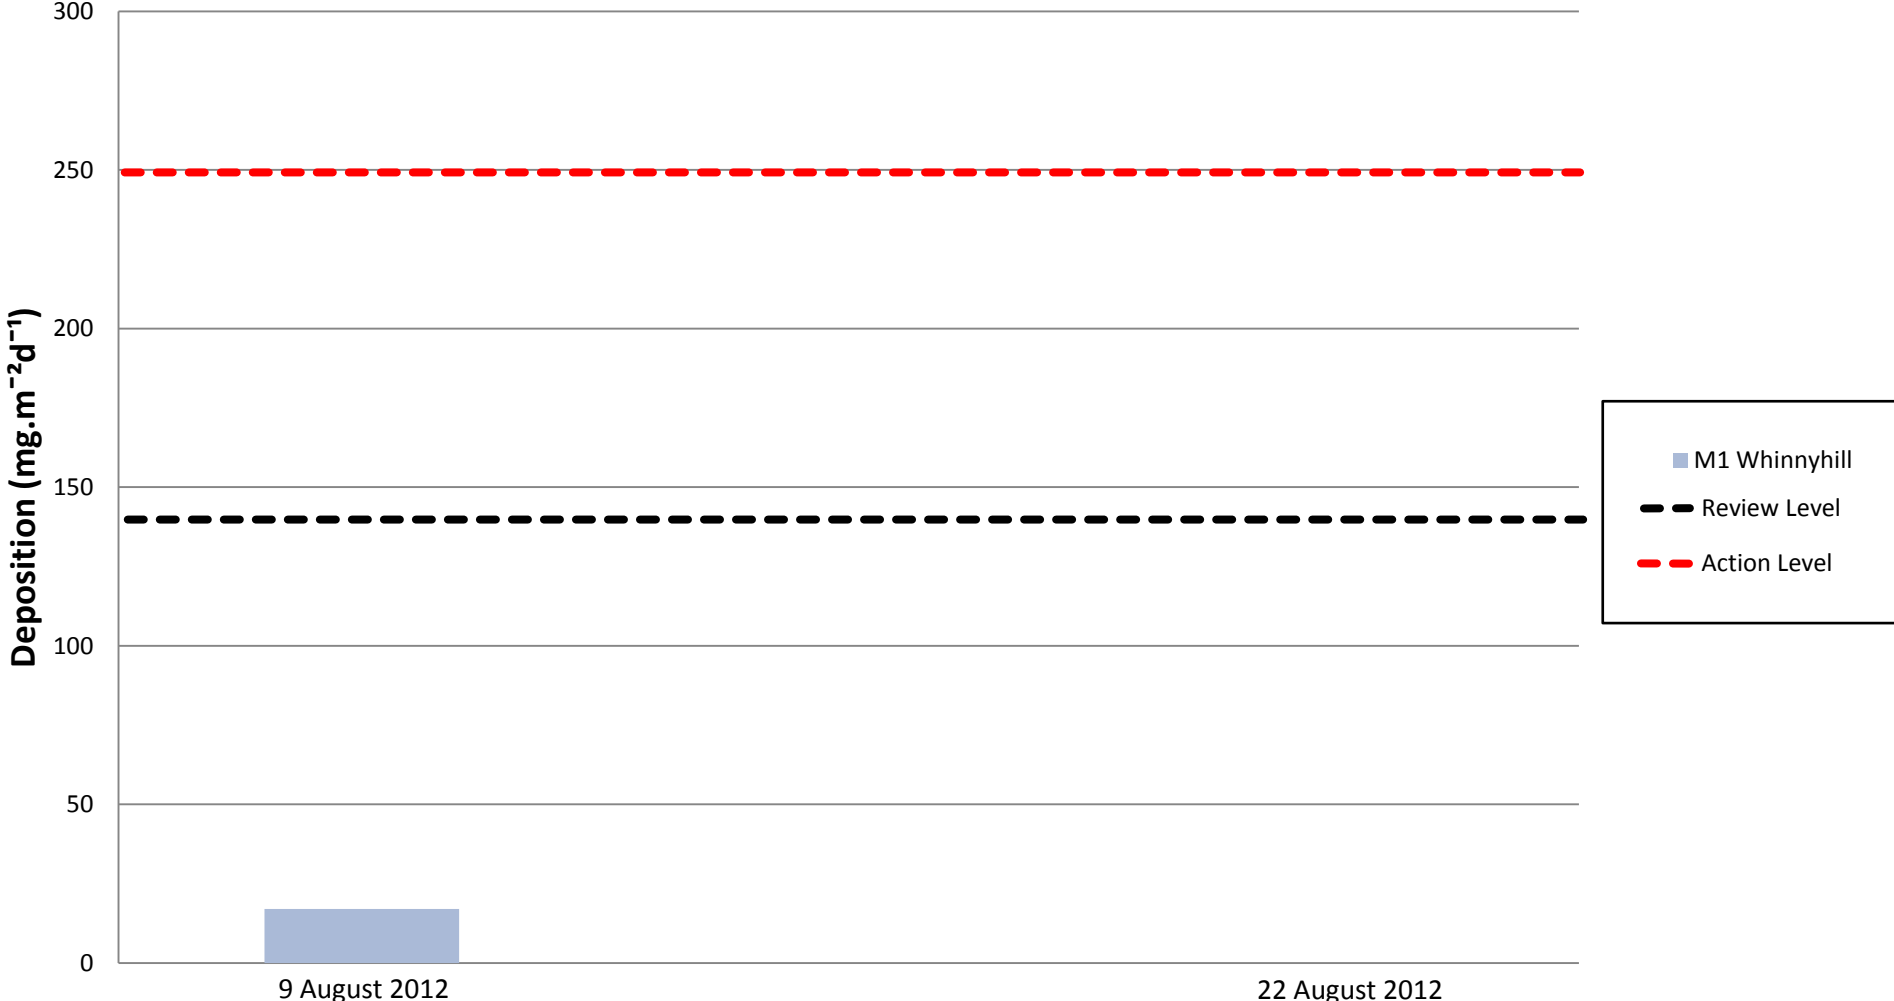
Frisbee Dust Deposition Results: Group 5

Note: Due to an error with the sampling bottle at this location, no data is available for the period ending on 22 August. Results covering the period 9 August to 6 September will be covered in the September report.
