Project **FORTH REPLACEMENT CROSSING**

**AIR QUALITY MONITORING REPORT
SEPTEMBER 2012**

Document number
REP-00062-00

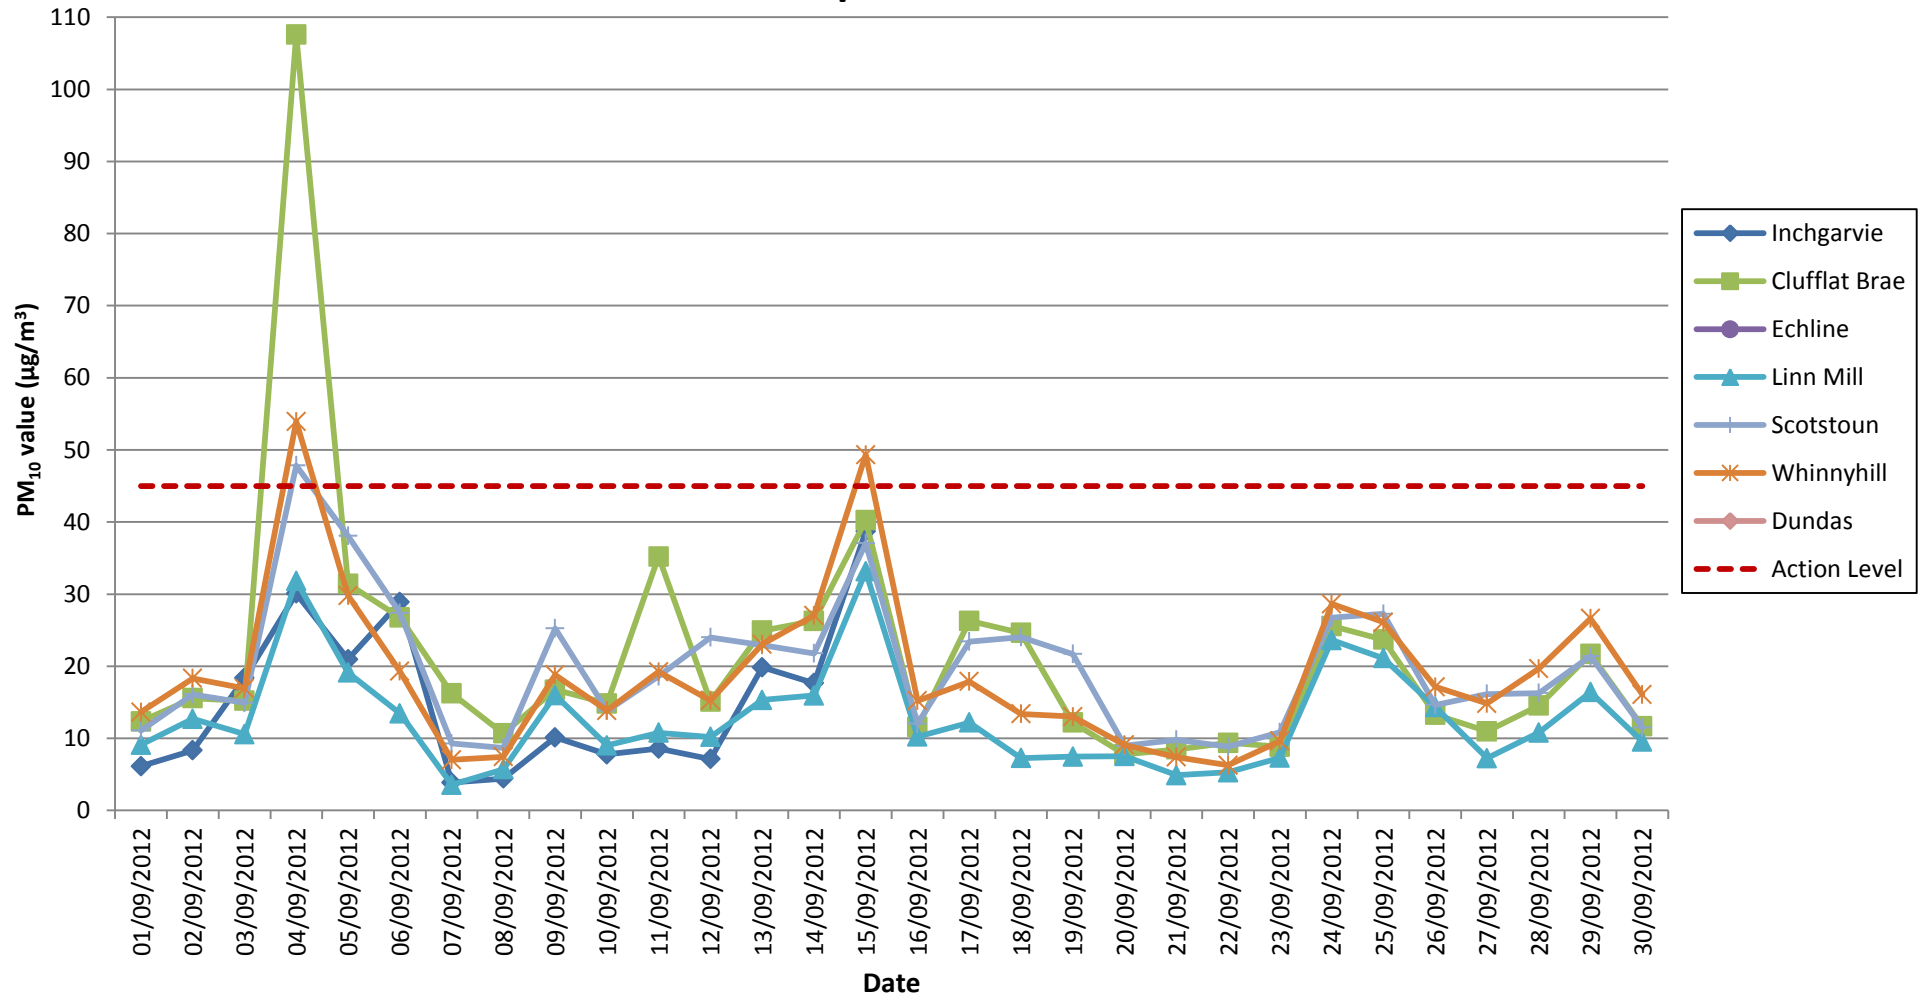
Air Quality Monitoring Particulate Matter (PM10) Results for all Monitoring Locations September 2012

3.1.1. Light scatter results for September 2012 have been presented in a monthly chart; this can be found in Appendix A. Generally, results show that the PM₁₀ levels were low and largely followed the same pattern across the site. There were two dates during September on which there were exceedances of the PM₁₀ threshold; these occurred on 4 September at Whinny Hill (53.94 µg/m³), Scotstoun (47.84 µg/m³) and Clufflat Brae (107.58 µg/m³) and on 15 September at Whinny Hill (49.31 µg/m³). Real time triggers were received by the Environmental Team on these dates and the causes were investigated immediately.

3.1.2. Construction works were on-going within the vicinity of the monitoring locations on the dates on which the exceedances were caused. Strong winds on these dates were found to be causing elevated dust levels across site, largely due to the wind blowing dust from trucks moving on the haul roads and areas of excavation within both the north and south works areas.

Note: Due to a power failure at Echline, no PM₁₀ data is available for this location. Due to an error associated with the Dundas device the results for this location have been excluded. Data is missing from Inchgarvie from 15/09/12 due to an error with the connection accidentally caused by a third party.

- 3.1.3.** In response to the exceedances, FCBC took a number of actions. As an immediate response to the triggers received the FCBC Environmental Team contacted the site engineers to ensure that the bowser was operating in the areas where inspections identified increased levels of dust. Further mitigations put in place by FCBC include the deployment of a second tractor to enable increased water bowser movements across site and an additional attachment for the water bowser to allow water to be sprayed over excavation areas.

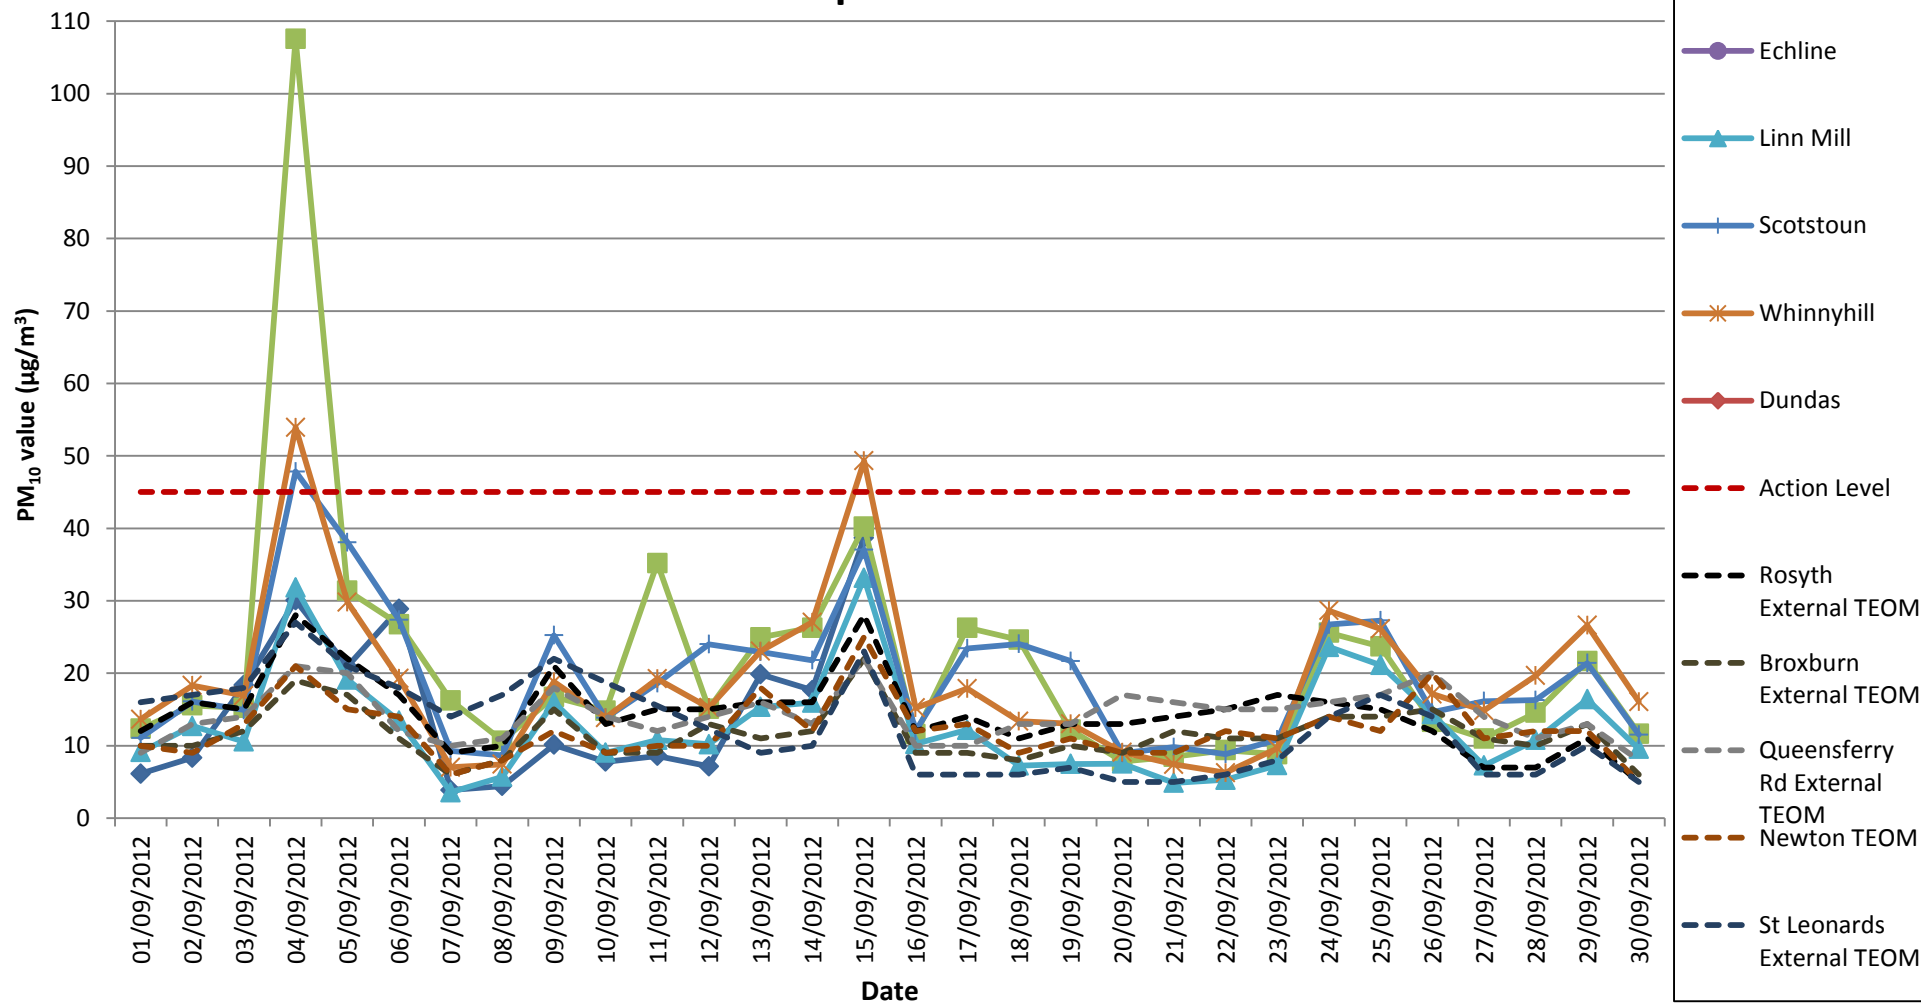
Particulate Matter (PM10) Results (Including TEOM Results) All Monitoring Locations September 2012

- 3.1.4.** The PM₁₀ results have also been compared to the daily mean results obtained from the TEOM air quality monitoring stations located in Newton, Rosyth, Broxburn, Queensferry Road, Edinburgh and St Leonards, Edinburgh (an urban background site). The TEOM at Newton was installed by West Lothian Council, facilitated by FCBC, during May. The comparison between the light scatter and TEOM results demonstrates that both sets of results generally follow the same pattern at similar levels, indicating that the pattern observed throughout September was largely due to regional changes in air quality.

- 3.1.5.** Elevated results were noted at all the TEOM monitoring locations on both dates on which exceedances were recorded at the light scatter meters on site. This, therefore, indicates that whilst the results obtained from the light scatter meters on site may have been exacerbated by increased dust levels arising on site, a regional increase was also noted on these dates. This is particularly true with regard to the exceedance on 15 September at Whinny Hill; it is possible that this result exceeded the limit due to the differences noted between the results from a light scatter and a TEOM as discussed in paragraph 2.2.

Note: Due to a power failure at Echline, no PM₁₀ data is available for this location. Due to an error associated with the Dundas device the results for this location have been excluded. Data is missing from Inchgarvie from 15/09/12 due to an error with the connection accidentally caused by a third party.

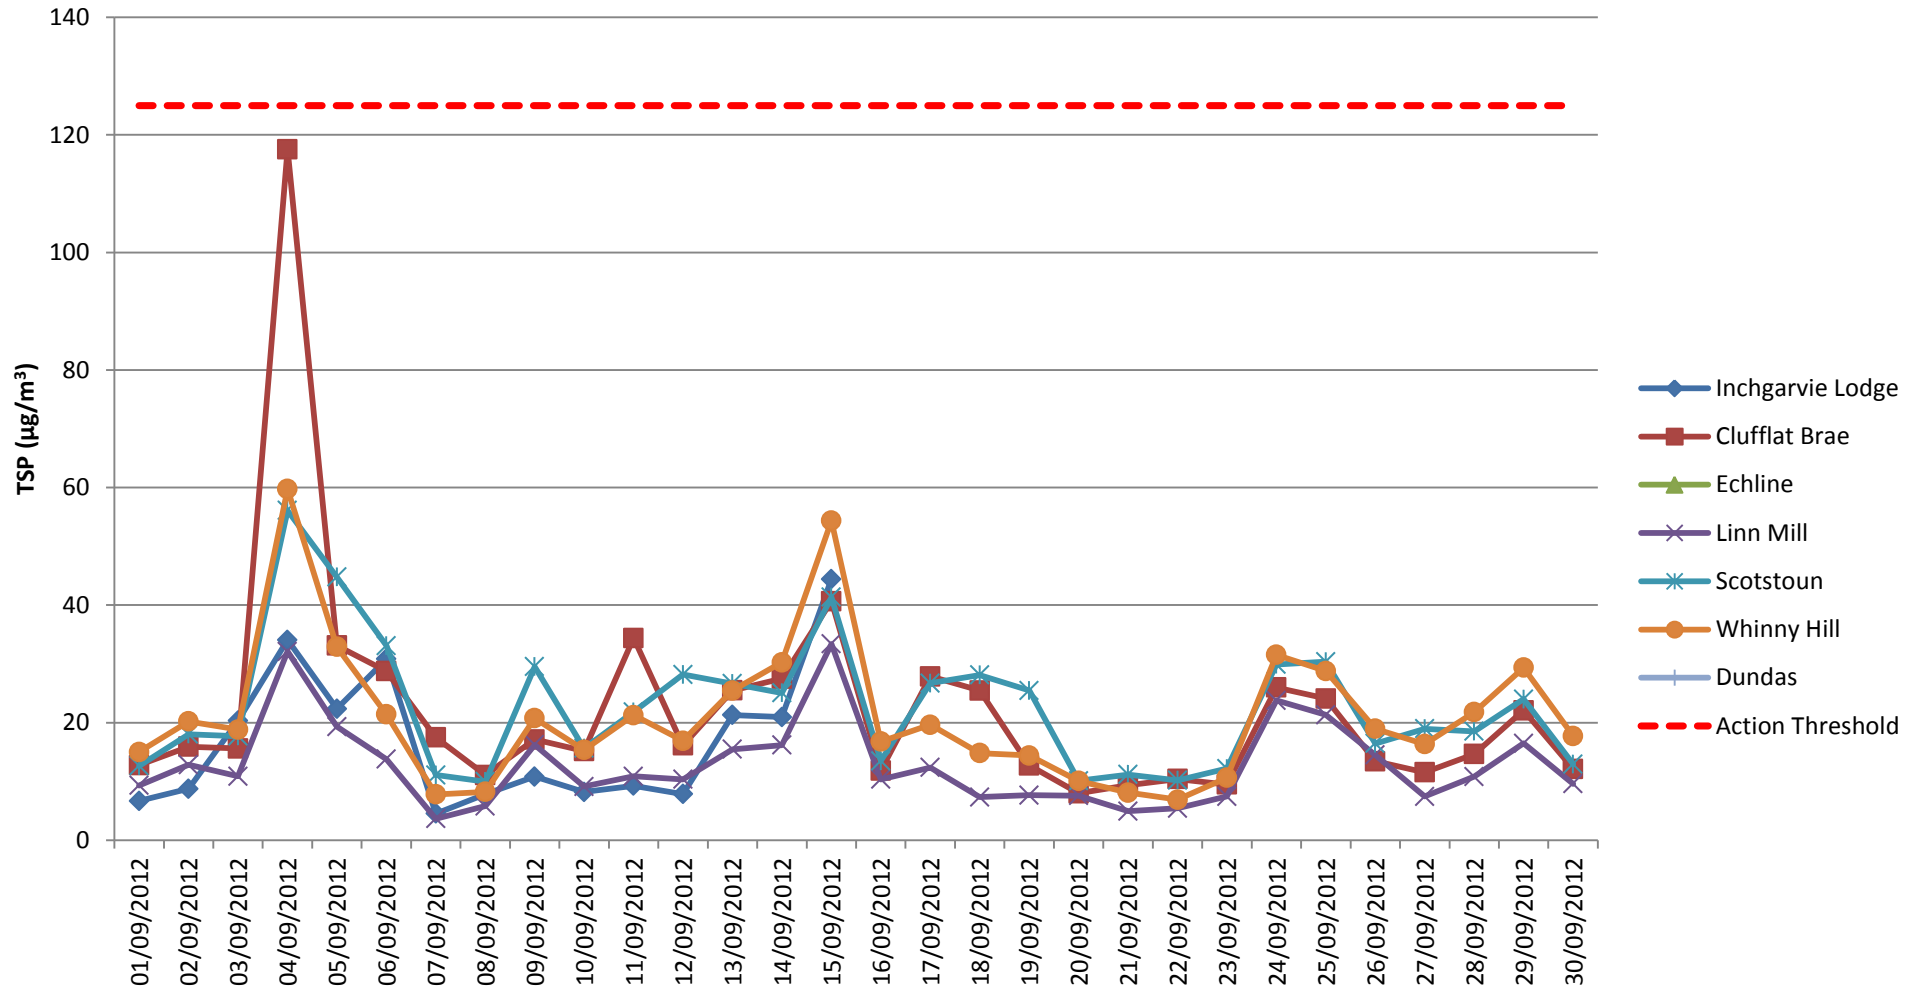
Total Suspended Particles (TSP) Results September 2012

- 3.2.1.** The TSP results for September 2012 have been presented in a monthly chart; this can be found in Appendix B. TSP levels at all monitoring locations throughout September were within the threshold level and found to follow a similar pattern across the site, demonstrating that in general the levels are influenced by regional changes in TSP levels, rather than construction works. Elevated results were noted at all locations, though notably Clufflat Brae, on the 4 September. As noted in paragraph 3.1.5, it is considered that construction works were likely to have influenced the results obtained, however strong winds were found to exacerbate the results and a regional increase was also noted on this date.

3.2.2. Due to a device error associated with the measurement of TSP at Dundas, the results for this location have been excluded from the graph. Measurements of TSP throughout September continued to be unrealistically low. FCBC have consulted with the supplier and are awaiting a visit from engineer to resolve the issue. Data is also missing for Echline due to the loss of power, as noted in paragraph 3.1.6.

Note: Due to a loss of power at Echline, no TSP results are available for this location. Due to errors associated with the TSP results for Dundas, these results have been excluded. Data is missing from Inchgarvie from 15/09/12 due to an error with the connection accidentally caused by at third party.

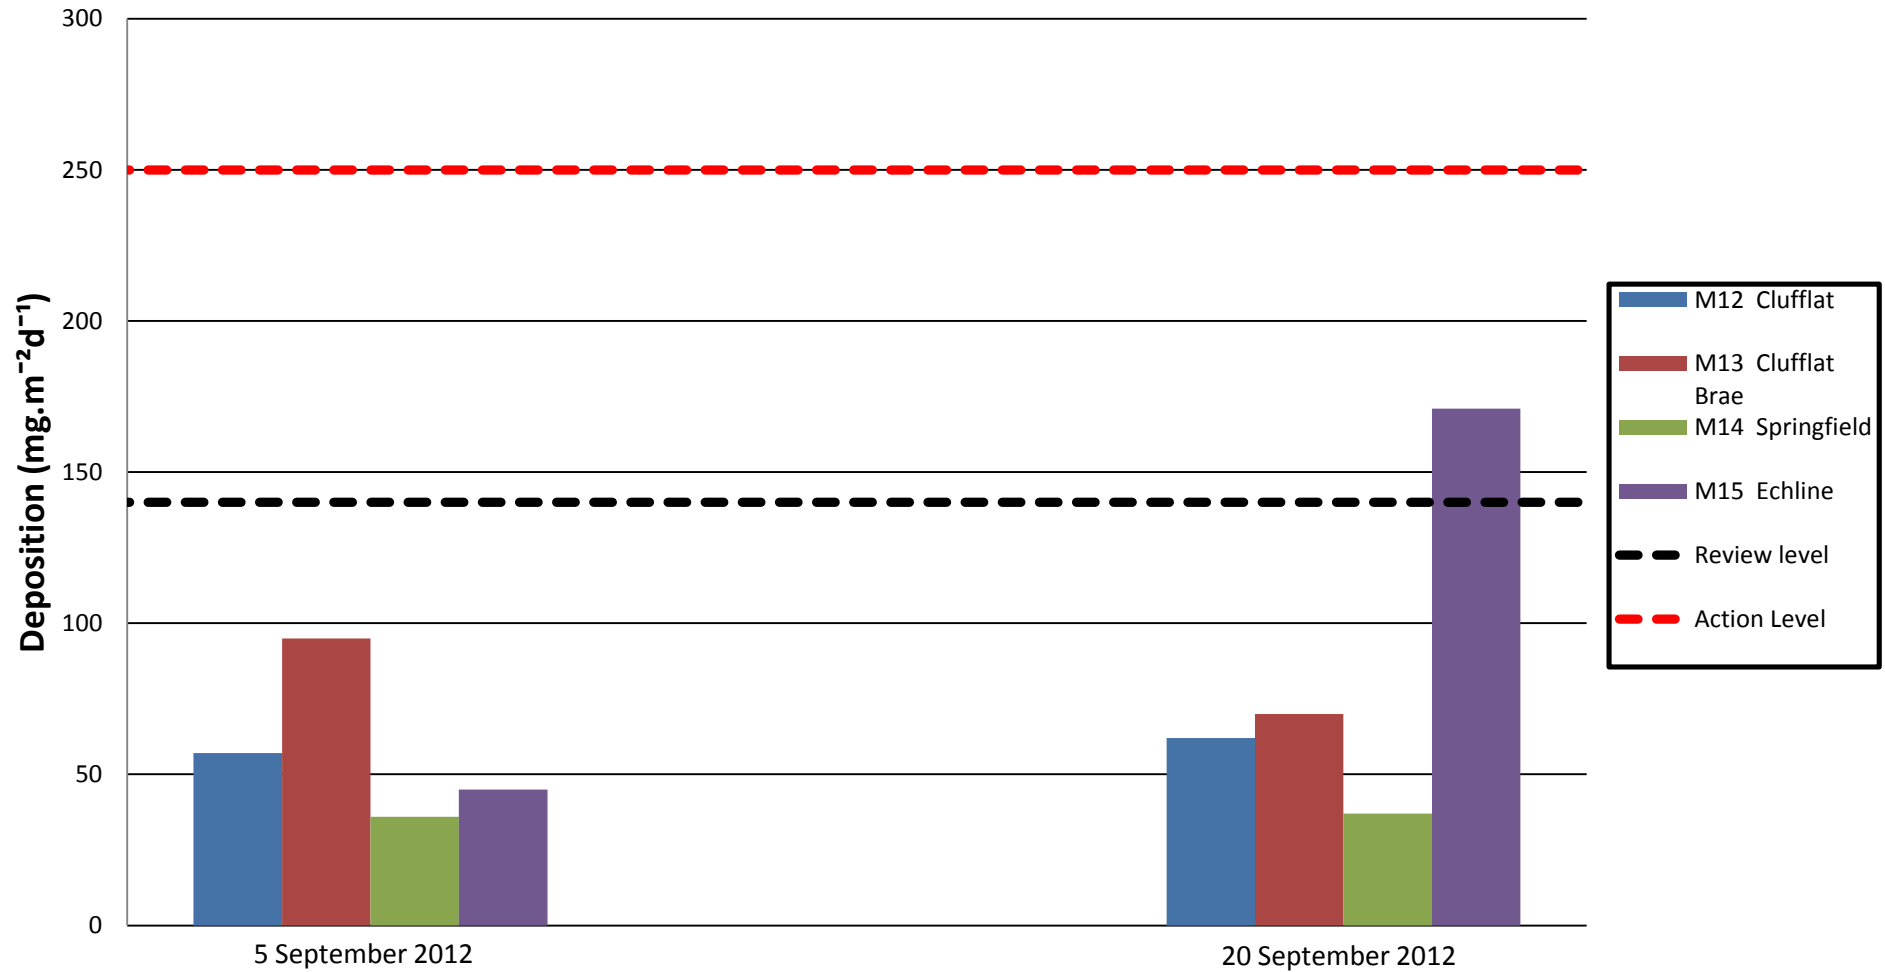
Frisbee Dust Deposition Results: Group 2
Locations: M12 Clufflat, M13 Clufflat Brae, M14 Springfield and M15 Echline

- 3.3.4.** Throughout September the dust deposition rates for all groups were within the site action level threshold. All dust deposition rates for Groups 1, 3 and 4 were also within the lower, site review level threshold. For Group 2, results for all locations were within the threshold dust deposition levels for the period ending on 5 September. However, there was an exceedance of the site review level at Echline (171 mg.m⁻²d⁻¹) for the period ending on the 20 September. The results for Group 5 show that results for Whinny Hill were within the threshold levels for the period ending on the 20 September, although there was an exceedance of the review level for the period ending on 5 September (161 mg.m⁻²d⁻¹).

- 3.3.5.** Due to the exceedances of the site review level during September, at two different locations, FCBC conducted a review into site wide dust levels and the construction works being undertaken at these locations. As construction works were being undertaken in the area around Echline Corner it is possible, therefore, that the exceedance at this location was caused by dust generated from these works. On 6 September, dust was noted blowing in strong winds from the area of the Queensferry gyratory excavation during the daily inspection (see paragraph 3.4.2) which may have influenced the results obtained for the Frisbee at Echline. Contact with the section engineers throughout the period ensured that the water bowser was in use at this location to dampen down as required. Additional mitigation measures were also

put in place during September both as a result of the light scatter PM₁₀ results and the Frisbee results (see paragraph 3.1.3).

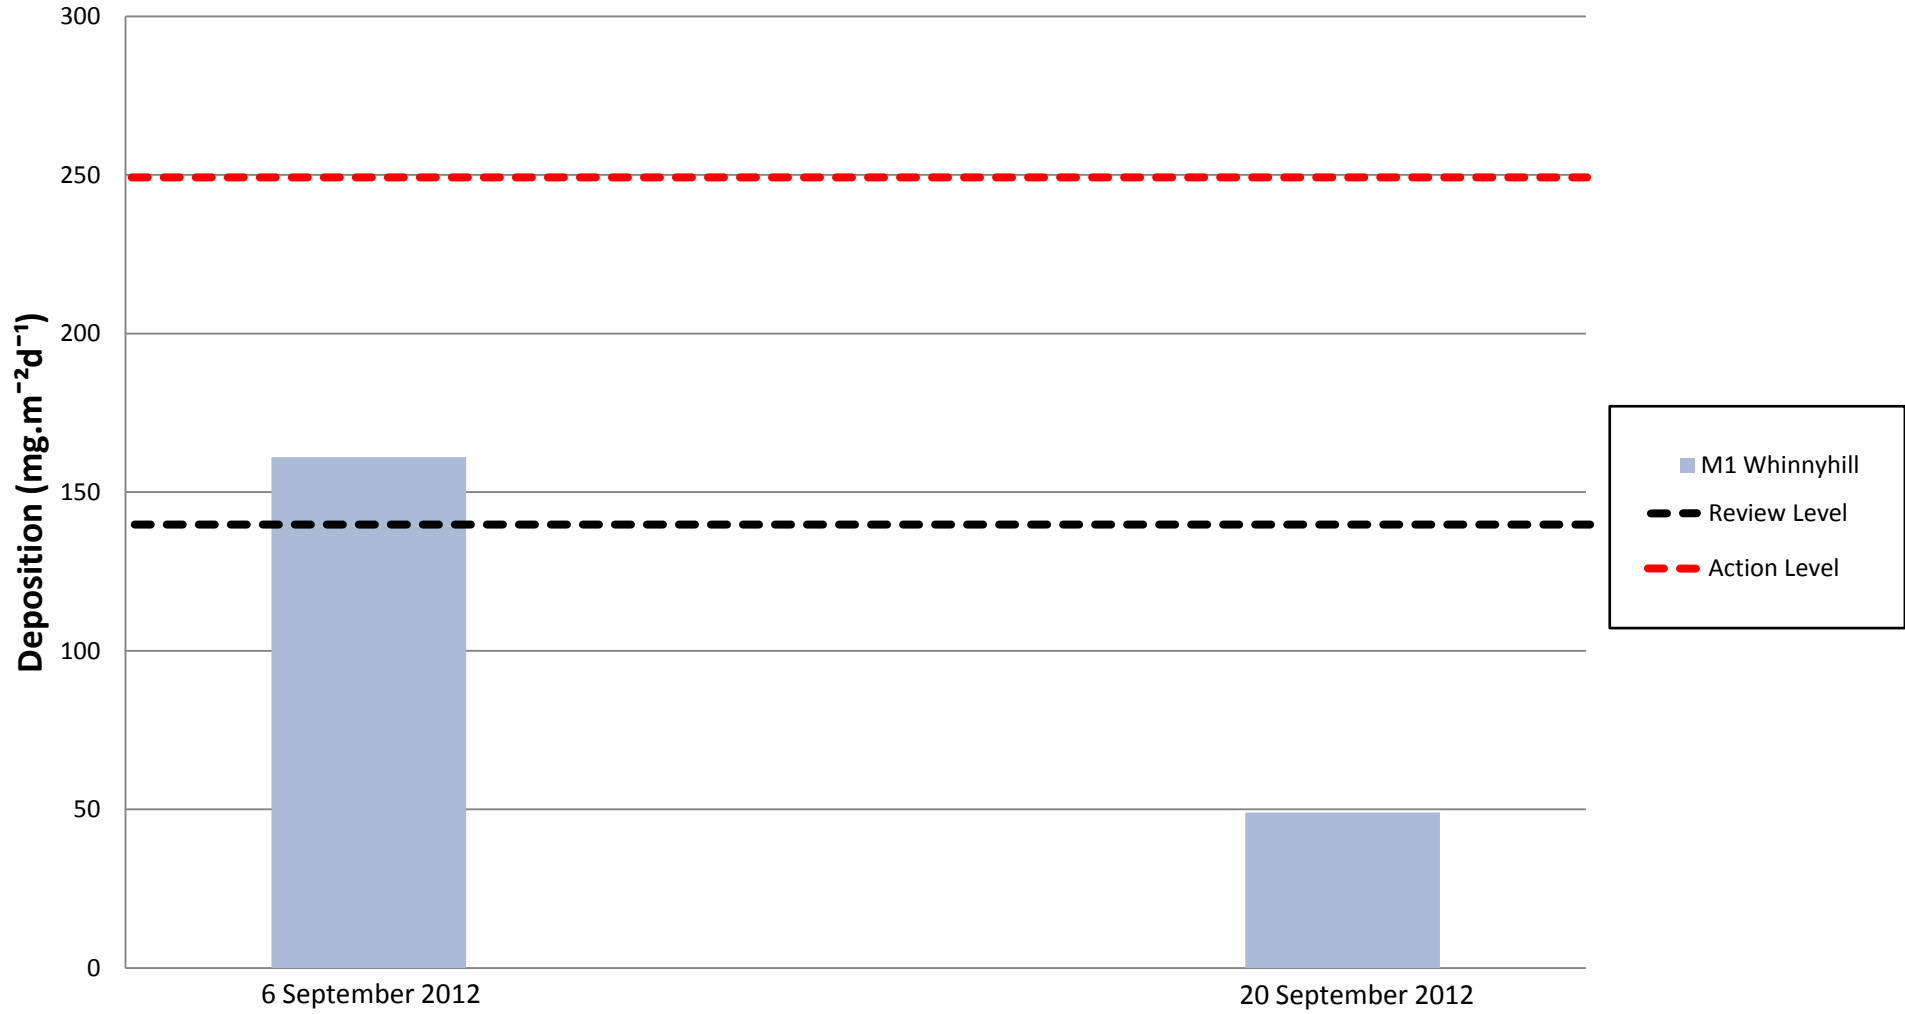
Frisbee Dust Deposition Results: Group 5

- 3.3.6.** With regard to the exceedance at Whinny Hill, it is likely that this result was influenced by increased dust levels noted within August due to faults with the dust extraction system on the drilling rig which were subsequently rectified. For further information regarding this please refer to the Air Quality Monitoring Report: August 2012 (REP-00060-00).

Note: Due to an error with the sampling bottle at this location, no data was collected from this location for the period ending on 22 August. The results presented for 5 September therefore cover the period 9 August to 6 September.
