**FORTH REPLACEMENT CROSSING**

**AIR QUALITY MONITORING REPORT  
 MAY 2013**

**REP-00117-00**

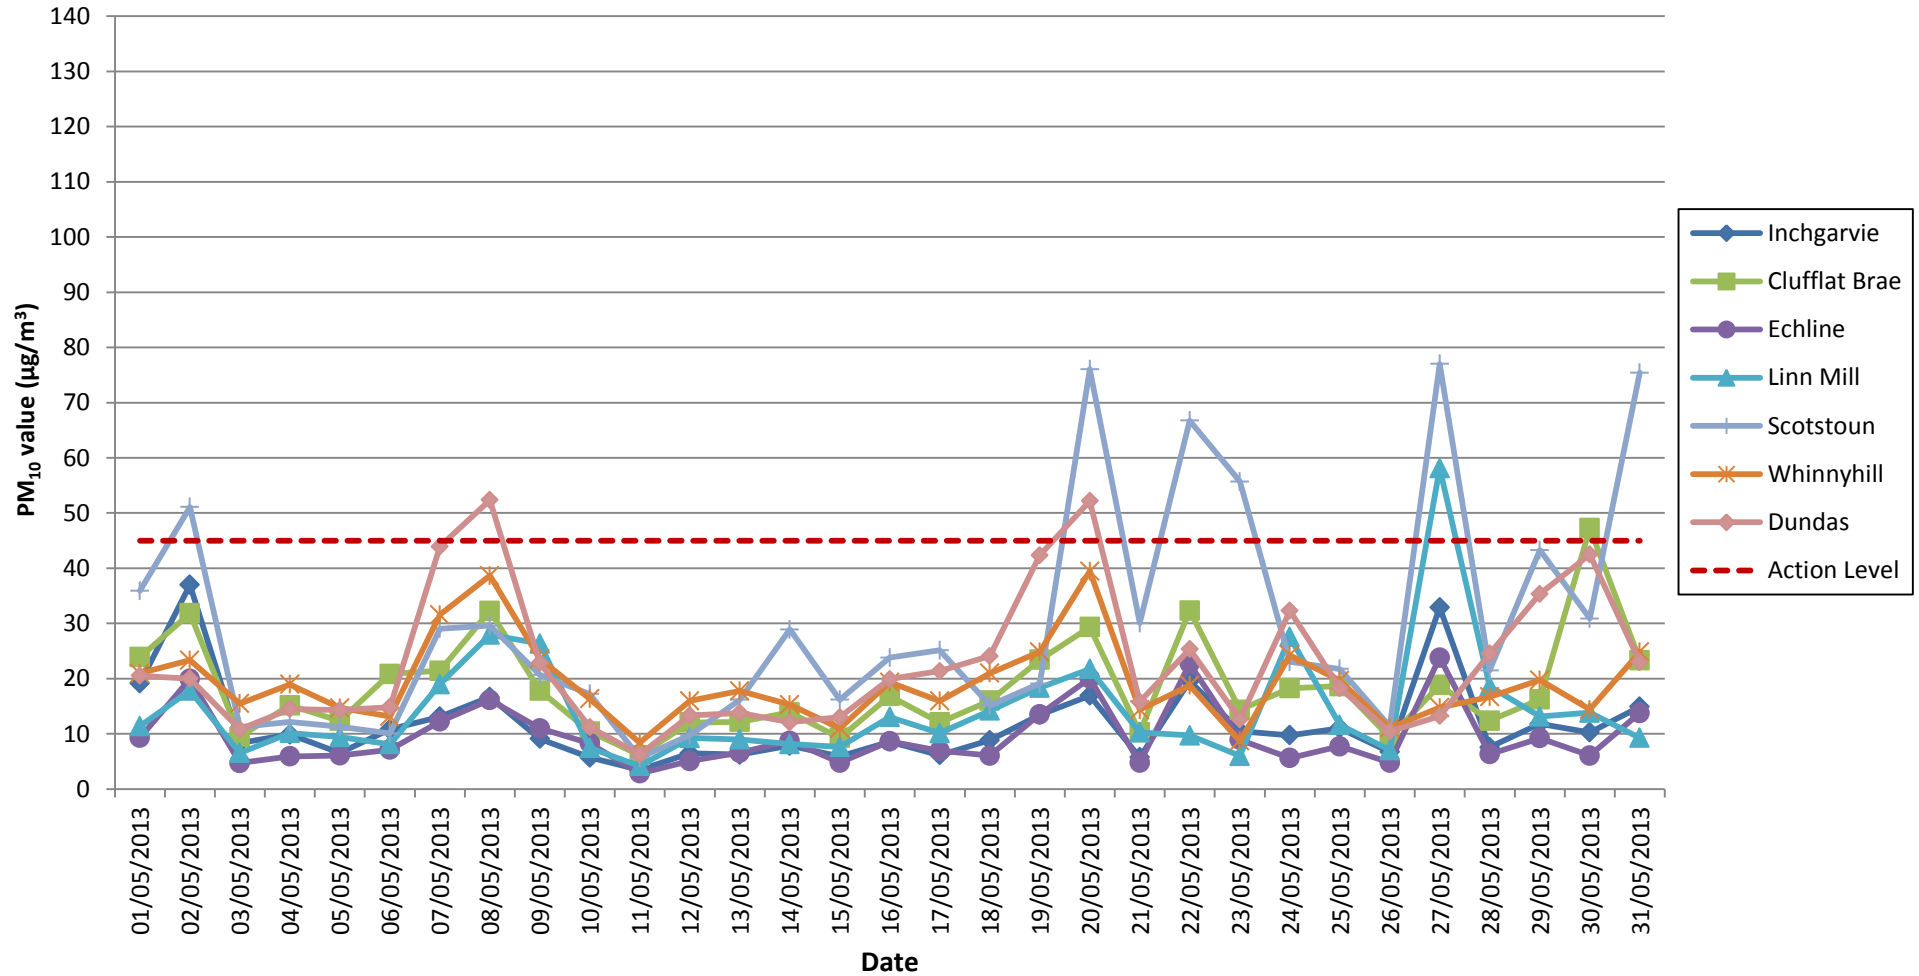
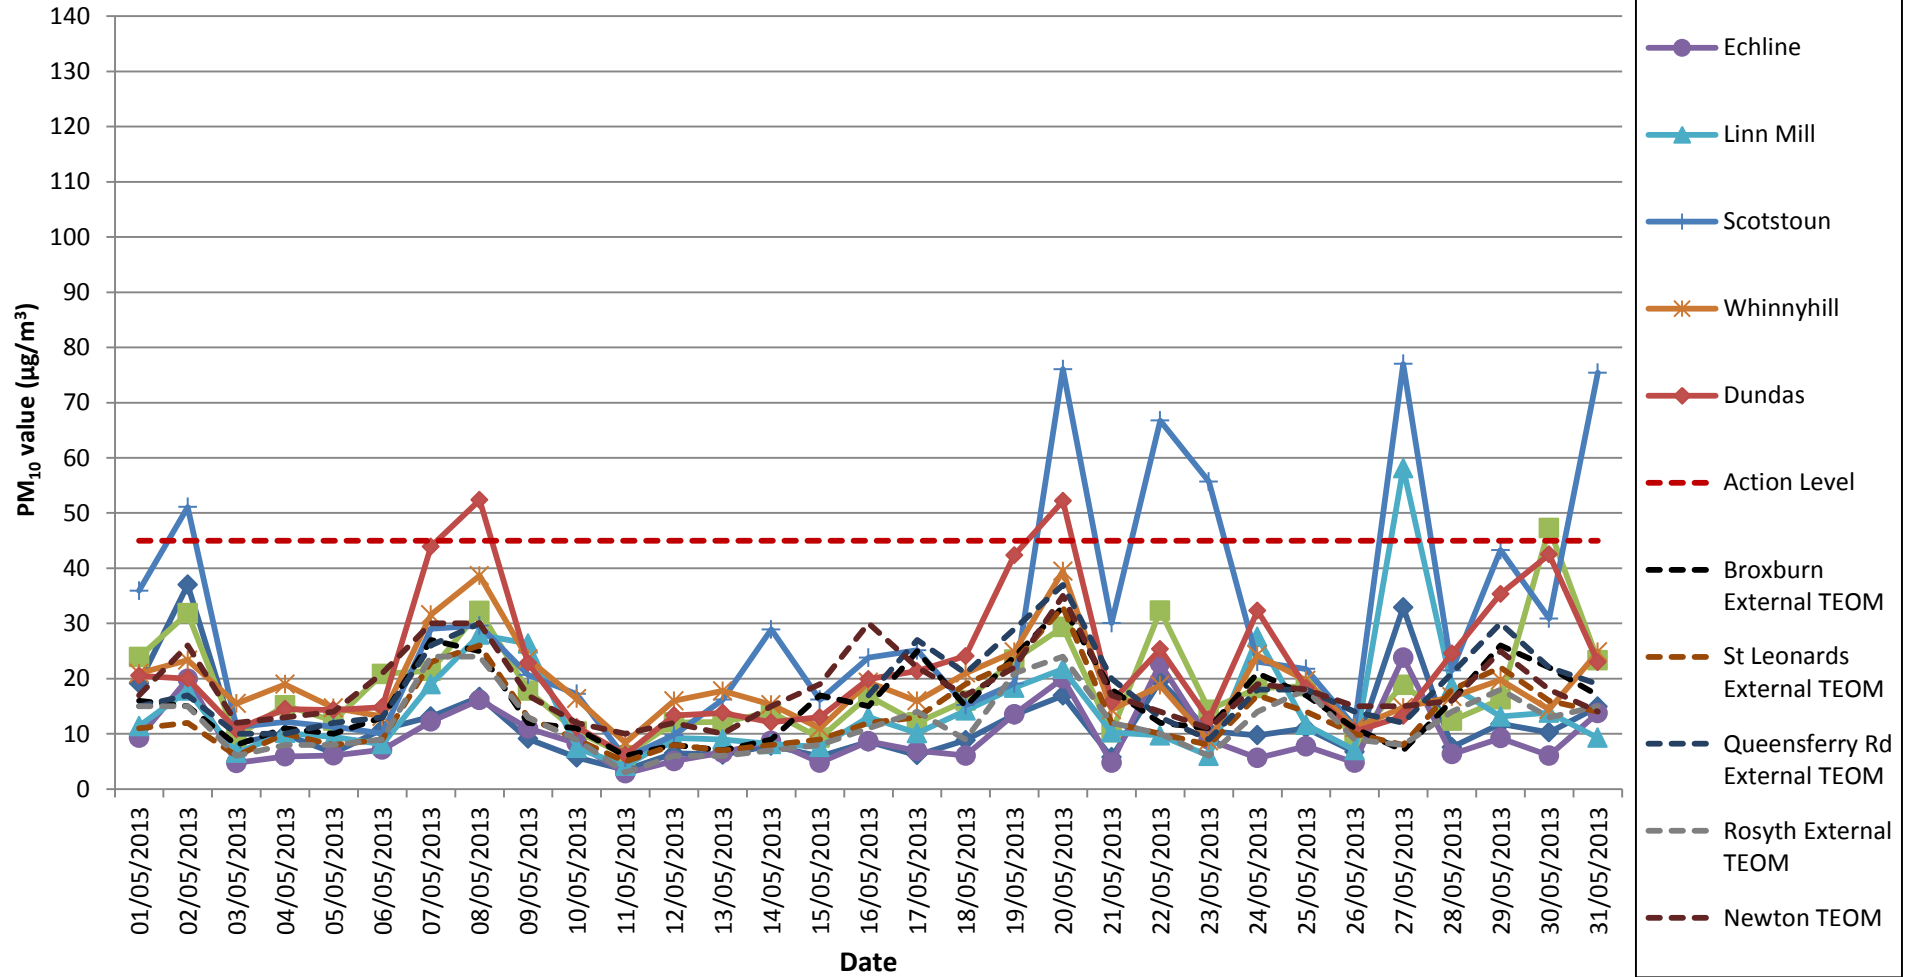
## Air Quality Monitoring Particulate Matter (PM10) Results for all Monitoring Locations May 2013

3.1.1. Light scatter results for May 2013 have been presented in a monthly chart; this can be found in Appendix A. Results show that the PM<sub>10</sub> levels were largely below threshold levels and generally followed the same pattern across the site, particularly during the first three weeks of May. During May there were eight days on which exceedances of the threshold occurred at four monitoring locations. Table 2 lists the locations at which the exceedances occurred on these dates. The dust log (section 3.4 and appendix D) provides further details with regard to the conditions and the actions taken as a result of each exceedance.

3.1.2. It is possible that construction works contributed to these exceedances, however, the results on 2, 8, 20, 22 and 27 May show the same trend across site, indicating that the results are generally caused by regional conditions. These dates coincide with days that were affected by notable weather conditions; in particular, 2, 22 and 27 May were affected by strong winds which influenced dust levels. On these dates, dust was also noted blowing in areas outwith the site boundary, including large plumes of dust being generated by agricultural activities in surrounding fields beyond the construction site. Therefore any dust

- 3.1.3.** The exceedances at Scotstoun on 23 and 31 May appear to be localised dust events. It is likely that the results for this monitor were affected by dust associated with the adjacent road. Windy conditions at this location on 23 May are also likely to have exacerbated the results, though rain showers were observed on this day, naturally dampening down the area. A road sweeper is in operation at this location which reduces the dust levels. It should also be noted that the monitor at this location is in a position that would result in higher dust levels than at the nearest sensitive receptors. The monitor is located immediately adjacent to the B800 road, whereas the nearest properties are located approximately 100m from the construction site entrance, and 25m from the road, behind a strip of mature trees and shrubs. It should also be noted that during May a dry wheel wash was installed at the site entrance near to Scotstoun.

- 3.1.4.** The exceedance at Clufflat Brae on 30 May also appears to be a localised dust event. Dry conditions were observed on site on this day and therefore it is possible that construction works influenced the results. Appropriate actions were taken in response to the alerts received, including dampening down.

- 3.1.5.** On all occasions where automatic trigger alerts were received within site operating hours, site investigations were undertaken. Where dust was found to be arising from site during inspections, appropriate action was taken in response. A bowser was in use site wide to dampen down, with second and third bowzers also available where conditions required. During conditions where dust was exacerbated by strong winds, FCBC endeavoured to dampen down haulage tracks and excavation areas as far as reasonably practicable.

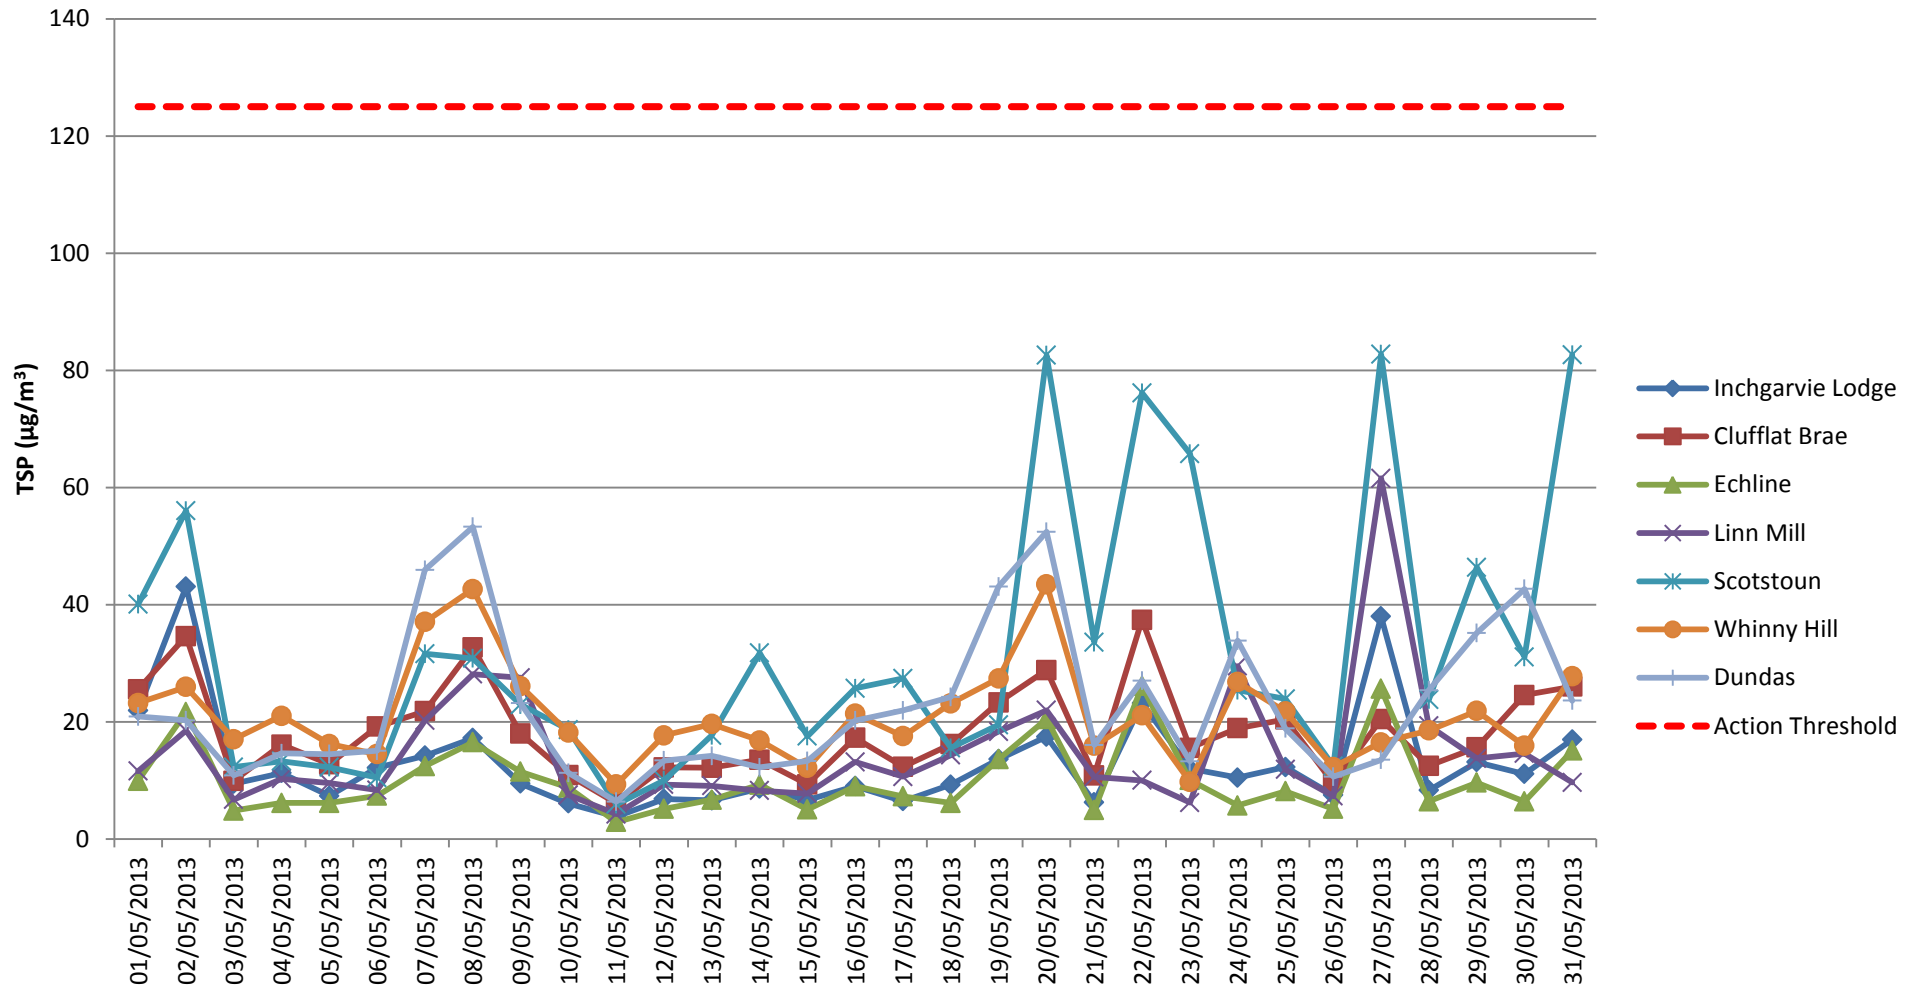
# Total Suspended Particles (TSP) Results May 2013

- 3.2.1.** The TSP results for May 2013 have been presented in a monthly chart; this can be found in Appendix B. The TSP levels at monitoring locations during May were generally low and all within the threshold level. All locations were mostly found to follow a similar pattern across the site, demonstrating that in general the levels were influenced by regional changes in TSP levels, rather than construction works.

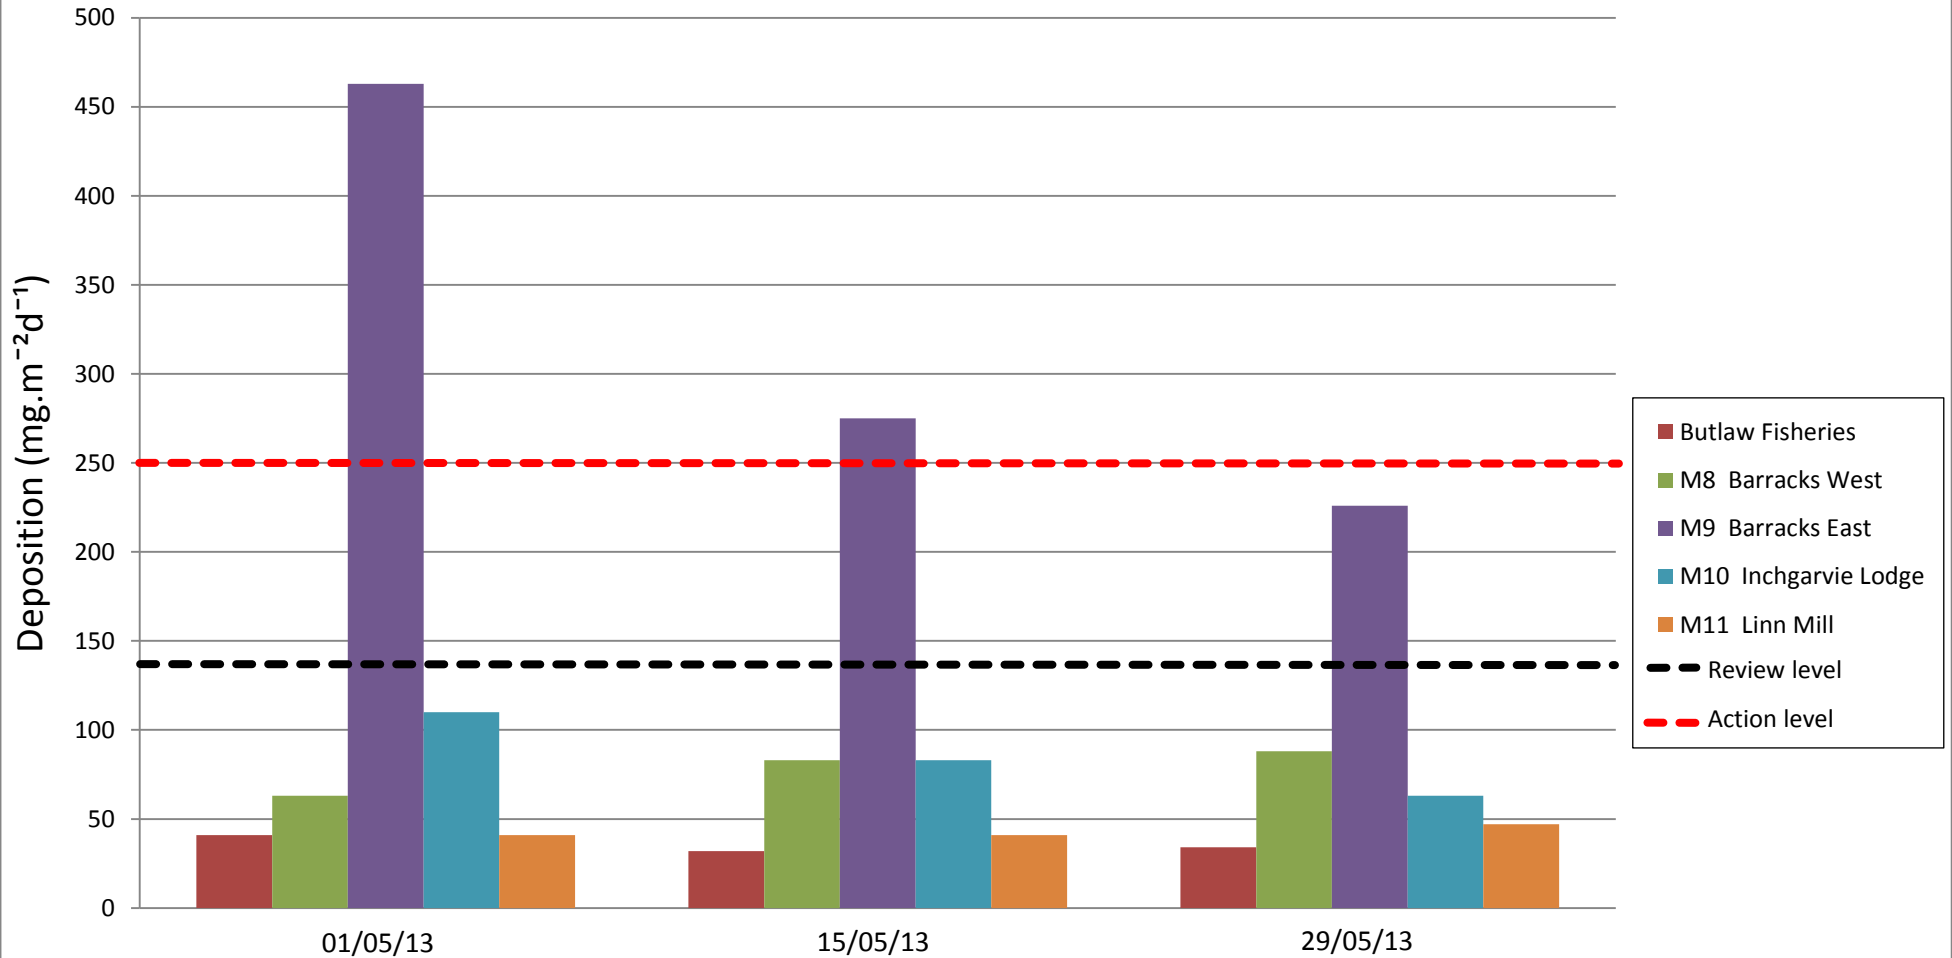
**Frisbee Dust Deposition Results: Group 1**  
**Locations: M7 Butlaw Fisheries, M8 Barracks West, M9 Barracks East, M10 Inchgarvie Lodge and M11 Linn Mill**

**3.3.5.** The exceedances of the action and review thresholds at Barracks East were caused by vehicles turning on a wet surface immediately adjacent to the Frisbee gauge and the deposition of fill material close by for the construction of the S5 causeway. However, this was an entirely localised exceedance as the results at Barracks West (located within 100 meters of Barrack East) show no high results. It should also be noted that there are no sensitive receptors in the vicinity of the Barracks East gauge.

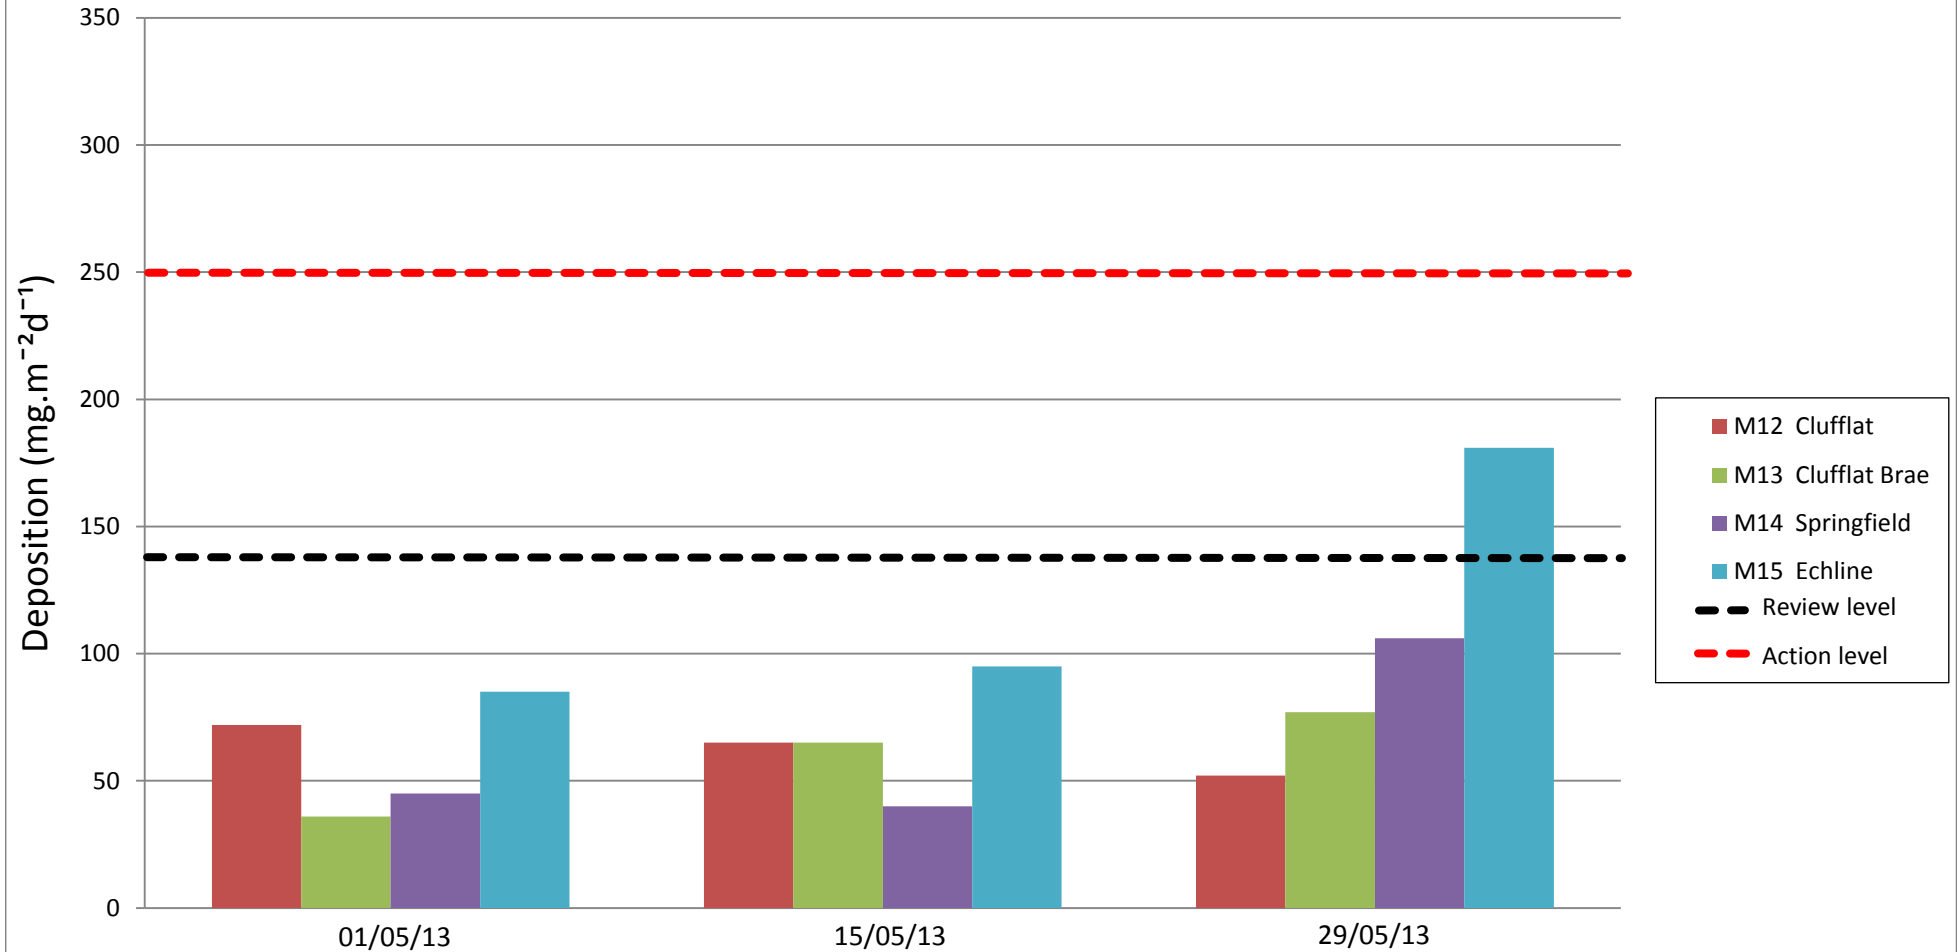
# Frisbee Dust Deposition Results: Group 2

- 3.3.8.** A review into the exceedance of the Echline threshold also identified non-construction related factors to have been influential on the results. Results of the particulate matter did not highlight any instances of dust at this location. Furthermore, works during this period were not in areas that would give rise to dust at this monitoring location. It is possible, therefore, that the position of the gauge near to trees resulted in some small vegetation particles affecting the results.

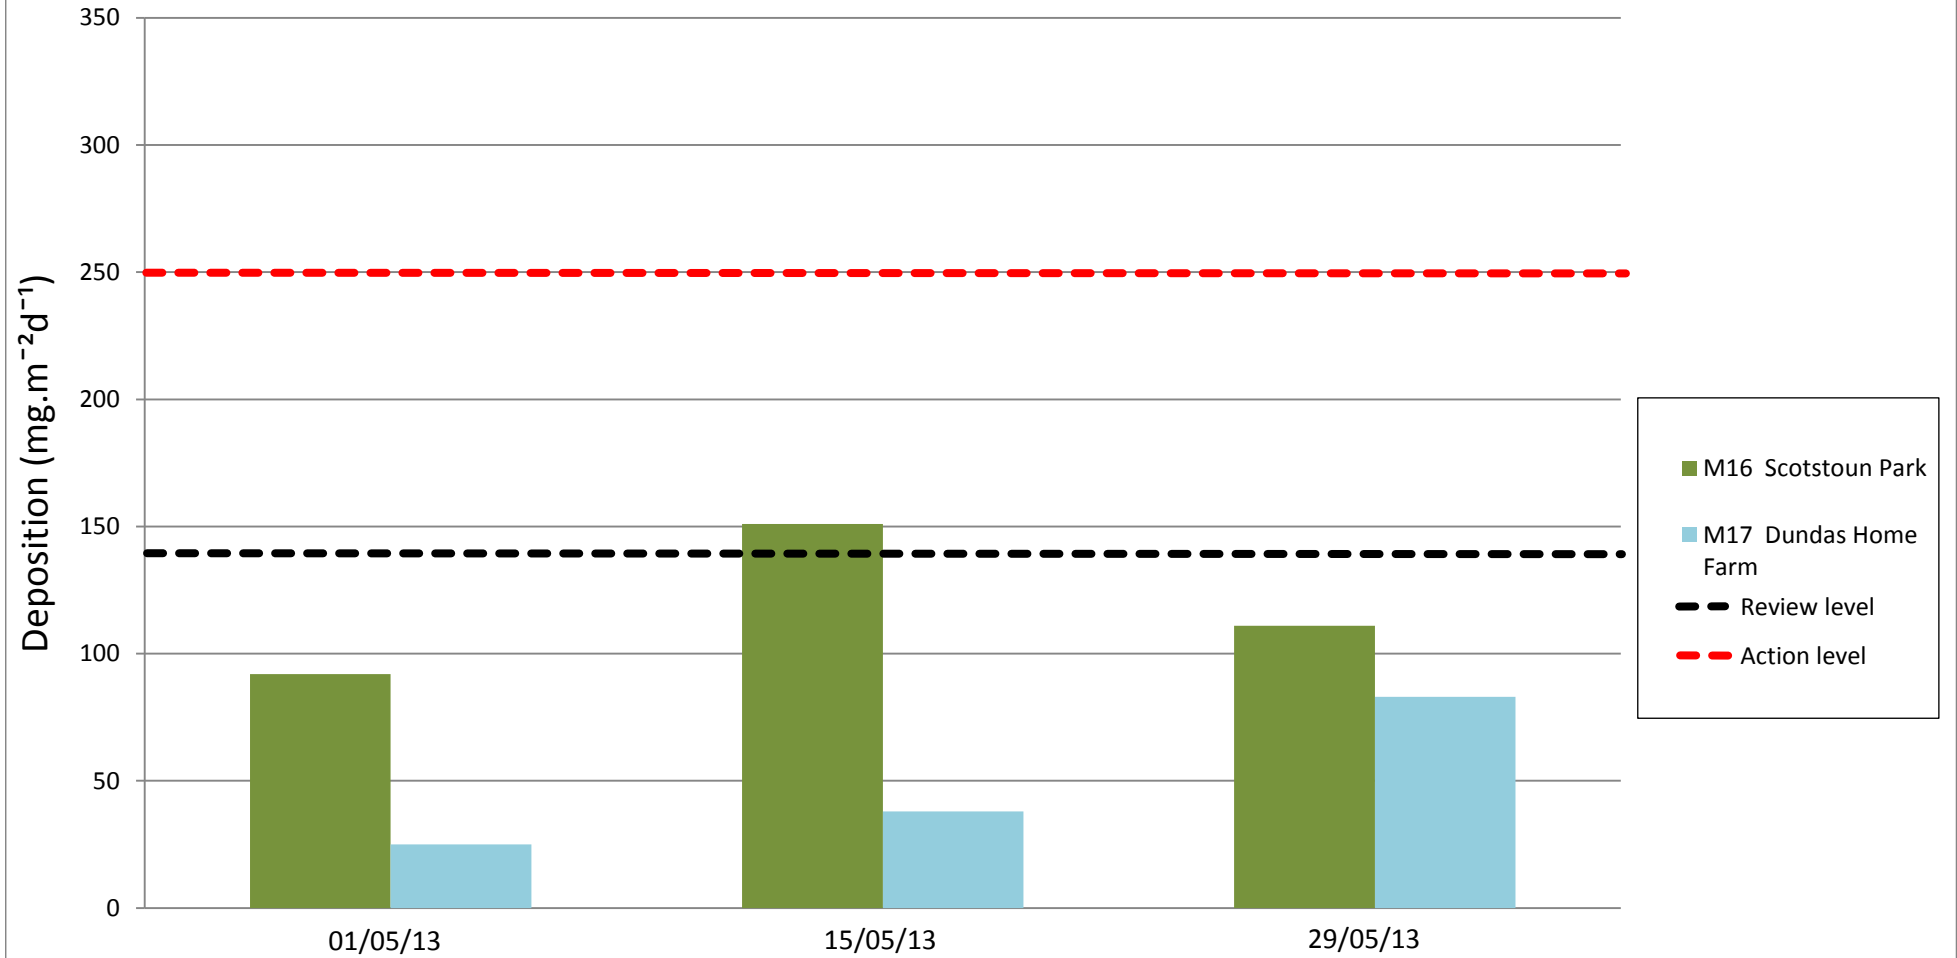
### Frisbee Dust Deposition Results: Group 3

**3.3.7.** Although the particulate matter results in the Scotstoun area identified the potential of dust from the road to increase dust levels at this monitoring location, the first 2 weeks of May were not largely affected by high particulate matter results at Scotstoun. The positioning of the Frisbee gauge (nearer to the receptors than the PM<sub>10</sub> meter) should generally indicate protection from road dust due to natural protection from trees and increased distance from the road. Rather, it is thought

that the exceedance occurred due to the effects of vegetation on the sample; on collection it was noted that the bottle was covered in grass cuttings and vegetation particles from overhanging trees were noted on the disc.
