**FORTH REPLACEMENT CROSSING**

**AIR QUALITY MONITORING REPORT**  
**JUNE 2013**

**REP-00124-00**

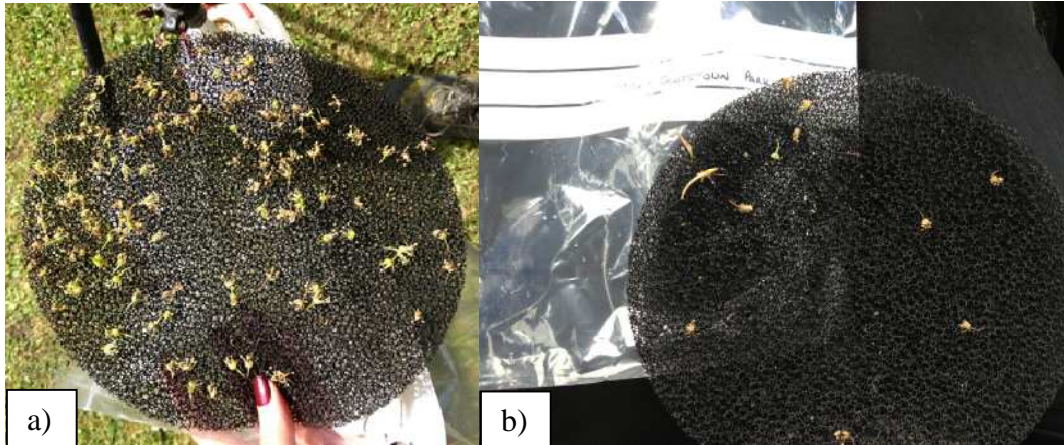
**Figure 3: Vegetation contamination on Frisbee discs**

Fortnight ending	Threshold Exceeded	Monitoring Location	Notable conditions at time of collection
12/06/13	Review	Springfield	Positioned under trees with presence of some vegetation particles on discs on both collections (see figure 3a).
26/06/13			
12/06/13	Review	Scotstoun	Positioned under trees with presence of some small vegetation particles on discs on both collections (see figure 3b).
26/06/13			
12/06/13	Review	Newton	Frisbee located under scaffolding and immediately adjacent to building works at property.
26/06/13	Review	Barracks East	Positioned at a turning area for vehicles using S5 causeway.

**3.3.5.** With regard to the exceedances at Scotstoun and Springfield, an appropriate review of the works in the area, the potential of works to have affected dust levels and any mitigation measures in place was undertaken. It is possible that these were caused by construction works due to the dust observed during some inspections and the particulate matter levels recorded by the light scatter meter at Scotstoun. Additional mitigation measures were therefore put in place (refer to 3.1.3). However, it should be noted that the samples collected were found to be contaminated with vegetation from mature trees above the gauge (see figures 3a and 3b) and therefore the exceedances are not considered to be entirely related construction works.

- a) example of contaminated sample from Springfield (taken on 12/06/13)
- b) example of contaminated sample from Scotstoun (taken on 12/06/13)

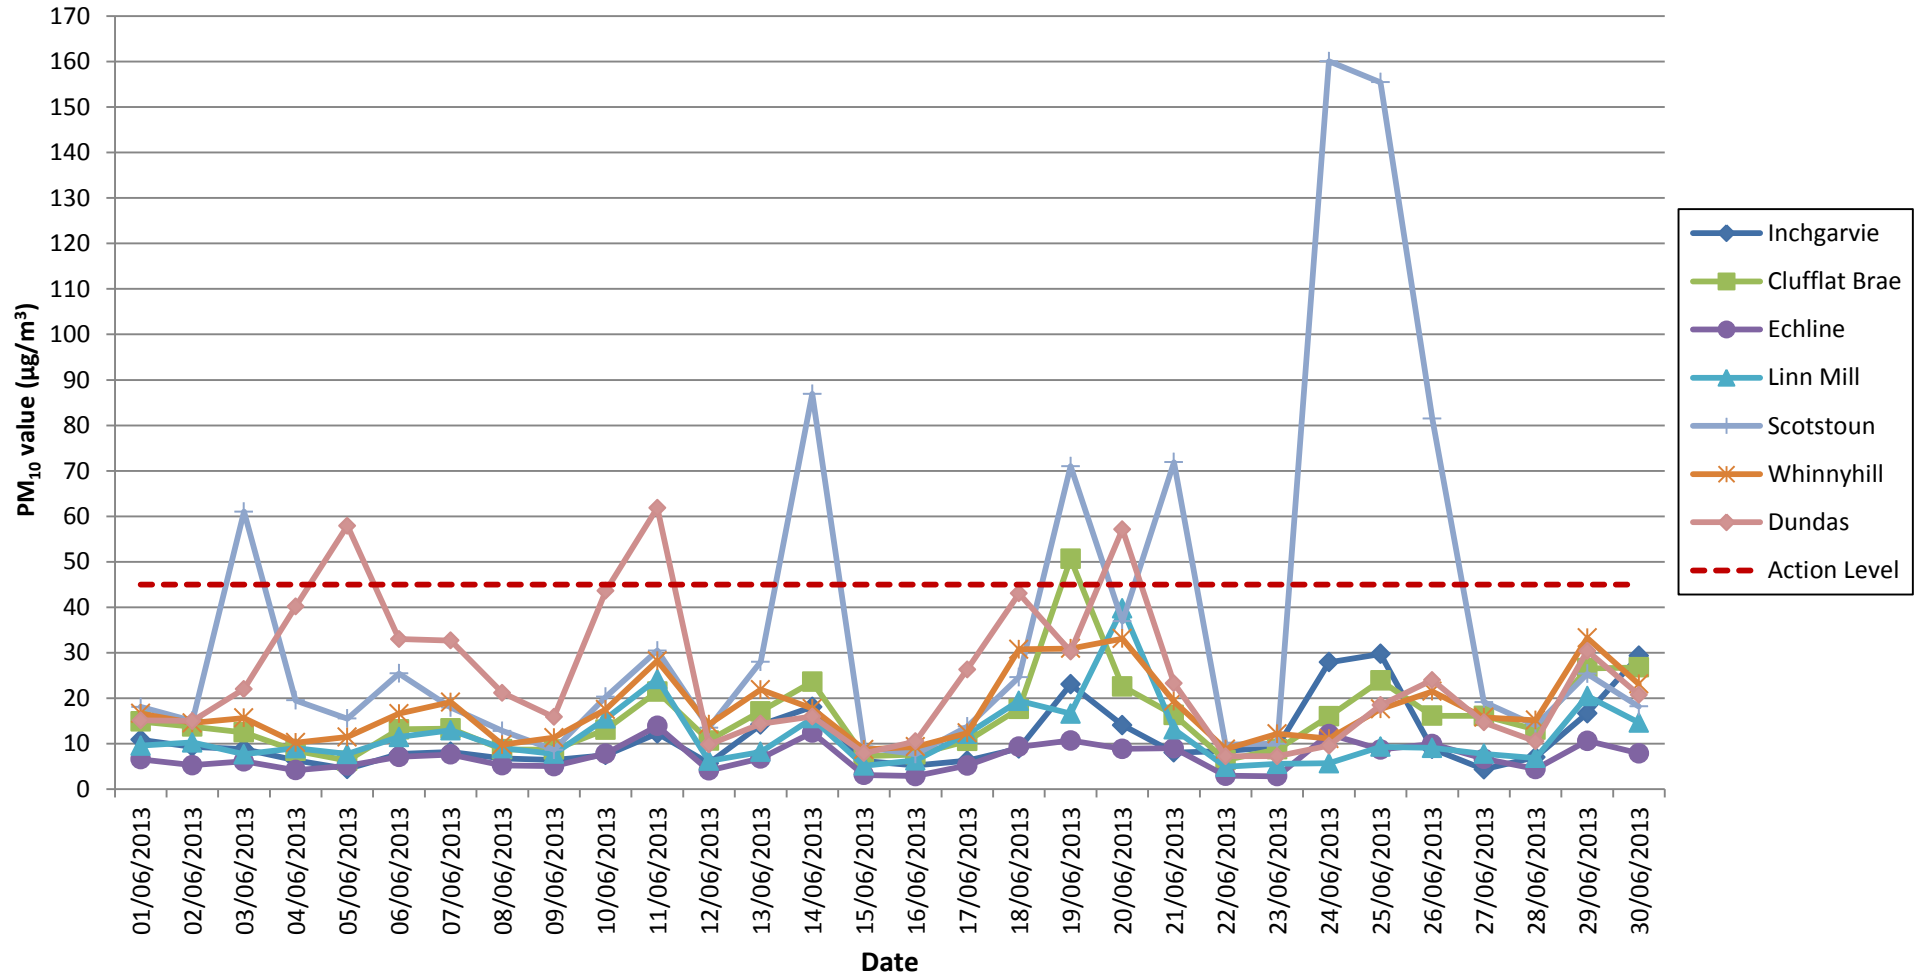
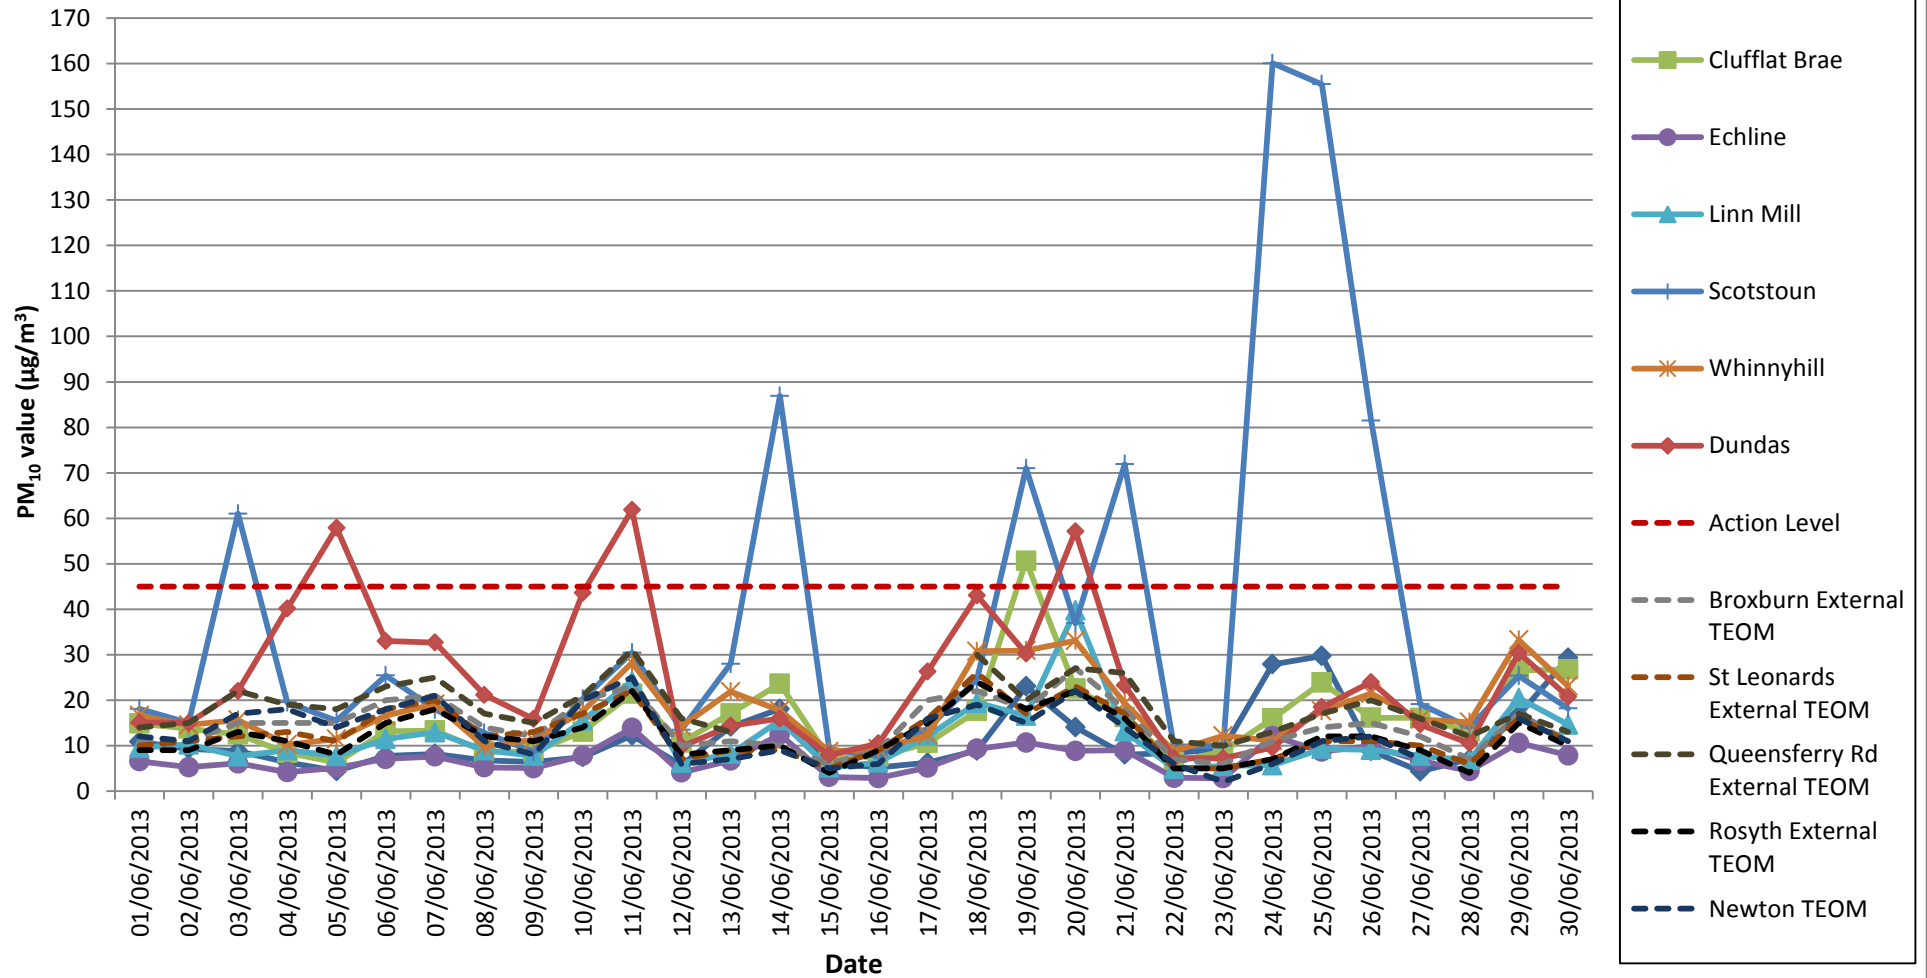
## Air Quality Monitoring Particulate Matter (PM10) Results for all Monitoring Locations June 2013

3.1.1. Light scatter results for June 2013 have been presented in a monthly chart; this can be found in Appendix A. Results show that the PM<sub>10</sub> levels were largely below threshold levels and generally followed the same pattern across the site. During June there were ten days on which exceedances of the threshold occurred. The majority of these exceedances occurred at Scotstoun, with one exceedance also recorded at Clufflat and exceedances on three days at Dundas. Table 2 lists the locations at which the exceedances occurred on these dates. The dust log (section 3.4 and appendix D) provides further details with regard to the conditions and the actions taken as a result of each exceedance.

Date	Monitoring Location	Notable conditions
03/06/13	Scotstoun	Vehicle movements - monitor in very close proximity to road
05/06/13	Dundas	Foggy conditions
11/06/13	Dundas	Hazy conditions. Rain showers in afternoon
14/06/13	Scotstoun	No dust observed during inspection. Likely to be due to close proximity to road
19/06/13	Scotstoun and Clufflat	Strong winds. Some dust blowing.
20/06/13	Dundas	Hazy conditions
21/06/13	Scotstoun	Hazy/misty conditions. Vehicle movements – monitor in very close proximity to road.
24/06/13	Scotstoun	High levels due to proximity to road and works between B800 and Dakota hotel – access track.
25/06/13	Scotstoun	High levels due to proximity to road and works between B800 and Dakota hotel – access track. Additional mitigation deployed
26/06/13	Scotstoun	High levels due to proximity to road and works between B800 and Dakota hotel – access track. Additional mitigation deployed.

- 3.1.2.** It is likely that construction works contributed to some of these exceedances. However, the results at Dundas are not considered to be related to construction. The meter at Dundas is particularly sensitive to foggy, misty and hazy conditions (see 2.2). The exceedance on 21 June at Scotstoun may also have been influenced by atmospheric conditions. Furthermore, the exceedances on 19 July coincide with a day that was affected by strong winds which influenced dust levels. On these dates, dust was also noted blowing in areas outwith the site boundary, including dust being generated by agricultural activities in surrounding fields beyond the construction site. Therefore any dust exceedances on these dates cannot be solely attributed to dust arising from site.

- 3.1.3.** The exceedances at Scotstoun on 3, 14, 21, 24, 25 and 26 June appear to be localised dust events. It is likely that the results for this monitor were affected by dust associated with the adjacent road. A road sweeper is in operation at this location which reduces the dust levels. Additionally, dust was noted when vehicles were entering and exiting the access track in to the works alongside the A90, between the B800 and the Dakota Hotel. During periods of high dust levels, the environmental department were notified by trigger alerts and there was close liaison with the works manager and section head of the south networks area to ensure that mitigation was in place. A bowser works full time on dust suppression in the south network areas; however, as a result of the dust levels during dry periods, an additional bowser was deployed in the south networks area.

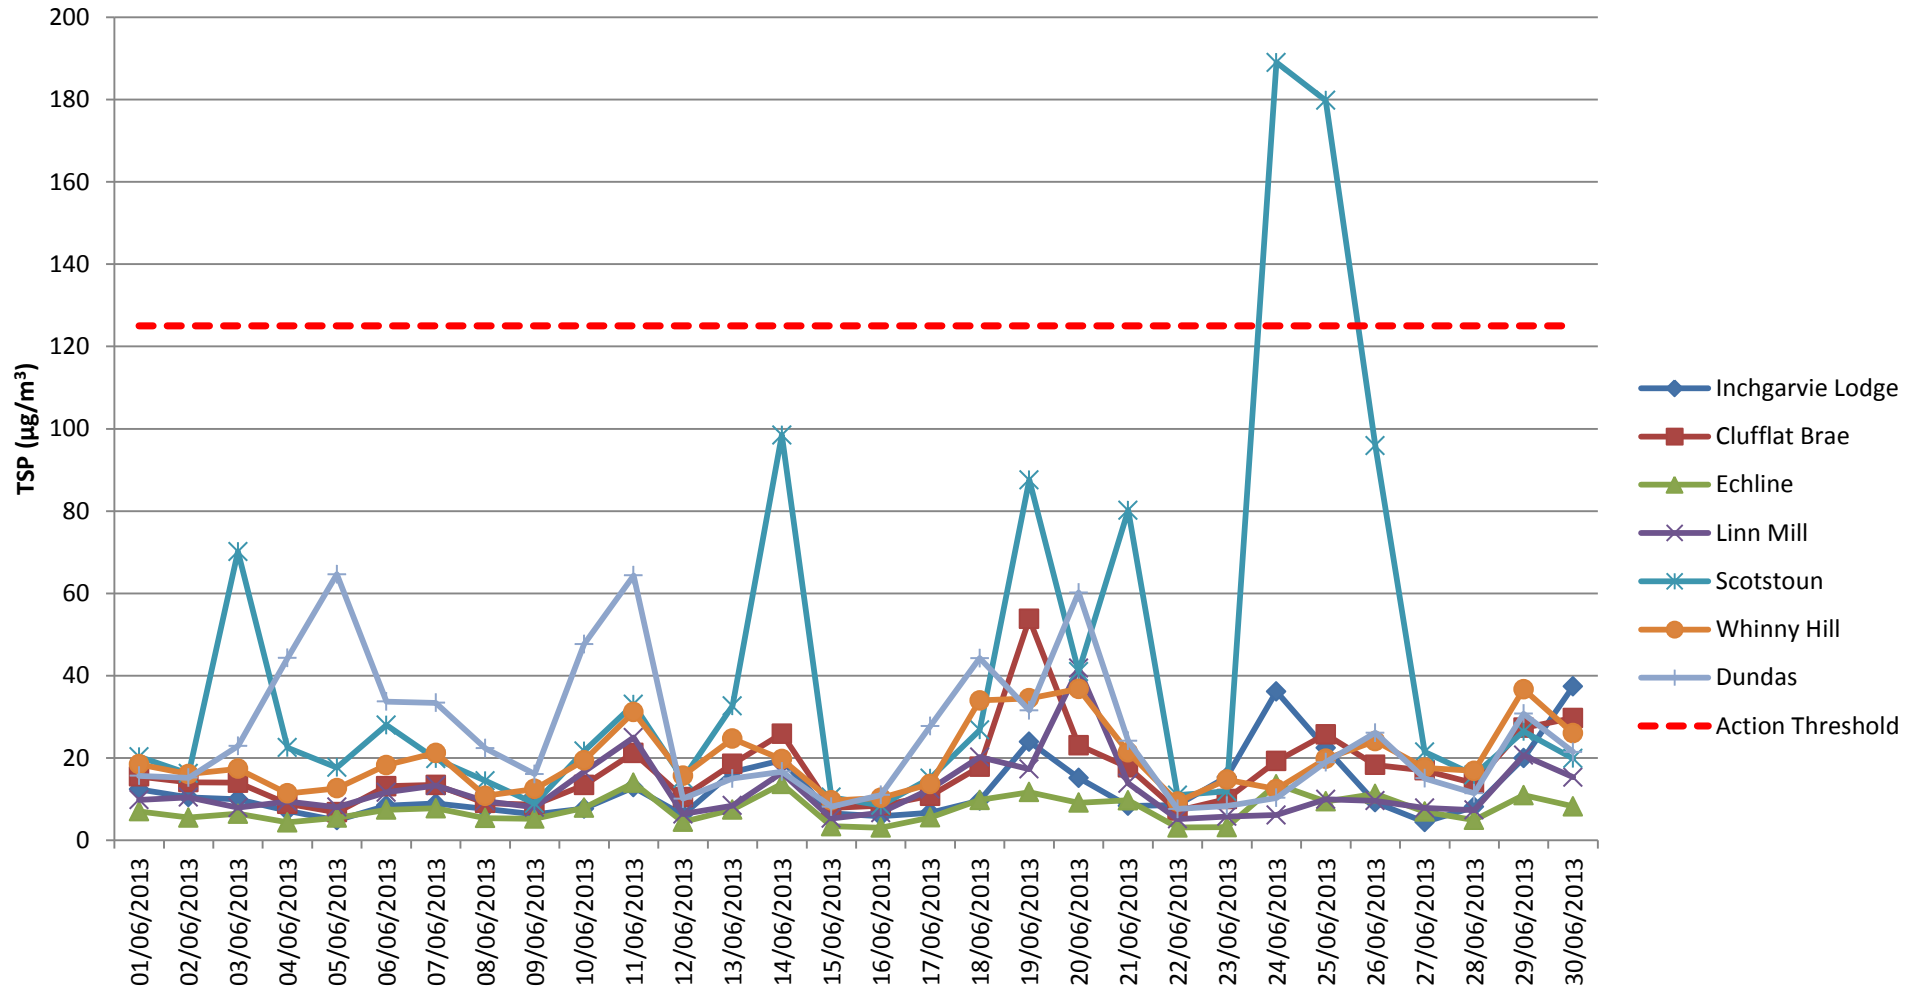
# Total Suspended Particles (TSP) Results June 2013

**3.2.1.** The TSP results for June 2013 have been presented in a monthly chart; this can be found in Appendix B. The TSP levels at monitoring locations during June were generally low and all within the threshold level, with the exception of 24 and 25 June at Scotstoun. These exceedances were related to the high PM<sub>10</sub> levels noted above (see 3.1). All locations were mostly found to follow a similar pattern across the site, demonstrating that in general the levels were influenced by regional changes in TSP levels, rather than construction works, with some exceptions relating to the PM<sub>10</sub> levels discussed in section 3.1.

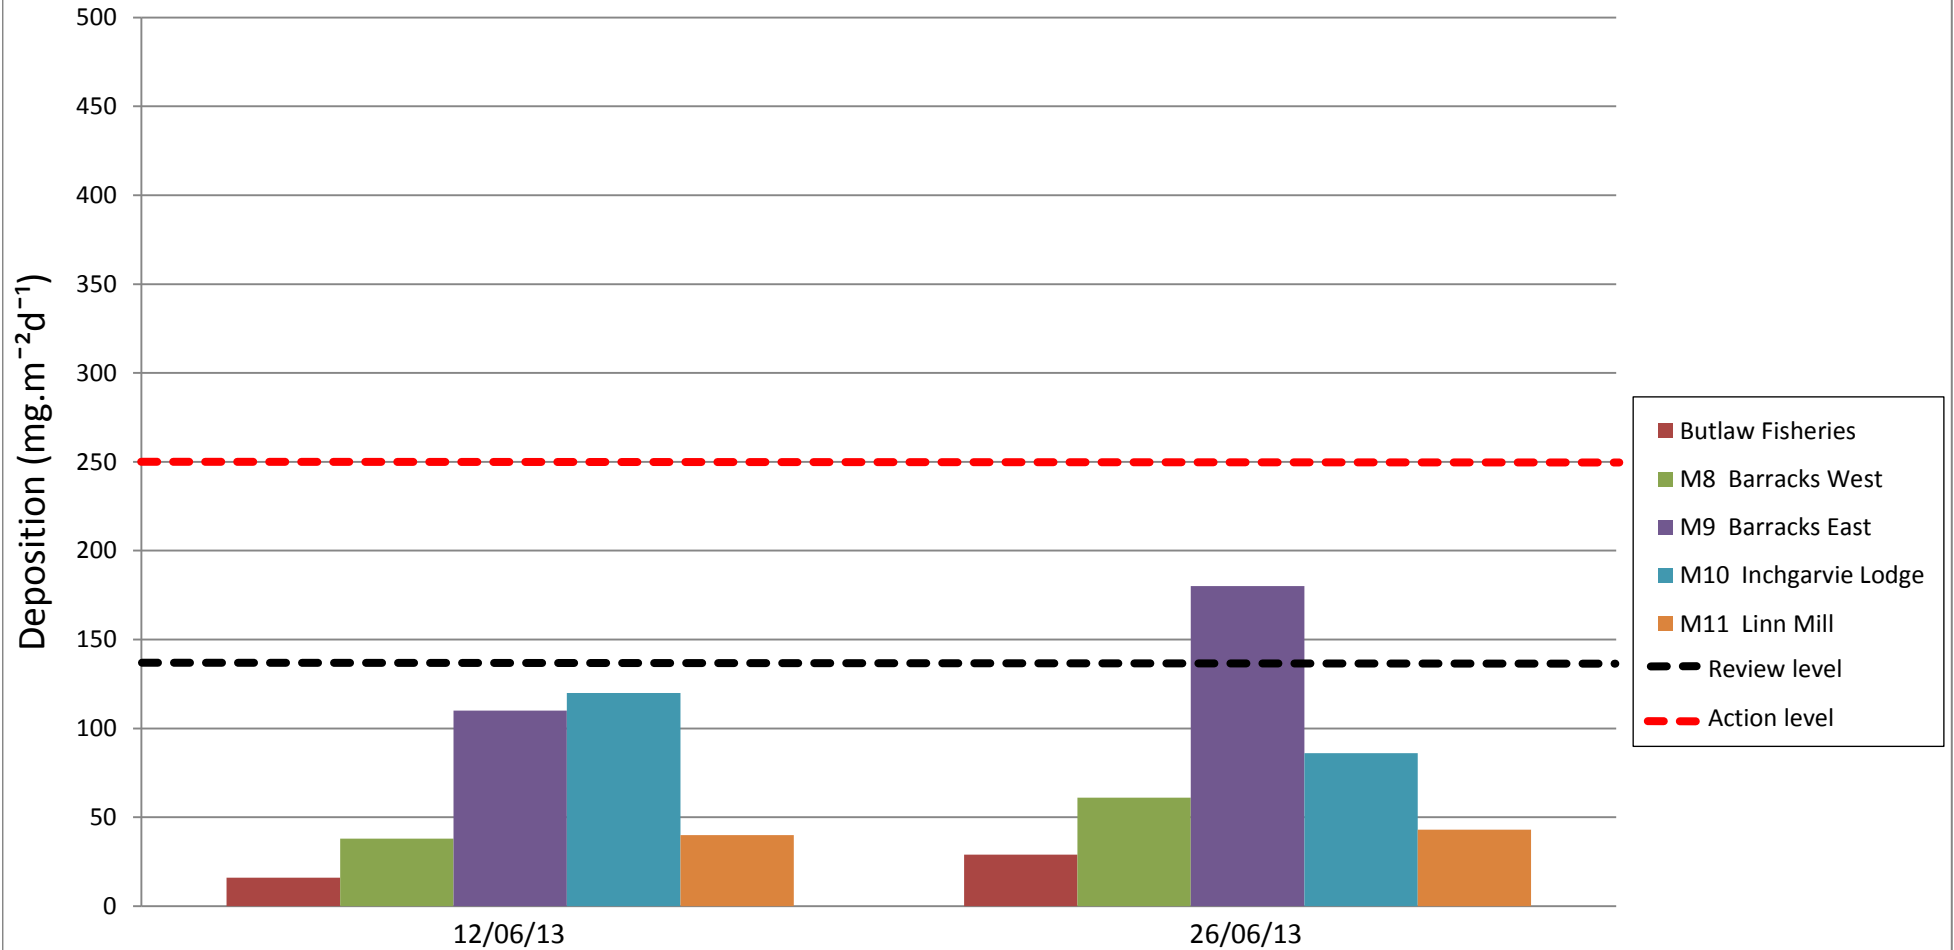
**Frisbee Dust Deposition Results: Group 1**  
**Locations: M7 Butlaw Fisheries, M8 Barracks West, M9 Barracks East, M10 Inchgarvie Lodge and M11 Linn Mill**

**3.3.7.** The exceedance of the review threshold at Barracks East is thought to have been caused by vehicles turning immediately adjacent to the Frisbee gauge and the deposition of fill material close by for the construction of the S5 causeway. However, this was an entirely localised exceedance as the results at Barracks West (located within 100 meters of Barrack East) show no high results. It should also be noted that there are no sensitive receptors in the immediate vicinity of the Barracks East gauge.

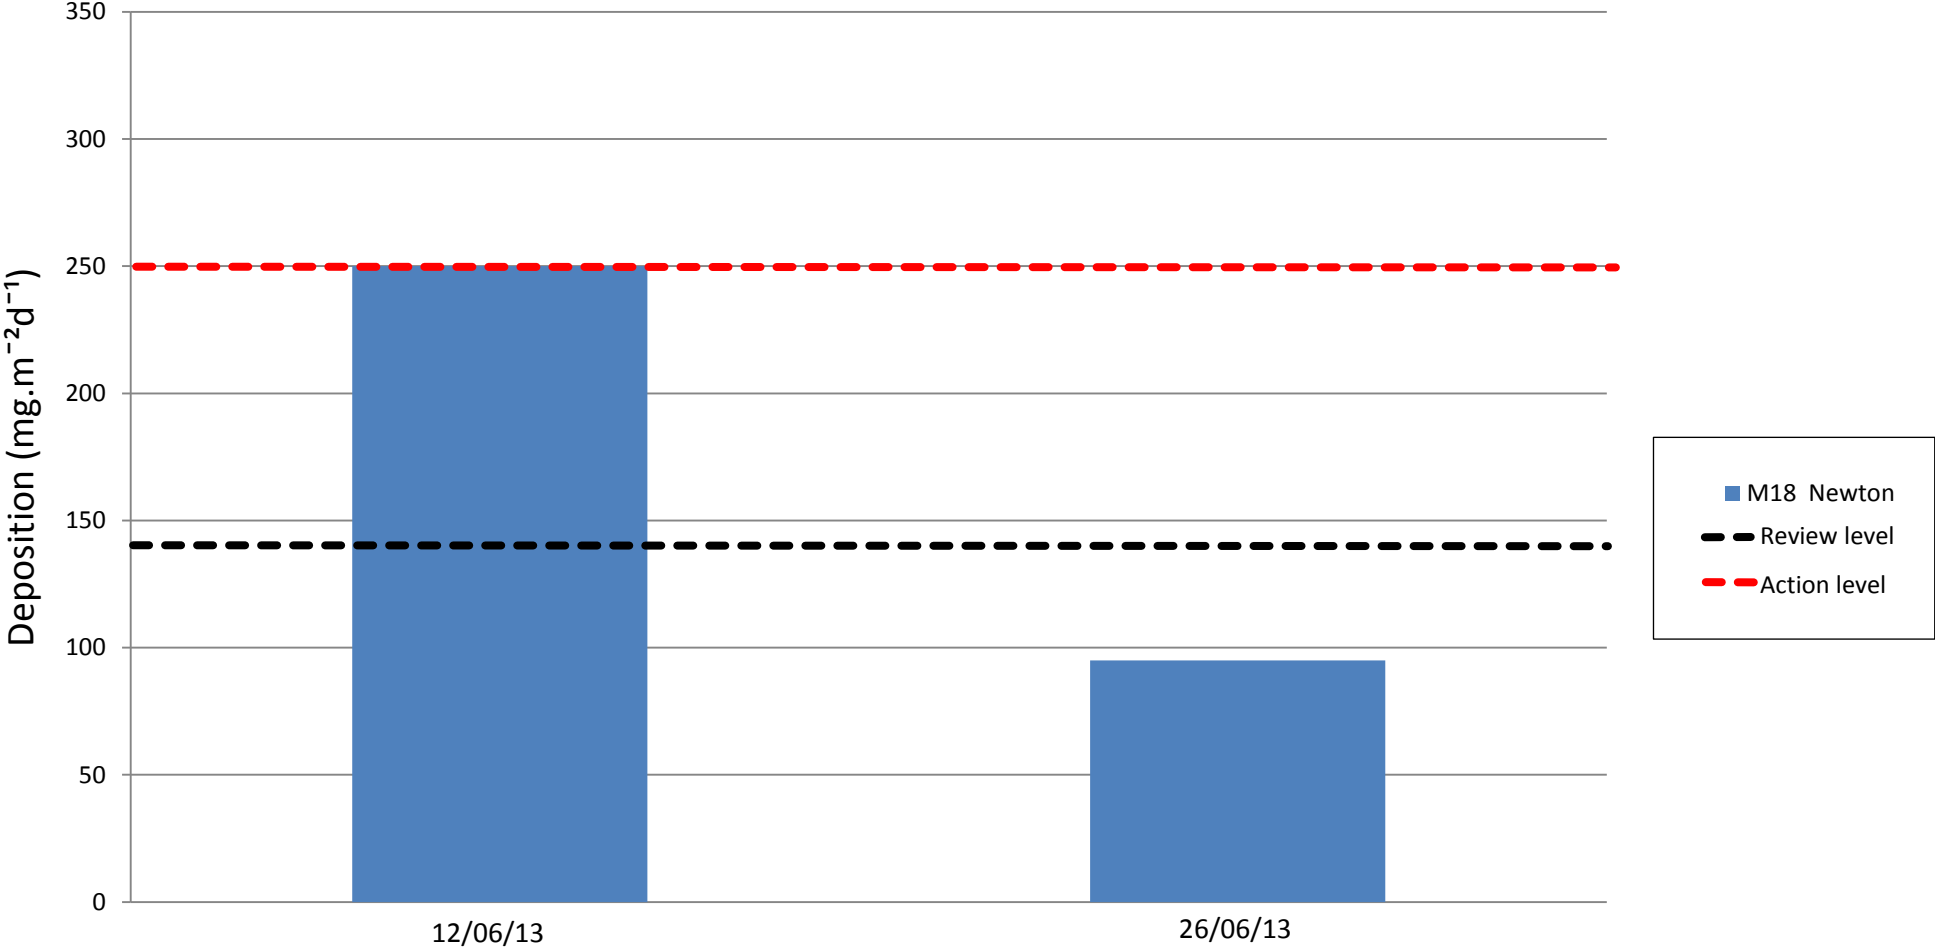
# Frisbee Dust Deposition Results: Group 4

**3.3.6.** The exceedance of the review level at Newton is not considered to be related to construction works. On-going building works at the property are immediately adjacent to the Frisbee gauge and therefore are thought to have contributed to the levels recorded at this location.
