Boulder Hazards Study - Phase 2A Boulder Hazard Inventory for A83 Beinn Luibhean

Document No. B2359902/TGE/REP/02 | 0

November 2022

Scottish Road Research Board

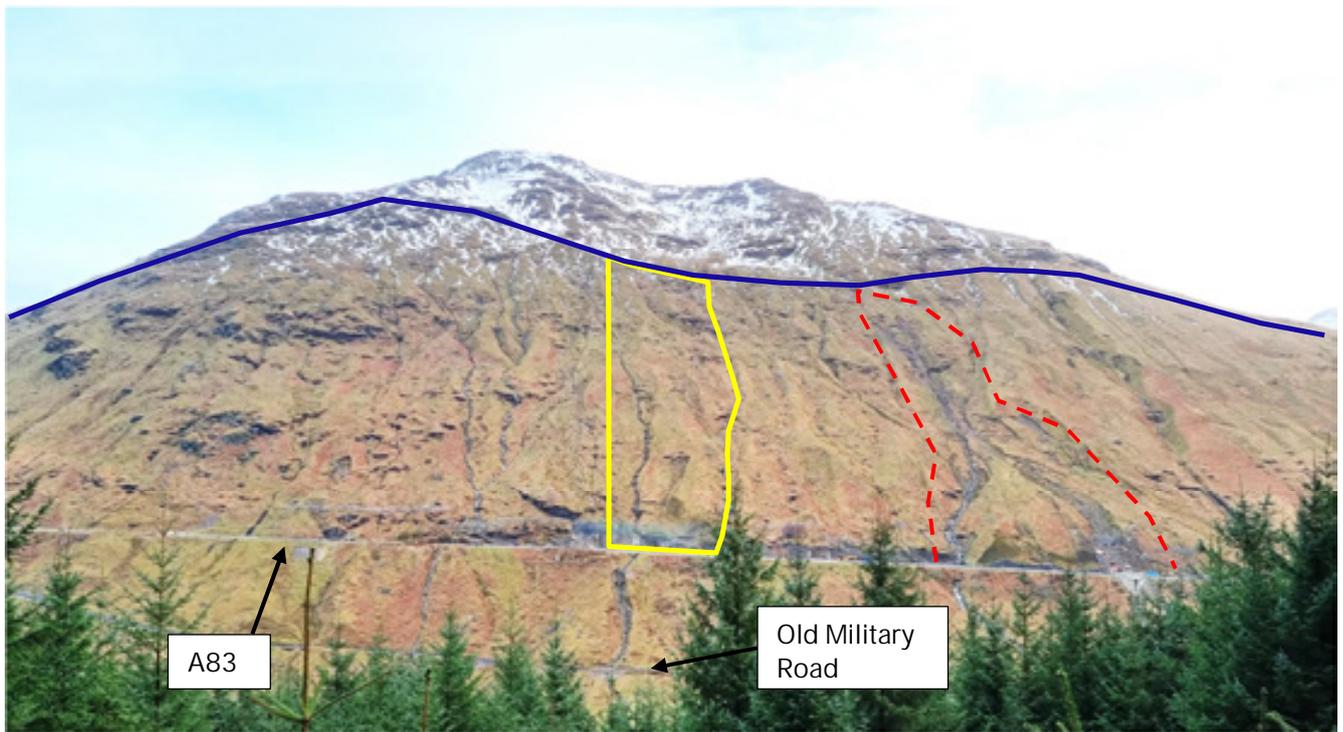
Figure 1-2 Photograph of the Beinn Luibhean hillside highlighting key features of the Study Area. The blue line marks the upper boundary of the study area. The red dashed line marks the area affected by the 2020 debris flows. The area with the yellow boundary outlines the Phase 1 trial area.

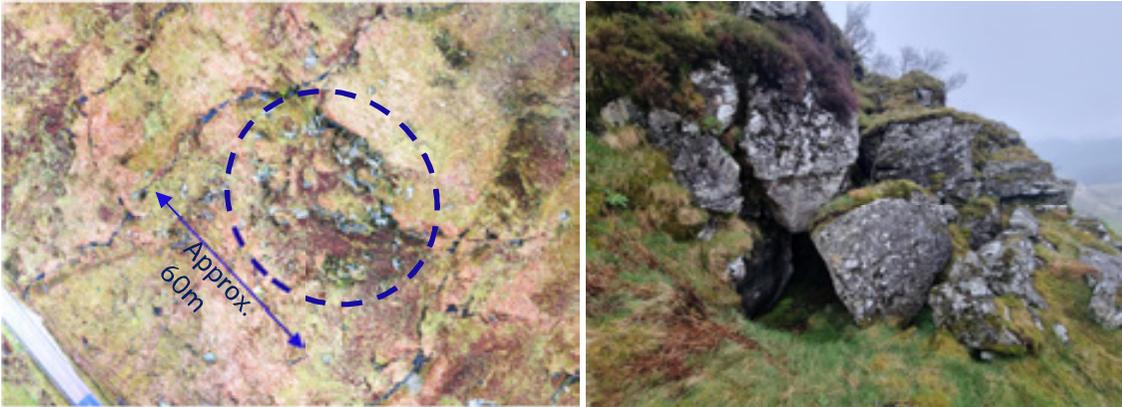
Feature Description	Photographs / Images
<p>Feature A – Approx. 60m long area of very large boulders below a series of rock cliffs. It is suspected that these boulders have been deposited following a rockslide due to their position on the slope. The boulders are stacked on top of one another, sometimes forming caves/hollows that are several metres in height. This area does not conform with the typical boulders found on the hillside that are usually discrete, or within a small cluster. Many of the boulders in this area are not resting upon soil, but on top of other boulders as illustrated in the accompanying photograph.</p> <p>The aerial view image was generated from the DEM, provided by GeoRope Ltd, using Pix4D viewing software (GeoRope ,2020)</p>

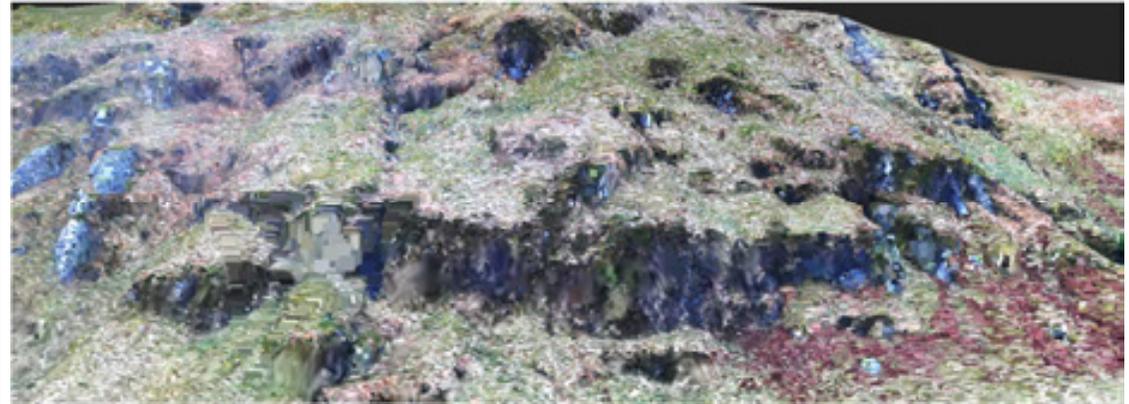
Feature C – Comprises an approximate 13,500m² (1.35Ha) area of rock cliffs interspersed with narrow grassy ledges. Field mapping in this area was restricted due to safety concerns relating to accessing the narrow ledges between the cliffs. Mapping was undertaken in this area where it was considered safe to do so.

The oblique image was generated from the DEM, provided by GeoRope Ltd, using Pix4D viewing software (GeoRope, 2020) The image shows rock cliffs in the lower section of Feature C.
