## **Appendix A15.2: Shierglas Farmhouse Structural Overview**

### **1 Executive Summary**

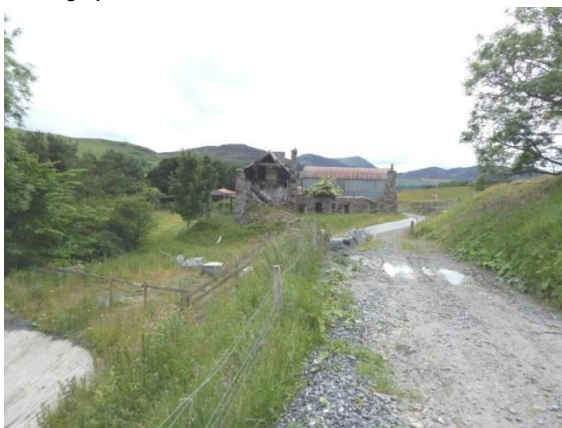
**Photograph 1: Access track to farmhouse**

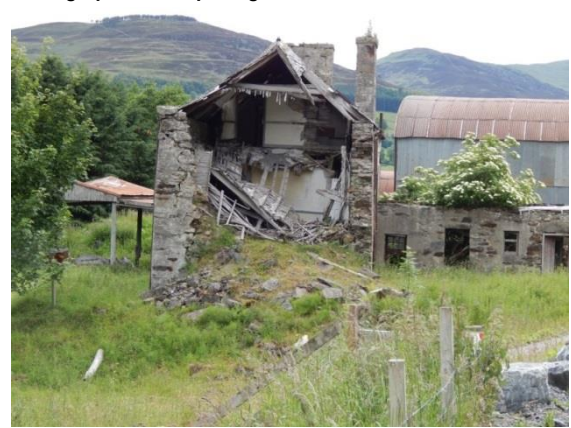
- 2.1.2 The Shierglas Farmhouse was constructed circa 1728 as dated from the “wedding lintol” over the main front door entrance. The property is in a poor state of repair and has been vacant for a number of years. The west gable of the two storey farmhouse has collapsed and the single storey part to the rear is simply a shell with no roof. Buildings of this age and traditional construction methods are not usually more susceptible to vibration than their modern equivalents. With the larger mass of their walls and floors they can be better able to dampen resonance from vibration. In the case of the Shierglas Farmhouse this can no longer be applied due to its poor condition, degradation and historical collapses.

- 3.1.5 It is noted on historic regional council inspection records that the structure has deteriorated rapidly over the last decade and that blasting from the limestone quarry adjacent to the building was a contributing factor. One such inspection report from 2014 states that the pace of the decay has appeared to slow following the loss of the west gable wall.

**Photograph 2: Collapsed gable end**

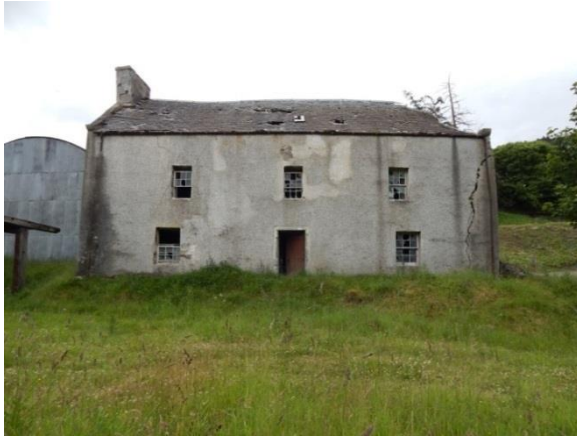
- 3.1.6 The foundations to a building of this age are likely to be simple and comprise of large stones laid directly onto virgin soil. The foundations to the farmhouse are suspected to be very shallow at only around 300mm below ground level. The shallow depth of the foundations not only leaves them susceptible to environmental factors such as frost heave, but also external factors such as accidental undermining through excavations. It was noted that an access track has been cut along the rear of the farmhouse to access an open fronted barn. This access track has resulted in a short but steep batter from the farmhouse down to the access track.

**Photograph 3: Ground levels reduced to form track**

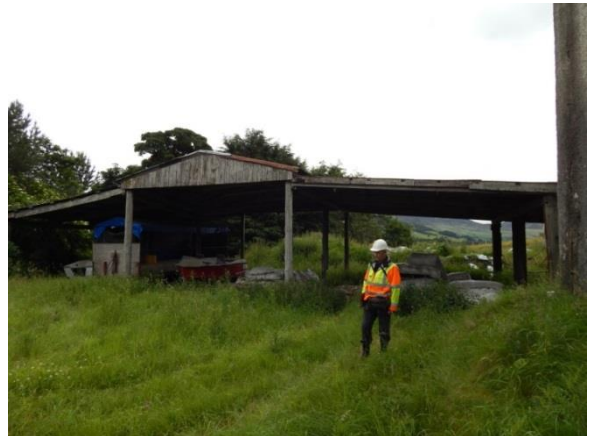
**Photograph 4: Open sided barn**

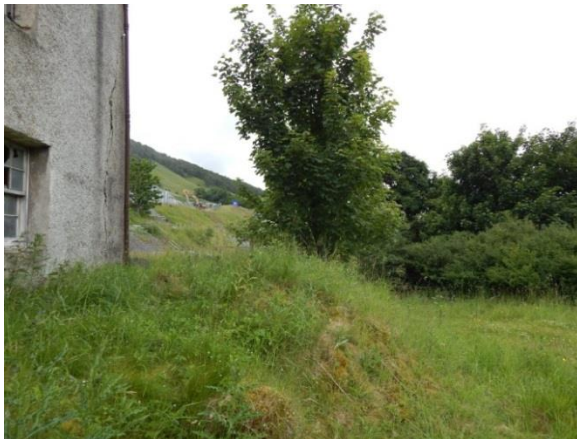
**Photograph 5: Batter from farmhouse to access track**

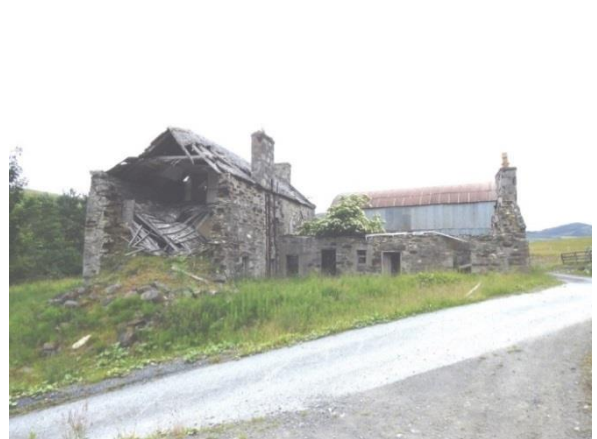
**Photograph 6: General view on farmhouse from west**
