Appendix 11.4

Hydromorphology Assessment Part 4

Annex 11.4.3 - Hydromorphological Catchment Assessment - 94

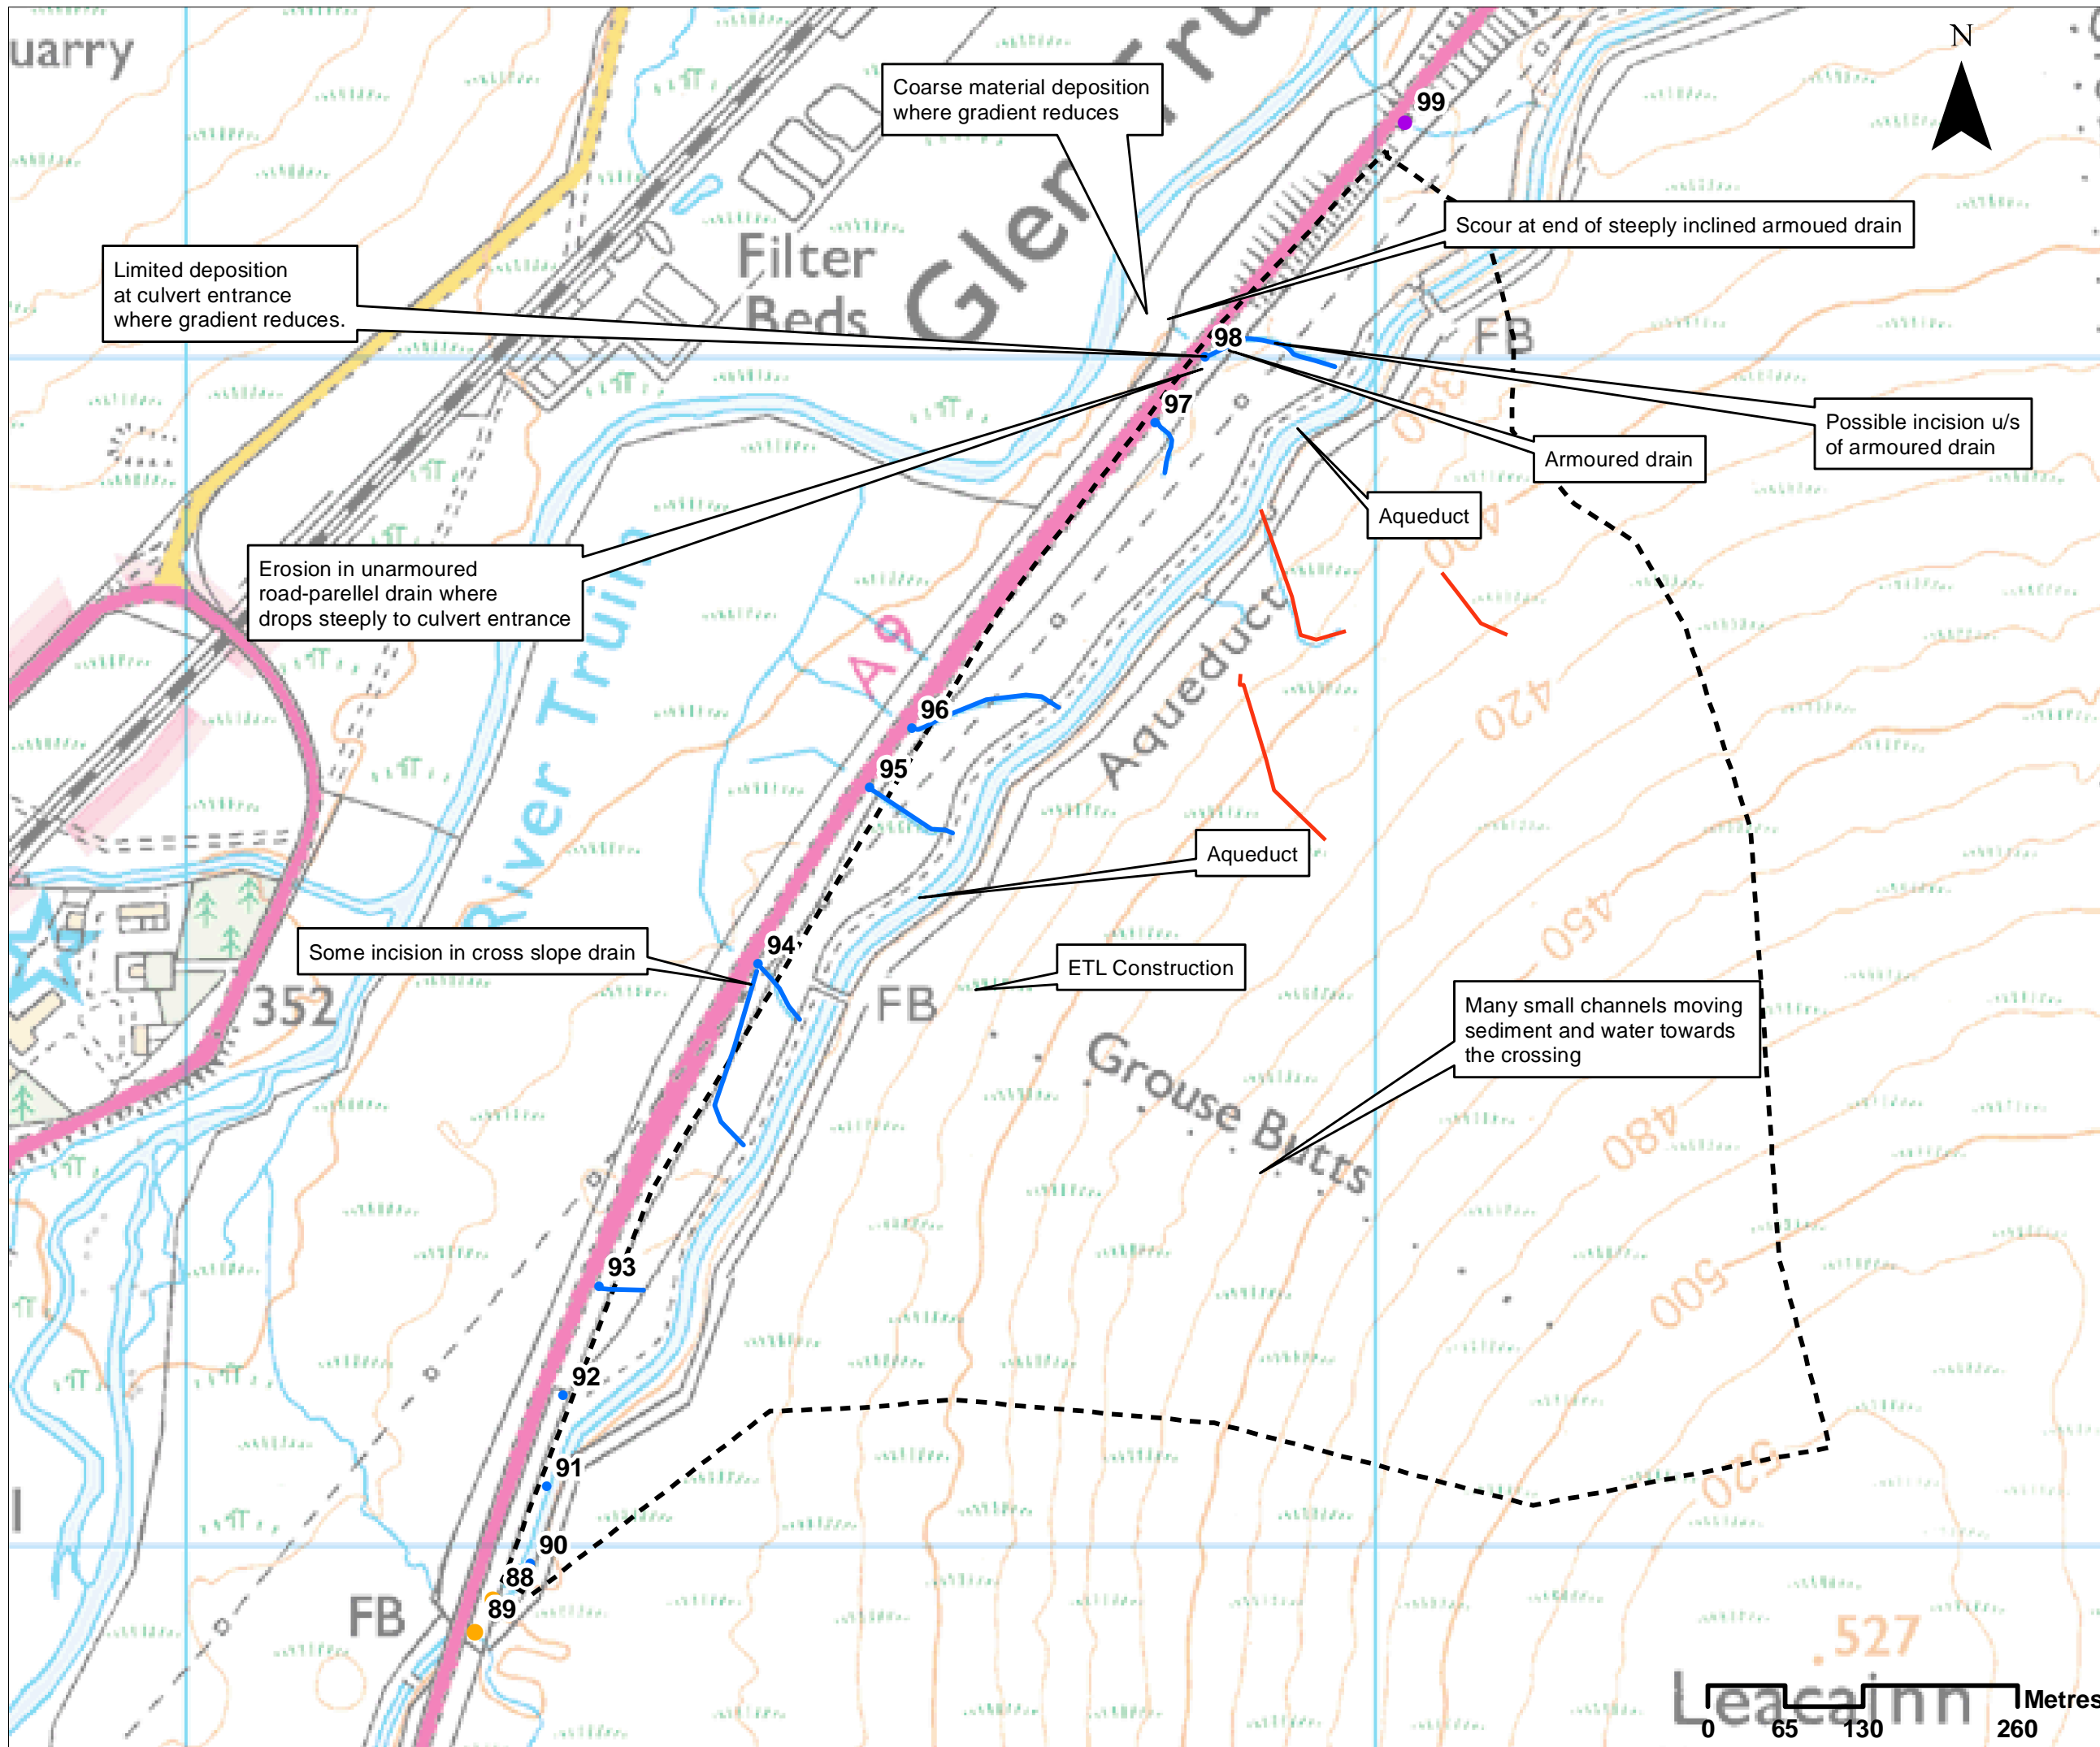
Limited deposition at culvert entrance where gradient reduces.

Coarse material deposition where gradient reduces

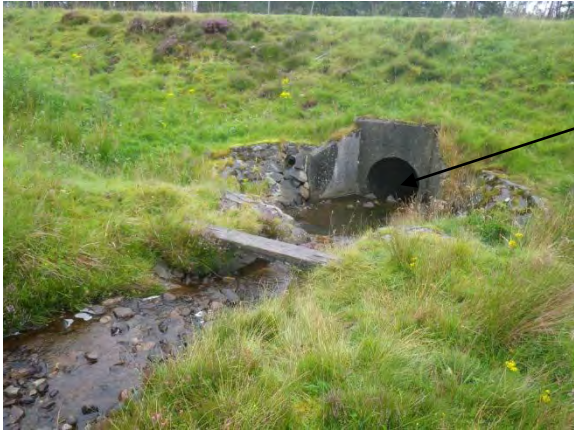
Photograph 11.4.3.65- Downstream to crossing

Crossing
entrance

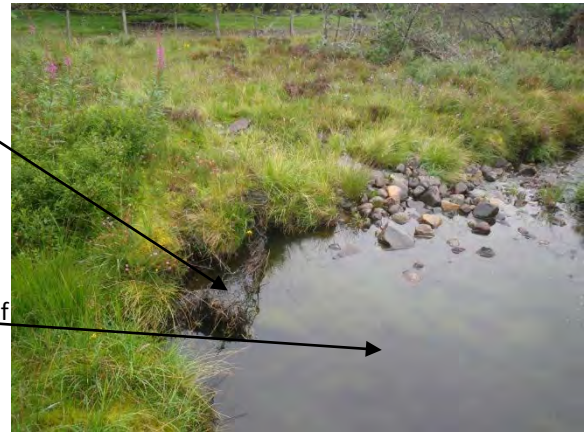
Damaged
gabion

Scour pool
downstream of
exit

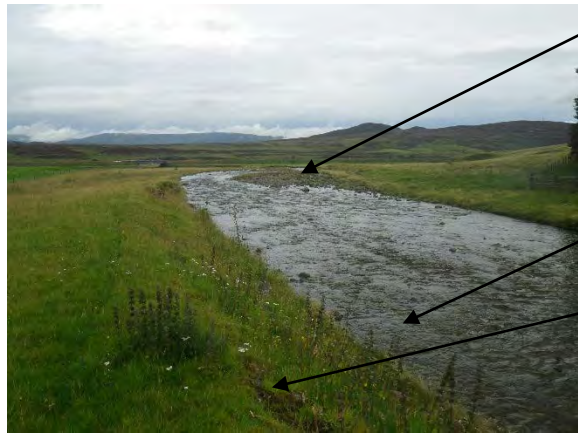
Photograph 11.4.3.78-Downstream

Cobble bar

Plane bed channel

Steep vegetated banks

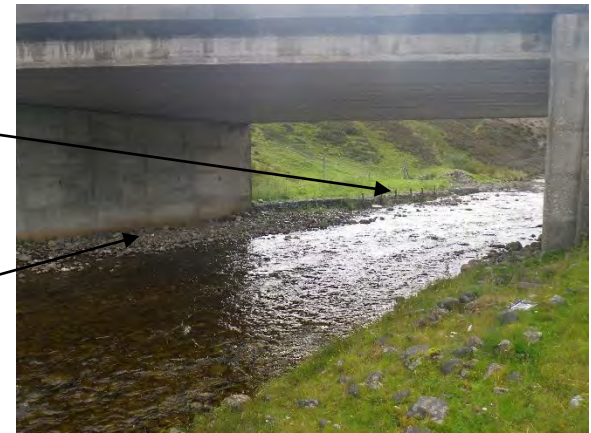
Gabion bank defence

Some deposition

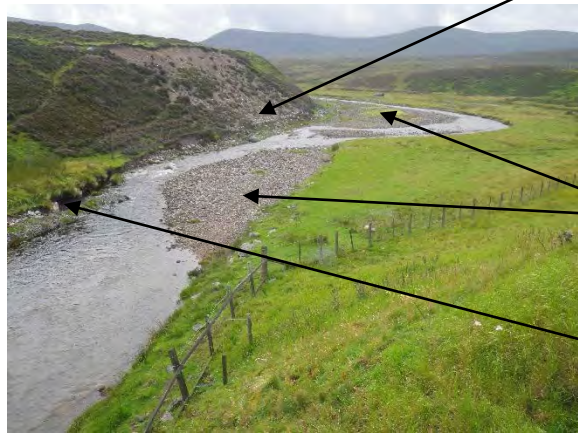
Photograph 11.4.3.81- Upstream

Erosion of valley side toe causing shallow slope failure

Bars formed due to local sediment supply

Bank erosion

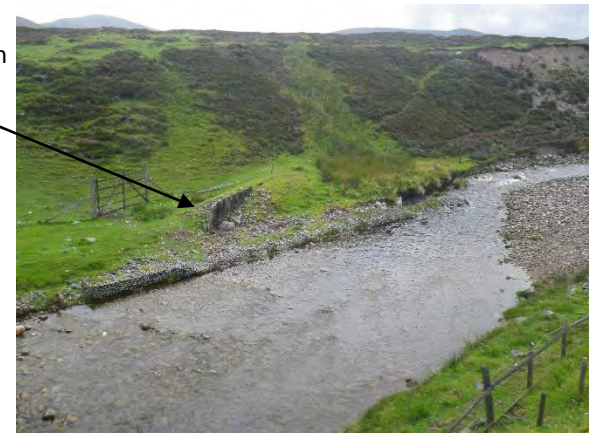
Photograph 11.4.3.82- Upstream

Flow deflection to keep flow under bridge

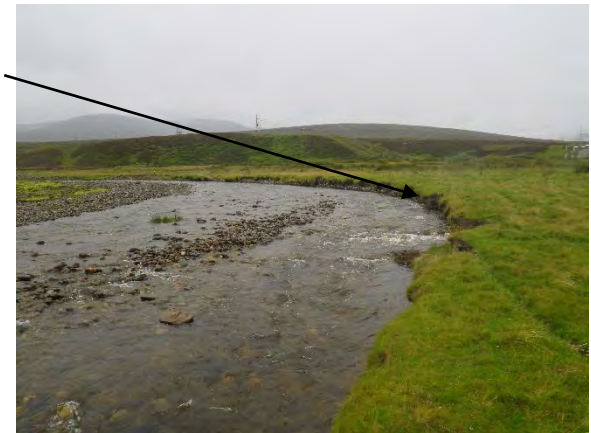
Photograph 11.4.3.84- Upstream

Erosion on outside of bend

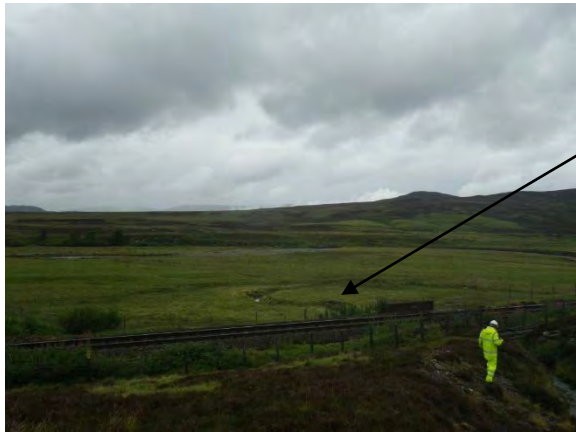
Photograph 11.4.3.91 -Downstream

Flat open floodplain

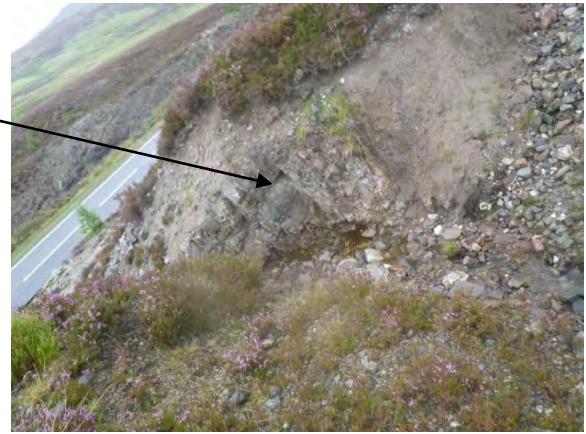
Photograph 11.4.3.100- Upstream of cascade

Bank instability
and erosion
caused by
channel
incision

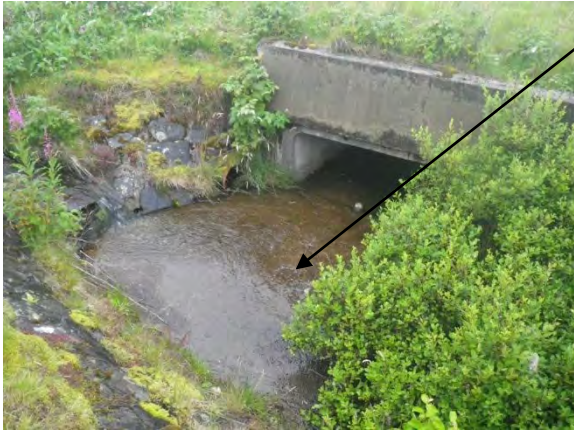
Photograph 11.4.3.104-Entrance to crossing

Concrete bed

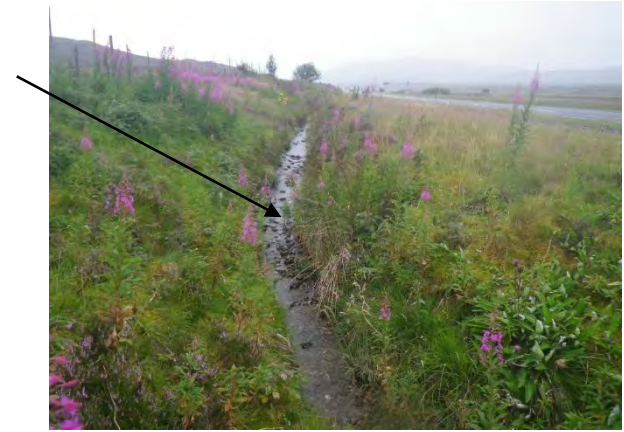
Photograph 11.4.3.105-Channel

Gravel in channel

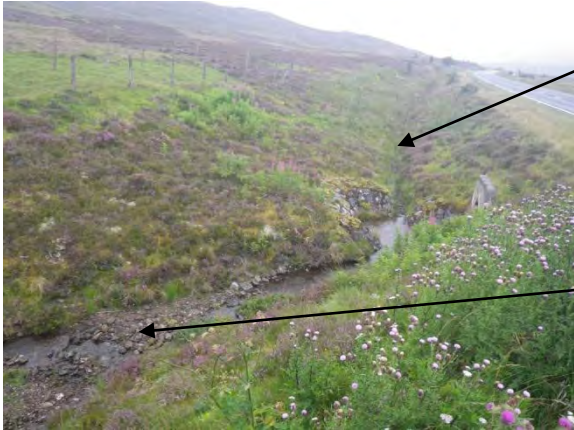
Photograph 208

Road drain
joining
channel

Small scale
gravel
deposition
