# Appendix 11.4

## Hydromorphology Assessment Part 2

## Annex 11.4.4 Hydromorphology Catchment Baselines

**Annex 11.4.3 - Hydromorphological Catchment Assessment - -3**

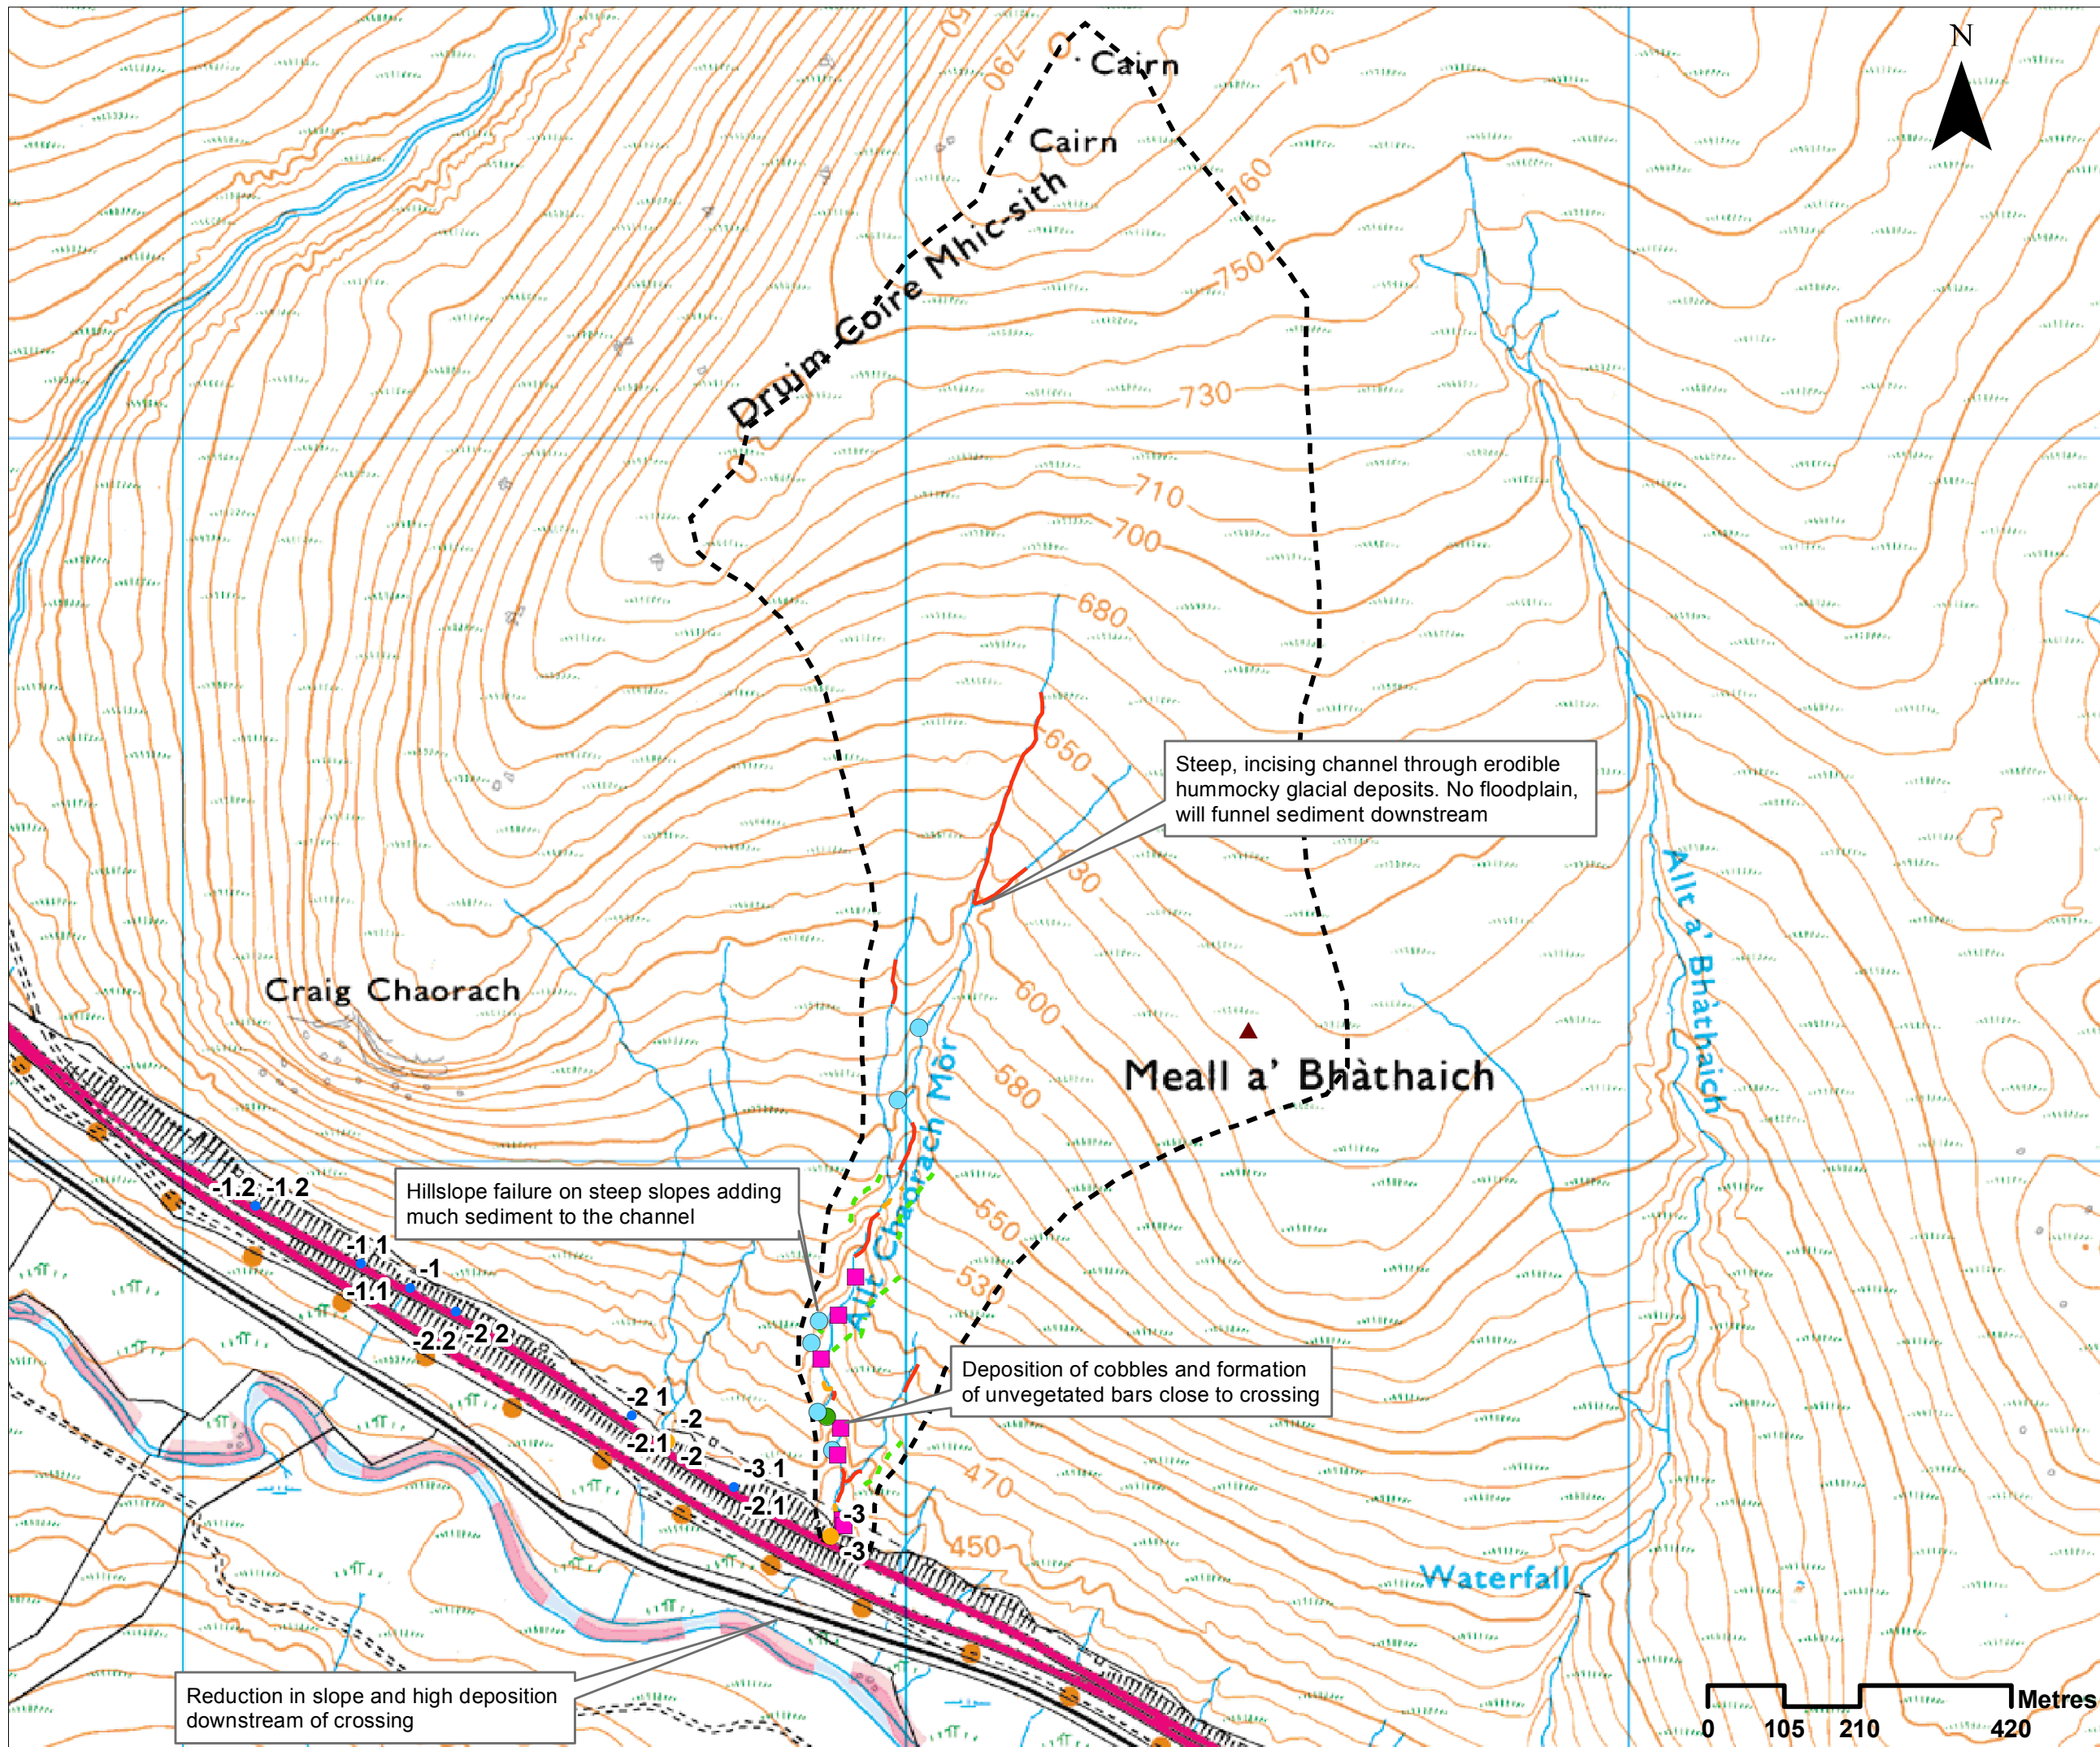
**PROJECT 7 GLEN GARRY TO DALWHINNIE EIA**  
**DRAWING 11.4.3.2. Catchment -3 Baseline Assessment**

Steep, incising channel through erodible hummocky glacial deposits. No floodplain, will funnel sediment downstream

Hillslope failure on steep slopes adding much sediment to the channel

Deposition of cobbles and formation of unvegetated bars close to crossing

Reduction in slope and high deposition downstream of crossing

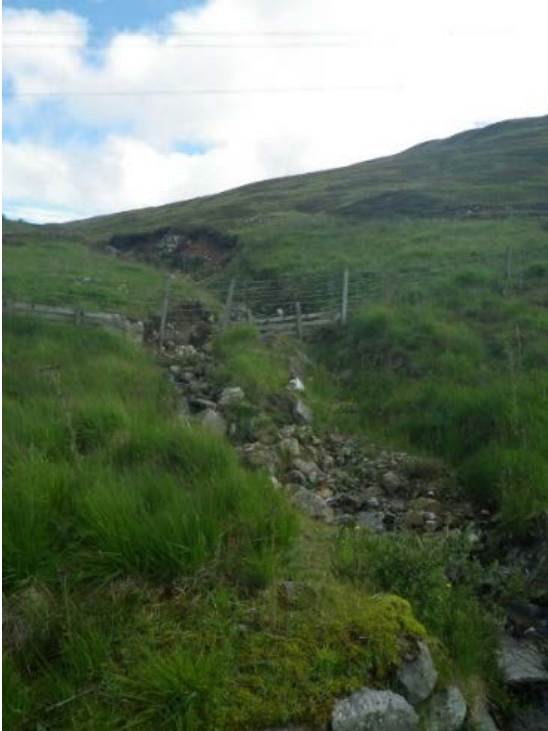
Photograph 11.4.3.1- Erosion upstream of crossing producing excess sediment

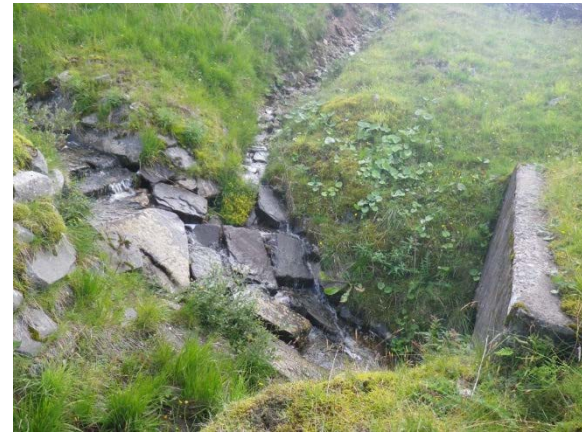
Photograph 11.4.3.2 – Culvert entrance

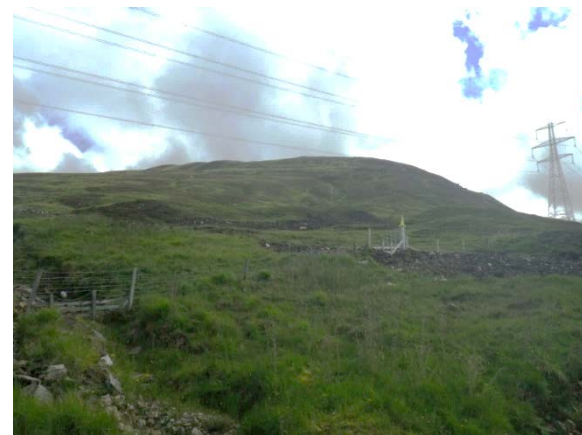
Photograph 11.4.3.3 Steep valley sides with multiple small channels

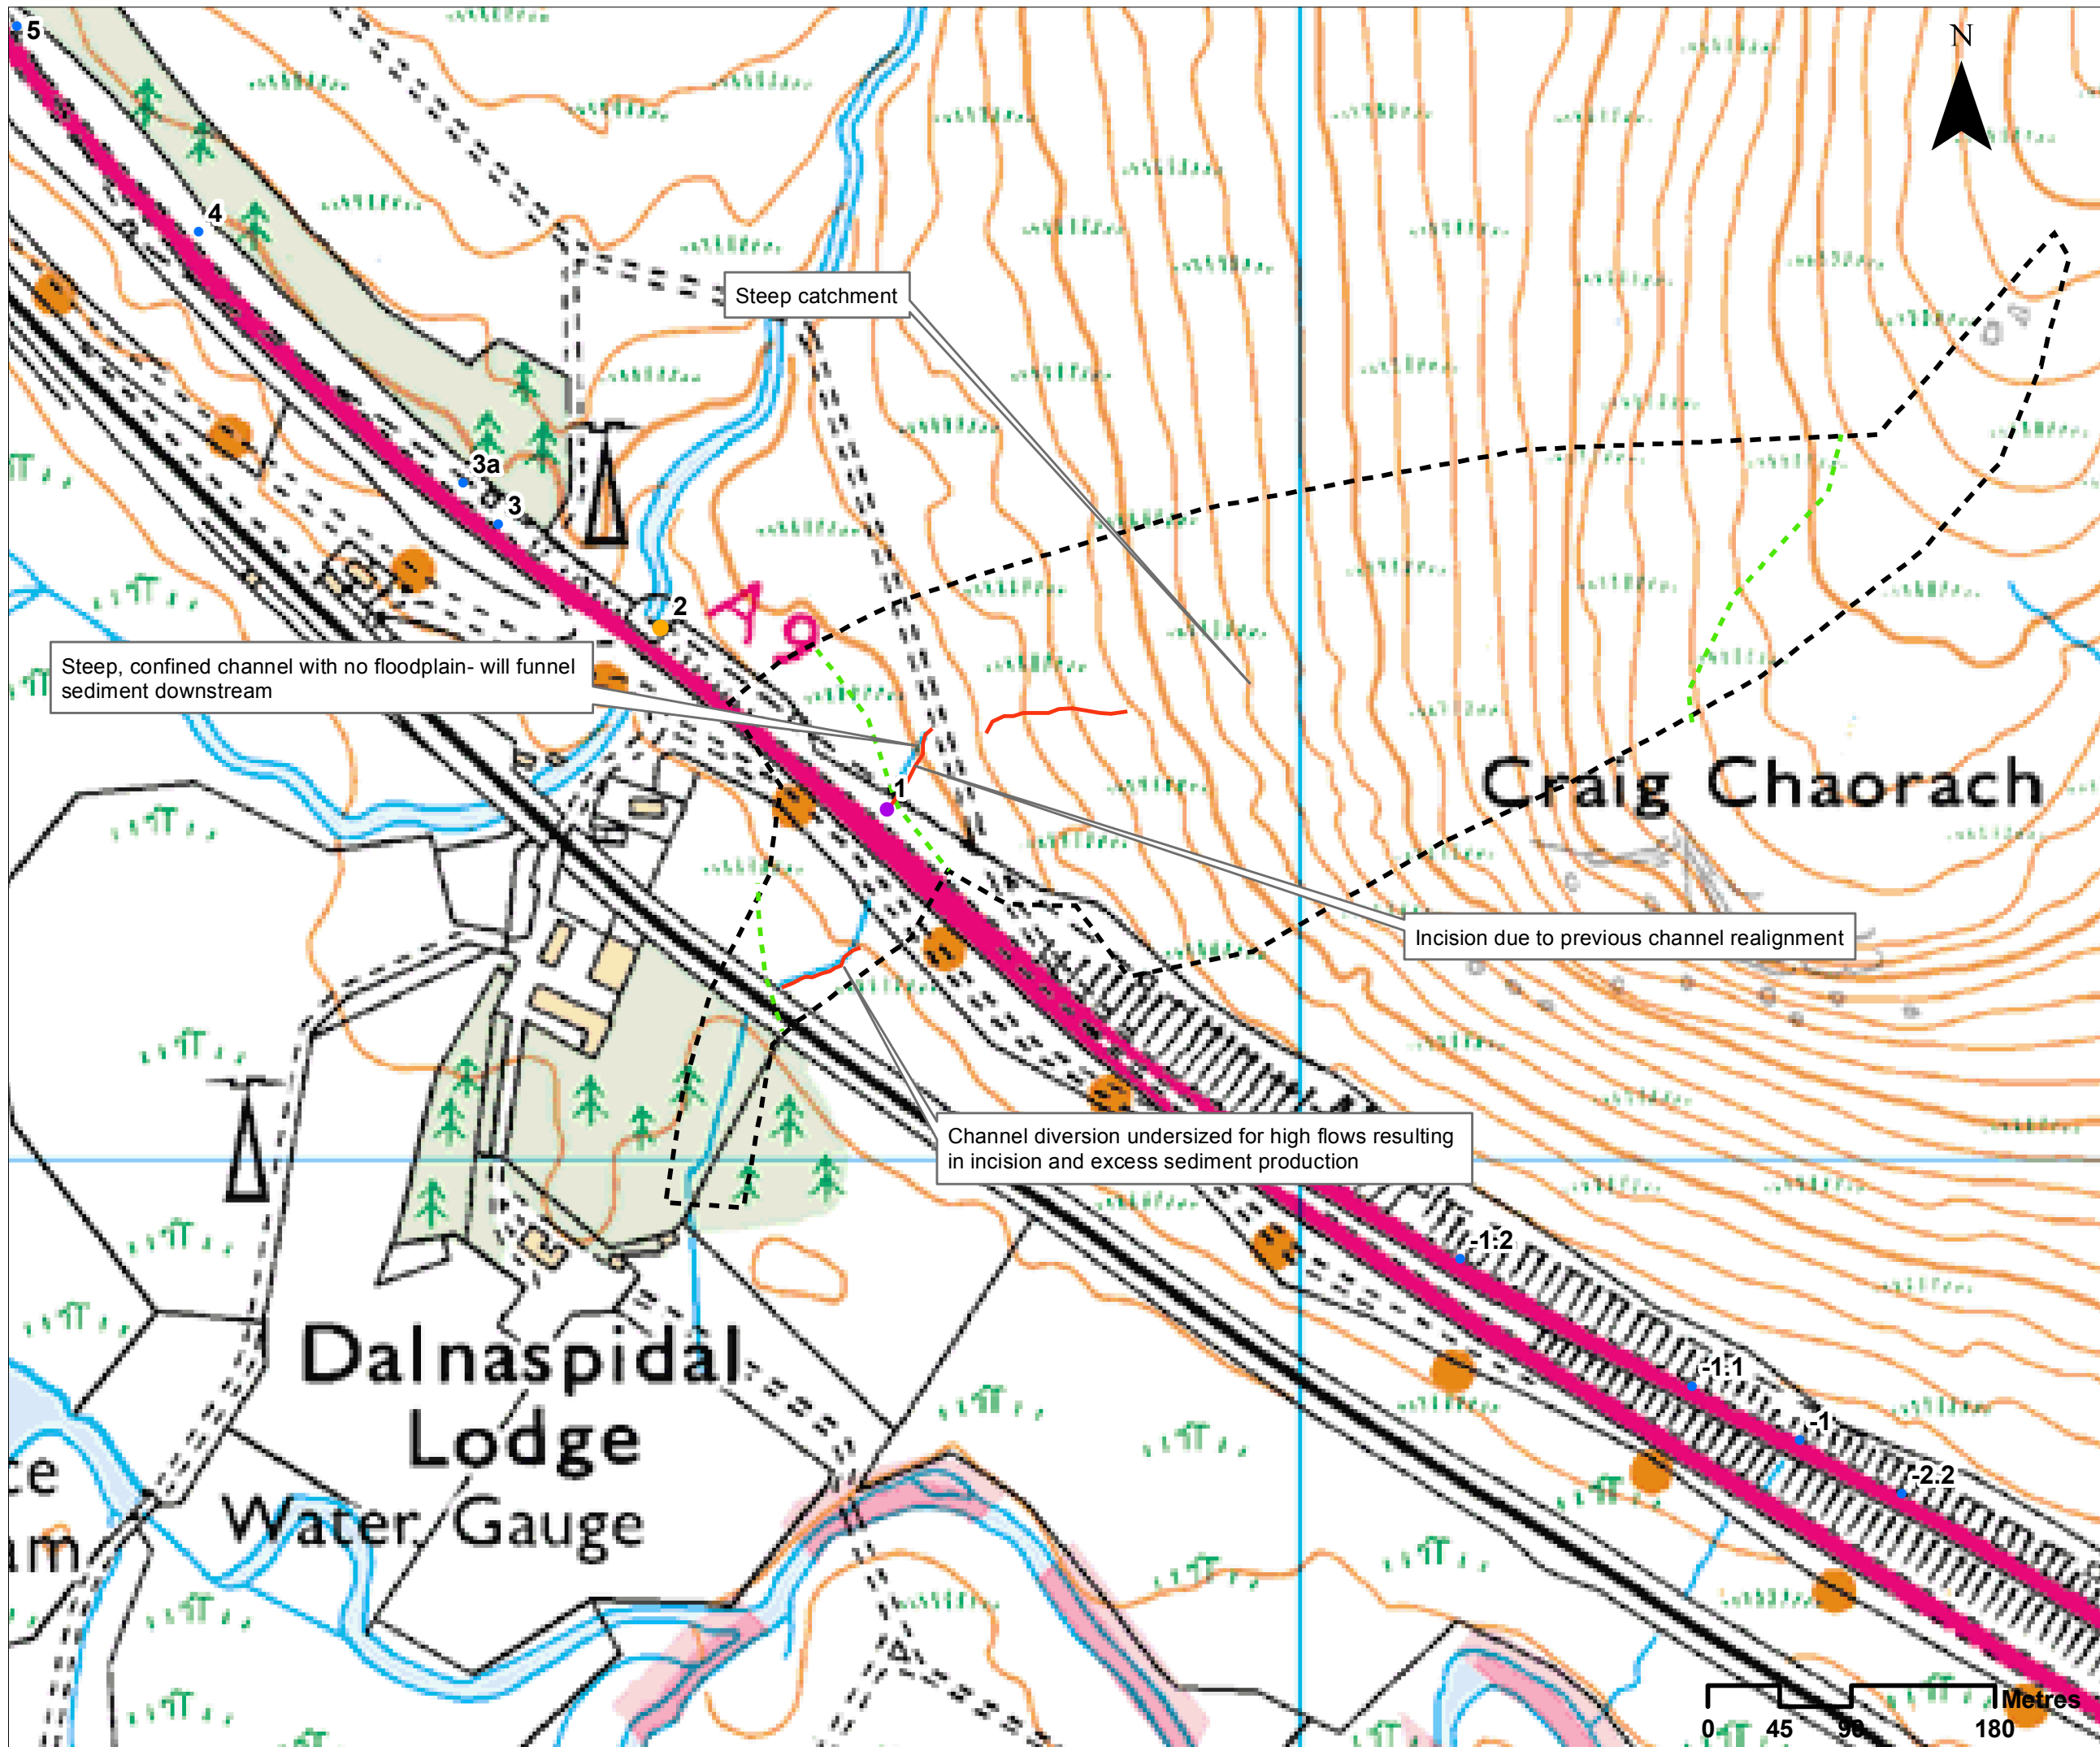
**PROJECT 7 GLEN GARRY TO DALWHINNIE EIA**  
**DRAWING 11.4.3.2. Catchment 1 Baseline Assessment**

Steep, confined channel with no floodplain- will funnel sediment downstream

Incision due to previous channel realignment

Channel diversion undersized for high flows resulting in incision and excess sediment production

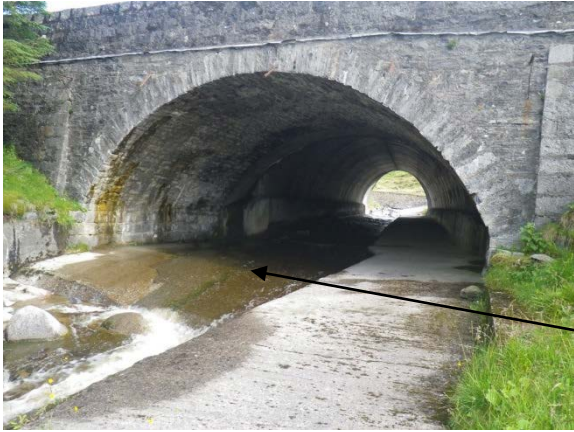
Concrete bed

Photograph 11.4.3.4- Crossing exit

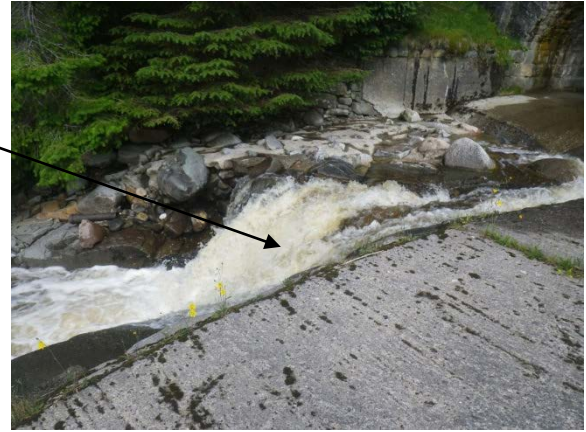
Scour to bed

Photograph 11.4.3.5-Scour creating step in bed downstream of crossing

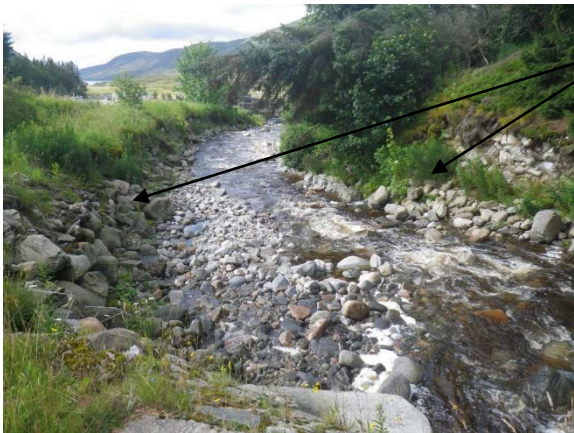
Steep boulder banks

Photograph 11.4.3.6 -Incision of channel

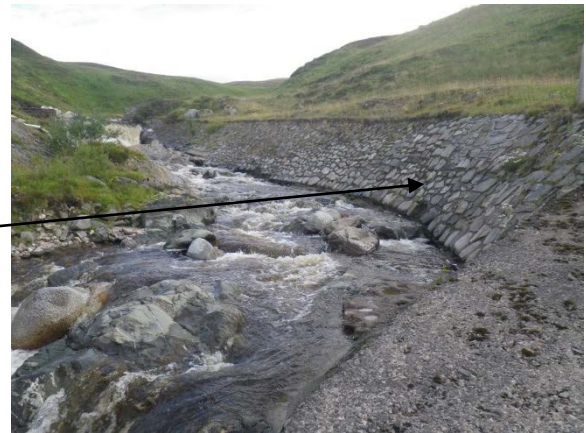
Steep pitched banks

Photograph 11.4.3.7 -Upstream of crossing

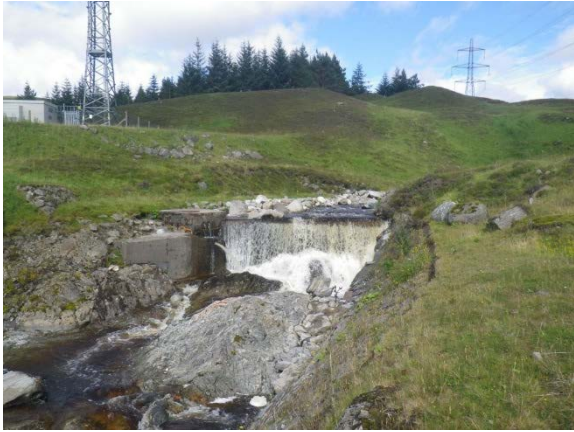
Photograph 11.4.3.8 -Weir upstream of crossing

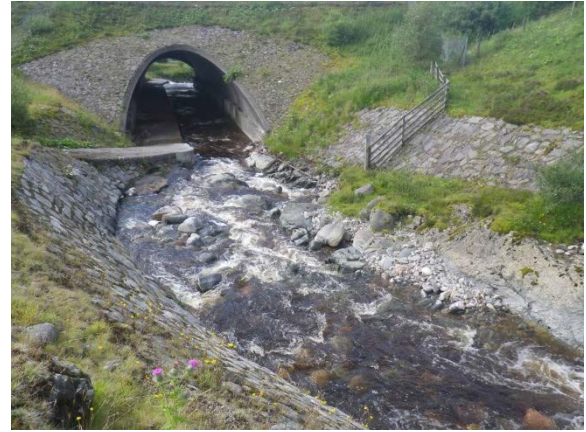
Photograph 11.4.3.9 -Upstream entrance to crossing

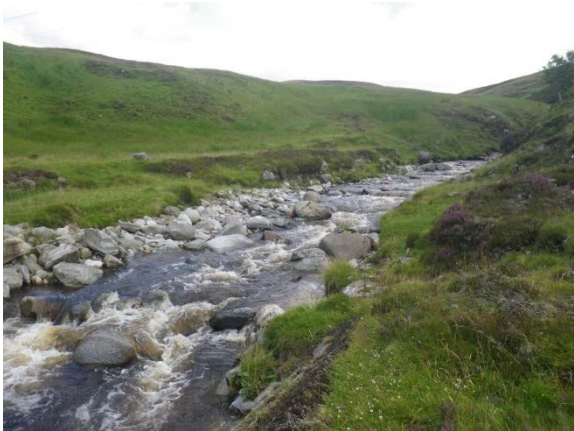
Photograph 11.4.3.10 -Cascade upstream of weir

Undercut concrete  
Upstream of weir

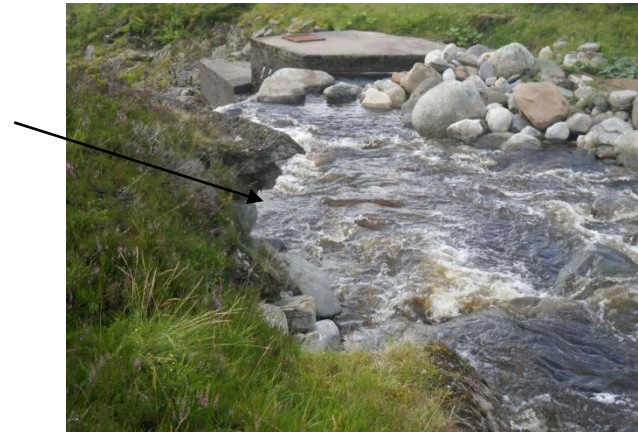
Photograph 11.4.3.11-Looking downstream

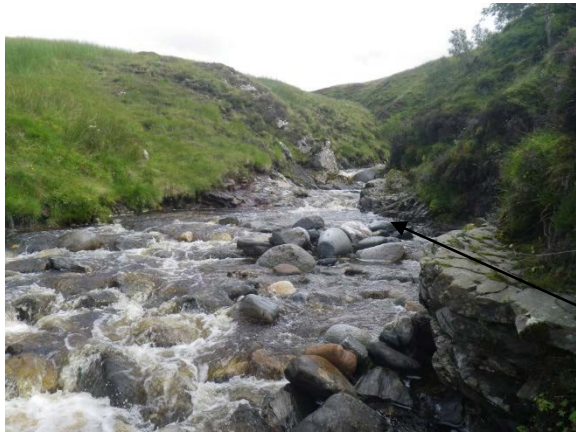
Undercutting

Photograph 11.4.3.12- Upstream, Upstream of crossing

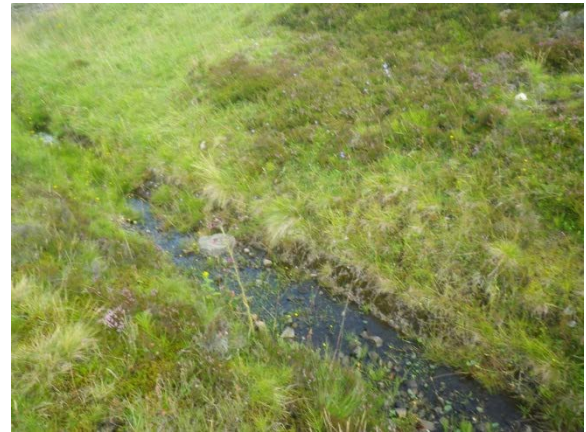
Photograph 11.4.3.13 -Drainage into crossing 2

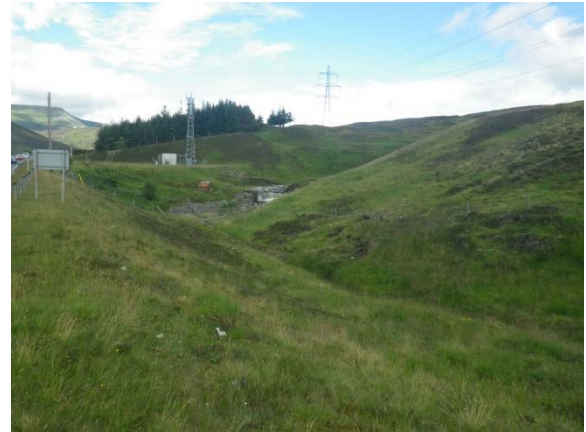
Photograph 11.4.3.15 -Drainage into crossing 2

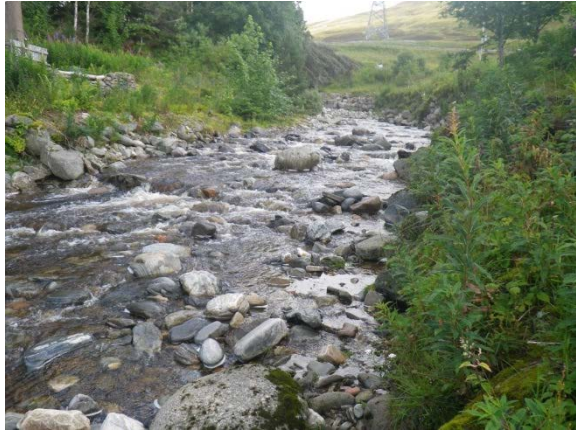
Photograph 11.4.3.16 Upstream cascade morphology

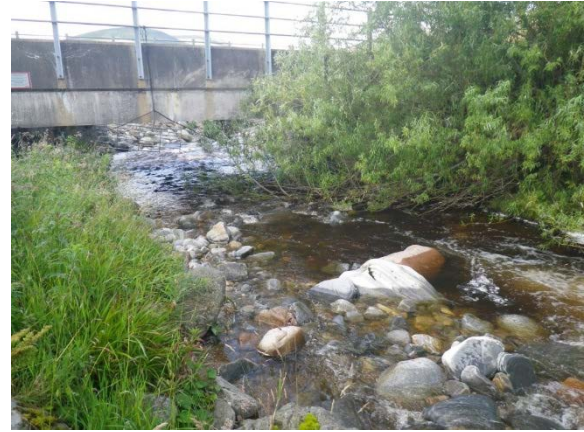
Photograph 11.4.3.17 downstream to railway crossing

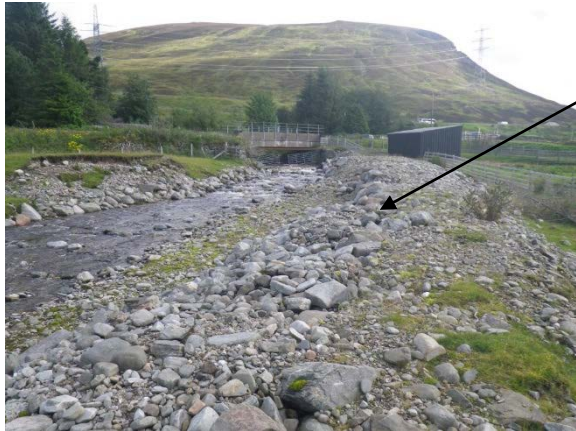
Embankment

Photograph 11.4.3.18 -Upstream to railway crossing

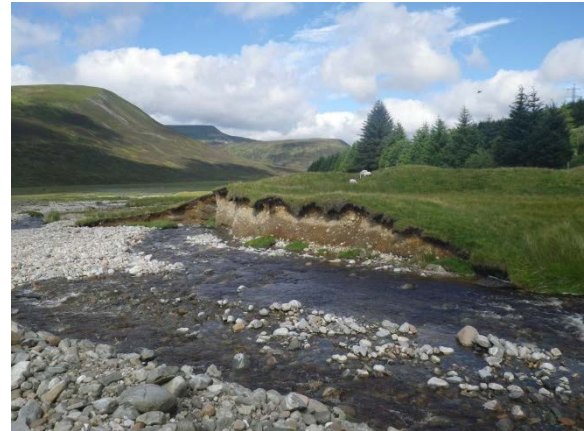
Photograph 11.4.3.19- Erosion of right bank side

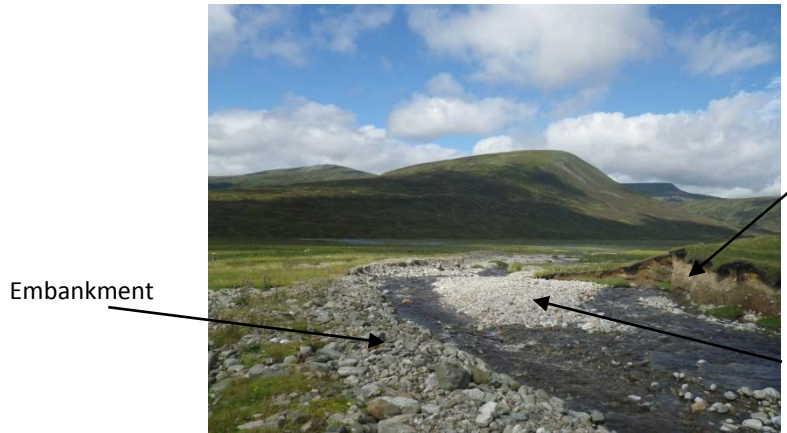
Embankment

Erosion to right bank

Boulder /cobble bar

Photograph 11.4.3.20 Downstream

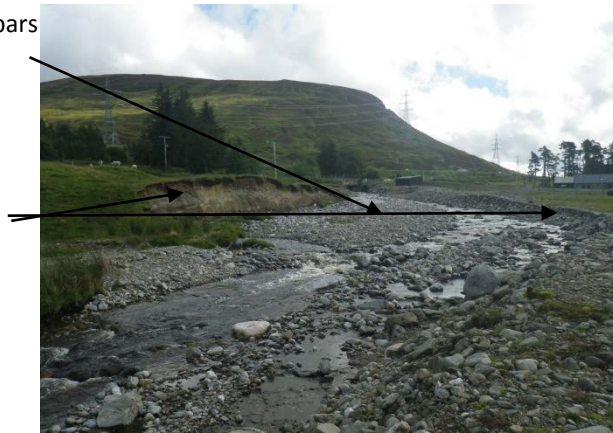
Deposition forming bars

Erosion to banks

Photograph 11.4.3.21 -Upstream

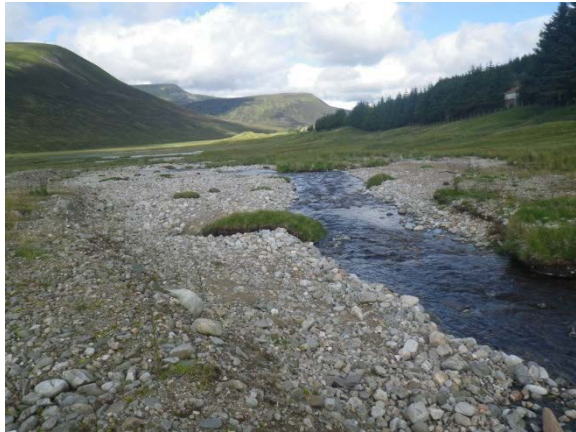
Photograph 11.4.3.22- Downstream deposition, with channel cut through

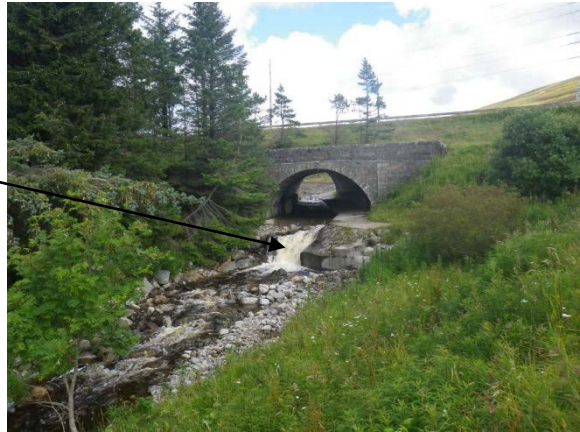
Change in bed level

Photograph 11.4.3.23-Upstream to crossing

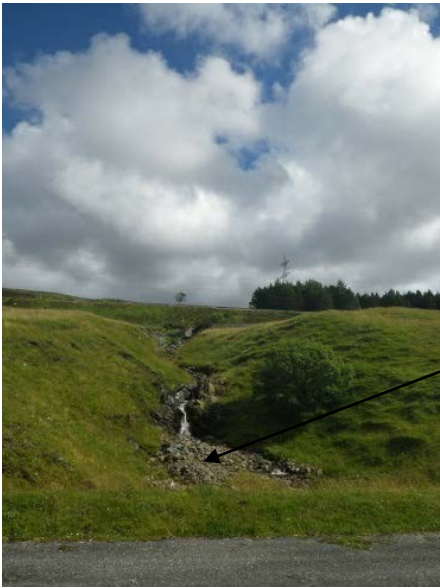
Deposition on entrance to NMU crossing

Photograph 11.4.3.24-Crossing exit

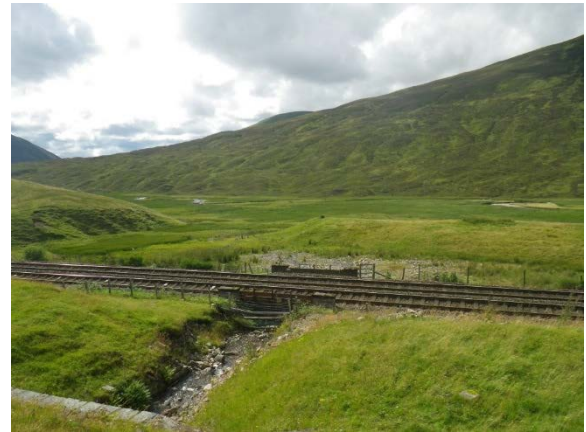
Photograph 11.4.3.25-Downstream to railway crossing

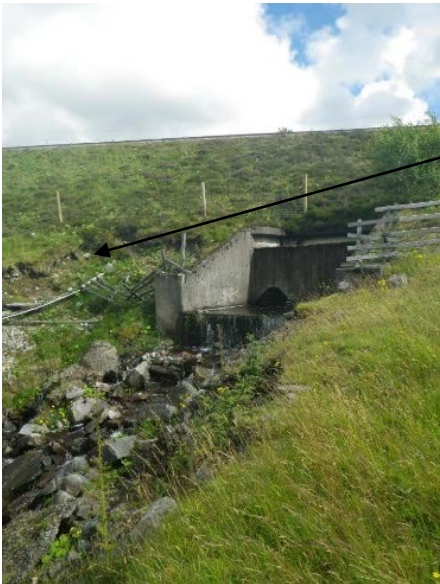
Some scour

Photograph 11.4.3.26- Crossing exit

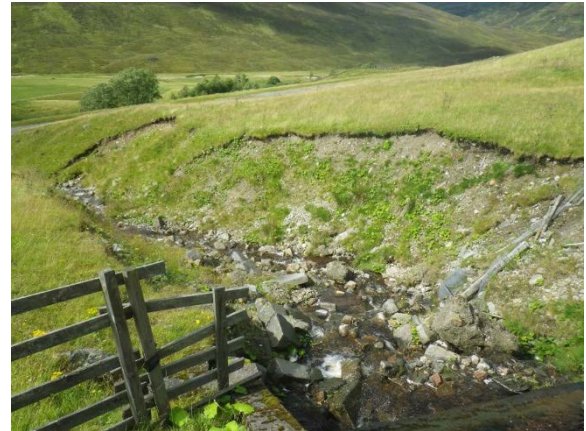
Photograph 11.4.3.27-Downstream bank instability due to channel insision

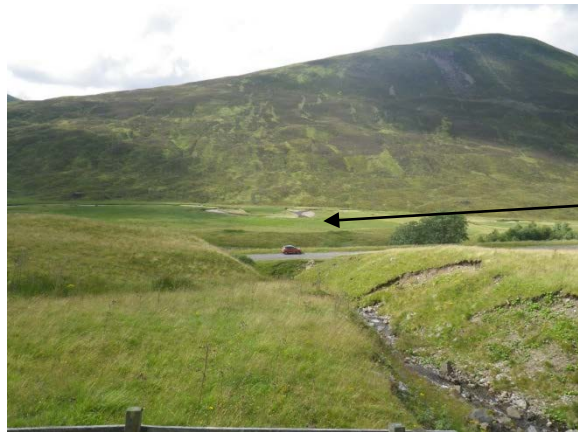
Photograph 11.4.3.28- Downstream

Slope drainage entering  
in concrete channel  
before crossing

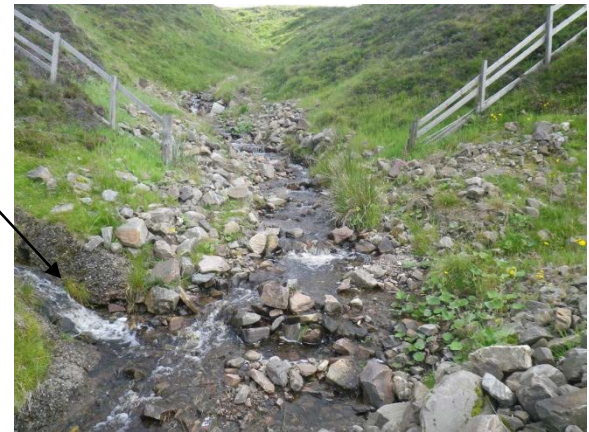
Flat and open floodplain

Photograph 11.4.3.29- Upstream

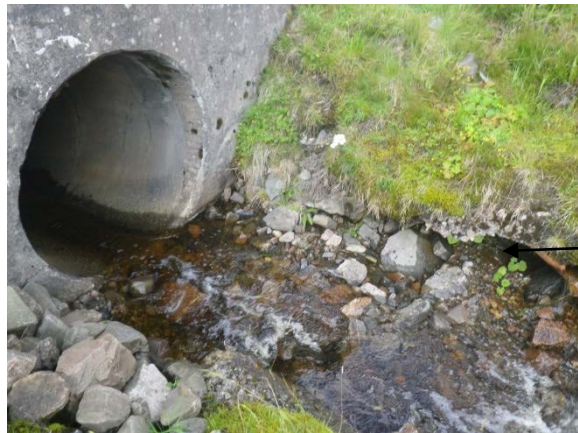
Photograph 11.4.3.30-Crossing entrance

Localised scour at  
entrance

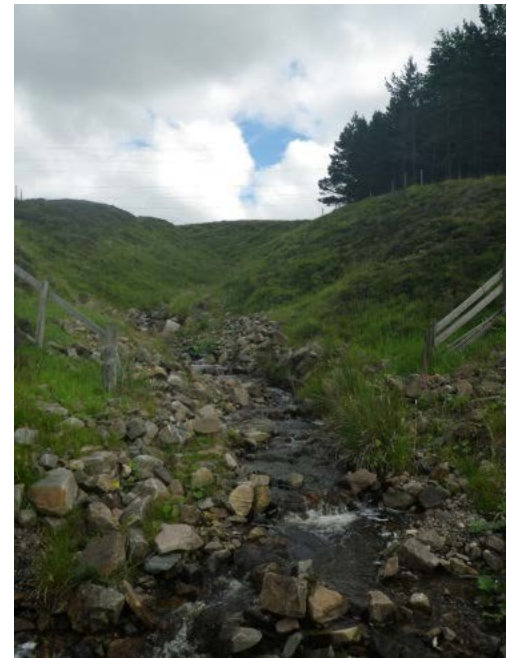
Photograph 11.4.3.31-Upstream,  
confined channel

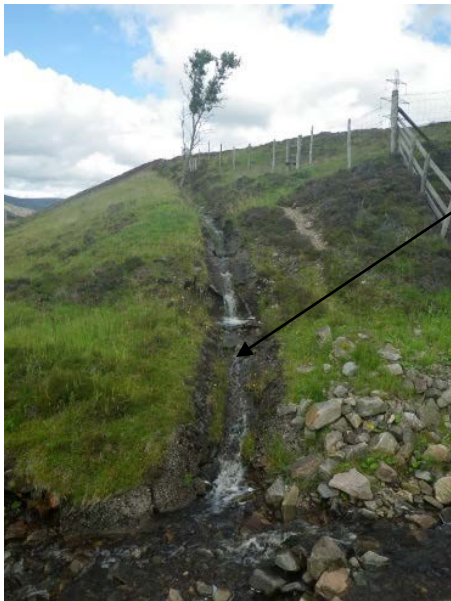
Scour and nick point erosion

Photograph 11.4.3.32-Steep drain inflow in concrete channel

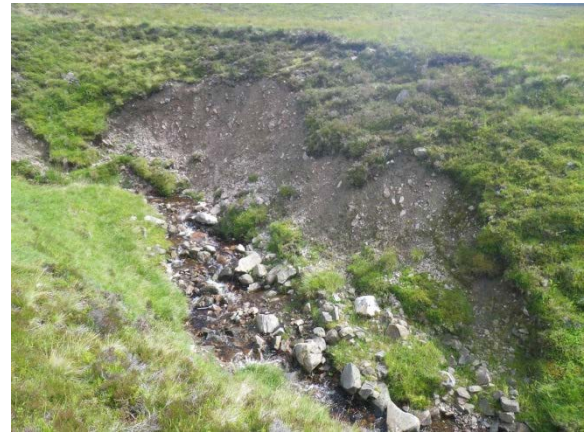
Photograph 11.4.3.33- Erosion of valley side

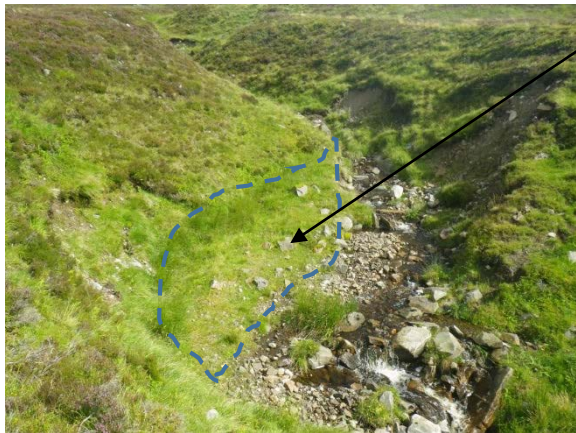
Small floodplain segment

Photograph 11.4.3.34- Upstream, channel incising

Floodplain segments

Smaller channel than downstream

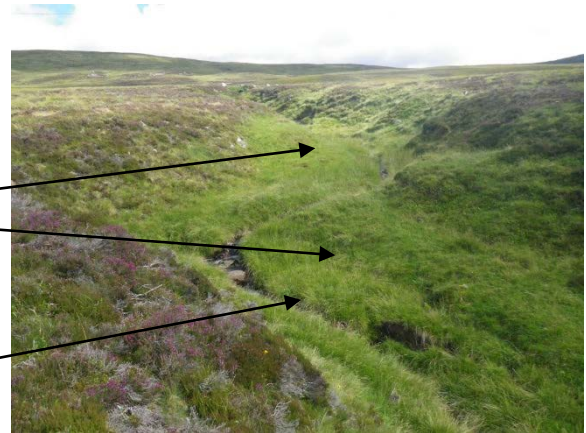
Photograph 11.4.3.35-Upstream, Stable channel

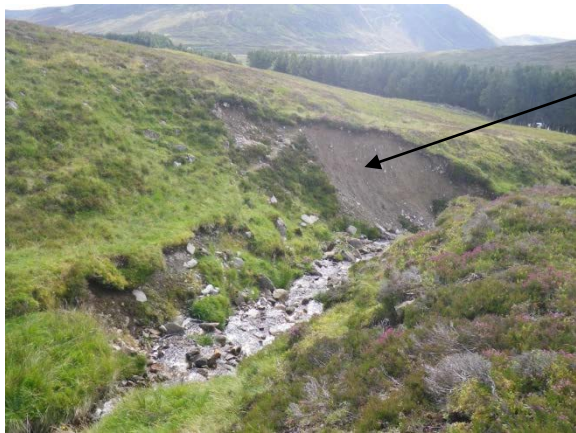
Erosion of valley side

Photograph 11.4.3.36- Incising channel

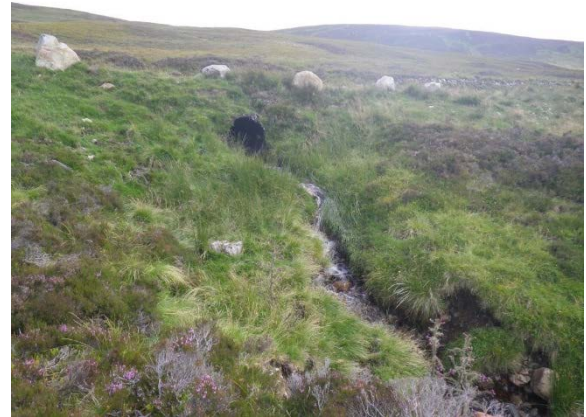
Photograph 11.4.3.37- Pipe under track
