Appendix 11.4

Hydromorphology
Assessment Part 4

Annex 11.4.4-Hydromorphological Catchment Assessment-159

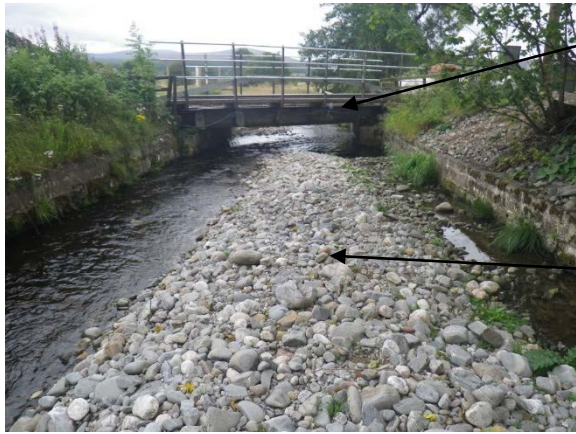
Photograph 11.4.4.54- Downstream

Deposition in channel

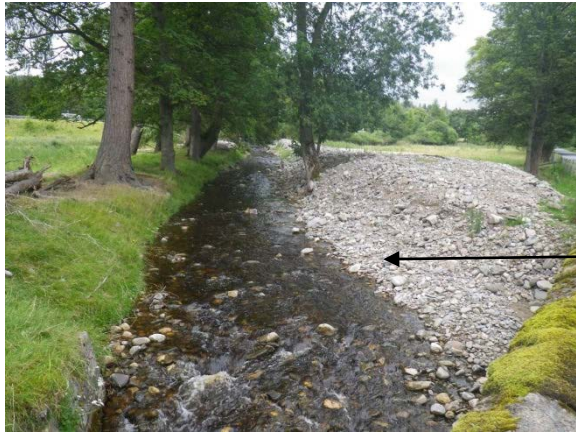
Photograph 11.4.4.56- Upstream

Deposition in channel and over banks occurring as high flows impound on road bridge

Embankment on right hand channel bank

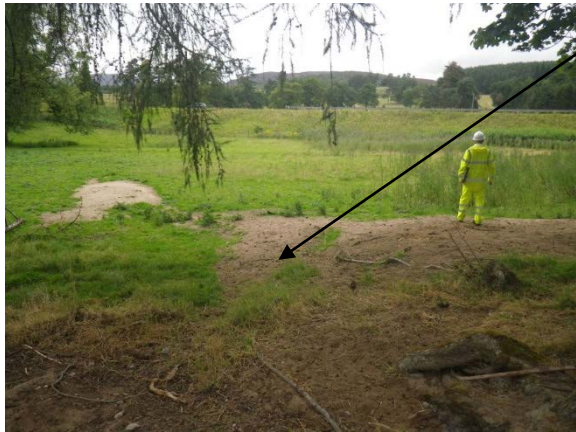
Photograph 11.4.4.58

Overbank
fines

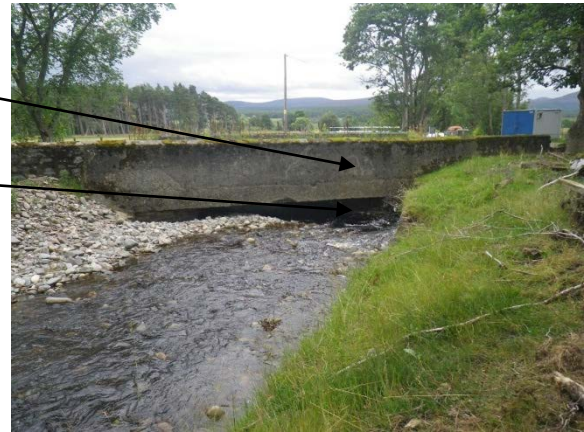
Photograph 11.4.4.59- Downstream

Little clearance

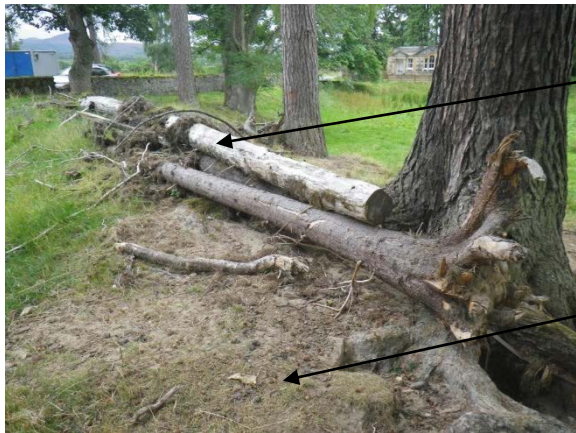
Photograph 11.4.4.60

Large woody
debris
deposited
during flood
event

Overbank
fines

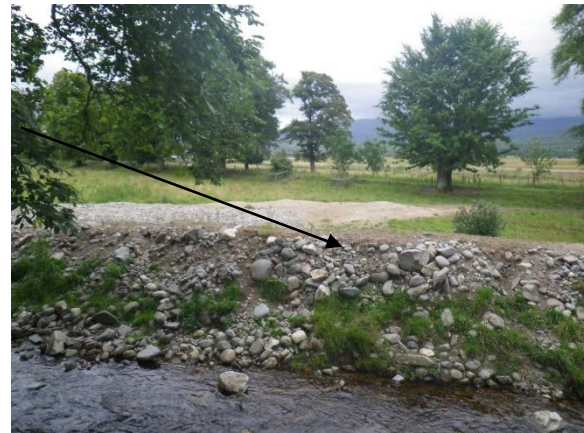
Photograph 11.4.4.61

Channel dredged
and arising put on
bank top,
reducing channel-
floodplain
connection

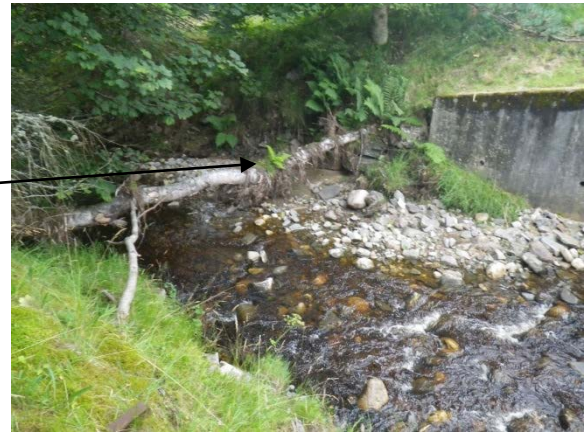
Photograph 11.4.4.63

Woody debris at crossing exit

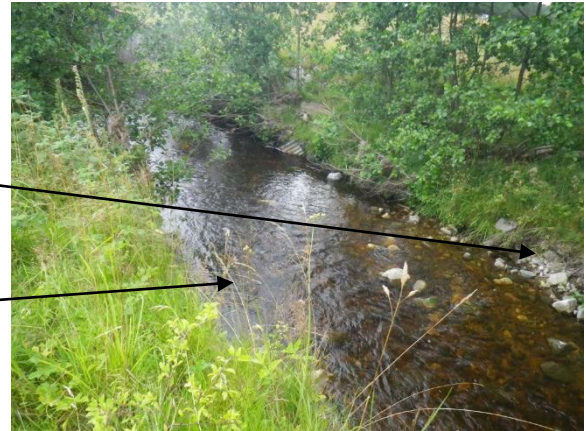
Photograph 11.4.4.65- Downstream

Bank scour

Plane bed morphology

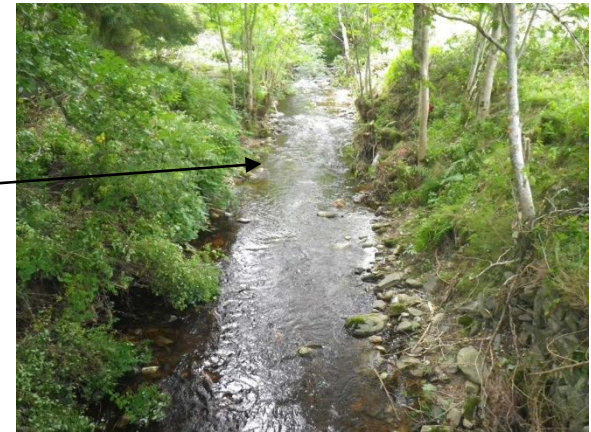
Photograph 11.4.4.67

Woody debris at
crossing exit
