FORTH REPLACEMENT CROSSING

**AIR QUALITY MONITORING REPORT
 APRIL 2014**

REP-00175-00

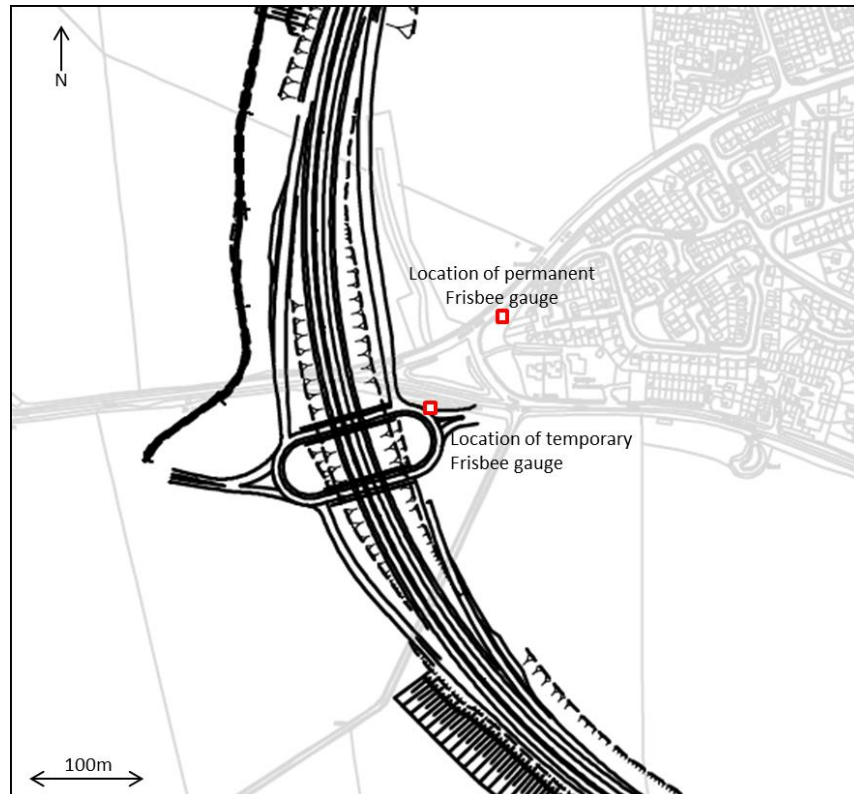
Figure 3: Location of additional temporary Frisbee gauge (Echline Corner)

- 3.1.3.** The period of the 16th – 17th April saw a rise above the review level of the Echline, Inchgarvie Lodge and Clufflat monitors. During this period there were mechanical issues with the bowser located on the South Network which is used to dampen bare ground on site for dust suppression. Issues were also experienced relating to the access of water from the Forth Estuary and SUDs ponds on site. As a result dust suppression measures for the gyratory area adjacent to the A904 were compromised. This combined with the earthworks and heavy vehicle movements that were taking place in the area resulted in increased levels of dust directly upwind of the three monitors in question. Inspections by members of the Environmental Department confirmed the high levels of dust around the gyratory area. The Whinny Hill and Scotstoun monitors also showed increased levels, although these remained below the review level. After reviewing the works taking place at Scotstoun and Whinny Hill it was concluded that no works that may give rise to dust were taking place. This suggests that background levels were raised in general across site during this period. However it is believed that due to the failure of the mitigation methods noted above the increase at Echline, Inchgarvie Lodge and Clufflat was caused by FCBC activities.

- 3.1.4.** As a result of the issues experienced with the mitigation methods during the 16th - 17th April a review of the procedures for dust suppression was undertaken for the area of the gyratory and the wider South Networks region. A new hydrant was installed to guarantee access to water in the case that abstraction from the estuary or SUDs ponds is not possible. Furthermore a review of dust suppression and works activities for the coming months was undertaken to reduce the likelihood of such an incident occurring again. FCBC's Environmental Department have also installed an extra Frisbee gauge adjacent to the A904 (Echline Corner) to monitor dust levels in the area and is conducting regular inspections at this location to ensure construction activities are not causing increased levels of dust. The additional monitor will remain in

place over the summer and its location and necessity will be reviewed on a monthly basis.

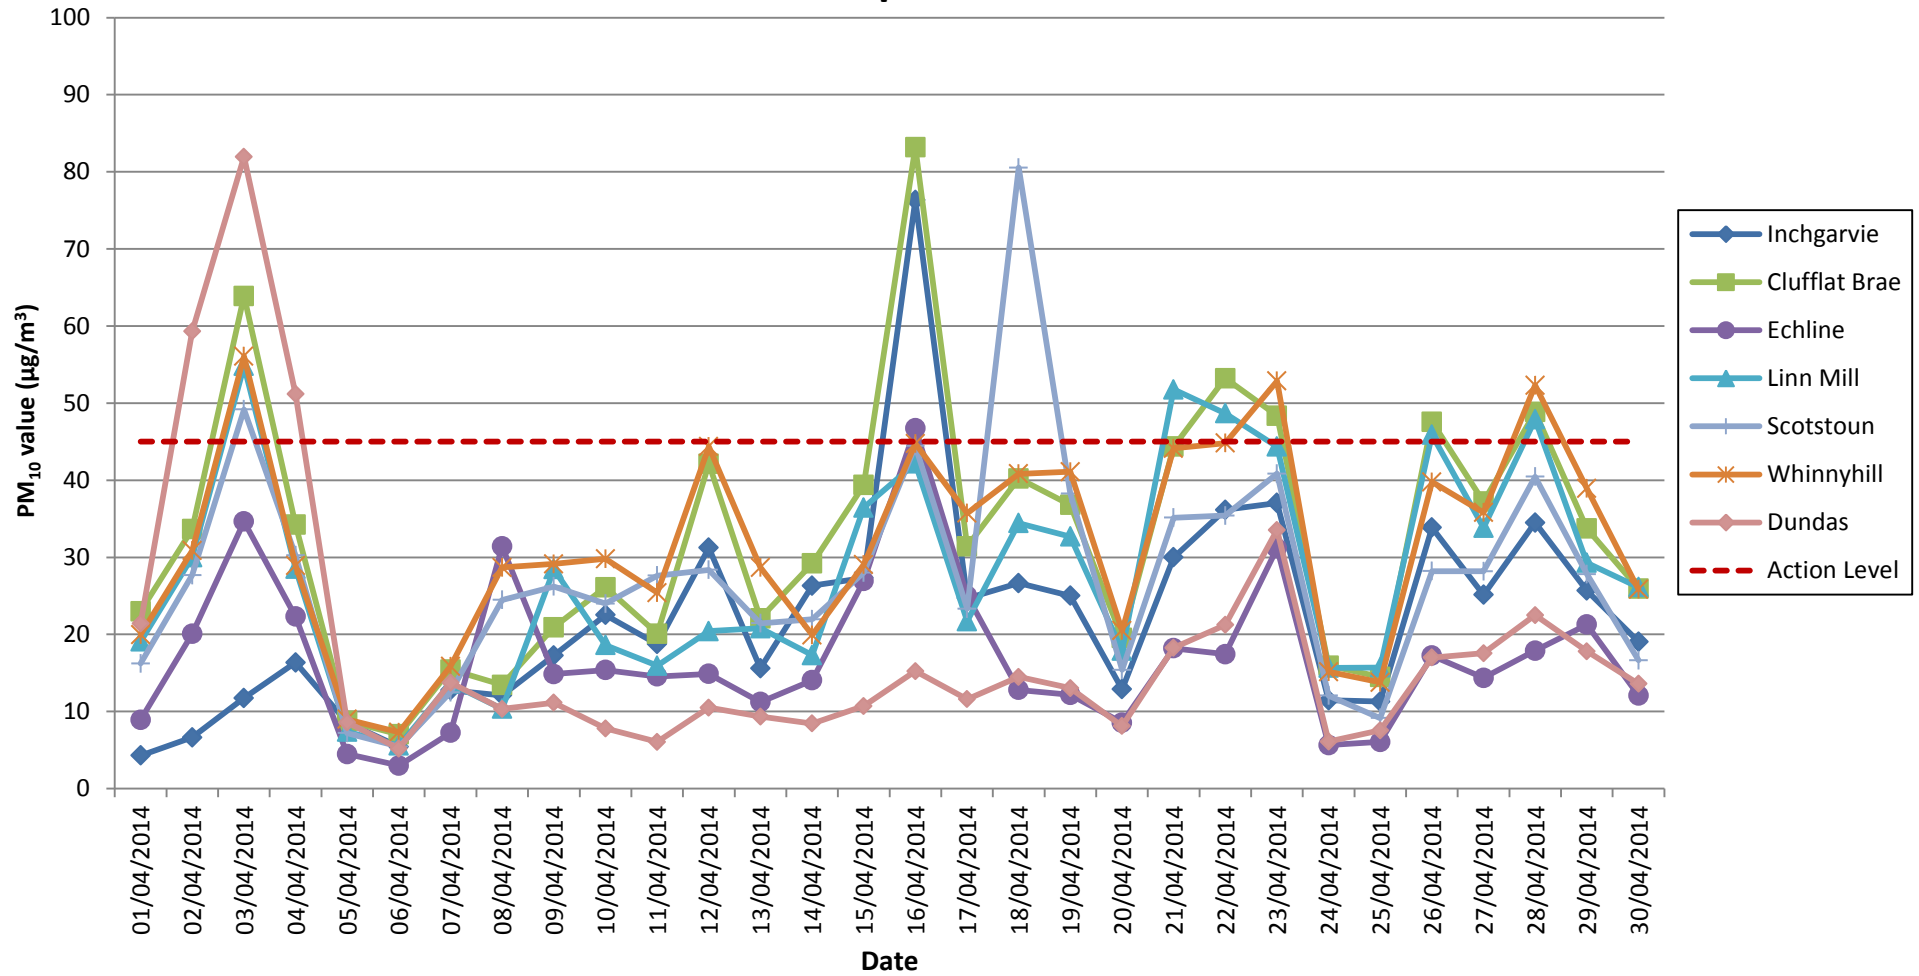
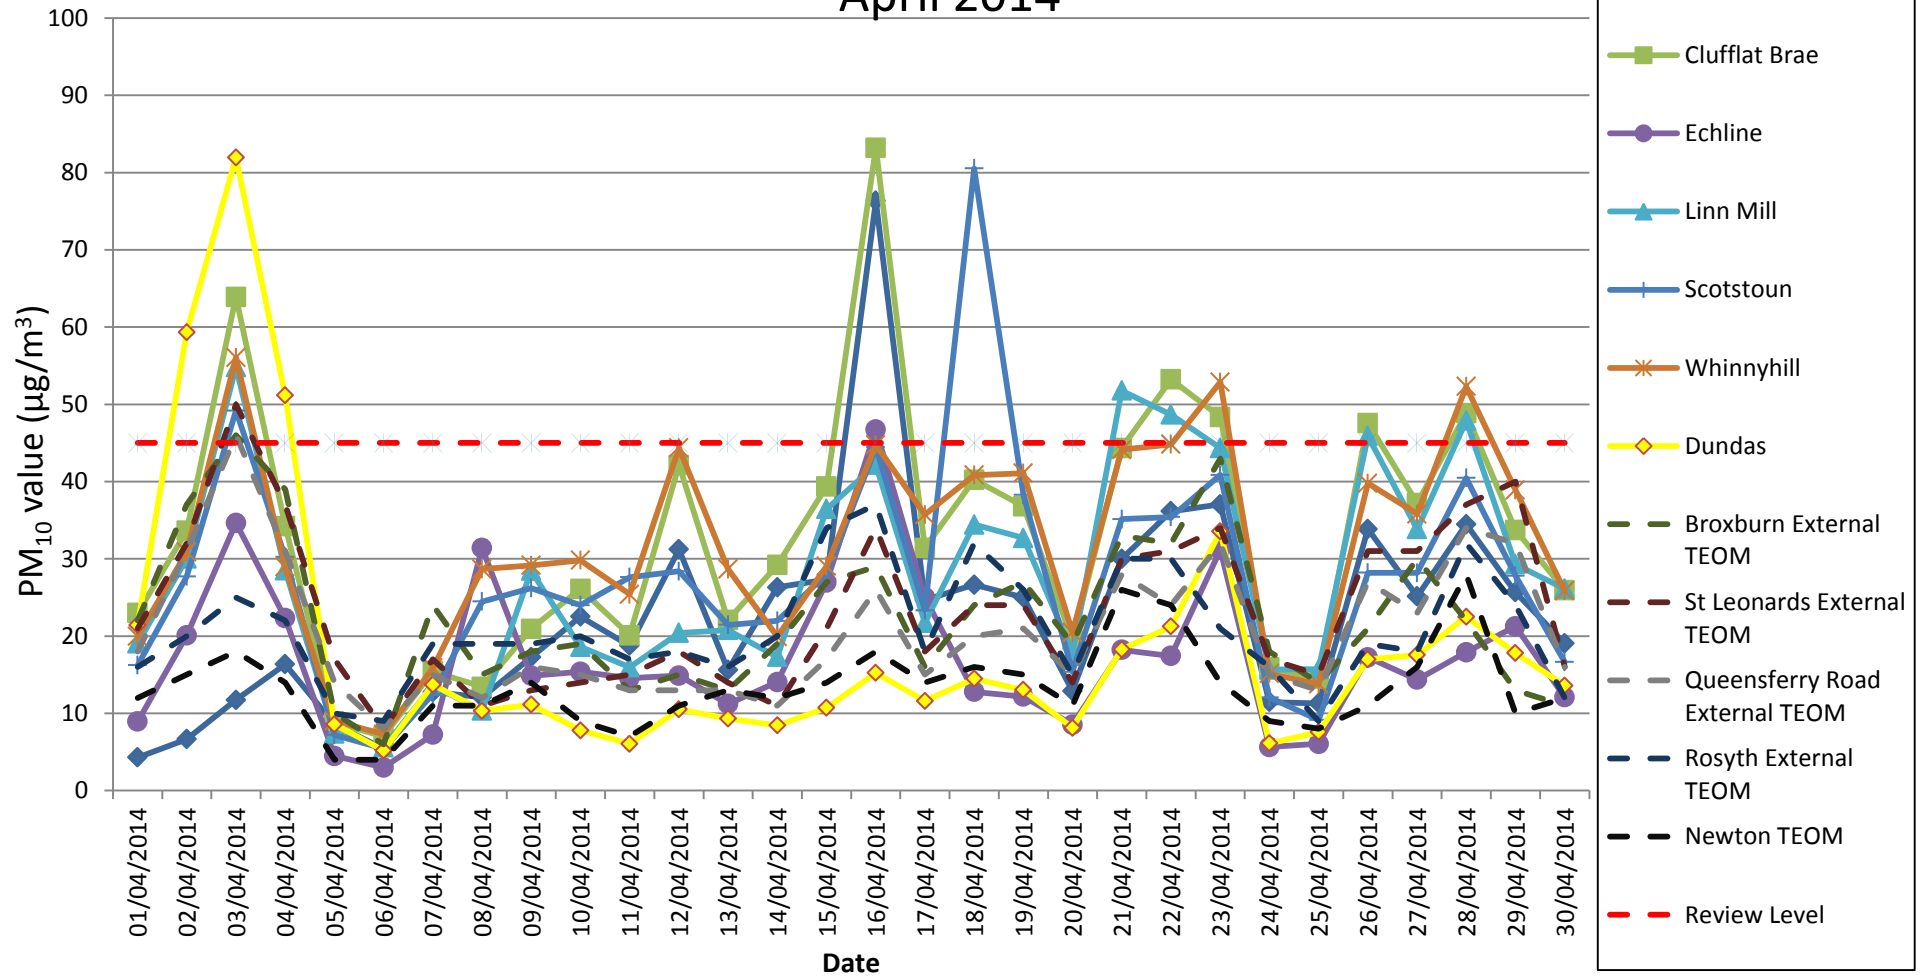
Air Quality Monitoring: Particulate Matter (PM10) Results for all Monitoring Locations, including TEOM data

3.1.1. Light scatter results for April 2014 have been presented in a monthly chart; this can be found in Appendix A. Results show that the PM₁₀ levels were below threshold levels throughout the month with the exception of four periods. All monitors showed an increase during 2nd - 4th, 16th - 17th, 21st - 23rd and 26th - 28th April. On each of these occasions a number of monitors exceeded the review level. All monitors with the exception of Inchgarvie Lodge exceeded the review level on one or more days during April. All 7 monitors follow the same general pattern throughout the month.

3.1.2. It was noted that foggy conditions occurred during the periods in question starting 2nd, 21st and 26th April which can affect the meter readings (see section 2.2). Ground conditions during these periods were damp or wet throughout. One of the periods of raised levels also occurred during a weekend with limited works activity occurring on site (26th-28th). The fact that all 7 monitors showed the same pattern would suggest that a regional event affected the levels across the whole area rather than the increases being related to works activities in one specific area affecting only a few monitors. The PM₁₀ results have also been compared to the daily mean results obtained from the TEOM air quality monitoring stations located in Newton, Rosyth, and Broxburn, and from the TEOM FDMS stations located at Queensferry Road. The same increases in levels during these periods can be seen in this TEOM data,

confirming that the increases were likely to be caused by a regional event rather than localised works activities.

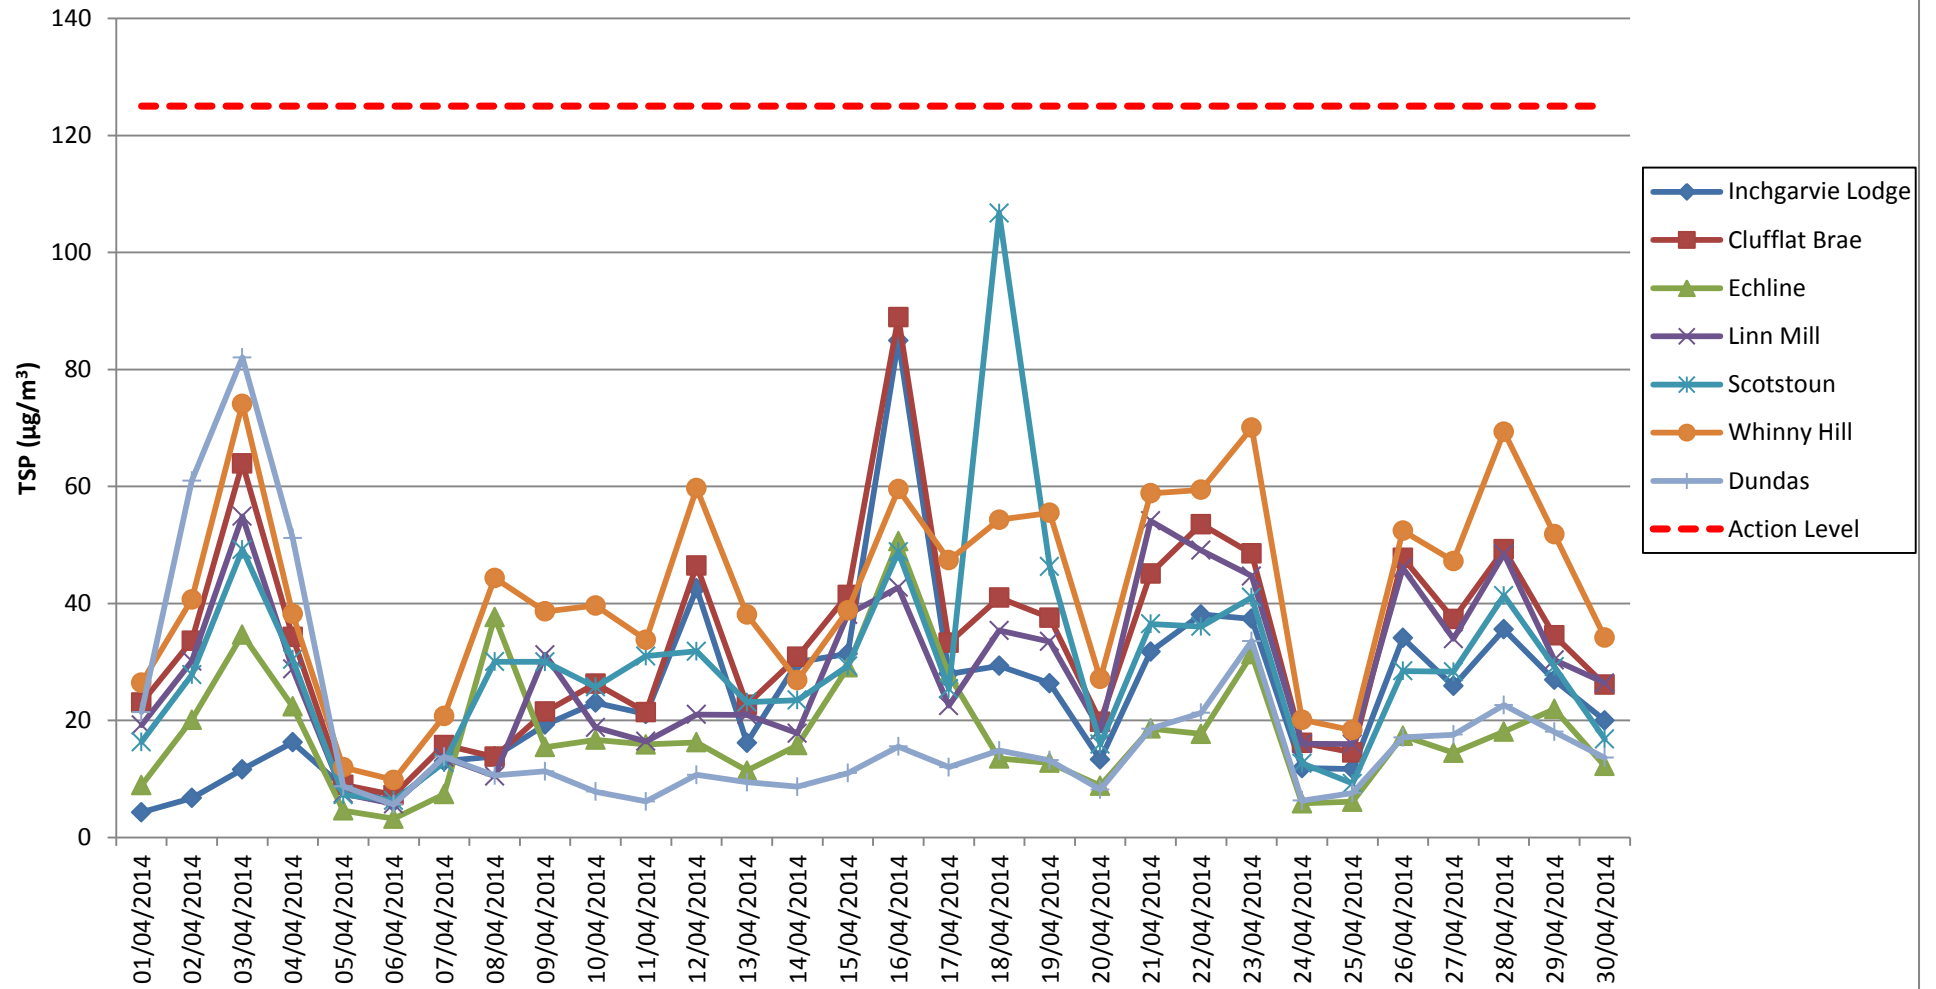
Total Suspended Particles (TSP) Results April 2014

3.2.1. The TSP results for April 2014 have been presented in a monthly chart; this can be found in Appendix B. The TSP levels at monitoring locations during April were found to be low and all within the threshold level. All locations were mostly found to follow a similar pattern across the site, demonstrating that, in general, the levels were influenced by regional changes in TSP levels, rather than construction works. During the period discussed in 3.1.3 the Inchgarvie Lodge, Clufflat Brae and Echline monitors see an increase similar to those seen in the PM₁₀ data though they never exceed the review level. Although a general increase can be observed at other locations on this day, the results together with the site observations would support the conclusions drawn in 3.1.3 that the increased levels are largely the result of localised construction activities rather than by a regional event.

3.2.2. The only other elevated reading that occurred during April was at Scotstoun on the 18th. Similar to the PM₁₀ levels for this location on that date, an extremely high reading (9593 µg/m³) was observed for the 5 minute period ending 07:59pm. The readings during working hours were in line with other locations, indicating that the increase was not related to FCBC construction works.

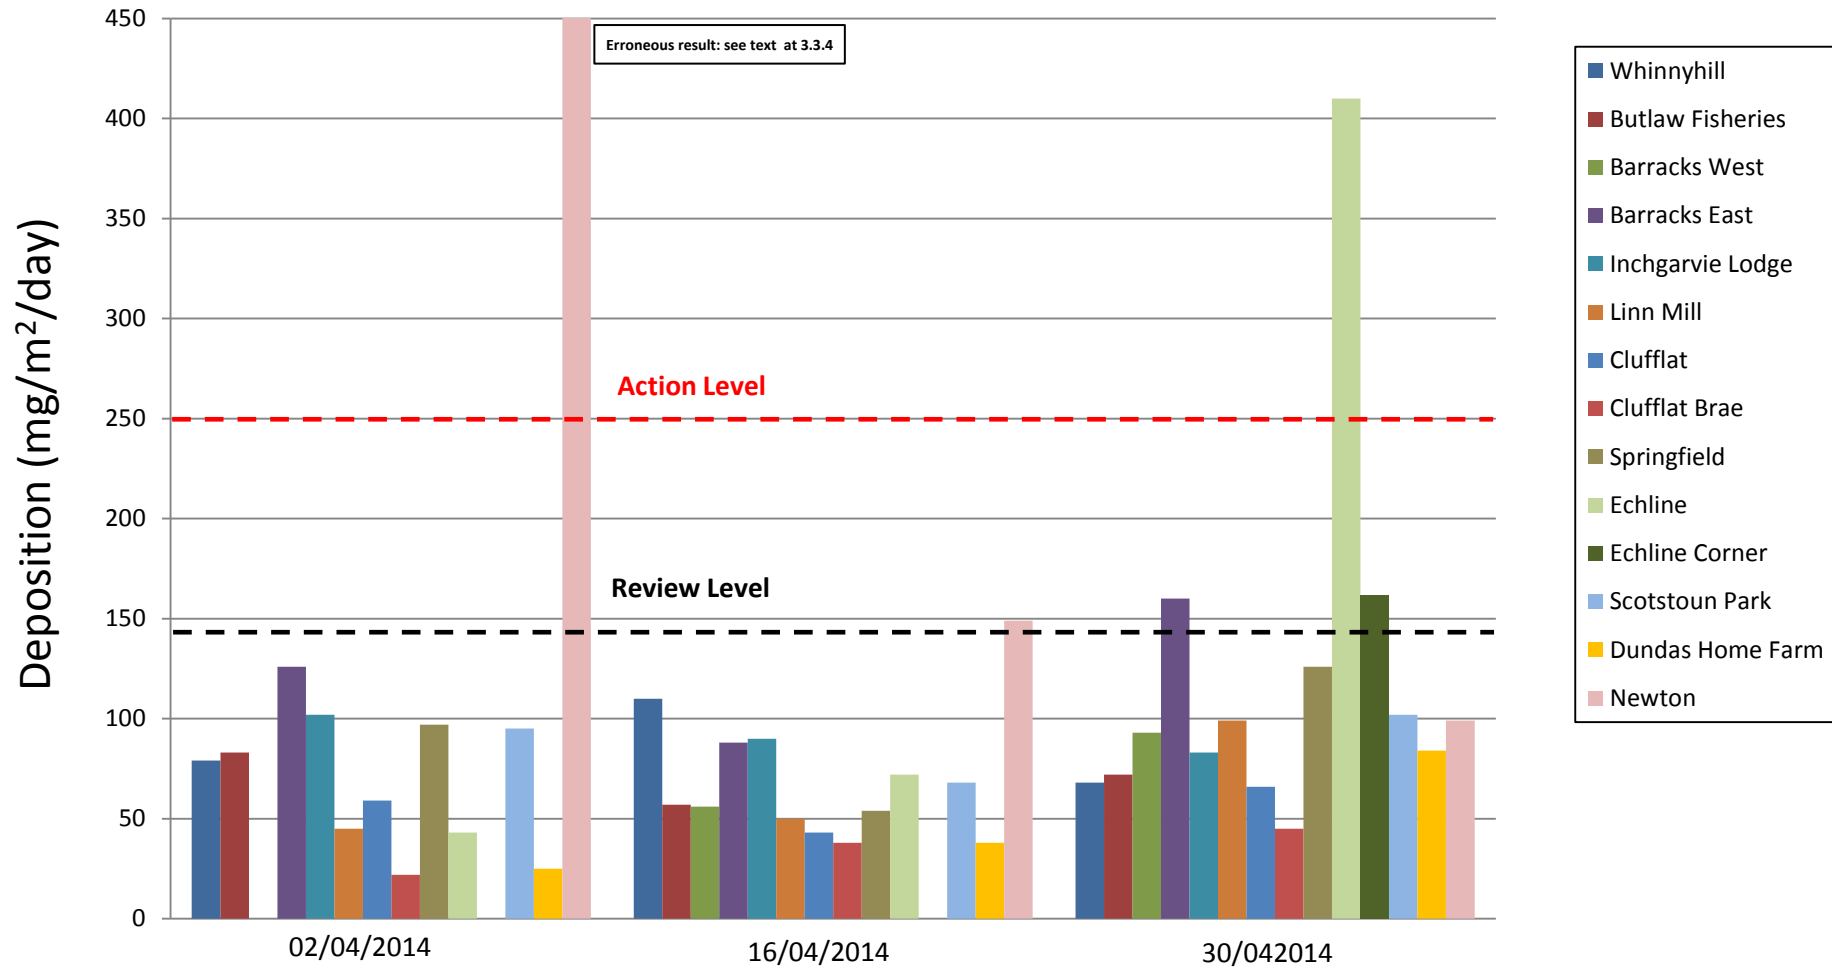
Frisbee Dust Deposition Results: April 2014

3.3.3. During April there were three exceedances of the site review level (see Table 4) and two exceedances of the action level. With the exception of the locations where exceedances occurred, Frisbee results from monitoring locations across site were generally found to be low. It should also be noted that after a minor alteration in location and some maintenance to the Barracks West Frisbee, the problems experienced at this location in March have been rectified.

- 3.3.5.** During the fortnight ending 2th April the Newton Frisbee registered levels above the action level followed by an exceedance of the review level during the fortnight ending 16th April. For these collections, the Frisbee was found to be blown over and resting against the adjacent fence, likely leading to contamination of the samples and erroneous results. After the collection on the 16th April the Frisbee was changed to a different gauge and has had regular checks to ensure that it remained upright. No issues have been experienced since the change. A review of works was undertaken and it was found that no FCBC construction activities took place in the area. A TEOM monitor is also located adjacent to the Frisbee which indicates low particulate matter levels during the period in question. The final Frisbee collection of the month indicates much lower dust deposition with levels below the review threshold. After a thorough review it was concluded that the high results at Newton cannot be explained by FCBC construction activities undertaken during this period and are likely to be due to the Frisbee blowing over. This has now been addressed.

- 3.3.6.** During the fortnight concluding the 30th April, Echline and Echline Corner Frisbees experienced levels above the Action and Review levels respectively. As outlined in section 3.1.3 the period of the 16th-17th saw increased levels of particulate matter believed to be due to construction activities and as a consequence increased inspections were conducted during this period. Having conducted increased inspections in the area over the fortnight in question and comparing the results obtained for the relevant TSP, PM₁₀ and TEOM data it was concluded that the levels observed at these gauges are a result of the issues experienced during the 16th-17th April. The actions to ensure this does not occur again are outlined in section 3.1.4.

3.3.8. During the fortnight ending 30th April the Barracks East Frisbee registered levels above the review level. A review of works was undertaken and it was found that no construction activities that would be likely to give rise to dust took place in the area. Activities taking place in the area were checked for dust during inspection on the 23rd and 29th April. Work in the barracks area around Pier S6 and S5 has predominantly been rebar work and activities related to concrete pours. Vehicle movements in the area were minimal due to the closed nature of the work going on and material being tracked out of the compound was negligible. There are also minimal exposed areas of ground in the vicinity that could generate dust. Other indicators such as TSP and Frisbee data were very low for the period at the nearest meter (Inchgarvie Lodge). After a thorough review it was concluded that the results cannot be explained by FCBC construction activities undertaken during this period. However, due to issues in this location in the past and the levels observed FCBC's Environmental Department will conduct increased inspections in the vicinity to ensure construction activities are not causing these results.
