Appendix A11.1: Baseline Conditions

1 Introduction

- 1.1.1 This Appendix provides a detailed description of the baseline conditions of the water features (WF) referred to in Chapter 11 (Road Drainage and the Water Environment) and as shown on Figures 11.1 and 11.2.

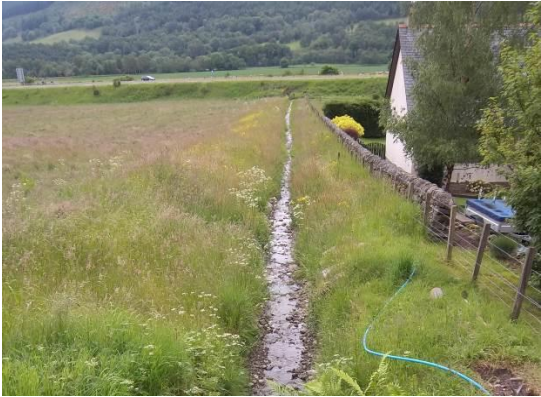
| Overview | |
|---|--|
| <p>Photograph 1: WF57 (Altrory Burn) – View downstream towards A9 embankment and culvert</p> | Water feature type: Minor watercourse |
| WFD hydromorphology status: not classified. The channel appears to be unstable in the upper catchment and actively eroding, with a wide corridor roughly 50m across. It then flows towards the A9 adjacent to an unnamed road, under which the water feature is culverted several times. WF57 has a straight planform upstream of the existing A9, and is embanked with no natural vegetated riparian corridor. The channel is then culverted under the existing A9, the Highland Main Line Railway and local access route, and continues in a buried culvert under the fields downstream. Historical map analysis shows that there has been no significant change in the channel planform since 1867. Channel straightening of the lower reaches pre-dates the historical maps. The maps do show, however, that in 1978 and earlier maps the downstream end of the water feature appears to be culverted under the A9, emerging in an open channel until the confluence with the River Tummel. | low |

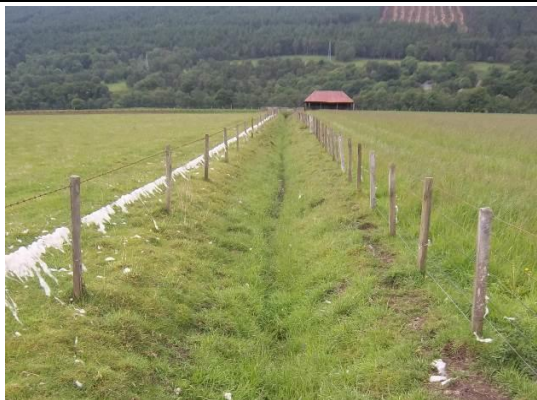
| Overview | |
|--|--|
| WFD hydromorphology status: not classified. WF58 is a small drain originating approximately 300m upstream of the existing A9. At the upstream extent, the channel had a vegetated riparian corridor consisting of grass and shrubs, with a steep sloping grassy left bank and shallow sloping ground on the right. The water feature then flows towards the existing A9 where it is culverted under the road and the Highland Main Line Railway. Downstream of this, the water feature emerges from a culvert and had a trapezoidal channel with a straight planform. There was no natural vegetated riparian corridor observed. At the time of the site visit, the channel was dry. The channel eventually discharges to the River Tummel. The water feature is not visible on historical maps. | low |

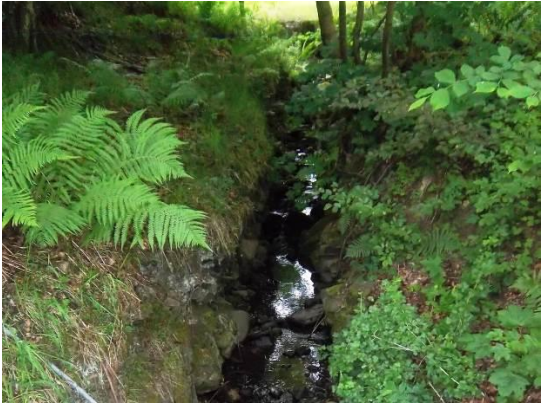
| Overview | |
|---|--|
| <p>WFD hydromorphology status: not classified.</p> <p>WF59 originates approximately 1.1km upstream of the existing A9. In the upper catchment, the channel appears to be unmodified, with a sinuous planform. Downstream of Balnacree Farm, the channel passes through agricultural land and appears to be modified with a straight planform. The channel is then culverted under a residential area, and again under General Wade's Military Road, before flowing in an open channel towards the existing A9.</p> <p>Upstream of General Wade's Military Road some deposits were observed forming on the channel bed, which consisted of cobble and gravel. Immediately downstream of the road, the water feature runs parallel to the north east of the existing A9. The water feature is culverted under the existing A9 and the Highland Main Line railway, with a further culvert downstream under the adjacent fields, ultimately discharging into the River Tummel.</p> <p>Historical map analysis shows that there is no significant change in the channel planform upstream of the A9 since 1867, except some slight channel migration upstream of Balnacree Farm. The maps do show, however, that in 1978 and earlier the water feature flows in an open channel downstream of the A9, joining a small tributary to flow into the River Tummel.</p> | low |

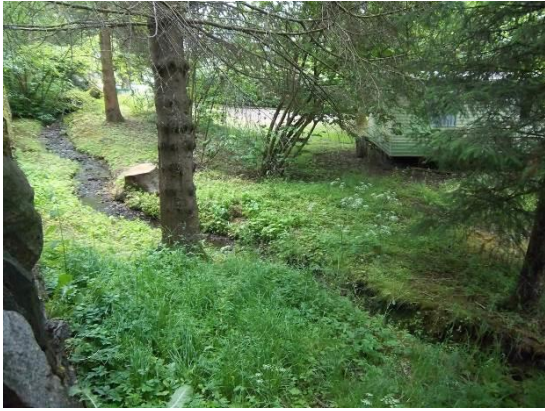
| Overview | |
|---|--|
| <p>Photograph 4: WF60 – Upstream view of reach parallel to General Wade’s Military Road (runs parallel to the north east of the A9)</p> | Water feature type: Minor watercourse |
| <p>WFD hydromorphology status: not classified.</p> <p>The channel has a sinuous planform through the wooded area with a semi-continuous riparian buffer zone. The channel substrate is composed of gravels and cobbles with some depositional features. The channel is culverted under the existing A9 and the Highland Main Line Railway, and continues in culvert to discharge into the River Tummel.</p> <p>For a more detailed description of the water feature, please refer to Appendix A11.5 (Fluvial Geomorphology).</p> | medium |

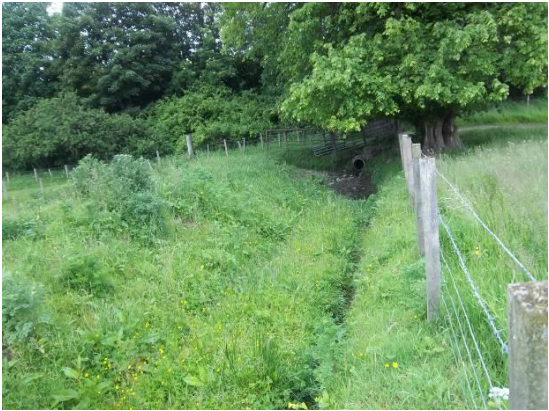
| Overview | |
|---|--|
| <p>Photograph 5: WF61 – View upstream towards A9 (farm culvert visible)</p> | Water feature type: Drainage channel |
| <p>WFD hydromorphology status: not classified.</p> <p>At the upstream extent, WF61 runs in open channel for a short distance before it reaches a small pond. The channel is culverted several times before reaching General Wade's Military Road. The channel appears to have a straightened planform, modified to follow the field boundaries in several places. At the wooded area immediately upstream of General Wade's Military Road, the channel appeared to be more natural, with a bed consisting of cobbles.</p> <p>Downstream of General Wade's Military Road, the channel appears to continue to be straightened before going into culvert under the existing A9 and the Highland Main Line Railway. Downstream of this culverted length, the channel continues to have a straightened planform with no vegetated riparian corridor. The substrate was observed to consist of silt. The water feature was then culverted under the fields to eventually discharge into the River Tummel.</p> <p>Historical map analysis shows that there is no significant change in the channel planform upstream of the A9 since 1867. The maps do show, however, that in 1978 and maps pre-dating this, the water feature flowed in an open channel downstream of the A9 which converges with WF60 before the confluence with the River Tummel.</p> | low |

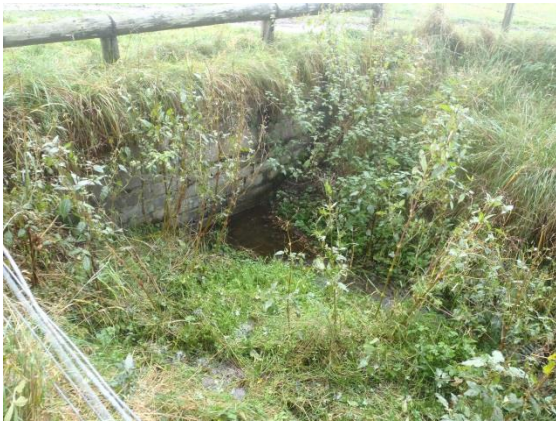
| Overview | |
|---|---|
| WFD hydromorphology status: not classified. WF191 originates approximately 50m upstream of Foss Road. The watercourse flows through a steep agricultural field and is culverted under Foss Road. Through the field, the channel had an artificially straightened planform with a width of approximately 0.3m (bankfull). The substrate was observed to be artificial upstream of the culvert inlet. The channel is culverted under Foss Road and then remains culverted between Foss Road and the adjacent field boundary for approximately 240m. The watercourse then enters an open channel, where it is met by a smaller channel (also culverted under Foss Road). The open channel is artificially straightened and overdeep, continuing for approximately 100m before discharging to the River Tummel. The substrate in this section of channel was observed to consist of silt and the channel was choked with vegetation. Historical map analysis shows that in maps from 1989 and those that pre-date this, the watercourse appears to have been an open channel between Foss Road and the adjacent field boundary, current OS mapping also shows this. Aside from this, there has been no significant change in the channel planform since 1867. | low |

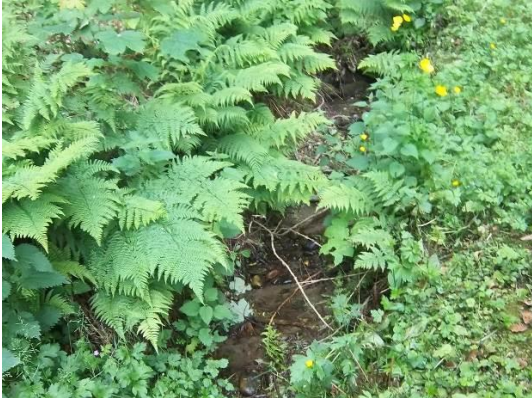
| Overview | |
|---|---|
| <p>Photograph 7: WF63 – View upstream of at entrance to Dunfallandy House Hotel</p> | Water feature type: Drainage channel |
| <p>WFD hydromorphology status: not classified.</p> <p>WF63 originates approximately 200m upstream of the existing A9. The water feature flows through a wooded area and is culverted under a local access route upstream of the existing A9. The channel has an artificially straightened planform, with a width of approximately 0.4m (bankfull). The substrate was observed to be predominantly silt with some gravels. The channel is culverted along the southern side of the existing A9 embankment for approximately 460m before discharging to the River Tummel.</p> <p>Historical map analysis shows that in maps from 1978 and those that pre-date this, the water feature appears to have originated approximately 50m further upstream before being culverted under the road at Dunfallandy House Hotel, then flowing north-east in an open channel along a field boundary for approximately 560m before discharging to the River Tummel. The planform appears to have been modified to its present alignment during the construction of the existing A9 embankment.</p> | low |

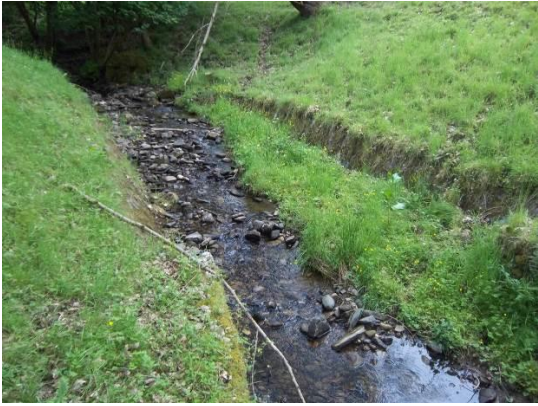
| Overview | |
|---|--|
| <p>Photograph 8: WF64 – View upstream of A9 culvert (note bank reinforcement)</p> | Water feature type: Minor watercourse |

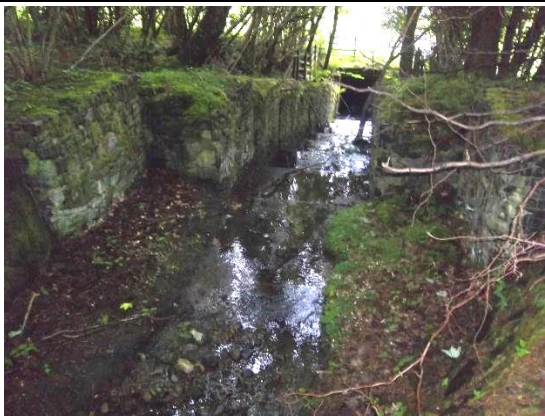
| Overview | |
|--|---|
| <p>WFD hydromorphology status: not classified.</p> <p>Upstream of the existing A9, the channel form is within a deep 'natural' v-shaped valley with continuous vegetated riparian zone. The channel has a sinuous planform with cobble and gravel substrate present. Large woody material was also observed.</p> <p>Downstream of the existing A9, the channel is modified with an artificially straightened planform with some artificial bank and bed material observed.</p> <p>For a more detailed description of the water feature, please refer to Appendix A11.5 (Fluvial Geomorphology).</p> | medium |

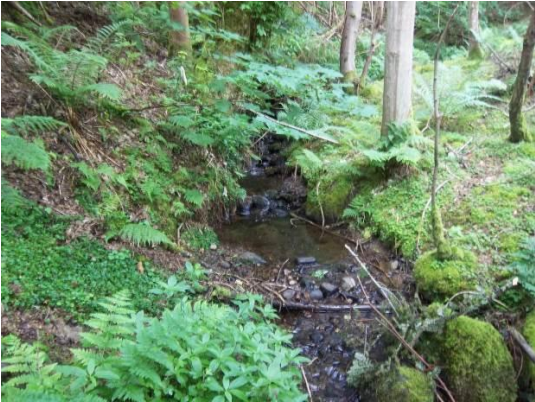
| Overview | |
|--|---|
| <p>Photograph 10: WF66 – view upstream away from A9 culvert</p> | Water feature type: Minor watercourse |
| <p>WFD hydromorphology status: not classified.</p> <p>WF66 has a natural sinuous planform observed through a wooded v-shaped valley. The channel has a step/pool sequence with cobble and gravel substrate present. Large woody material was observed within the channel.</p> <p>For a more detailed description of the water feature, please refer to Appendix A11.5 (Fluvial Geomorphology).</p> | medium |

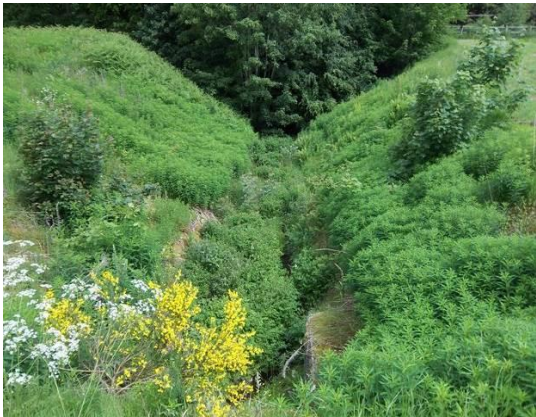
| Overview | |
|--|--|
| <p>Photograph 11: WF67 – view downstream away from A9 culvert</p> | Water feature type: Drainage channel |

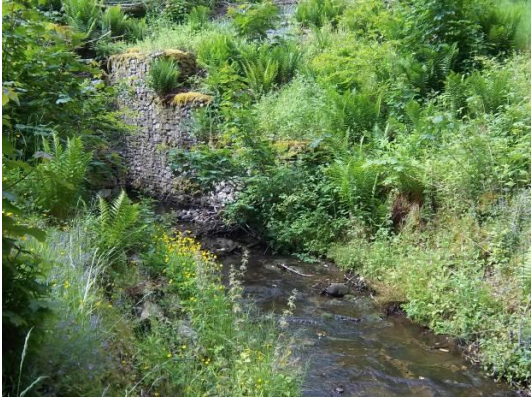
| Overview | |
|---|--|
| <p>Photograph 12: WF68 – view upstream towards A9 culvert</p> | Water feature type: Minor watercourse |
| <p>WFD hydromorphology status: not classified.</p> <p>Upstream of the existing A9, the channel is natural with a sinuous planform, a step/pool sequence and boulder, cobble and gravel substrate was observed. The channel is situated within a deep v-shaped valley with substantial morphological diversity. Downstream of the existing A9, the channel is modified with a uniform cross-section. A knickpoint was observed, located near to the confluence with Loch Faskally; here concrete reinforcement was observed to be undermined.</p> <p>For a more detailed description of the water feature, please refer to Appendix A11.5 (Fluvial Geomorphology).</p> | high |

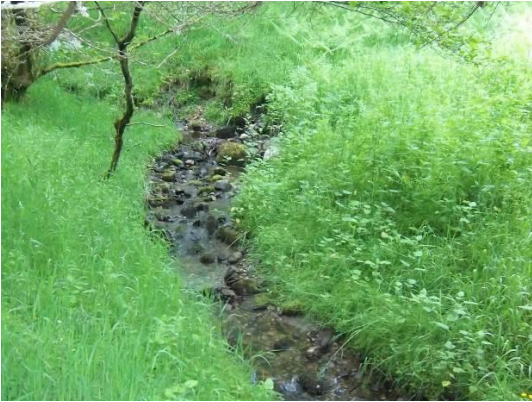
| Overview | |
|--|---|
| <p>Photograph 13: WF69 –upstream view away from A9 and confluence with additional channels</p> | Water feature type: Minor watercourse |
| <p>WFD hydromorphology status: not classified.</p> <p>The channel is divided into two branches, one which was artificially straightened and the second which has a sinuous planform with some step/pool sequences. The channel substrate was observed to consist of cobble and gravels. Erosion and deposition were evident; however, the channel primarily functioned as a sediment store (i.e. more deposition occurring). Upstream of the culvert under the existing A9, the channel is artificial, composed of reinforced bed and banks.</p> <p>For a more detailed description of the water feature, please refer to Appendix A11.5 (Fluvial Geomorphology).</p> | medium |

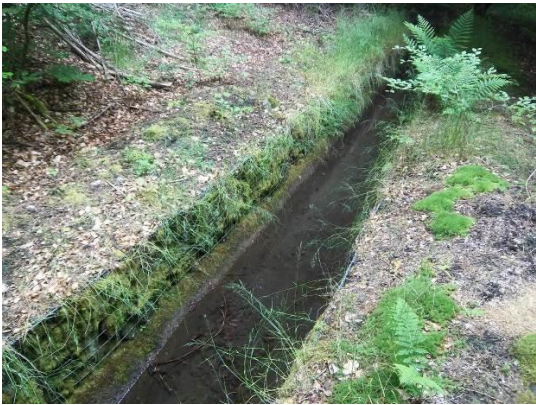
| Overview | |
|---|--|
| <p>WFD hydromorphology status: not classified.</p> <p>WF71 originates upstream of the Highland Main Line railway, where it is piped beneath the railway line. The channel is a man-made ditch which is culverted under the existing A9 and A924 before discharging into the River Tummel. The channel flows through woodland and has a trapezoidal, concrete lined cross-section. There was no perceptible flow in the channel and silt deposition was observed. Historical map analysis shows that there is no significant change in the channel planform throughout the length of the water feature since 1867, although the majority of the watercourse has been culverted beneath the existing A9.</p> | low |

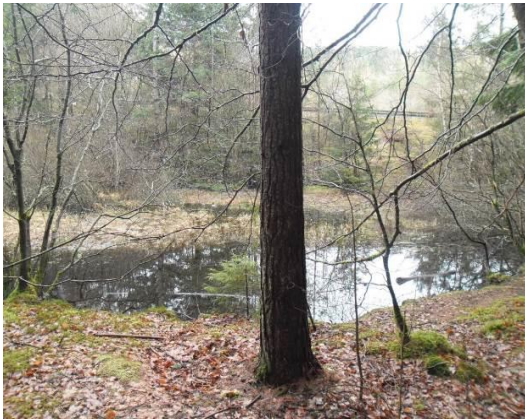
| Overview | |
|--|--|
| <p>Photograph 15: WF72 – view across pond towards B8019</p> | Water feature type: Pond and drainage channel |
| <p>WF72 is not included in the SEPA Flood Map (fluvial) as it has a catchment area less than 3km². The water feature is predominantly located in an area of forest and includes a pond and a drainage channel.</p> <p>The existing A9 culvert has been simulated to convey the 0.5% AEP (200-year) plus CC event with free flow conditions being predicted to occur within the culvert and upstream flows remaining within bank. Sufficient freeboard is also simulated between the peak headwater level and the inlet soffit level. There are no residential properties located within the vicinity of this channel.</p> | Low |

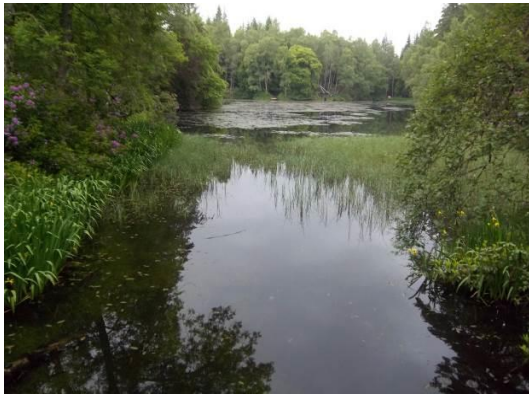
| Overview | |
|--|--|
| <p>Photograph 16: WF73 – view across Loch Dunmore from footbridge</p> | Water feature type: Drainage channels and loch |
| WF73 is fed by WF74, which originates approximately 150m upstream of the existing A9. Downstream of the A9 and B8019 culverts, the water feature flows through wet woodland into Loch Dunmore. The channel was a narrow drain with a sinuous planform with a substrate observed to be consisted of silt. Downstream of a large ponded area, the channel was observed to be dry. Historical map analysis shows that the channel planform has remained largely consistent since 1875. There is, however, a change in the location of the confluence with the River Tummel, which shifted upstream when Loch Faskally was formed. | low |

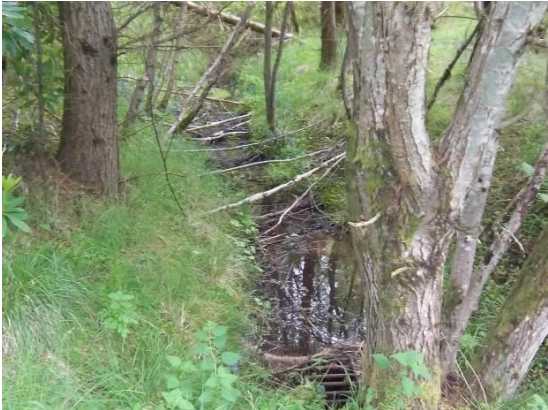
| Overview | |
|---|--|
| <p>Photograph 17: WF74 – View upstream of A9 and modified section</p> | Water feature type: Minor watercourse |
| <p>WFD hydromorphology status: not classified.</p> <p>Upstream of the existing A9 (northern branch), the channel is modified with a uniform cross-section and a straight planform. The channel substrate is composed of silt, and large woody material was observed.</p> <p>Upstream of the existing A9 (eastern branch) and downstream of the existing A9, the channel is sinuous with a step/pool sequence and cobble and gravel substrate. Channel incision was noted and the reach is operating as a sediment exchange zone.</p> <p>For a more detailed description of the water feature, please refer to Appendix A11.5 (Fluvial Geomorphology).</p> | medium |

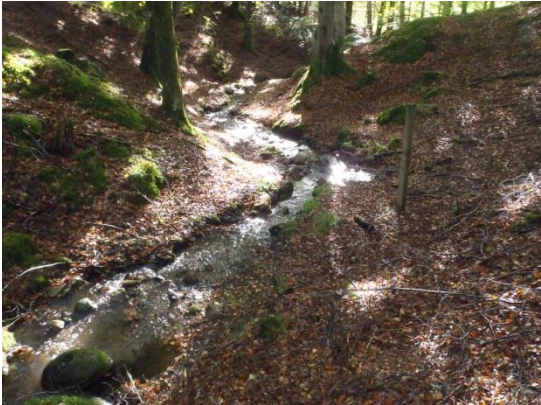
| Overview | |
|---|--|
| WFD hydromorphology status: not classified. The channel is a natural bedrock cascade with some silt substrate observed. Low flow was observed, with moss growth on rocks in the channel, indicating stability. The riparian corridor was observed to be continuous on both banks. For a more detailed description of the water feature, please refer to Appendix A11.5 (Fluvial Geomorphology). | medium |

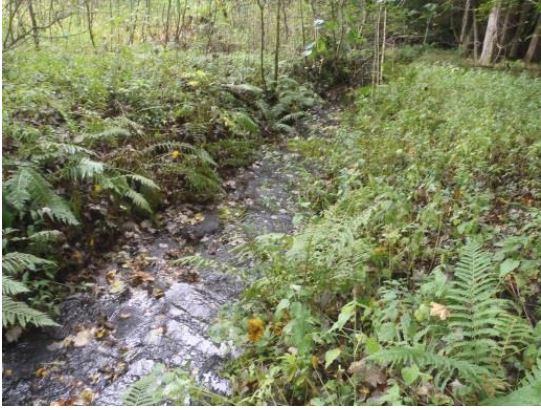
| Overview | |
|---|--|
| <p>Photograph 19: WF77 – View looking downstream of the B8079</p> | Water feature type: Minor watercourse |

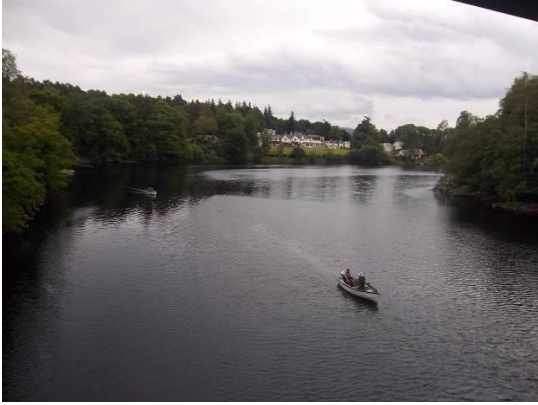
| Overview | |
|---|---|
| SEPA hydromorphology status: Moderate Potential. WF75 is an online loch of the River Tummel, with over 50m wide riparian corridor on both banks. Along the shores of the loch, there are cobble beaches mixed with some sand. The substrate at the margins of the loch was observed to consist of cobble, sand and silt. Bank modification is present in some locations. For a more detailed description of the water feature, please refer to Appendix A11.5 (Fluvial Geomorphology). | medium |

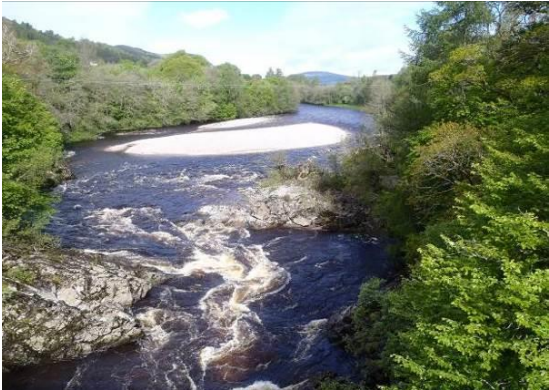
| Overview | |
|--|---|
| <p>Photograph 22: WF100 (River Garry) at Killiecrankie</p> | Water feature type: Major watercourse |
| <p>WFD hydromorphology status for "Errochty Water confluence to Loch Faskally": Moderate (2013).</p> <p>WF100 is a naturally active meandering, single thread gravel and cobble bed river with river terraces observed to in the floodplain. The channel has steep valley sides and large depositional features that are characteristic of this river within a defined low flow channel.</p> <p>For a more detailed description of the water feature, please refer to Appendix A11.5 (Fluvial Geomorphology).</p> | high |
