# Appendix 11.4

## Hydromorphology Assessment Part 1

- 1.1.1 This appendix presents the detail of the hydromorphology assessment of the Proposed Scheme for Project 8 – Dalwhinnie to Crubenmore (Central Section) of the A9 Dualling Programme. It supports the summarised findings presented in **Chapter 11** of the Environmental Statement (ES). The Proposed Scheme that was assessed is described in **Chapter 5** of the ES.

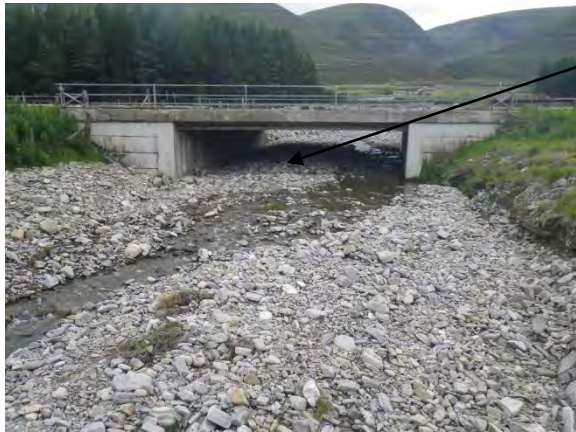
Photograph 11.4.3.1- Upstream towards crossing

Deposition  
under  
bridge

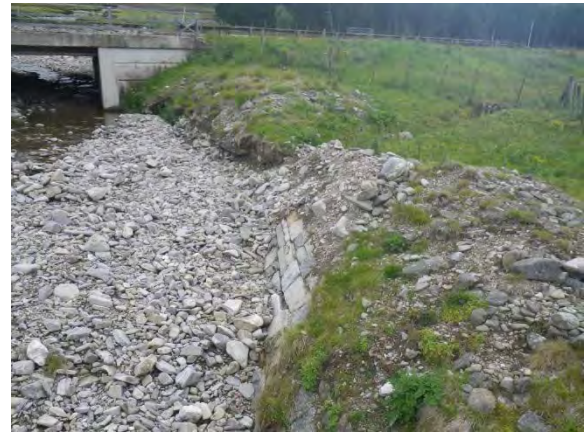
Photograph 11.4.3.2- Erosion of right bank

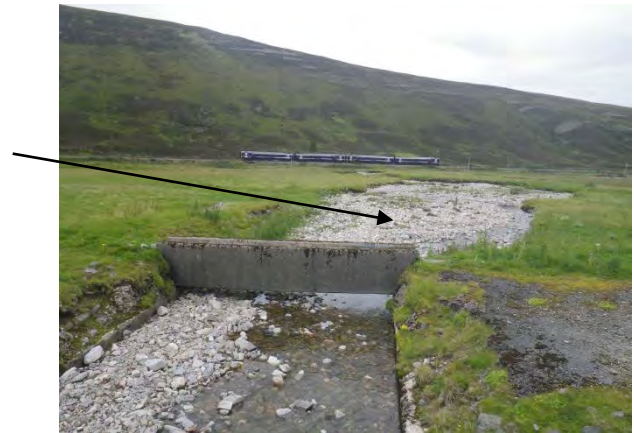
Photograph 11.4.3.4- Unknown structure crossing downstream

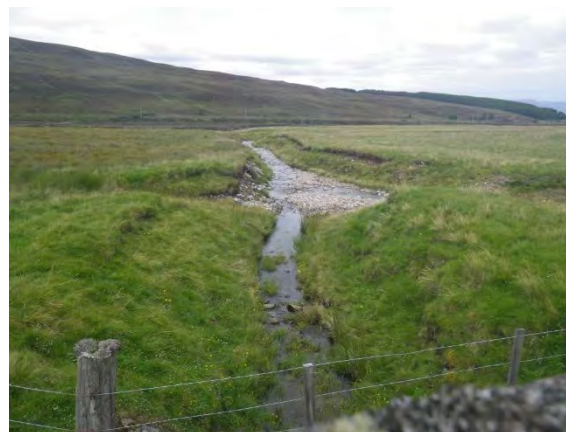
Photograph 11.4.3.9- Downstream to confluence with crossing 64, failing channel banks

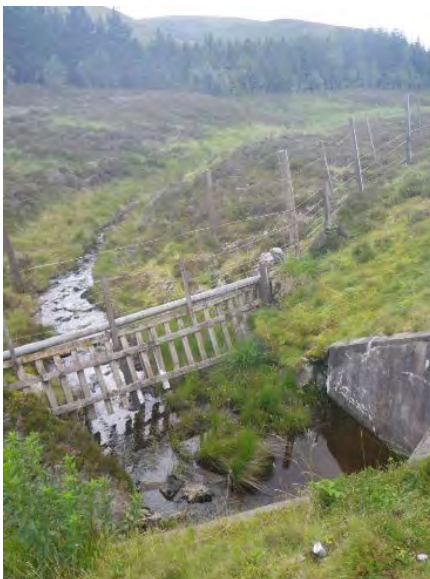
Photograph 11.4.3.10- Upstream of crossing, confined channel

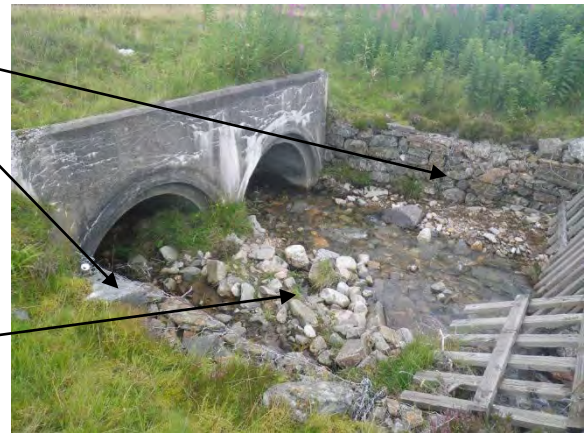
11.4.3.14 - Deposition of coarse material in culvert entrance

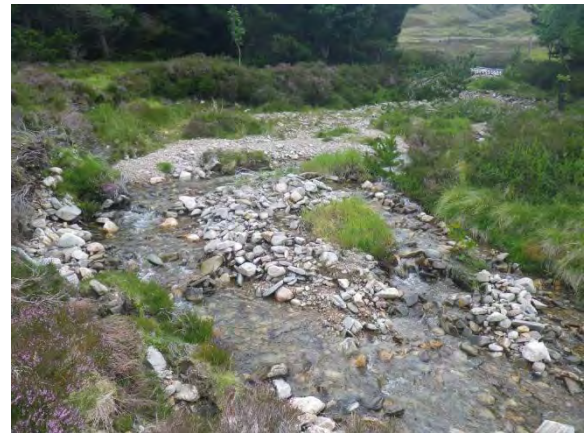
Photograph 11.4.3.18- Sediment rich channel

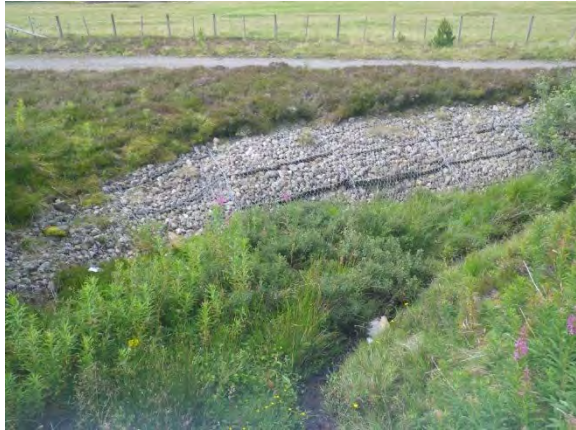
Photograph 11.4.3.21 – Gabions on left bank of channel have been undercut. Channel is undersized for high flows

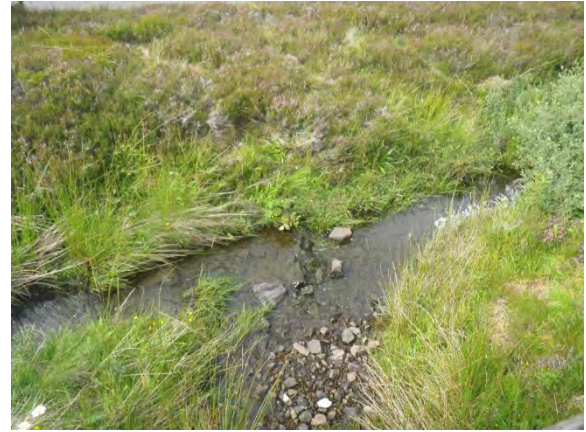
Photograph 11.4.3.23 – Erosion of concrete slabs in bed of drainage channel. High energy system despite lower bed slope than upstream channels

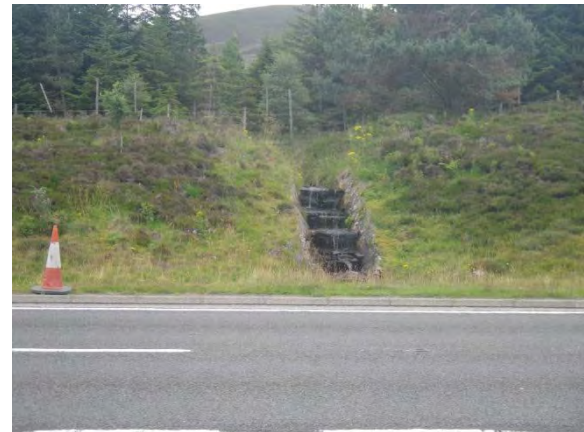
Some damage to apron from high energy flows

Photograph 11.4.3.26 – Looking upstream-  
Stepped cascade into crossing

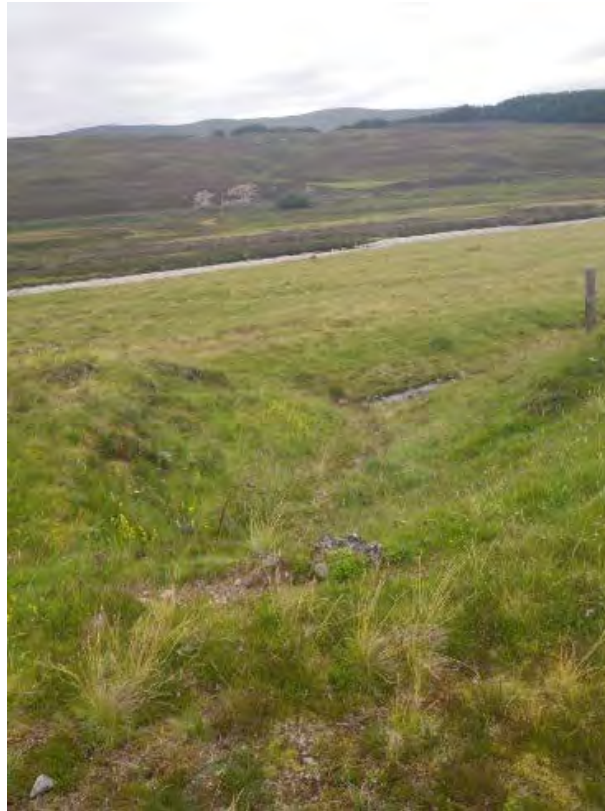
Photograph 11.4.3.30 – Ephemeral channel-No flow  
at time of survey

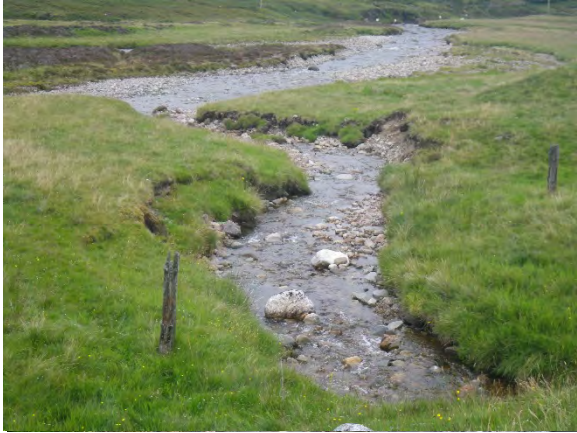
Photograph 11.4.3.31 –Downstream to confluence-Geotechnical bank failures downstream
