Appendix 11.4

Hydromorphology Assessment Part 5

Annex 11.4.3 - Hydromorphological Catchment Assessment - 64

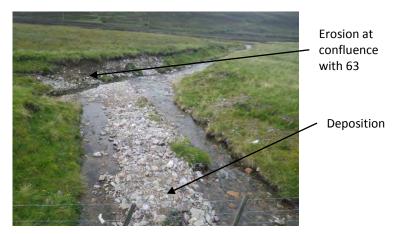
Bank Erosion

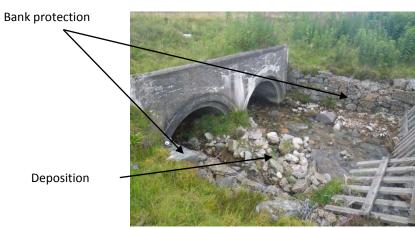
11.4.3.100 – Deposition of coarse material in culvert entrance
