Project **FORTH REPLACEMENT CROSSING**

**AIR QUALITY MONITORING REPORT  
AUGUST 2016**

**REP-00292** Rev  
**00**

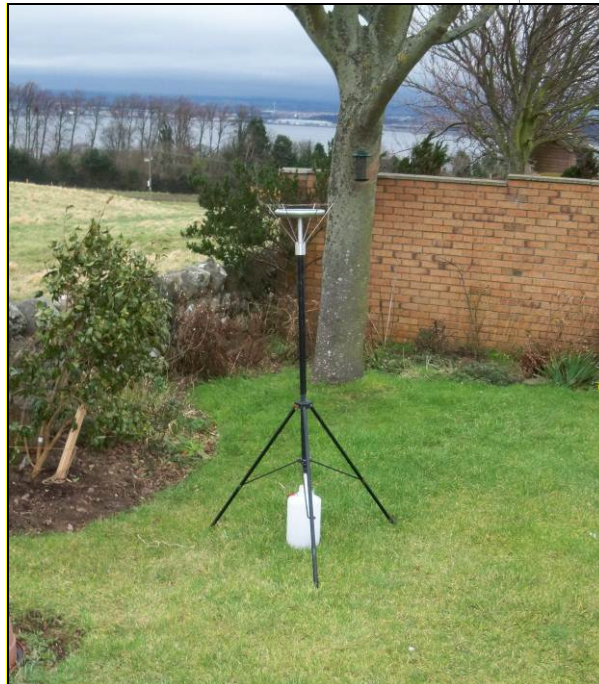
**Figure 1: Example of an Installed Frisbee Gauge Meter**

**2.1.** Air quality is being monitored on site using both automatic light scatter dust meters and Frisbee gauge dust deposition monitoring. Twelve Frisbee gauges are currently set up at sensitive locations across the site to measure dust deposition rates (Figure 1). Seven automatic light scatter meters have also been installed at various sensitive locations to measure real time particulate matter (PM<sub>10</sub>) concentrations and the Total Suspended Particle (TSP) concentrations (Figure 2). These meters are calibrated annually. Table 1 lists the air quality monitoring equipment present at each monitoring location, including the date it was installed.

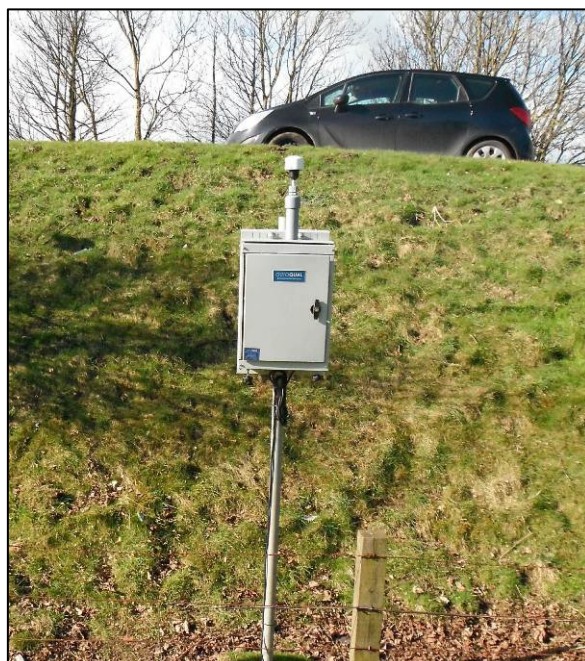
**Figure 2: Example of an installed Automatic Light Scatter Dust Meter**

**2.2.** Light scatter type monitoring equipment have been selected as a site monitoring tool to create a live network which assesses the levels of fugitive particulate matter, principally airborne dust. These monitors require less space, maintenance and power than other real time monitors such as a Tapered Element Oscillating Microbalance (TEOM) which is used and designed to measure particulate levels to exceedingly high standards, including measuring long-term compliance to statutory limits. Light scatter meters are more practicable to deploy. However, the meters do generally record levels higher than those measured by the TEOM. The meters can also be affected by atmospheric moisture content which further increases reported levels. Accordingly, any elevations of statutory limits should be treated as precautionary exceedances. The monitors are reliable for on-site monitoring and the establishment of action thresholds to ensure unforeseen activities generating significant dust are identified and suitably controlled. Light scatter meters are becoming the construction and waste industries norm for particulate dust monitoring.
