FCBC
Queensferry
Crossing

Project **FORTH REPLACEMENT CROSSING**

**AIR QUALITY MONITORING REPORT
MAY 2016**

REP-00282

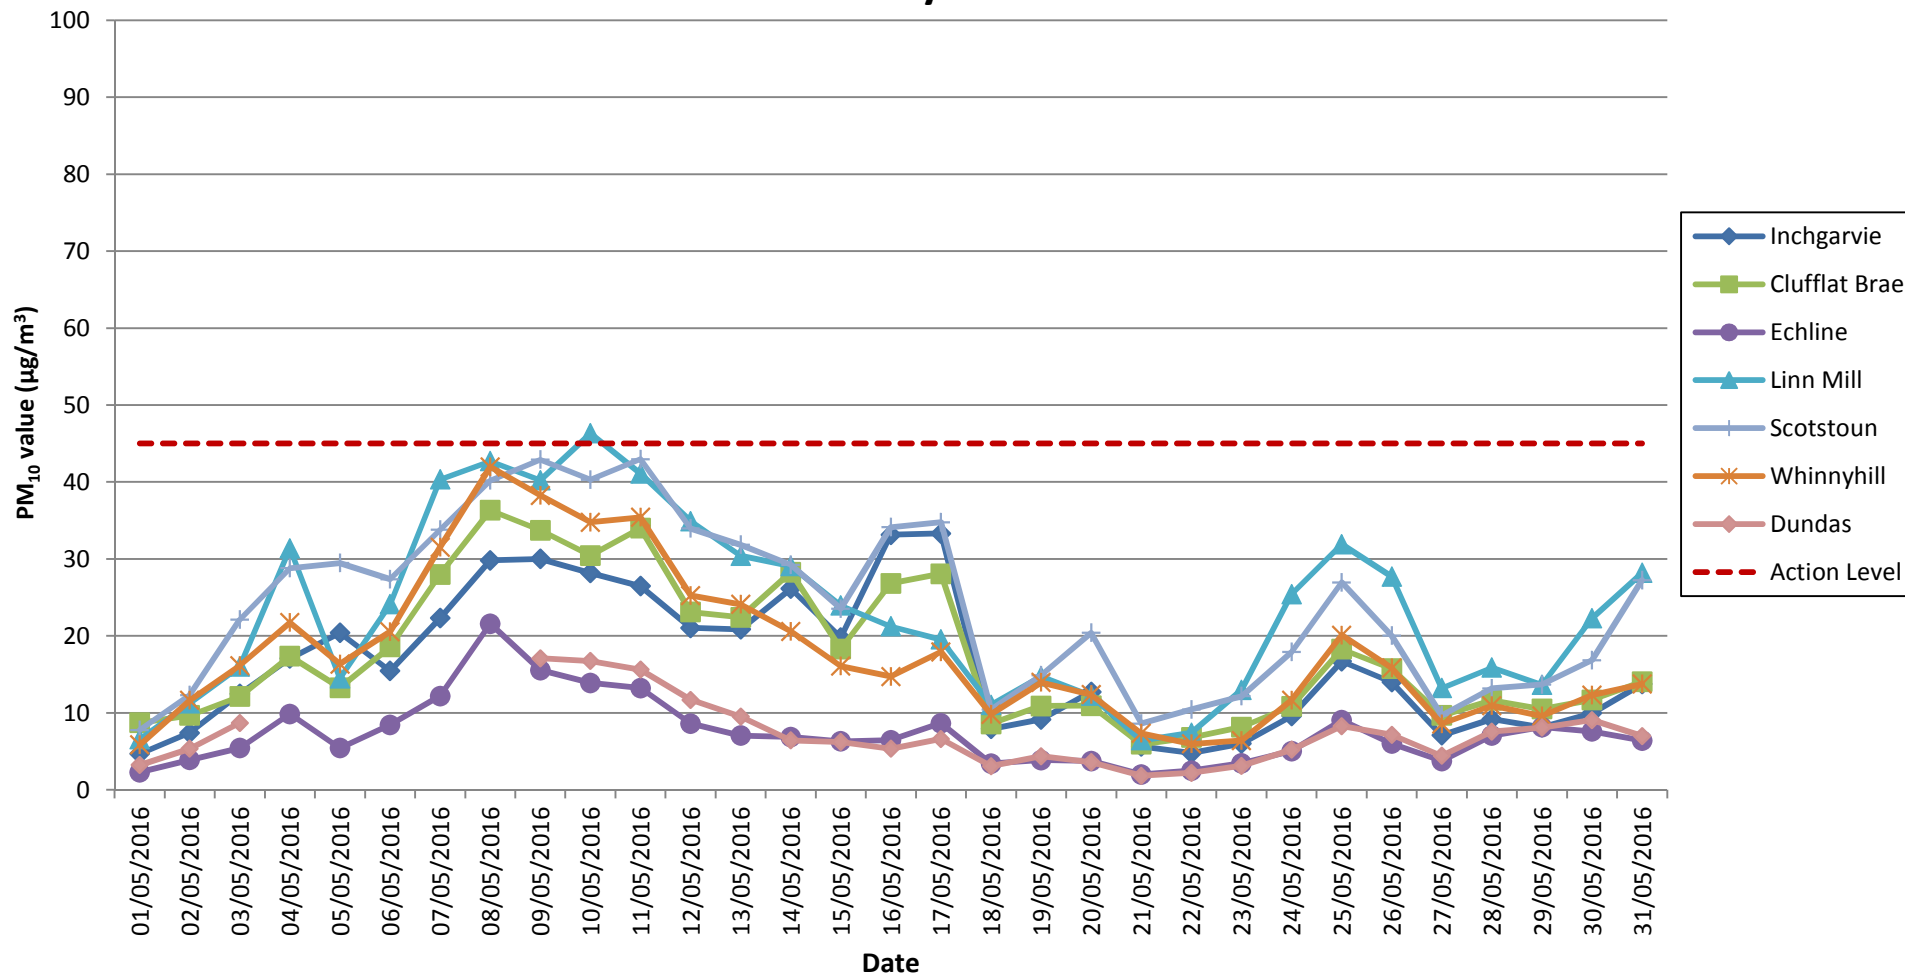
Particulate Matter (PM10) Results for all Monitoring Locations

Note: Please note there was no data at Dundas from the 4th-8th May due to a problem with the monitor.

3.1.1. Light scatter results for May 2016 have been presented in a monthly chart; this can be found in Appendix A. Results show that the PM₁₀ levels were below threshold levels throughout May with the exception of Linn Mill on the 10th May. All monitors generally follow the same pattern throughout the month. However, the PM₁₀ results for Linn Mill show a slight increase on the 10th May which just exceeds the threshold. On this day the Linn Mill light scatter meter registered 15 minute exceedances for PM₁₀. The FCBC Environmental Coordinator investigated the area and confirmed that conditions were not dusty and that sufficient mitigation was in place. All other monitors also showed an increase on this day.

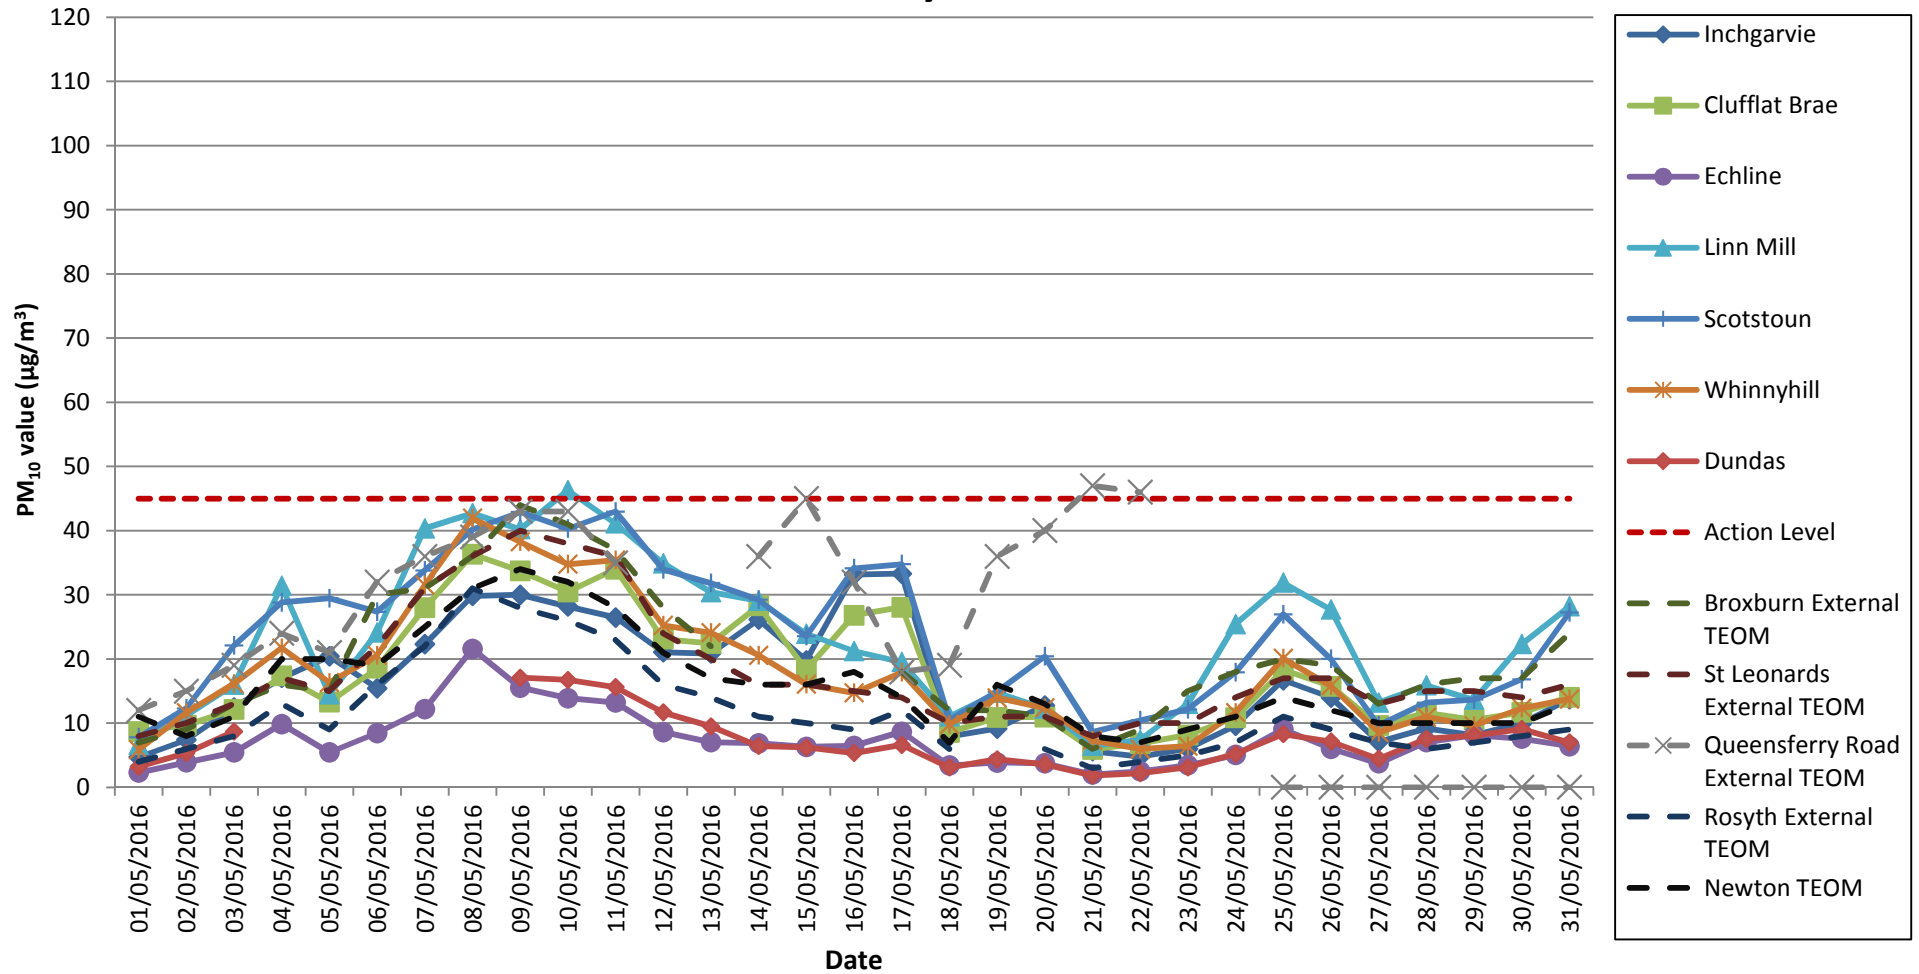
Air Quality Monitoring: Particulate Matter (PM10) Results for all Monitoring Locations, including TEOM data May 2015

Note: Please note there was no data at Dundas from the 4th-8th May due to a problem with the monitor.

3.1.2. The PM₁₀ results have also been compared to the daily mean results obtained from the TEOM air quality monitoring stations located in Newton, Rosyth, and Broxburn, and from the TEOM FDMS station located at Queensferry Road and St Leonards, Edinburgh (an urban background site). The TEOM at Newton was installed by West Lothian Council, facilitated by FCBC, during January 2012. The comparison between the light scatter and TEOM results demonstrates that both sets of results generally follow the same pattern, although the light scatter meter results indicate some higher peaks of PM₁₀ throughout May. The higher levels of PM₁₀ observed at Linn Mill (3.1.1 above) are largely consistent with the TEOM results for the same period. The pattern observed throughout May was largely driven by regional changes in air quality.

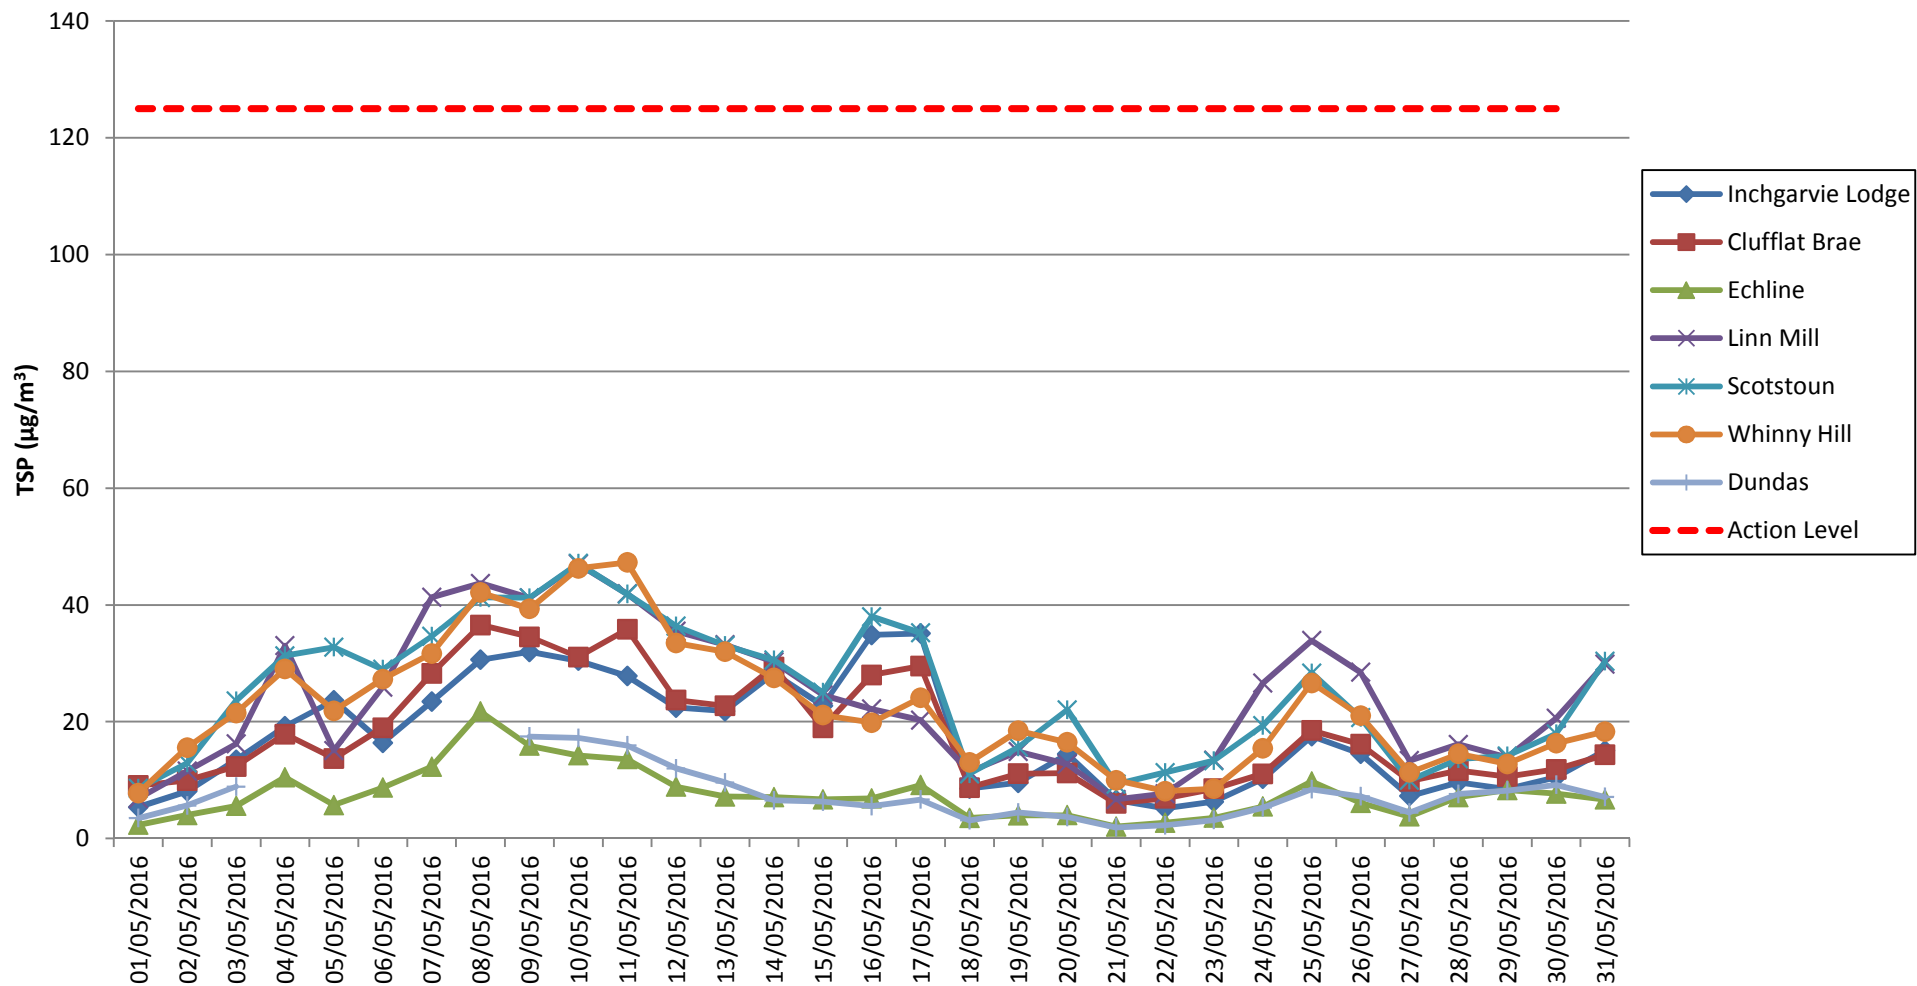
Total Suspended Particles (TSP) Results May 2016

Note: Please note there was no data at Dundas from the 4th-8th May due to a problem with the monitor.

3.2.1. The TSP results for May 2016 have been presented in a monthly chart; this can be found in Appendix B. The TSP levels at monitoring locations during May were found to be low and all within the threshold. All locations across the site were found to follow a similar pattern (similar to that observed for PM₁₀ levels). As with PM₁₀ it is considered that the TSP levels across site were influenced by regional changes in TSP levels.

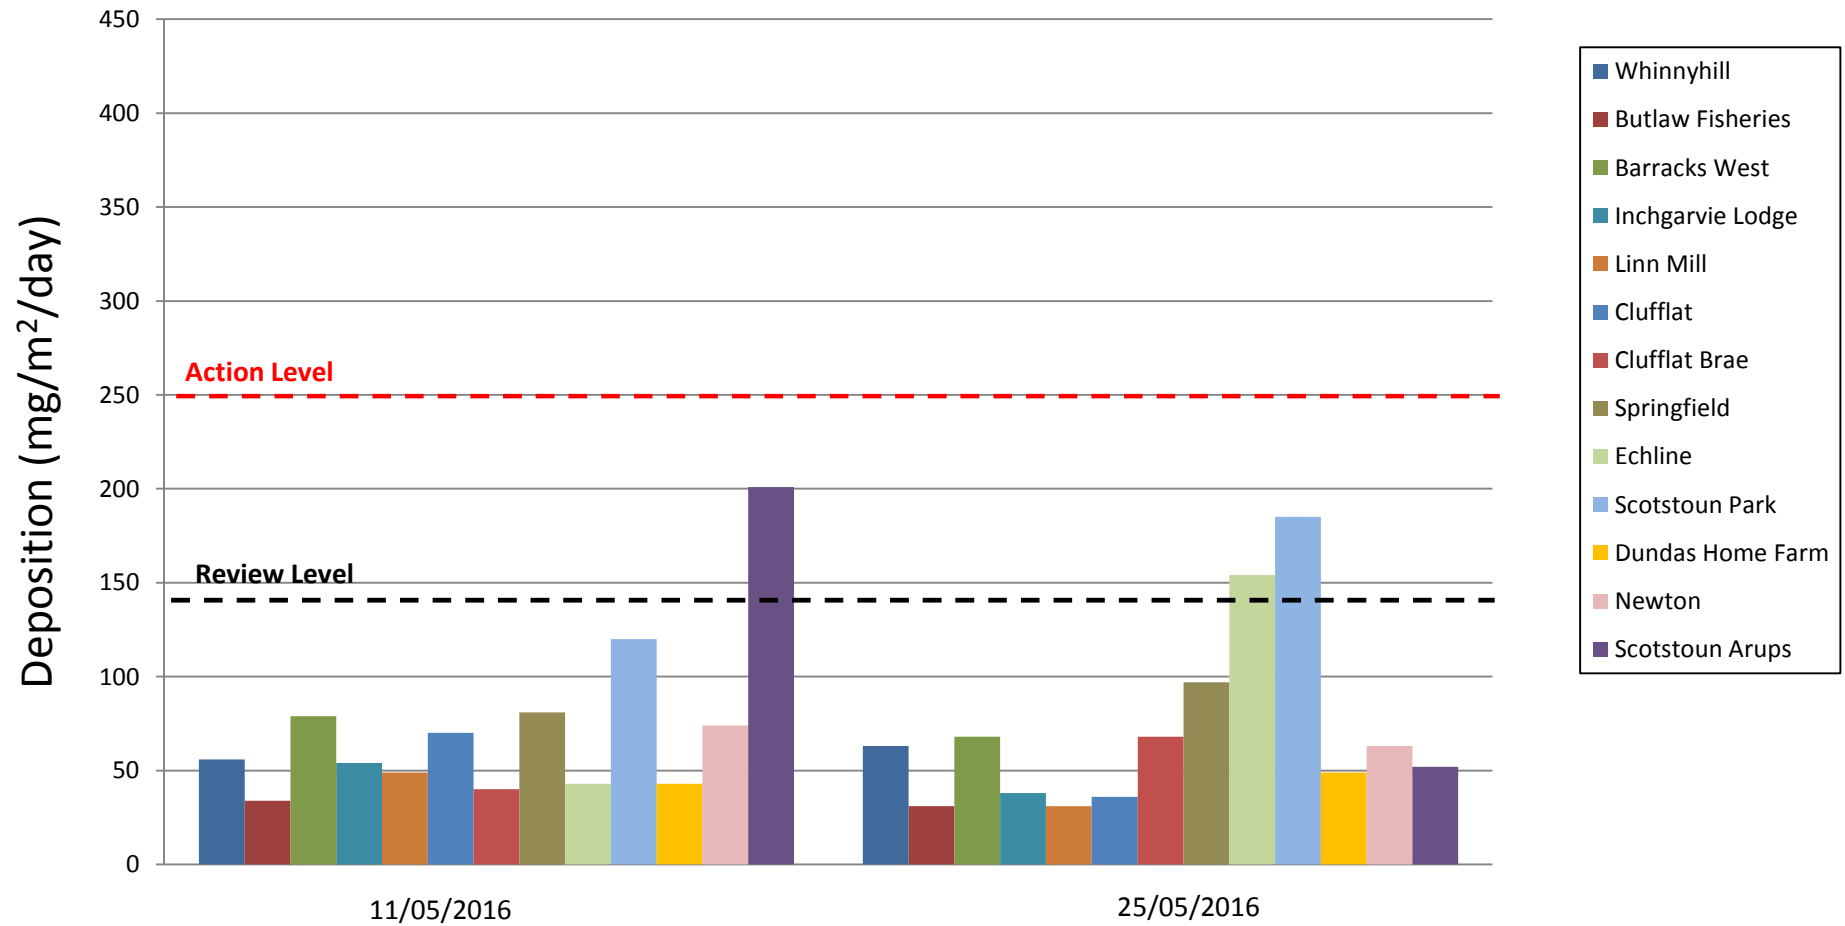
Frisbee Dust Deposition Results: May 2016

3.3.3. During May there was one exceedance of the review level at the temporary Frisbee at Scotstoun Arups for the fortnight concluding 11th May. However, this is an erroneous result as the filter of the Frisbee was found on the ground during collection. There were also exceedances of the review level at Scotstoun and Echline for the fortnight concluding 25 May. With regards to the exceedance at Scotstoun, the light scatter meter at this location indicated mostly low levels of PM₁₀ and TSP during this fortnight. The temporary Frisbee at Scotstoun Arups, which is located closer to the FCBC works, indicates a significantly lower result than for the permanent Frisbee during this period. This suggests that the higher results obtained recently at the permanent monitoring location are not entirely due to FCBC activities. As noted in previous reports, other construction work (not project related) is ongoing in the Scotstoun area. However, FCBC will continue to monitor Forth Replacement Crossing construction closely as works progress and provide mitigation as necessary. With regards to the exceedance at Echline, the light scatter meter at this location indicated mostly low levels of PM₁₀ and TSP during this fortnight. The closest FCBC works during this time were over 150m away and are considered unlikely to cause high levels of dust. During the same time period the FCBC noise monitor indicated residential works taking place in this vicinity. It is possible that these works may have been the cause of the exceedance.

Note: The result for Scotstoun Arups for fortnight ending 11 May was erroneous due to filter being found on ground

3.3.1. The Frisbee dust deposition results for May 2016 have been presented in a chart and can be found in Appendix C. Two collections were made in May; these occurred on the 11th and 25th May 2016.

3.3.2. The site action level for the dust deposition rate has been set at 250 mg/m²/day. Exceedances of this level are treated as a potential incident and a review of the works in the vicinity of the site is instigated. A lower site review level has been set at 140 mg/m²/day. Where concentrations
