**FORTH REPLACEMENT CROSSING**

**AIR QUALITY MONITORING REPORT  
 DECEMBER 2014**

**REP -00211**

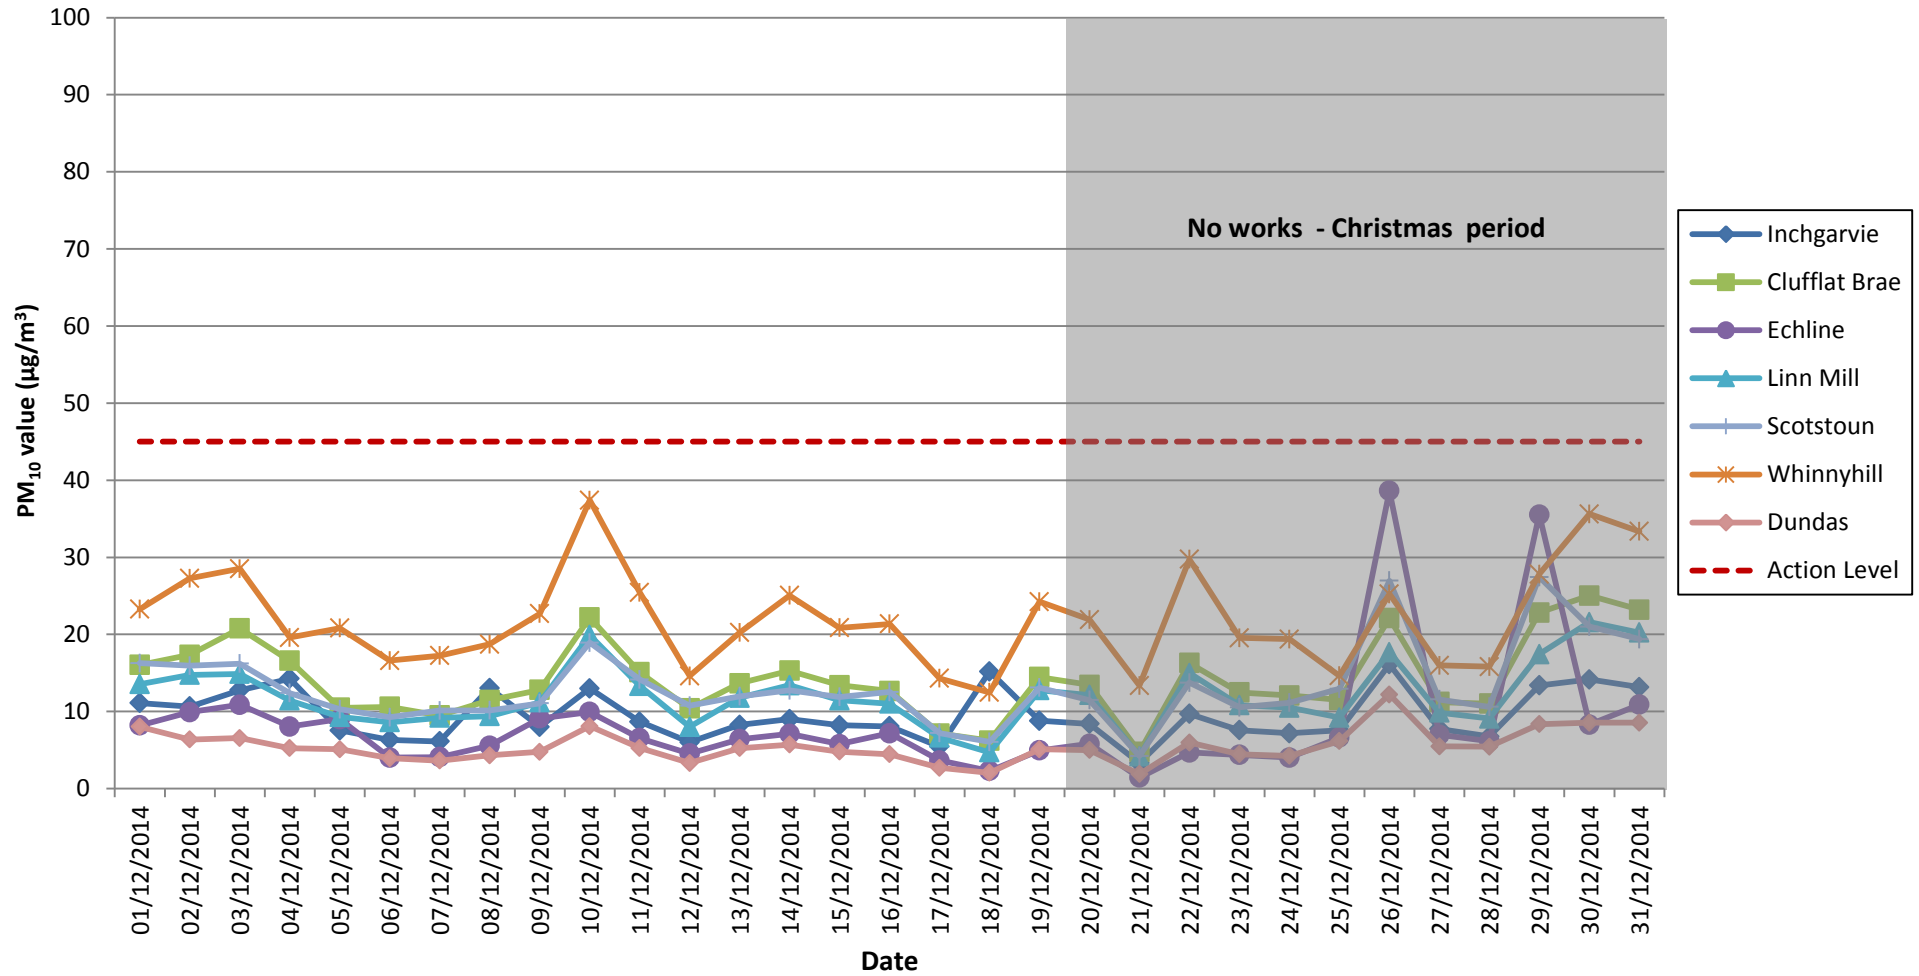
## **APPENDIX A: LIGHT SCATTER METER RESULTS**

## Particulate Matter (PM10) Results for all Monitoring Locations

### December 2014

**3.1.1.** Light scatter results for December 2014 have been presented in a monthly chart; this can be found in Appendix A. Results show that the PM<sub>10</sub> levels were below threshold levels throughout the month. All the monitors follow the same general pattern throughout the month. The Echline monitor registered increased levels on the 26<sup>th</sup> and 29<sup>th</sup> although the action level was not reached and there were no works taking place on site during this time. Increased levels were observed at all monitors on the 26<sup>th</sup>, although the Echline monitor was the most pronounced.

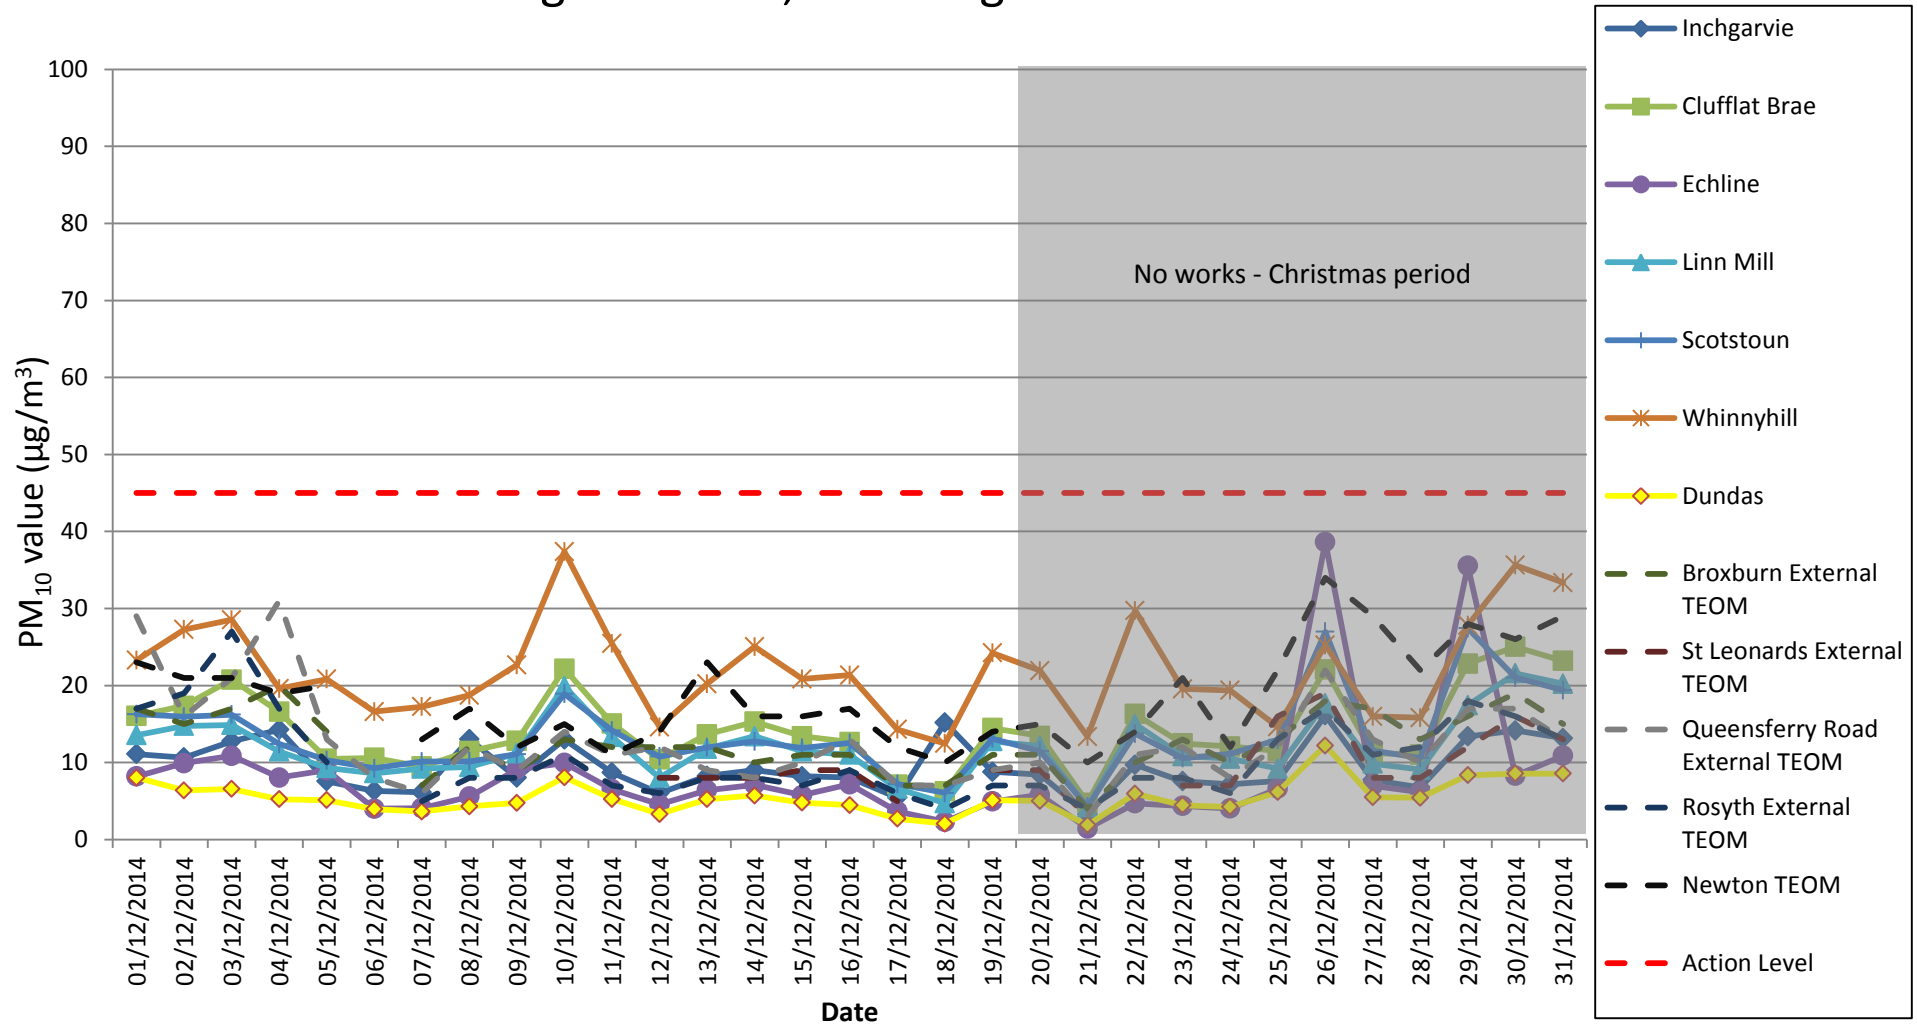
## Air Quality Monitoring: Particulate Matter (PM10) Results for all Monitoring Locations, including TEOM data December 2014

Note: TEOM data missing from scottish air quality for the St Leonards monitor since 12<sup>th</sup> September until 12<sup>th</sup> December. Data is also missing at St Leonards for the 18<sup>th</sup> and 22<sup>nd</sup> and for the 06<sup>th</sup> at Broxburn, Rosyth and Newton.

**3.1.2.** The PM<sub>10</sub> results have also been compared to the daily mean results obtained from the TEOM air quality monitoring stations located in Newton, Rosyth, and Broxburn, and from the TEOM FDMS station located at Queensferry Road, Edinburgh. The TEOM at Newton was installed by West Lothian Council, facilitated by FCBC, during May 2012. The comparison between the light scatter and TEOM results demonstrates that both sets of results generally follow the same pattern at similar levels, indicating that the pattern observed throughout December was largely driven by regional changes in air quality.

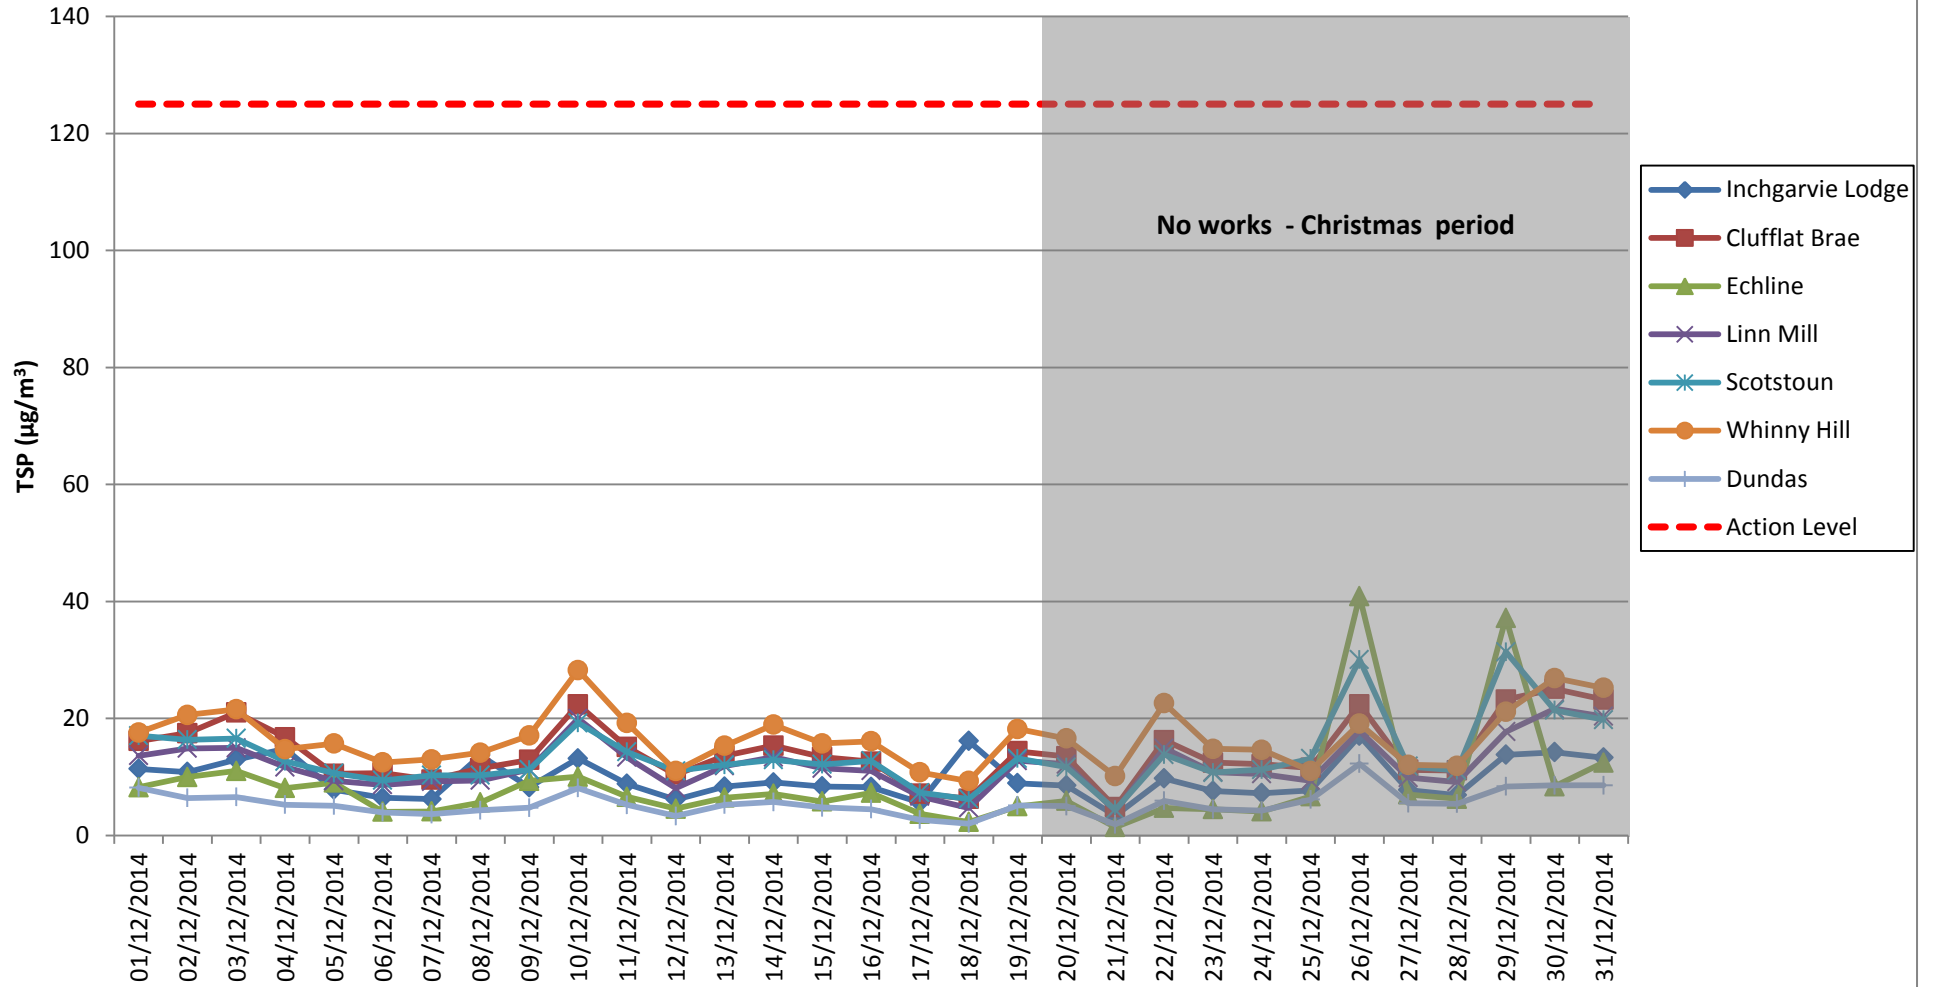
## **APPENDIX B: TOTAL SUSPENDED PARTICLES**

# Total Suspended Particles (TSP) Results December 2014

**3.2.1.** The TSP results for December 2014 have been presented in a monthly chart; this can be found in Appendix B. The TSP levels at monitoring locations during December were found to be low and all within the threshold level. All locations across the site were mostly found to follow a similar pattern, demonstrating that, in general, the levels were influenced by regional changes in TSP levels, rather than construction works.

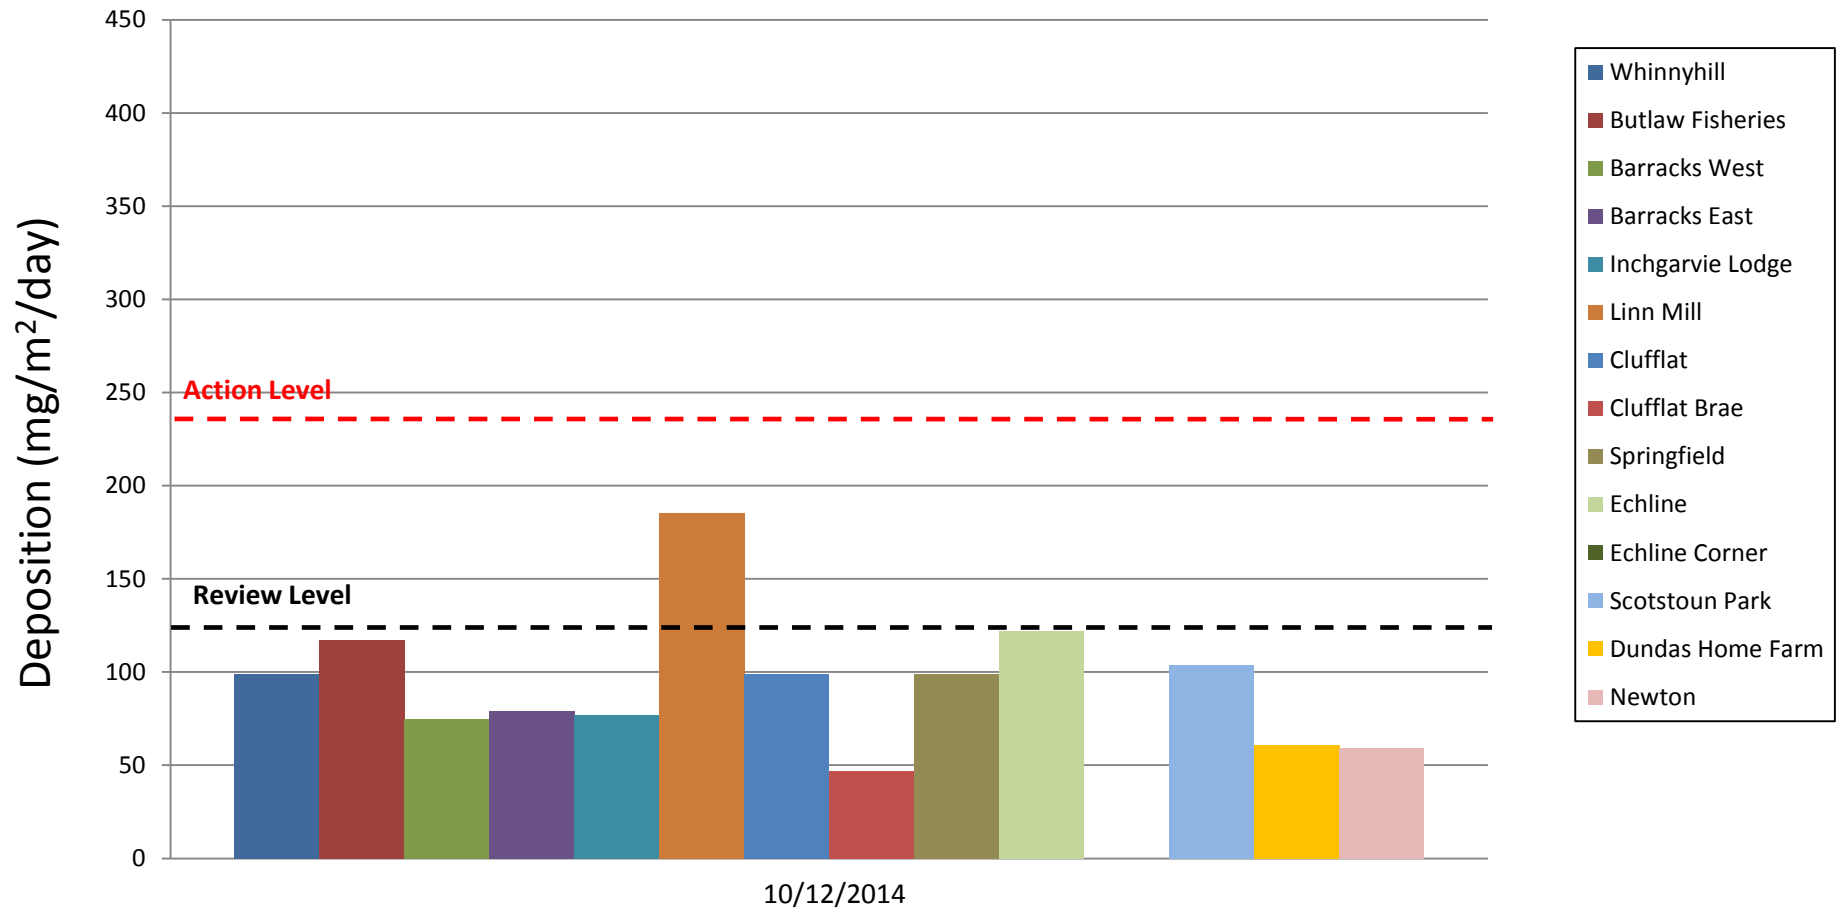
## **APPENDIX C: FRISBEE GAUGE RESULTS**

## Frisbee Dust Deposition Results: December 2014

Note: No collection took place on the 24/12/2014 due to the Christmas period. Next collection will take place on the 08/01/2015 and will be analysed for the 4 week period. Echline Corner has been omitted due to the sample bottle being found away from the gauge, upturned and empty (see Section 3.3.6).

**3.3.1.** The Frisbee dust deposition results for December 2014 have been presented in a chart and can be found in Appendix C. This includes an additional Frisbee (Echline Corner) currently located south of the A904 in proximity to the Echline monitor. This temporary Frisbee is used to provide additional information and its results are presented alongside the 13 permanent monitors. Frisbee dust deposition results were collected fortnightly, and the results averaged over this fortnight period to give a daily dust deposition rate. One collection was made in December, on the 10<sup>th</sup>. No collection took place on the 24<sup>th</sup> due to the festive period. The next collection will take place on the 8<sup>th</sup> January 2015 and will cover the previous 4 weeks rather than a fortnight.

**3.3.2.** The site action level for the dust deposition rate has been set at 250 mg/m<sup>2</sup>/day. Exceedances of this level are treated as a potential incident and a review of the works in the vicinity of the site is instigated. A lower site review level has been set at 140 mg/m<sup>2</sup>/day. Where concentrations exceed the lower review threshold the site works are reviewed to ensure good practice is implemented; it is essentially a warning that additional controls may be required.

**3.3.3.** During December there was one exceedance of the site review level and no exceedances of the action level (see Table 2).

**3.3.5.** During the two week period ending the 10<sup>th</sup> December the Linn Mill gauge registered above the Review Level. However, a review of works was undertaken and it was found that no construction activities that would be likely to give rise to dust took place in the area during this period. PM<sub>10</sub> and TSP data were low for the period at the same location. After a thorough review it was concluded that the results cannot be explained by FCBC construction activities undertaken during this period.

**3.3.6.** The sample bottle for the Echline Corner Frisbee gauge was found approximately 10m away from the gauge, upturned and completely empty of liquid. The gauge was also found on the ground, presumably blown over. During the early part of December the site experienced sustained periods of strong wind (Appendix D). The Echline Corner gauge is situated in a location that is more exposed than the other gauge locations.
