Forth Crossing Bridge Constructors

FORTH REPLACEMENT CROSSING

**AIR QUALITY MONITORING REPORT
 MARCH 2014**

REP-00172-00

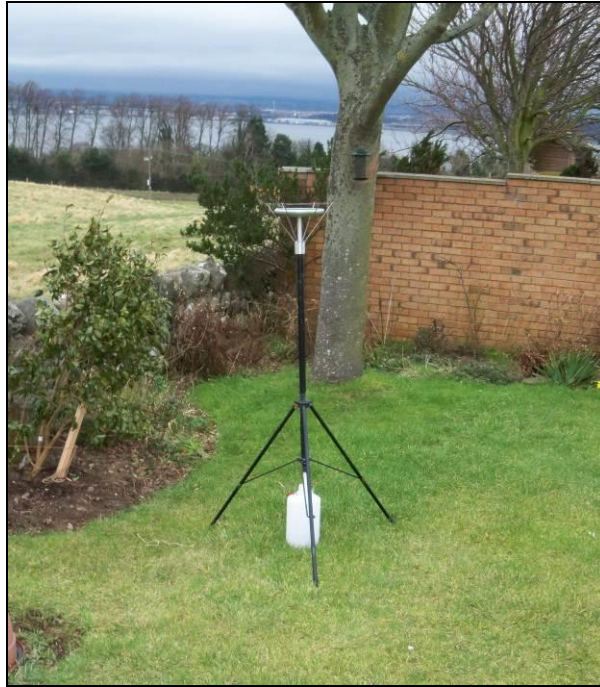
Figure 1: Example of an Installed Frisbee Gauge Meter

2.1. Air quality is being monitored on site using both automatic light scatter dust meters and Frisbee gauge dust deposition monitoring. Thirteen Frisbee gauges are set up at sensitive locations across the site to measure dust deposition rates (Figure 1). Seven automatic light scatter meters have also been installed at various sensitive locations to measure real time particulate matter (PM₁₀) concentrations and the Total Suspended Particle (TSP) concentrations (Figure 2). These meters are calibrated annually. Table 1 lists the air quality monitoring equipment present at each monitoring location. The installation of the air quality monitoring equipment was not simultaneous across the site, installation dates are also given in Table 1.

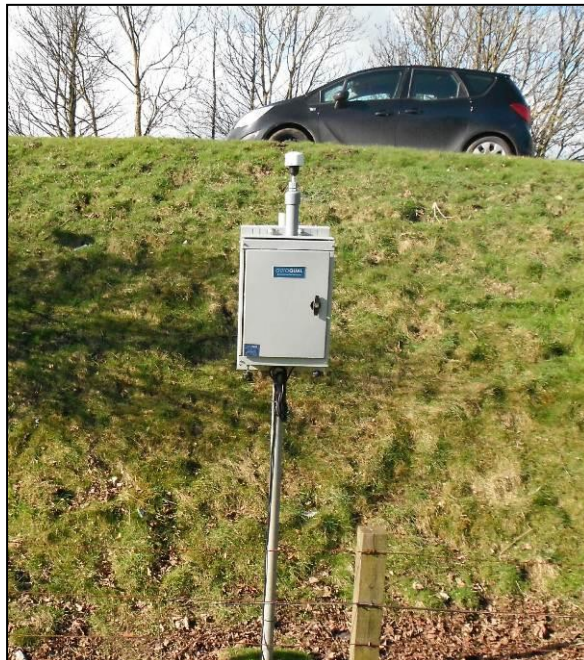
Figure 2: Example of an installed Automatic Light Scatter Dust Meter

2.2. Light scatter type monitoring equipment have been selected as a site monitoring tool to create a live network which assesses the levels of fugitive particulate matter, principally airborne dust. These monitors require less space, maintenance and power than other real time monitors such as a Tapered Element Oscillating Microbalance (TEOM) which is used and designed to measure particulate levels to exceedingly high standards, including measuring long-term compliance to statutory limits. Light scatter meters are more practicable to deploy. However, the meters do generally record levels higher than those measured by the TEOM. The meters can also be affected by atmospheric moisture content which further increases reported levels. Accordingly, any elevations of statutory limits should be treated as precautionary exceedances. The monitors are reliable for on-site monitoring and the establishment of action thresholds to ensure unforeseen activities generating significant dust are identified and suitably controlled. Light scatter meters are becoming the construction and waste industries norm for particulate dust monitoring.

2.3. In association with air quality monitoring across the site, weather conditions (temperature and relative humidity) are also continually measured by the light scatter meters at Inchgarvie Lodge and Clufflat Brae. Weather stations, located at the sound level meters at Echline and Linn Mill which are adjacent to the light scatter meters at these monitoring locations, also continually record weather data, including temperature, relative humidity, wind speed and wind direction.

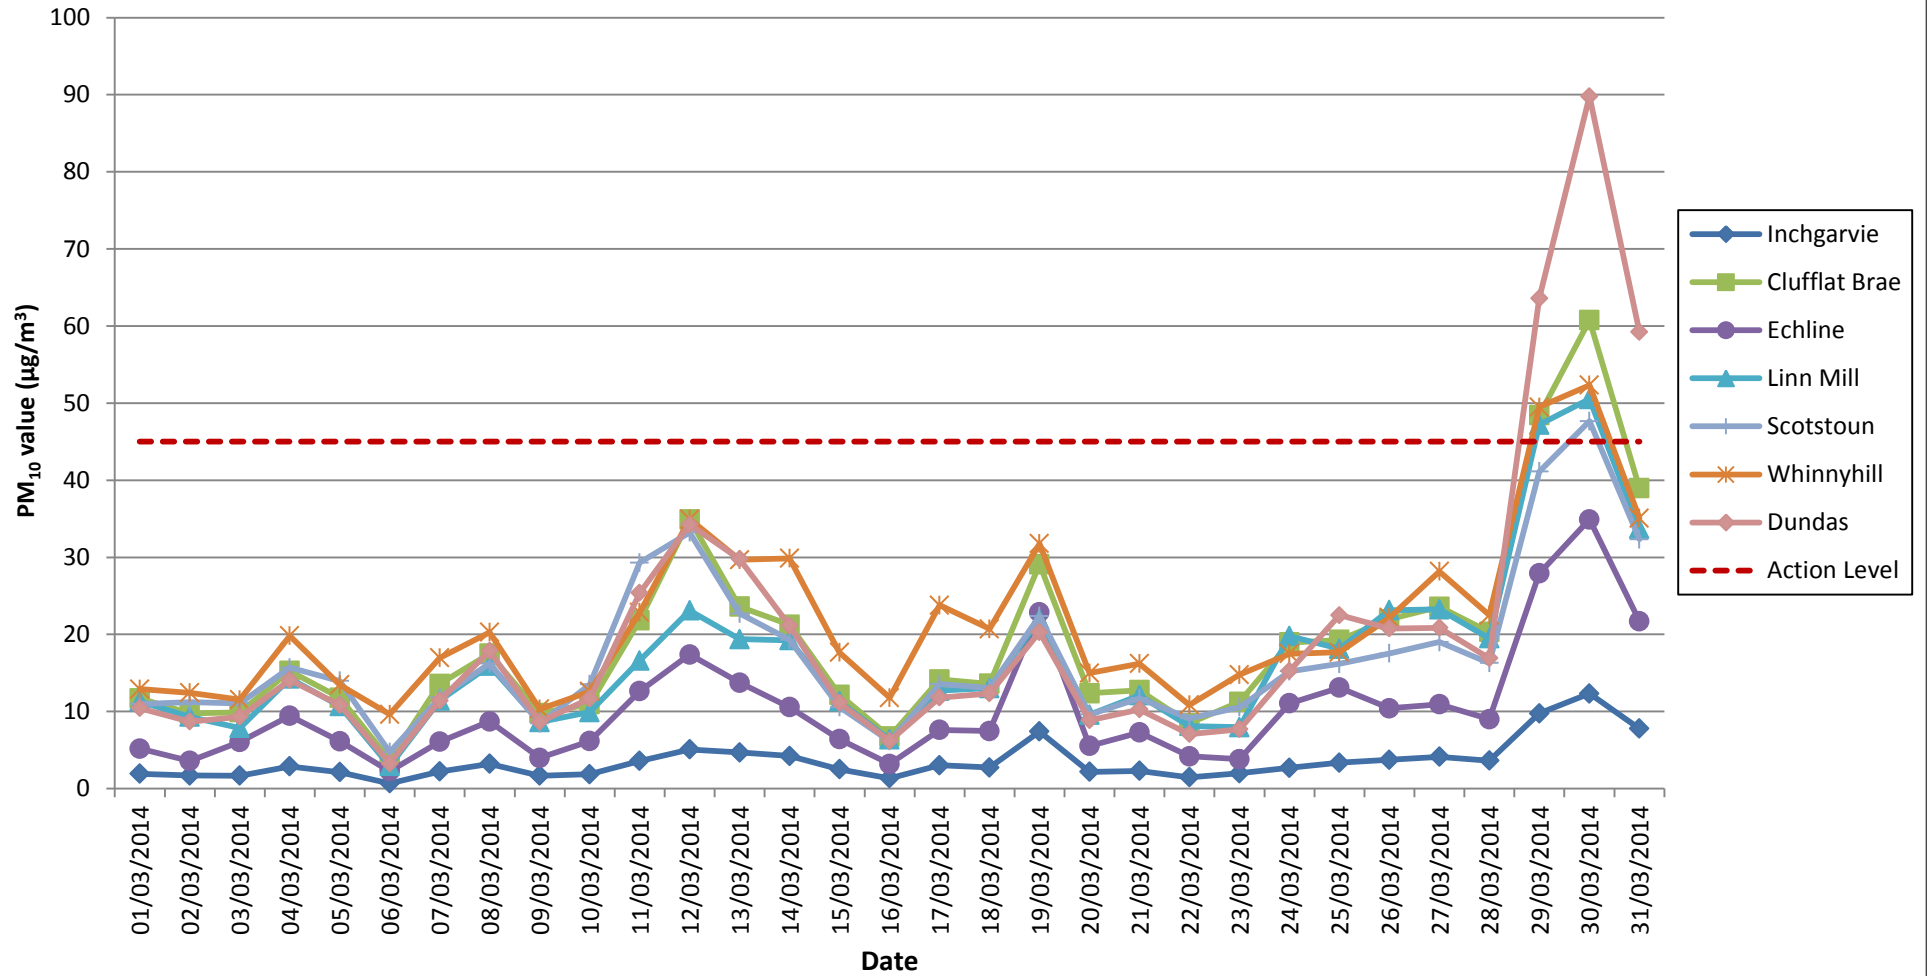
Particulate Matter (PM10) Results for all Monitoring Locations

- 3.1.1.** Light scatter results for March 2014 have been presented in a monthly chart; this can be found in Appendix A. Results show that the PM₁₀ levels were below threshold levels throughout the month with the exception of 29th to 31st March. All monitors showed an increase through the 29th and 30th with levels starting decreasing on the 31st. All monitors with the exception of Echline and Inchgarvie Lodge exceeded the action on one or more days during this short period. All 7 monitors follow the same general pattern throughout the month.

- 3.1.2.** It was noted that high levels of fog occurred on the 29th and 30th March which can affect the meter readings (see section 2.2). Also the first reports of anecdotal evidence of dust from a Saharan dust storm were noted during this period the dust storm was subsequently widely reported in the news in early April. The raised levels also occurred during a weekend with limited works activity occurring on site. The fact that all 7 monitors showed the same pattern would suggest that a regional event affected the levels across the whole area rather than the increases being related to works activities in one specific area affecting only a few monitors.

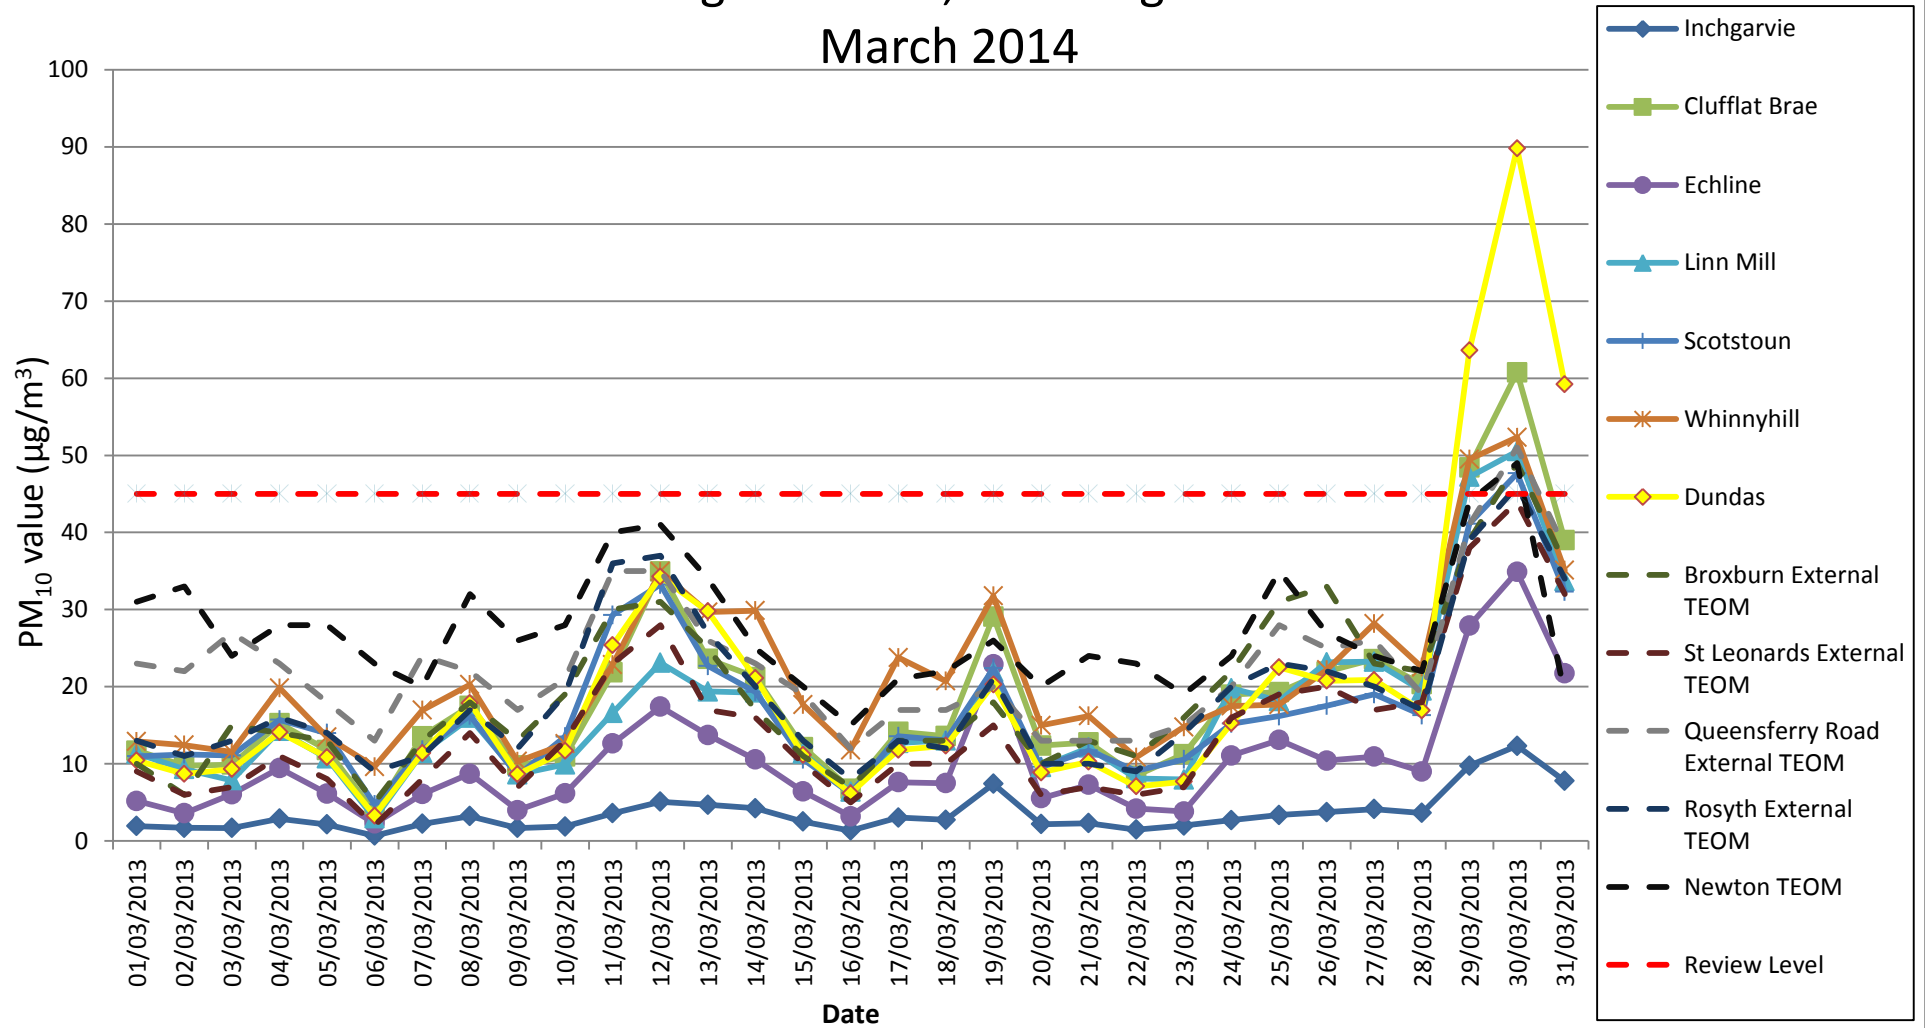
Air Quality Monitoring: Particulate Matter (PM10) Results for all Monitoring Locations, including TEOM data March 2014

- 3.1.3.** The PM₁₀ results have also been compared to the daily mean results obtained from the TEOM air quality monitoring stations located in Newton, Rosyth, and Broxburn, and from the TEOM FDMS stations located at Queensferry Road, Edinburgh and St Leonards, Edinburgh (an urban background site). The same increase in levels at the end of March can be seen in the TEOM data, confirming that the increases were likely to be caused by a regional event rather than works activities.

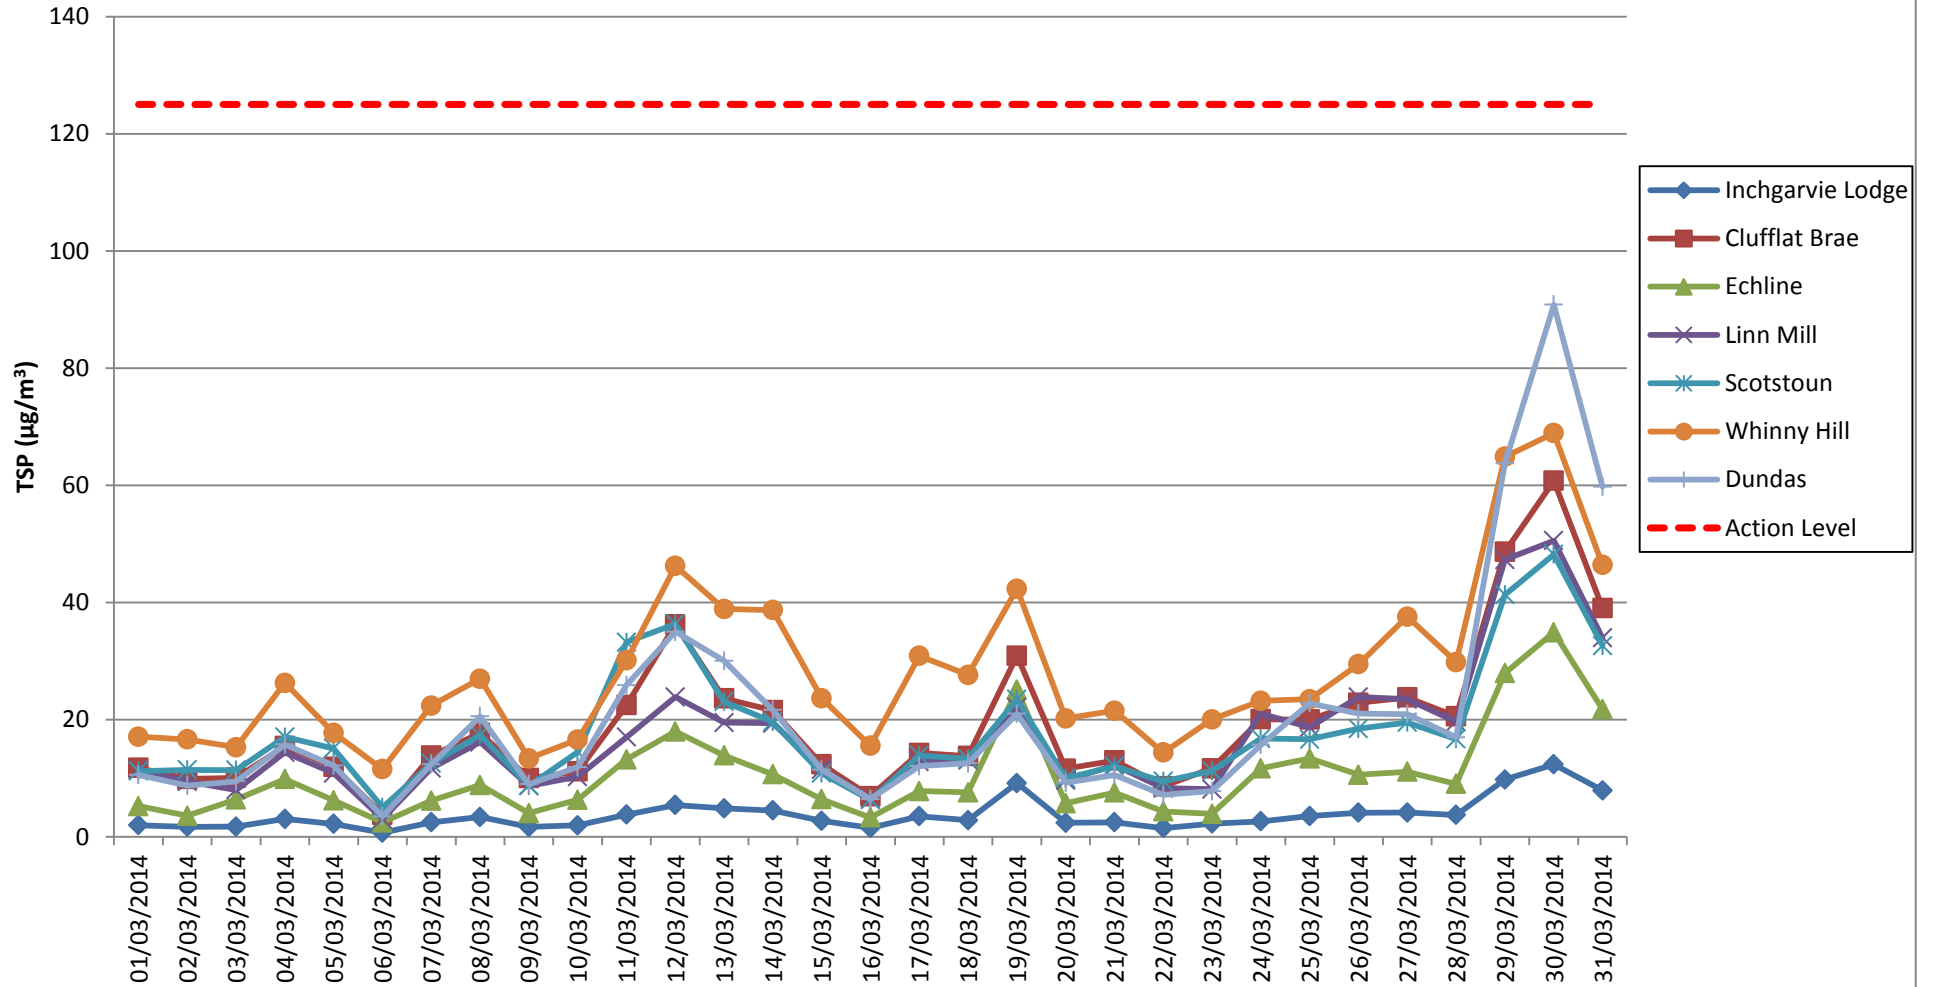
Total Suspended Particles (TSP) Results March 2014

3.2.1. The TSP results for March 2014 have been presented in a monthly chart; this can be found in Appendix B. The TSP levels at monitoring locations during March were found to be low and all within the threshold level. All locations were mostly found to follow a similar pattern across the site, demonstrating that, in general, the levels were influenced by regional changes in TSP levels, rather than construction works. The same increase at the end of the month (29th-31st March) that was observed in the TEOM and PM₁₀ data is observed in the TSP also, though the action level is never reached.

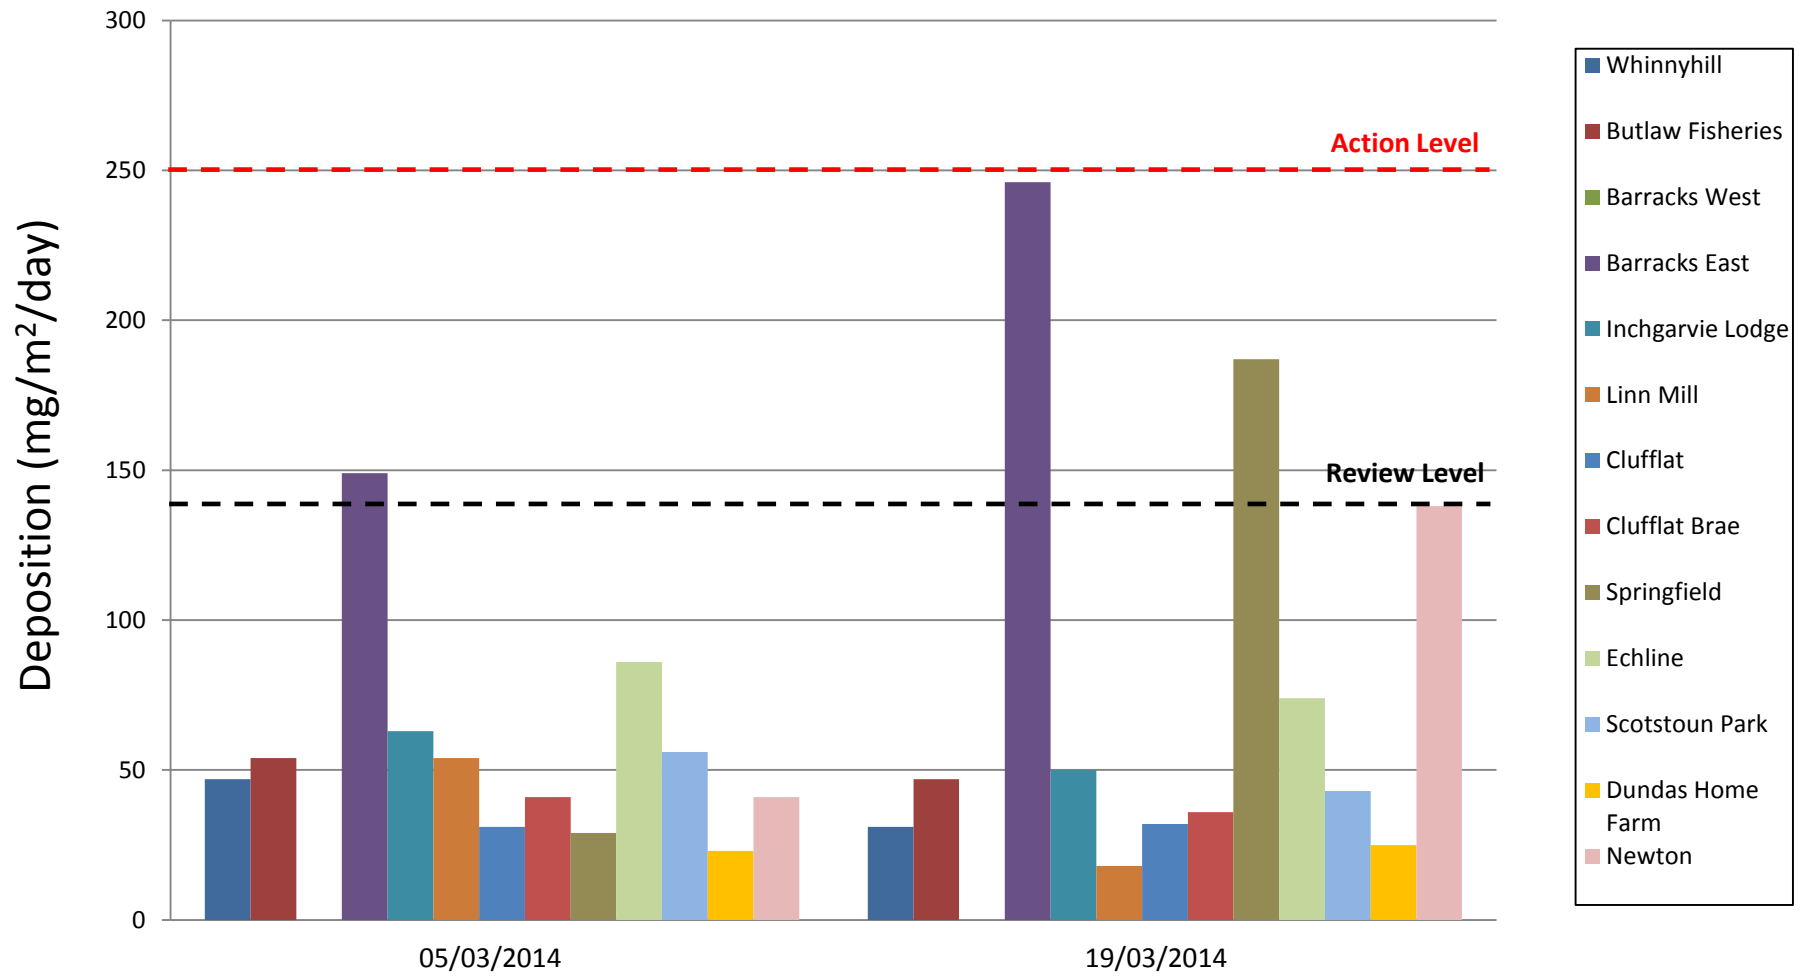
Frisbee Dust Deposition Results: March 2014

3.3.1. The Frisbee dust deposition results for March 2014 have been presented in a chart and can be found in Appendix C. Frisbee dust deposition results were collected fortnightly, and the results averaged over this fortnight period to give a daily dust deposition rate. Two collections were made in March, on the 5th and 19th. The next collection will take place on the 3rd April 2014.

3.3.2. The site action level for the dust deposition rate has been set at 250 mg/m²/day. Exceedances of this level are treated as a potential incident and a review of the works in the vicinity of the site is instigated. A lower, site review level has been set at 140 mg/m²/day. Where concentrations exceed the lower action threshold the site works are reviewed to ensure good practice is implemented; it is essentially a warning that additional controls may be required.

3.3.3. During March there were three exceedances of the site review level (see Table 4) and no exceedances of the action level. With the exception of the locations where exceedances occurred, Frisbee results from monitoring locations across site were generally found to be low, with the exception of Newton (19/04/2014). It should also be noted that the collection bottle for the sample for Barracks

West was found overturned and located away from the Frisbee during both collections in March. As such, a review of the location and setup is underway.

3.3.5. During both two week periods the Barracks East Frisbee registered levels above the review level. However, a review of works was undertaken and it was found that no construction activities that would be likely to give rise to dust took place in the area. Activities taking place in the area were checked for dust during inspection on the 17th and 21st March. Work in the barracks area around Pier S6 has predominantly been rebar work and activities related to concrete pours. Vehicle movement in the area were minimal due to the closed nature of the work going on and material being tracked out of the compound was negligible. There are also minimal exposed areas of ground in the vicinity that could generate dust and almost constant damp or wet conditions on the

ground. Other indicators such as PM₁₀, TSP and Frisbee data were very low for the period at the nearest meter (Inchgarvie). After a thorough review it was concluded that the results cannot be explained by FCBC construction activities undertaken during this period. However, given the ongoing issue of unexplained elevated results at Barracks East, an alternative location for the Frisbee, in the same vicinity, is currently being investigated.

- 3.3.6.** With regard to the exceedance of the review level at Springfield for the week concluding 19th March 2014, a further review into works undertaken in the vicinity took place. However, during the period in question no construction activities that would be likely to give rise to dust took place in the area and damp ground conditions will have suppressed windblown dust from bare ground. Three other monitoring locations are situated within 250m of the Springfield Frisbee (Clufflat, Clufflat Brae and Inchgarvie Lodge), all of which showed low levels for indicators (TSP, PM₁₀ and Frisbee data) during this period. These factors would indicate that the exceedance at this location was not related to FCBC works. However, considering the elevated levels in consecutive months FCBC will conduct increased inspections in the vicinity to ensure construction activities are not causing these results.
