Project FORTH REPLACEMENT CROSSING

# **CONSTRUCTION NOISE MONITORING REPORT: MAY 2015**

Made by: Steven Westwater	Checked By: Lindsay McIntyre		
Initials: SWR	Initials: LME		
Document number		Rev	
REP-00233		01	
This degree at it is intellectual preparate of ECDC Construction IV Convince distribution usage and information on contents

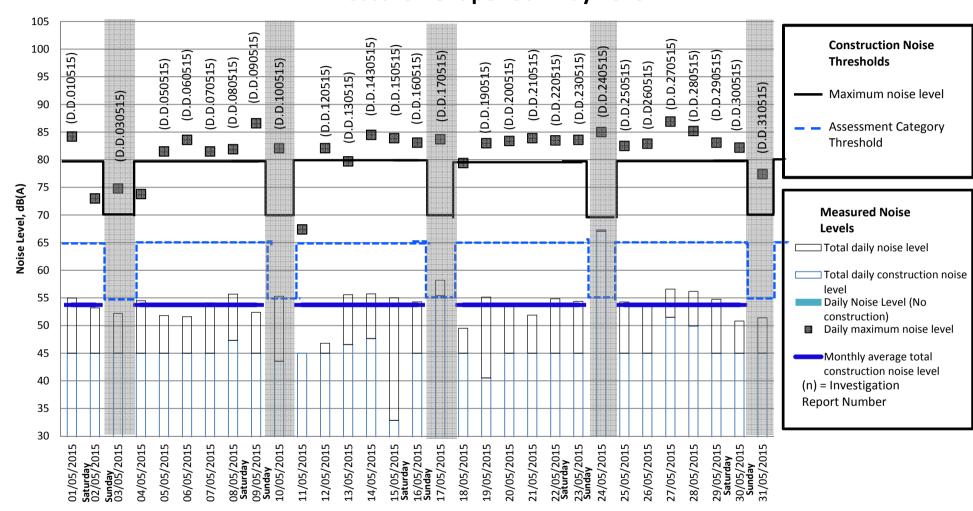
**Note:** The grey areas of the chart represent days on which no construction works have been conducted. The Sunday average has not been included as no Sunday works have been conducted at this location.

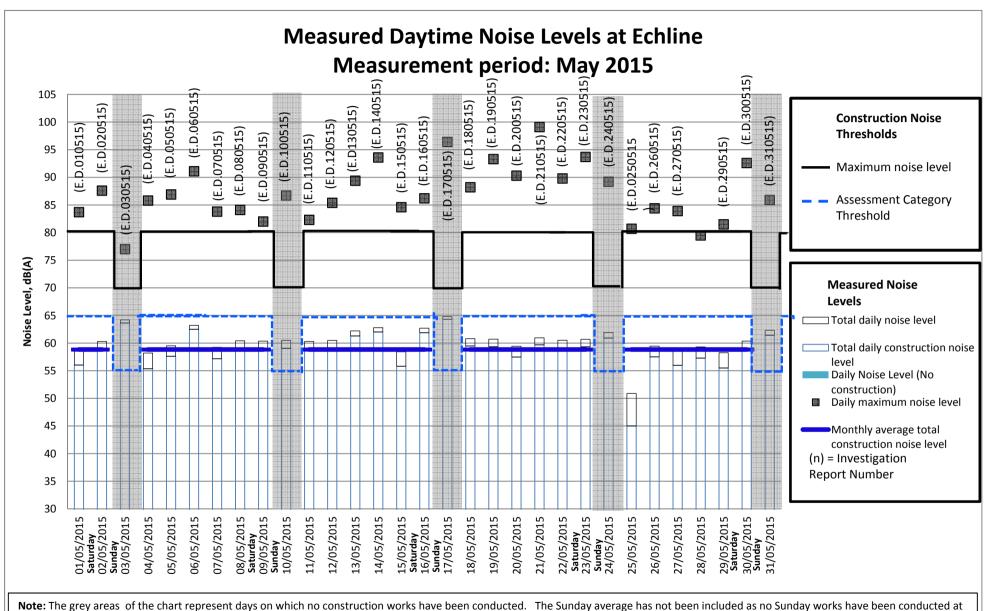
**Note:** The grey areas of the chart represent days on which no construction works have been conducted. The Sunday average has not been included as no Sunday works have been conducted at this location.

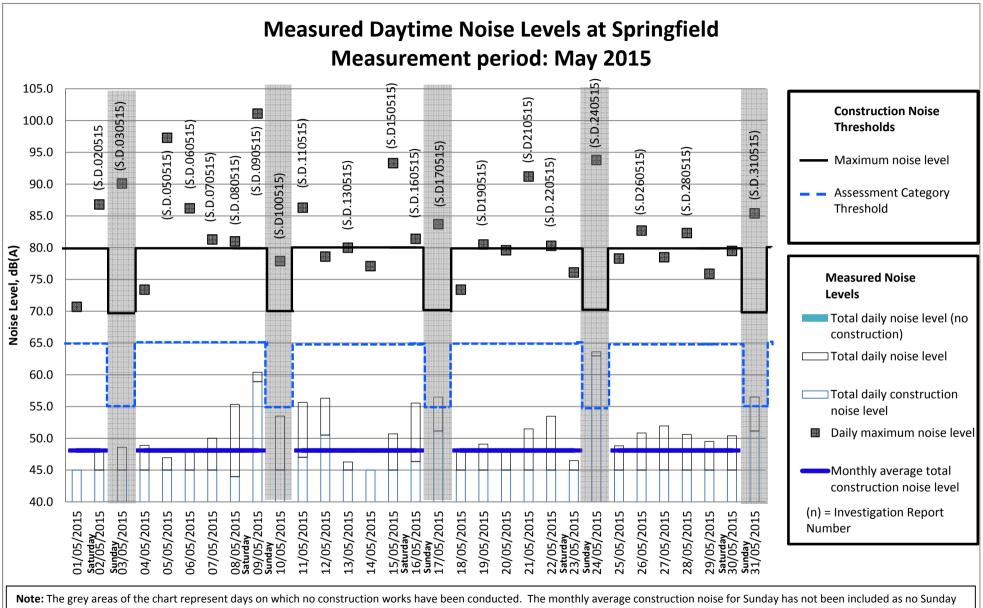
works have been conducted at this location. Data is missing for 19/05/13 due to device error.

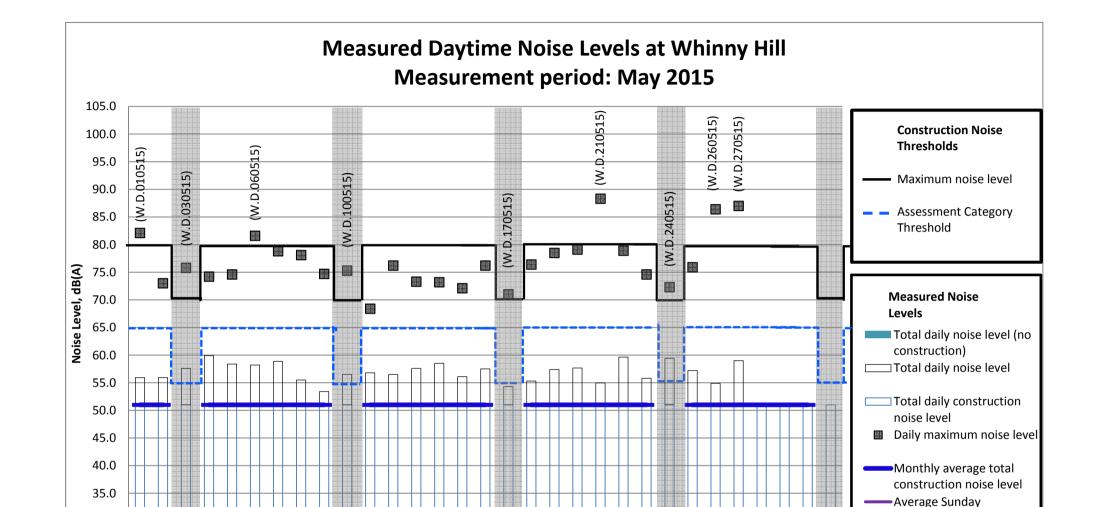
Note: The grey areas of the chart represent days on which no construction works have been conducted. There is no data from 27/04/2015 - 31/04/2015 due to monitor maintance
