Project **FORTH REPLACEMENT CROSSING**

**VIBRATION MONITORING REPORT
JANUARY 2015**

Document number REP-00220	Rev 01
-------------------------------------	------------------

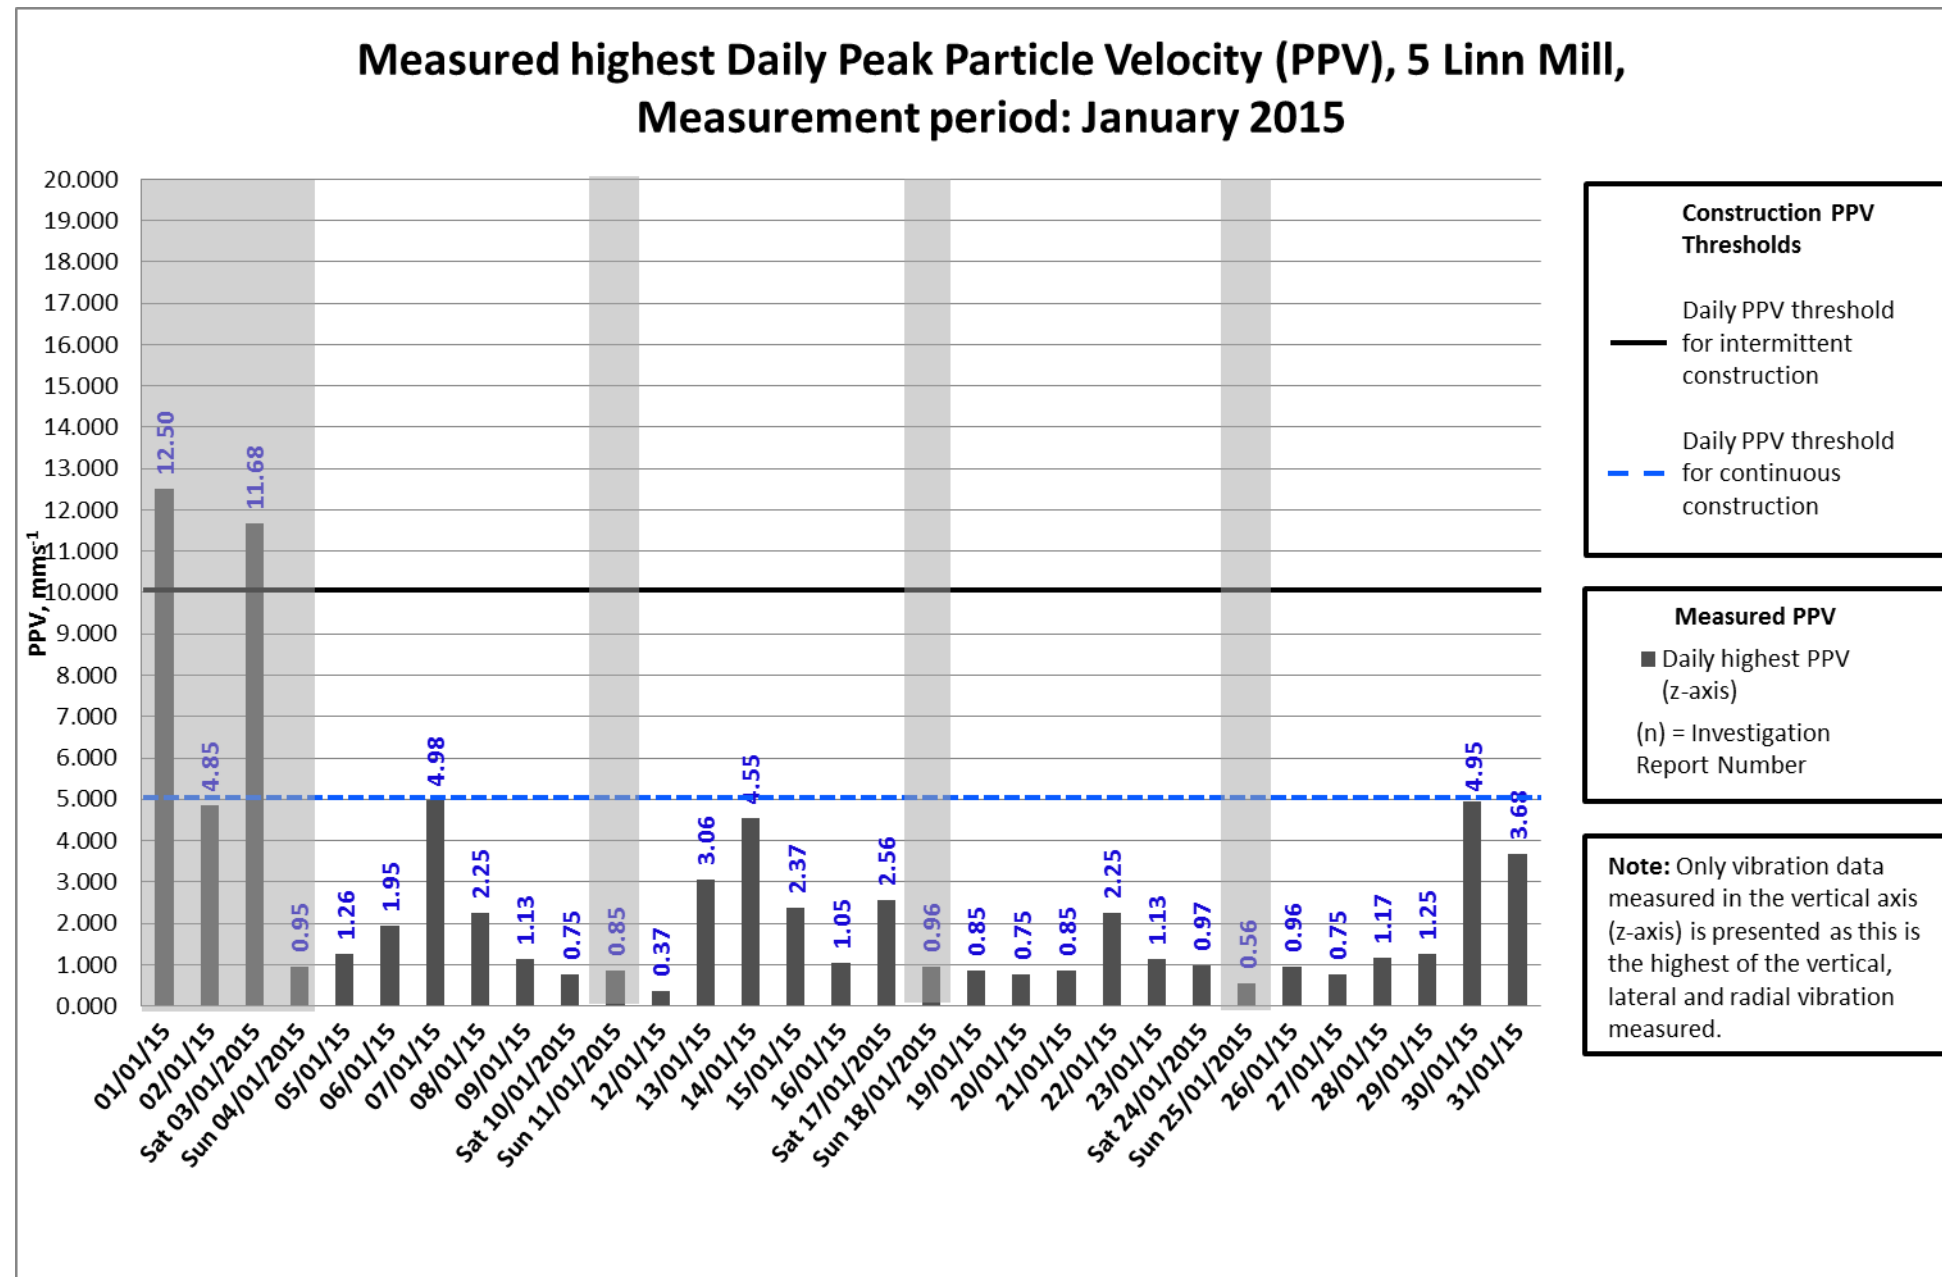
- The grey areas of the chart represent the days on which no construction works were undertaken; no works were conducted in the vicinity of the Linn Mill monitor on Sundays.
- No FCBC works took place between 01/01/15– 04/01/15.

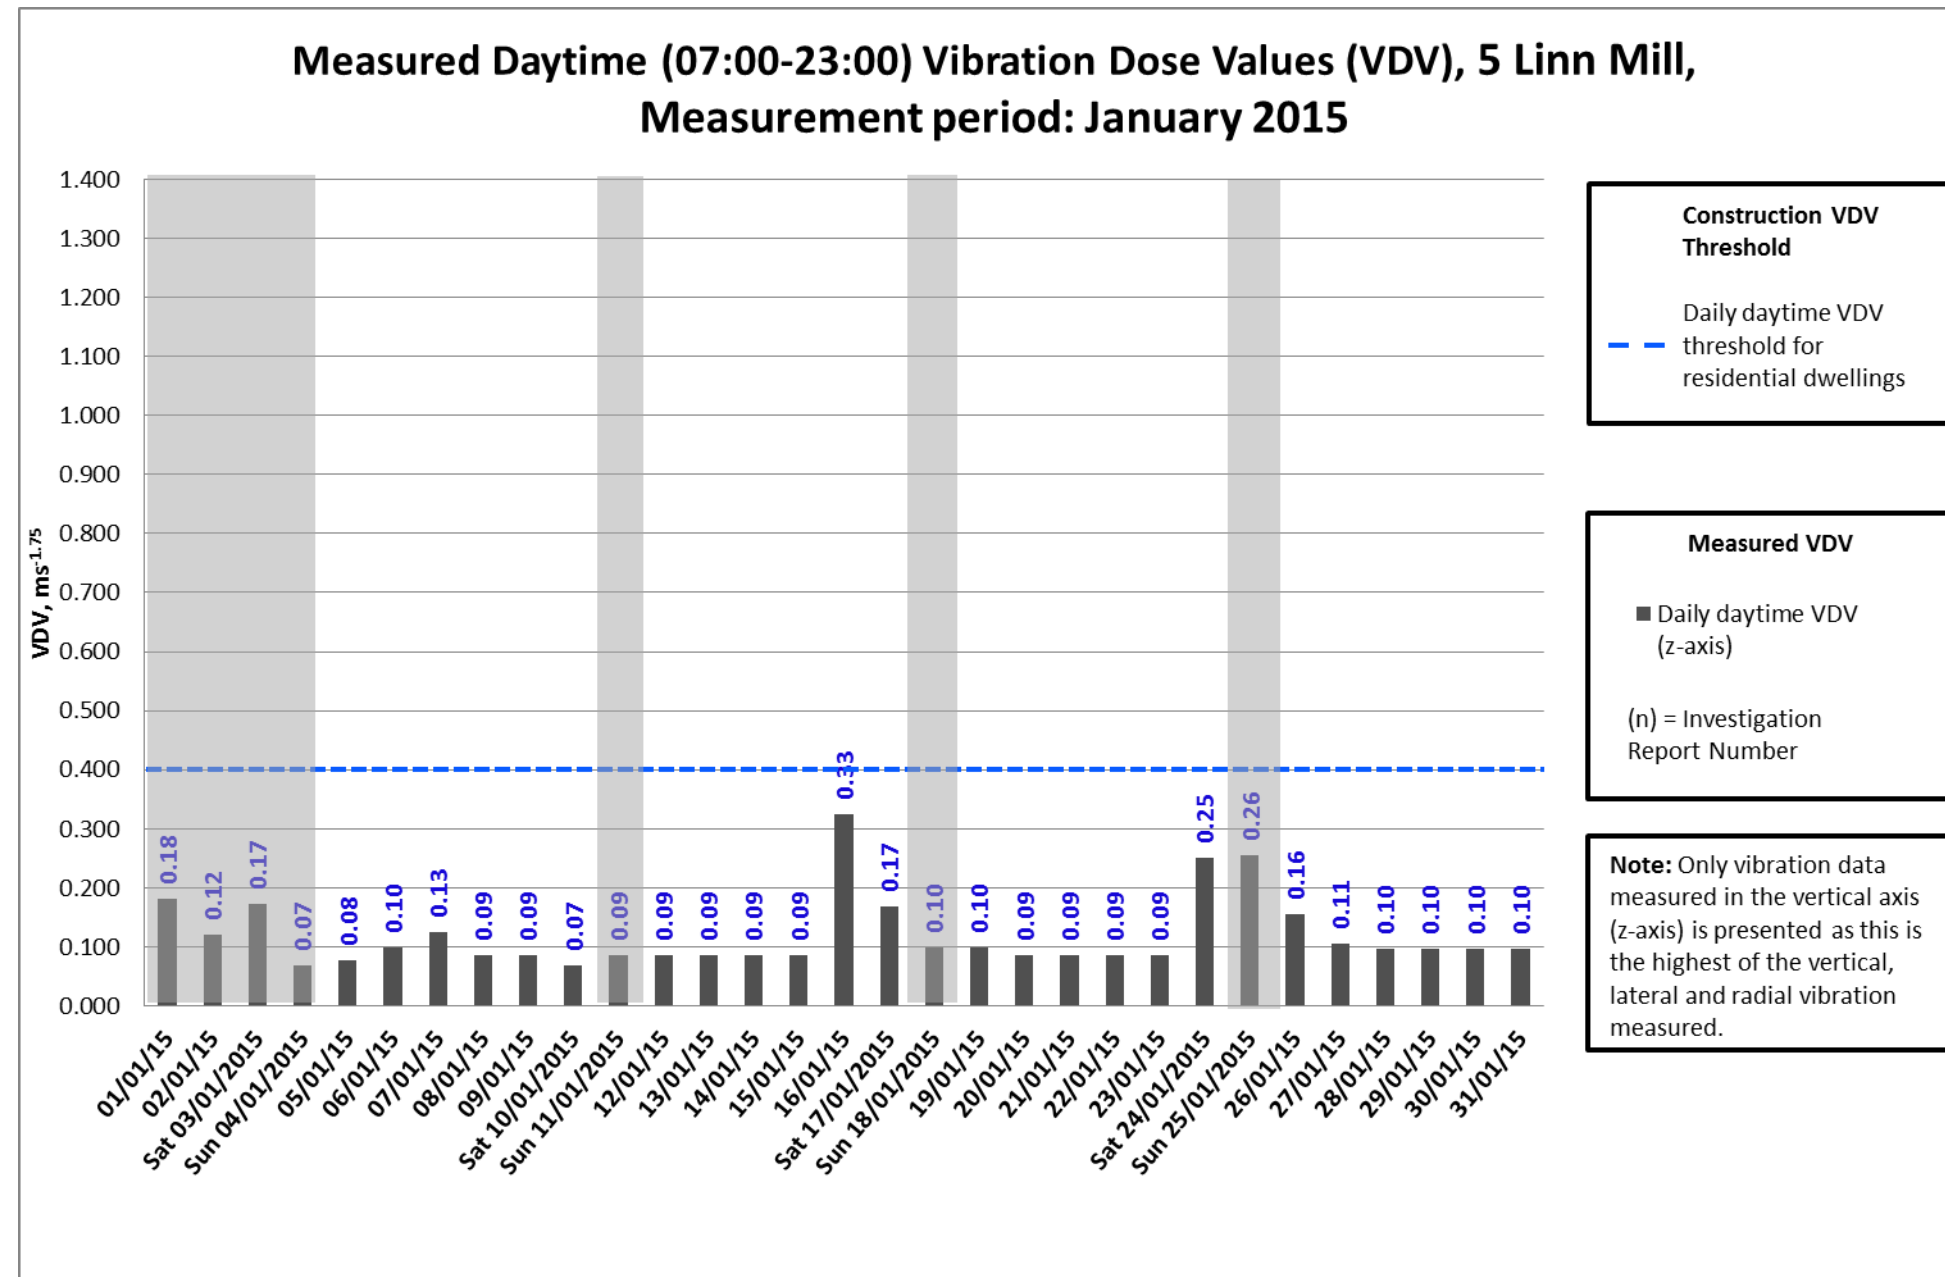
- The grey areas of the chart represent the days on which no construction works were undertaken; no works were conducted in the vicinity of the Linn Mill monitor on Sundays.
- No FCBC works took place between 01/01/15 – 04/01/15.

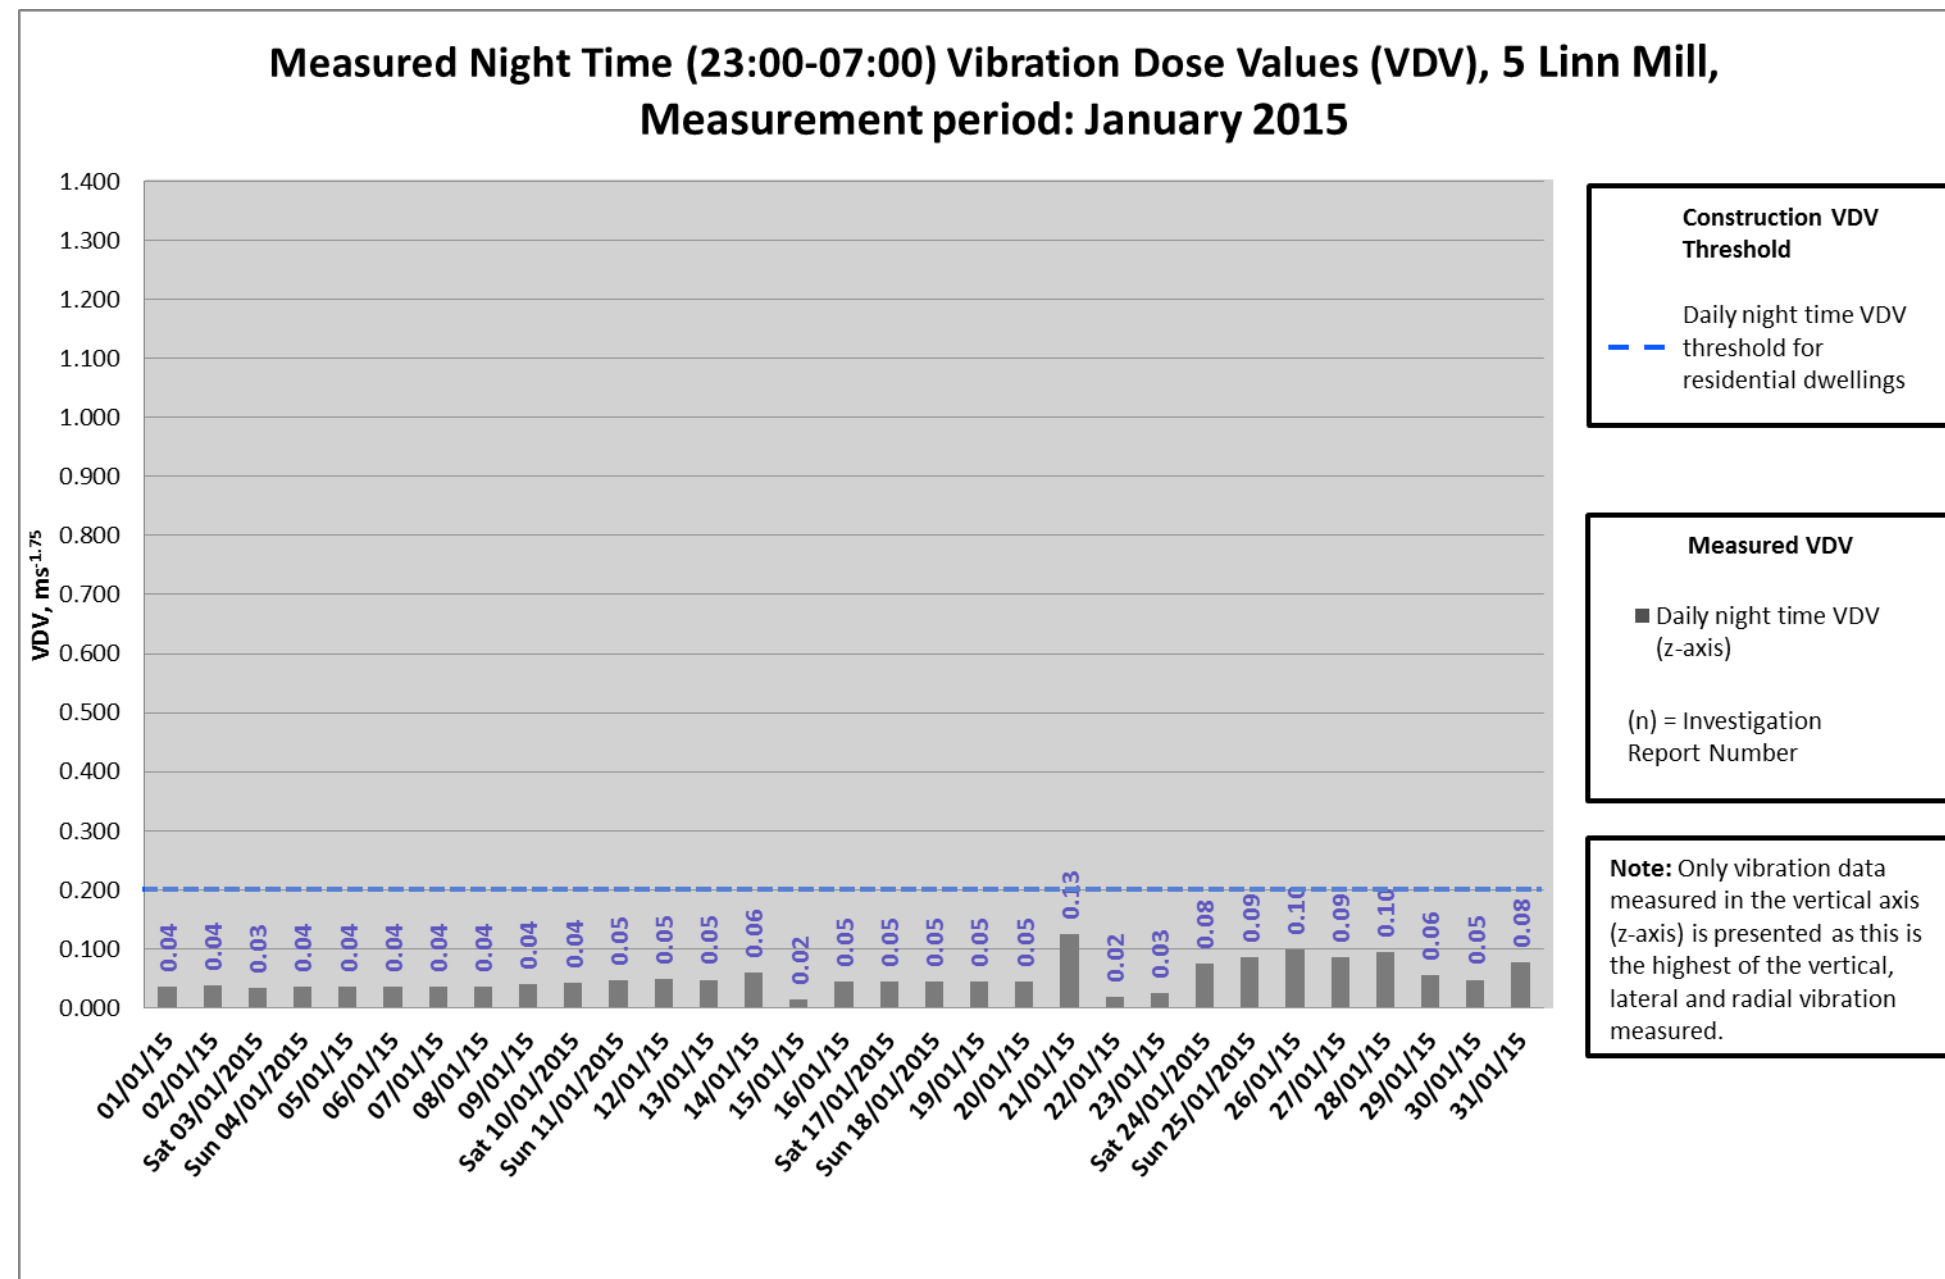
- The grey areas of the chart represent the days on which no construction works were undertaken; no night time works were conducted in the vicinity of the Linn Mill vibration monitor throughout the month of January 2015. This graph is included for illustrative purposes only.
- No FCBC works took place between 01/01/15 – 04/01/15.

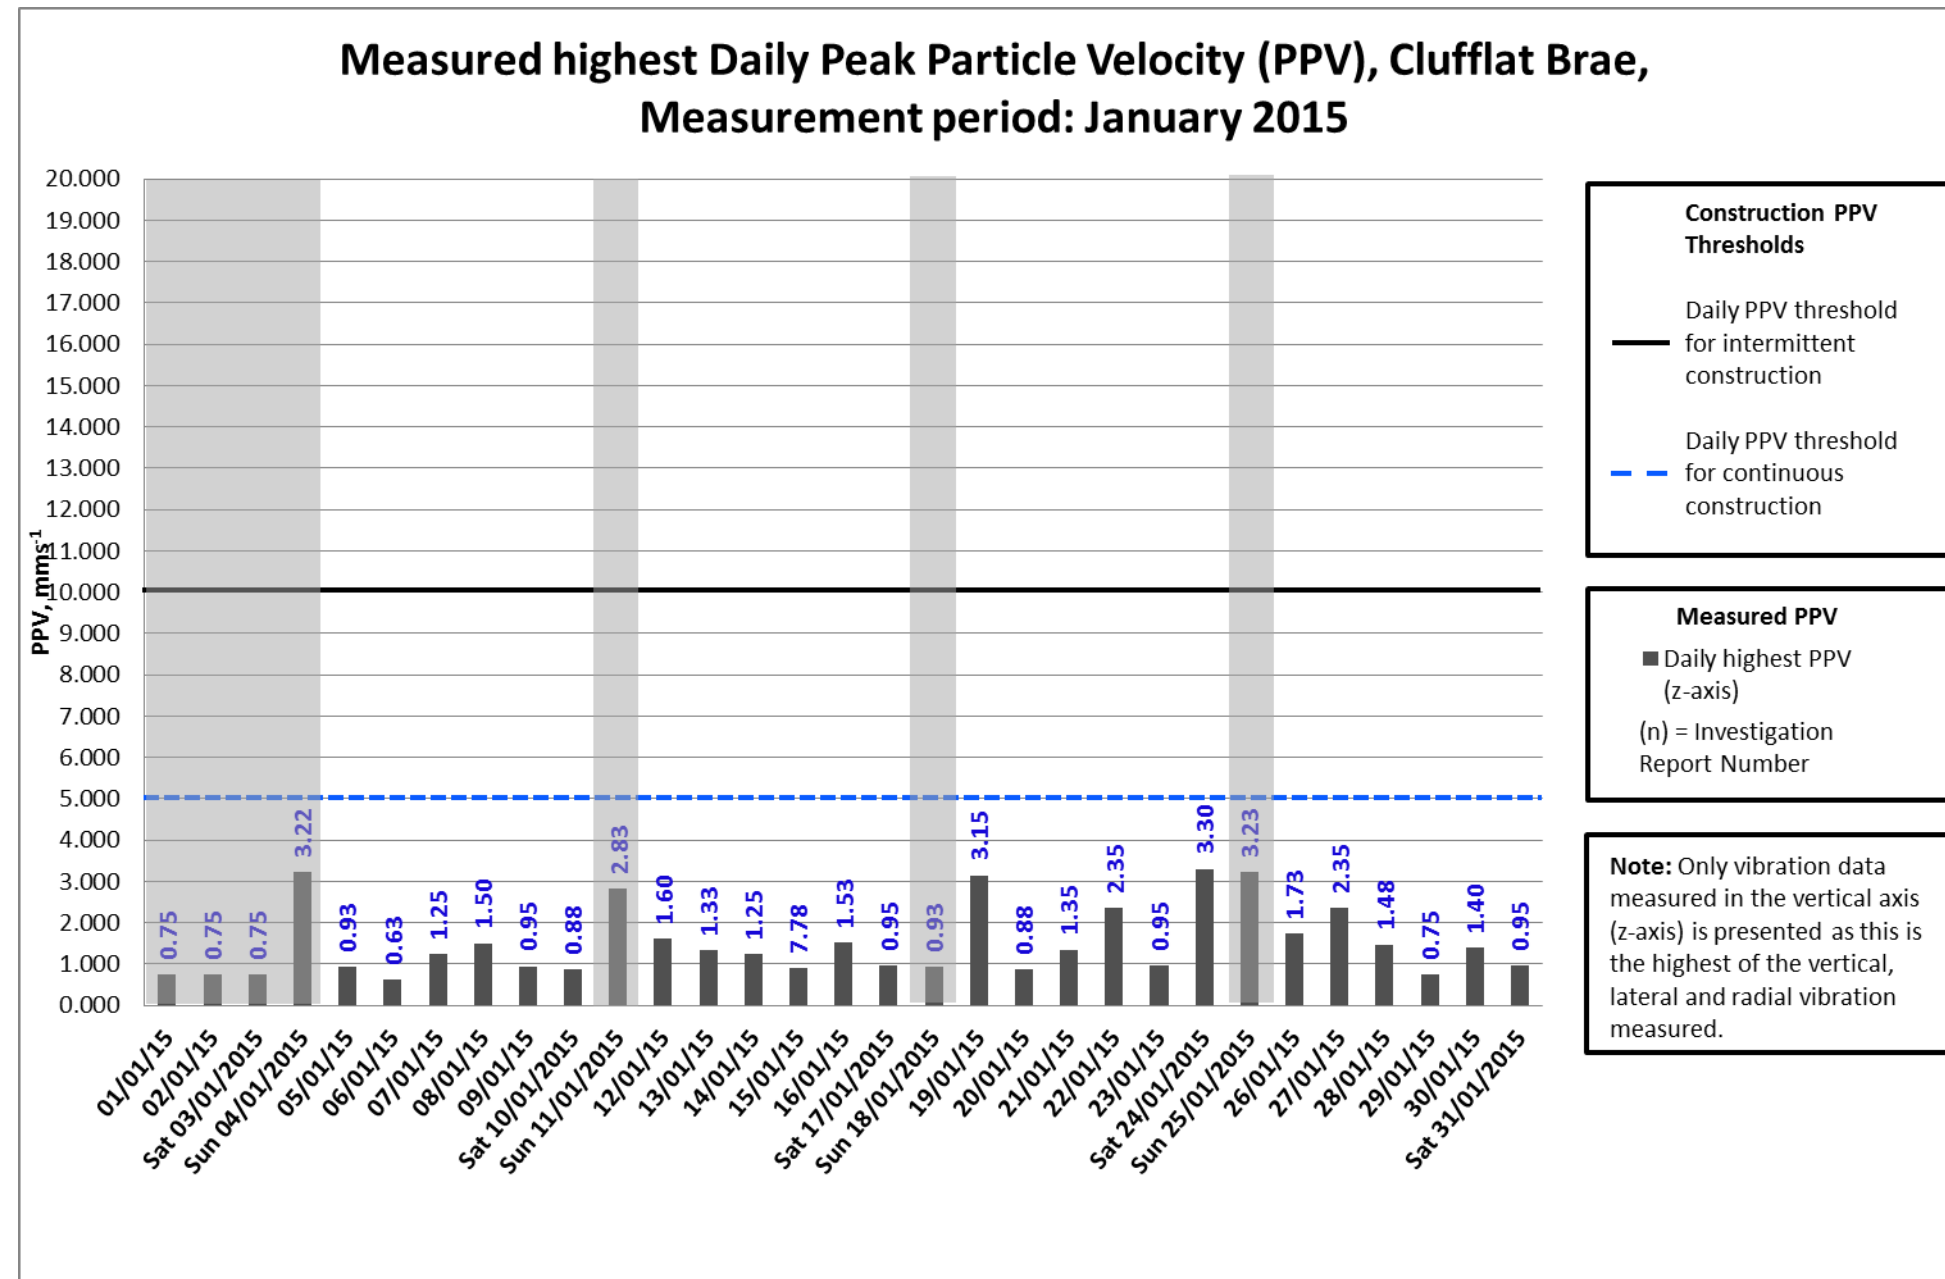
- The grey areas of the chart represent the days on which no construction works were undertaken; no works were conducted in the vicinity of the Clufflat Brae monitor on Sundays.
- No FCBC works took place between 01/01/15 – 04/01/15.

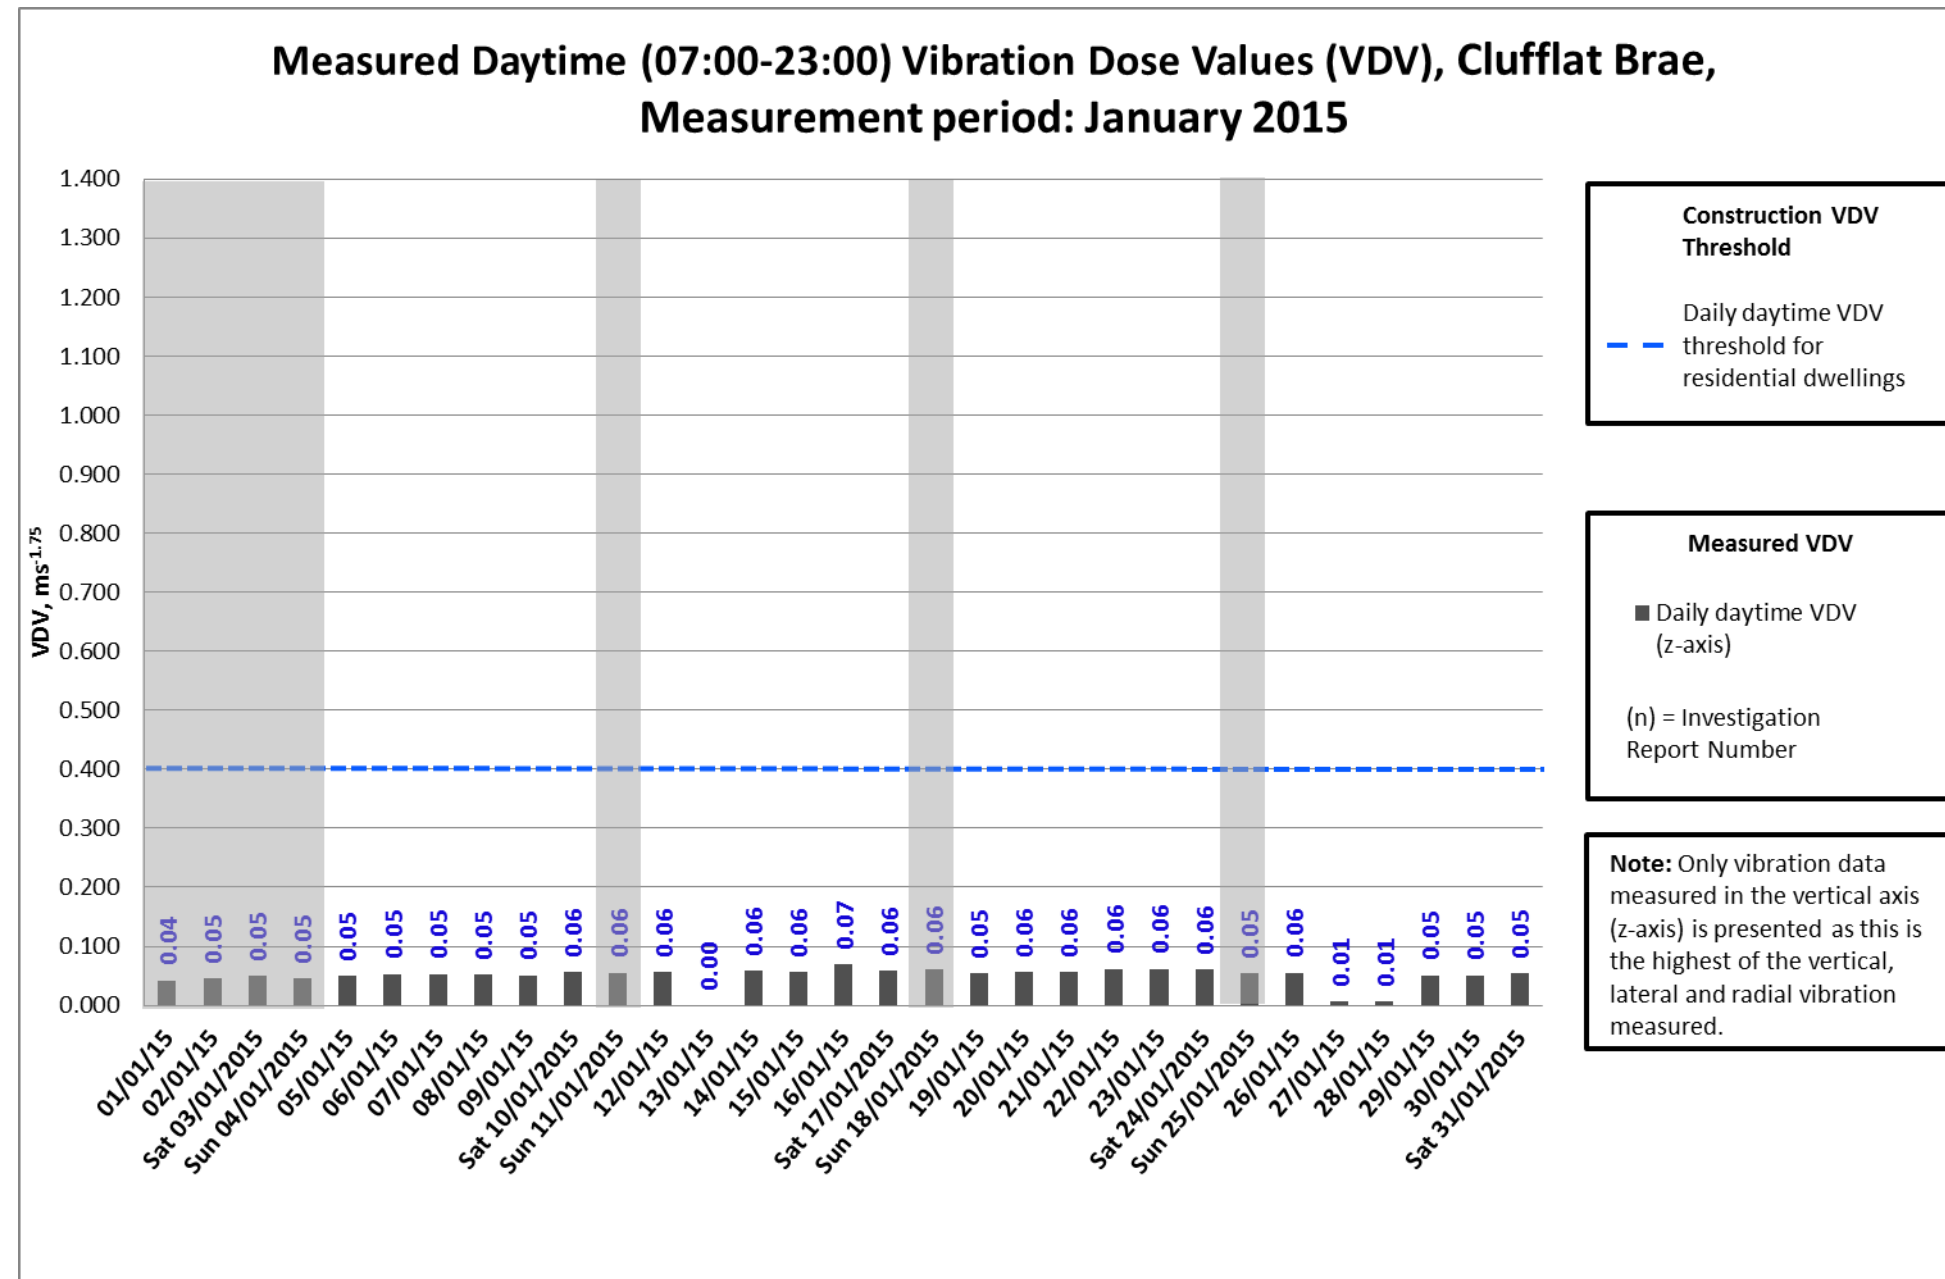
- The grey areas of the chart represent the days on which no construction works were undertaken; no works were conducted in the vicinity of the Clufflat Brae monitor on Sundays.
- No FCBC works took place between 01/01/15– 04/01/15.

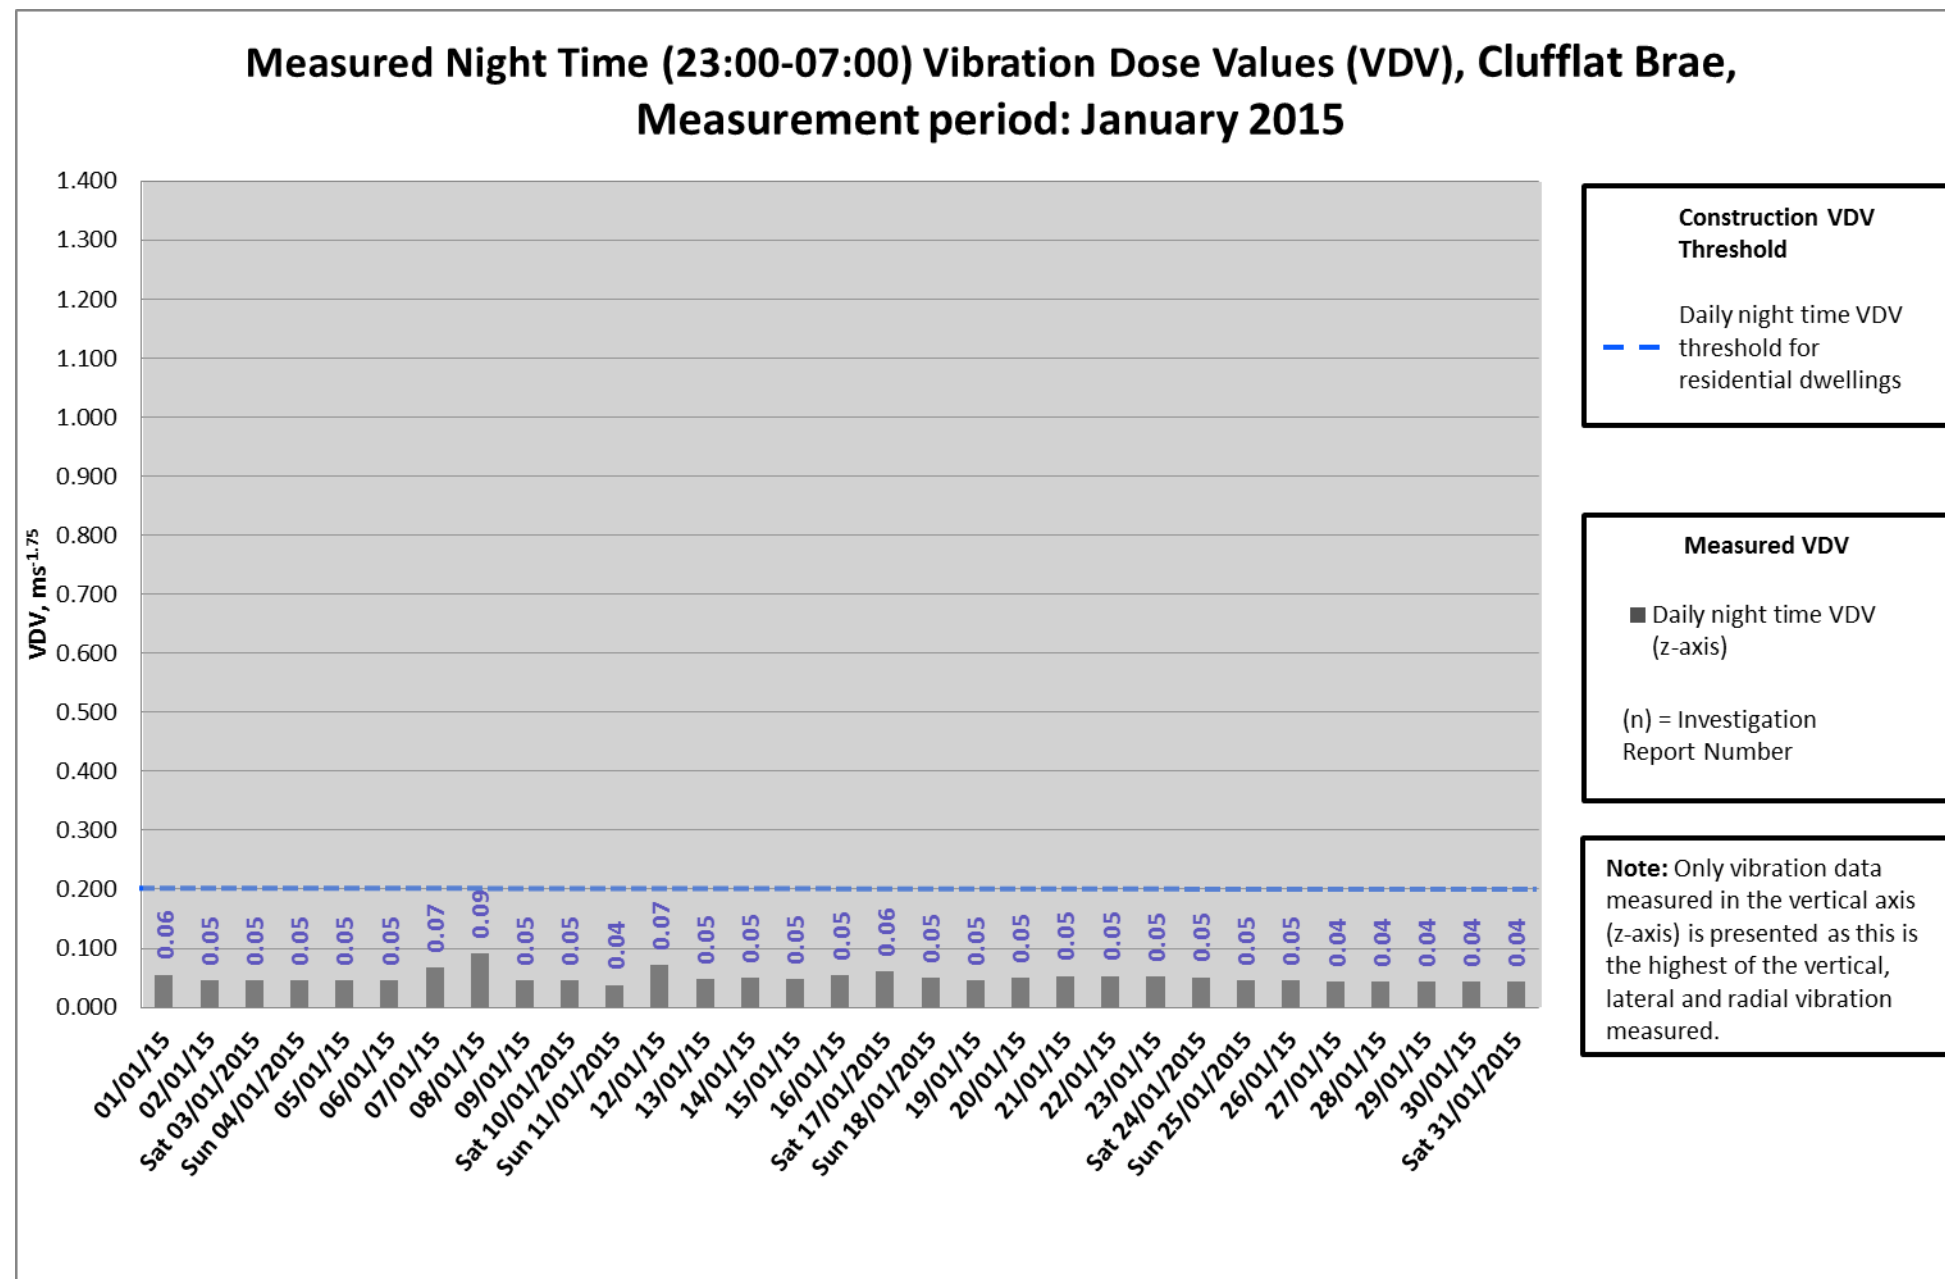
- The grey areas of the chart represent the days on which no construction works were undertaken; no night time works were conducted in the vicinity of the Clufflat Brae vibration monitor throughout the month of January 2015. This graph is included for illustrative purposes only.
- No FCBC works took place between 01/01/15 – 04/01/15.

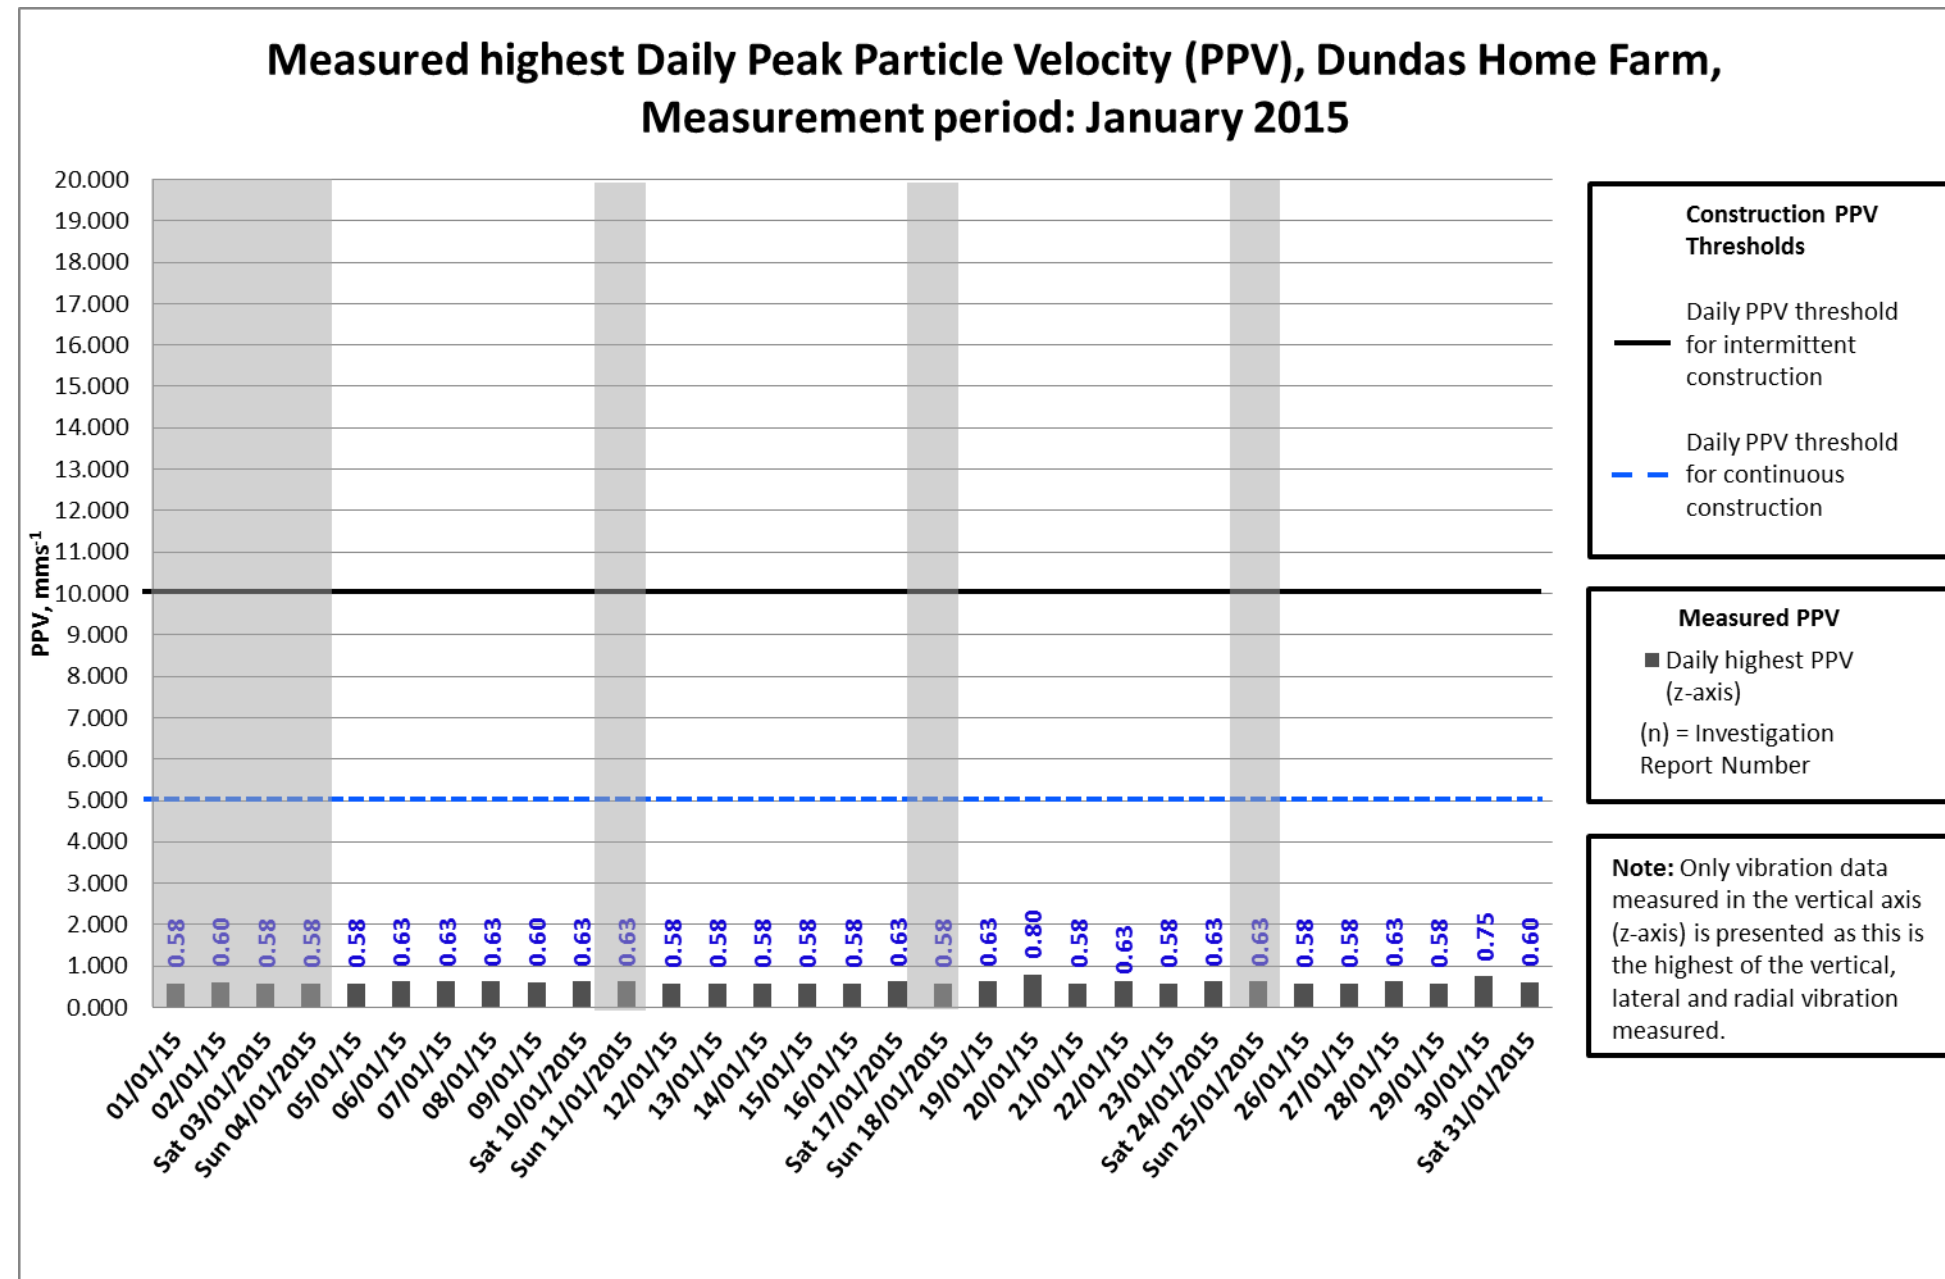
- The grey areas of the chart represent the days on which no construction works were undertaken; no works were conducted in the vicinity of the Dundas monitor on Sundays.
- No FCBC works took place between 01/01/15 – 04/01/15.

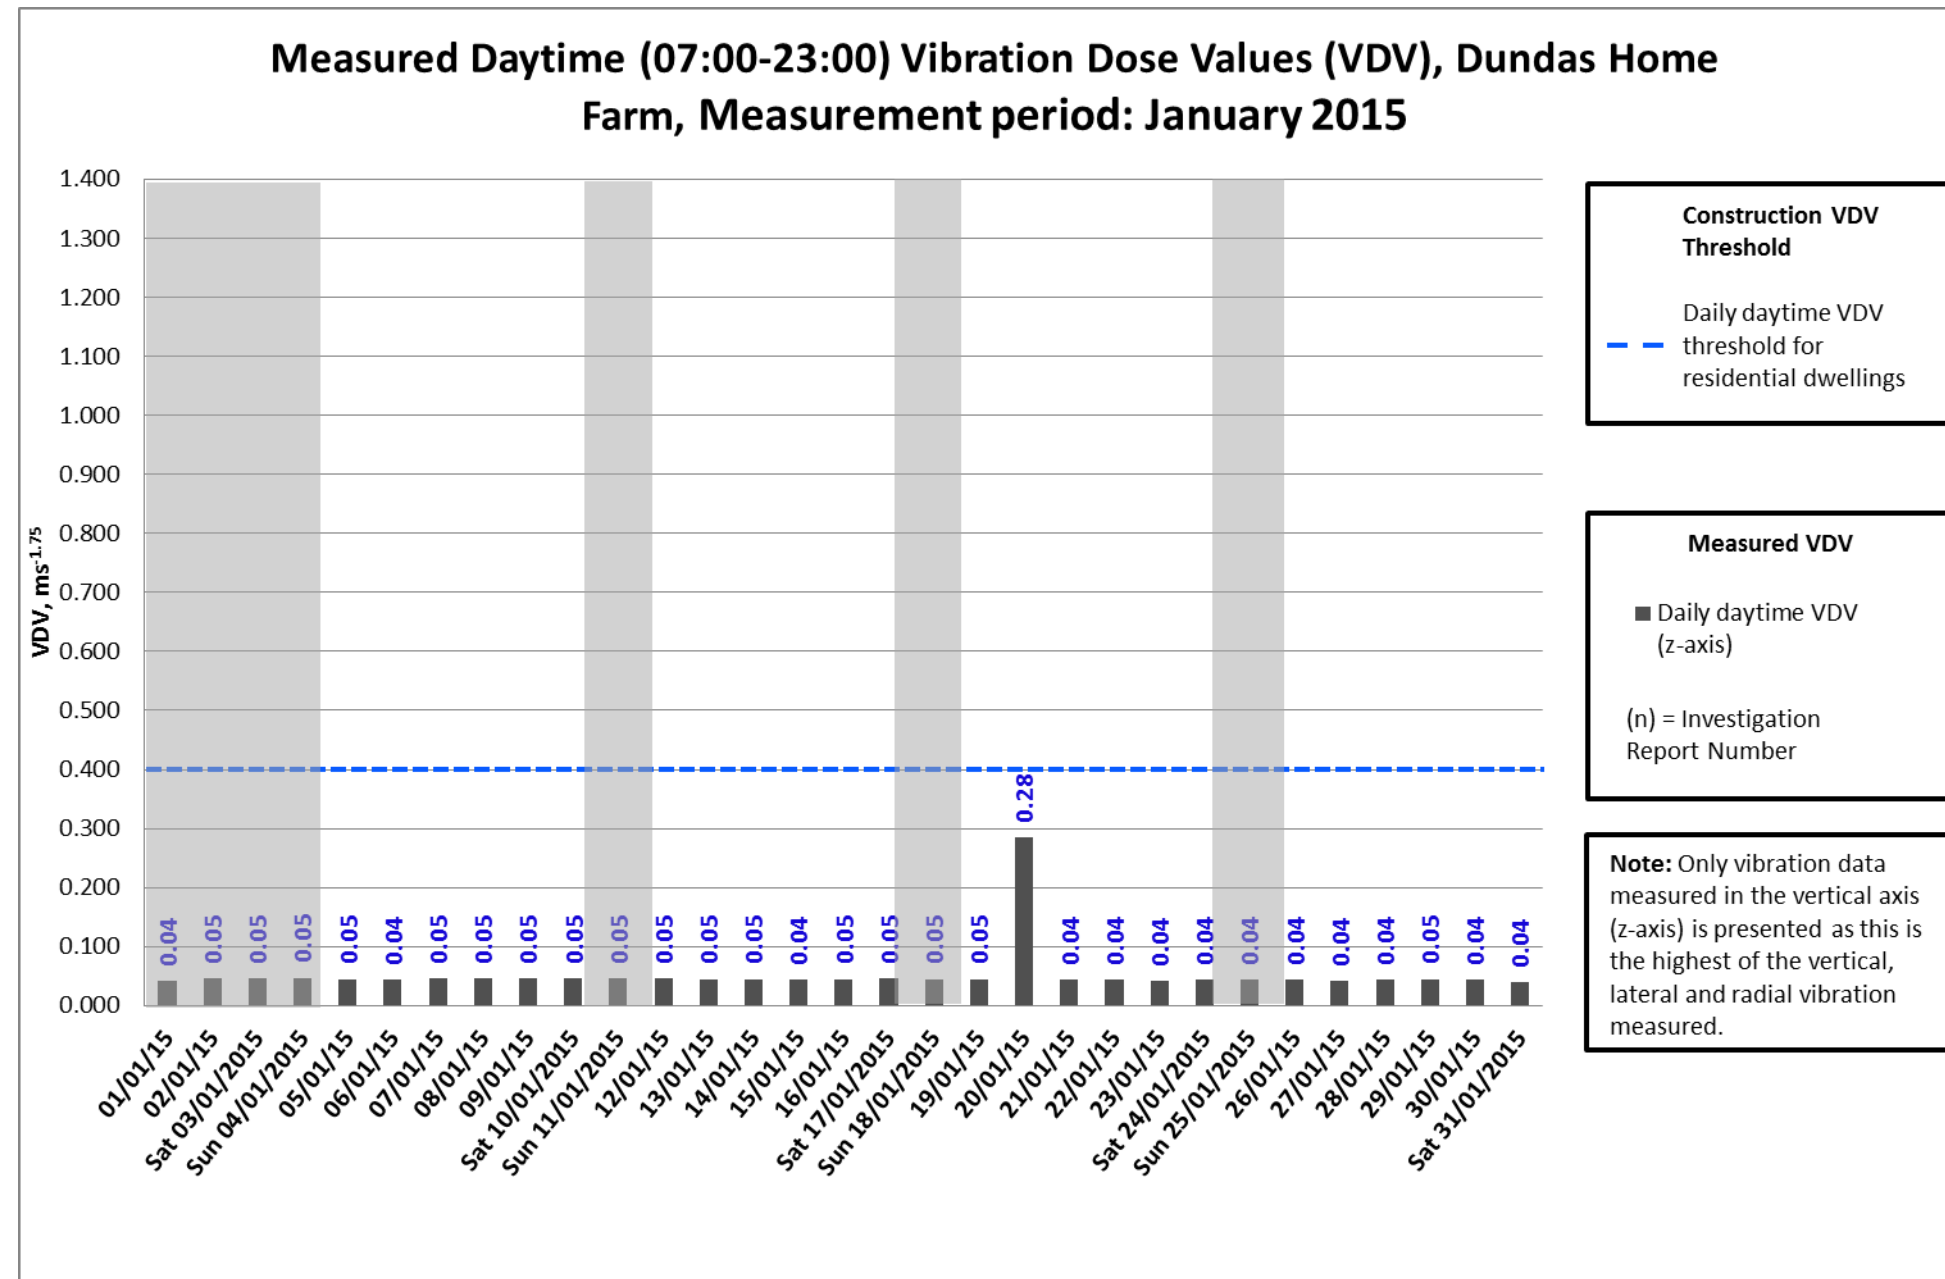
- The grey areas of the chart represent the days on which no construction works were undertaken; no works were conducted in the vicinity of the Dundas monitor on Sundays.
- No FCBC works took place between 01/01/15 – 04/01/15.

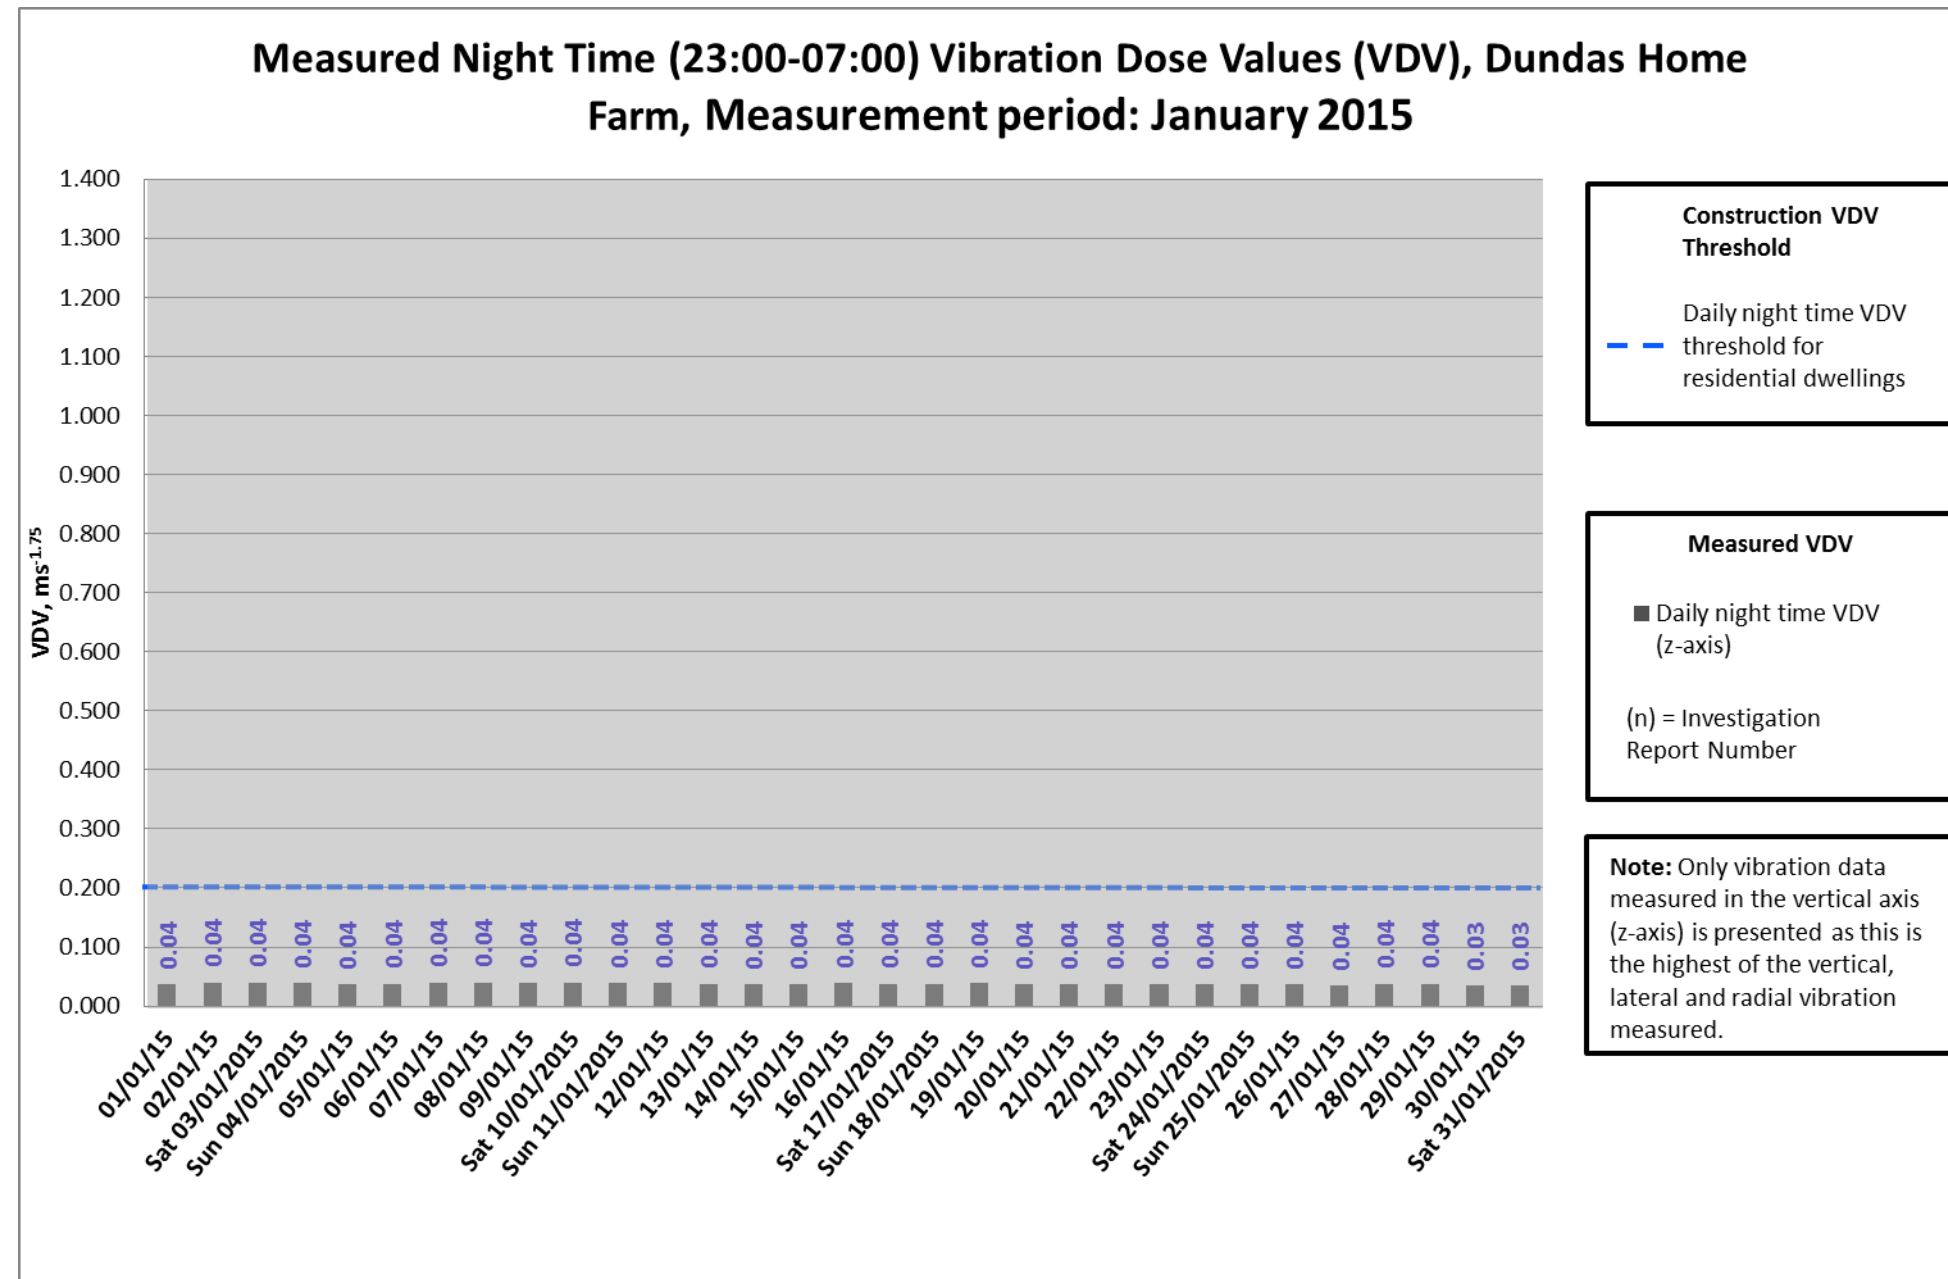
- The grey areas of the chart represent the days on which no construction works were undertaken; no night time works were conducted in the vicinity of the Dundas Home Farm vibration monitor throughout the month of January 2015. This graph is included for illustrative purposes only.
- No FCBC works took place between 01/01/15 – 04/01/15.
