Project **FORTH REPLACEMENT CROSSING**

**VIBRATION MONITORING REPORT
JANUARY 2015**

Document number REP-00220	Rev 01
-------------------------------------	------------------

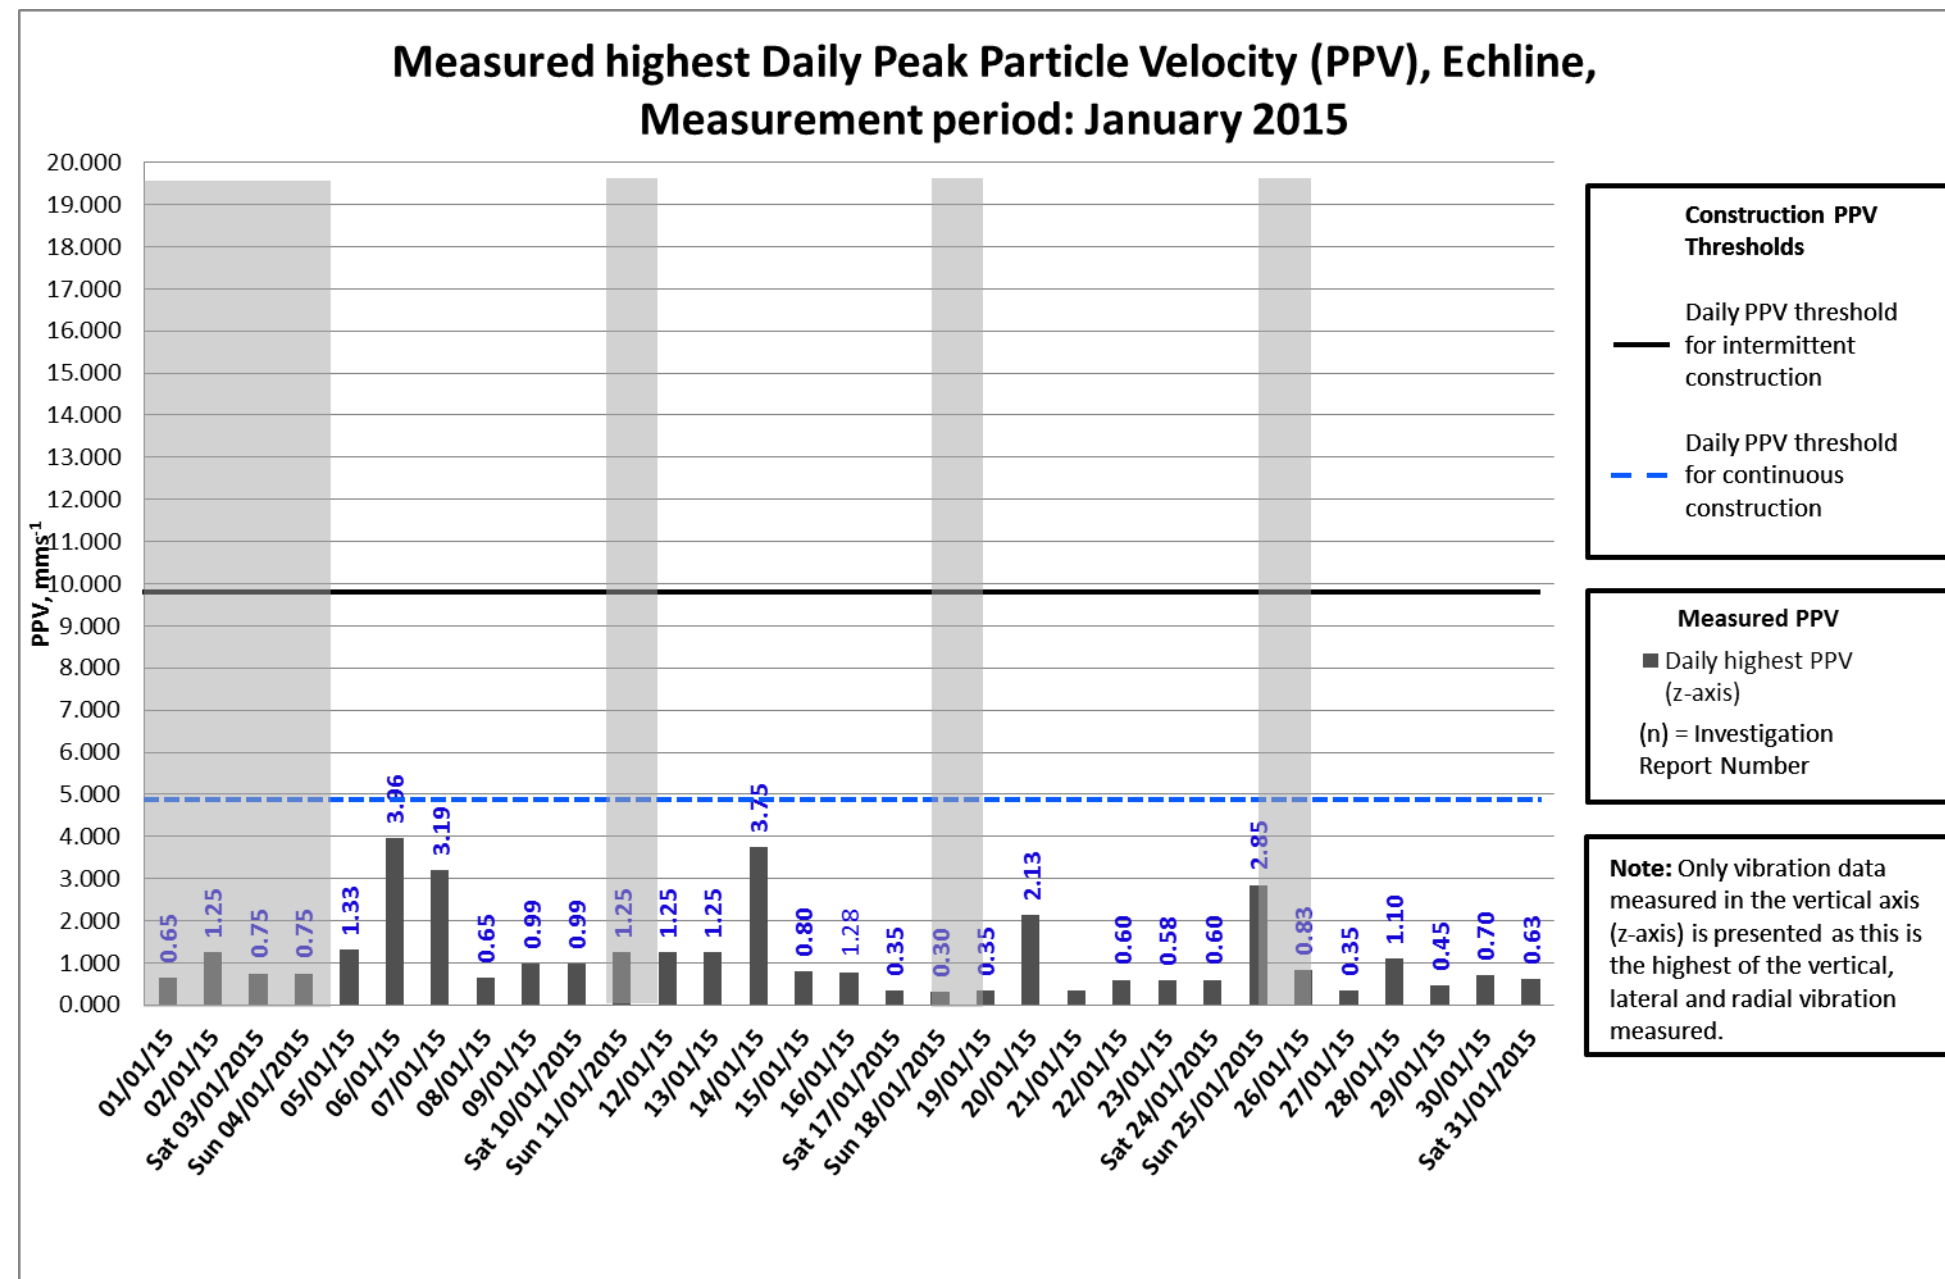
- The grey areas of the chart represent the days on which no construction works were undertaken; no works were conducted in the vicinity of the Echline monitor on Sundays.
- No FCBC works took place between 01/01/15 – 04/01/15.

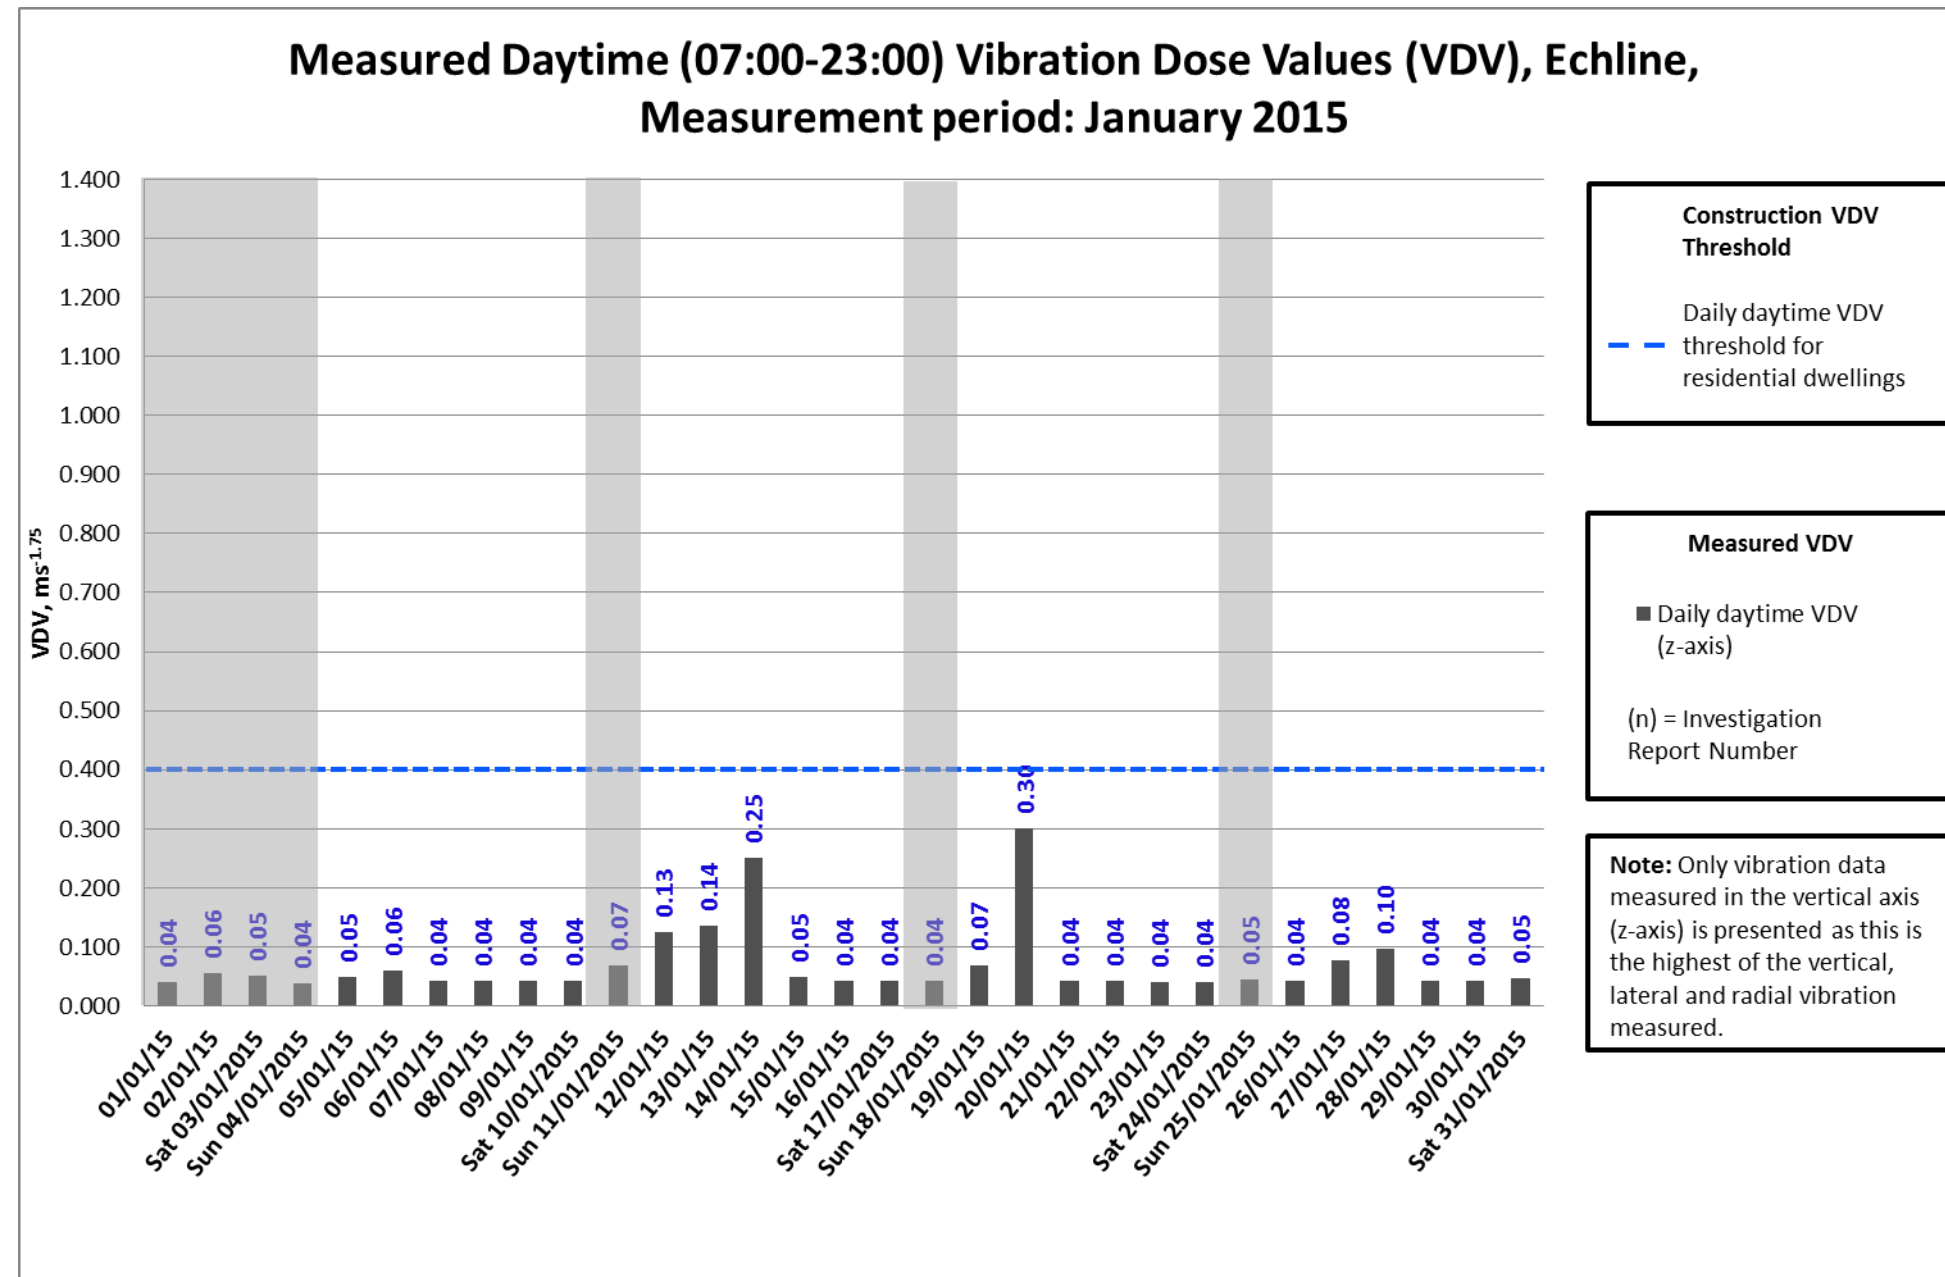
- The grey areas of the chart represent the days on which no construction works were undertaken; no works were conducted in the vicinity of the Echline monitor on Sundays.
- No FCBC works took place between 01/01/15 – 04/01/15

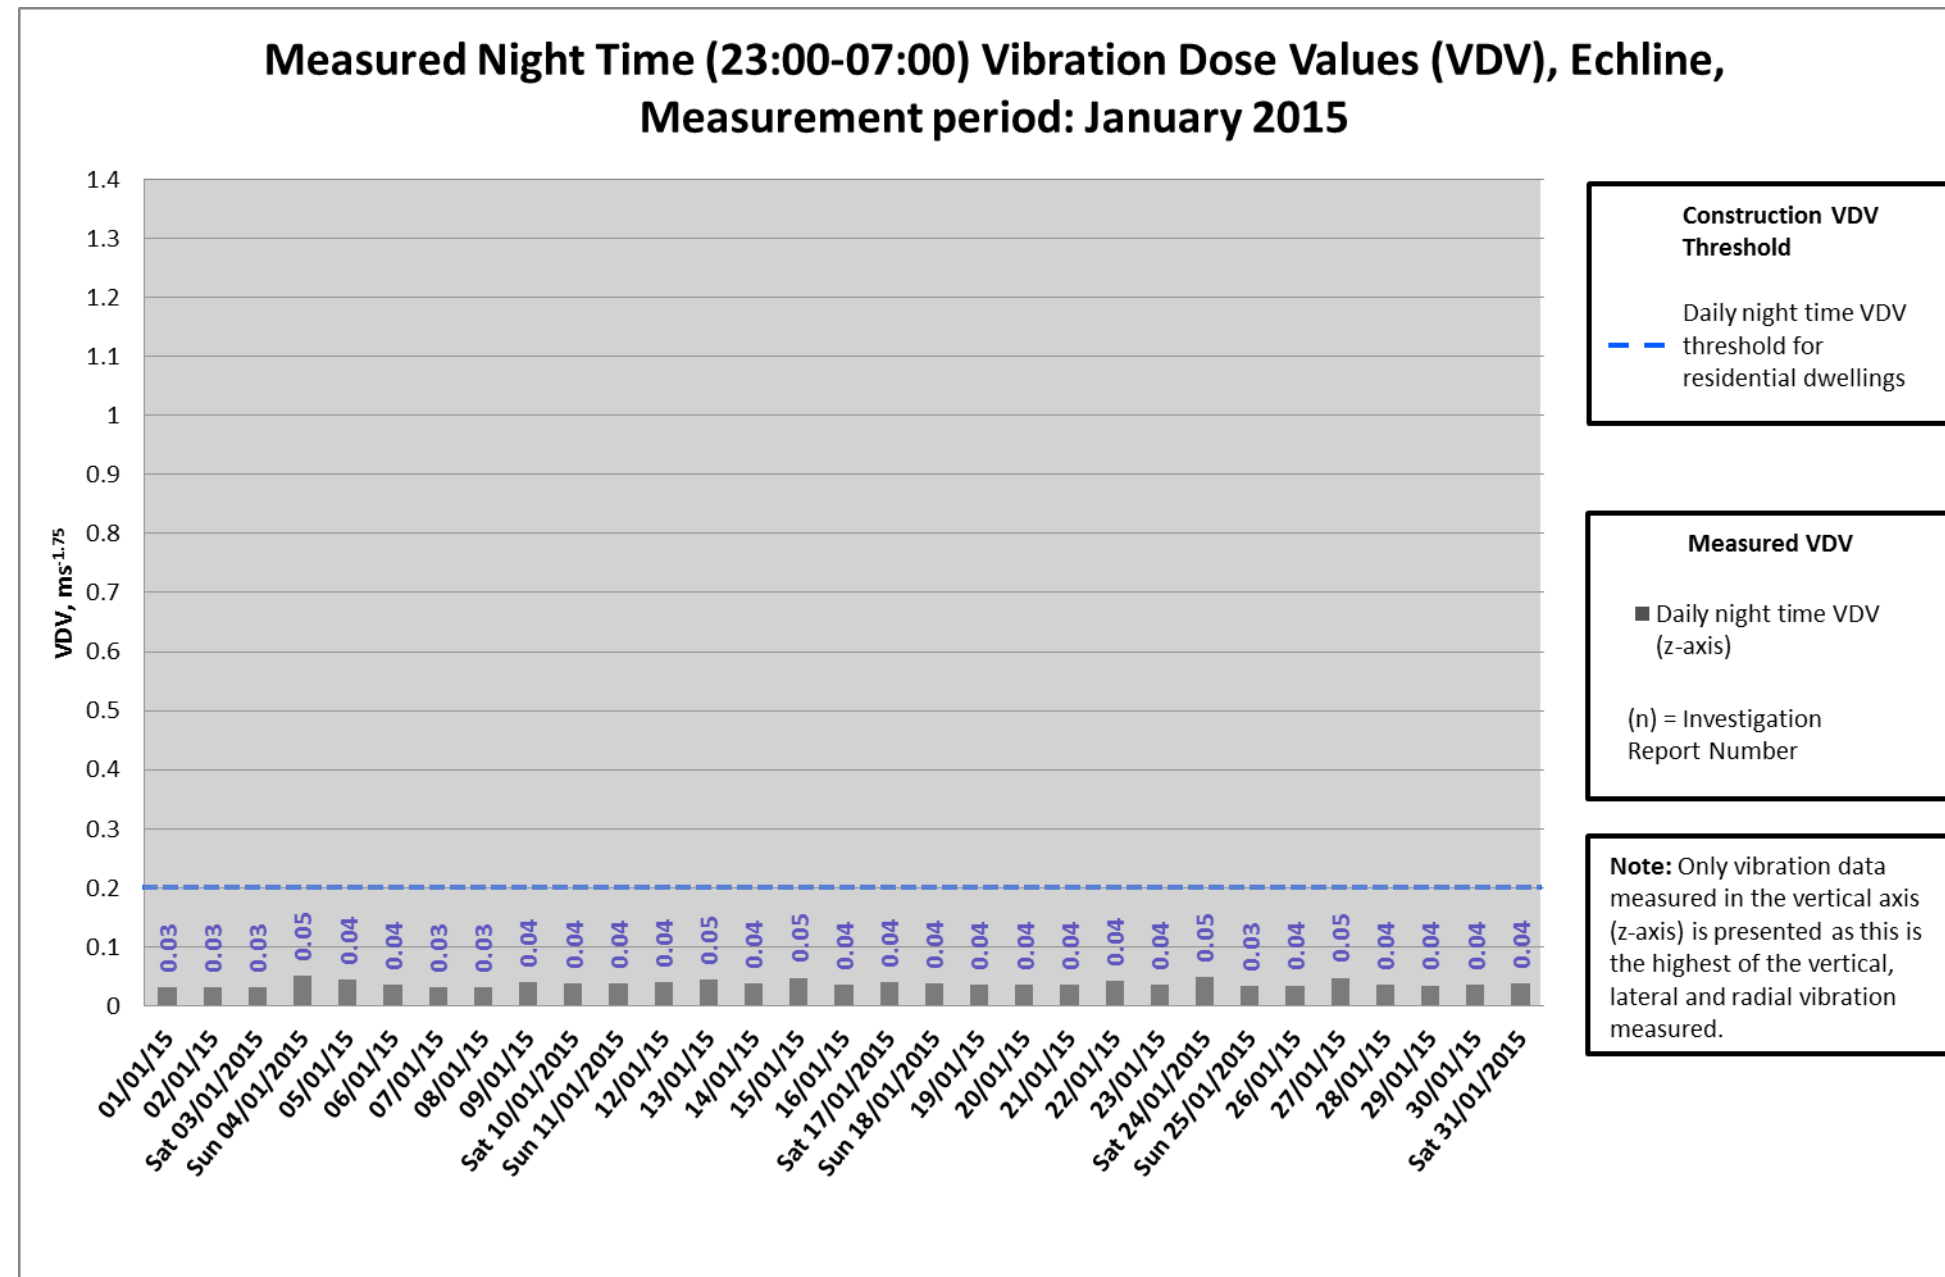
- The grey areas of the chart represent the days on which no construction works were undertaken; no night time works were conducted in the vicinity of the Echline vibration monitor throughout the month of January 2015. This graph is included for illustrative purposes only.
- No FCBC works took place between 01/01/15 – 04/01/15.

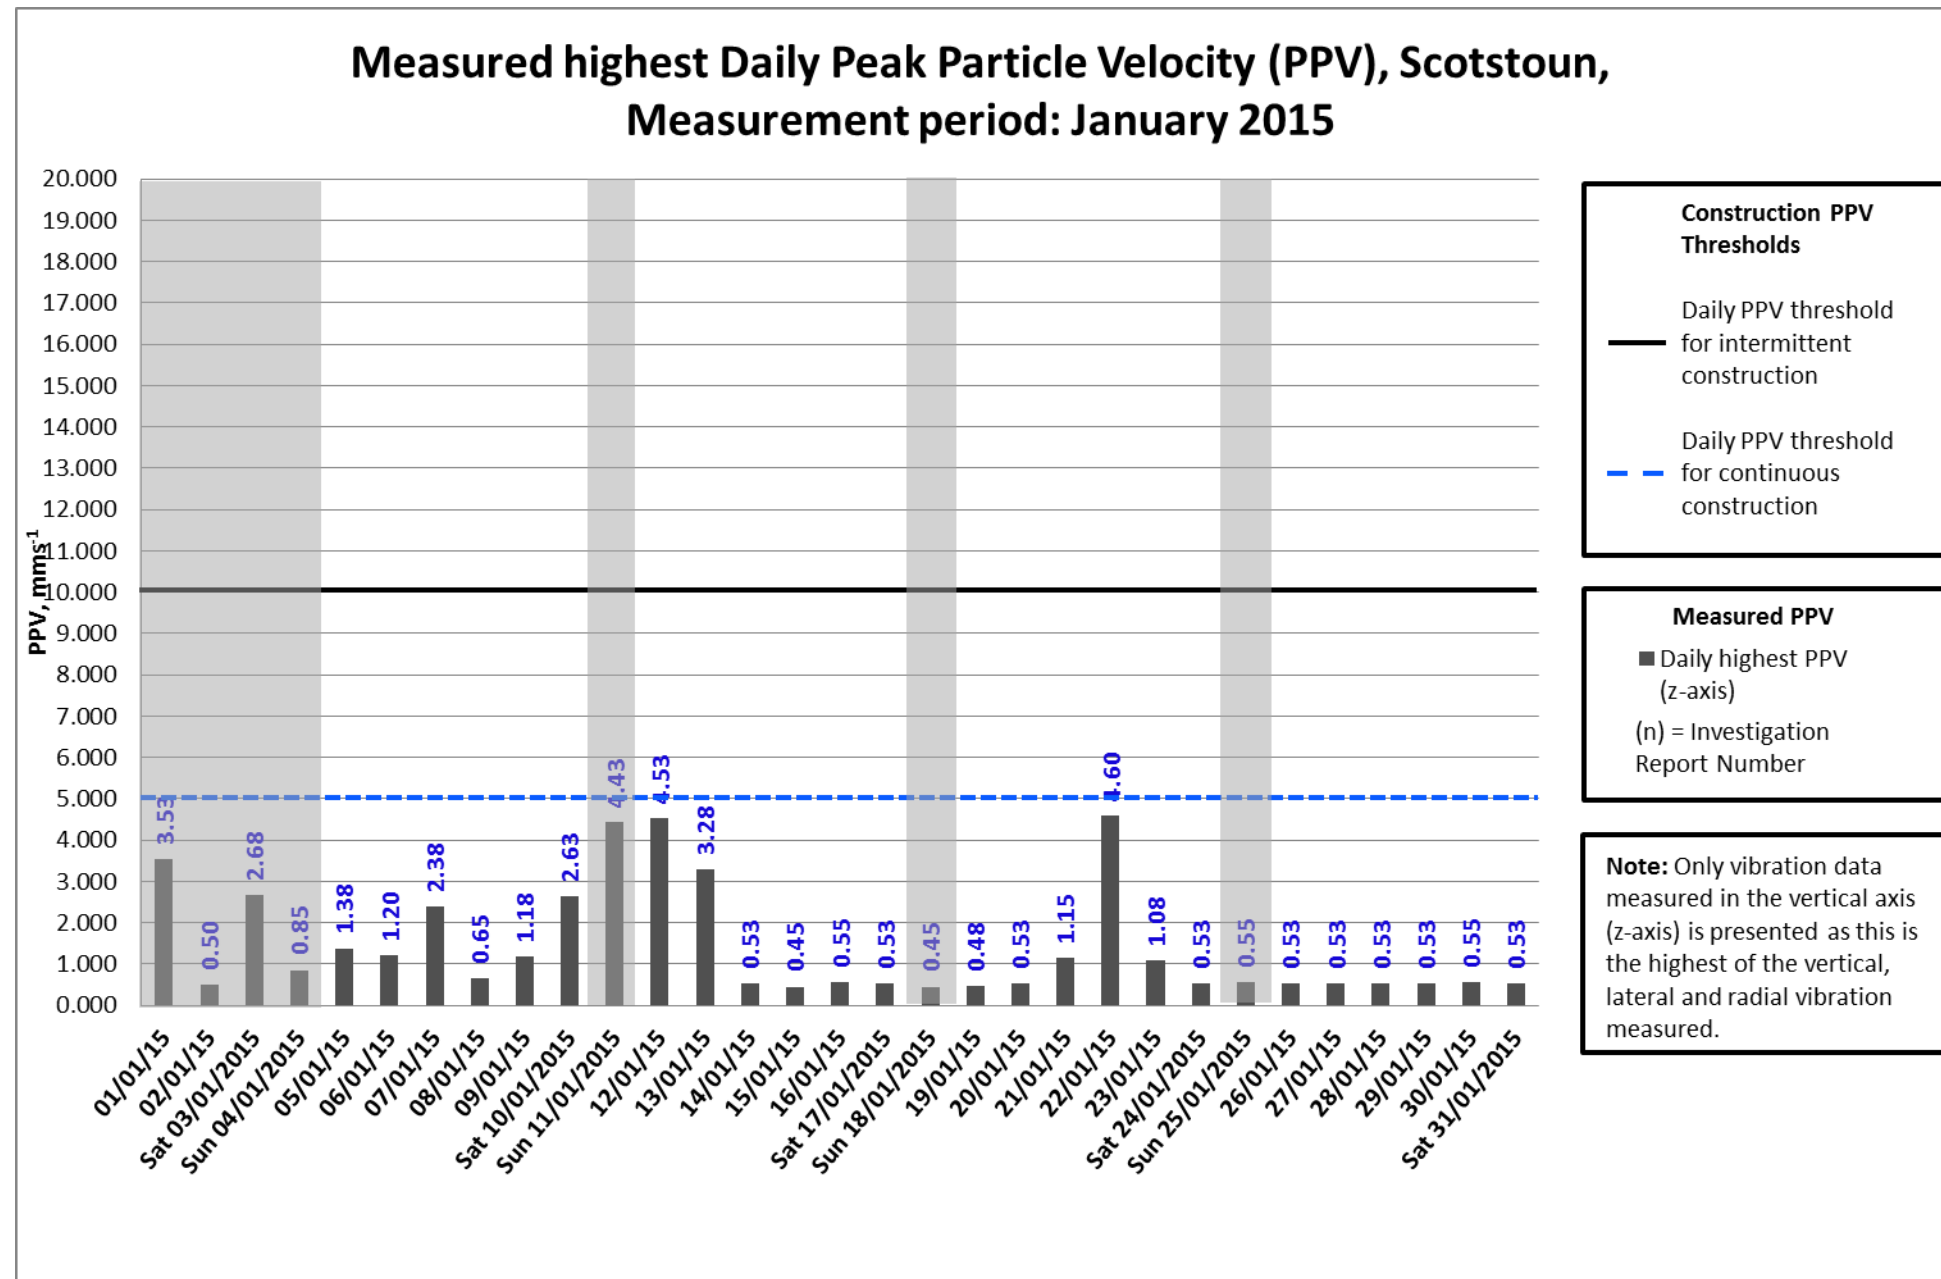
- The grey areas of the chart represent the days on which no construction works were undertaken; no works were conducted in the vicinity of the Scotstoun monitor on Sundays.
- No FCBC works took place between 01/01/15 – 04/01/15.

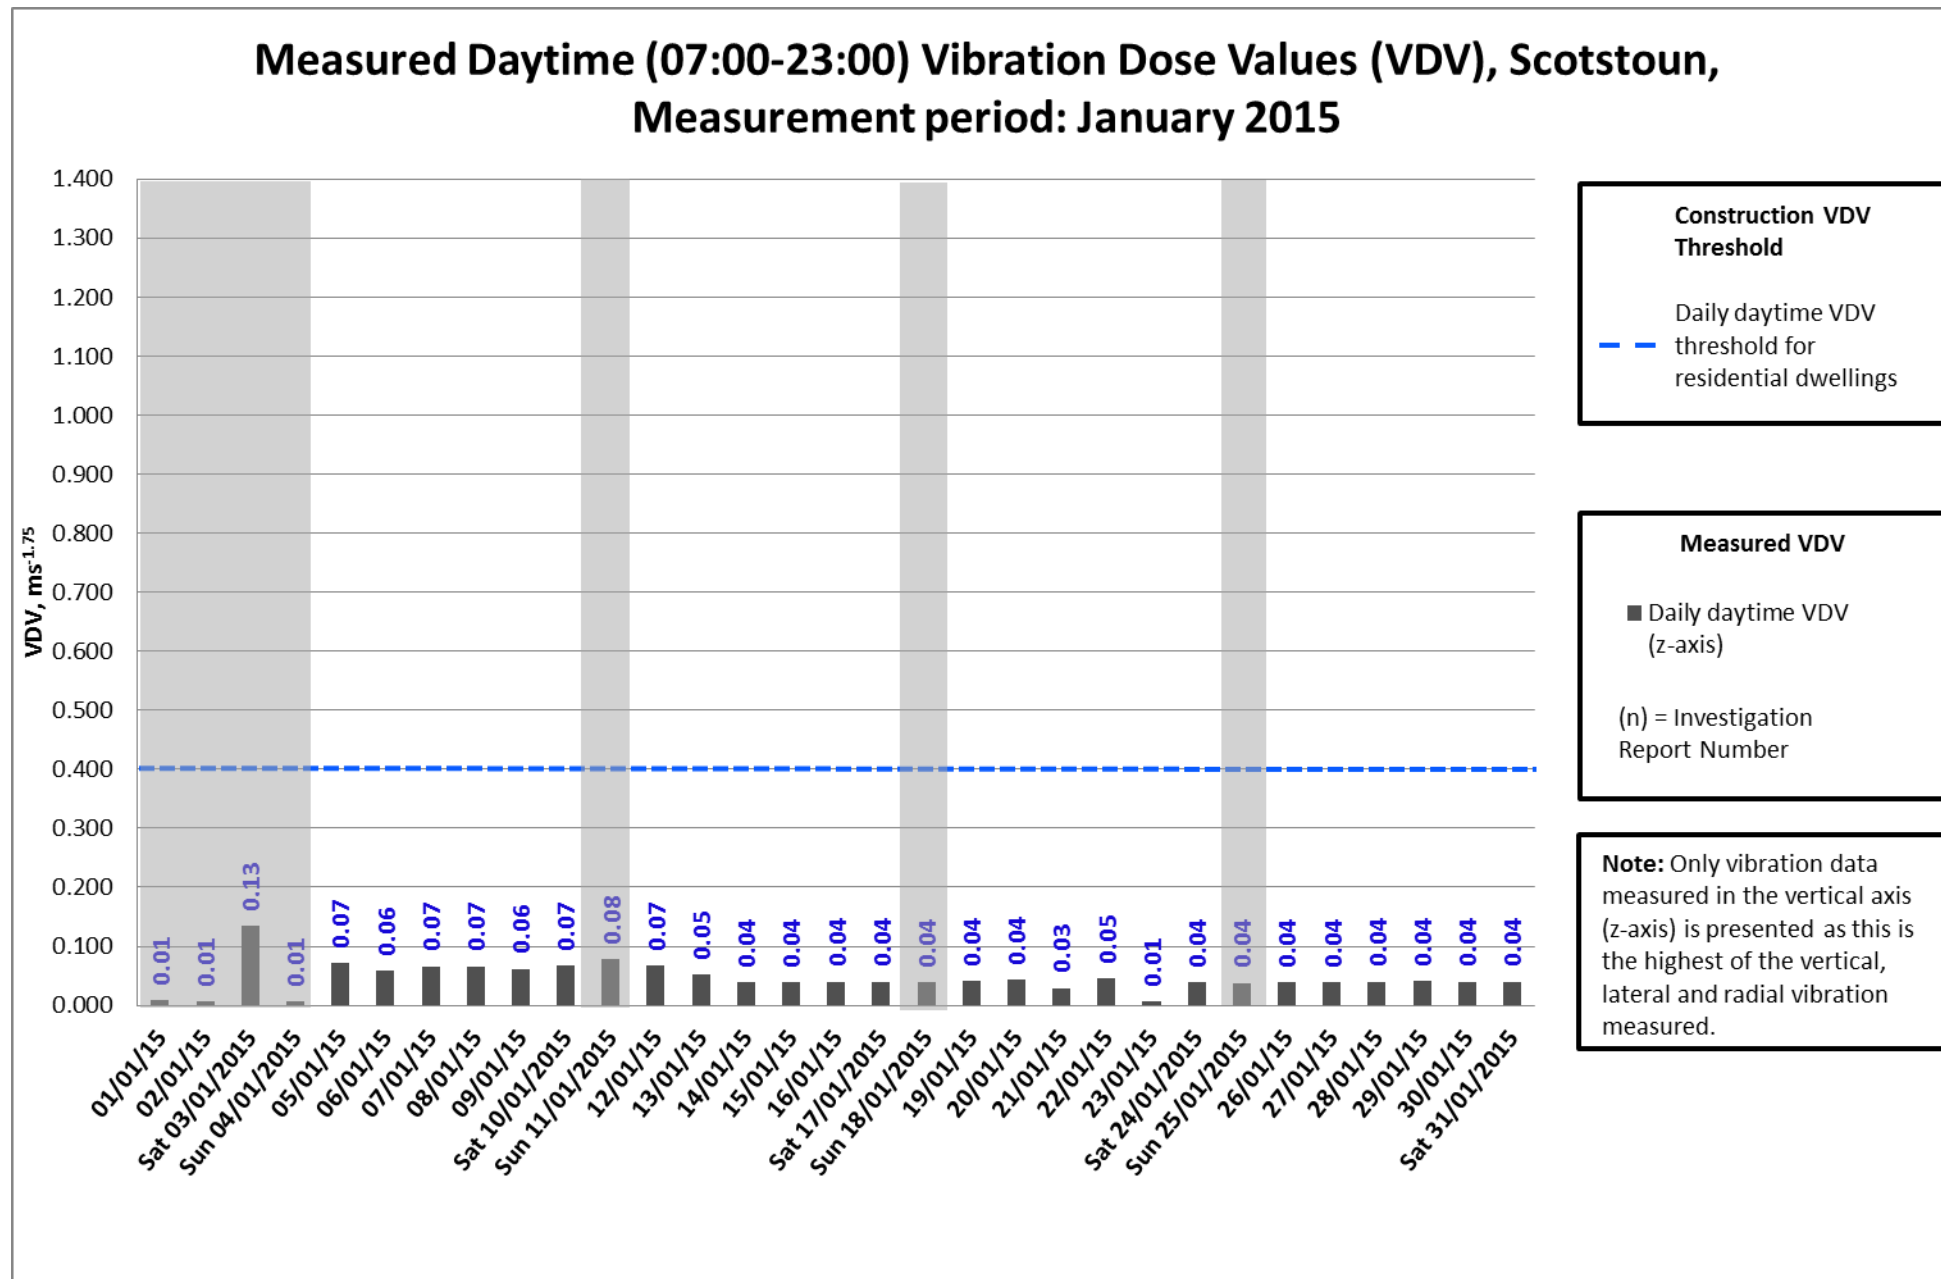
- The grey areas of the chart represent the days on which no construction works were undertaken; no works were conducted in the vicinity of the Scotstoun monitor on Sundays.
- No FCBC works took place between 01/01/15– 04/01/15.

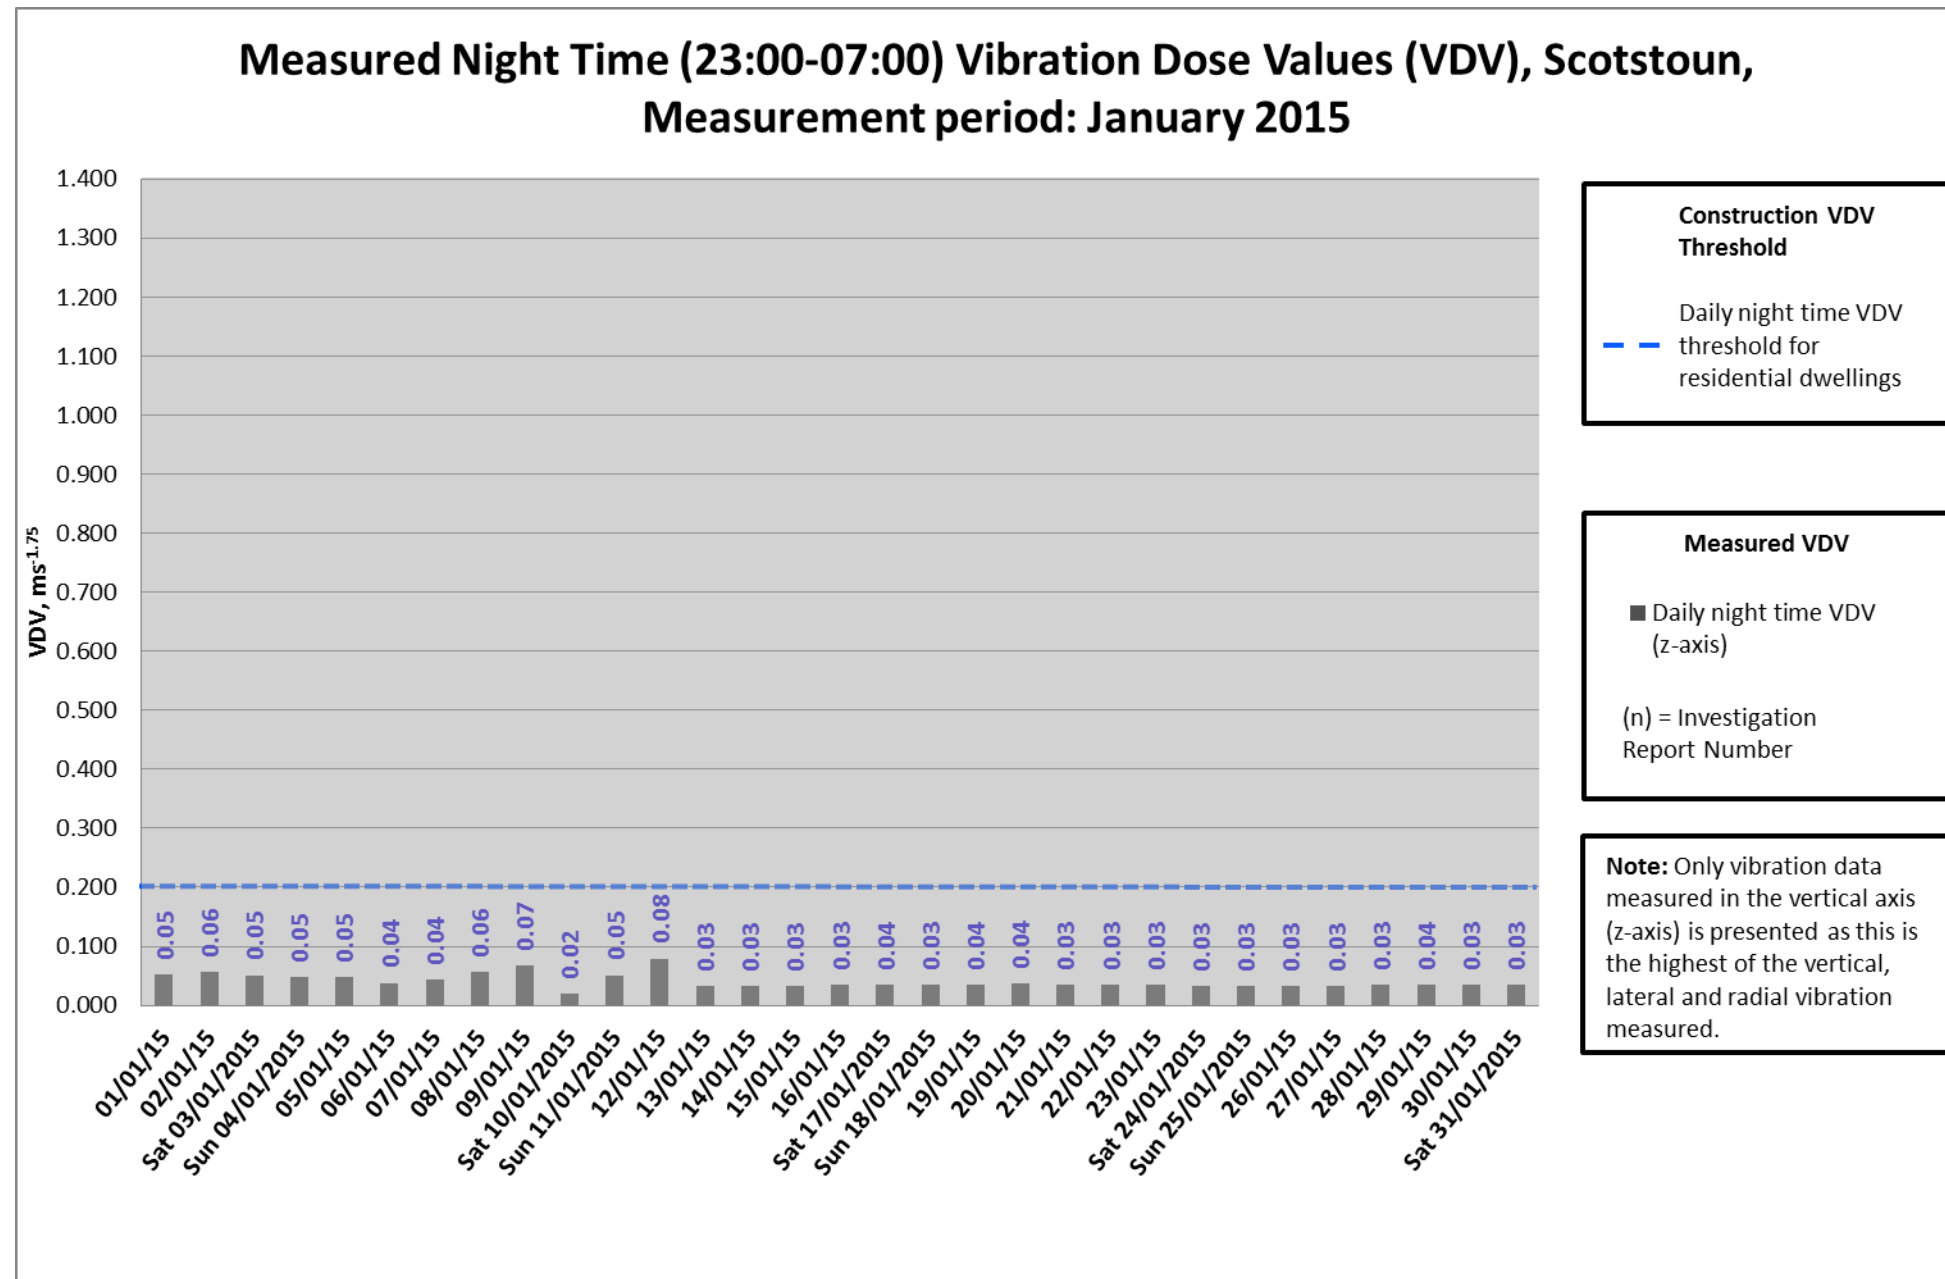
- The grey areas of the chart represent the days on which no construction works were undertaken; no night time works were conducted in the vicinity of the Scotstoun vibration monitor throughout the month of January 2015. This graph is included for illustrative purposes only.
- No FCBC works took place between 01/01/15 – 04/01/15.

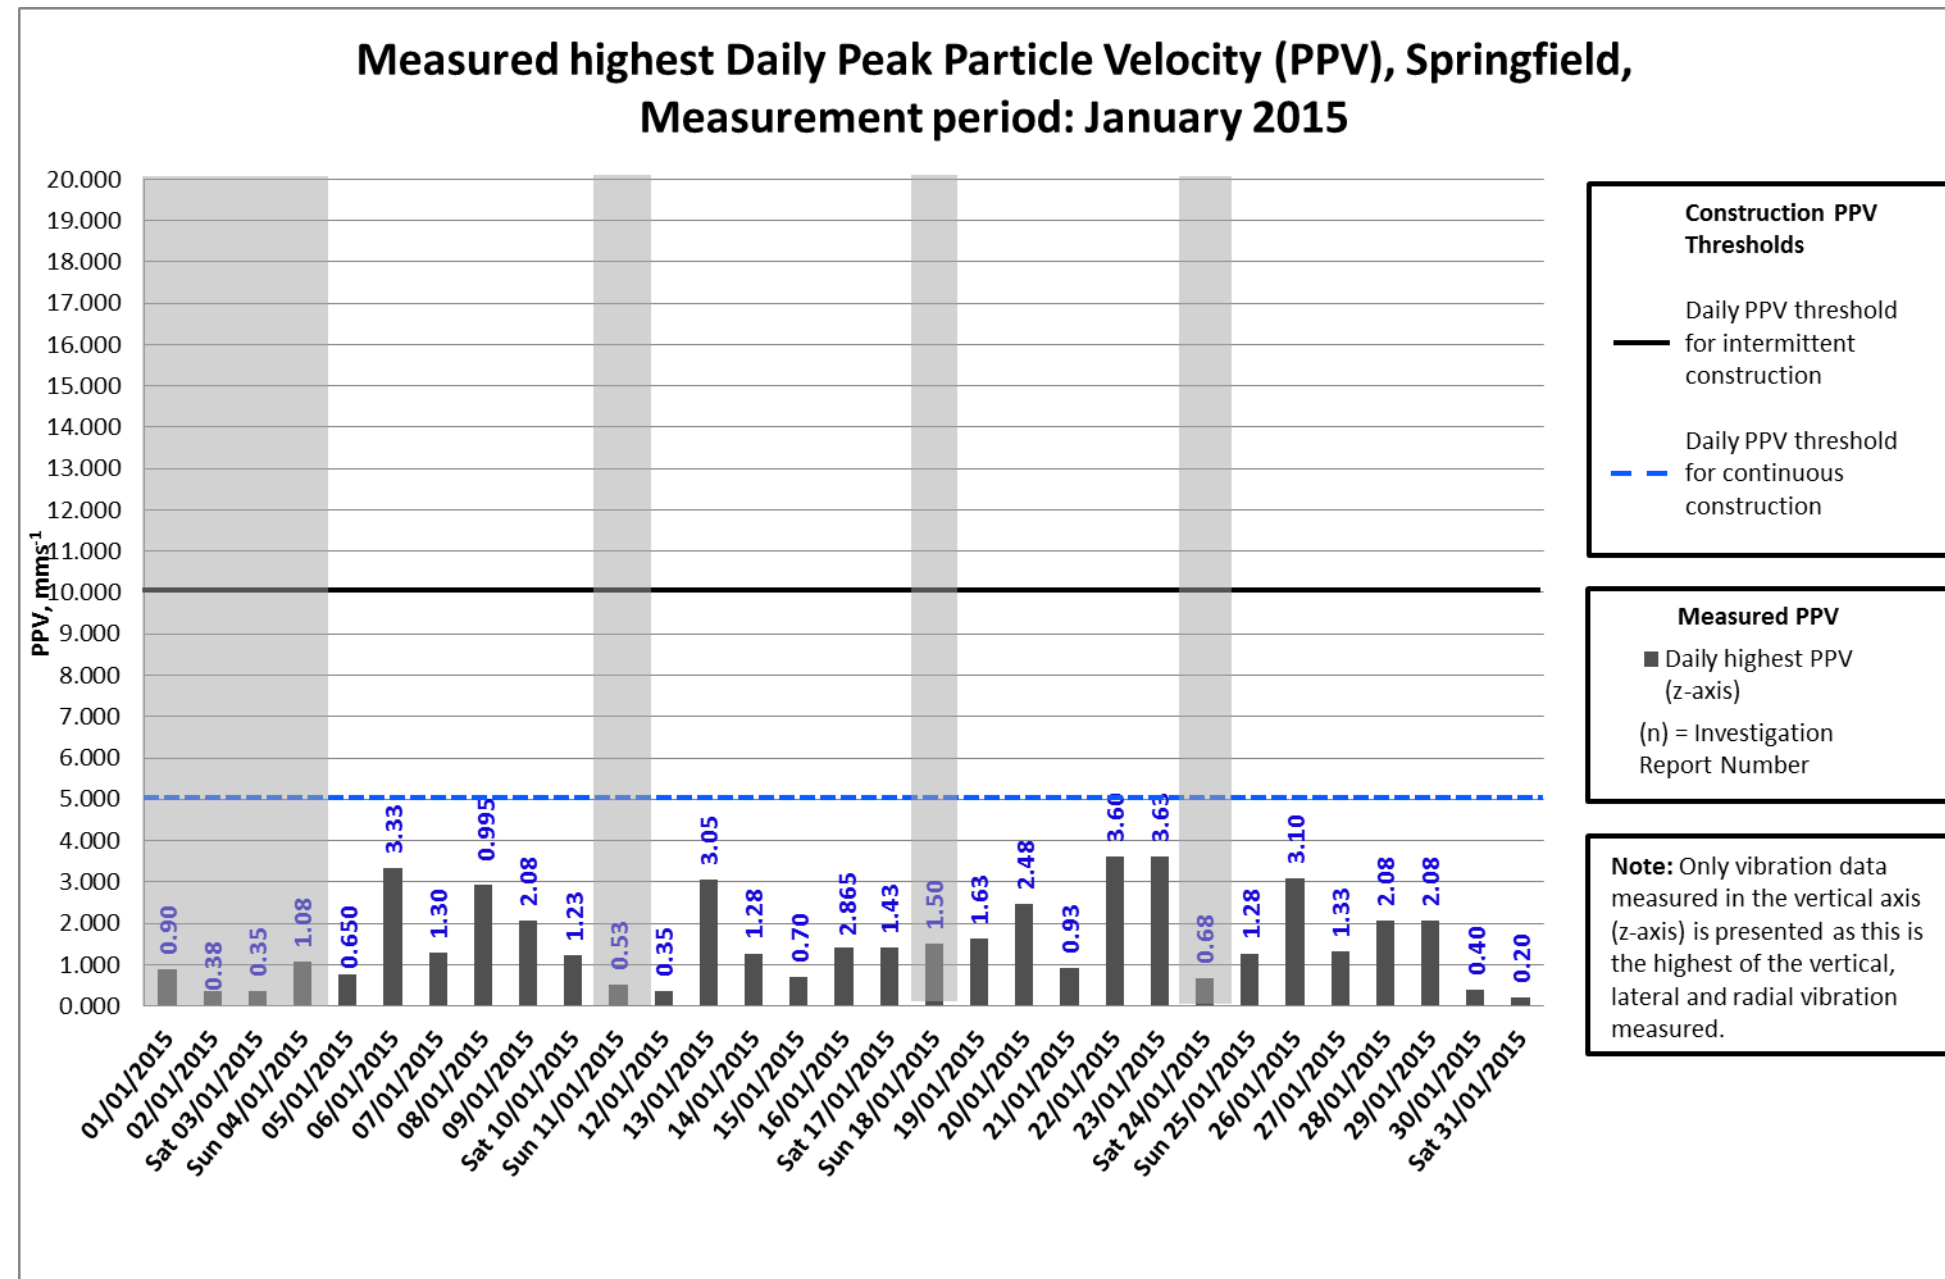
- The grey areas of the chart represent the days on which no construction works were undertaken; no works were conducted in the vicinity of the Springfield monitor on Sundays.
- No FCBC works took place between 01/01/15 – 04/01/15.

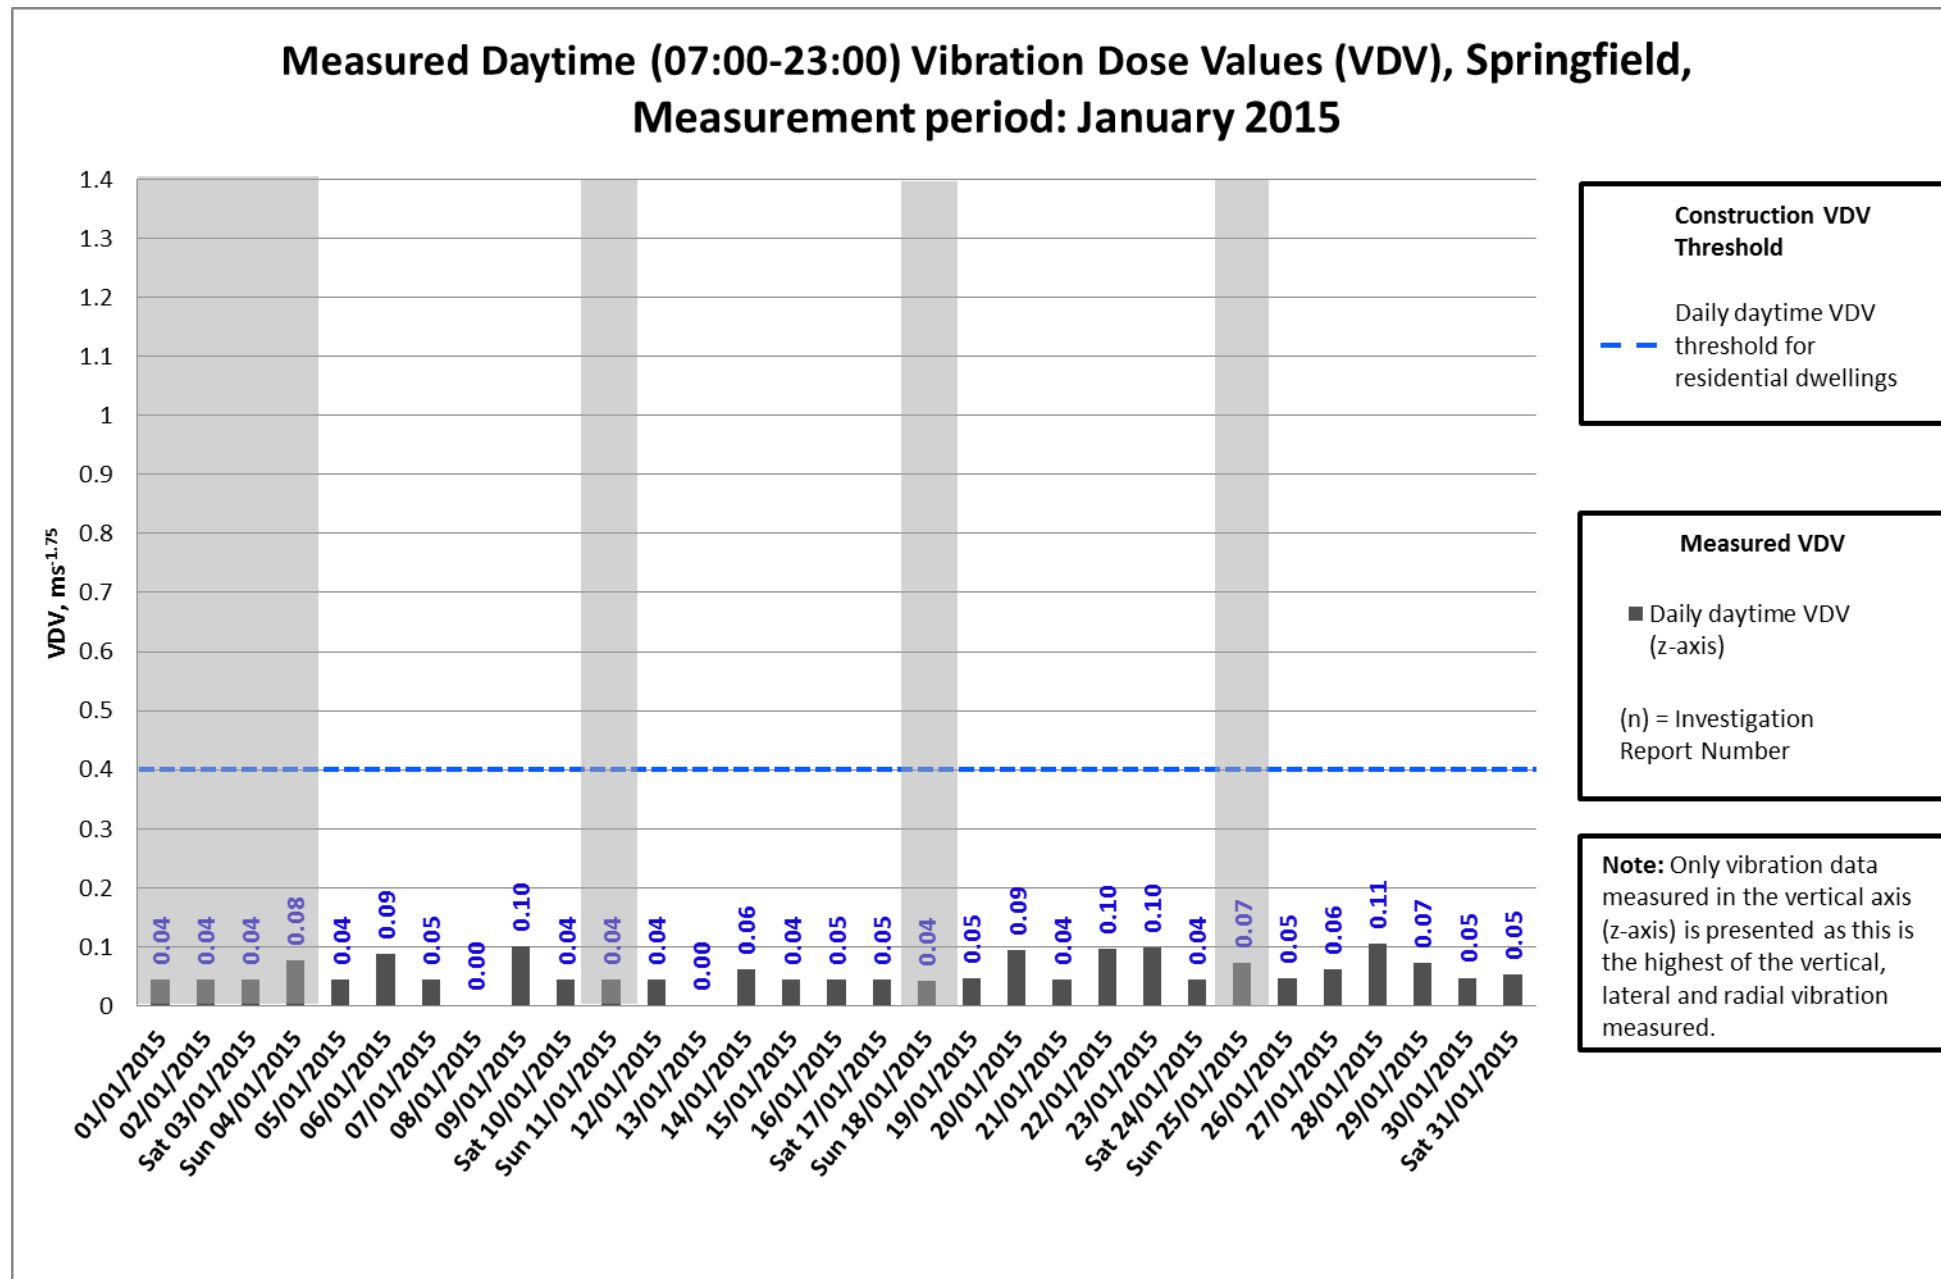
- The grey areas of the chart represent the days on which no construction works were undertaken; no works were conducted in the vicinity of the Springfield monitor on Sundays.
- No FCBC works took place between 01/01/15 – 04/01/15.

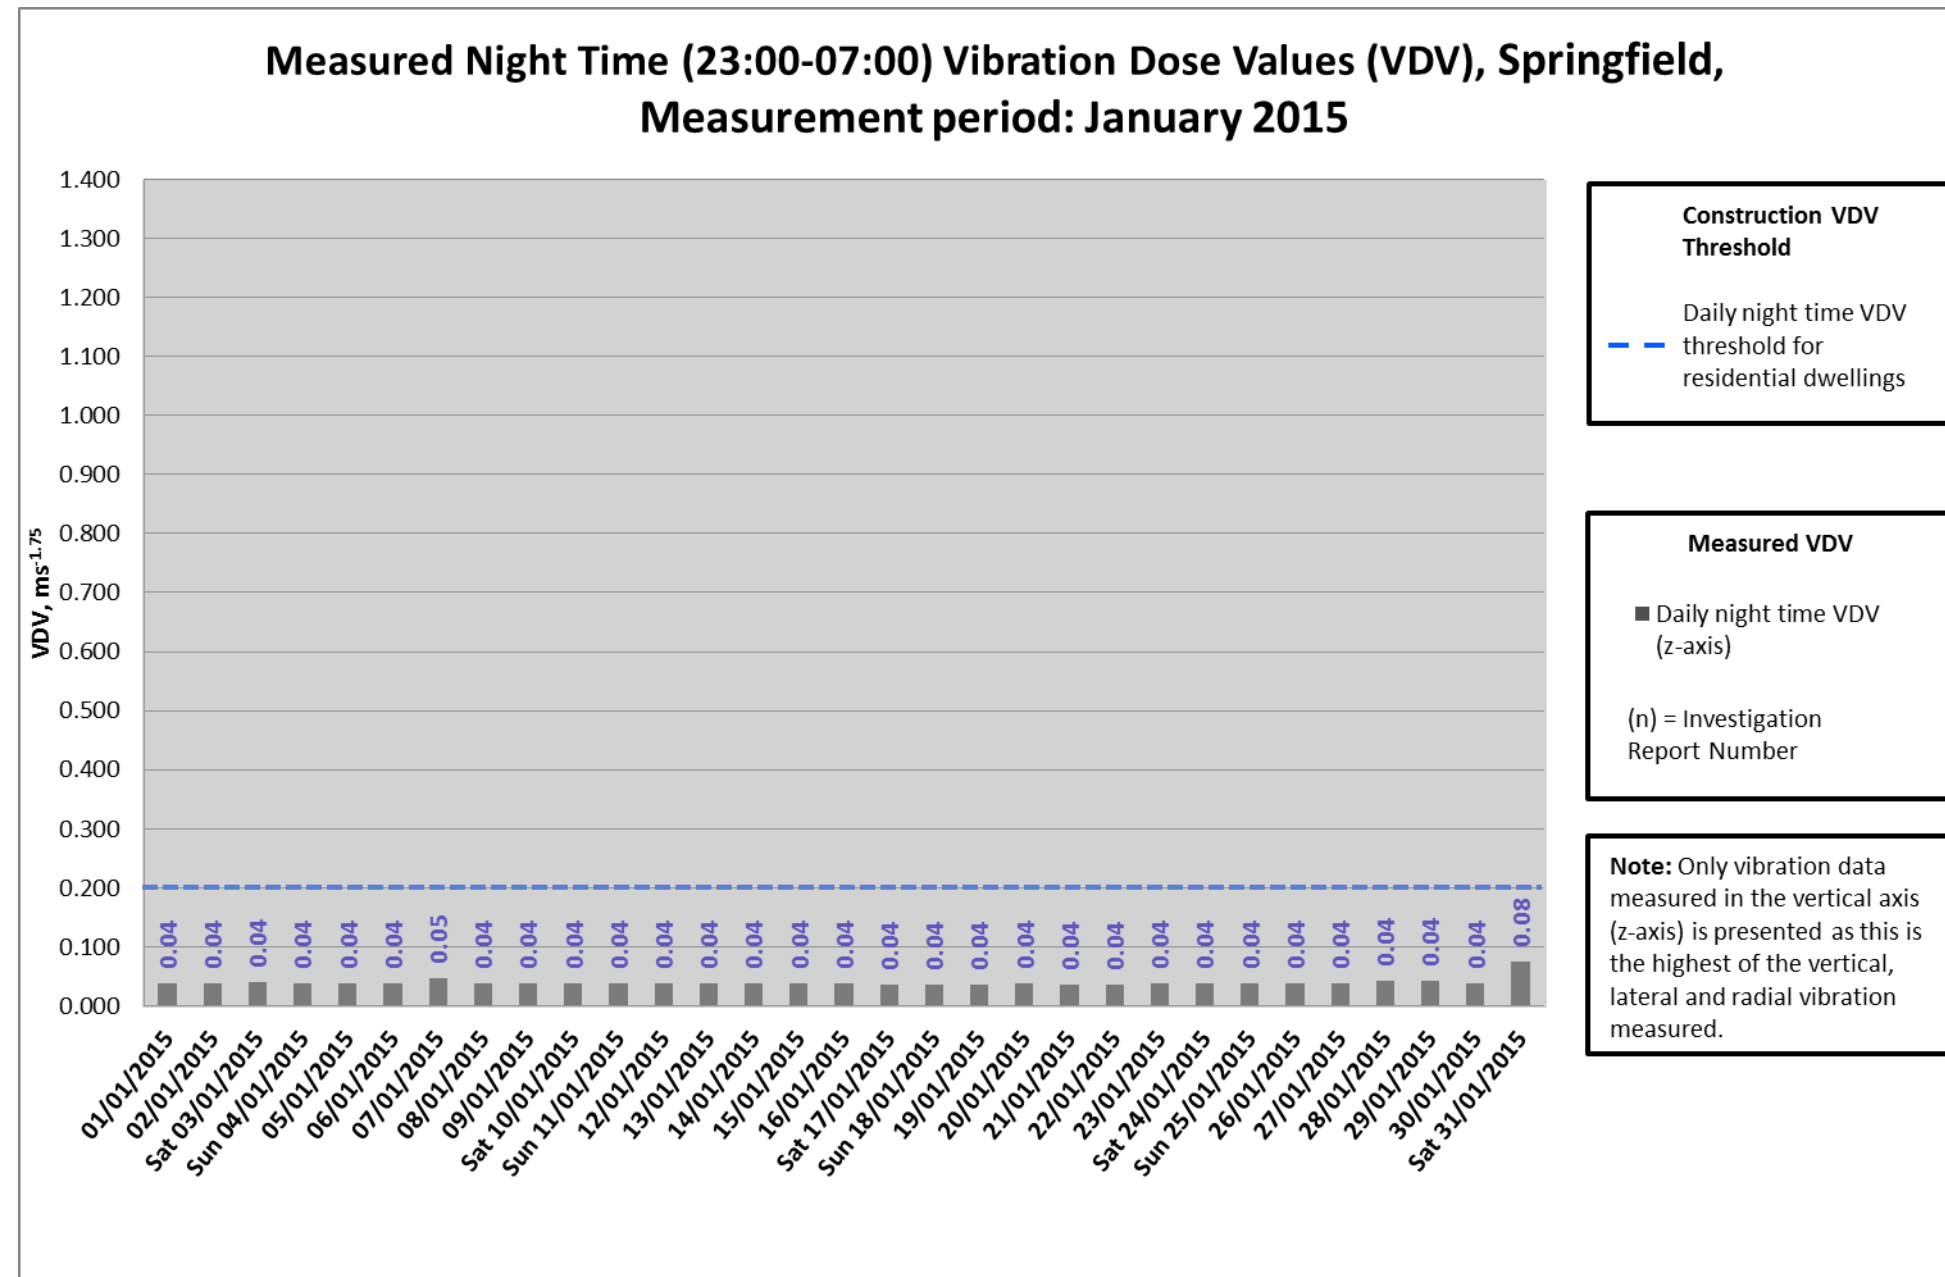
- The grey areas of the chart represent the days on which no construction works were undertaken; no night time works were conducted in the vicinity of the Springfield vibration monitor throughout the month of January 2015. This graph is included for illustrative purposes only.
- No FCBC works took place between 01/01/15 – 04/01/15.
