Project **FORTH REPLACEMENT CROSSING**

**VIBRATION MONITORING REPORT
JANUARY 2015**

Document number REP-00220	Rev 01
-------------------------------------	------------------

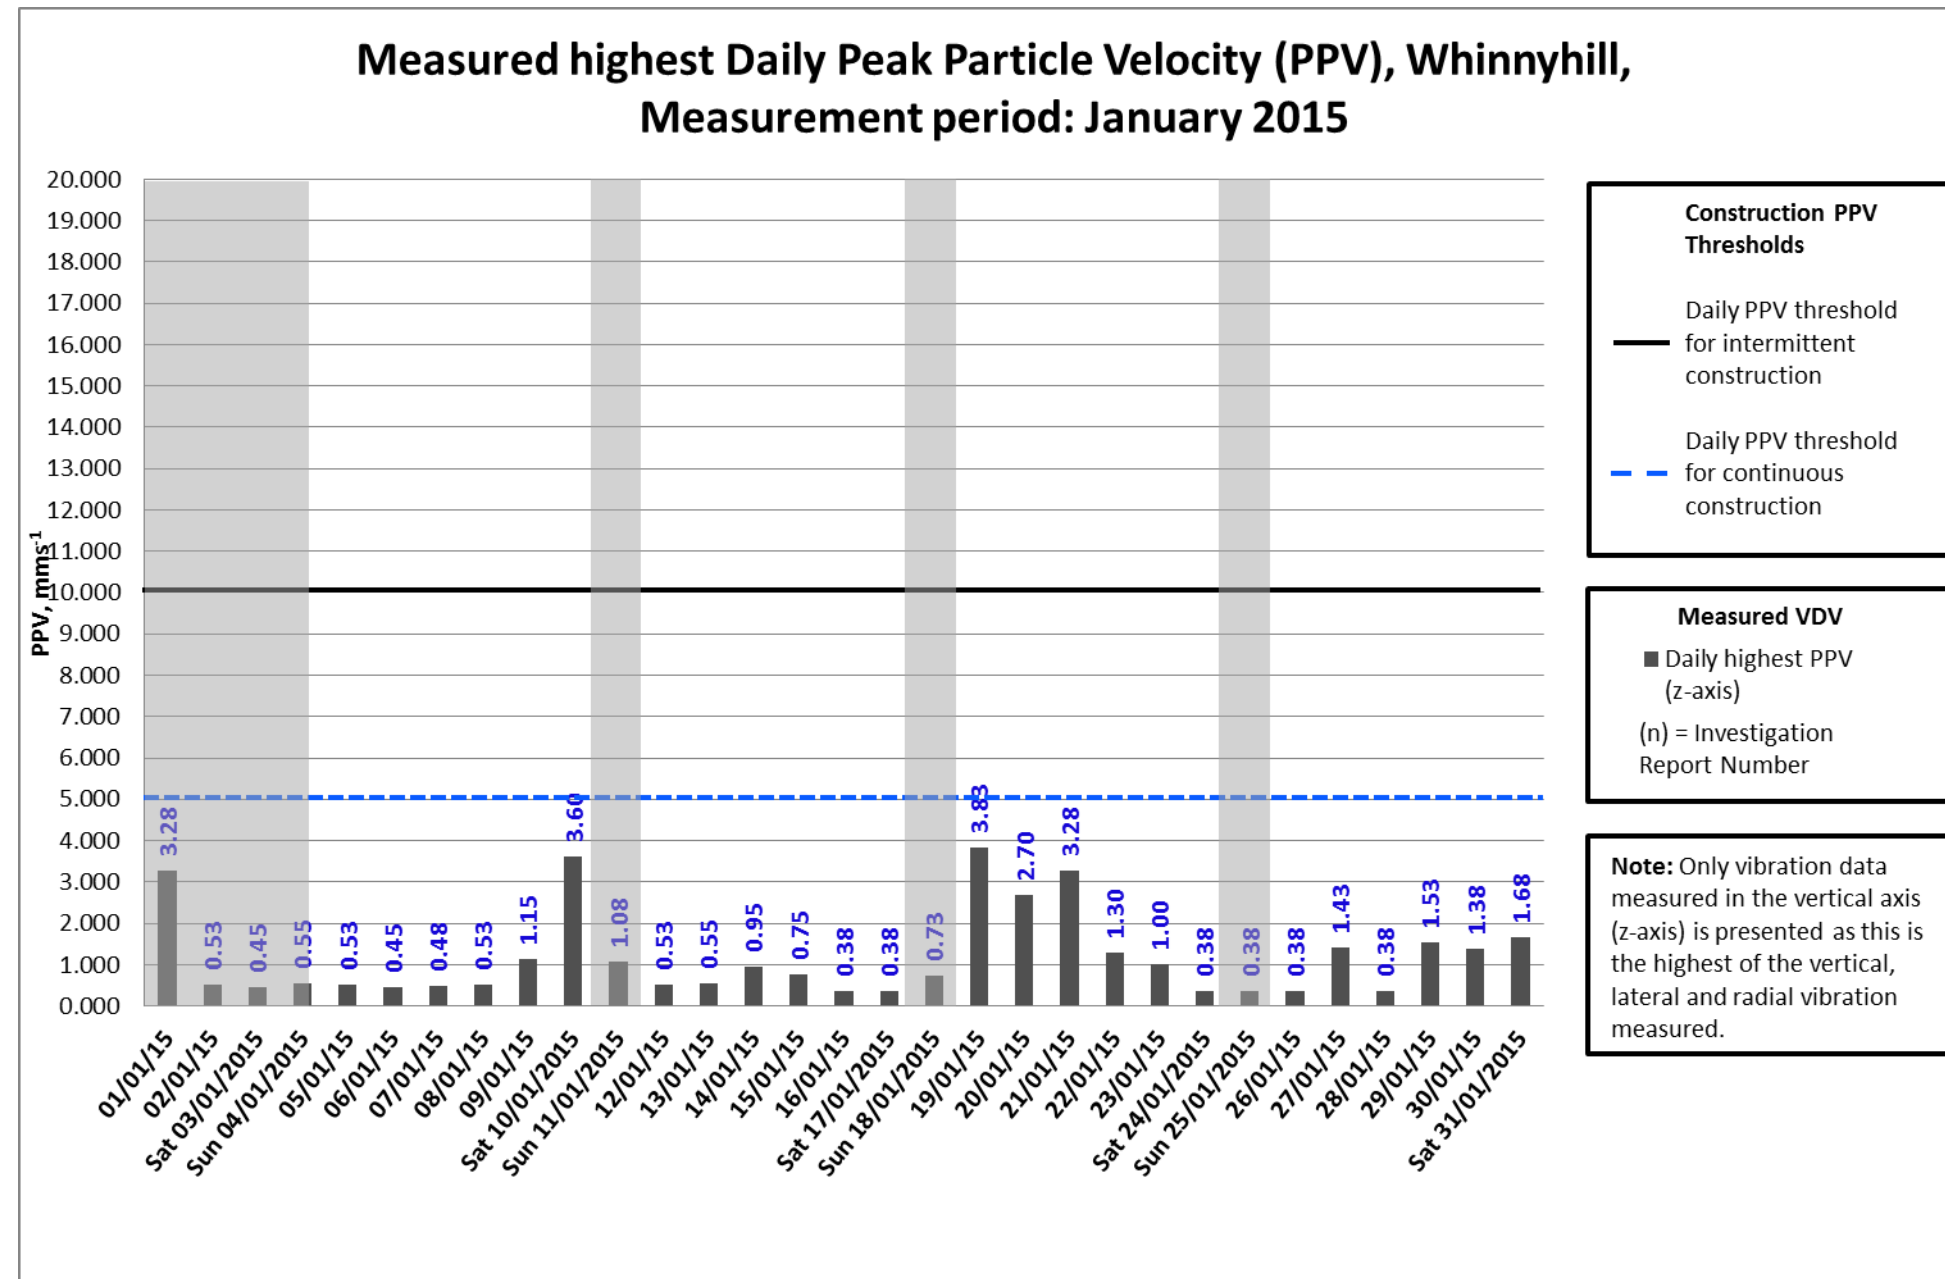
- The grey areas of the chart represent the days on which no construction works were undertaken; no works were conducted in the vicinity of the Whinnyhill monitor on Sundays.
- No FCBC works took place between 01/01/15 – 04/01/15.

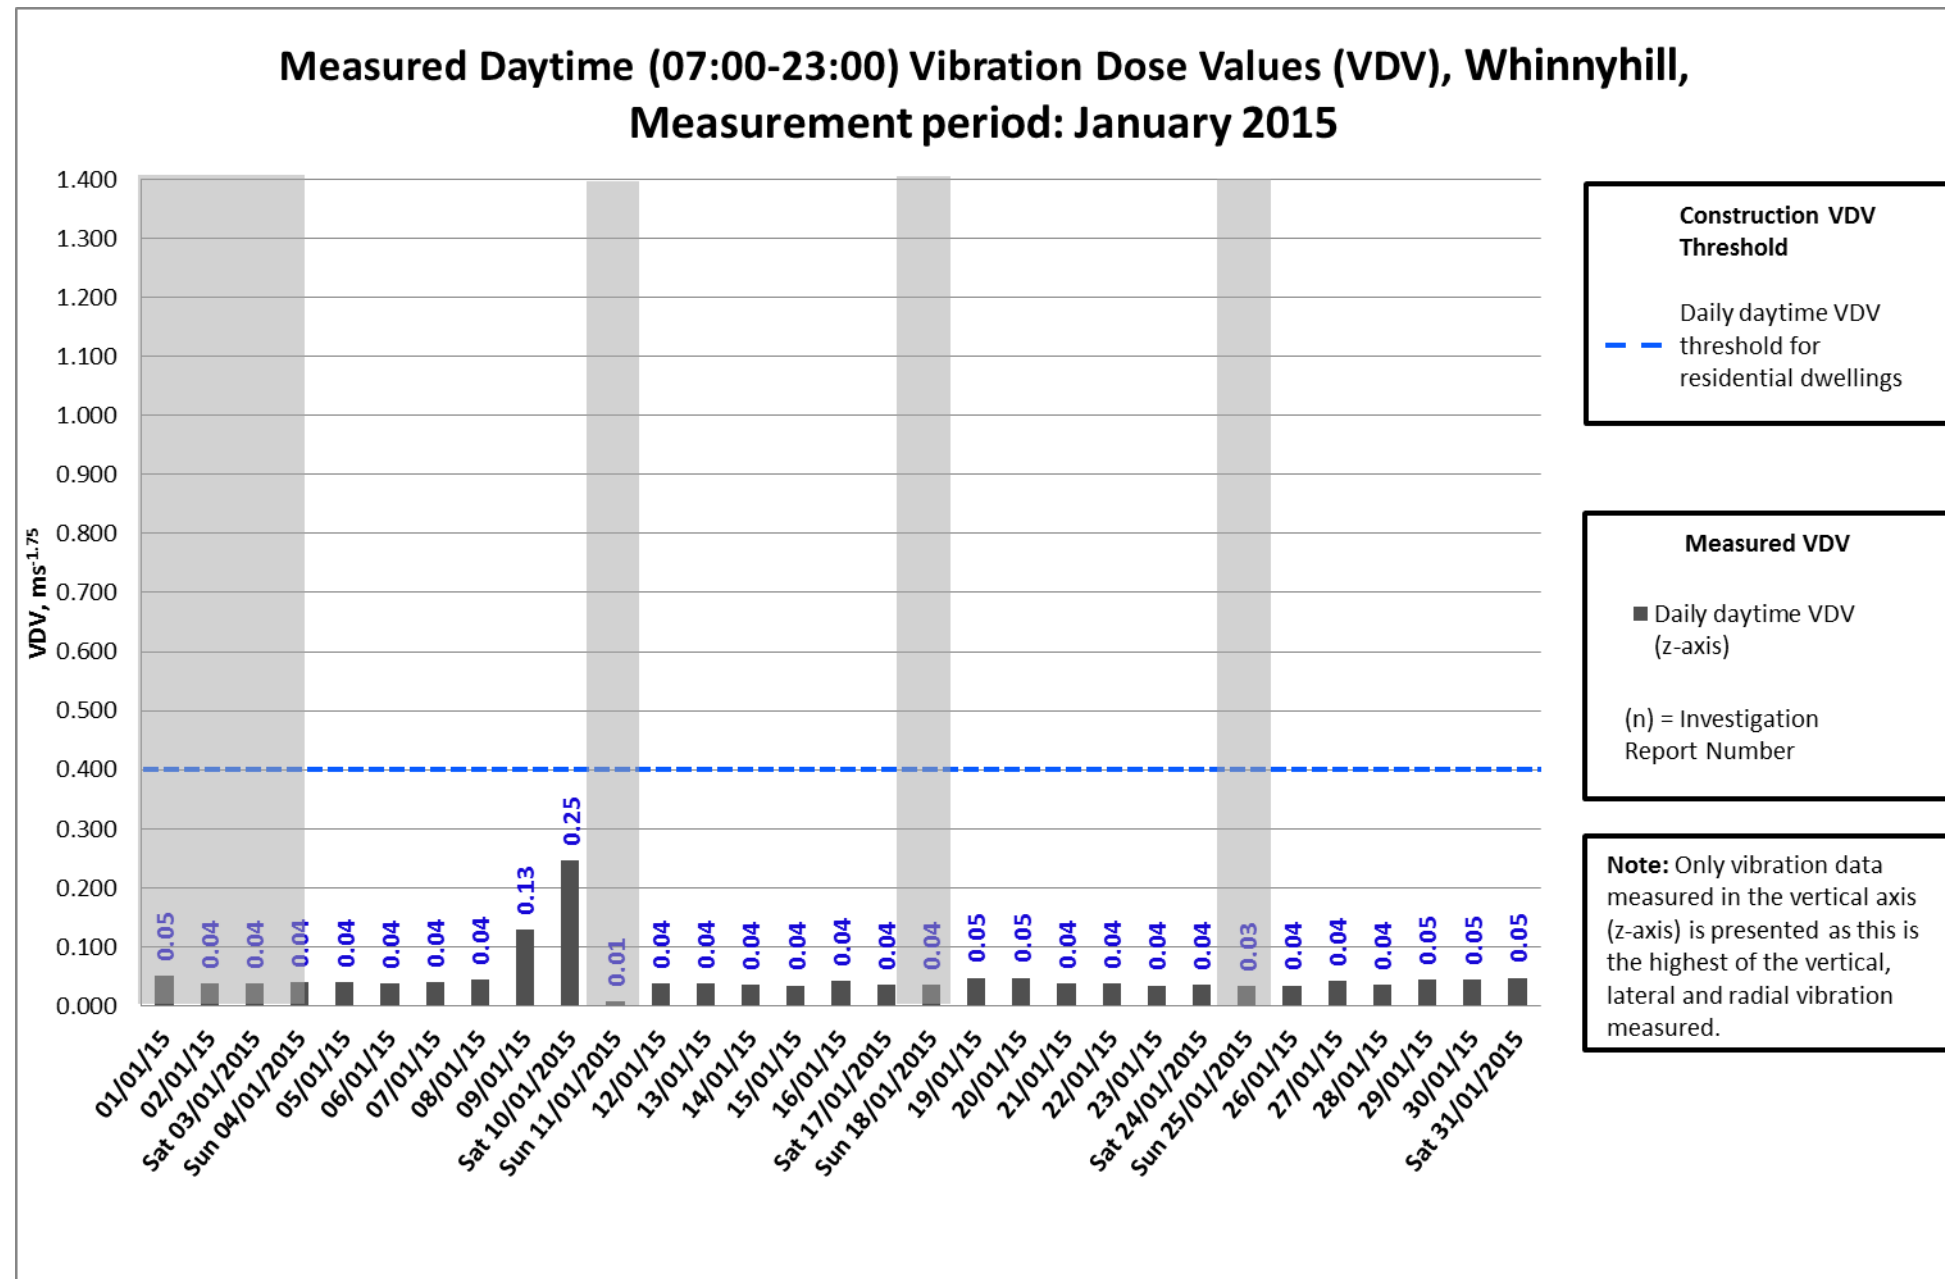
- The grey areas of the chart represent the days on which no construction works were undertaken; no works were conducted in the vicinity of the Whinnyhill monitor on Sundays.
- No FCBC works took place between 01/01/15 – 04/01/15.

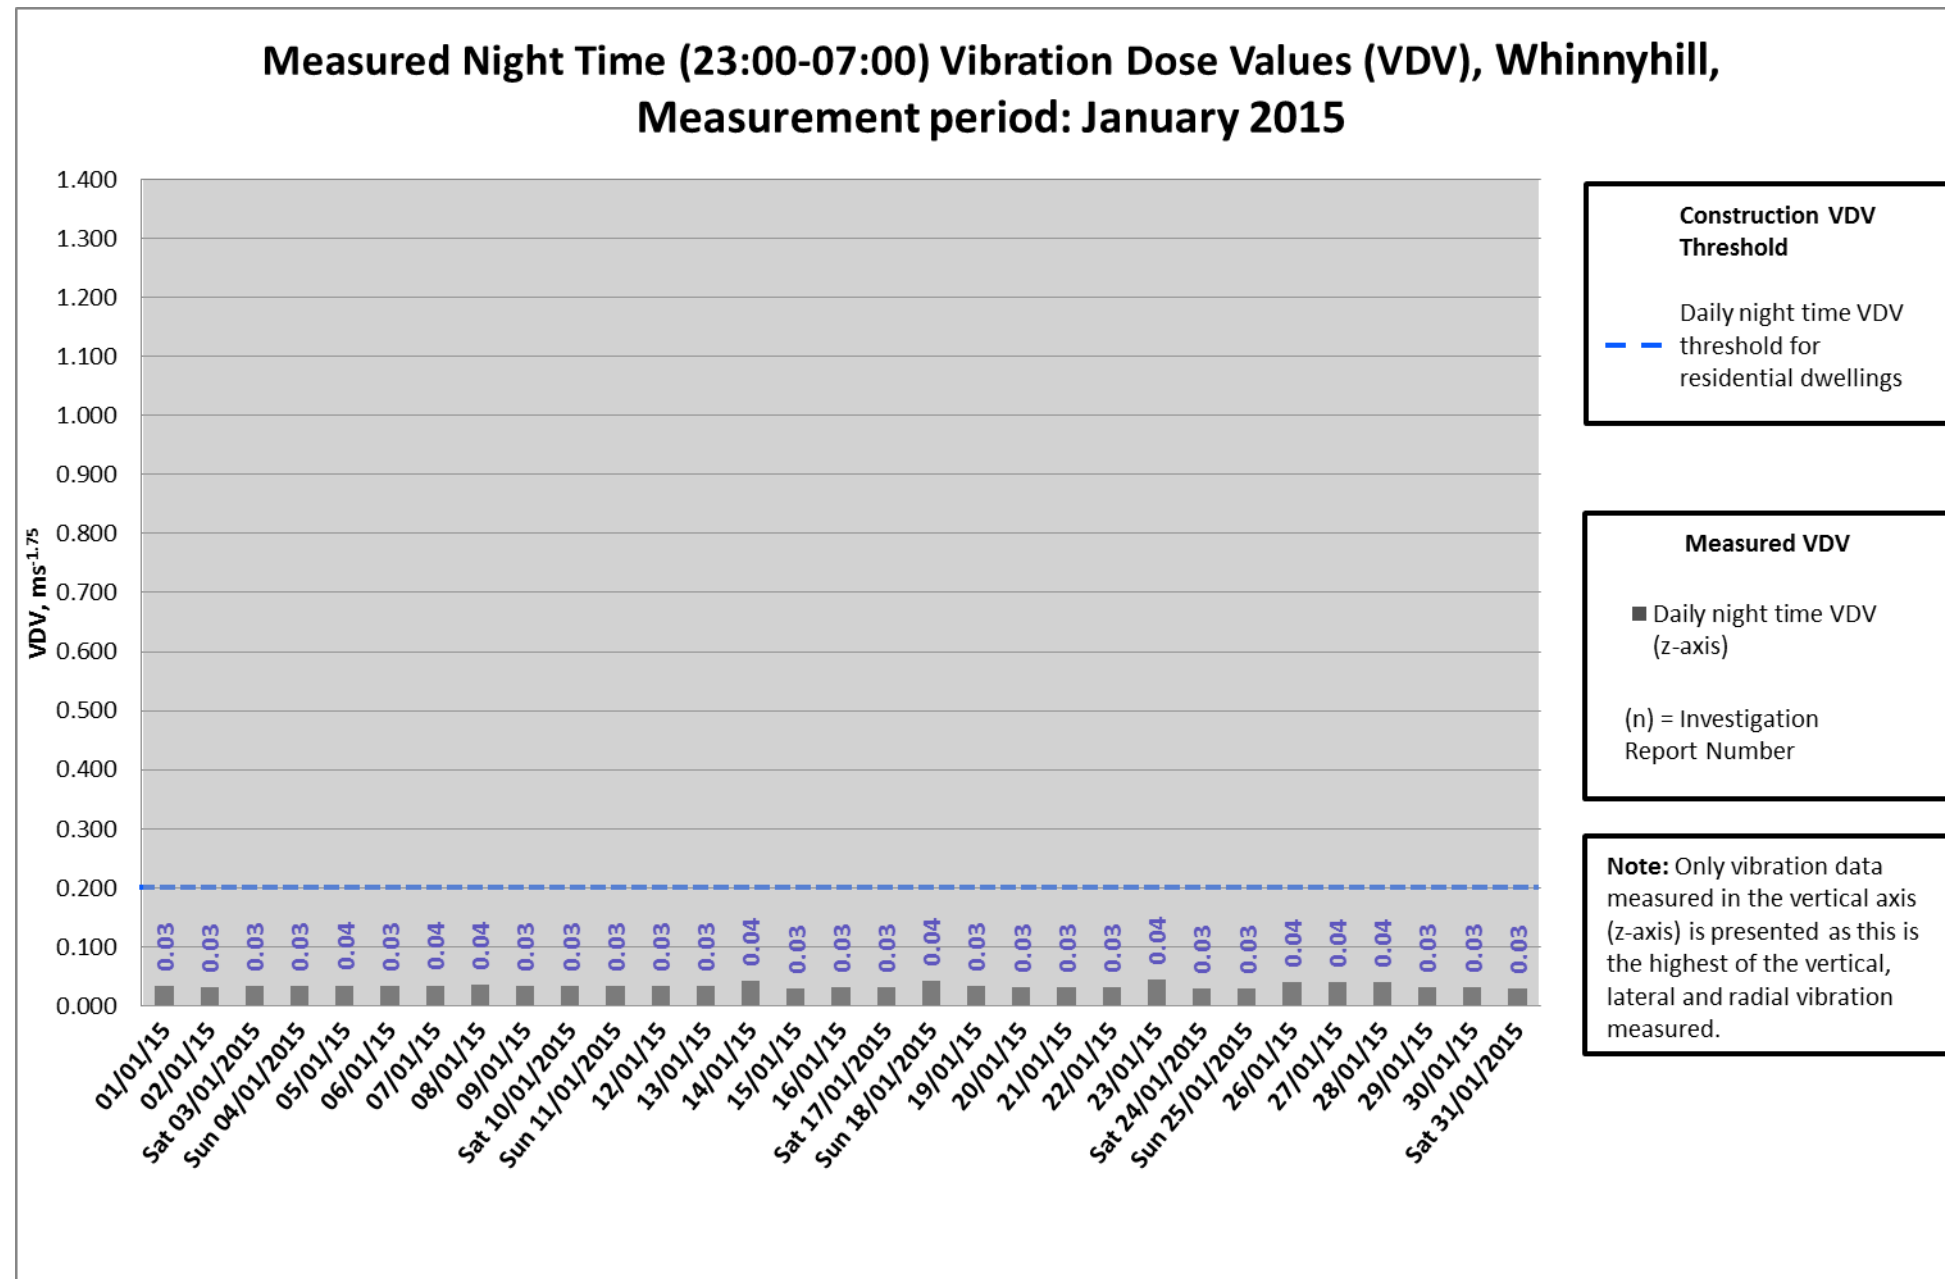
- The grey areas of the chart represent the days on which no construction works were undertaken; no night time works were conducted in the vicinity of the Whinnyhill vibration monitor throughout the month of January 2015. This graph is included for illustrative purposes only.
- No FCBC works took place between 01/01/2015 – 04/01/15.
