Project **FORTH REPLACEMENT CROSSING**

VIBRATION MONITORING REPORT
MAR 2013

Document number	Rev
REP-00109	00

**VIBRATION MONITORING REPORT
CONSTRUCTION OF PIER S6 COFFERDAM**

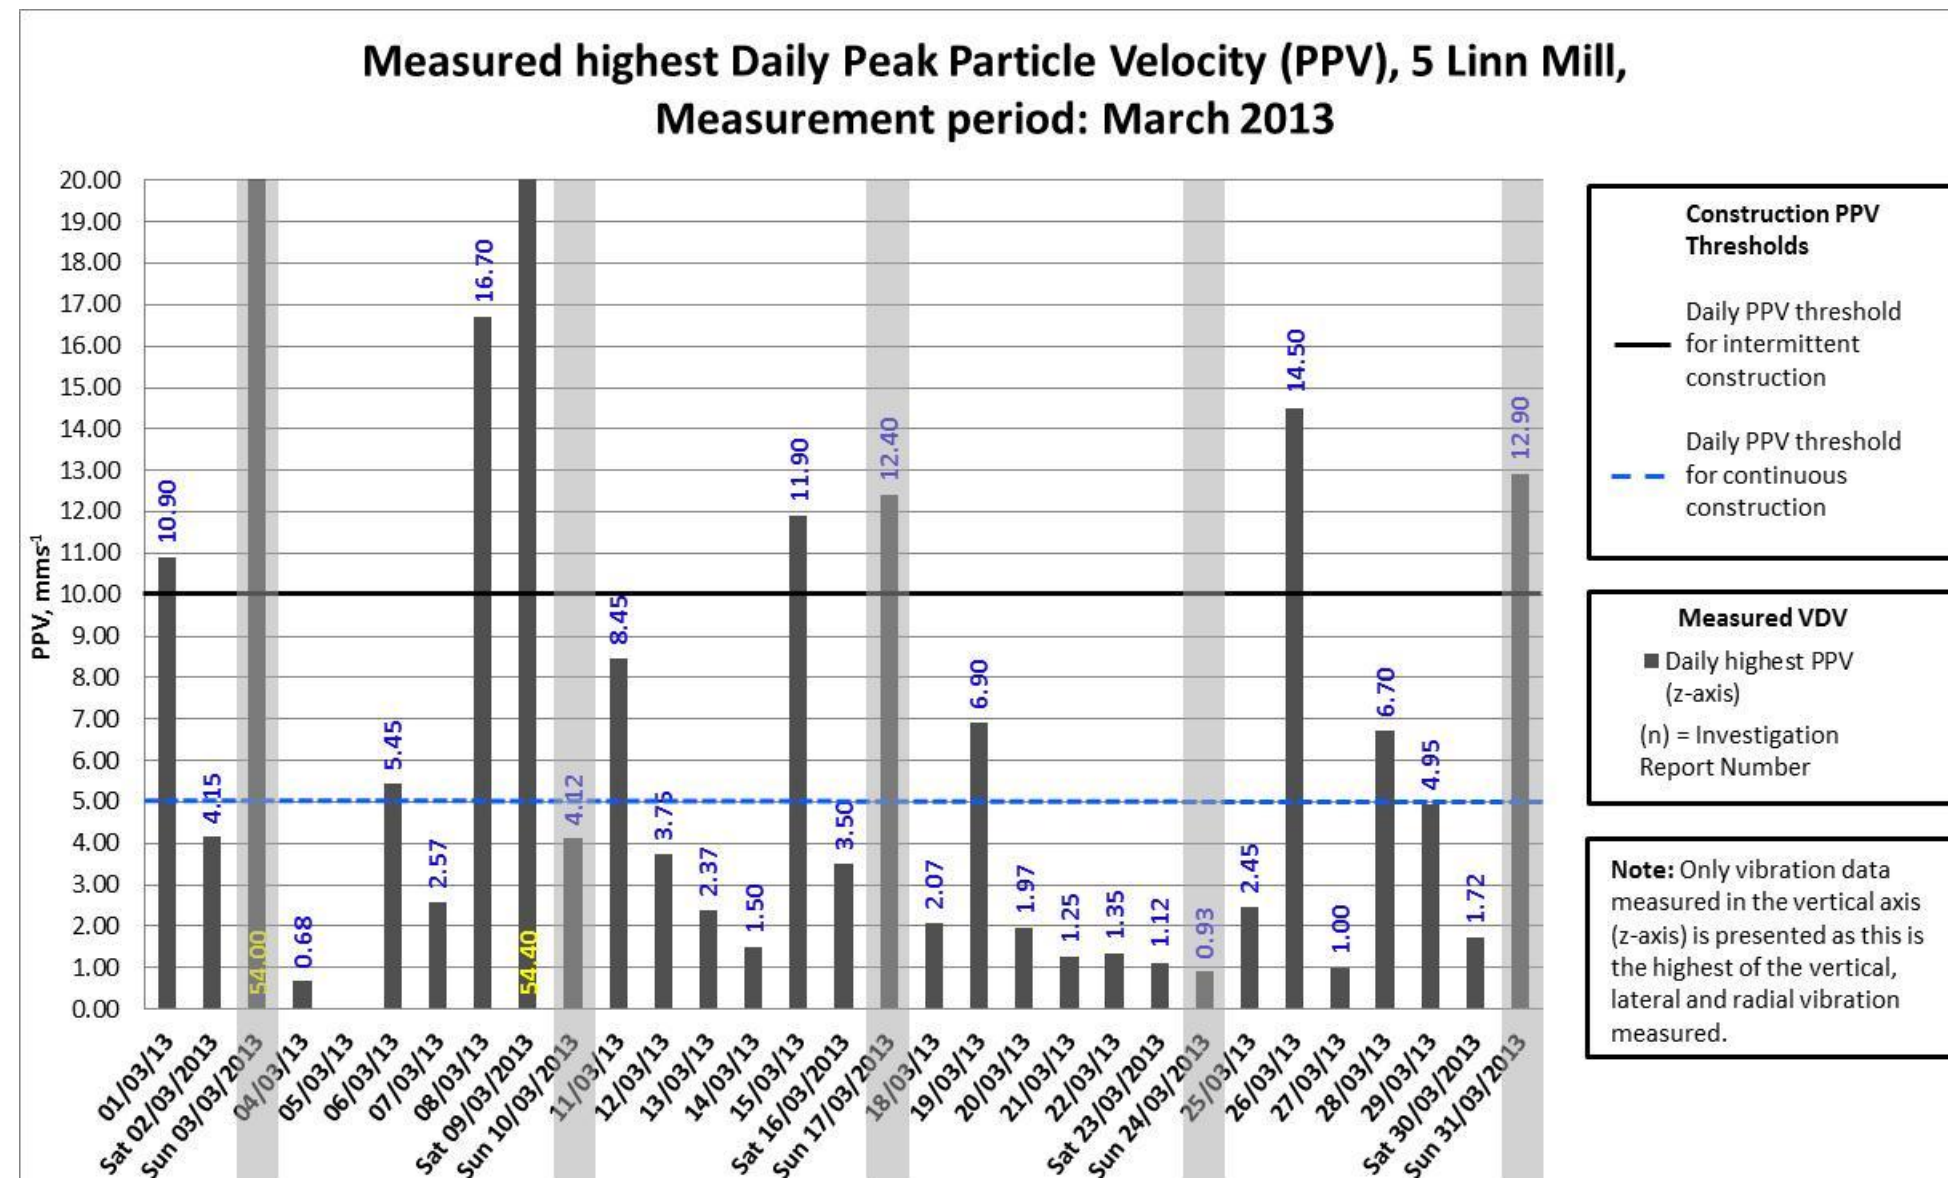
- The grey areas of the chart represent the days on which no construction works were undertaken; no works were conducted on Sundays.
- The PPV values on 01/03/13, 06/03/13, 08/03/13, 09/03/13, 11/03/13, 15/03/13, 19/03/13, 26/03/13 & 28/03/13 have been investigated, and have been seen to be individual, isolated events within each period (see Vibrock PPV graph below from 08/03/13). Furthermore, these particular levels cannot have been generated as a result of FCBC construction, as the only works to be conducted on these dates in the vicinity of the monitor, were backfill works at pier S7 and reinforcement and formwork at South Abutment, which did not involve any vibration inducing plant or equipment.
- Data is missing from 05/03/13 due to device error.

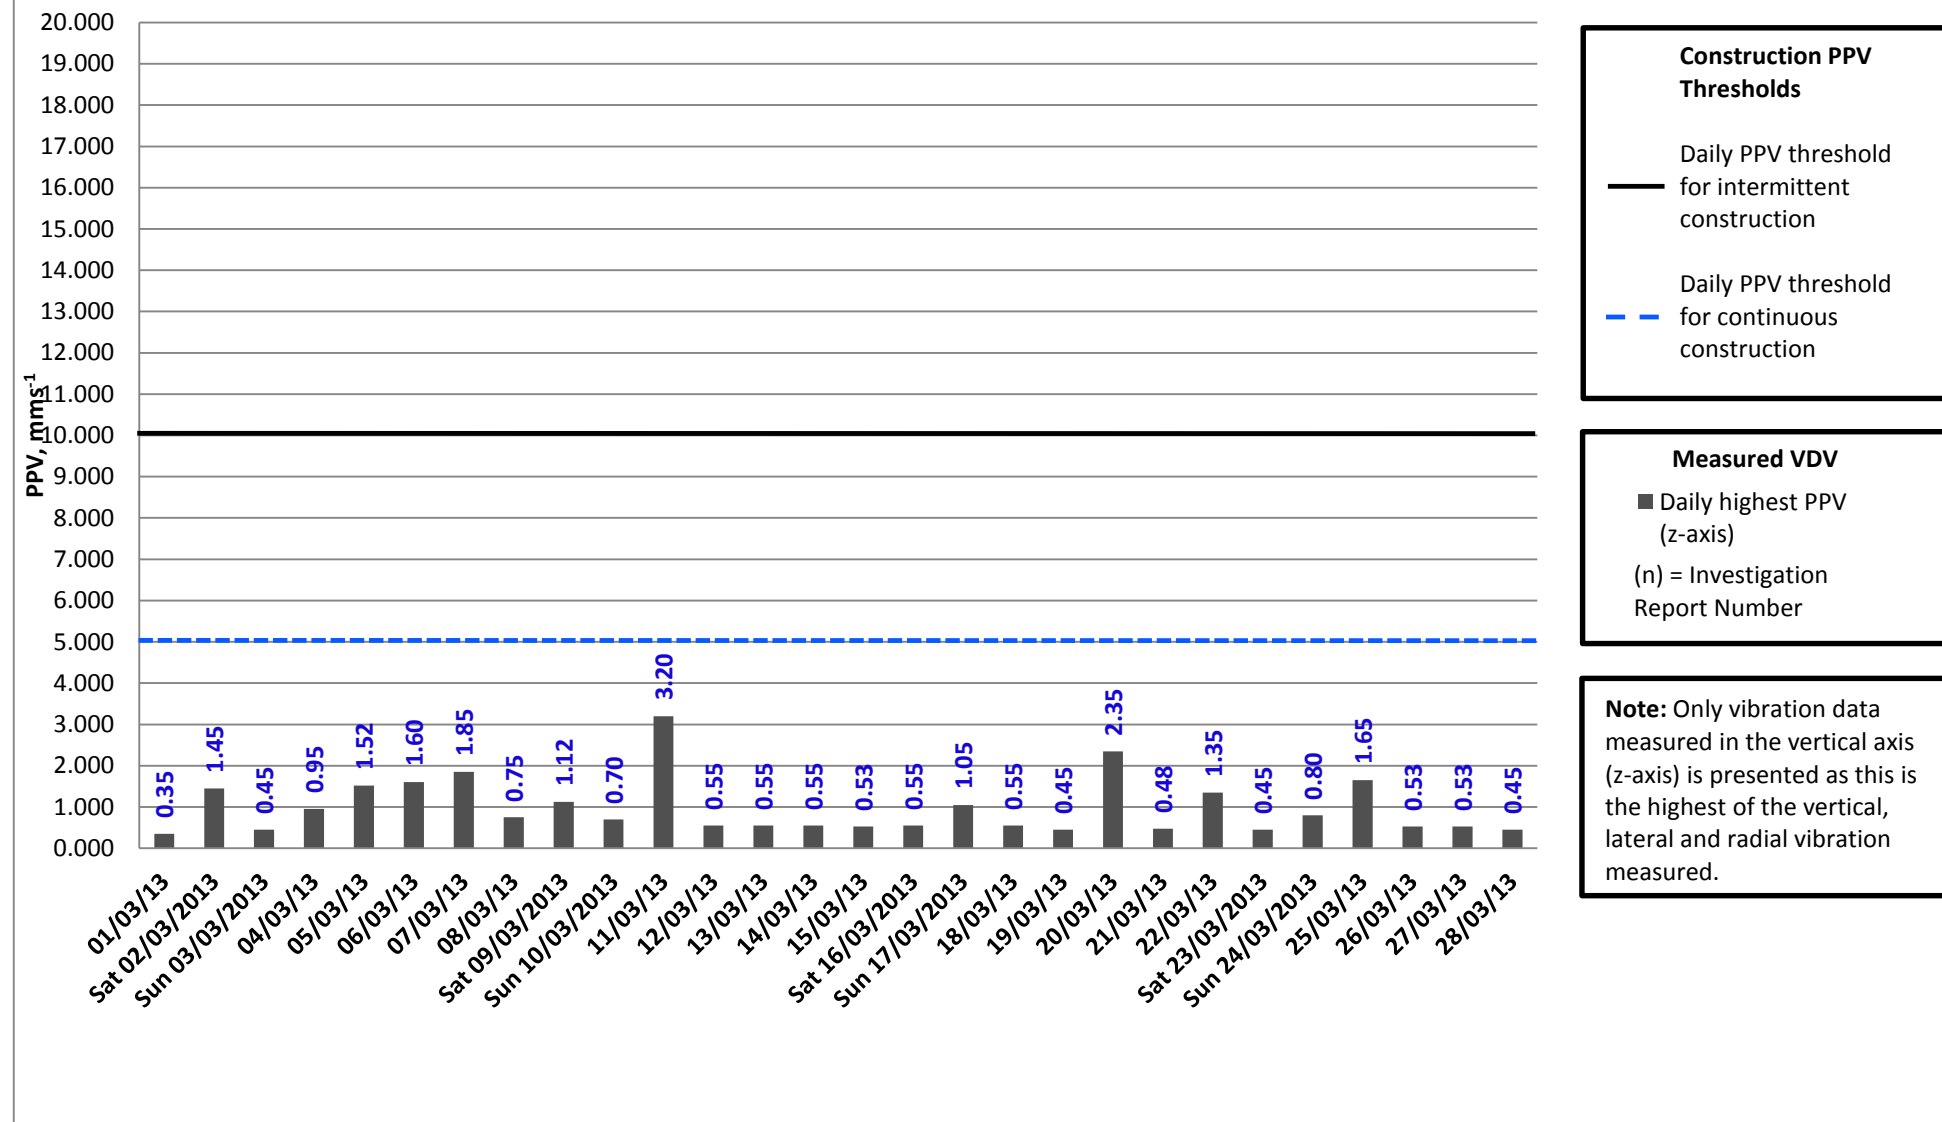
Measured highest Daily Peak Particle Velocity (PPV), Butlaw Fisheries, Measurement period: March 2013

Note: Only vibration data measured in the vertical axis (z-axis) is presented as this is the highest of the vertical, lateral and radial vibration measured.

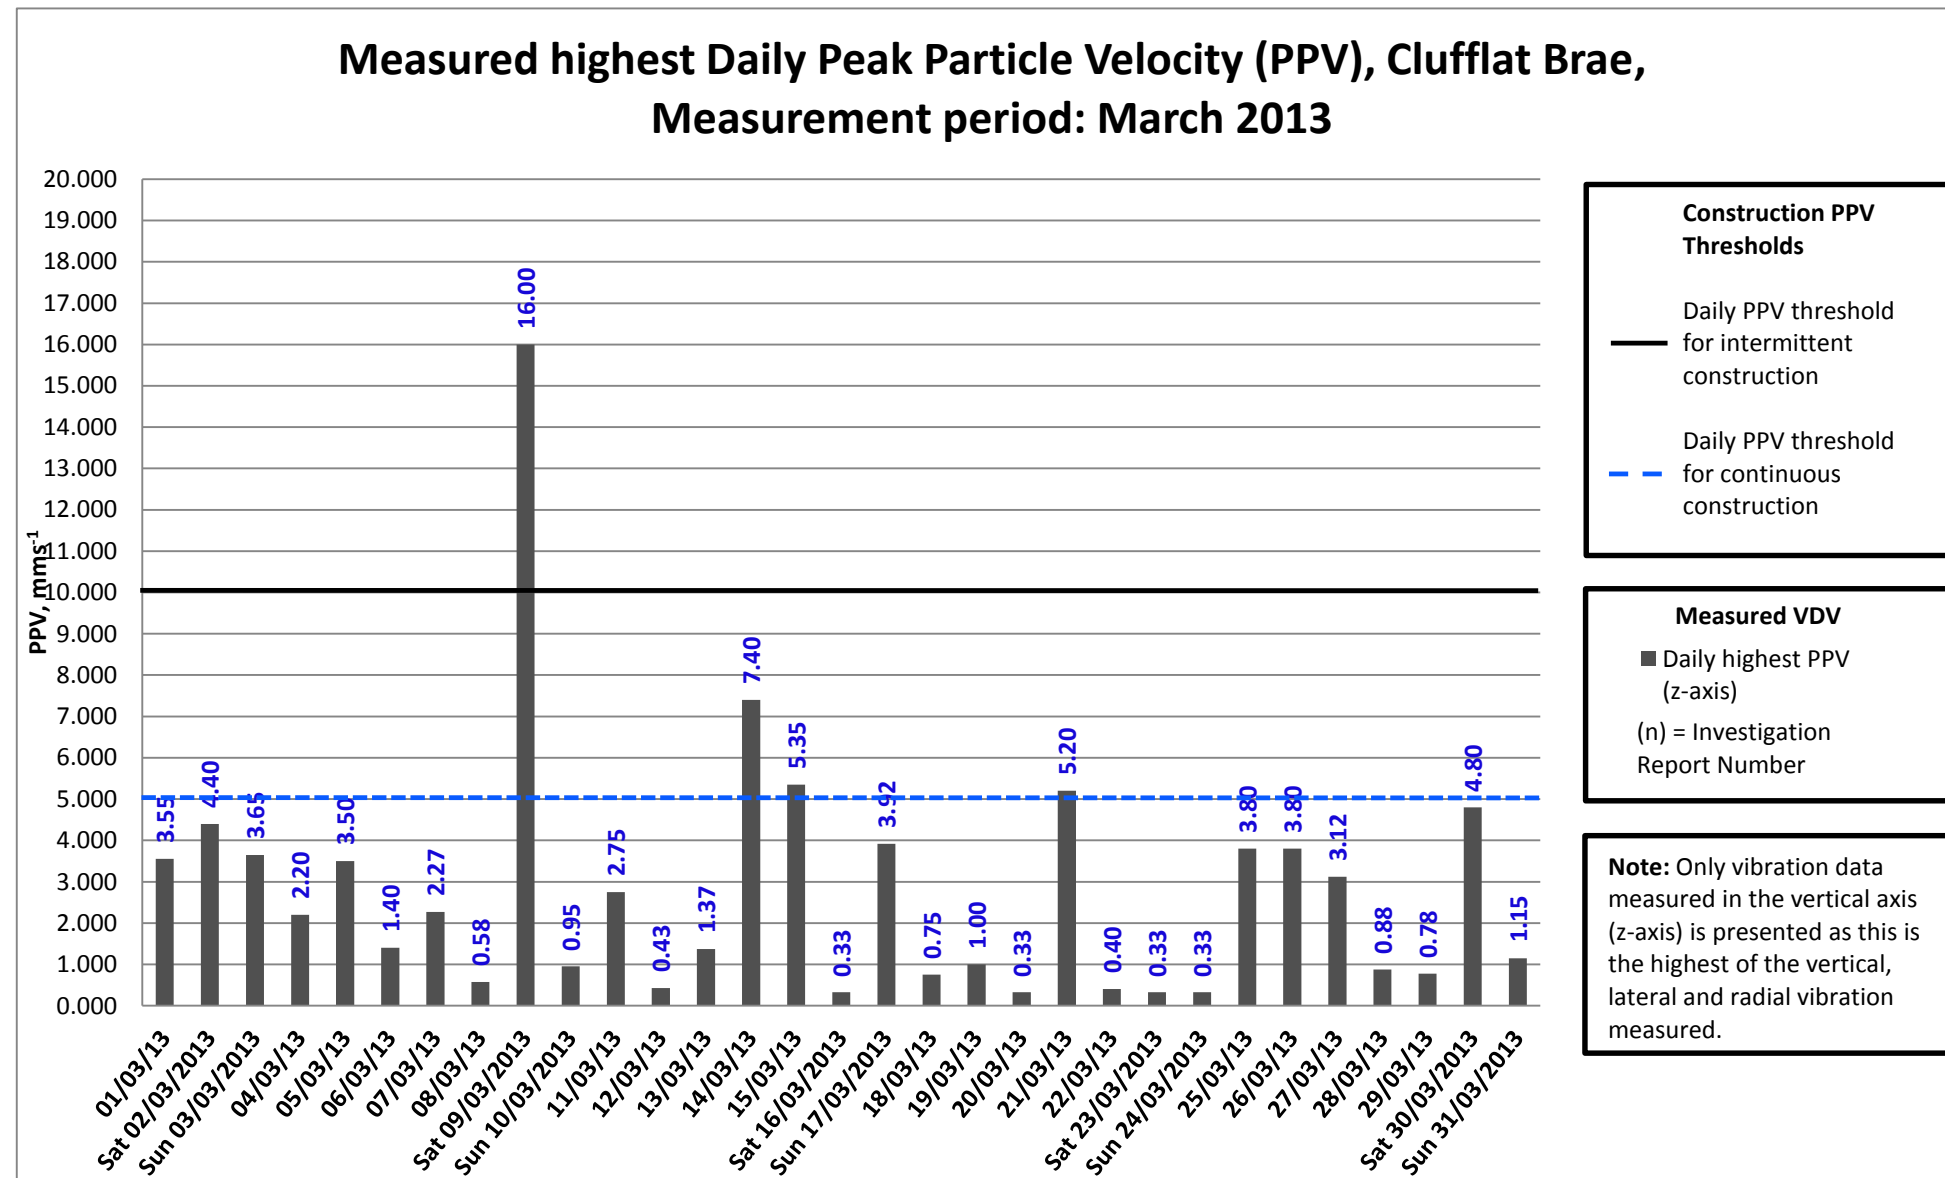
- The grey areas of the chart represent the days on which no construction works were undertaken; no works were conducted on Sundays.
- The PPV values on 09/03/13, 14/03/13, 15/03/13 and 21/03/13 have been investigated, and have been seen to be individual, isolated events within each period (see Vibrock PPV graph below from 09/03/13). The latter three of these PPVs are within the intermittent threshold of 10mm/s. Furthermore, these particular levels cannot have been generated as a result of FCBC construction, as the only works to be conducted on these dates in the vicinity of the monitor, were backfill works at pier S7 and reinforcement and formwork at South Abutment, which did not involve any vibration inducing plant or equipment.

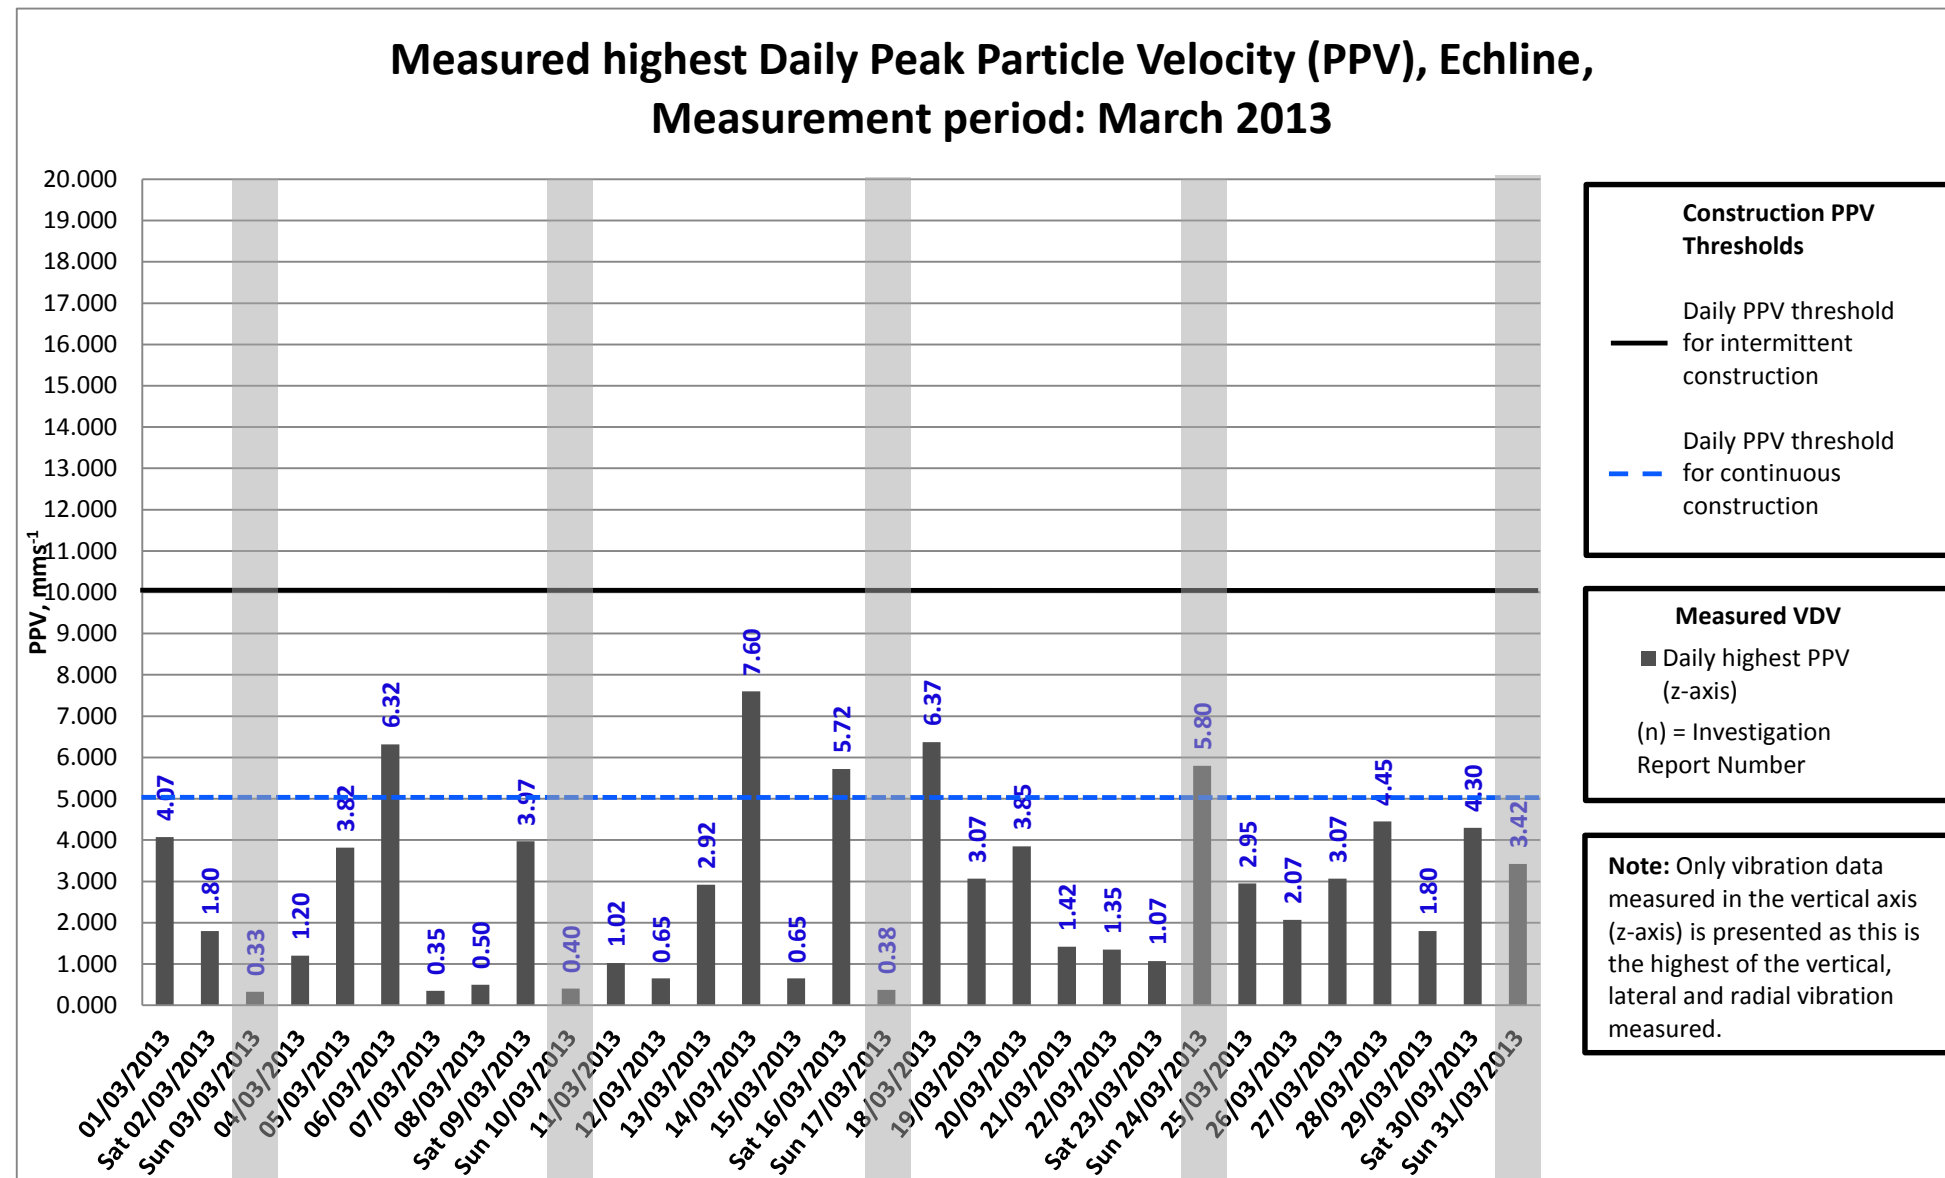
- The grey areas of the chart represent the days on which no construction works were undertaken; no works were conducted on Sundays.
- The PPV values on 06/03/13, 14/03/13, 16/03/13 & 18/03/13 have all been investigated, and have been seen to be individual, isolated events within each period (see Vibrock PPV graph below from 05/02/13), and are all within the intermittent threshold of 10mm/s. Furthermore, these particular levels cannot have been generated as a result of FCBC construction, as the only works to be conducted on these dates in the vicinity of the monitor, were excavation of rock at Queensferry gyratory, and drainage works at A904/U221. The only vibration inducing plant or equipment involved in these activities were rock breakers, which were operated a minimum distance of 40m from the monitor (and nearest receptors), and a vibratory rollers, which were operated a minimum distance of 80m from the monitor (and nearest receptors), and can thus be discounted as the source of these particular PPVs. Considering the location of the monitor, these levels are likely due to road traffic (e.g. occasional HGVs passing by).

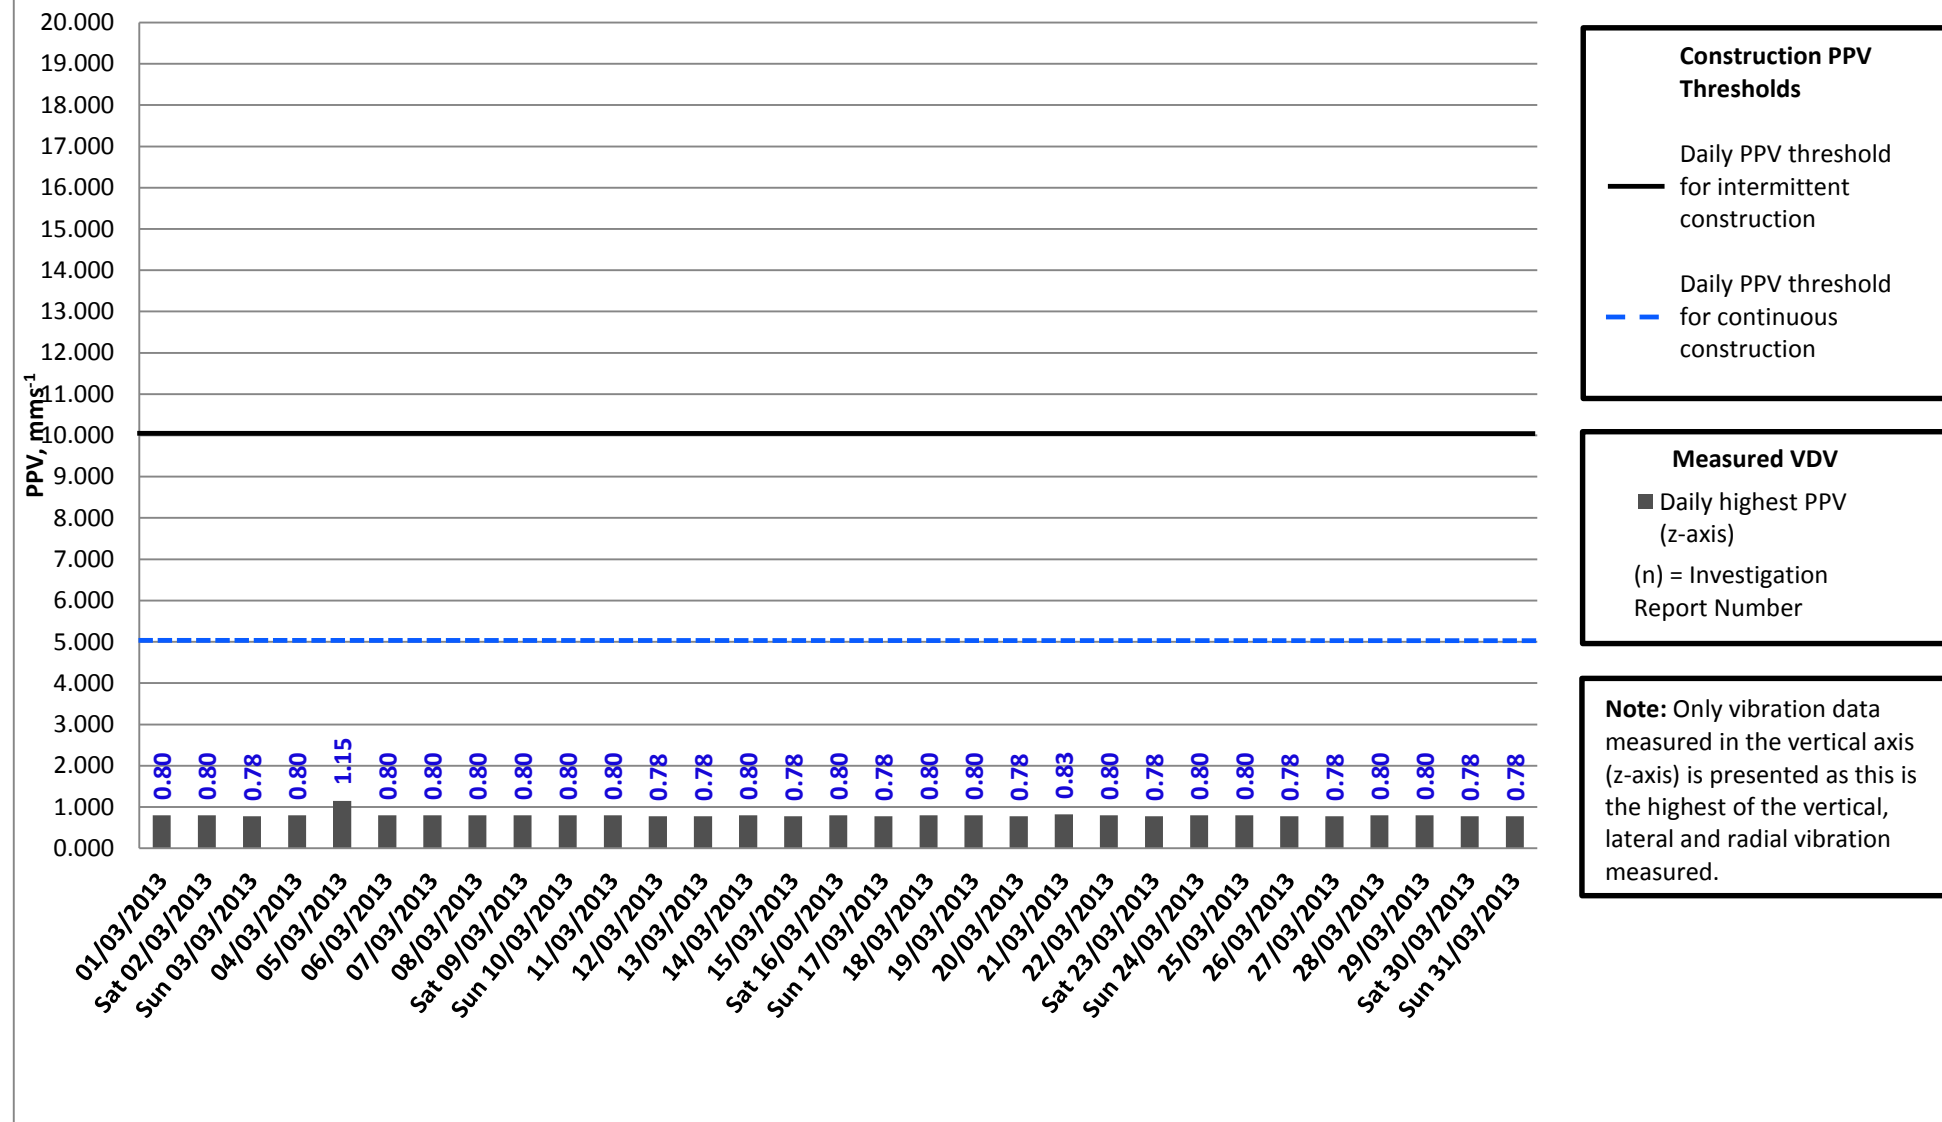
Measured highest Daily Peak Particle Velocity (PPV), Inchgarvie Lodge, Measurement period: March 2013

Note: Only vibration data measured in the vertical axis (z-axis) is presented as this is the highest of the vertical, lateral and radial vibration measured.

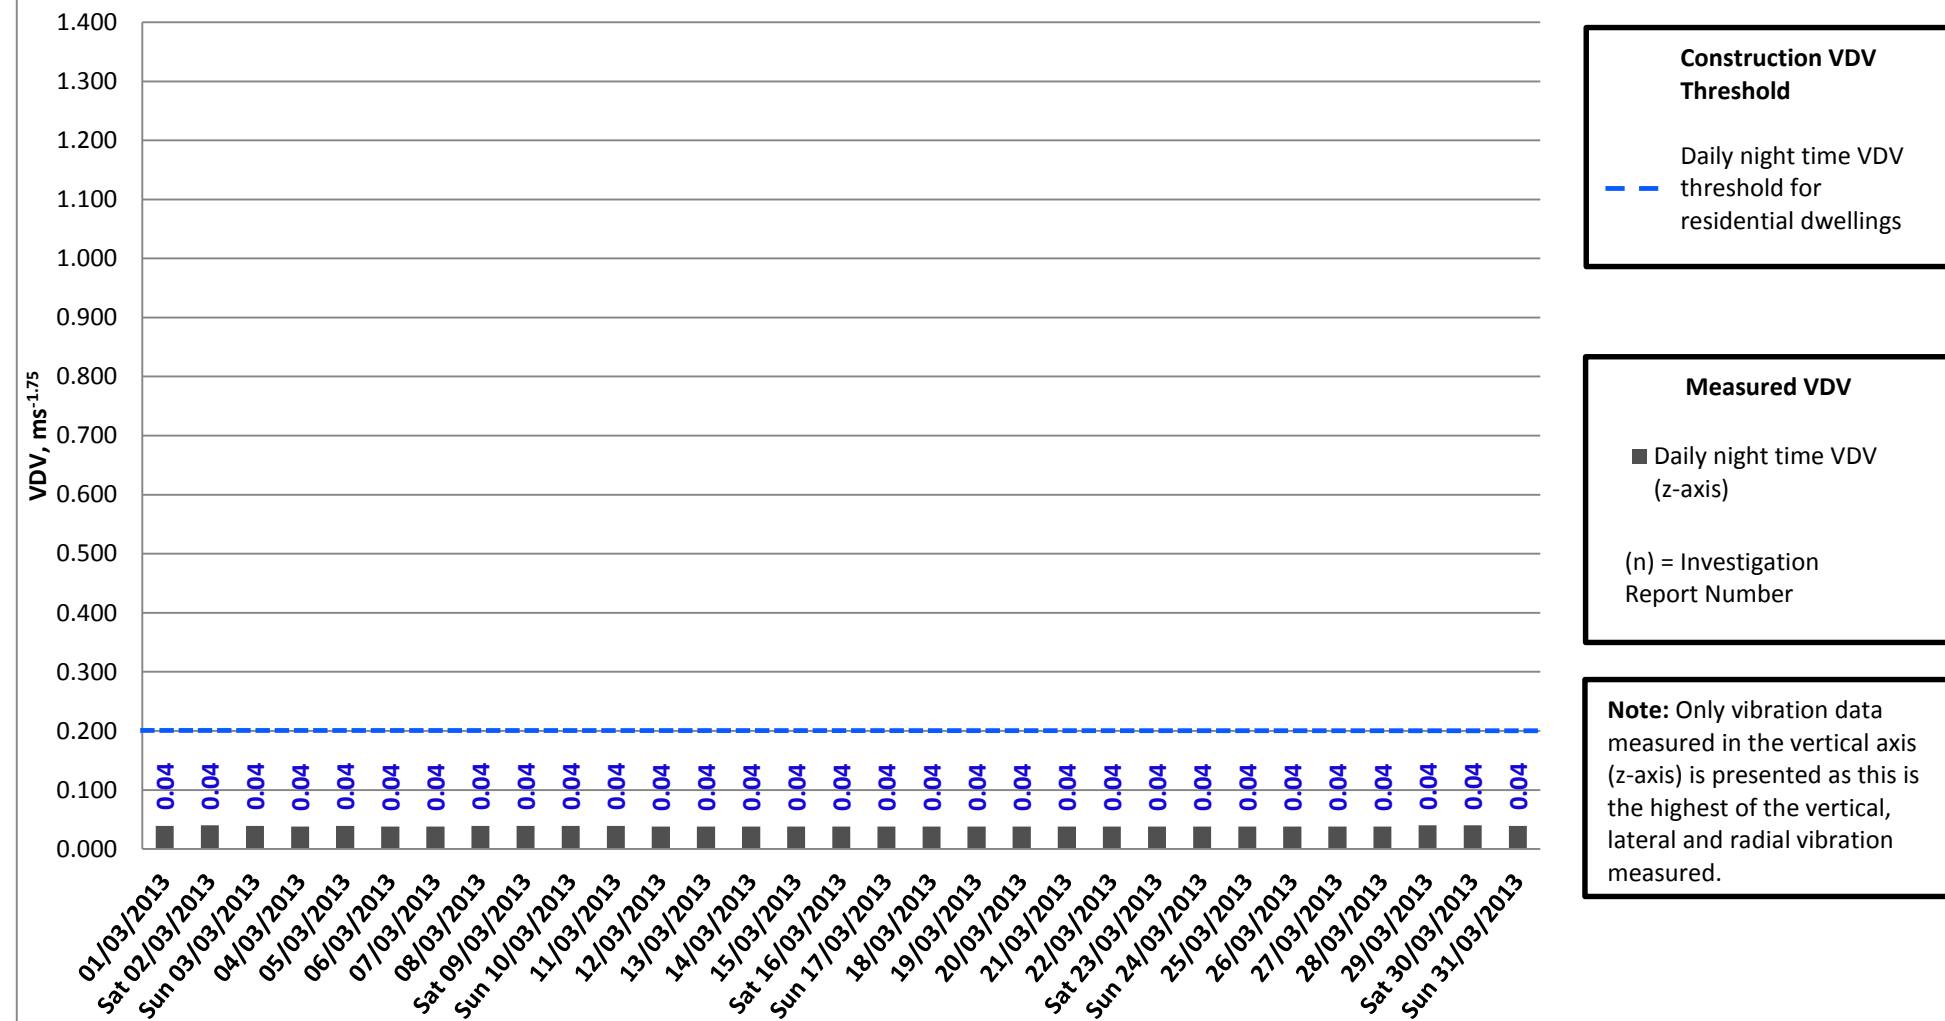
Measured Night Time (23:00-07:00) Vibration Dose Values (VDV), Inchgarvie Lodge, Measurement period: March 2013

Note: Only vibration data measured in the vertical axis (z-axis) is presented as this is the highest of the vertical, lateral and radial vibration measured.

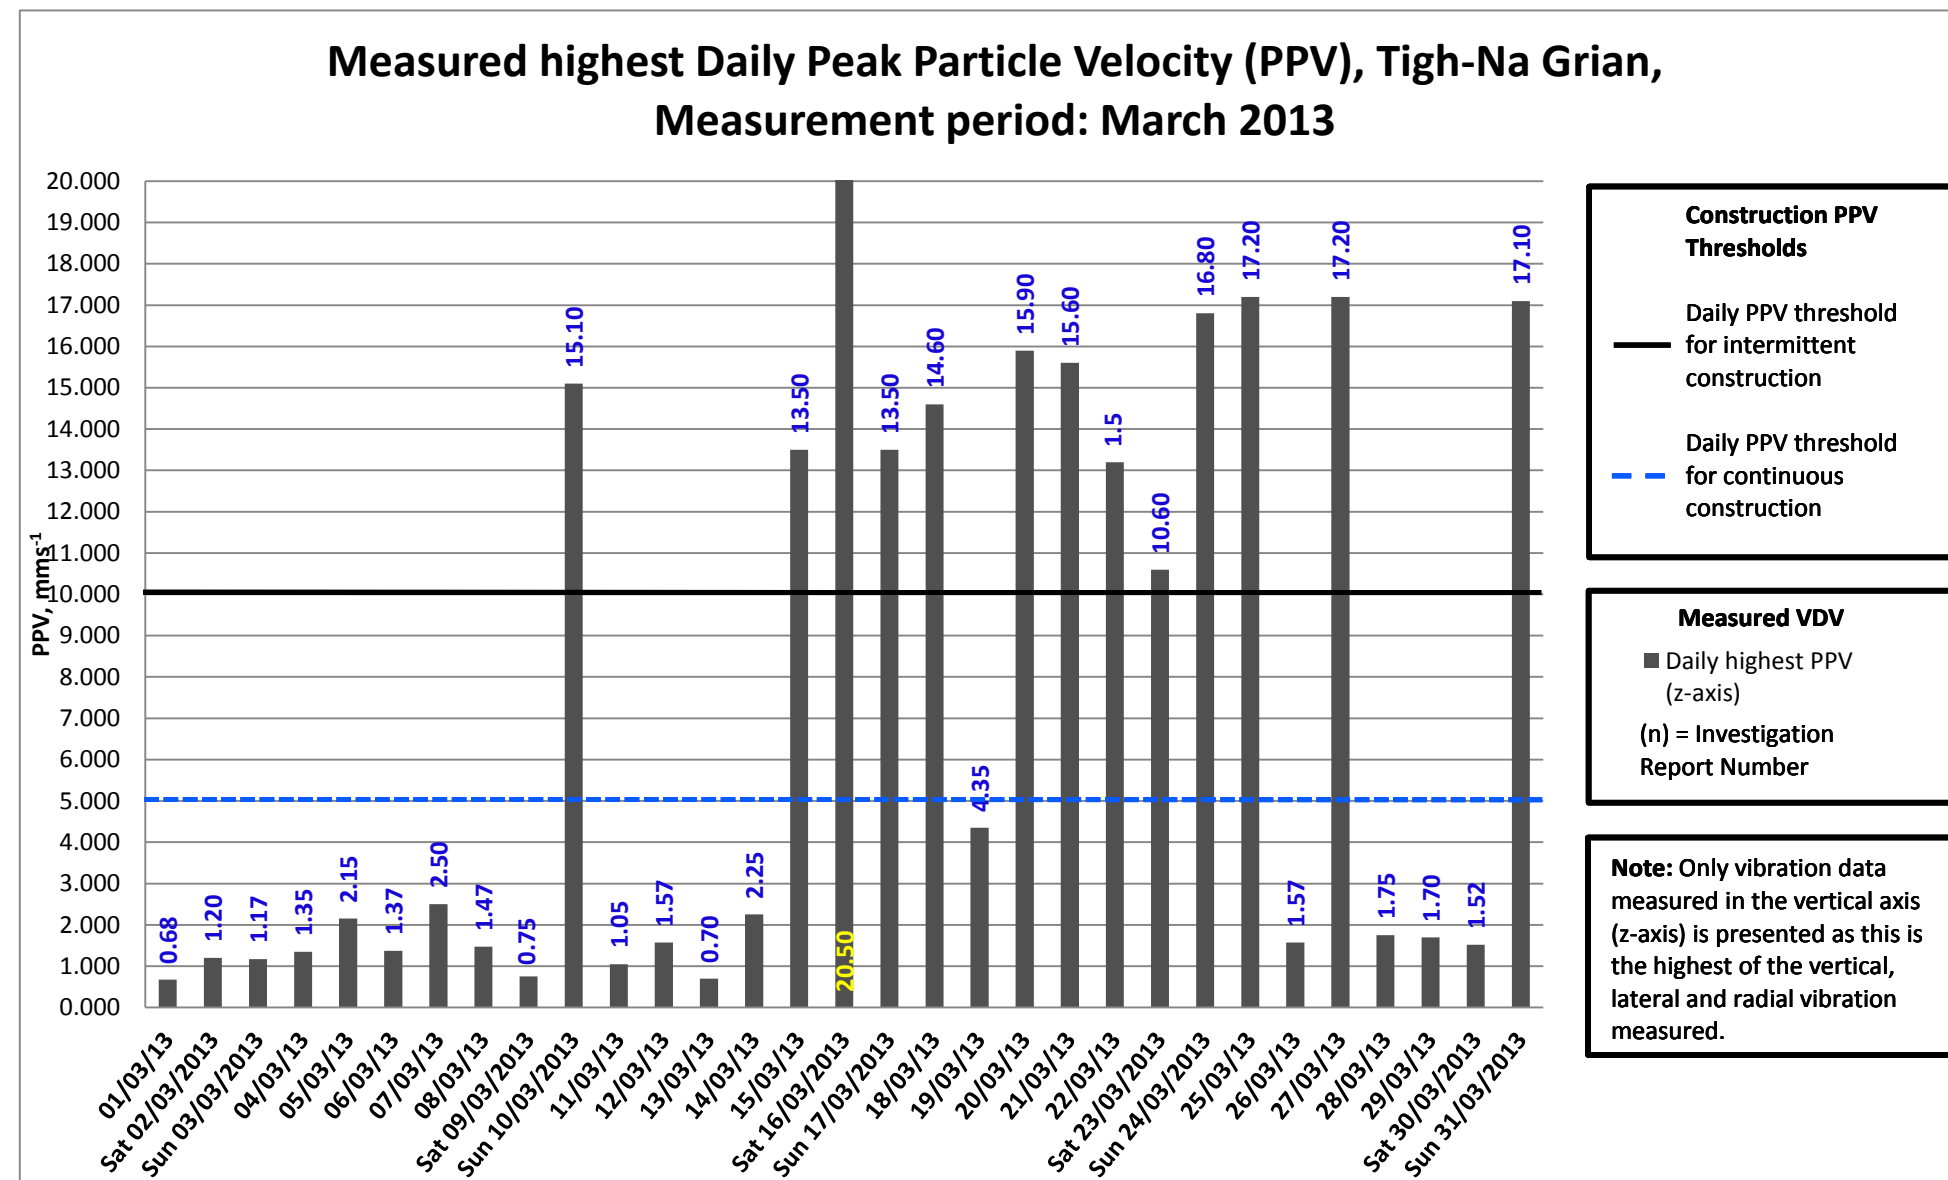
- The grey areas of the chart represent the days on which no construction works were undertaken; no works were conducted on Sundays.
- The PPV values on 10/03/13, 15/03-18/03/13, 20/03-25/03/13, 27/03/13 and the 31/03/13 have been investigated, and have been seen to be individual, isolated events within each period (see Vibrock PPV graph below from 16/03/13). These particular levels cannot have been generated as a result of FCBC construction, as the only works to be conducted on these dates in the vicinity of the monitor, were caisson excavation at the North Tower. There was no vibration inducing plant or equipment involved in this activity, thus it can be discounted as the source of these particular PPVs. Considering the location of the monitor, these levels likely resulted from local interference (e.g. resident movement in close proximity to the monitor).

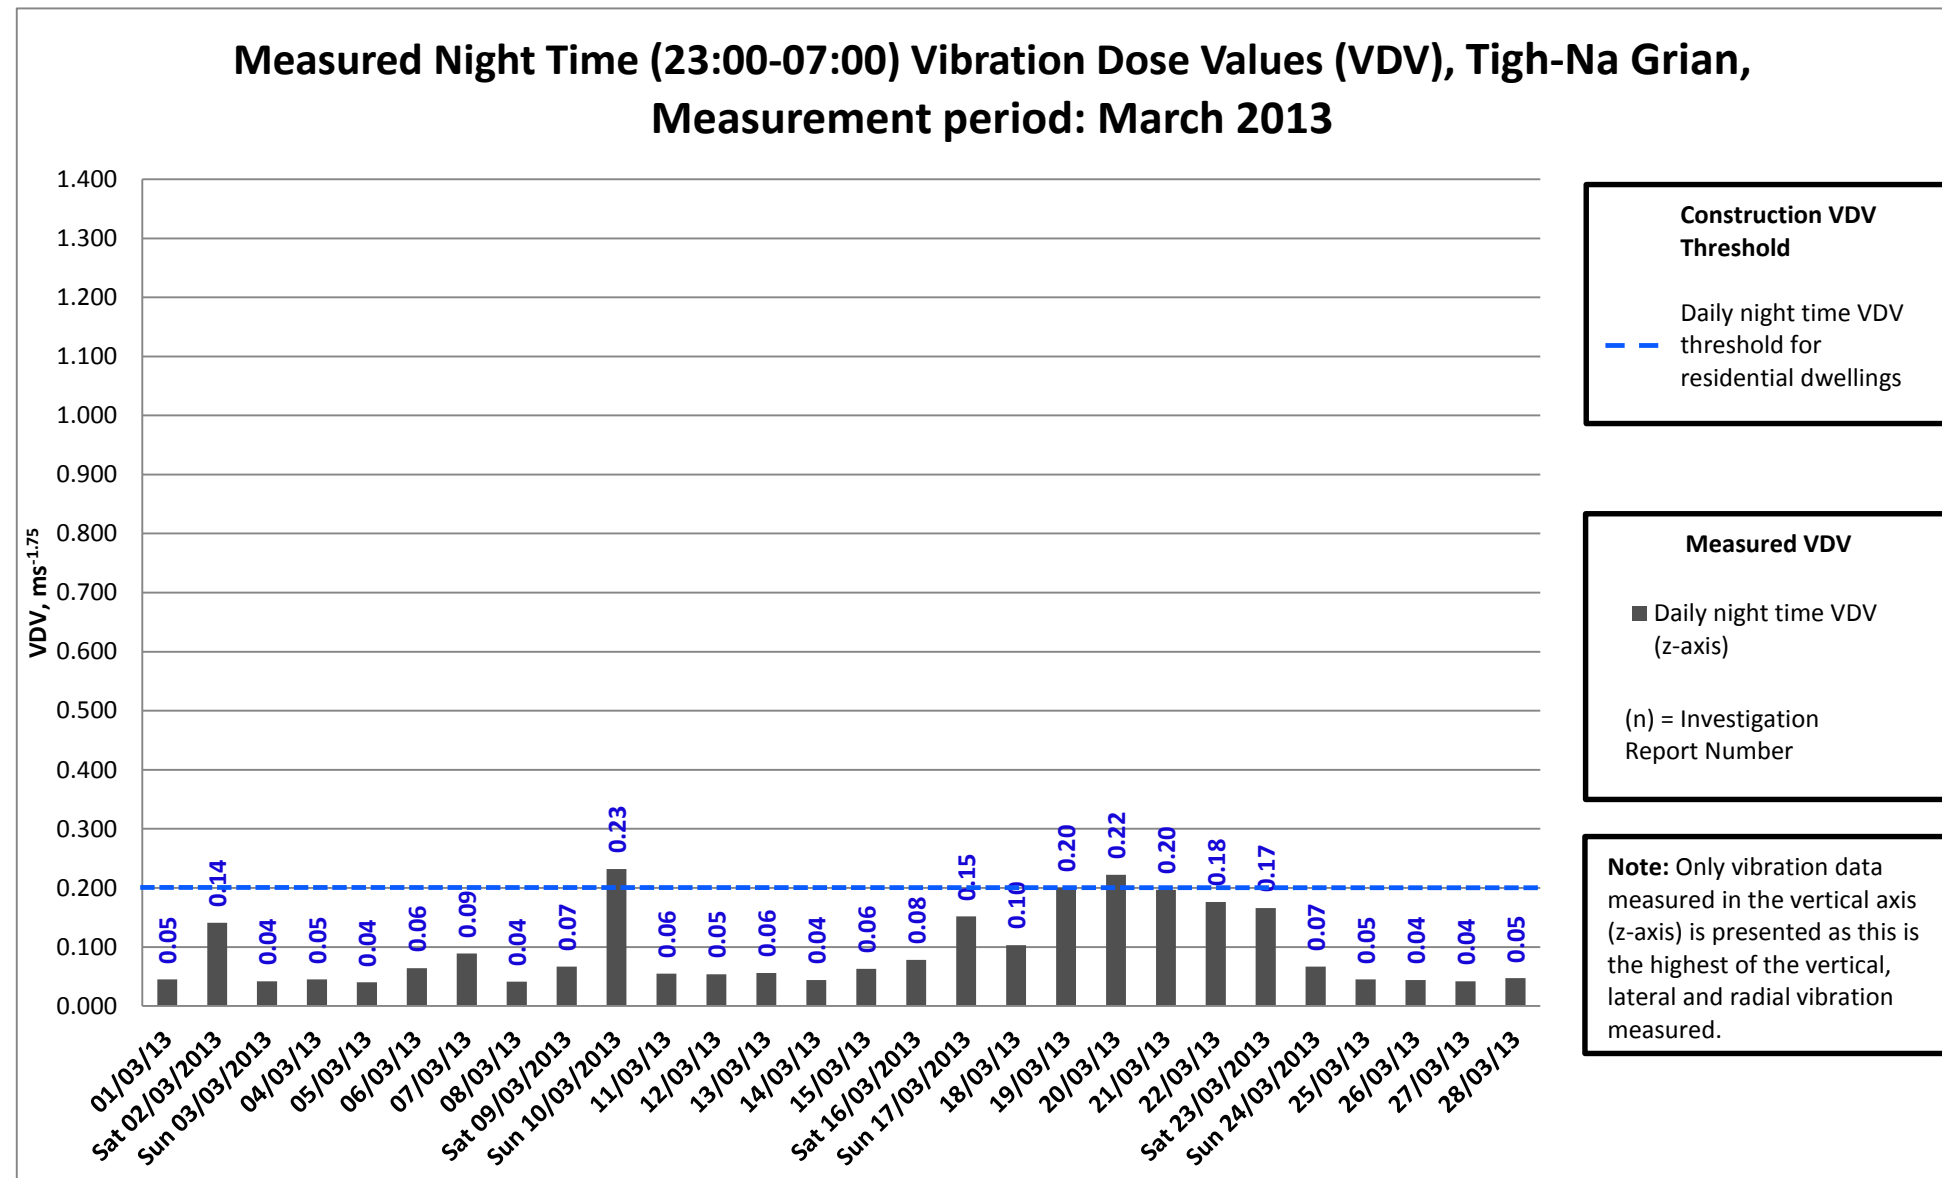
- VDV exceedances on the 10/03/13 and the 20/03/13 have been investigated. These particular levels cannot have been generated as a result of FCBC construction, as the only works to be conducted on these dates in the vicinity of the monitor, were caisson excavation at the North Tower. There was no vibration inducing plant or equipment involved in this activity, thus it can be discounted as the source of these particular VDV's.

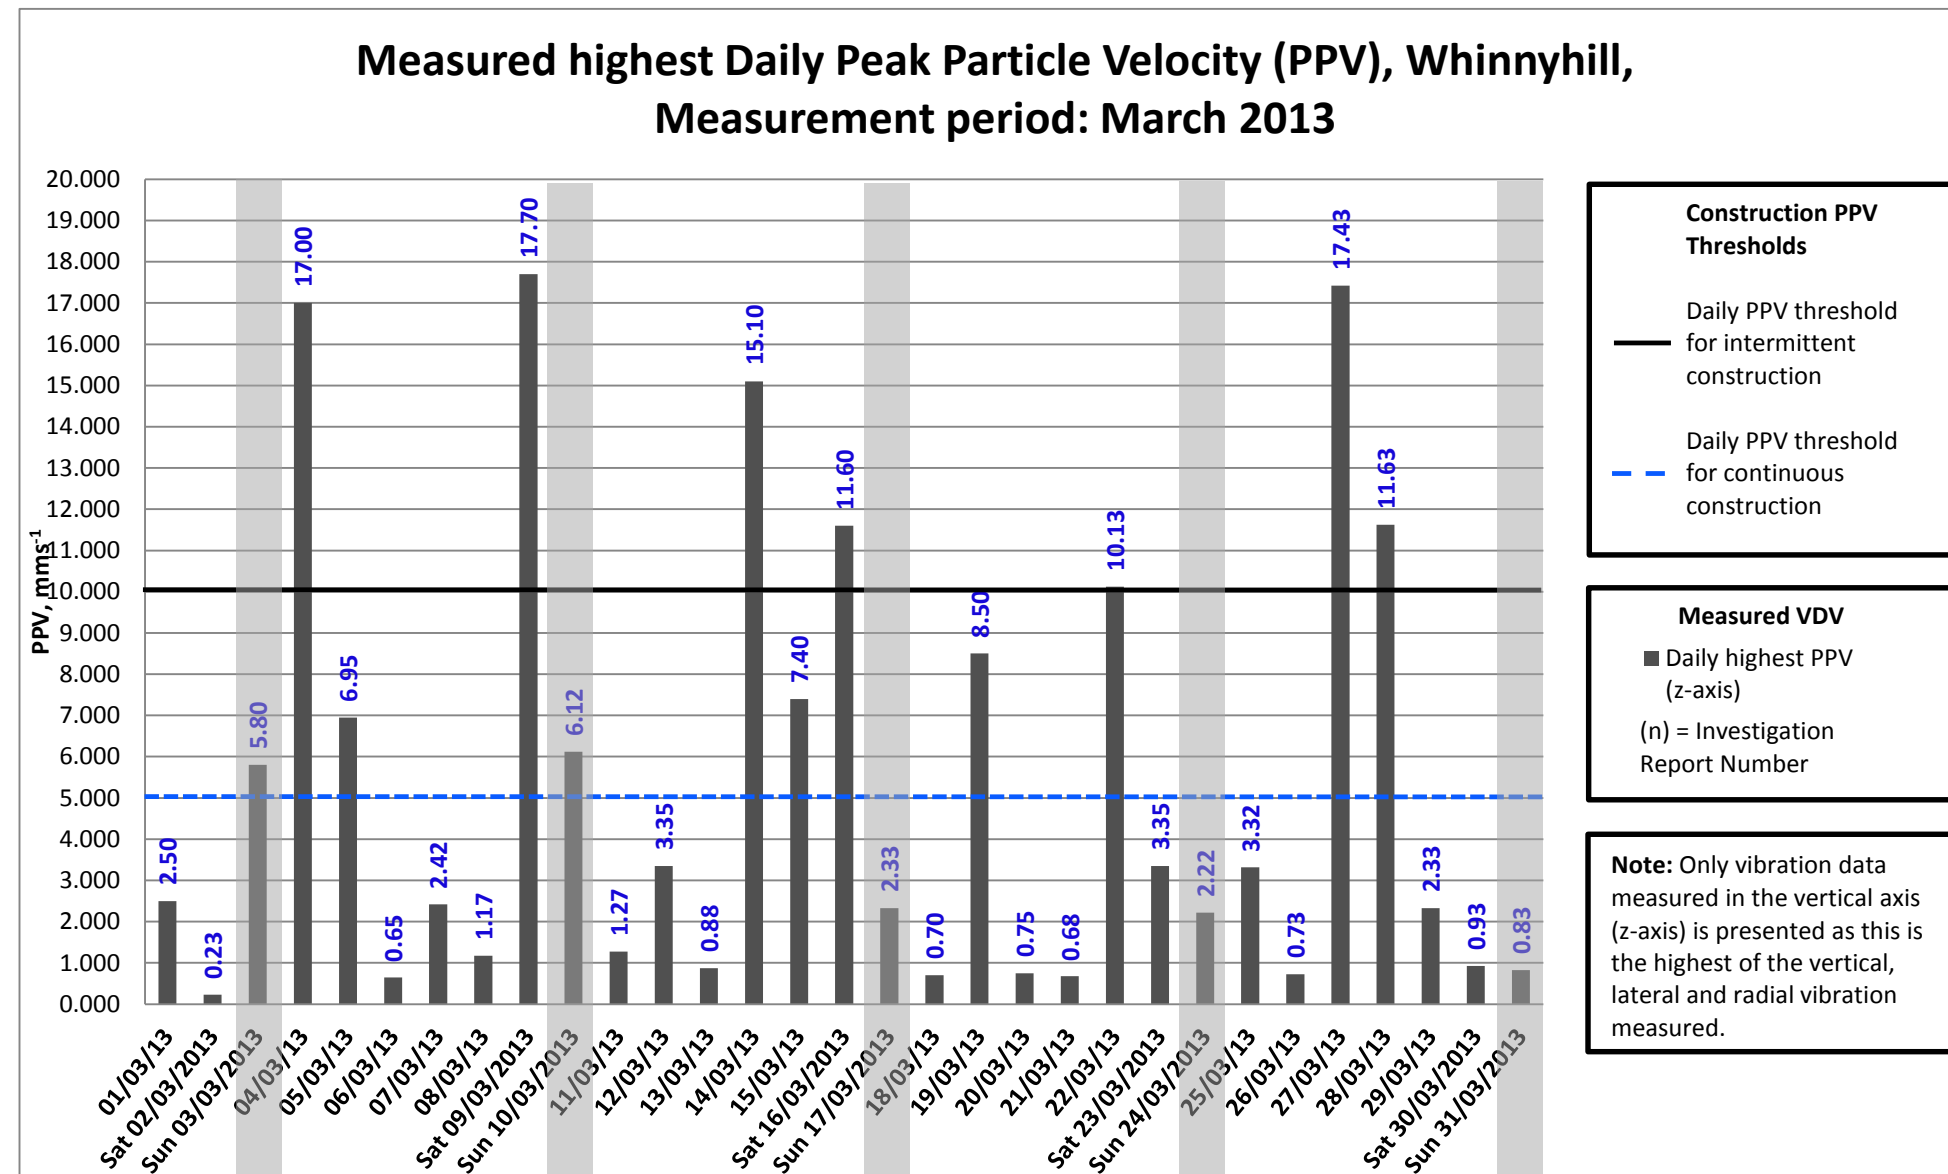
- The grey areas of the chart represent the days on which no construction works were undertaken; no works were conducted on Sundays.
- All PPV exceedances have been investigated, and have been seen to be individual, isolated events within each period (see Vibrock PPV graph below from 14/03/13). The only vibration inducing plant or equipment involved in these activities were rock breakers, which were operated a minimum distance of 270m from the monitor (and nearest receptors), and can thus be discounted as the source of these particular PPVs. Considering the location of the monitor, these levels likely resulted from local interference (e.g. resident movement in close proximity to the monitor).
