Project **FORTH REPLACEMENT CROSSING**

VIBRATION MONITORING REPORT
MAR 2013

Document number	Rev
REP-00109	00

**VIBRATION MONITORING REPORT
CONSTRUCTION OF PIER S6 COFFERDAM**

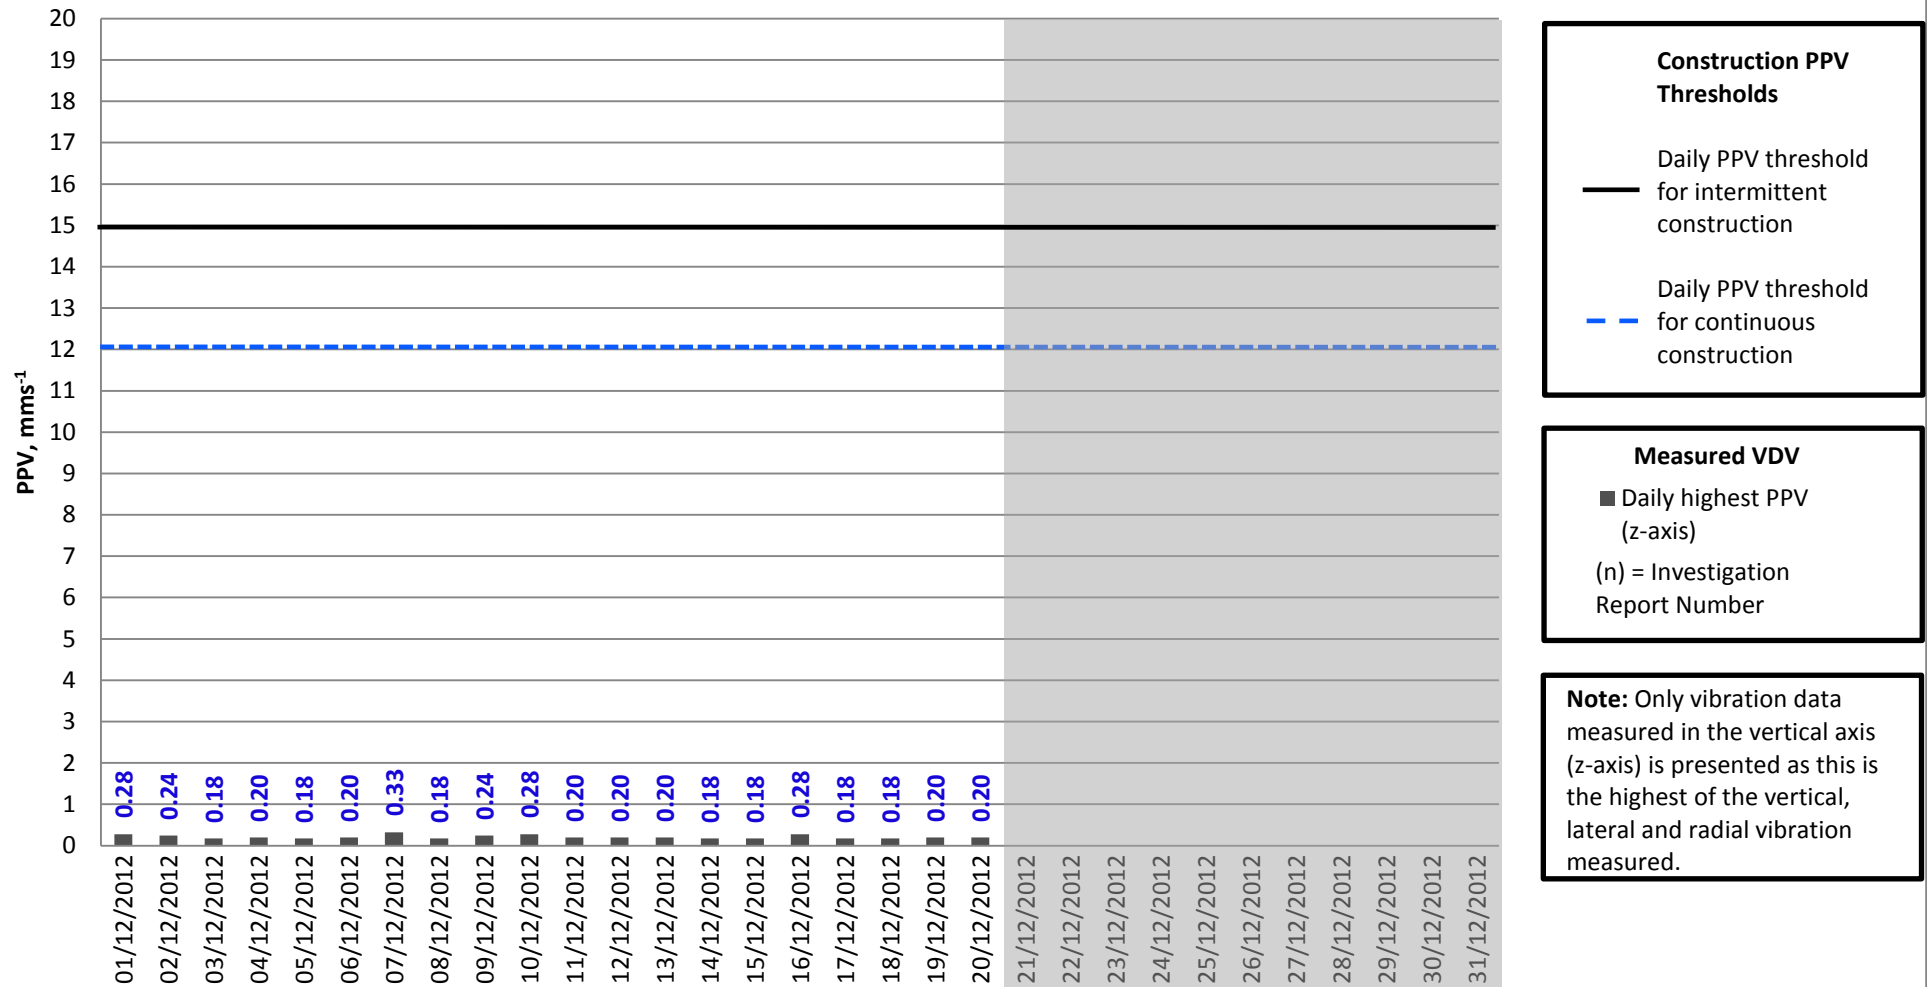
Measured highest daily Peak Particle Velocity (PPV), Bunker Steps (VIBROCK 1)

Measurement period: December 2012

Note: Only vibration data measured in the vertical axis (z-axis) is presented as this is the highest of the vertical, lateral and radial vibration measured.

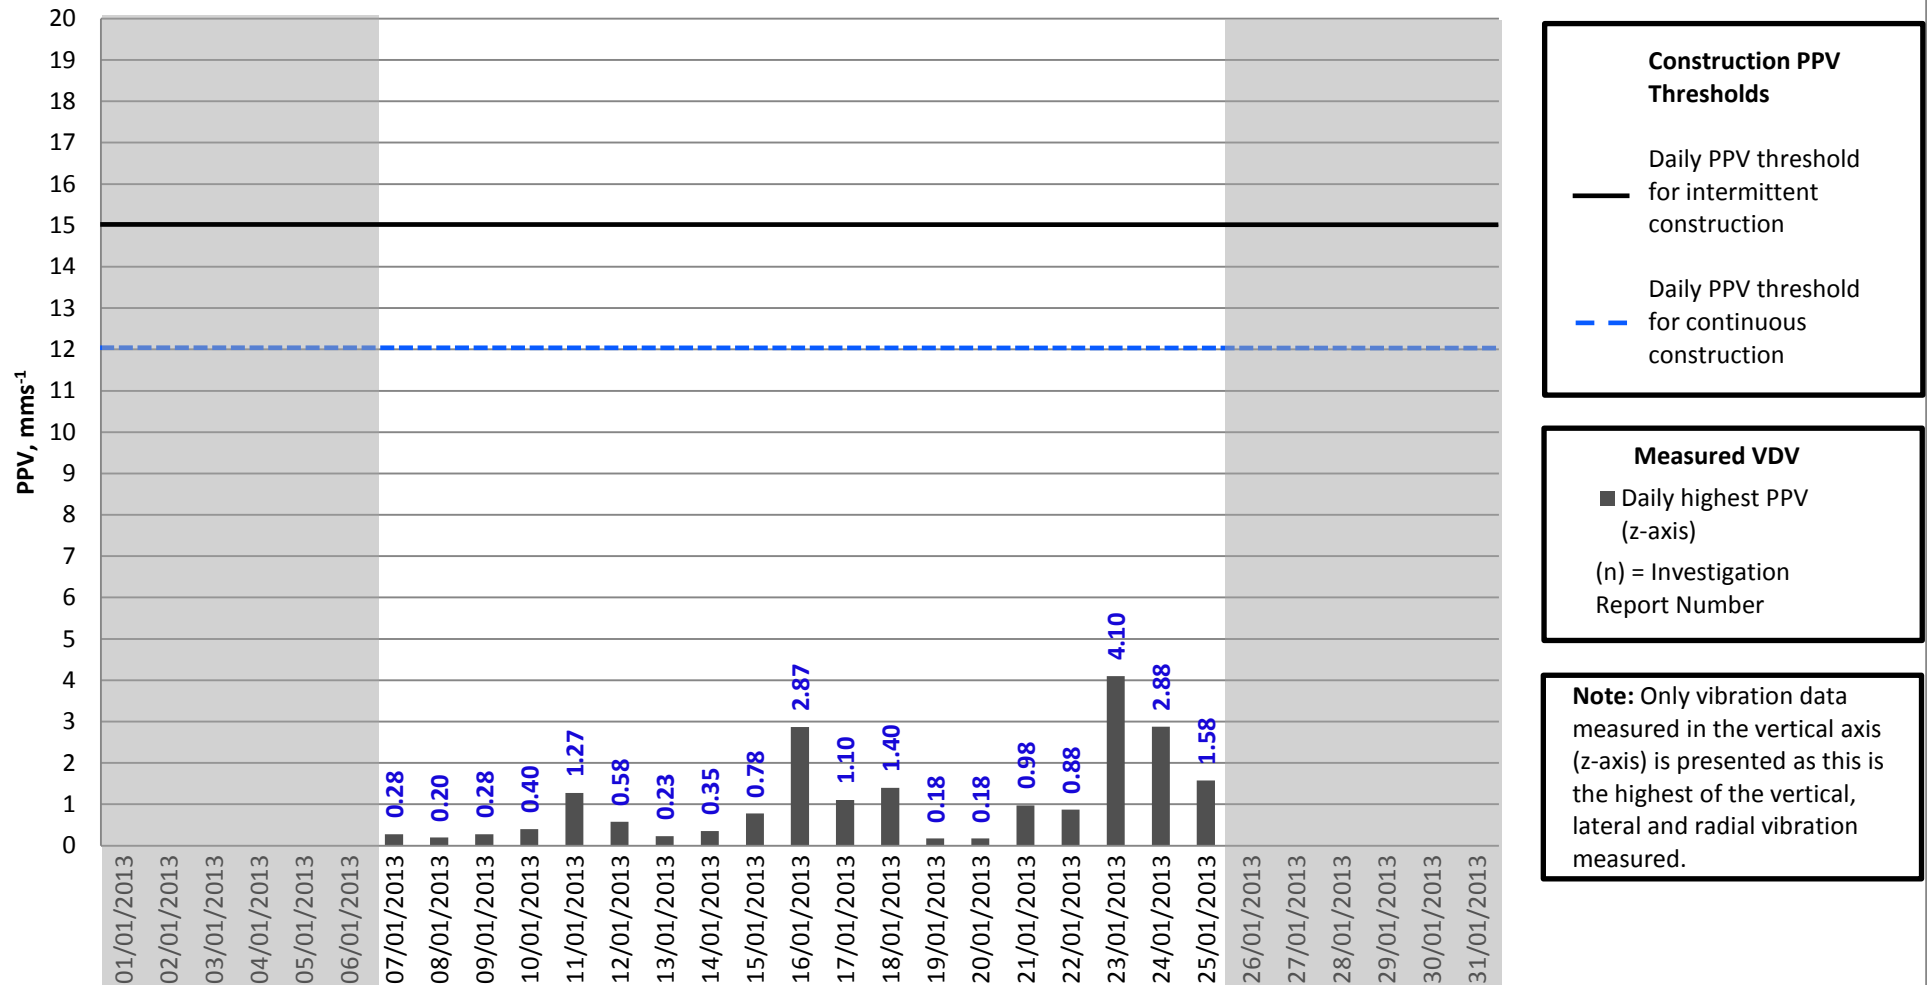
Measured highest daily Peak Particle Velocity (PPV), Bunker Steps (VIBROCK 1)

Measurement period: January 2013

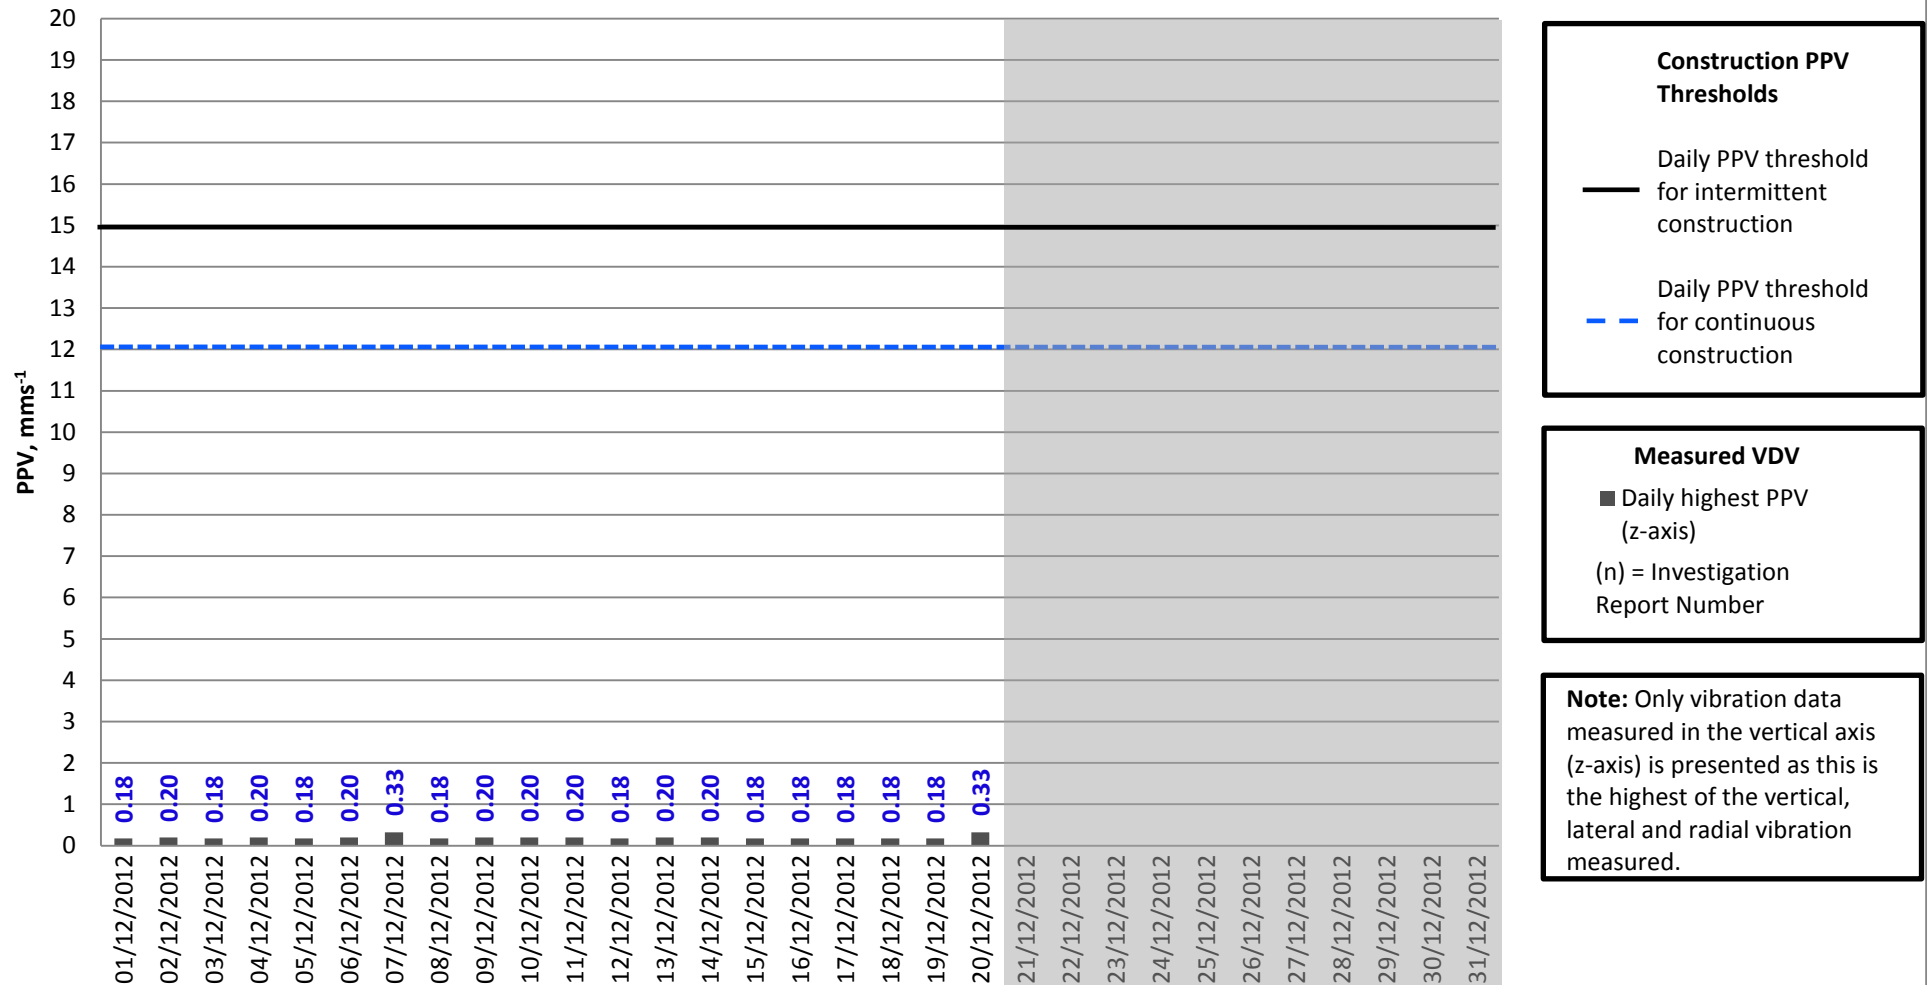
Measured highest daily Peak Particle Velocity (PPV), Bunker Ground (VIBROCK 2)

Measurement period: December 2012

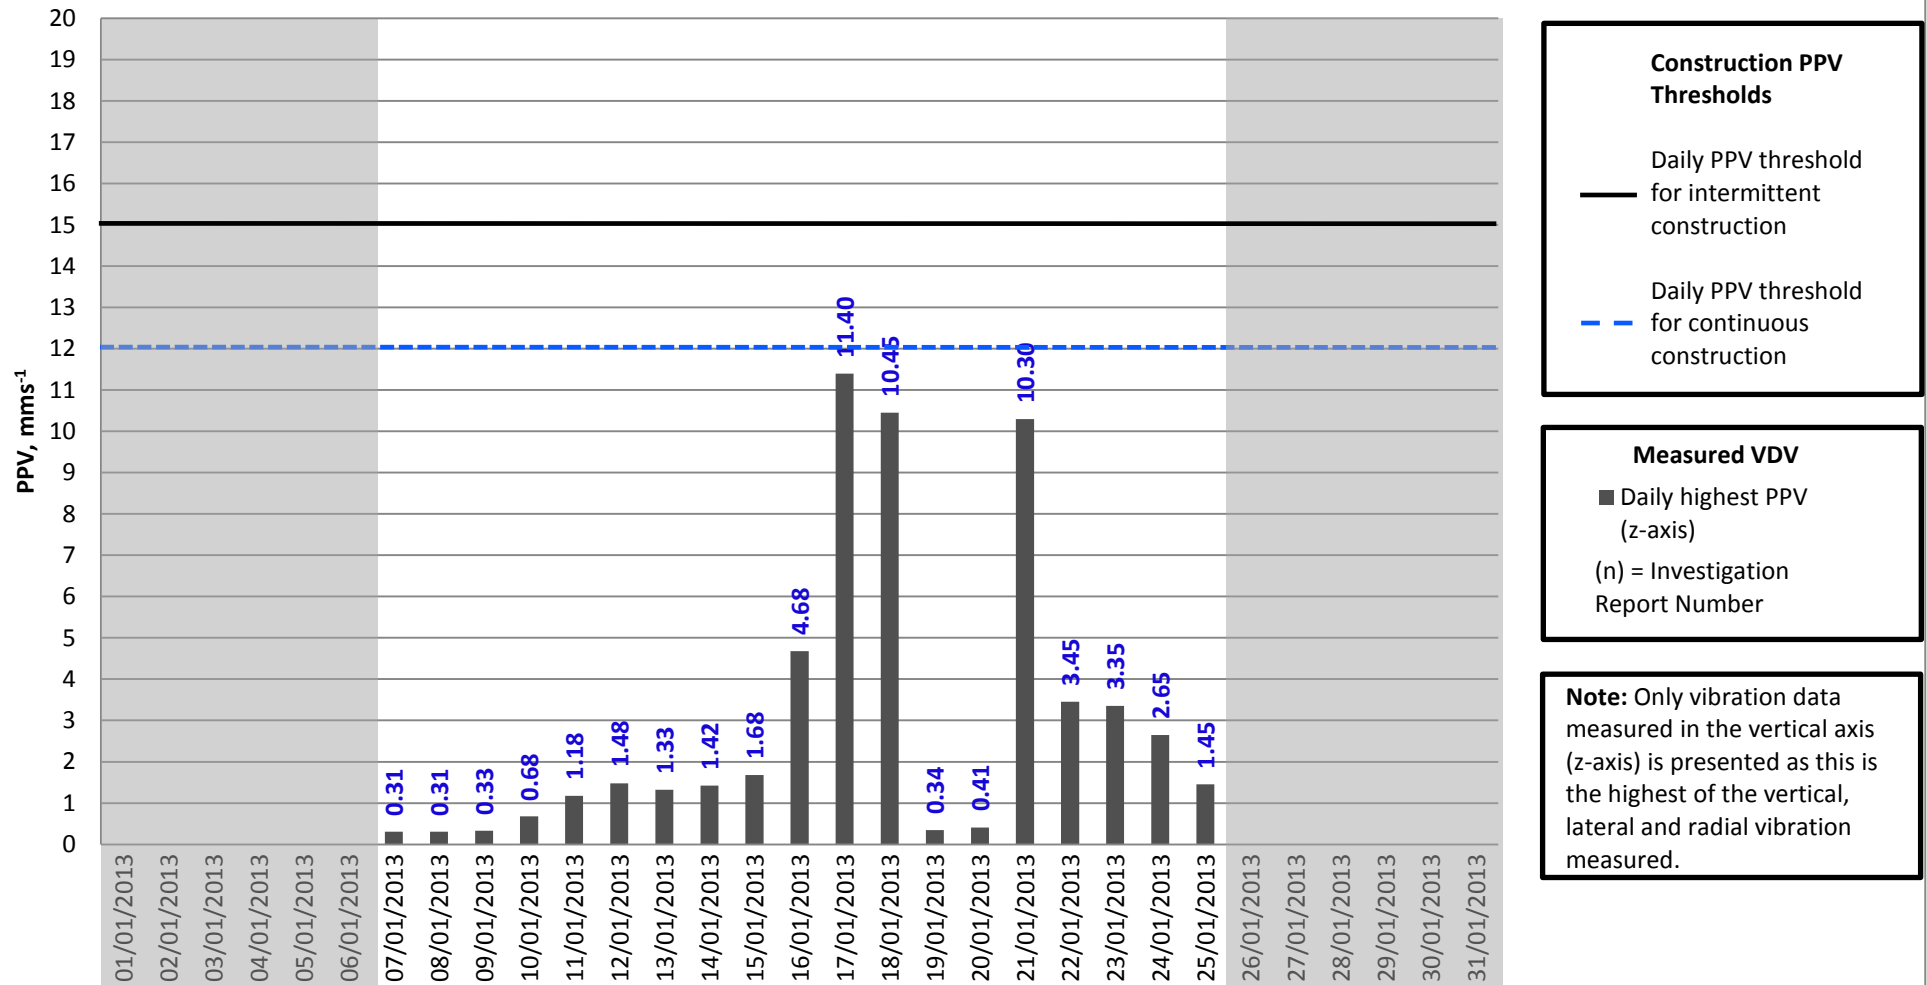
Measured highest daily Peak Particle Velocity (PPV), Bunker Ground (VIBROCK 2)

Measurement period: January 2013

Note: The grey areas of the chart represent the days on which no construction works were undertaken; no works were conducted at Pier S6 over the Christmas period - 20/01/13 to 06/01/13. Piling works were completed at Pier S6 on 25/01/13.

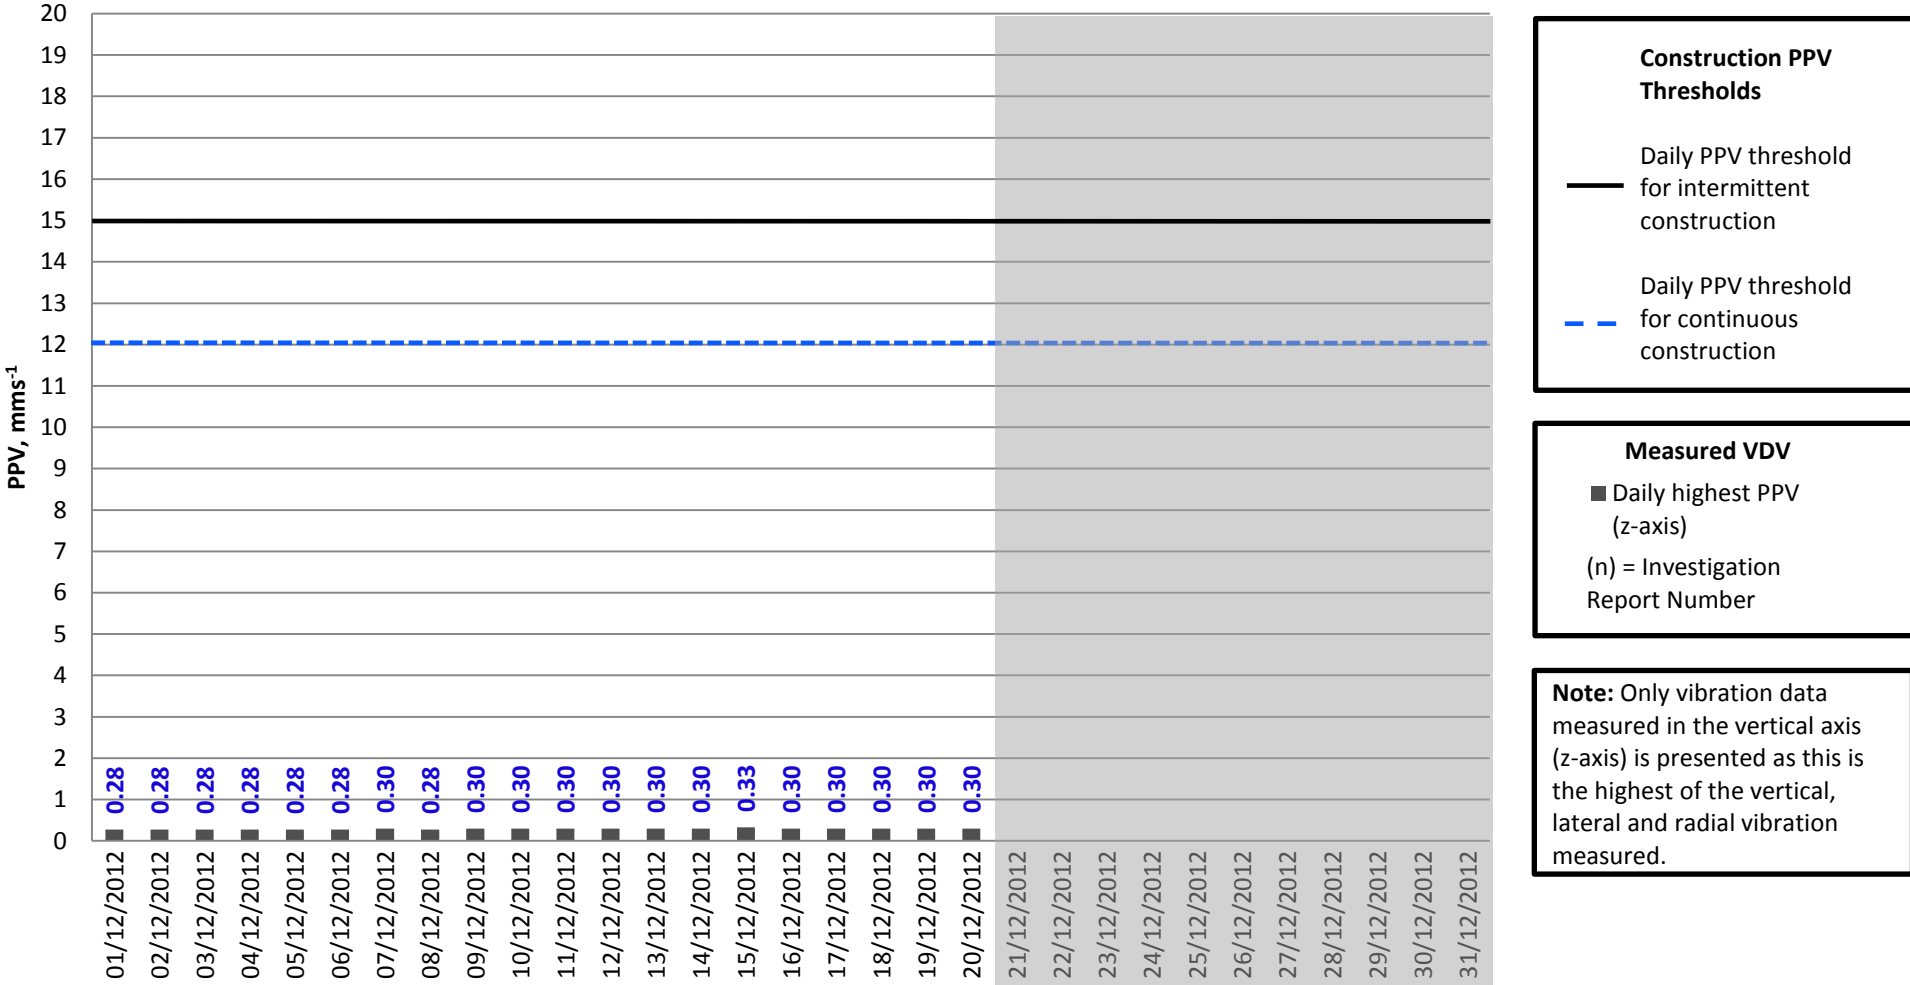
Measured highest daily Peak Particle Velocity (PPV), Bunker Roof (VIBROCK 3) Measurement period: December 2012

Note: The grey areas of the chart represent the days on which no construction works were undertaken; no works were conducted at Pier S6 over the Christmas period - 20/01/13 to 06/01/13
