Forth Replacement Crossing M9J1a Project
 Dust Monitoring
 Fortnightly Analysis

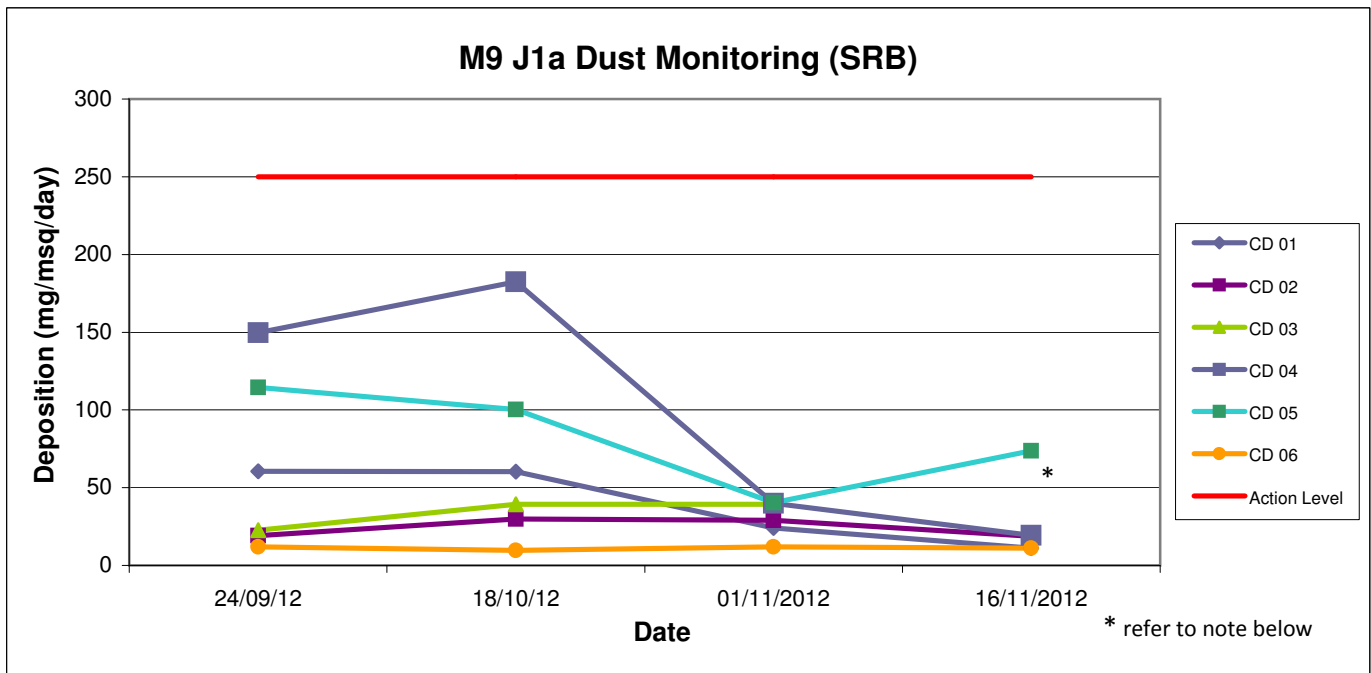
Location of Receptors

- CD01 - Kirklands Park Grove boundary with Kirkliston Leisure Centre
- CD02 - 2 Millrig Cottages, Kirkliston (at closest boundary to site)
- CD03 - 95 King Edwards Way (at closest boundary to site)
- CD04 - 15-17 Buie Rigg (at closest boundary to site)
- CD05 - Construction Compound exit onto B9080
- CD06 - Overton Cottages (at closest boundary to site)

Note: monitor CD03 was not accessible on 16 November 2012 due to temporary access restrictions as has therefore been removed from these results. However, due to the lack of construction work in the vicinity of monitor CD03 in recent weeks, in combination with the recent wet weather, it is considered highly likely that dust levels measured at CD03 would be within acceptable limits.

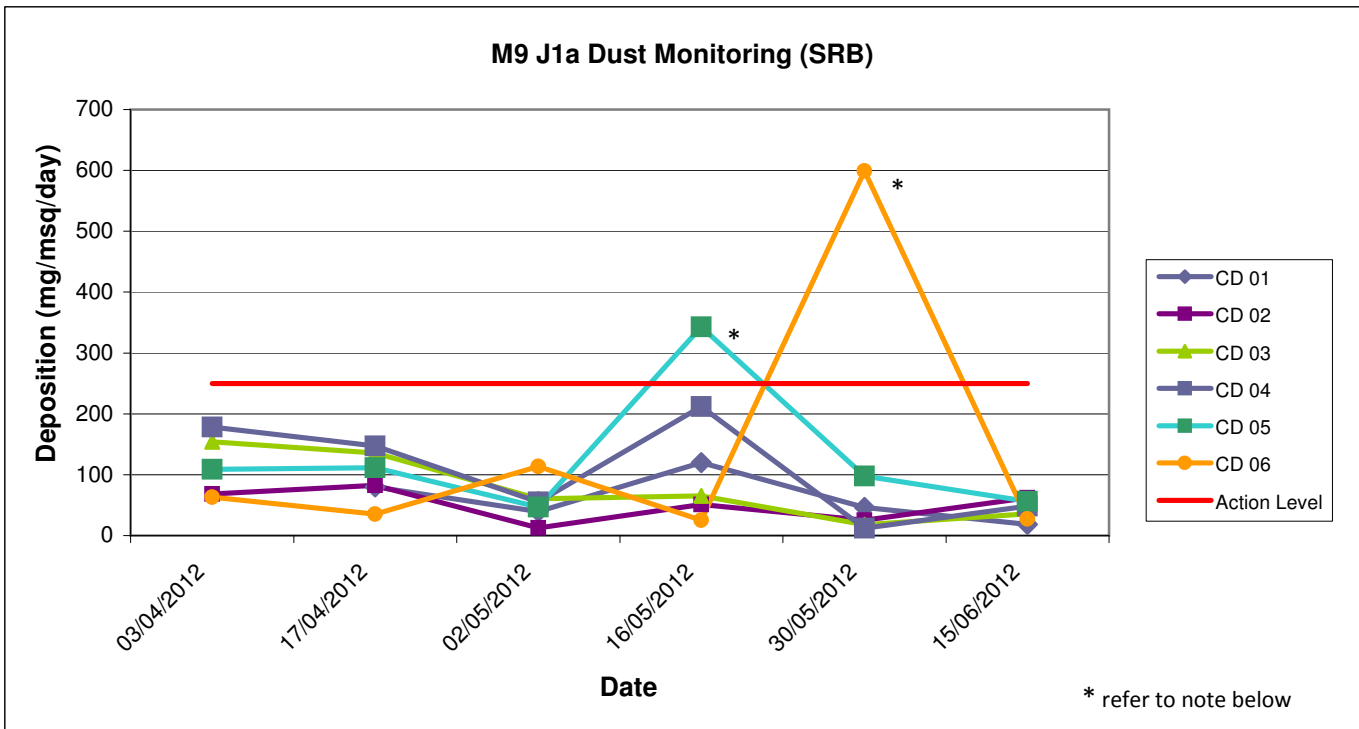
Location of Receptors

- CD01 - Kirklands Park Grove boundary with Kirkliston Leisure Centre
- CD02 - 2 Millrig Cottages, Kirkliston (at closest boundary to site)
- CD03 - 95 King Edwards Way (at closest boundary to site)
- CD04 - 15-17 Buie Rigg (at closest boundary to site)
- CD05 - Construction Compound exit onto B9080
- CD06 - Overton Cottages (at closest boundary to site)

Note: monitor CD01 had been tampered with when collected on the 3 April 2012 and has therefore been removed from these results.

Note: the exceedence at monitor CD05 at the construction compound on the 16 May 2012 has been investigated and is not believed to have been caused by elevated levels of airborne dust. The rainfall monitoring data indicates high rainfall (38mm) in the five days prior to collection which would act to suppress any airborne dust. The exceedence is likely to have been caused by debris falling from adjacent roof works at the construction compound during this period.

Note: the exceedence at monitor CD06 on the 30 May 2012 has been investigated and is not believed to have been caused by elevated levels of airborne dust. The site logs indicate that no works were occurring at this location in the two weeks prior to the collection of this sample. In addition rainfall monitoring data indicates rainfall of 14-15mm over the two week period. Therefore this sample is believed to be an anomaly.

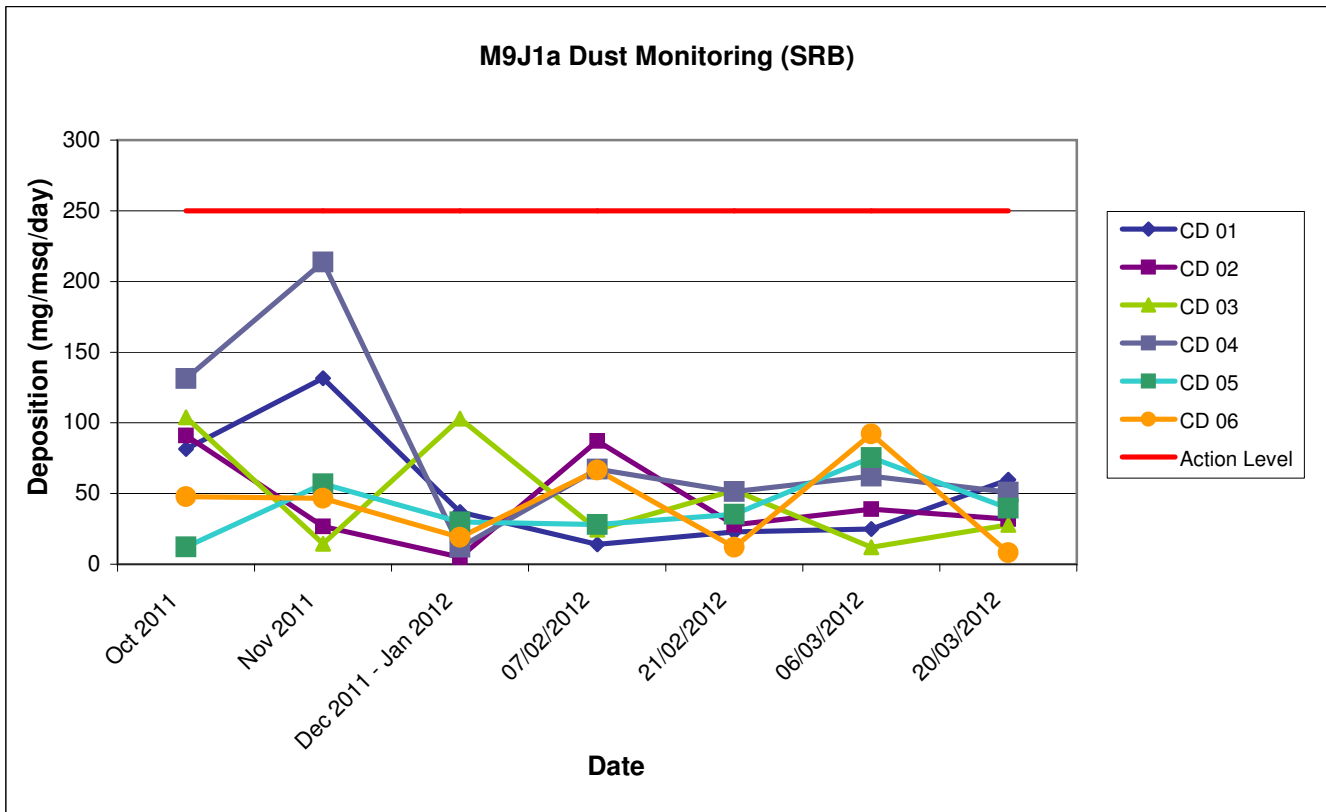
Location of Receptors

- CD01 - Kirklands Park Grove boundary with Kirkliston Leisure Centre
- CD02 - 2 Millrig Cottages, Kirkliston (at closest boundary to site)
- CD03 - 95 King Edwards Way (at closest boundary to site)
- CD04 - 15-17 Buie Rigg (at closest boundary to site)
- CD05 - Construction Compound exit onto B9080
- CD06 - Overton Cottages (at closest boundary to site)
