Forth Crossing Bridge Constructors

FORTH REPLACEMENT CROSSING

AIR QUALITY MONITORING REPORT
MARCH 2012

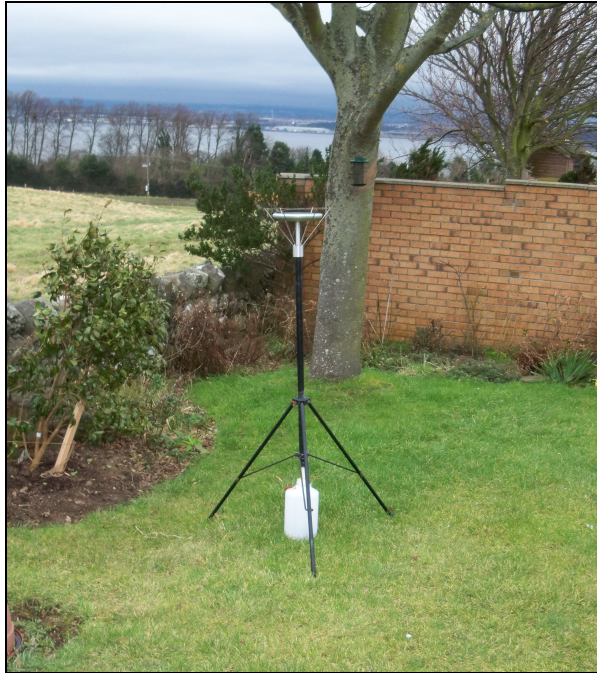
Figure 1: Example of an Installed Frisbee Gauge Meters

- 2.1.** Air quality is being monitored on site using both automatic light scatter dust meters and Frisbee gauge dust deposition monitoring. Thirteen Frisbee gauges are set up at sensitive locations across the site to measure dust deposition rates (Figure 1). Seven automatic light scatter meters have also been installed at various sensitive locations to measure real time particulate matter (PM₁₀) concentrations (Figure 2). Table 1 lists the air quality monitoring equipment present at each monitoring location.

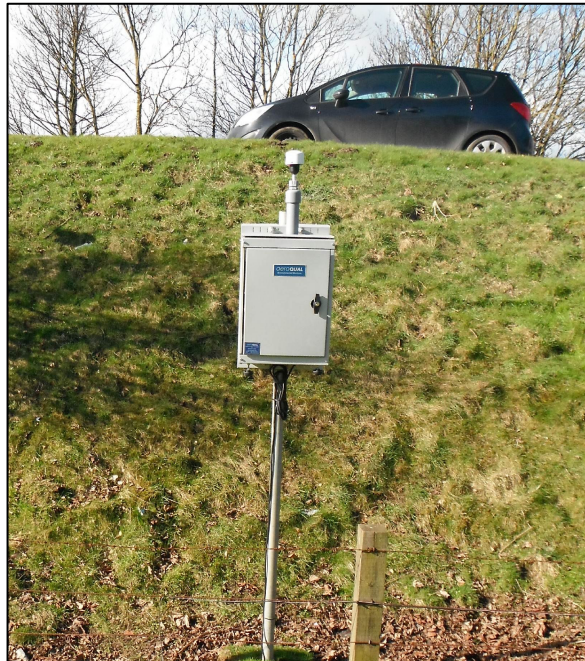
Figure 2: Example of an installed Automatic Light Scatter Dust Meter

- 2.2.** Light scatter type monitoring equipment have been selected as a site monitoring tool to create a live network which assesses the levels of fugitive particulate matter, principally airborne dust. The monitors require less space, maintenance and power than other real time monitors such as TEOM which is used and designed to measure particulate levels to exceedingly high standards including measuring long term compliance to statutory limits. Light scatter meters are more practicable to deploy and are the construction and waste industry standard for measuring airborne particulate matter and defining action thresholds to ensure controls are suitably applied. The meters do generally record levels higher than those measured by the TEOM. The meters can also be affected by atmospheric moisture content which further increases reported levels. Accordingly any elevations of statutory limits should be treated as precautionary exceedances. The monitors are reliable for on-site monitoring and the establishment of action thresholds to ensure unforeseen activities generating significant dust are identified and suitably controlled. Light scatter meters are becoming the construction and waste industries norm for particulate dust monitoring.
