Project **FORTH REPLACEMENT CROSSING**

AIR QUALITY MONITORING REPORT
MARCH 2013

Document number
REP-000-00103-00

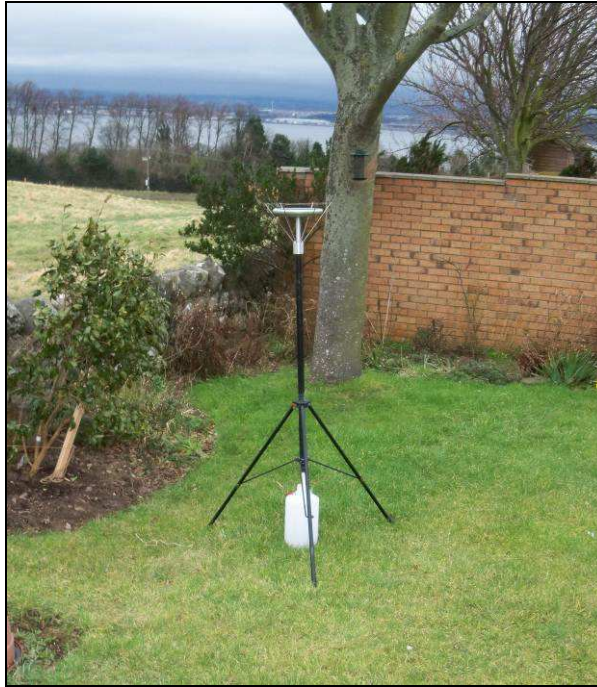
Figure 1: Example of an Installed Frisbee Gauge Meters

2.1. Air quality is being monitored on site using both automatic light scatter dust meters and Frisbee gauge dust deposition monitoring. Thirteen Frisbee gauges are set up at sensitive locations across the site to measure dust deposition rates (Figure 1). Seven automatic light scatter meters have also been installed at various sensitive locations to measure real time particulate matter (PM₁₀) concentrations and the Total Suspended Particle (TSP) concentrations (Figure 2). Table 1 lists the air quality monitoring equipment present at each monitoring location. The installation of the air quality monitoring equipment was not simultaneous across the site, thus installation dates are also given in Table 1.

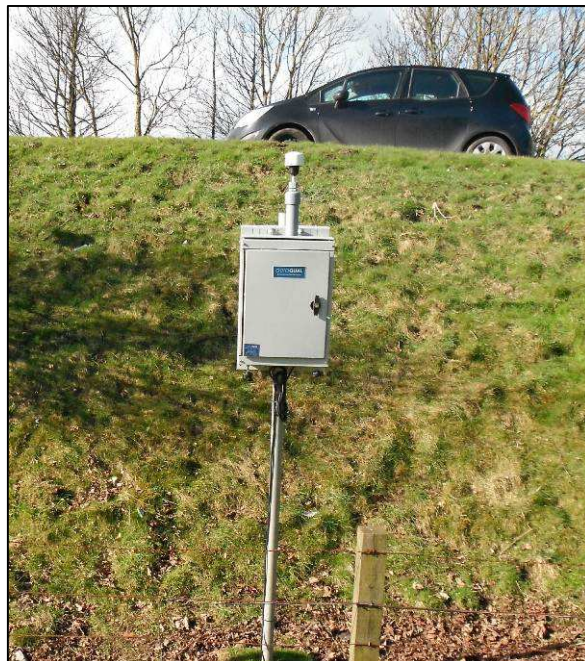
Figure 2: Example of an installed Automatic Light Scatter Dust Meter

2.2. Light scatter type monitoring equipment have been selected as a site monitoring tool to create a live network which assesses the levels of fugitive particulate matter, principally airborne dust. These monitors require less space, maintenance and power than other real time monitors such as a Tapered Element Oscillating Microbalance (TEOM) which is used and designed to measure particulate levels to exceedingly high standards, including measuring long-term compliance to statutory limits. Light scatter meters are more practicable to deploy. However, the meters do generally record levels higher than those measured by the TEOM. The meters can also be affected by atmospheric moisture content which further increases reported levels. Accordingly, any elevations of statutory limits should be treated as precautionary exceedances. The monitors are reliable for on-site monitoring and the establishment of action thresholds to ensure unforeseen activities generating significant dust are identified and suitably controlled. Light scatter meters are becoming the construction and waste industries norm for particulate dust monitoring.

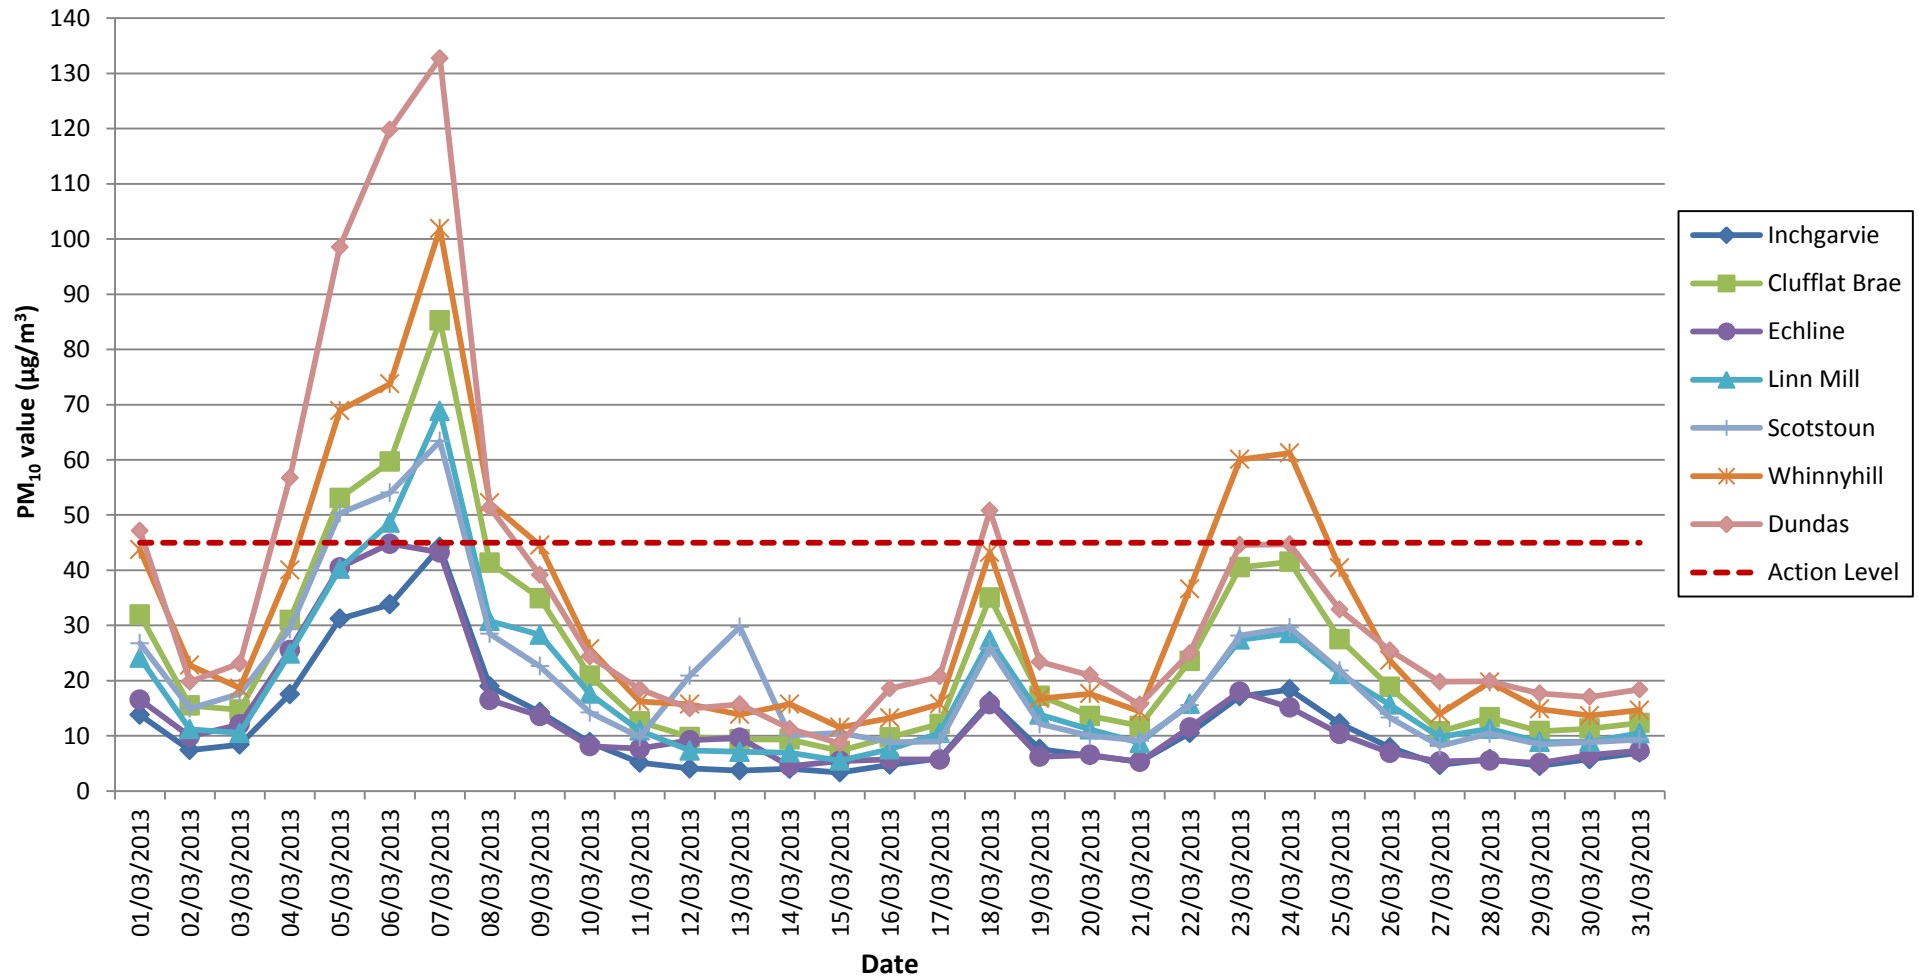
Particulate Matter (PM10) Results for all Monitoring Locations

Note: The exceedances of the threshold are not related to construction works. Please refer to section 3 of the Air Quality Monitoring Report: March 2013

3.1.1. Light scatter results for March 2013 have been presented in a monthly chart; this can be found in Appendix A. Results show that the PM₁₀

levels were largely below threshold levels and followed the same pattern across the site. During March there were nine days on which exceedances of the threshold occurred. Table 2 lists the locations at which the exceedances occurred on these dates.

3.1.2. The exceedances are not considered to have been caused by construction works. The results show the same trend across site, indicating that the results are likely caused by regional conditions, as opposed to localised dust events caused by construction works. Frisbee results confirm that dust levels across site were low throughout the period (see 3.3 Frisbee Dust Deposition Results).

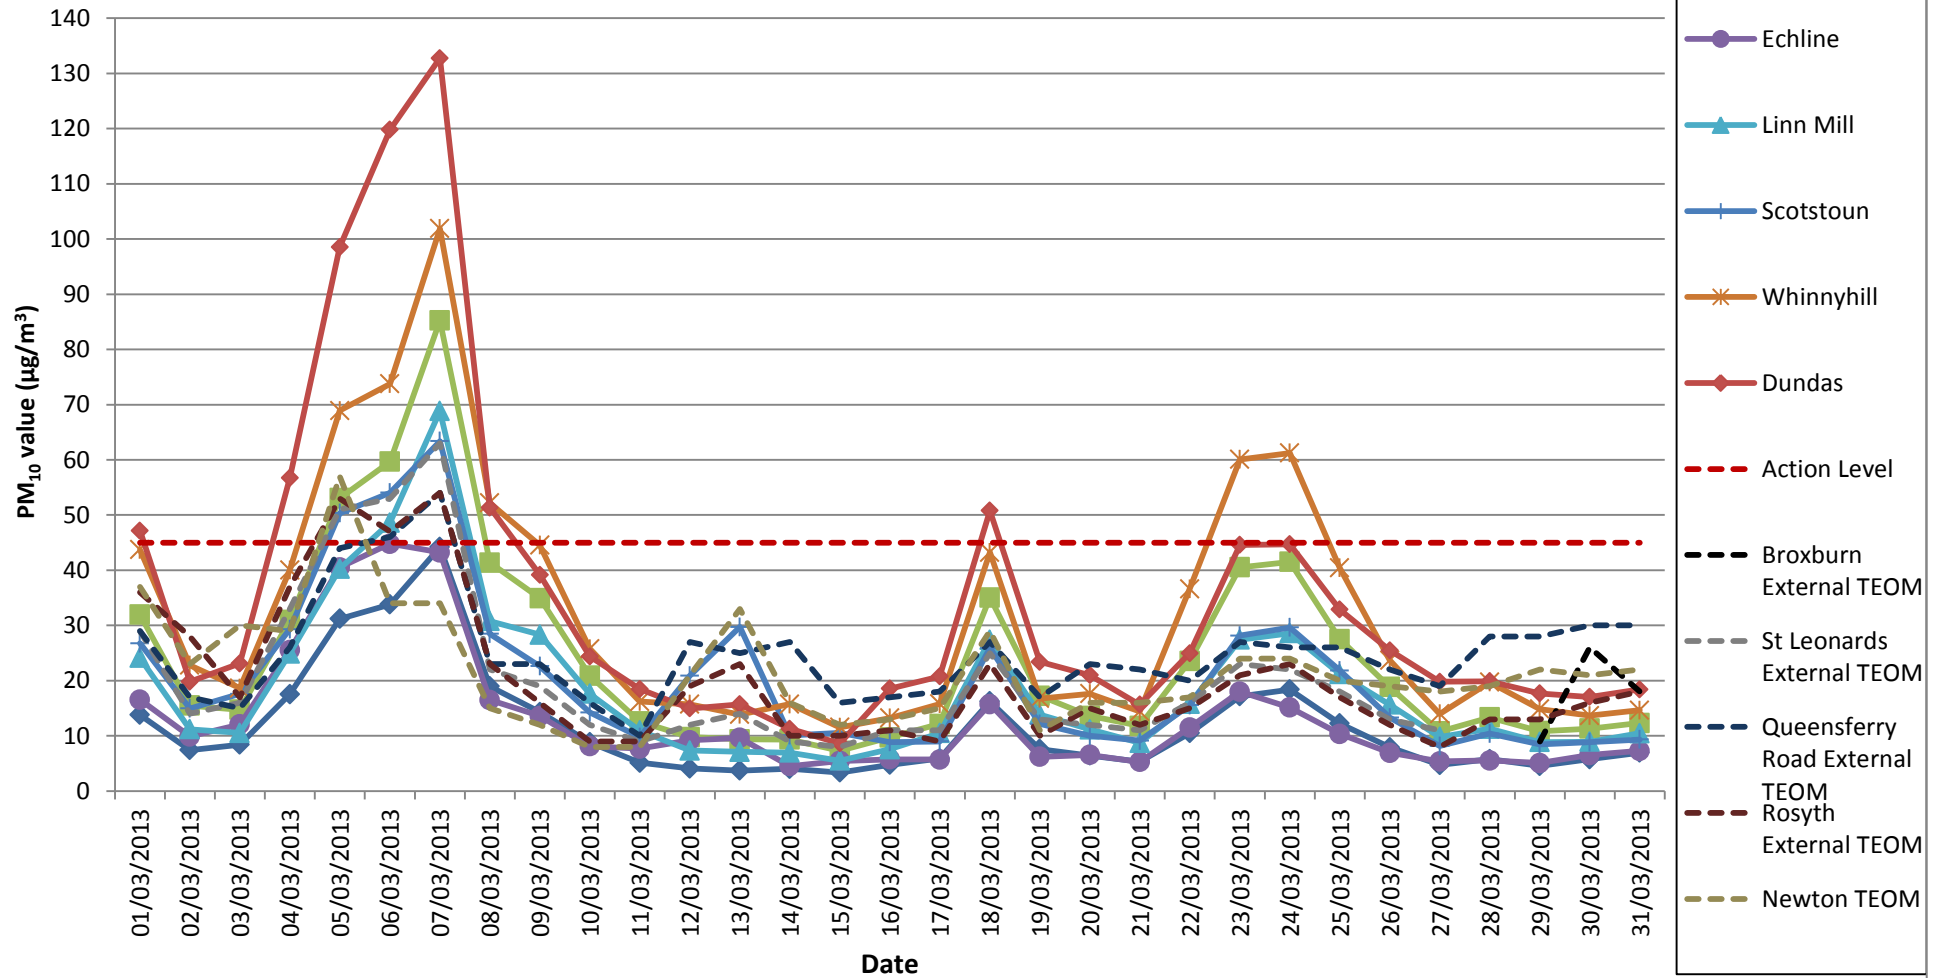
Air Quality Monitoring Particulate Matter (PM10) Results for all Monitoring Locations March 2013

Note: The exceedances of the threshold are not related to construction works. Please refer to section 3 of the Air Quality Monitoring Report: March 2013

3.1.4. The PM₁₀ results have also been compared to the daily mean results obtained from the TEOM air quality monitoring stations located in Newton, Rosyth, Broxburn, Queensferry Road, Edinburgh and St Leonards, Edinburgh (an urban background site). The TEOM at Newton was installed by West Lothian Council, facilitated by FCBC, during May 2012. The comparison between the light scatter and TEOM results demonstrates that both sets of results generally follow the same pattern at similar levels, indicating that the pattern observed throughout March was largely due to regional changes in air quality.

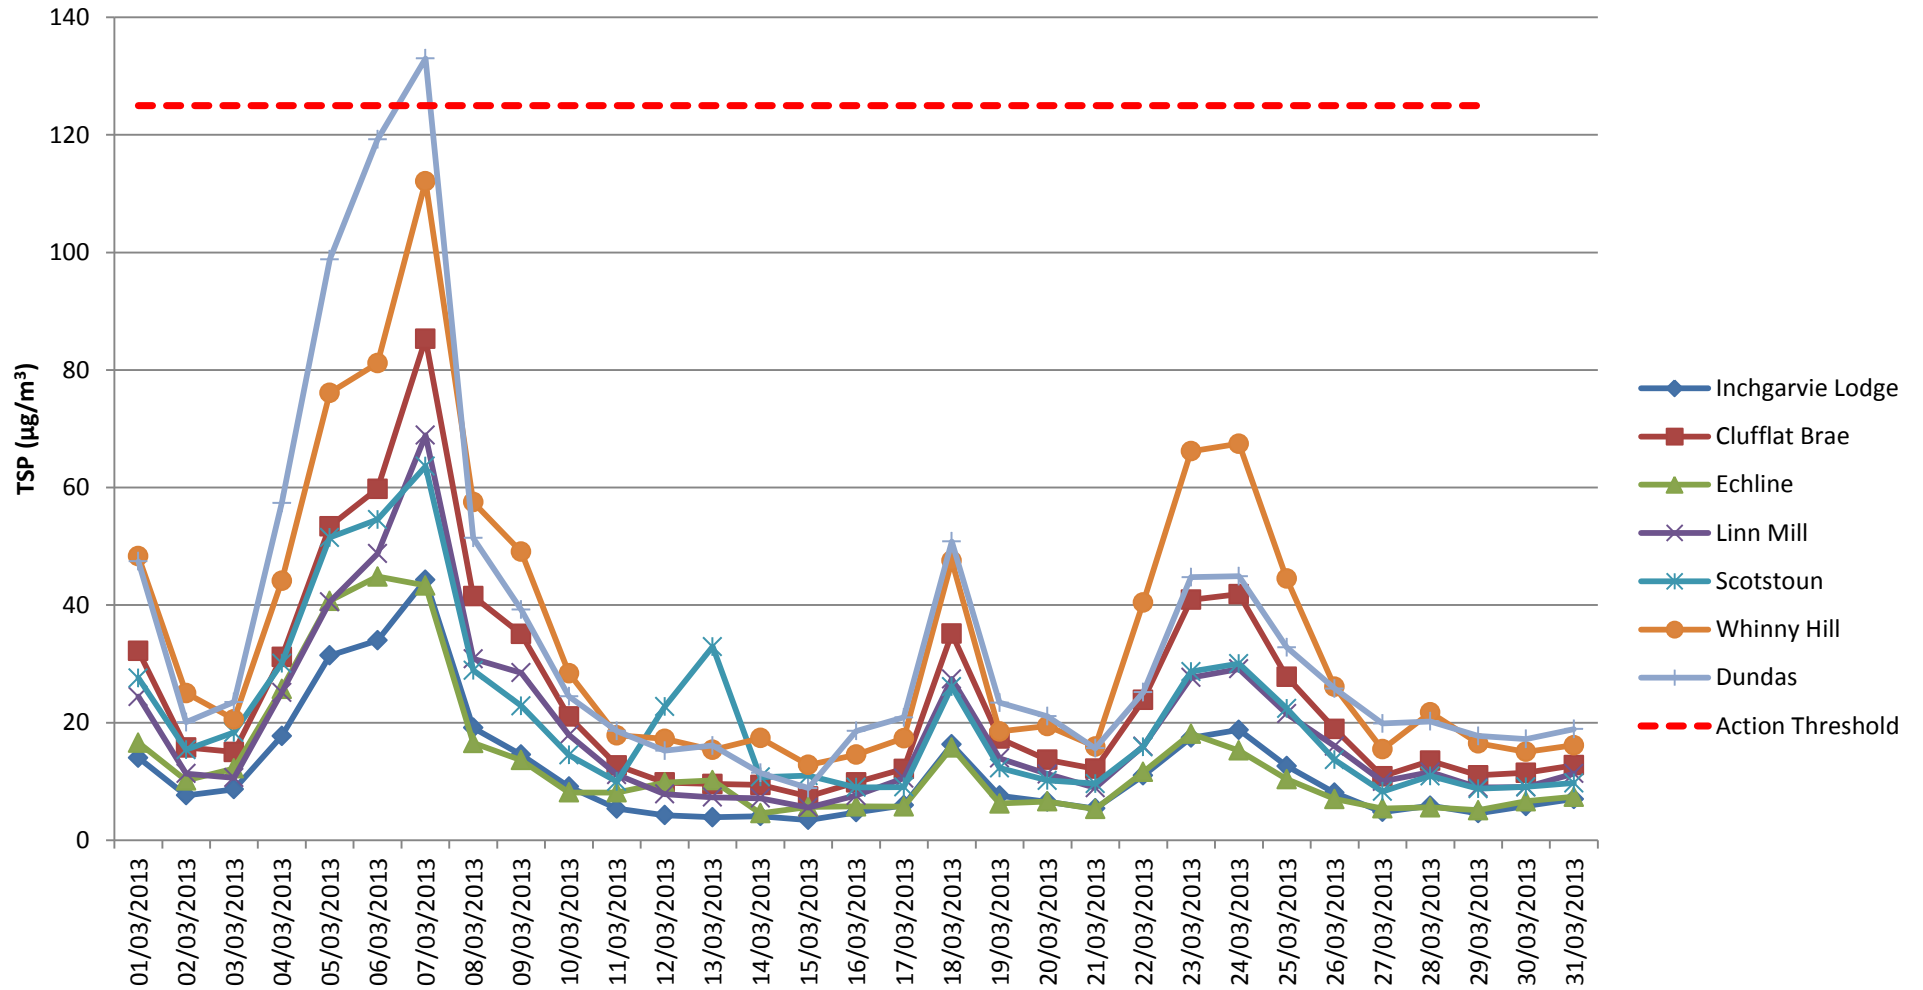
Total Suspended Particles (TSP) Results March 2013

3.2.1. The TSP results for March 2013 have been presented in a monthly chart; this can be found in Appendix B. The TSP levels at monitoring locations during March were generally low and within the threshold level. A single exceedance occurred on 7 March at Dundas. However, this exceedance is not considered to be related to construction works and is thought to be related to regional changes in air quality as discussed in relation to particulate matter concentrations in paragraphs 3.1.2 and 3.1.3. All locations were found to follow a similar pattern across the site, demonstrating that in general the levels are influenced by regional changes in TSP levels, rather than construction works.

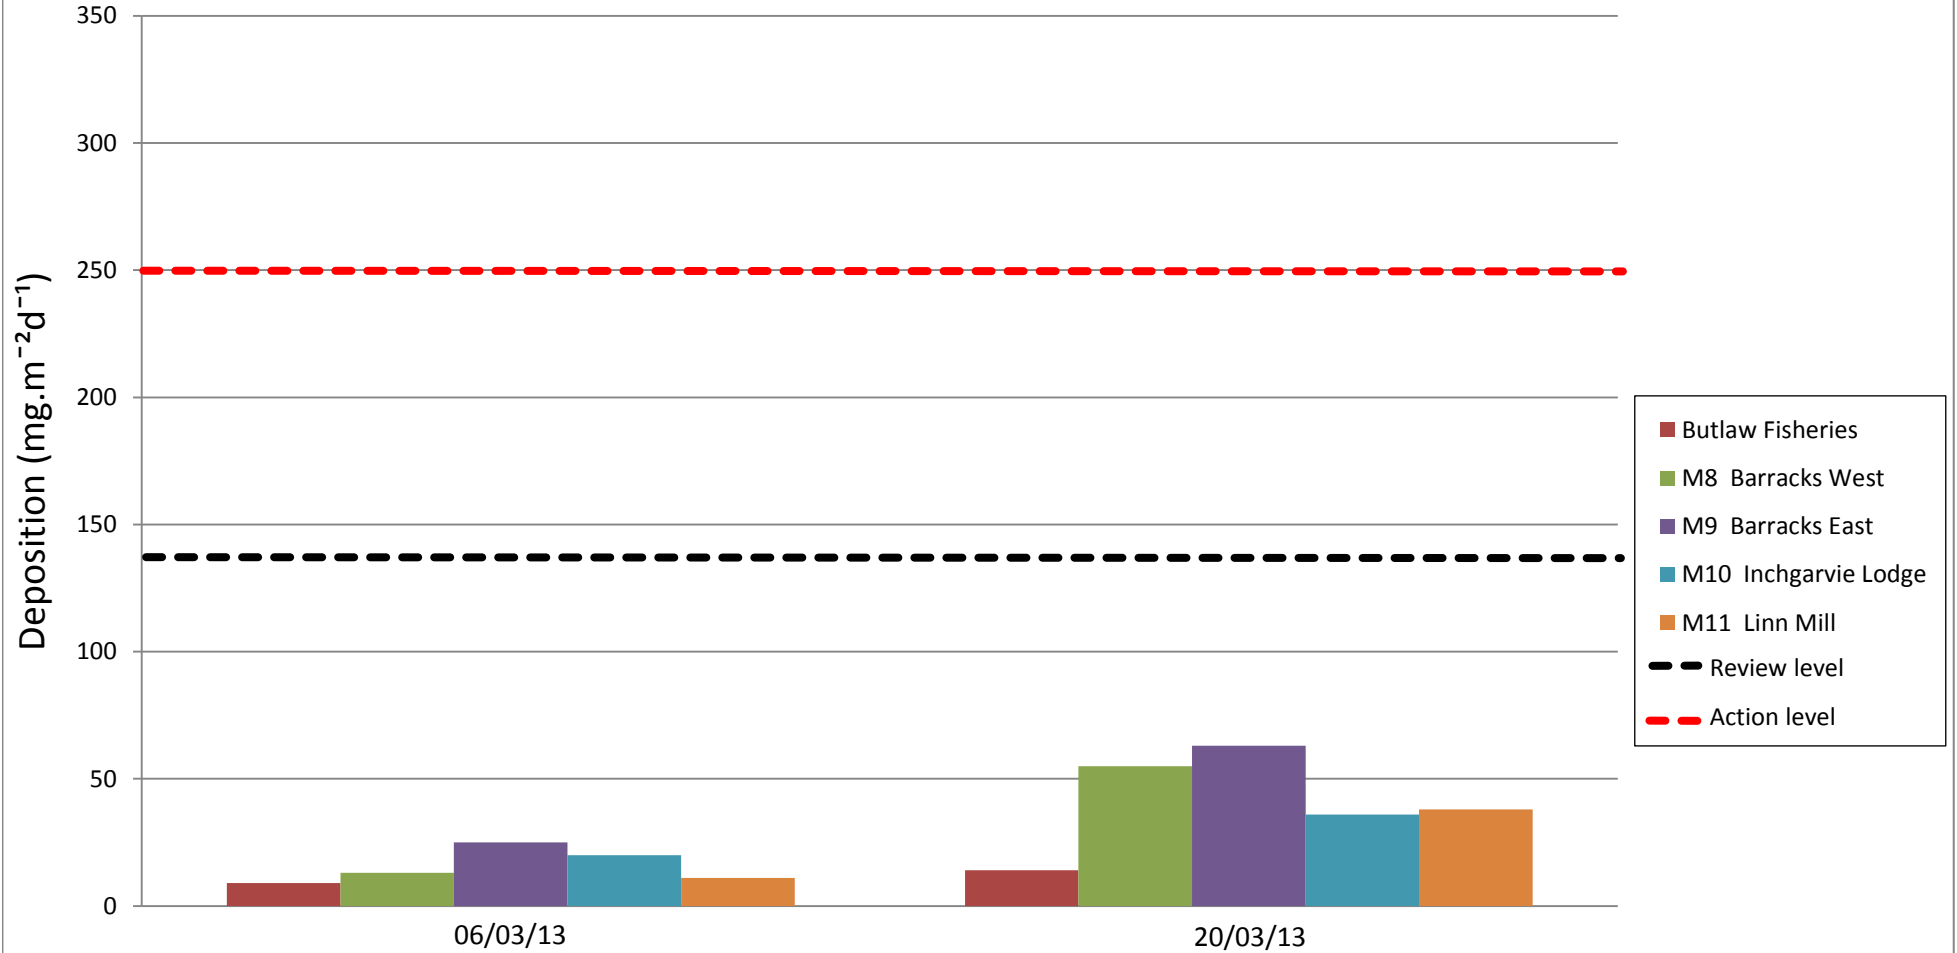
Frisbee Dust Deposition Results: Group 1
Locations: M7 Butlaw Fisheries, M8 Barracks West, M9 Barracks East, M10 Inchgarvie Lodge and M11 Linn Mill

3.3.2. Frisbee dust data deposition results were collected fortnightly, and the results averaged over this fortnight period to give a daily dust deposition rate. Two collection dates fell during March; one on the 6 March, with another a fortnight later on the 20 March 2013. Due to unforeseen circumstances related to the delivery of the samples to the testing laboratory, the collection due on 20 March was delayed until 22 March. This resulted in the results being averaged over 16 days between 6 March and 22 March rather than the usual fortnightly period.

3.3.4. During March there were no exceedances of the threshold levels. Frisbee results from all monitoring locations across site were found to be low.

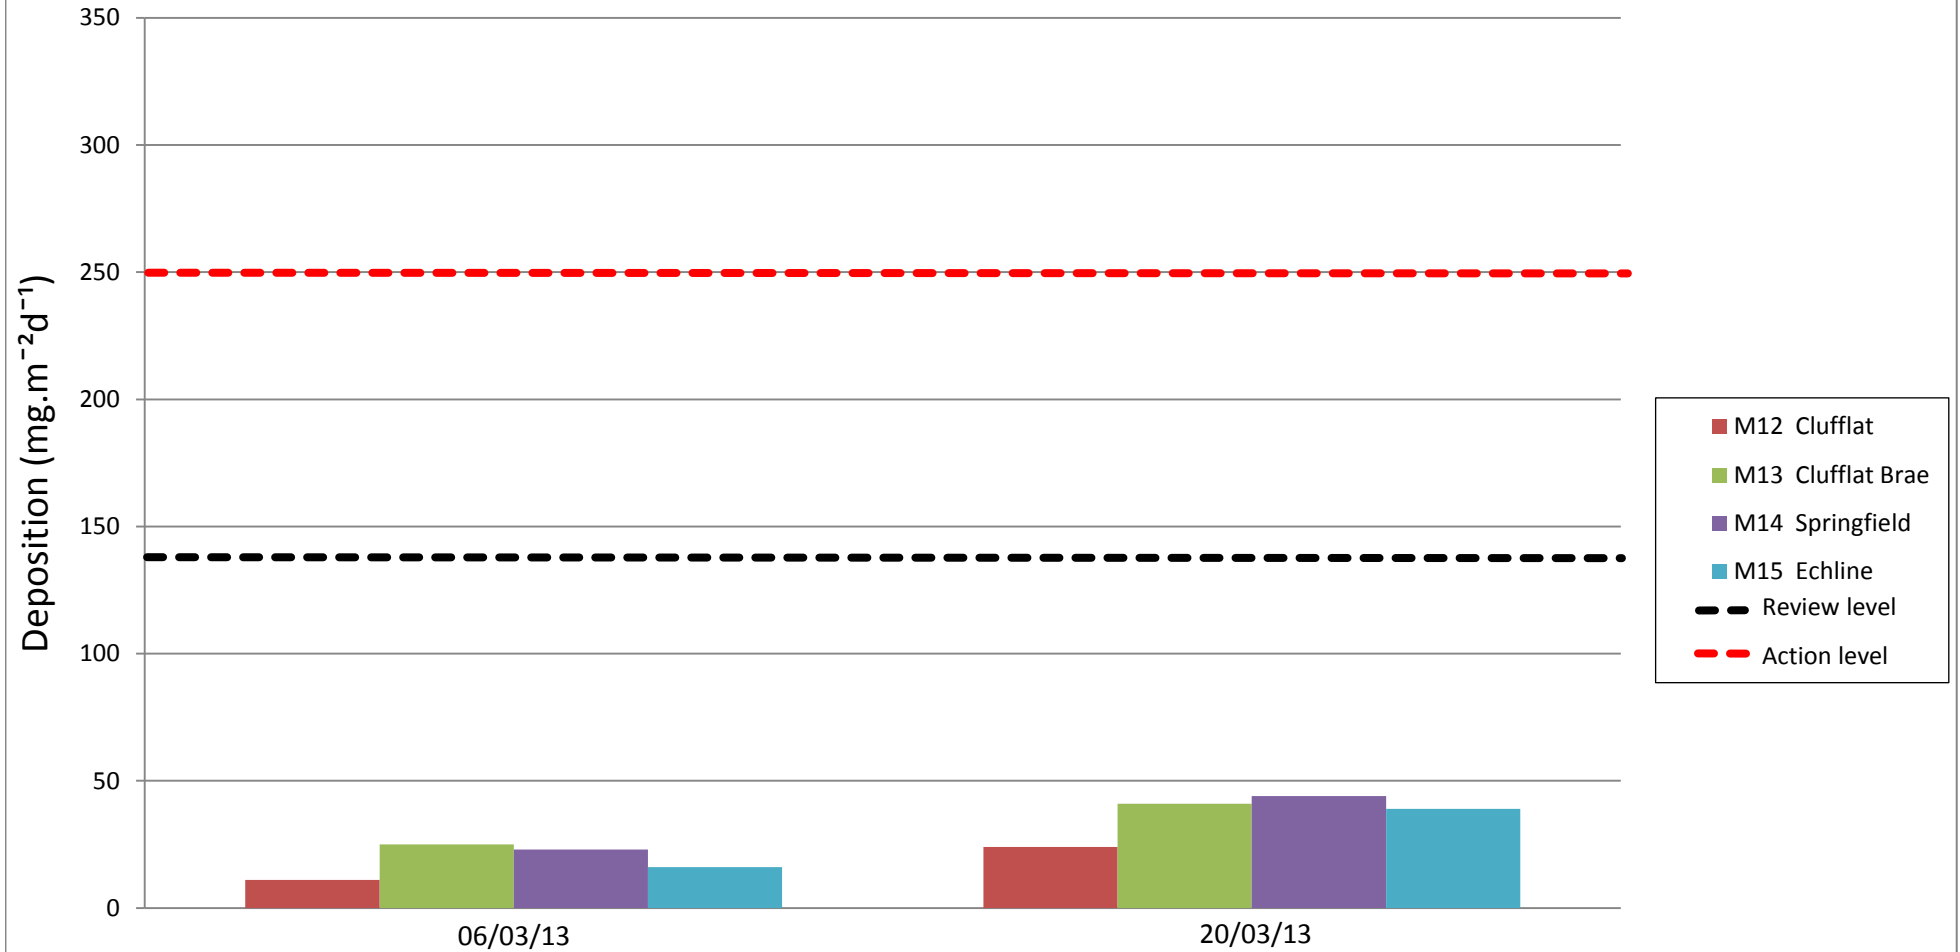
Frisbee Dust Deposition Results: Group 2

Locations: M12 Clufflat, M13 Clufflat Brae, M14 Springfield and M15 Echline

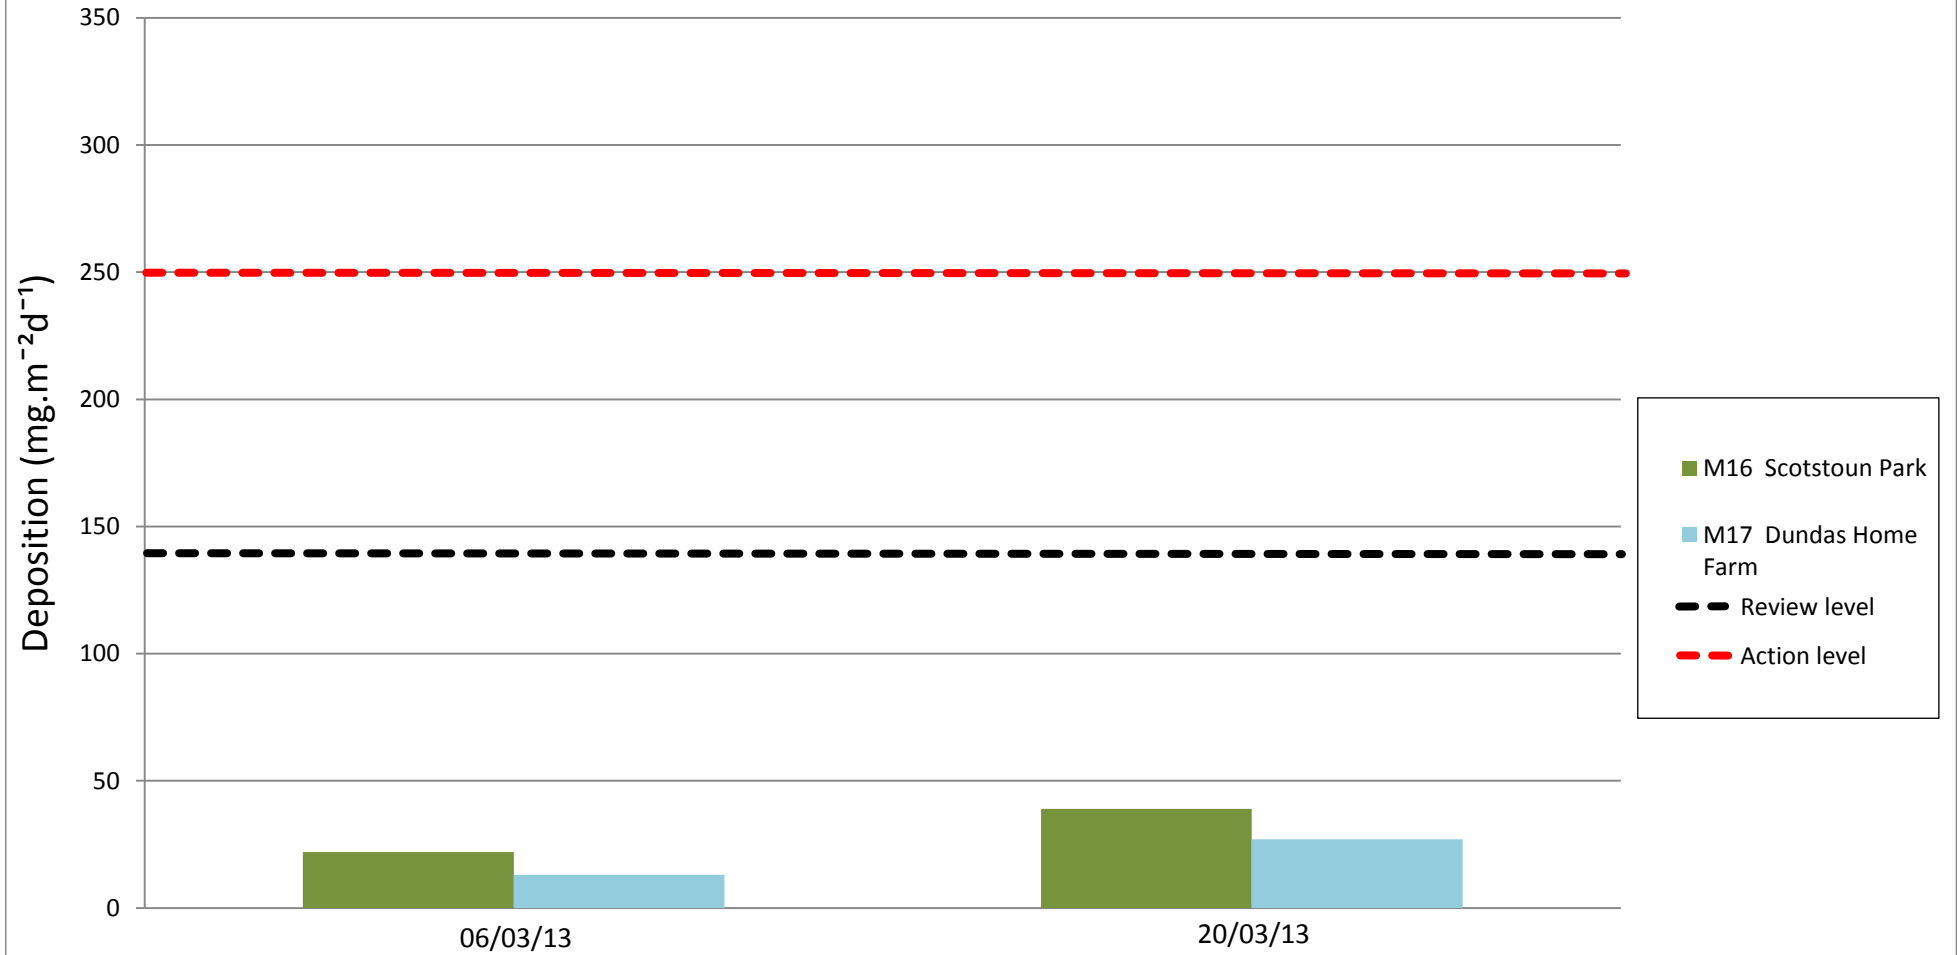
Frisbee Dust Deposition Results: Group 3

Locations: M16 Scotstoun Park and M17 Dundas Home Farm

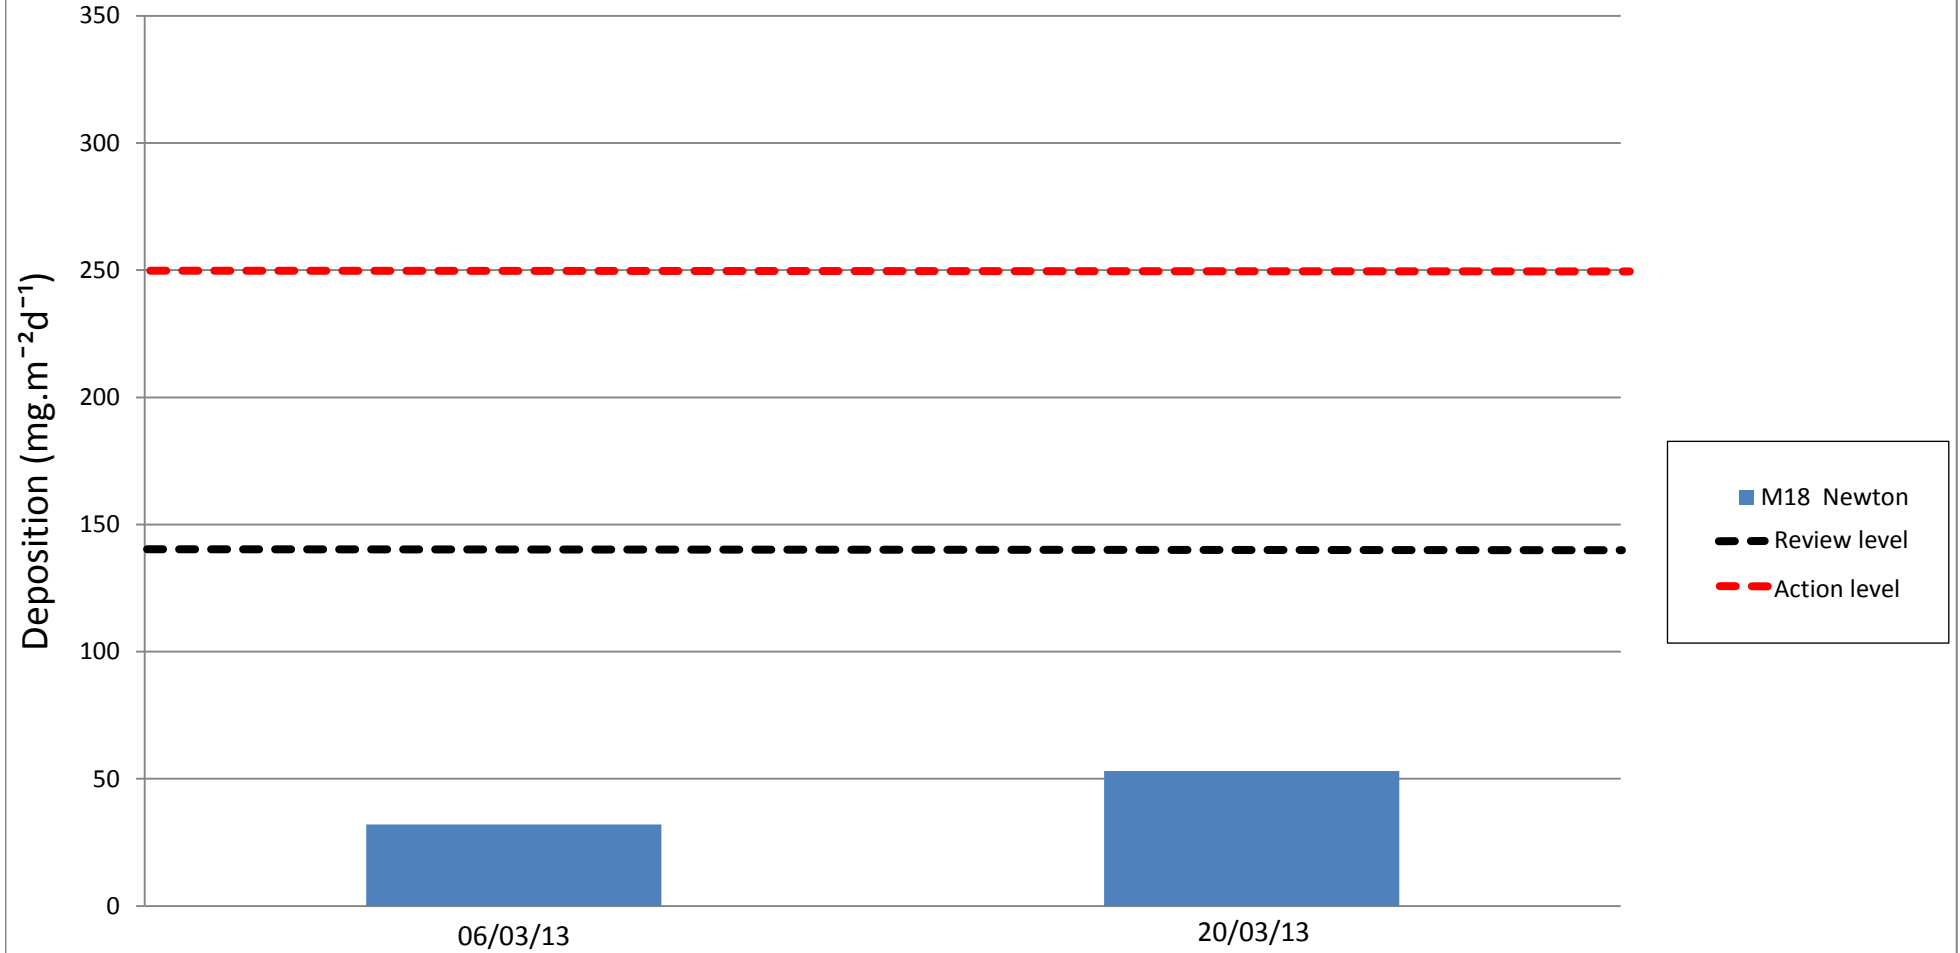
Frisbee Dust Deposition Results: Group 4

Locations: M18 Newton

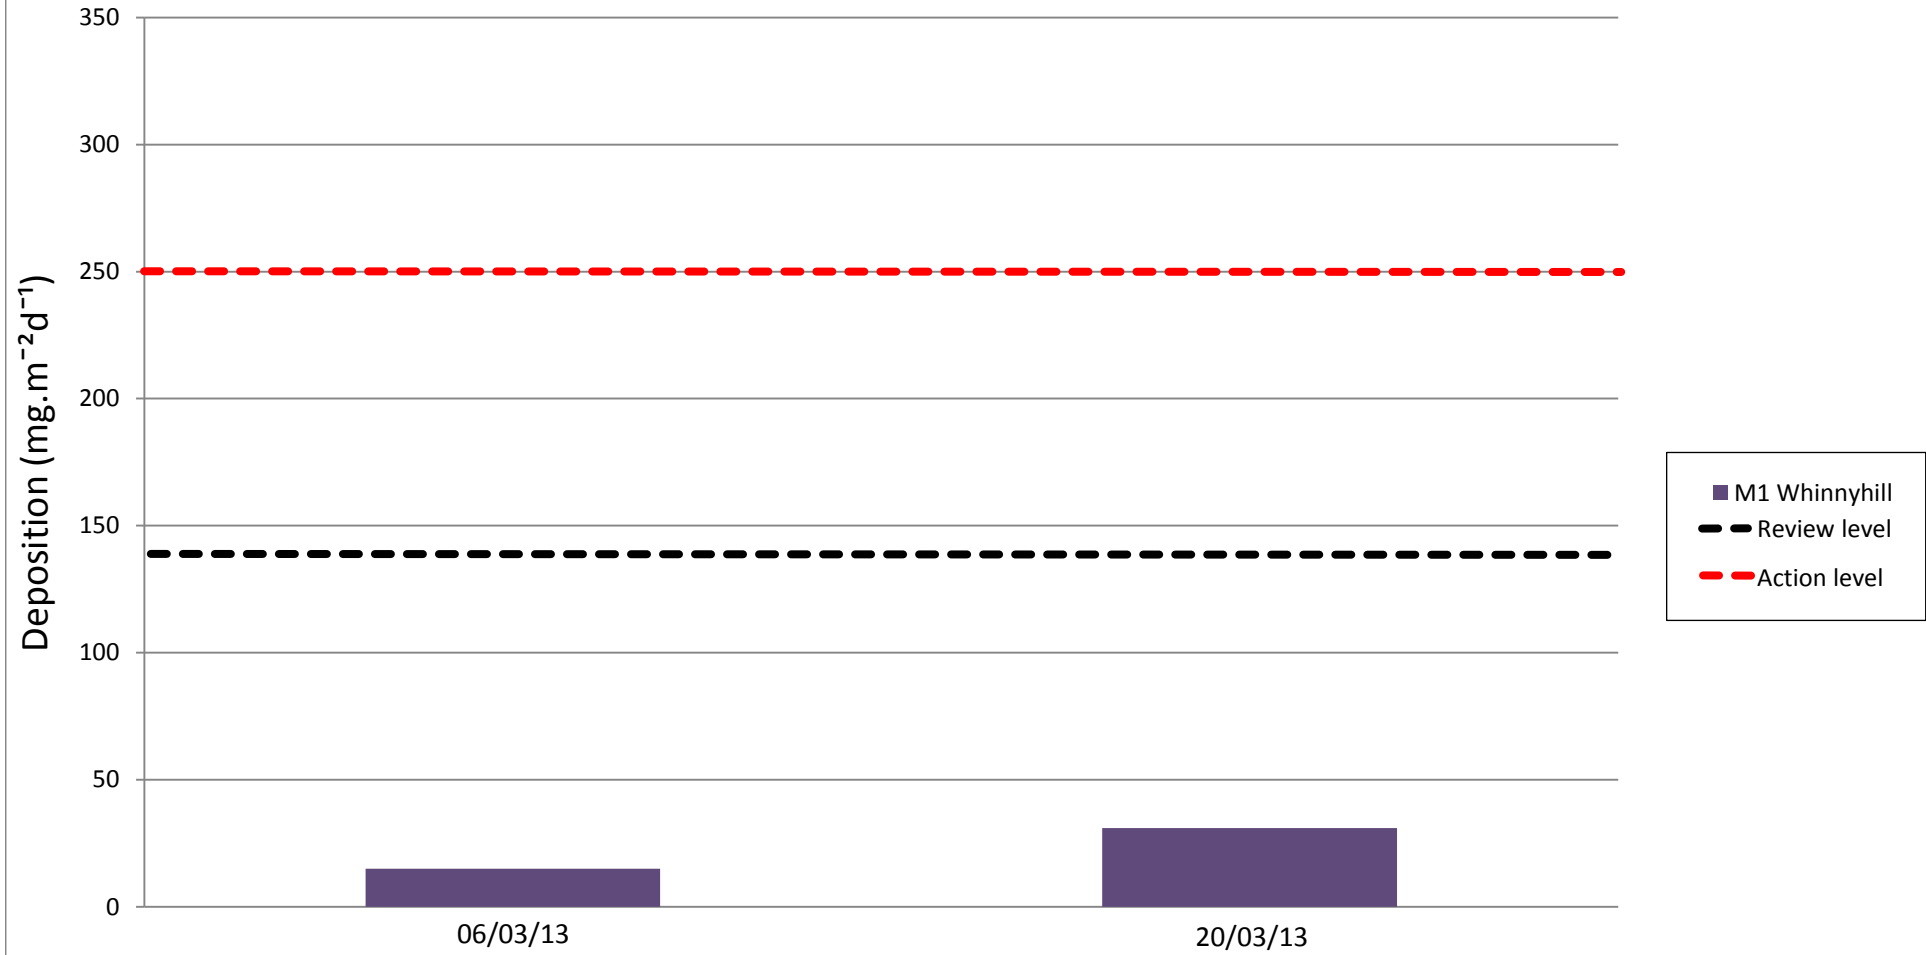
Frisbee Dust Deposition Results: Group 5

Locations: M1 Whinny Hill
