FORTH REPLACEMENT CROSSING

**AIR QUALITY MONITORING REPORT
 FEBRUARY 2014**

REP-00169-00

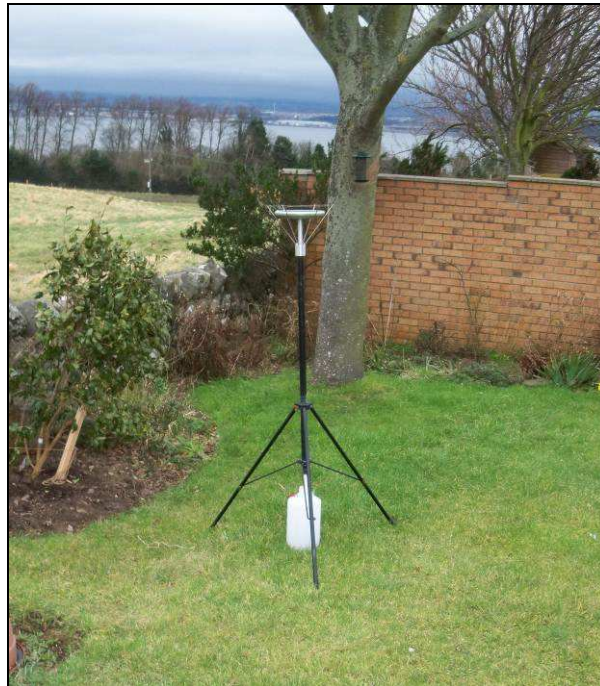
Figure 1: Example of an Installed Frisbee Gauge Meter

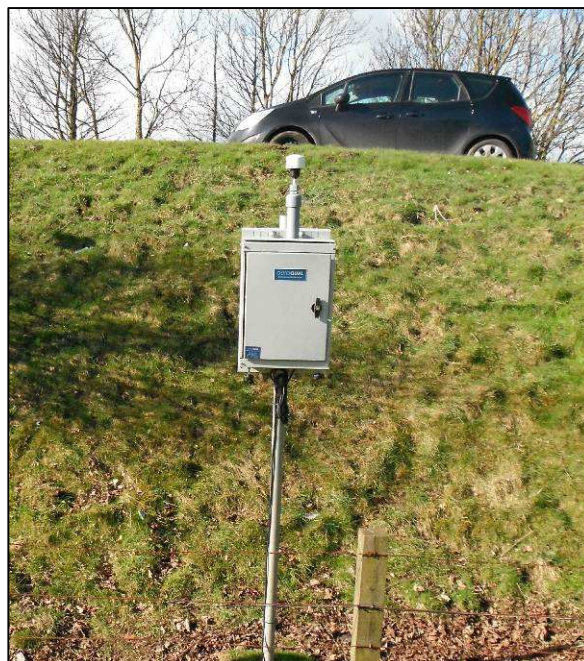
Figure 2: Example of an installed Automatic Light Scatter Dust Meter
