Forth Crossing Bridge Constructors

Project **FORTH REPLACEMENT CROSSING**

**AIR QUALITY MONITORING REPORT
AUGUST 2014**

Document number
REP-00193-00

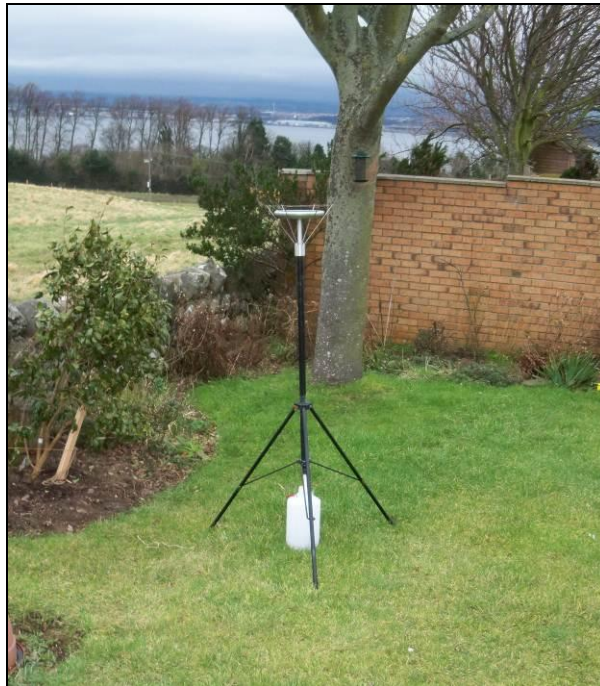
Figure 1: Example of an Installed Frisbee Gauge Meter

- 2.1.** Air quality is being monitored on site using both automatic light scatter dust meters and Frisbee gauge dust deposition monitoring. Thirteen Frisbee gauges are set up at sensitive locations across the site to measure dust deposition rates (Figure 1). Seven automatic light scatter meters have also been installed at various sensitive locations to measure real time particulate matter (PM₁₀) concentrations and the Total Suspended Particle (TSP) concentrations (Figure 2). These meters are calibrated annually. Table 1 lists the air quality monitoring equipment present at each monitoring location, including the date it was installed.

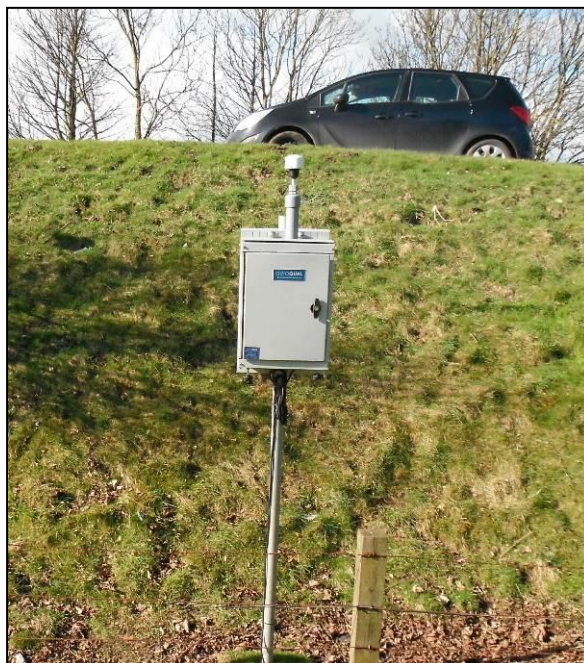
Figure 2: Example of an installed Automatic Light Scatter Dust Meter

- 2.2.** Light scatter type monitoring equipment have been selected as a site monitoring tool to create a live network which assesses the levels of fugitive particulate matter, principally airborne dust. These monitors require less space, maintenance and power than other real time monitors such as a Tapered Element Oscillating Microbalance (TEOM) which is used and designed to measure particulate levels to exceedingly high standards, including measuring long-term compliance to statutory limits. Light scatter meters are more practicable to deploy. However, the meters do generally record levels higher than those measured by the TEOM. The meters can also be affected by atmospheric moisture content which further increases reported levels. Accordingly, any elevations of statutory limits should be treated as precautionary exceedances. The monitors are reliable for on-site monitoring and the establishment of action thresholds to ensure unforeseen activities generating significant dust are identified and suitably controlled. Light scatter meters are becoming the construction and waste industries norm for particulate dust monitoring.
