Project **FORTH REPLACEMENT CROSSING**

**AIR QUALITY MONITORING REPORT  
OCTOBER 2014**

Document number	Rev
<b>REP -00202</b>	<b>00</b>

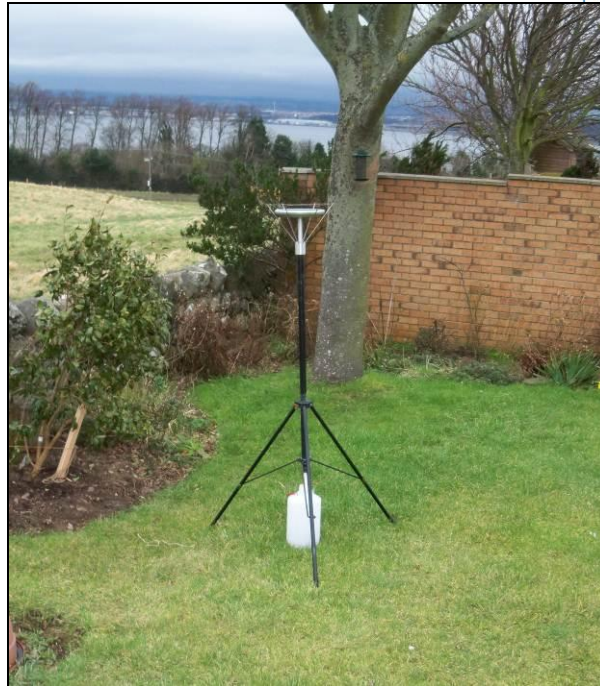
**Figure 1: Example of an Installed Frisbee Gauge Meter**

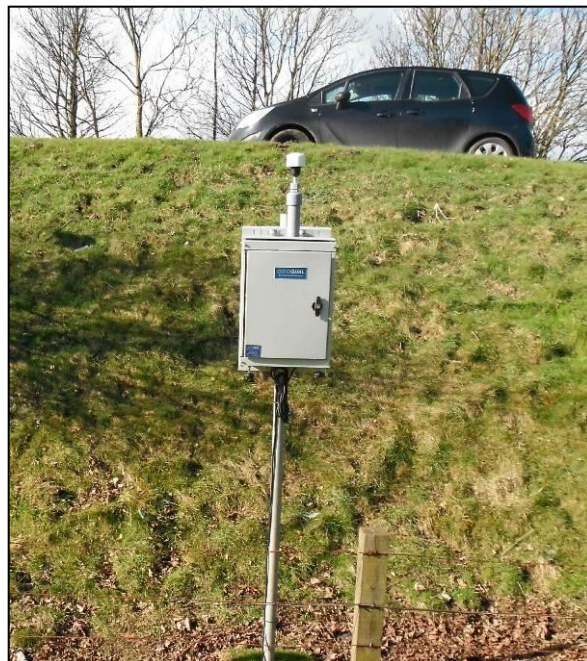
**Figure 2: Example of an installed Automatic Light Scatter Dust Meter**

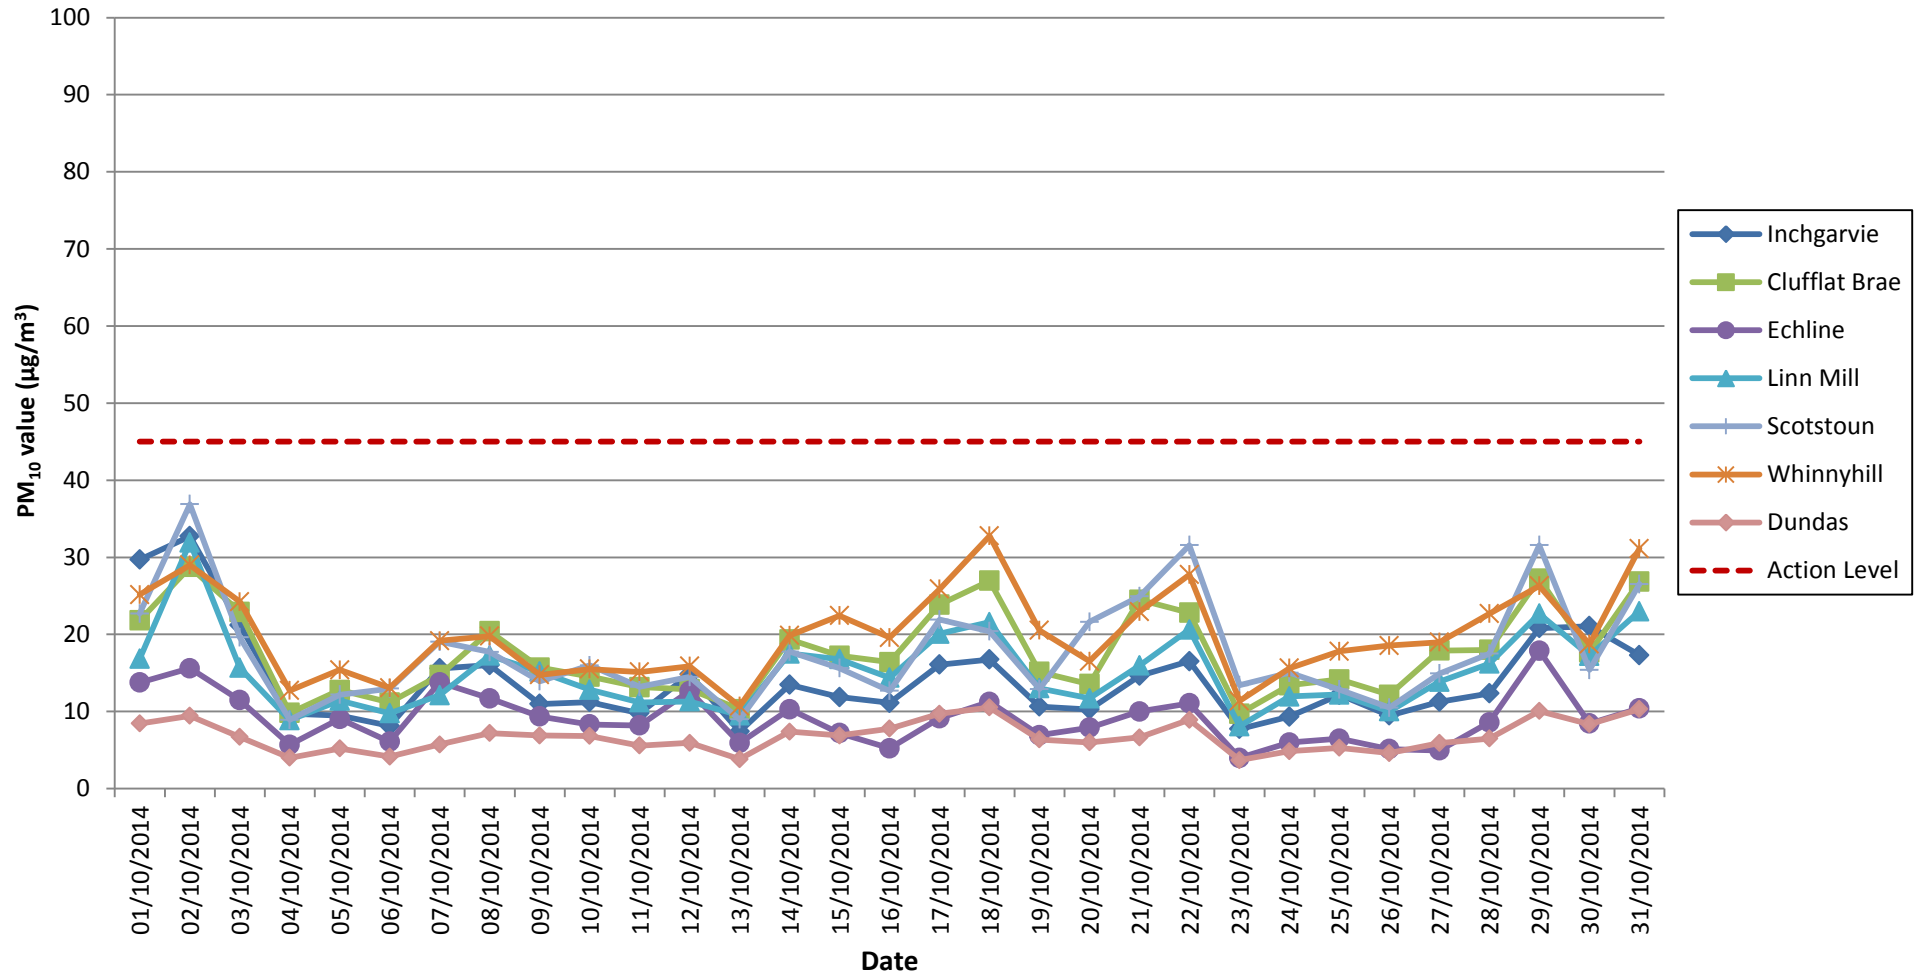
## Particulate Matter (PM10) Results for all Monitoring Locations

3.1.1. Light scatter results for October 2014 have been presented in a monthly chart; this can be found in Appendix A. Results show that the PM<sub>10</sub> levels were below threshold levels throughout the month. All the monitors follow the same general pattern throughout the month.

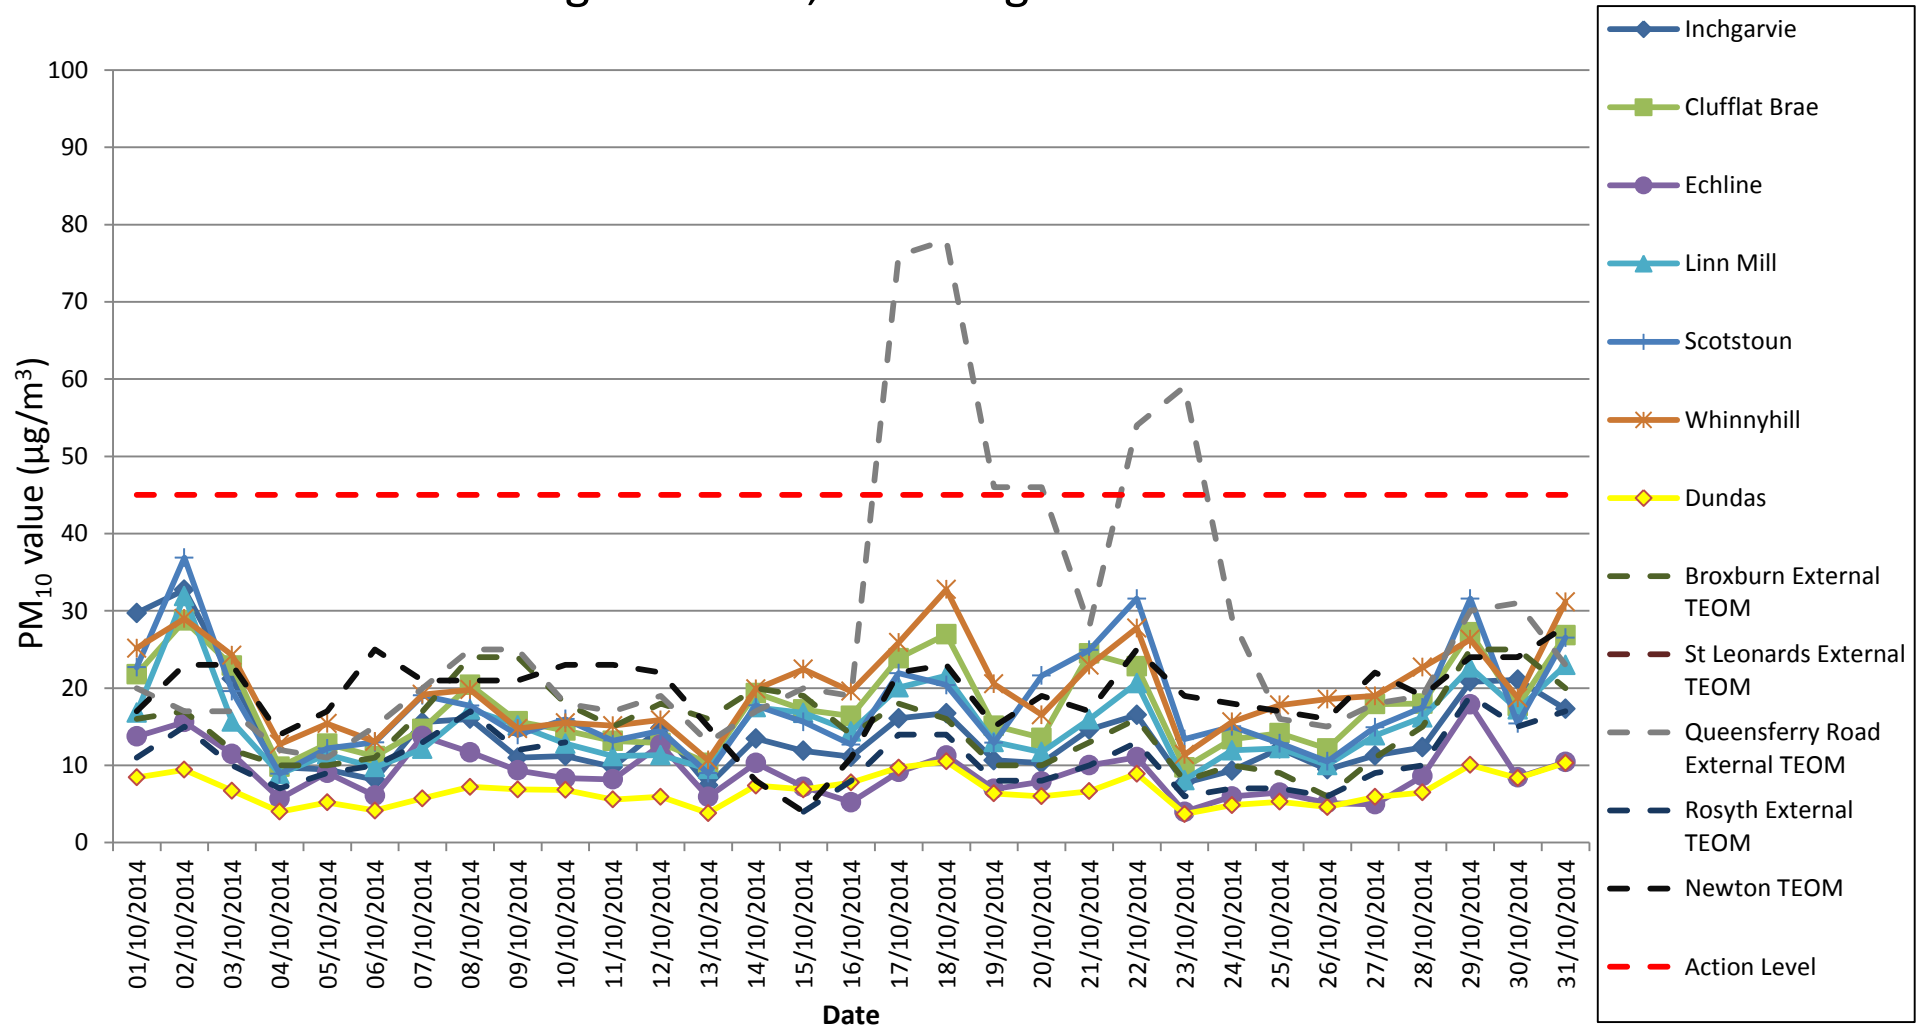
## Air Quality Monitoring: Particulate Matter (PM10) Results for all Monitoring Locations, including TEOM data October 2014

3.1.2. The PM<sub>10</sub> results have also been compared to the daily mean results obtained from the TEOM air quality monitoring stations located in Newton, Rosyth, and Broxburn, and from the TEOM FDMS station located at Queensferry Road, Edinburgh. No data was available from the TEOM FDMS monitor at St Leonards, Edinburgh. The TEOM at Newton was installed by West Lothian Council, facilitated by FCBC, during May 2012. The comparison between the light scatter and TEOM

results demonstrates that both sets of results generally follow the same pattern at similar levels, indicating that the pattern observed throughout October was largely driven by regional changes in air quality. Though it should be noted that the Queensferry Road, Edinburgh monitor registered much higher levels during 17<sup>th</sup>- 24<sup>th</sup> September. However as mentioned above, this monitor is only used as a reference and is not related to FCBC activities or equipment.

Note: TEOM data missing from scottish air quality for the 11-14 October for Rosyth and no data has been recorded at the St Leonards monitor since 12th September.

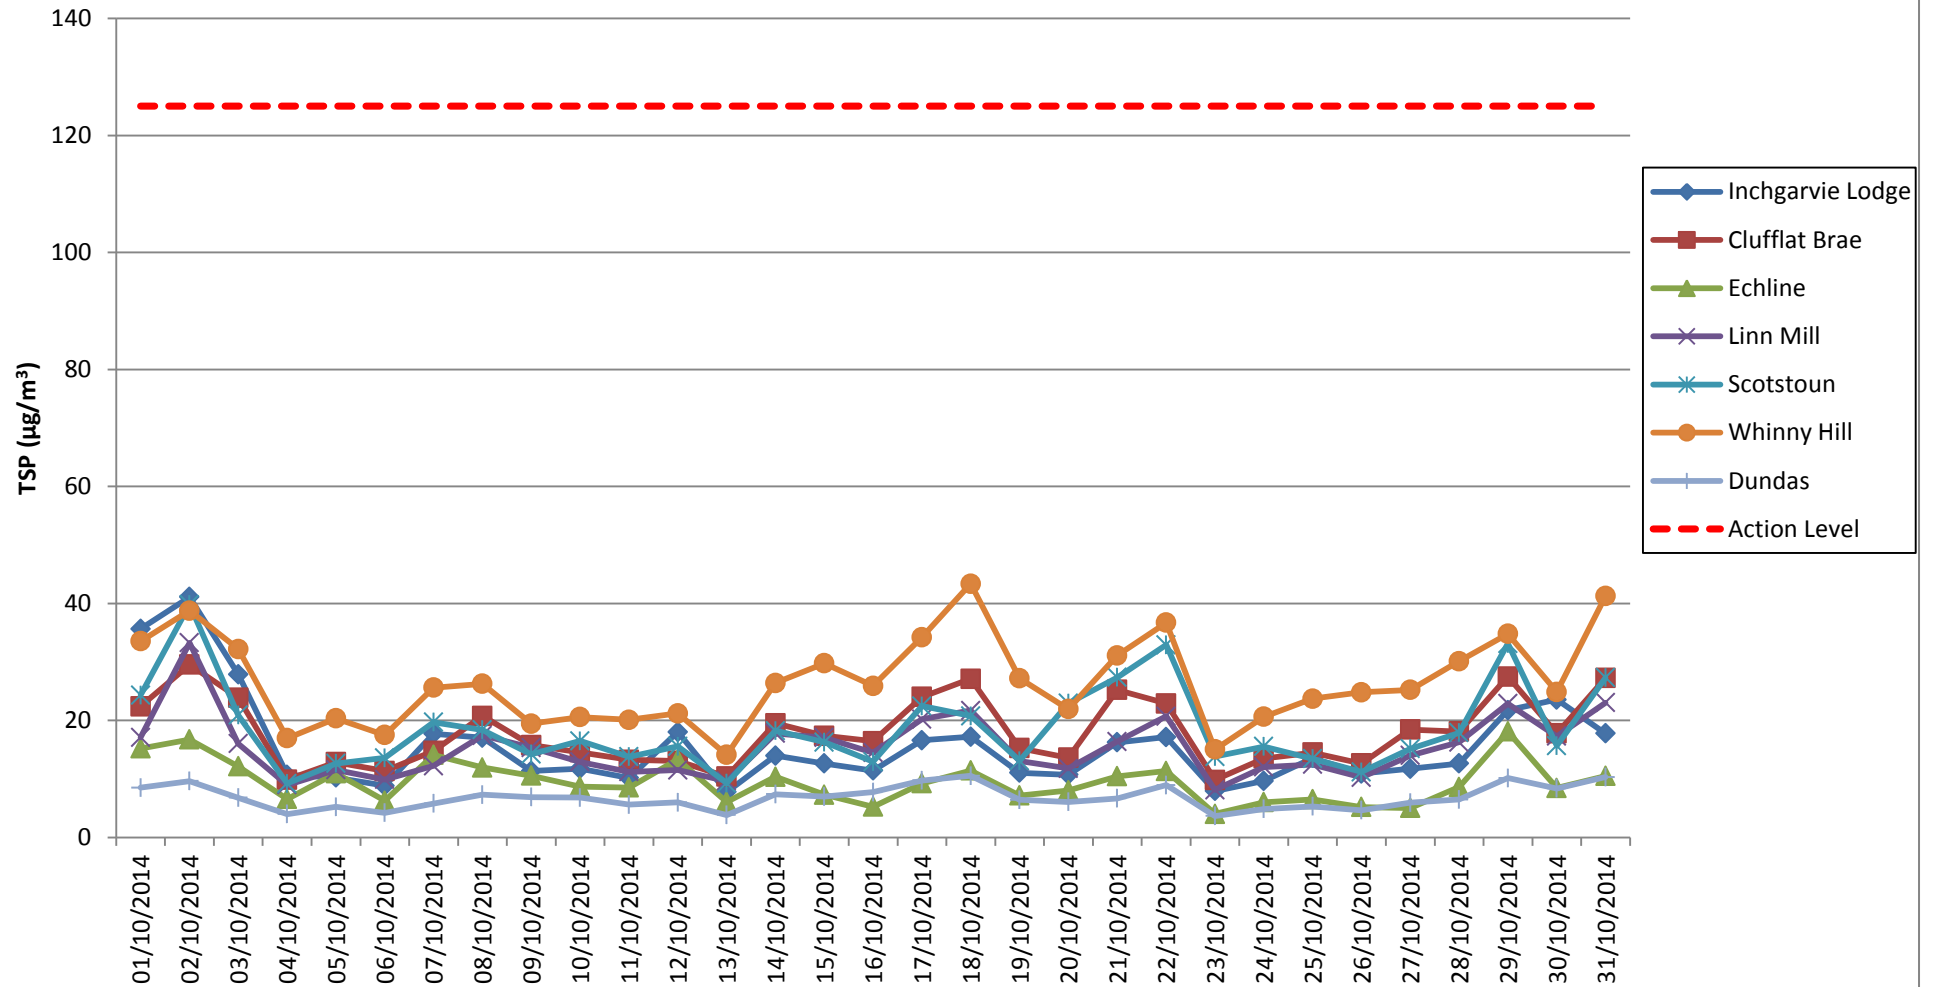
# Total Suspended Particles (TSP) Results October 2014

**3.2.1.** The TSP results for October 2014 have been presented in a monthly chart; this can be found in Appendix B. The TSP levels at monitoring locations during October were found to be low and all within the threshold level. All locations across the site were mostly found to follow a similar pattern, demonstrating that, in general, the levels were influenced by regional changes in TSP levels, rather than construction works.

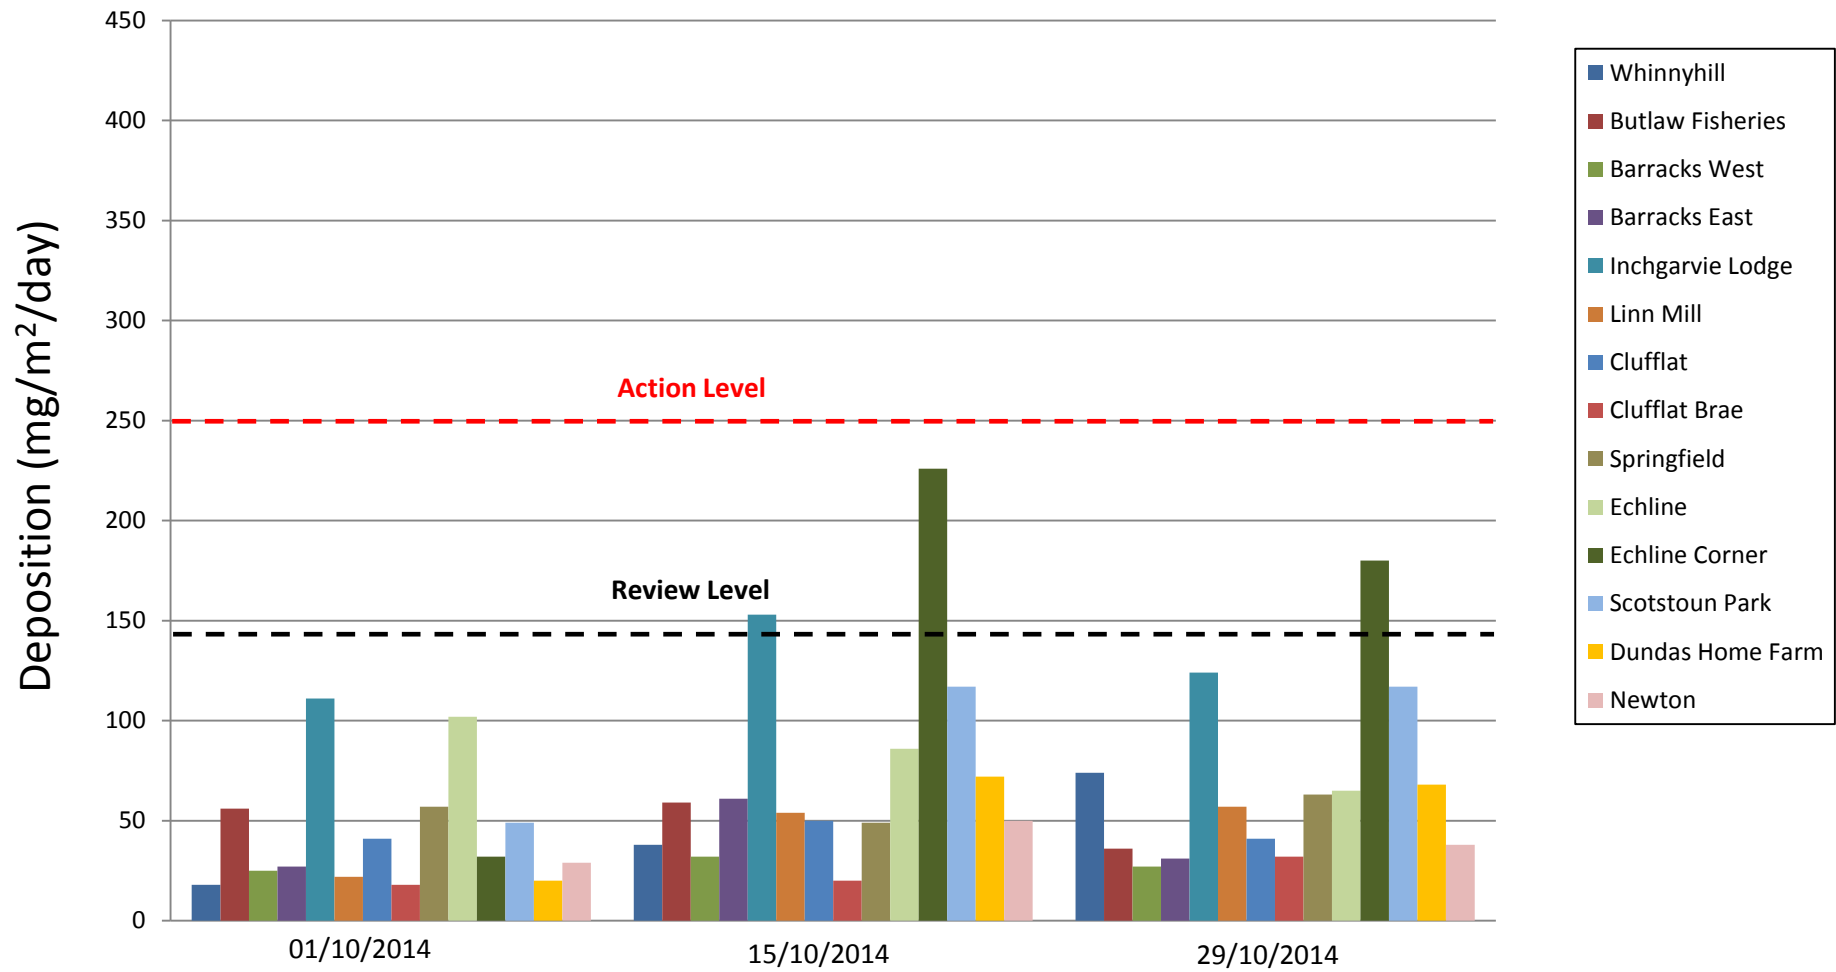
## Frisbee Dust Deposition Results: October 2014

**3.3.1.** The Frisbee dust deposition results for October 2014 have been presented in a chart and can be found in Appendix C. This includes an additional Frisbee (Echline Corner) currently located south of the A904 in proximity to the Echline monitor. This temporary Frisbee is used to provide additional information and its results are presented alongside the 13 permanent monitors. Frisbee dust deposition results were collected fortnightly, and the results averaged over this fortnight period to give a daily dust deposition rate. Three collections were made in October, on the 1<sup>st</sup>, 15<sup>th</sup> and 29<sup>th</sup>. The next collection will take place on the 12<sup>th</sup> November 2014.

- 3.3.3.** During October there were three exceedances of the site review level and no exceedances of the action level (see Table 2).

**3.3.5.** With regards to the exceedance of the review level at Inchgarvie Lodge for the fortnight concluding 15<sup>th</sup> October, a review into works undertaken in the vicinity was carried out. Finishing work on the brickwork cladding was taking place on the newly installed wall to the rear of Inchgarvie Lodge, in immediate proximity to the gauge (within 10m). It should be noted that site works do not usually occur at this location and the wall construction is a short-term activity. This means that during this period the gauge was essentially within the construction site. A review of the works in the area, weather conditions, and the mitigation measures in place was undertaken. Considering all the factors, the proximity of the work is believed to be responsible for the exceedance. Three other gauges (Clufflat, Clufflat Brae & Barracks East) are located within 150m of the Inchgarvie Lodge gauge, all of which registered low readings during the same period. It is concluded that while construction activities on and around the wall caused the exceedance at the Inchgarvie Frisbee gauge, mitigation was in place which limited the increase in dust to the immediate area and prevented it from migrating off site. Completion of the wall construction occurred during November with the exception of some planting. Due to the continued elevated levels observed at this location additional checks will be undertaken to ensure that mitigation measures are effective.

**3.3.6.** During the periods ending 15<sup>rd</sup> and 29<sup>th</sup> October the Echline Corner Frisbee registered levels above the review level. This is an additional temporary Frisbee that was put in place after a dust incident during April. It has been positioned within the construction site and provides information regarding dust levels generated on-site. A review of the works was undertaken and it was found that although construction activities that could give rise to dust took place in the area during this period, mitigation was in place to prevent dust migrating off-site. The

Echline gauge, which is located within 200m of the Echline Corner Frisbee gauge, registered low levels during the same periods suggesting that the levels of dust at source on site were above review level but mitigation has prevented dust migrating off-site. In general, levels measured at the Echline Corner gauge have been continually higher than the other Frisbees that are located around the edges of the site, closer to residential areas. In an attempt to gather more representative data, the location of this gauge is being reviewed with a view to identifying an alternative location within the same area of works.
