Project **FORTH REPLACEMENT CROSSING**

**AIR QUALITY MONITORING REPORT
MARCH 2015**

Document number	Rev
REP -00226	00

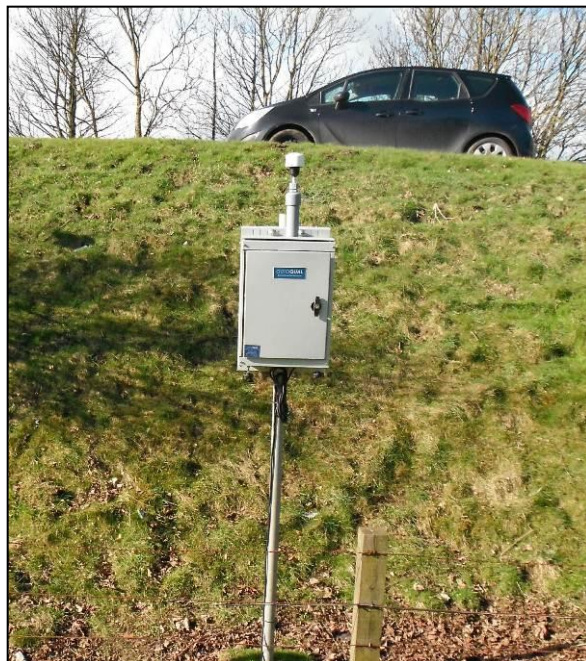
Figure 2: Example of an installed Automatic Light Scatter Dust Meter

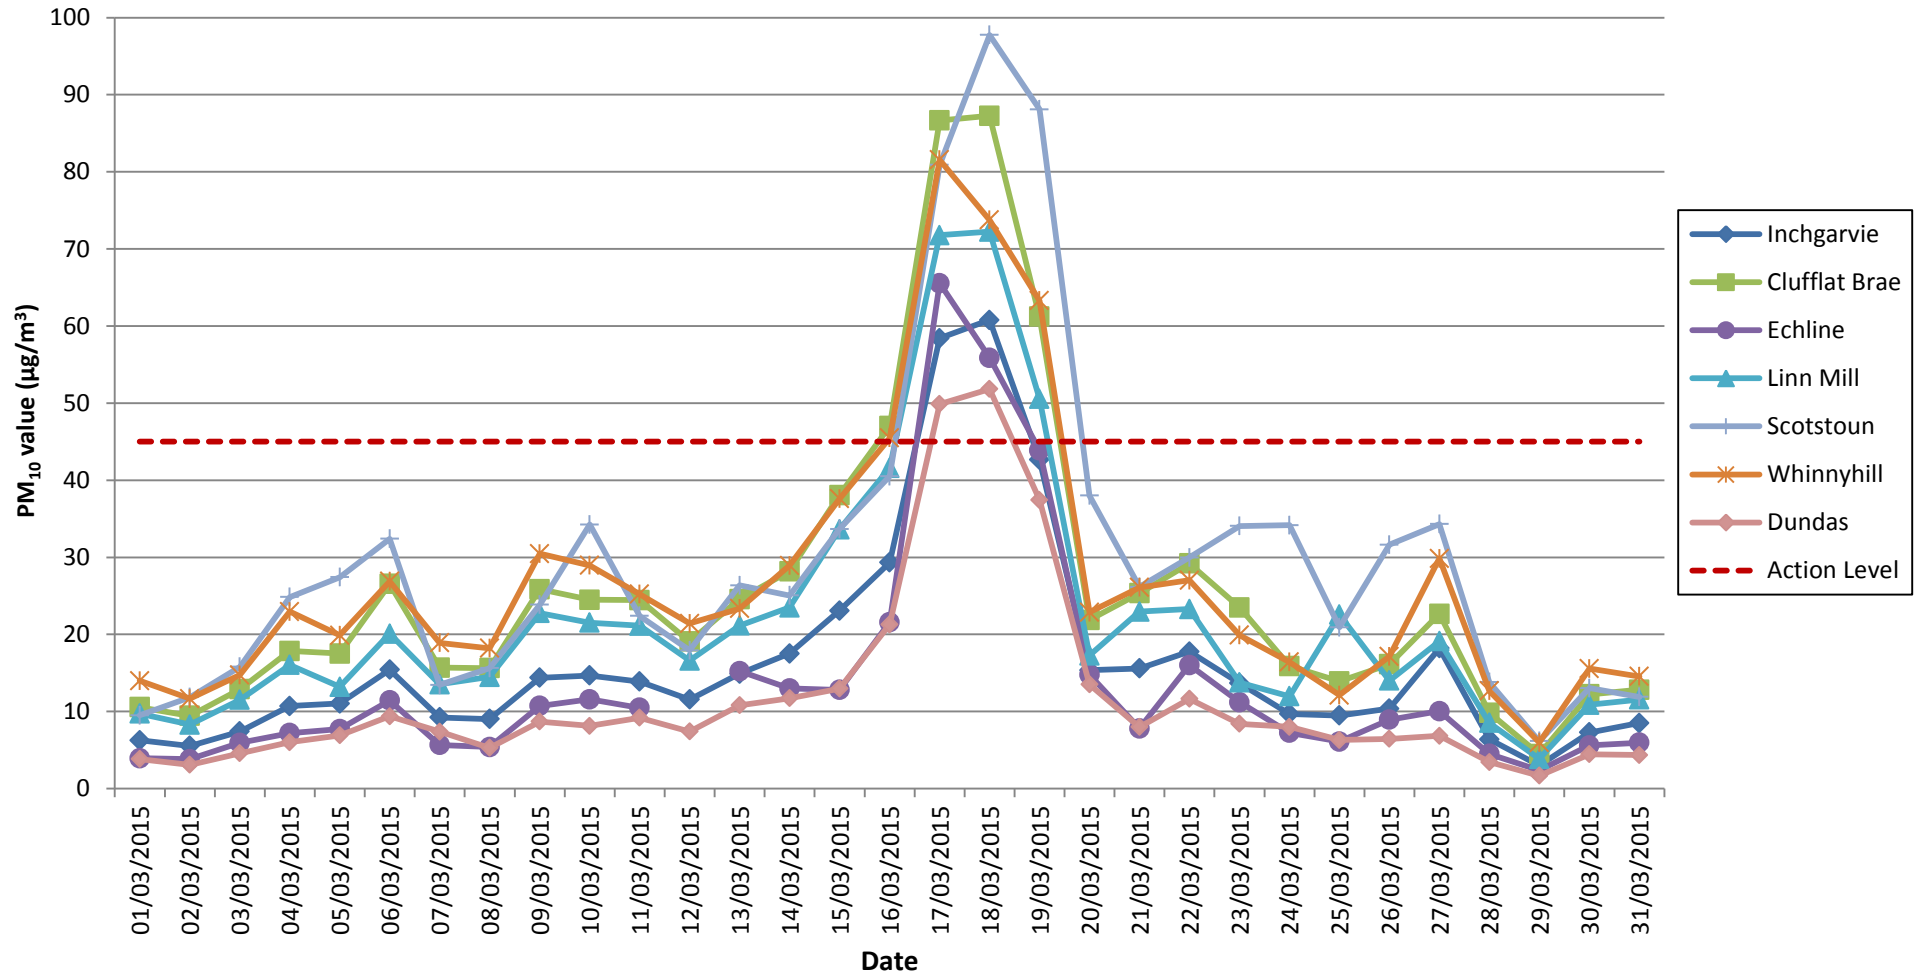
- 3.1.1.** Light scatter results for March 2015 have been presented in a monthly chart; this can be found in Appendix A. Results show that the PM₁₀ levels were below threshold levels throughout the month with the exception of the 16th- 19th March. During this period all monitors registered levels above the action level on at least 2 days.

- 3.1.2.** During the period of high readings the Department of the Environment, Food and Rural Affairs issued an alert regarding an area of increased levels of air pollution passing over the UK. This combined with the fact all monitors registered high levels suggests that the results were driven by regional/national changes in air quality rather than being driven by construction related activities.

Particulate Matter (PM10) Results for all Monitoring Locations

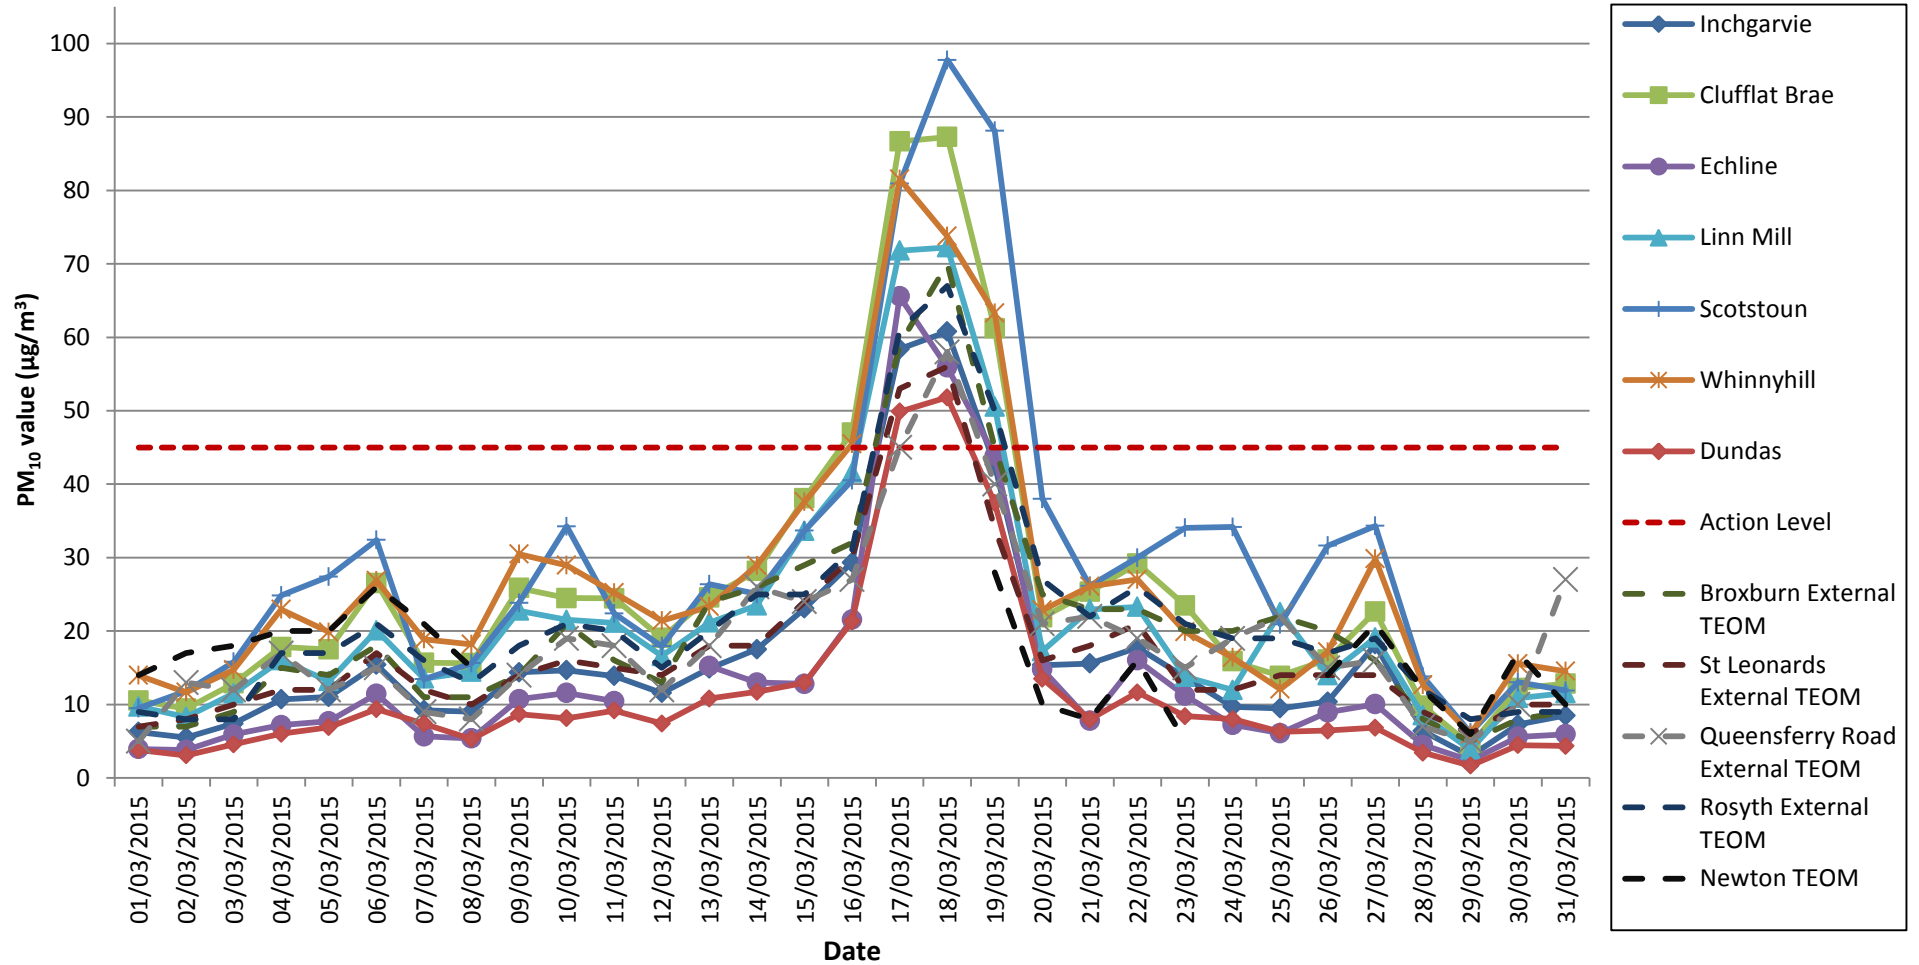
- 3.1.3.** The PM₁₀ results have also been compared to the daily mean results obtained from the TEOM air quality monitoring stations located in Newton, Rosyth, and Broxburn, and from the TEOM FDMS station located at Queensferry Road and St Leonards, Edinburgh (an urban background site). The TEOM at Newton was installed by West Lothian Council, facilitated by FCBC, during May 2012. The comparison between the light scatter and TEOM results demonstrates that both sets of results generally follow the same pattern, including an increase in

levels over the period 16th – 19th March, indicating that the pattern observed throughout March was largely driven by regional changes in air quality rather than by construction related activities.

Air Quality Monitoring: Particulate Matter (PM10) Results for all Monitoring Locations, including TEOM data March 2015

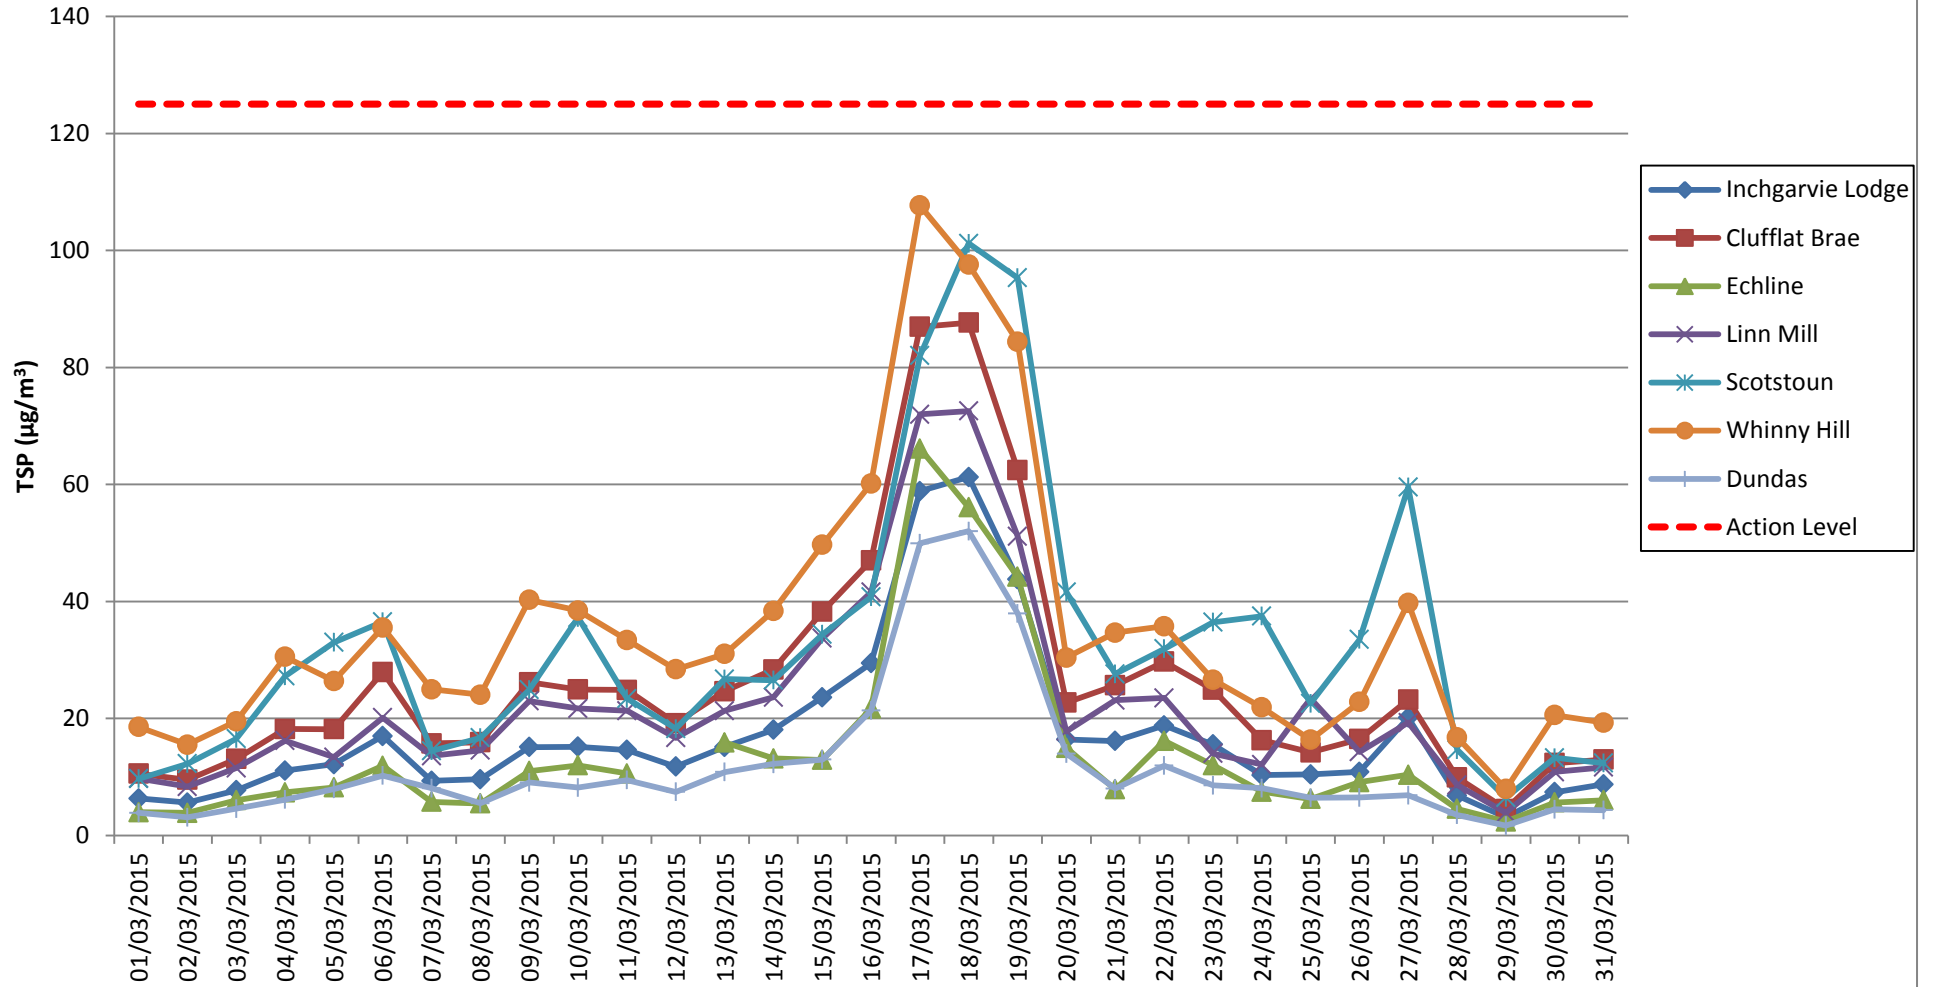
- 3.2.1.** The TSP results for March 2015 have been presented in a monthly chart; this can be found in Appendix B. The TSP levels at monitoring locations during March were found to be low and all within the threshold level. All locations across the site were mostly found to follow a similar pattern, including an increase during the 16th-19th March, similar to that observed for PM₁₀ levels. This demonstrates that, in general, the levels were influenced by regional changes in TSP levels, rather than construction works.

Total Suspended Particles (TSP) Results

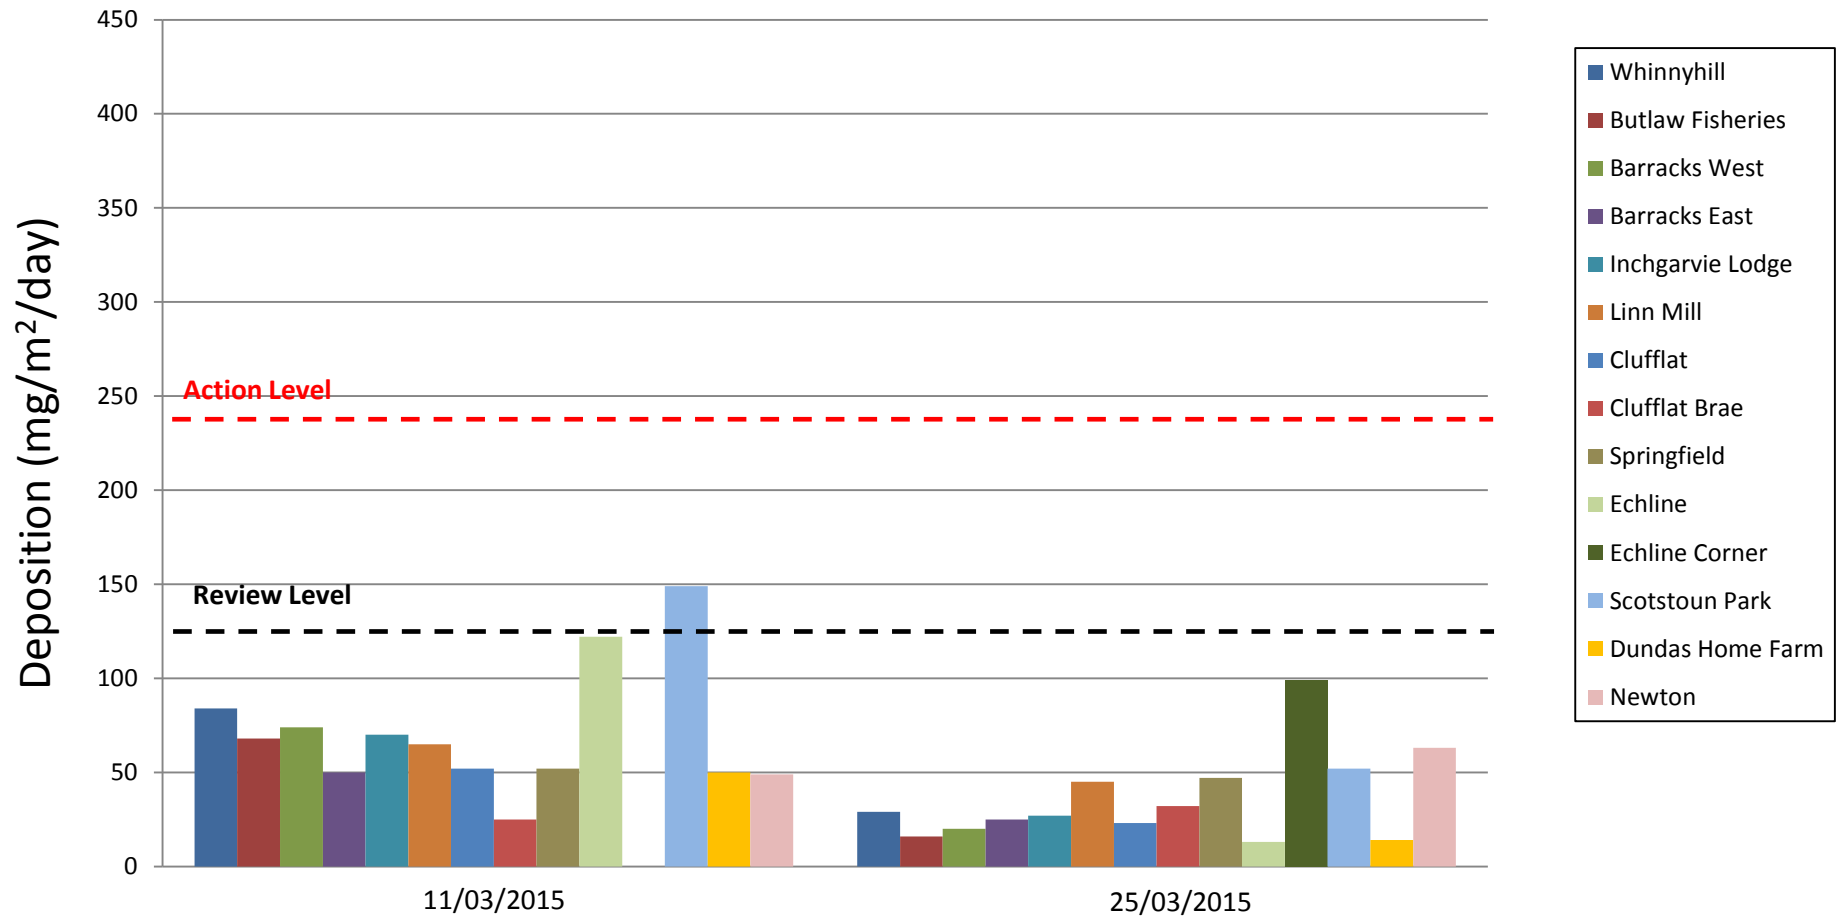
- 3.3.2.** The site action level for the dust deposition rate has been set at 250 mg/m²/day. Exceedances of this level are treated as a potential incident and a review of the works in the vicinity of the site is instigated. A lower site review level has been set at 140 mg/m²/day. Where concentrations exceed the lower review threshold the site works are reviewed to ensure good practice is implemented; it is essentially a warning that additional controls may be required.
- 3.3.3.** During March there was one exceedance of the site review level and no exceedances of the action level (see Table 2).

- 3.3.6.** For the collection on the 11th March the sample bottle for the Echline Corner Frisbee gauge was found away from the gauge, upturned and empty. The gauge was also found on the ground, presumably blown over.

Frisbee Dust Deposition Results: March 2015

Note: Echline Corner (11/03/2015) has been omitted due to the sample bottle being found away from the gauge, upturned and empty (see Section 3.3.6).
