Project **FORTH REPLACEMENT CROSSING**

**AIR QUALITY MONITORING REPORT
AUGUST 2015**

REP-00247

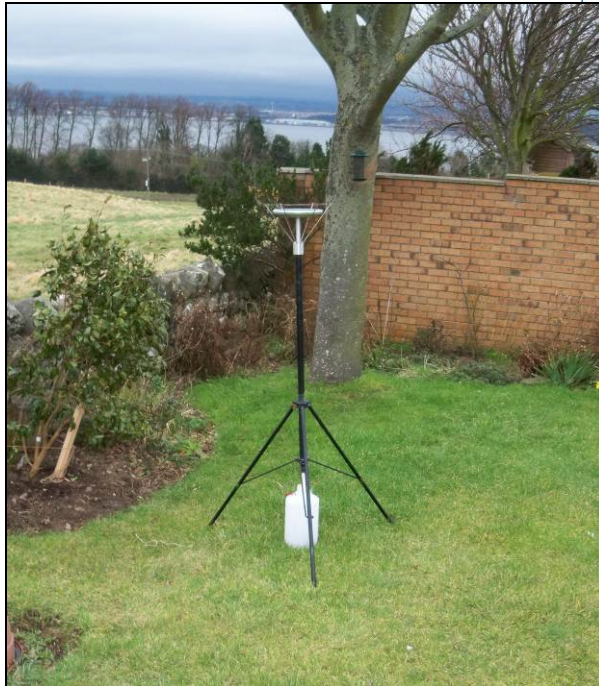
2.1. Air quality is being monitored on site using both automatic light scatter dust meters and Frisbee gauge dust deposition monitoring. Thirteen Frisbee gauges are set up at sensitive locations across the site to measure dust deposition rates (Figure 1). Seven automatic light scatter meters have also been installed at various sensitive locations to measure real time particulate matter (PM₁₀) concentrations and the Total Suspended Particle (TSP) concentrations (Figure 2). These meters are calibrated annually. Table 1 lists the air quality monitoring equipment present at each monitoring location, including the date it was installed.

Figure 1: Example of an Installed Frisbee Gauge Meter

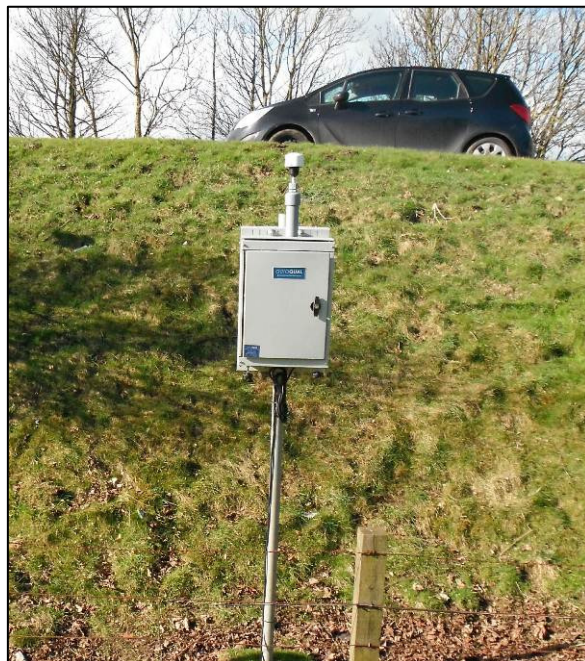
2.2. Light scatter type monitoring equipment have been selected as a site monitoring tool to create a live network which assesses the levels of fugitive particulate matter, principally airborne dust. These monitors require less space, maintenance and power than other real time monitors such as a Tapered Element Oscillating Microbalance (TEOM) which is used and designed to measure particulate levels to exceedingly high standards, including measuring long-term compliance to statutory limits. Light scatter meters are more practicable to deploy. However, the meters do generally record levels higher than those measured by the TEOM. The meters can also be affected by atmospheric moisture content which further increases reported levels. Accordingly, any elevations of statutory limits should be treated as precautionary exceedances. The monitors are reliable for on-site monitoring and the establishment of action thresholds to ensure unforeseen activities generating significant dust are identified and suitably controlled. Light scatter meters are becoming the construction and waste industries norm for particulate dust monitoring.

Figure 2: Example of an installed Automatic Light Scatter Dust Meter
