Project **FORTH REPLACEMENT CROSSING**

**AIR QUALITY MONITORING REPORT
SEPTEMBER 2015**

REP-00252 Rev
00

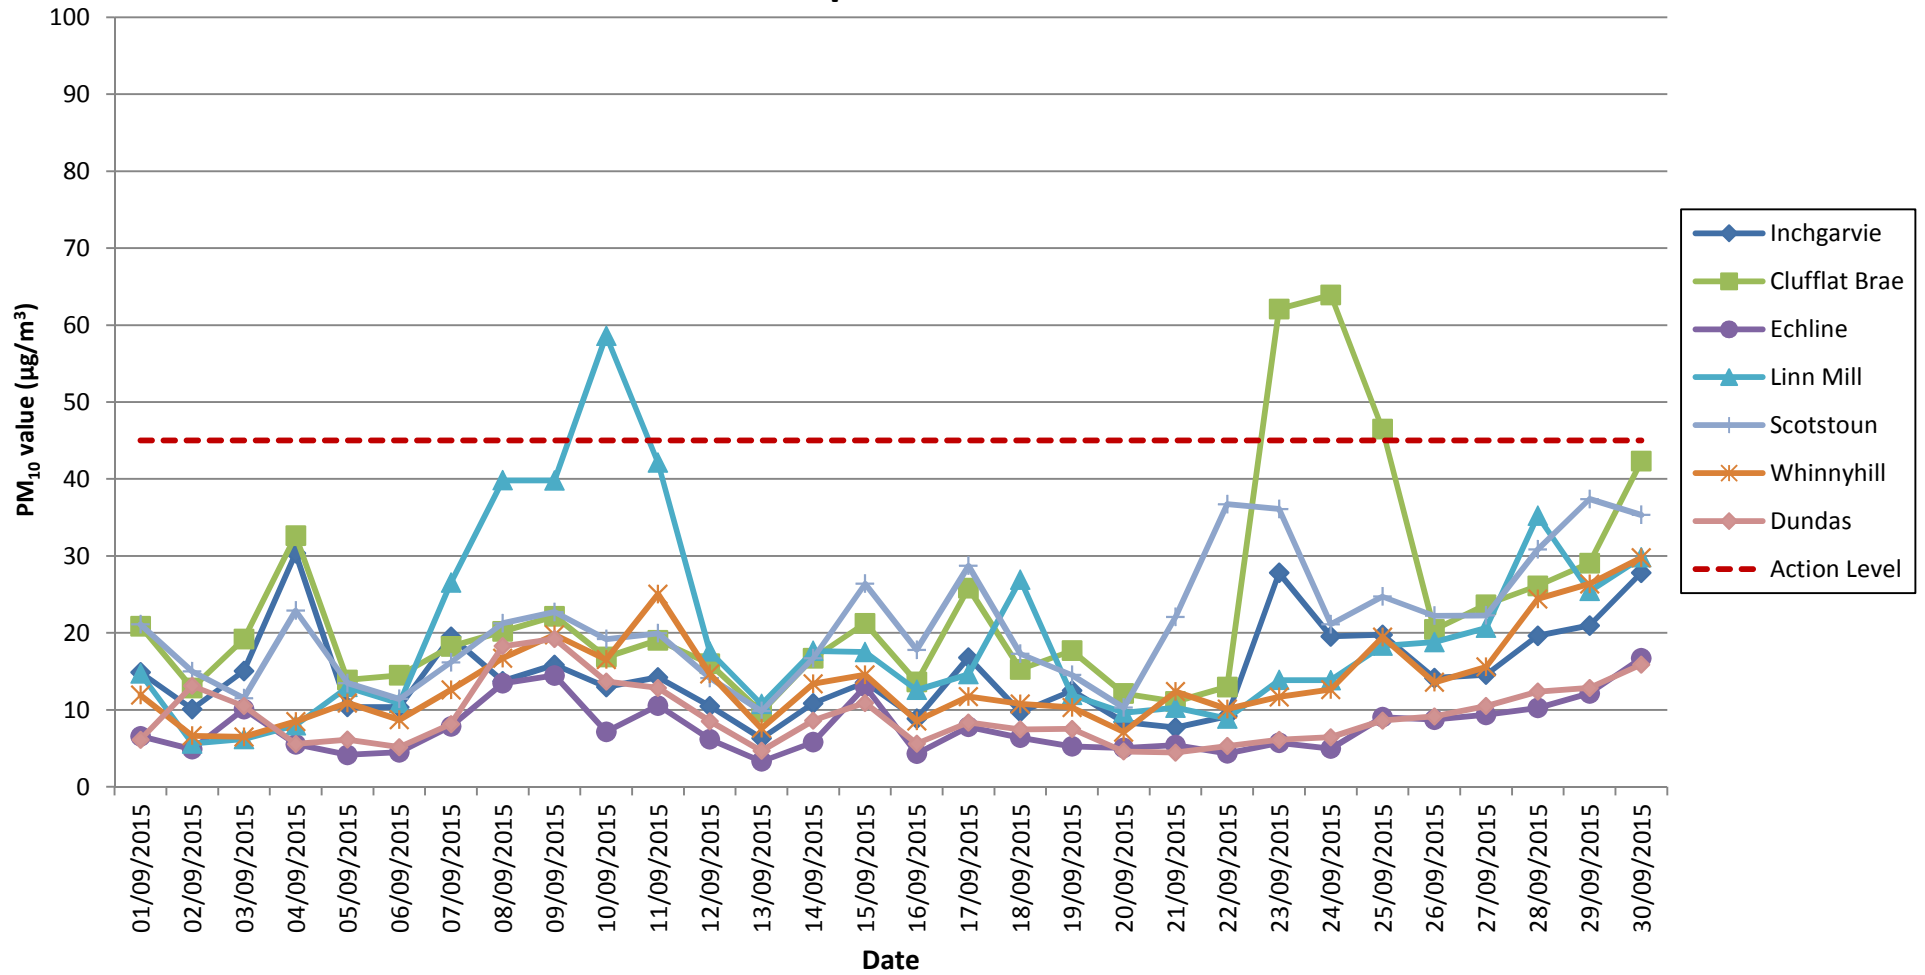
Particulate Matter (PM10) Results for all Monitoring Locations

September 2015

3.1.1. Light scatter results for September 2015 have been presented in a monthly chart; this can be found in Appendix A. Results show that the PM₁₀ levels were mostly below threshold levels throughout the month with the exception of four exceedances. One exceedance occurred on the 10th September at Linn Mill. The other three exceedances occurred at Clufflat Brae on the 23rd – 25th September. With regards to the exceedance on the 10th at Linn Mill, this corresponds with dry weather

conditions and may be due partly to construction activities, particularly earthworks undertaken in the vicinity. The PM₁₀ results at this location between the 8th and 11th September are also generally elevated compared to other locations. Bowser activity will continue in the earthworks area, particularly during dry conditions. The exceedances on the 23rd – 25th at Clufflat also correspond with dry weather conditions and are likely to have been caused by the test pier removal located close to Clufflat (approx. 180m). The other monitor in the area (Inchgarvie) also showed a slight increase on the 23rd (although well below the action level) so it appears that the dust produced from the test pier removal was not entirely localised.

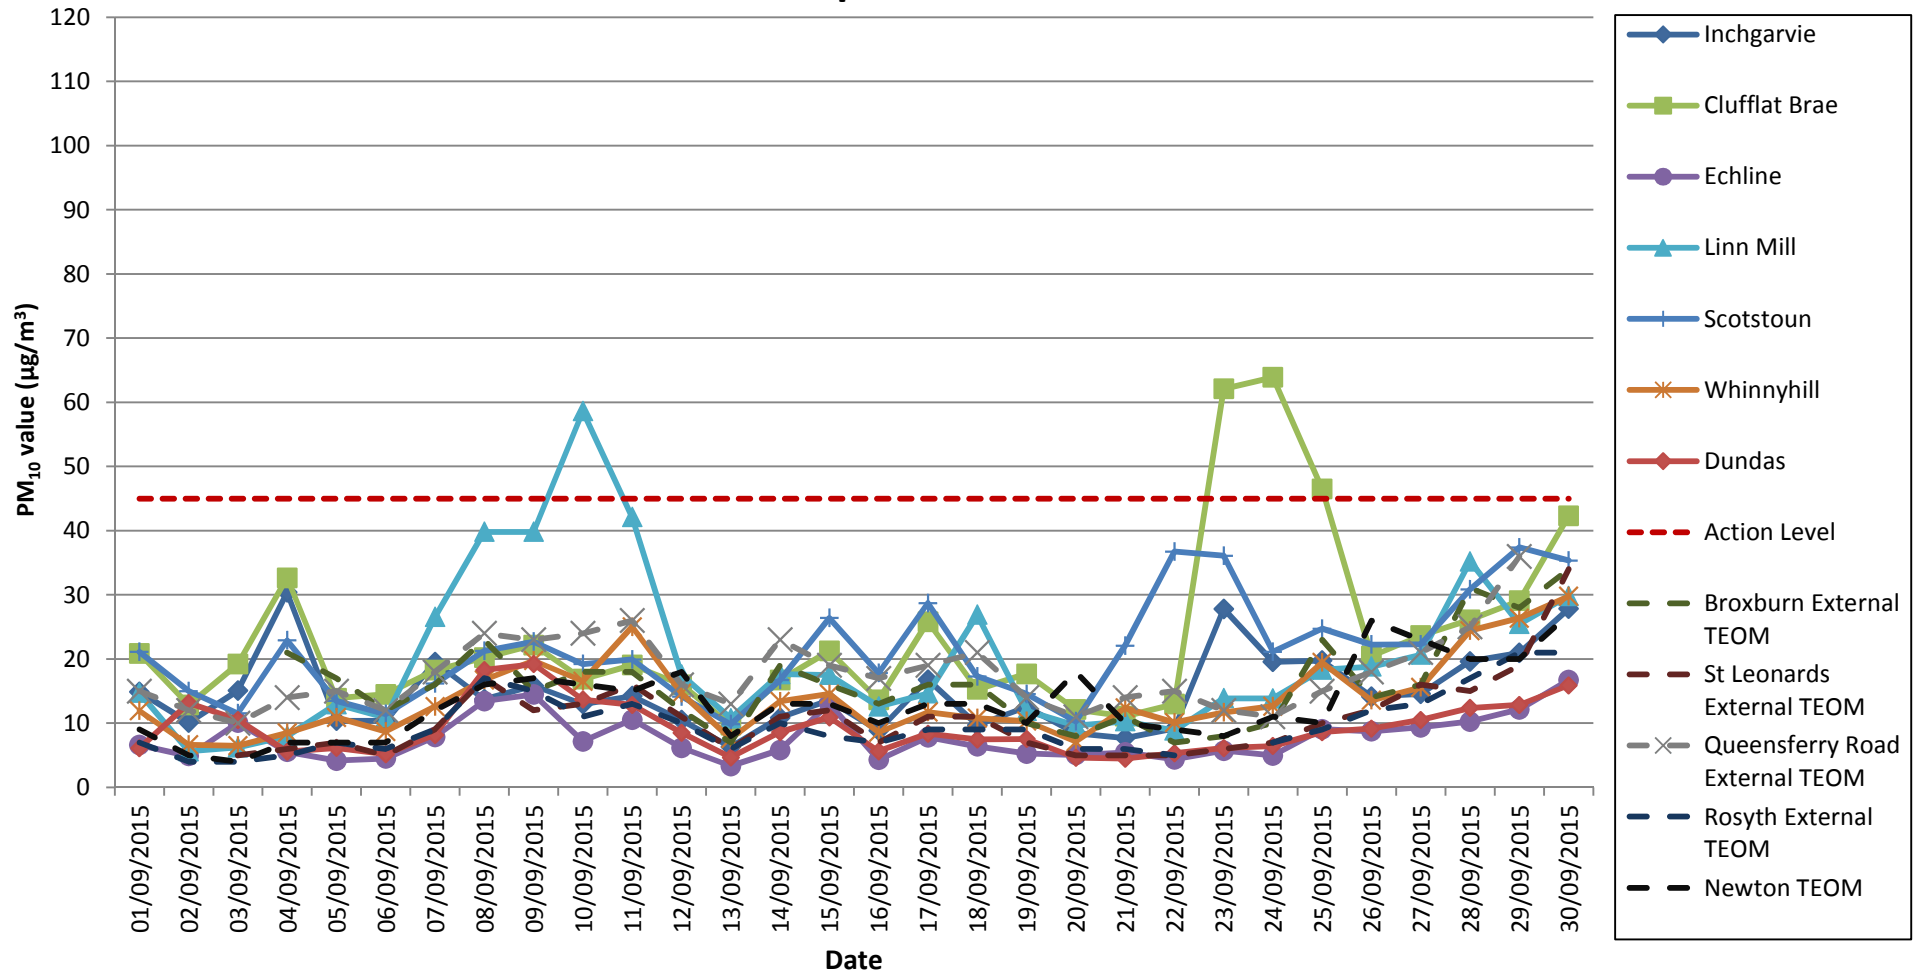
Air Quality Monitoring: Particulate Matter (PM10) Results for all Monitoring Locations, including TEOM data September 2015

- 3.1.2.** The PM₁₀ results have also been compared to the daily mean results obtained from the TEOM air quality monitoring stations located in Newton, Rosyth, and Broxburn, and from the TEOM FDMS station located at Queensferry Road and St Leonards, Edinburgh (an urban background site). The TEOM at Newton was installed by West Lothian Council, facilitated by FCBC, during September 2012. The comparison between the light scatter and TEOM results demonstrates that both sets of results generally follow the same pattern, indicating that the pattern observed throughout September was largely driven by regional changes in air quality, with the exception of the exceedances noted in 3.1.1 above. The increases observed for Clufflat and Linn Mill during the month may be due to construction activities, particularly main carriageway earthworks and the test pier removal. TEOM data shows low concentrations of PM₁₀ for the 23rd September, further suggesting that site works were responsible for the high levels recorded at Clufflat on that date. Bowser activity will continue in the earthworks area, particularly during dry conditions. The test pier removal was completed on the 25th September.

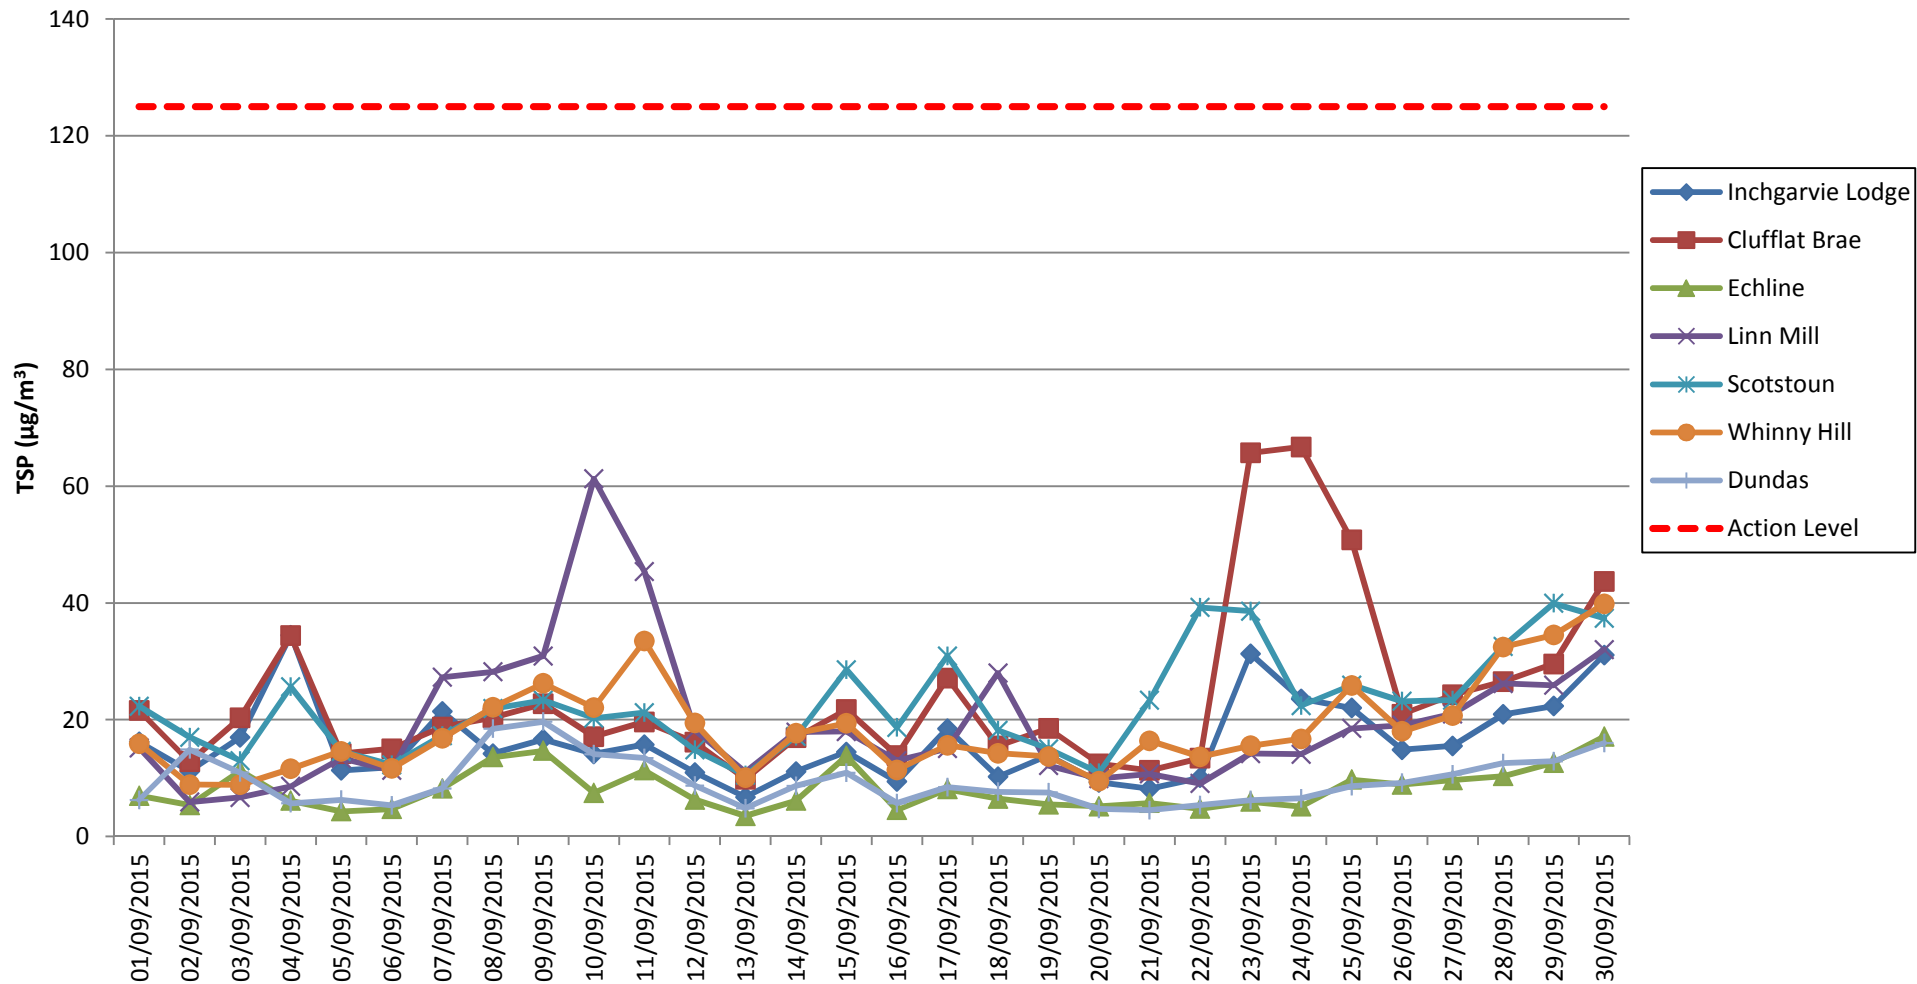
Total Suspended Particles (TSP) Results September 2015

3.2.1. The TSP results for September 2015 have been presented in a monthly chart; this can be found in Appendix B. The TSP levels at monitoring locations during September were found to be generally low and all within the threshold. All locations across the site were mostly found to follow a similar pattern (similar to that observed for PM₁₀ levels) but with higher levels noted at a few locations. As with PM₁₀ it is considered that, in general, the TSP levels across site were influenced by regional changes in TSP levels, with the exception of the increases corresponding to the higher PM₁₀ levels noted in 3.1.1.

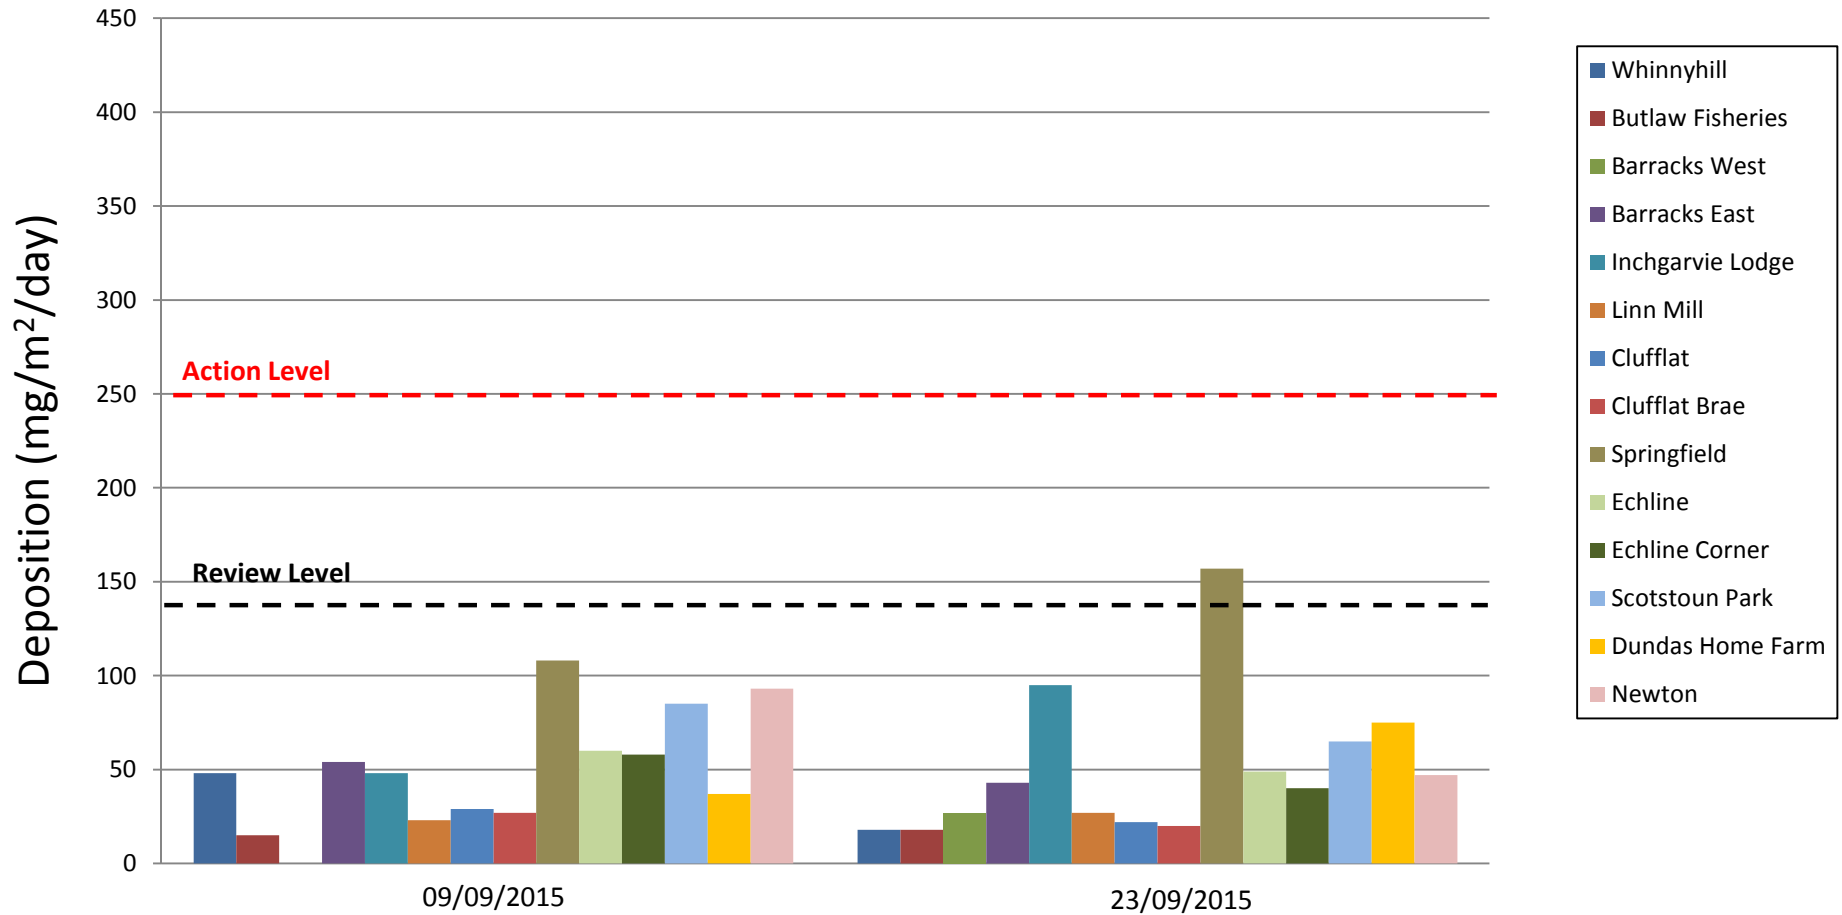
Frisbee Dust Deposition Results: September 2015

3.3.1. The Frisbee dust deposition results for September 2015 have been presented in a chart and can be found in Appendix C. This includes an additional Frisbee (Echline Corner) currently located south of the A904 in proximity to the Echline monitor. This temporary Frisbee is used to provide additional information and its results are presented alongside the 13 permanent monitors. Frisbee dust deposition results were collected fortnightly, and the results averaged over this fortnight period to give a daily dust deposition rate. Two collections were made to cover the results for September; these occurred on the 9th and 23rd September 2015.

3.3.2. The site action level for the dust deposition rate has been set at 250 mg/m²/day. Exceedances of this level are treated as a potential incident and a review of the works in the vicinity of the site is instigated. A lower site review level has been set at 140 mg/m²/day. Where concentrations exceed the lower review threshold the site works are reviewed to ensure good practice is implemented; it is essentially a warning that additional controls may be required.

3.3.3. During September there was one exceedance of the review level at Springfield for the fortnight concluding 23rd September. It is considered possible that this result may be partly due to the test pier removal that started on the 23rd September, see section 3.1.1, although the other Frisbees located nearby do not show elevated levels (Clufflat and Clufflat Brae). This activity was located approximately 120m from the Springfield Frisbee. The test pier removal work is now complete.
