Project **FORTH REPLACEMENT CROSSING**

**AIR QUALITY MONITORING REPORT
JANUARY 2016**

REP-00267

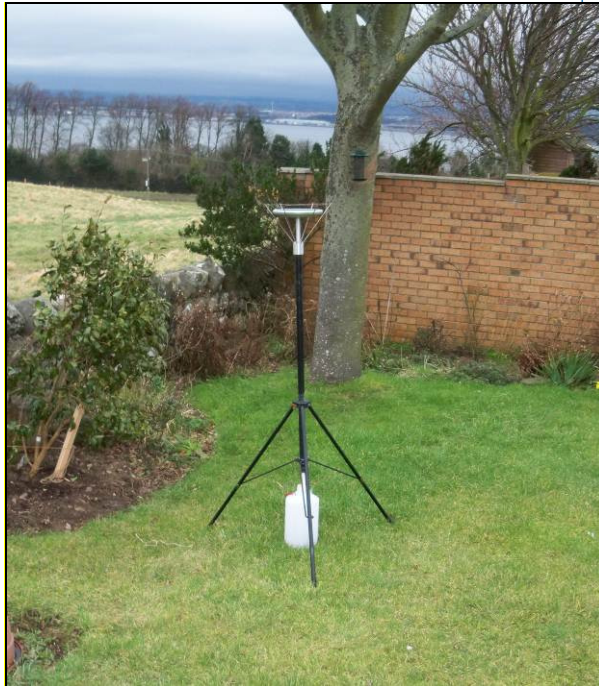
Figure 1: Example of an Installed Frisbee Gauge Meter

2.1. Air quality is being monitored on site using both automatic light scatter dust meters and Frisbee gauge dust deposition monitoring. Thirteen Frisbee gauges are set up at sensitive locations across the site to measure dust deposition rates (Figure 1). Seven automatic light scatter meters have also been installed at various sensitive locations to measure real time particulate matter (PM₁₀) concentrations and the Total Suspended Particle (TSP) concentrations (Figure 2). These meters are calibrated annually. Table 1 lists the air quality monitoring equipment present at each monitoring location, including the date it was installed.

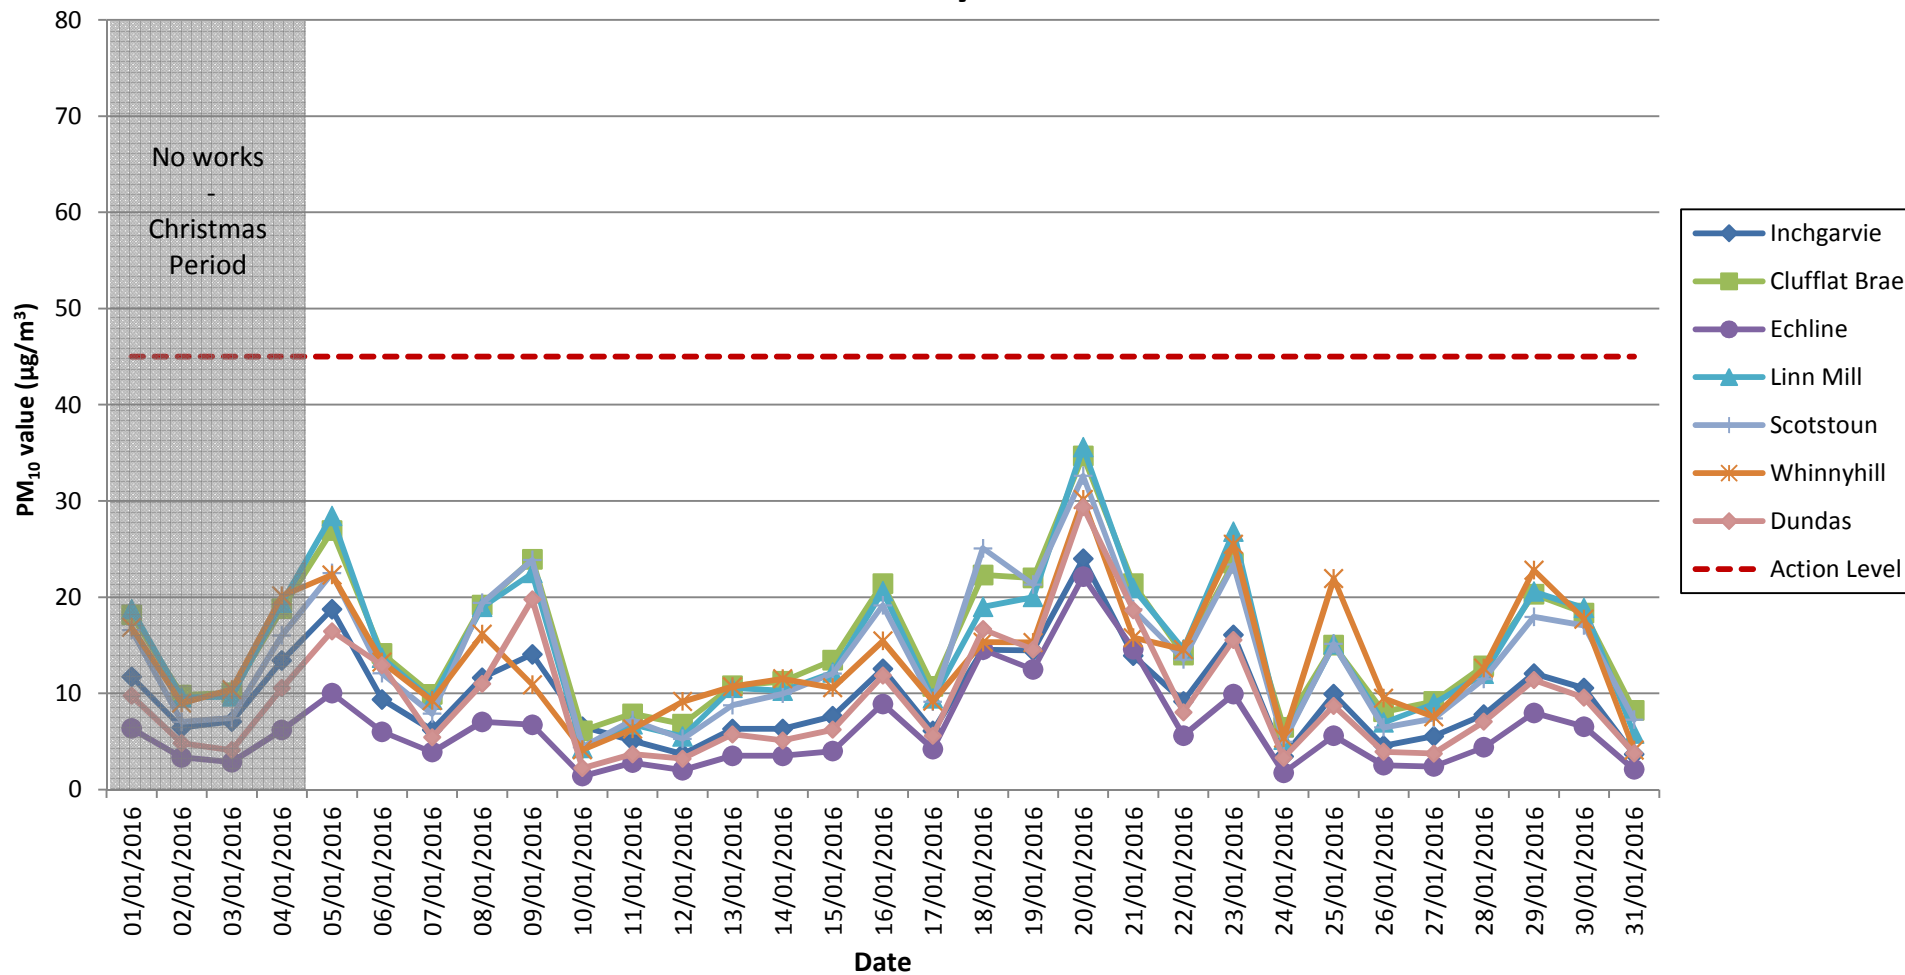
Particulate Matter (PM10) Results for all Monitoring Locations

3.1.1. Light scatter results for January 2016 have been presented in a monthly chart; this can be found in Appendix A. Results show that the PM₁₀ levels were well below threshold levels throughout January. All monitors follow the same pattern throughout the month.

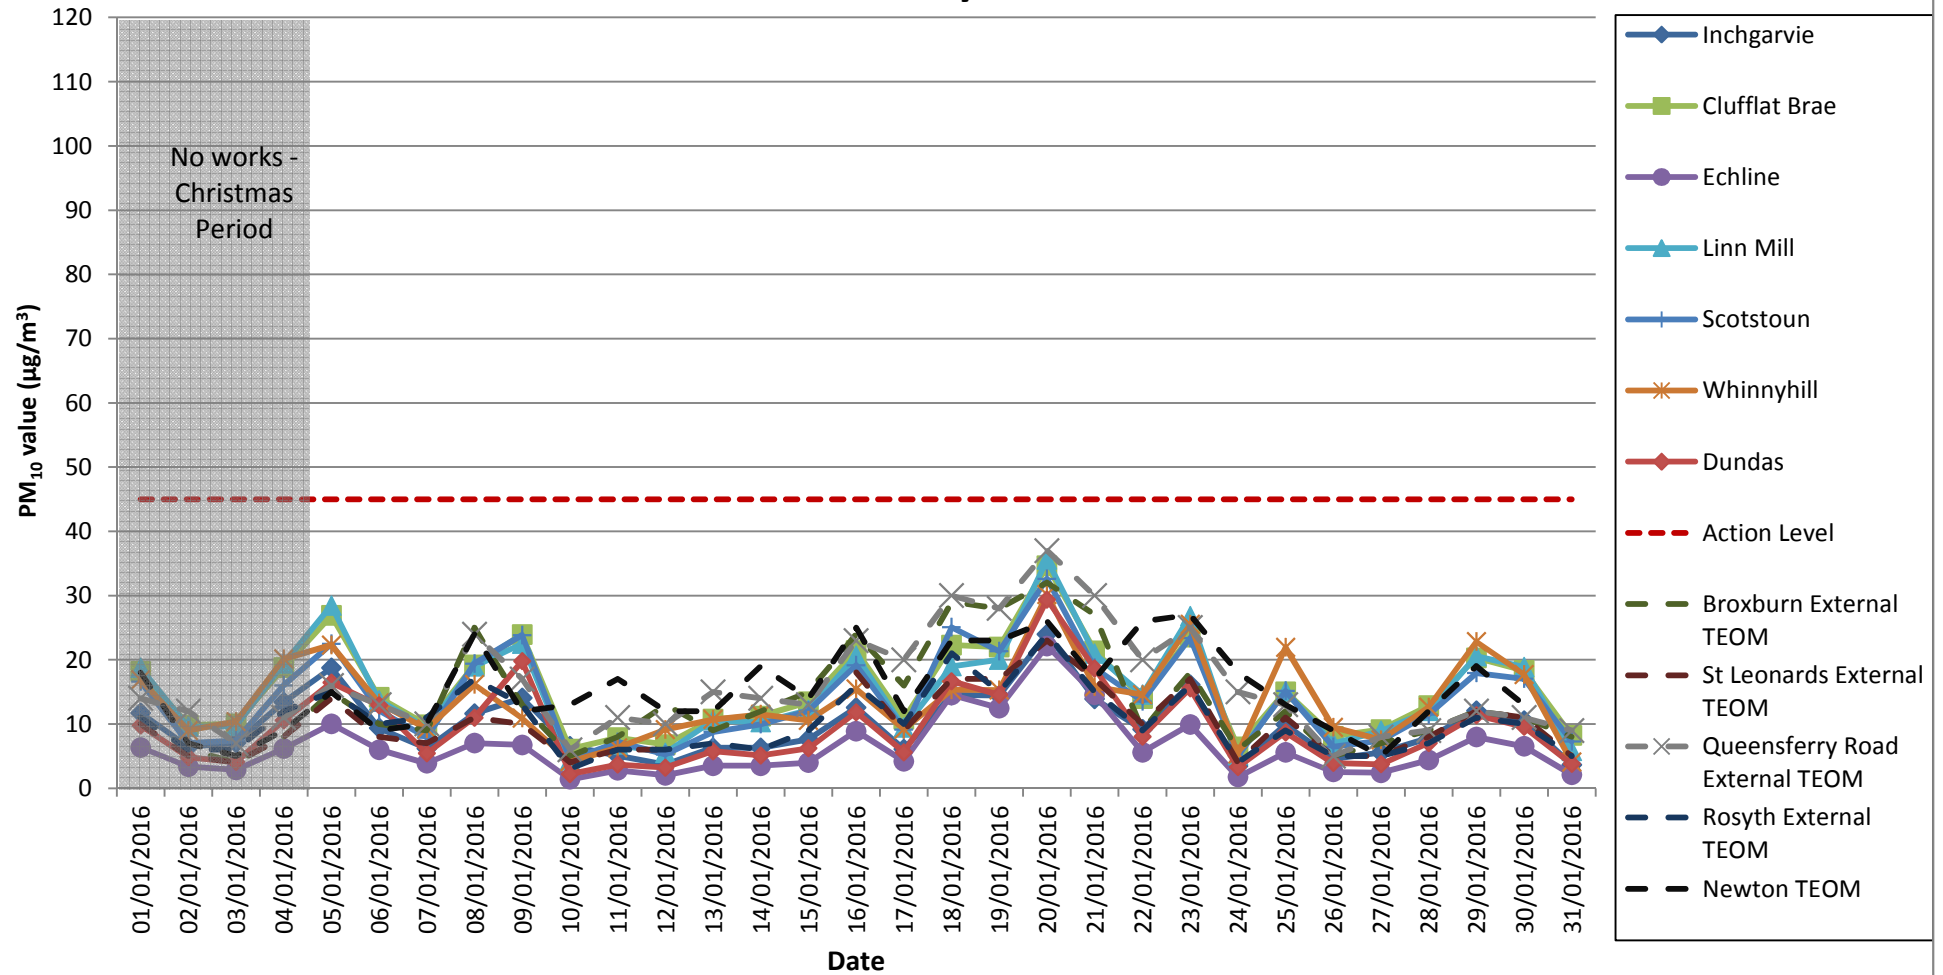
Air Quality Monitoring: Particulate Matter (PM10) Results for all Monitoring Locations, including TEOM data January 2016

3.1.2. The PM₁₀ results have also been compared to the daily mean results obtained from the TEOM air quality monitoring stations located in Newton, Rosyth, and Broxburn, and from the TEOM FDMS station located at Queensferry Road and St Leonards, Edinburgh (an urban background site). The TEOM at Newton was installed by West Lothian

Council, facilitated by FCBC, during January 2012. The comparison between the light scatter and TEOM results demonstrates that both sets of results generally follow the same pattern, indicating that the pattern observed throughout January was largely driven by regional changes in air quality.

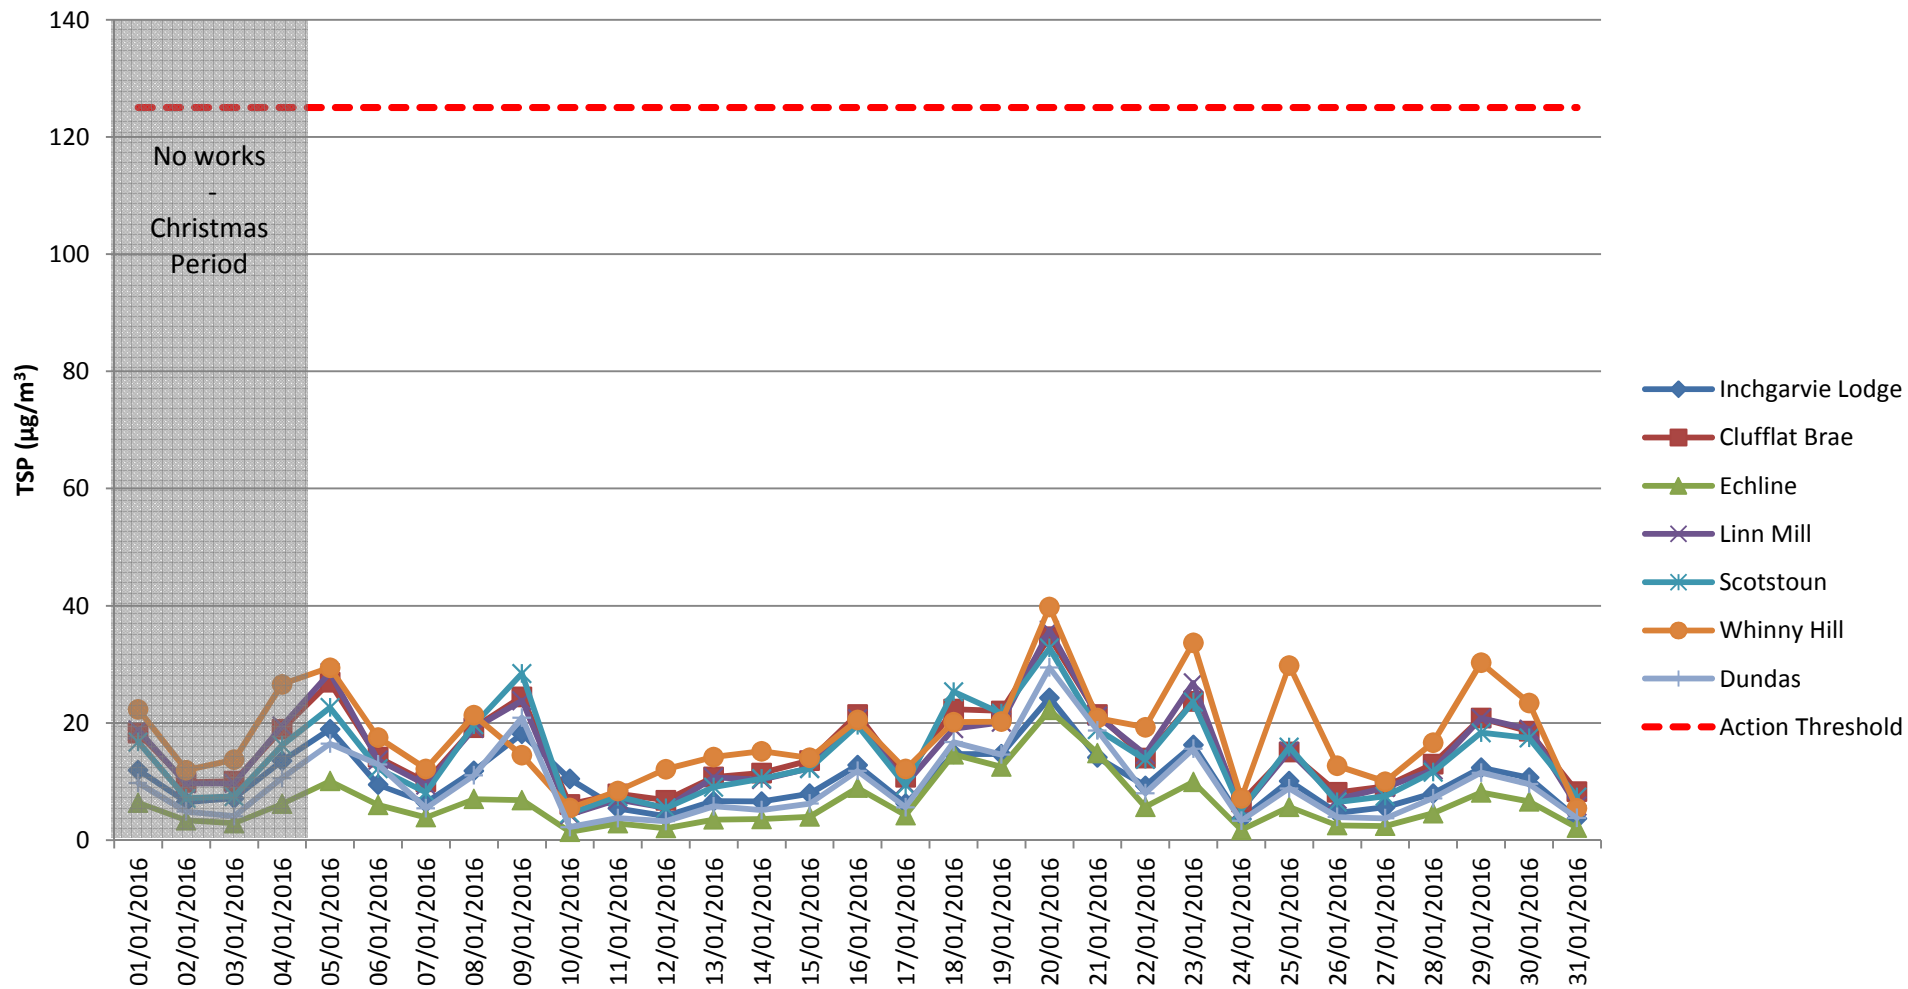
Total Suspended Particles (TSP) Results January 2016

3.2.1. The TSP results for January 2016 have been presented in a monthly chart; this can be found in Appendix B. The TSP levels at monitoring locations during January were found to be low and all within the threshold. All locations across the site were found to follow a similar pattern (similar to that observed for PM₁₀ levels). As with PM₁₀ it is considered that the TSP levels across site were influenced by regional changes in TSP levels.

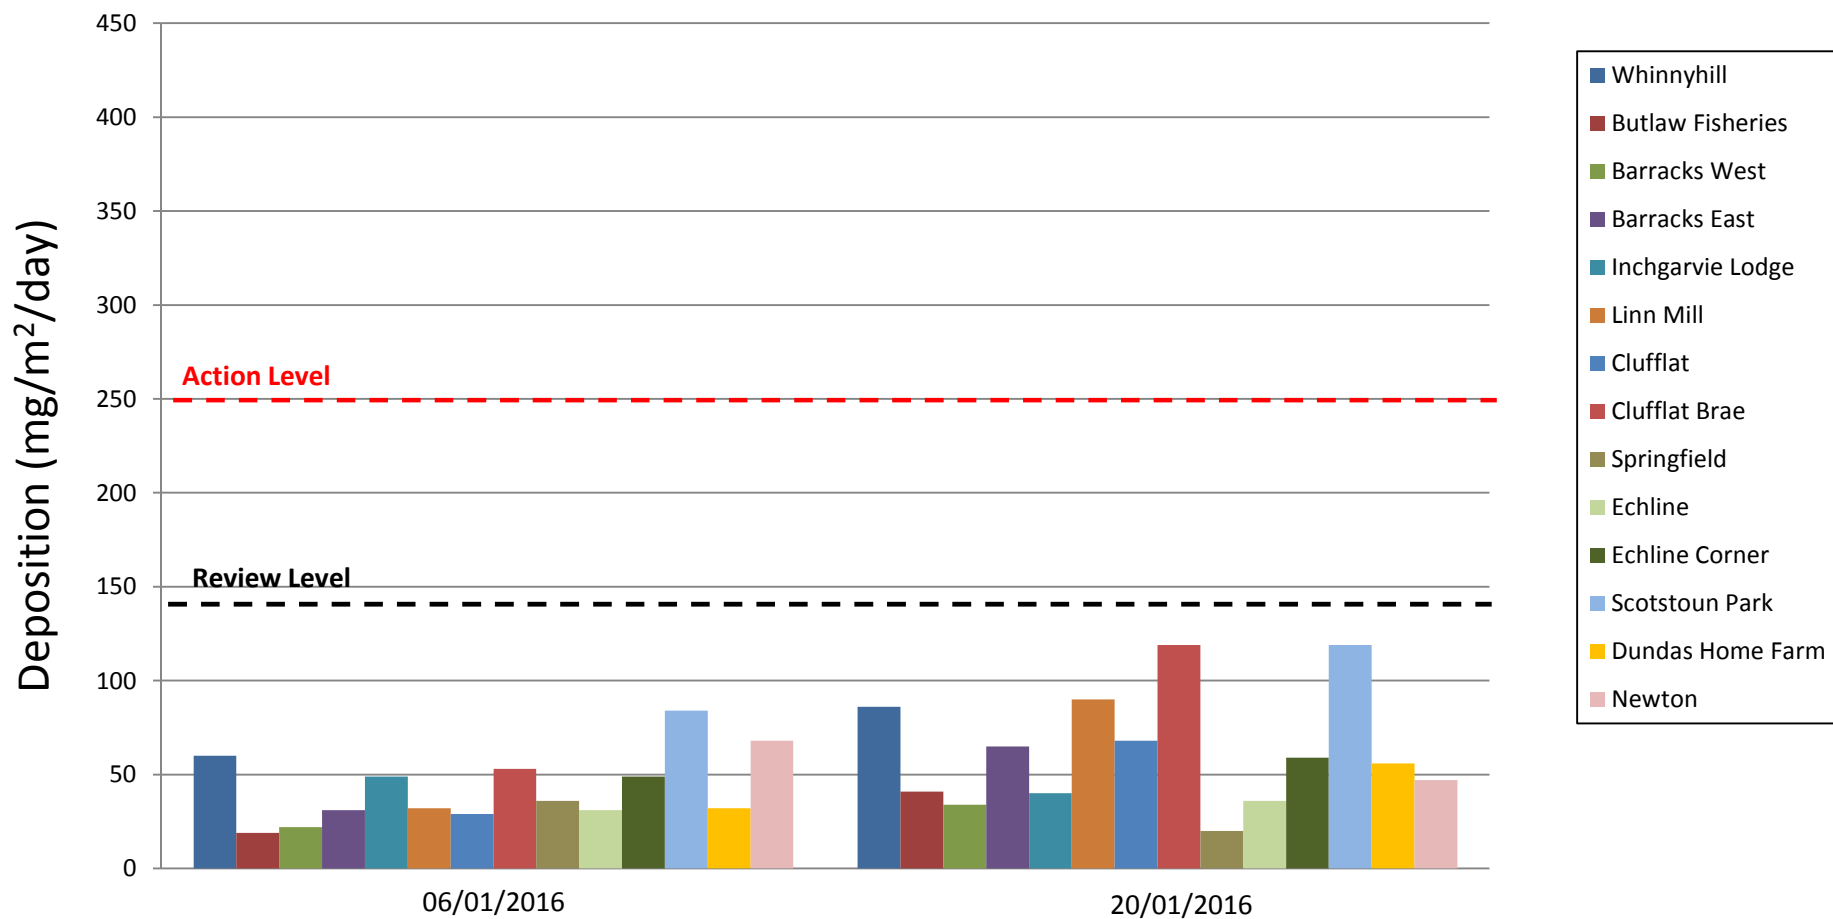
Frisbee Dust Deposition Results: January 2016

3.3.1. The Frisbee dust deposition results for January 2016 have been presented in a chart and can be found in Appendix C. This includes an additional Frisbee (Echline Corner) currently located south of the A904 in proximity to the Echline monitor. This temporary Frisbee is used to provide additional information and its results are presented alongside the 13 permanent monitors. Due to the progression of the project and the reduction of earthworks in the area, FCBC removed the temporary Echline corner monitor on 20 January 2016. FCBC also removed the Barracks East Frisbee on the 21st January 2016 as the location of the monitor is no longer accessible. The Barracks West Frisbee is located only 200m from the Barracks East Frisbee and will continue to provide dust deposition results for this area. Frisbee dust deposition results were collected fortnightly, and the results averaged over this fortnight period to give a daily dust deposition rate. Two collections were made in January; these occurred on the 6th and 20th January 2016.

3.3.2. The site action level for the dust deposition rate has been set at 250 mg/m²/day. Exceedances of this level are treated as a potential incident and a review of the works in the vicinity of the site is instigated. A lower site review level has been set at 140 mg/m²/day. Where concentrations exceed the lower review threshold the site works are reviewed to ensure good practice is implemented; it is essentially a warning that additional controls may be required.

3.3.3. During January there were no exceedances of either the site review or action levels.
