Project **FORTH REPLACEMENT CROSSING**

**AIR QUALITY MONITORING REPORT  
JUNE 2016**

**REP-00286** Rev  
**01**

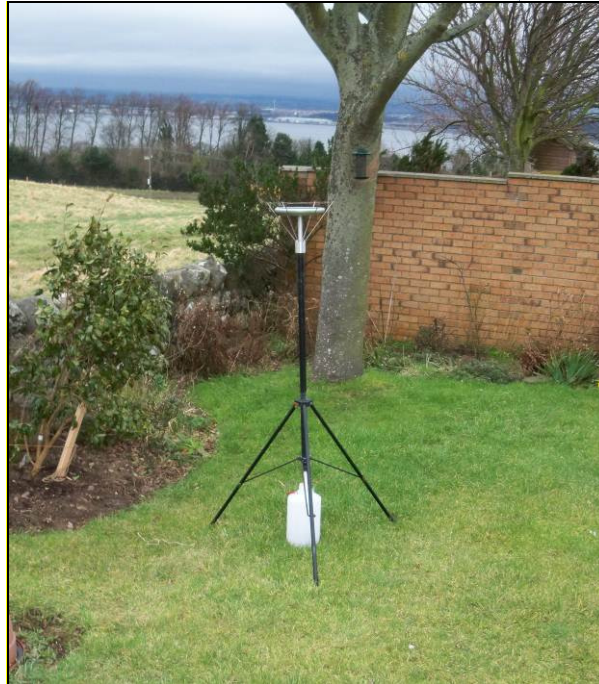
**Figure 1: Example of an Installed Frisbee Gauge Meter**

**2.1.** Air quality is being monitored on site using both automatic light scatter dust meters and Frisbee gauge dust deposition monitoring. Twelve Frisbee gauges are currently set up at sensitive locations across the site to measure dust deposition rates (Figure 1). Seven automatic light scatter meters have also been installed at various sensitive locations to measure real time particulate matter (PM<sub>10</sub>) concentrations and the Total Suspended Particle (TSP) concentrations (Figure 2). These meters are calibrated annually. Table 1 lists the air quality monitoring equipment present at each monitoring location, including the date it was installed.

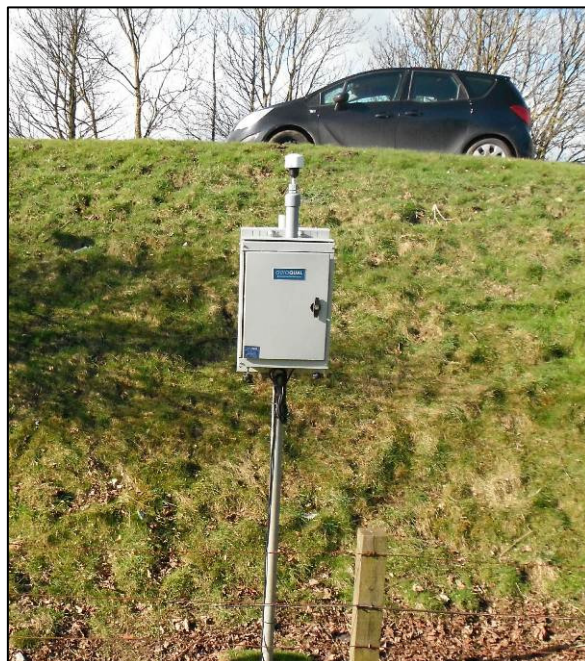
**Figure 2: Example of an installed Automatic Light Scatter Dust Meter**

**2.2.** Light scatter type monitoring equipment have been selected as a site monitoring tool to create a live network which assesses the levels of fugitive particulate matter, principally airborne dust. These monitors require less space, maintenance and power than other real time monitors such as a Tapered Element Oscillating Microbalance (TEOM) which is used and designed to measure particulate levels to exceedingly high standards, including measuring long-term compliance to statutory limits. Light scatter meters are more practicable to deploy. However, the meters do generally record levels higher than those measured by the TEOM. The meters can also be affected by atmospheric moisture content which further increases reported levels. Accordingly, any elevations of statutory limits should be treated as precautionary exceedances. The monitors are reliable for on-site monitoring and the establishment of action thresholds to ensure unforeseen activities generating significant dust are identified and suitably controlled. Light scatter meters are becoming the construction and waste industries norm for particulate dust monitoring.
