**Aberdeen Western Peripheral Route**  
**Environmental Statement Appendices 2007**  
**Part C: Southern Leg**  
**Appendix 30.2 – Ambient Noise Data**

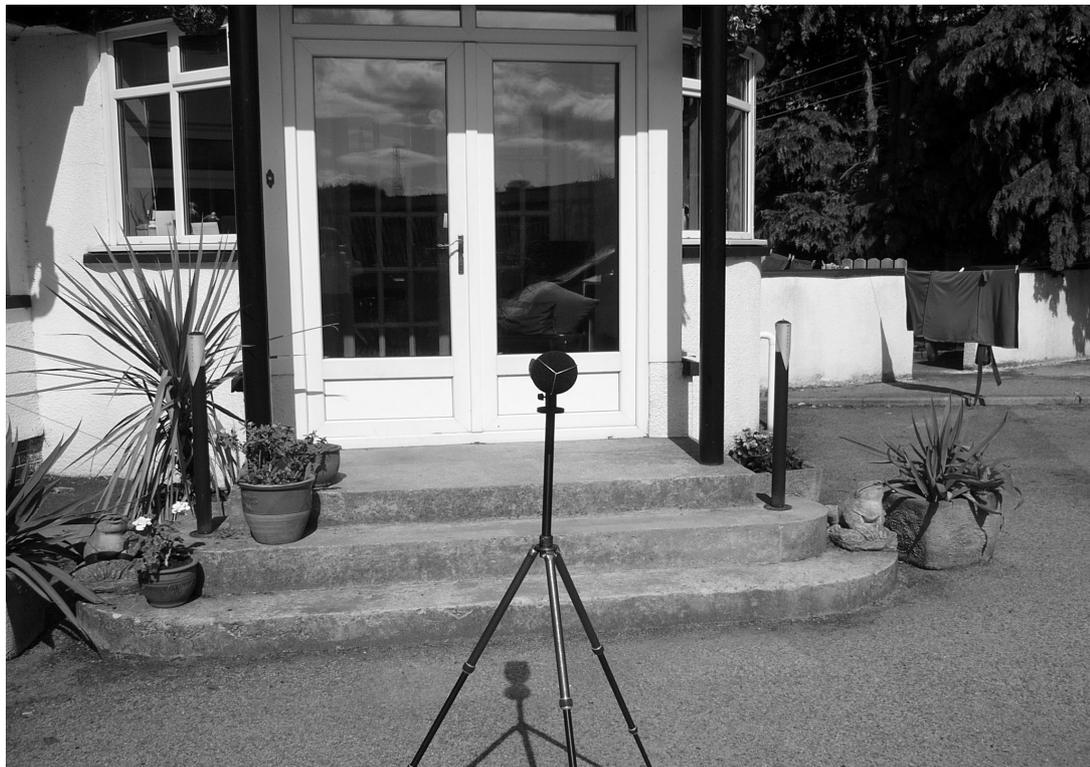
**Figure 1 – Measurement Location 1**

**Location 1 Westholme:** The measurement location was 3.5m from the west facing door of the property. The sound level meter was located 1.2m above the ground in free field conditions. The monitoring equipment was calibrated both before and after the measurement period using an acoustic calibrator, which has itself been calibrated against a reference set traceable to National and International Standards. There was no shift in the observed calibration level.

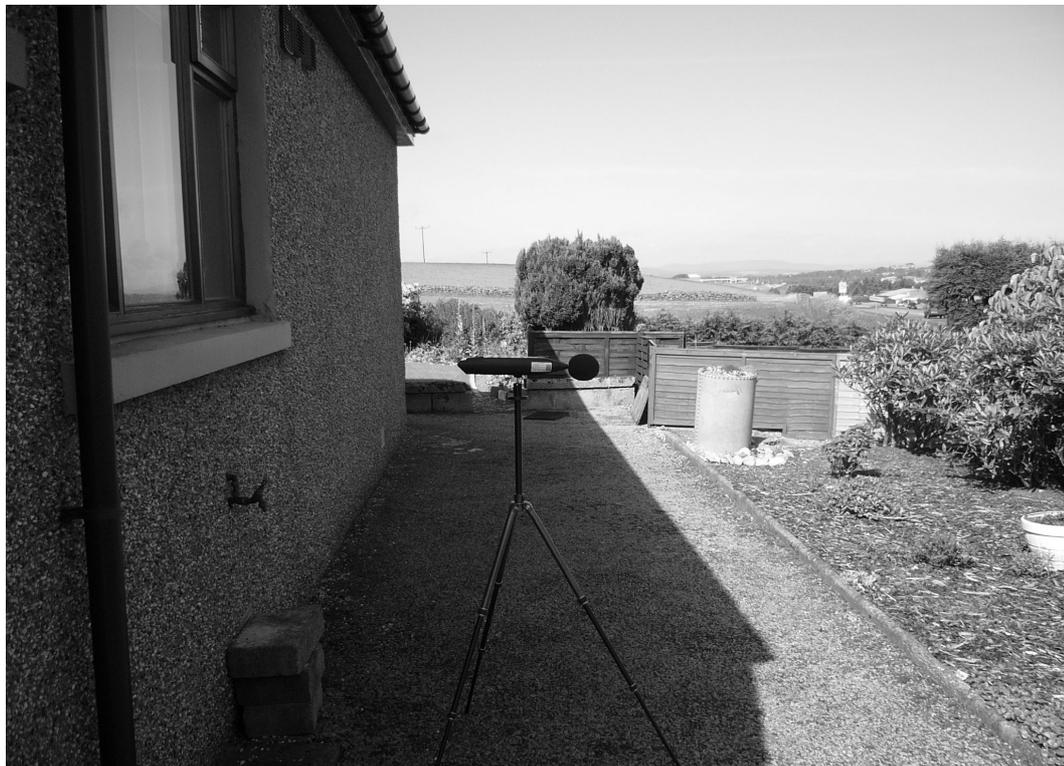
**Figure 2 – Measurement Location 2**

**Location 2 Ardenlea:** The A944 is located directly to the north of the property boundary. The measurement location was 1m from the north facing window within the grounds of the property. The sound level meter was located 1.2m above the ground at 1m from the façade. The monitoring equipment was calibrated both before and after the measurement period using an acoustic calibrator, which has itself been calibrated against a reference set traceable to National and International Standards. There was no shift in the observed calibration level.

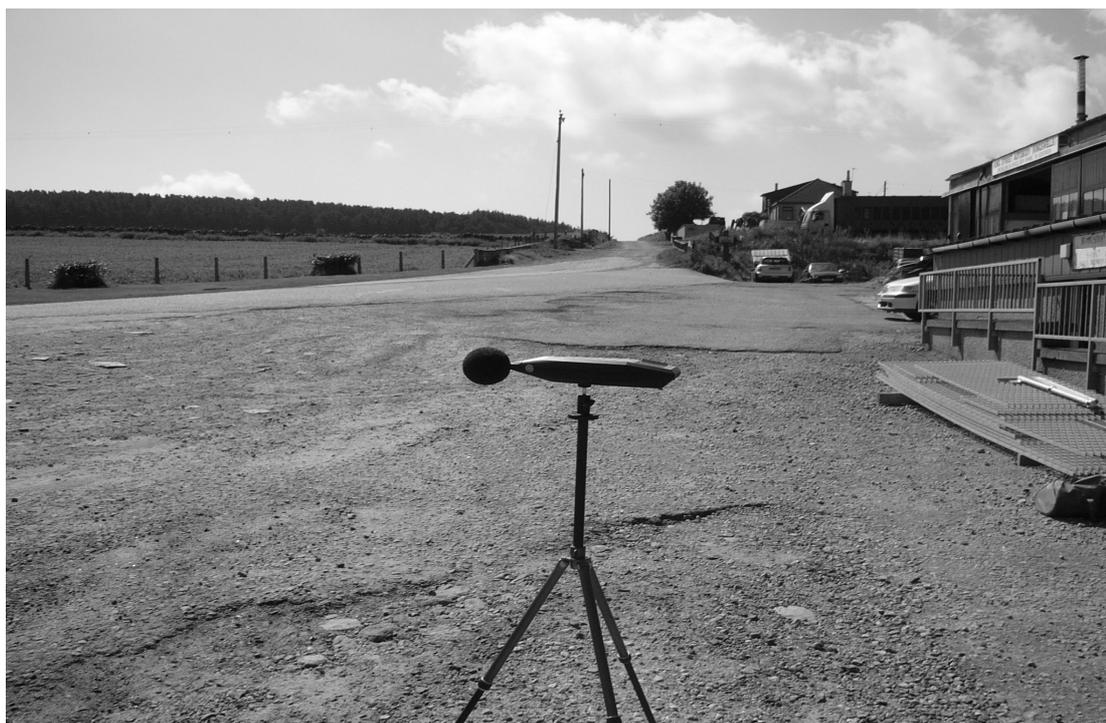
**Figure 3 – Measurement Location 3**

**Location 3 Clark & Sutherland:** The A944 is situated approximately 40m to the north of the property boundary. The measurement location was 4.1m from the east facing door of the property. The sound level meter was located 1.2m above the ground in free field conditions. The monitoring equipment was calibrated both before and after the measurement period using an acoustic calibrator, which has itself been calibrated against a reference set traceable to National and International Standards. There was no shift in the observed calibration level.

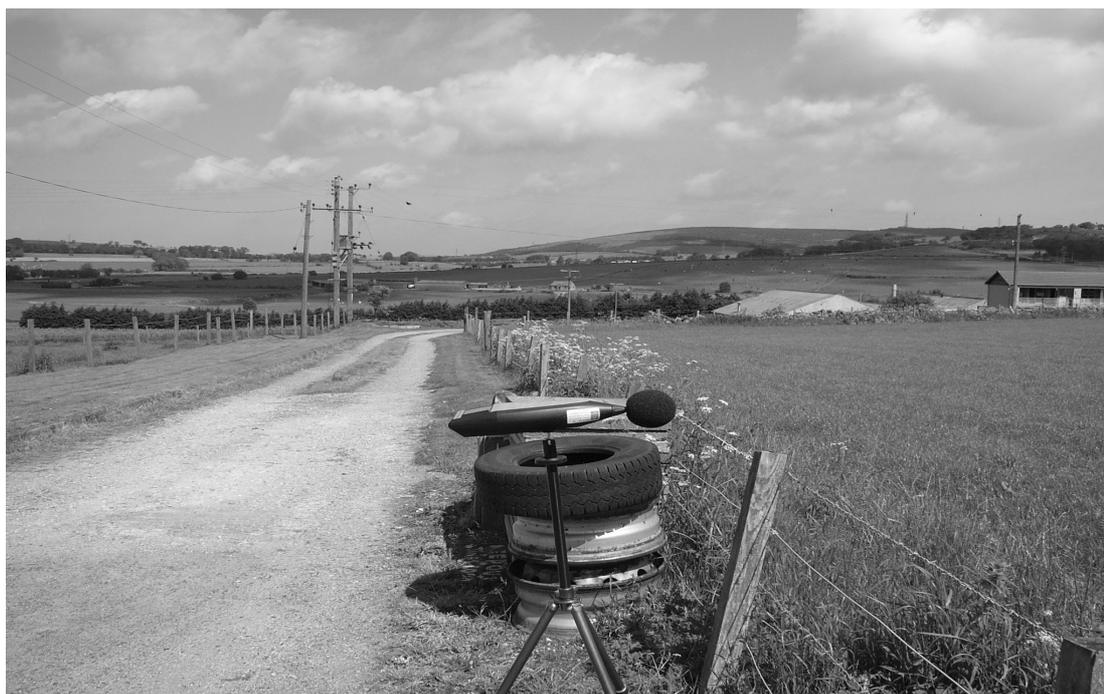
**Figure 4 – Measurement Location 4**

**Location 4 Hillview:** The measurement location was 7.7m from the north east facing window of the property. The sound level meter was located 1.2m above the ground in free field conditions. The monitoring equipment was calibrated both before and after the measurement period using an acoustic calibrator, which has itself been calibrated against a reference set traceable to National and International Standards. There was no shift in the observed calibration level.

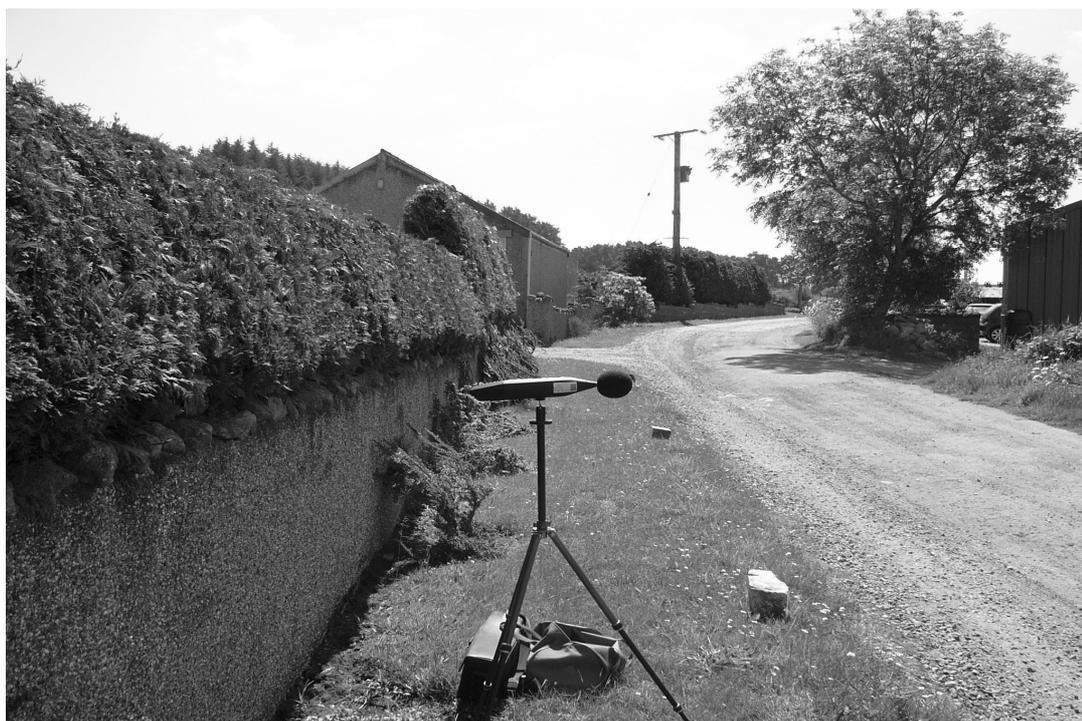
**Figure 5 – Measurement Location 5**

**Location 5 Benview:** There is an access road to other properties passing directly to the west of the property. The measurement location was 1m in front of the western boundary wall of the property and 1m from the façade of the house was a further 5m behind the wall. The sound level meter was located 1.2m above the ground, at 1m from the facade. The monitoring equipment was calibrated both before and after the measurement period using an acoustic calibrator, which has itself been calibrated against a reference set traceable to National and International Standards. There was no shift in the observed calibration level.

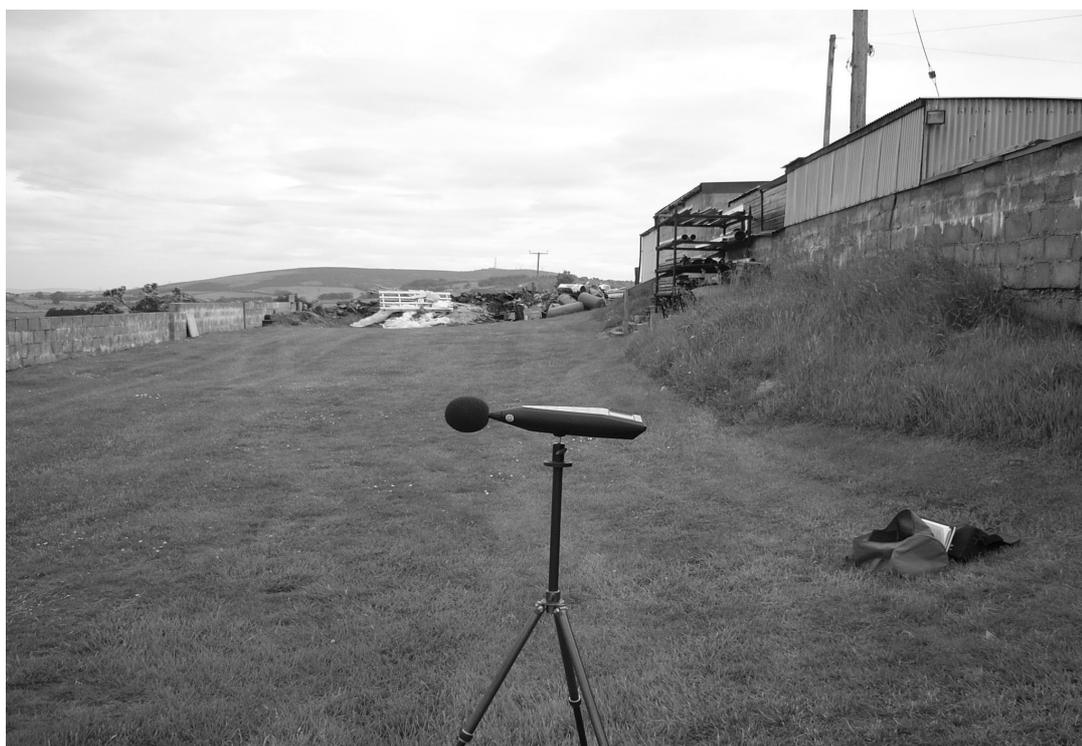
**Figure 6 – Measurement Location 6**

**Location 6 Tigh – na – Bruaich:** There is an access road to other properties passing directly to the east of the property. The measurement location was 8.9m from the west facing window of the property. The sound level meter was located 1.2m above the ground in free field conditions. The monitoring equipment was calibrated both before and after the measurement period using an acoustic calibrator, which has itself been calibrated against a reference set traceable to National and International Standards. There was no shift in the observed calibration level.

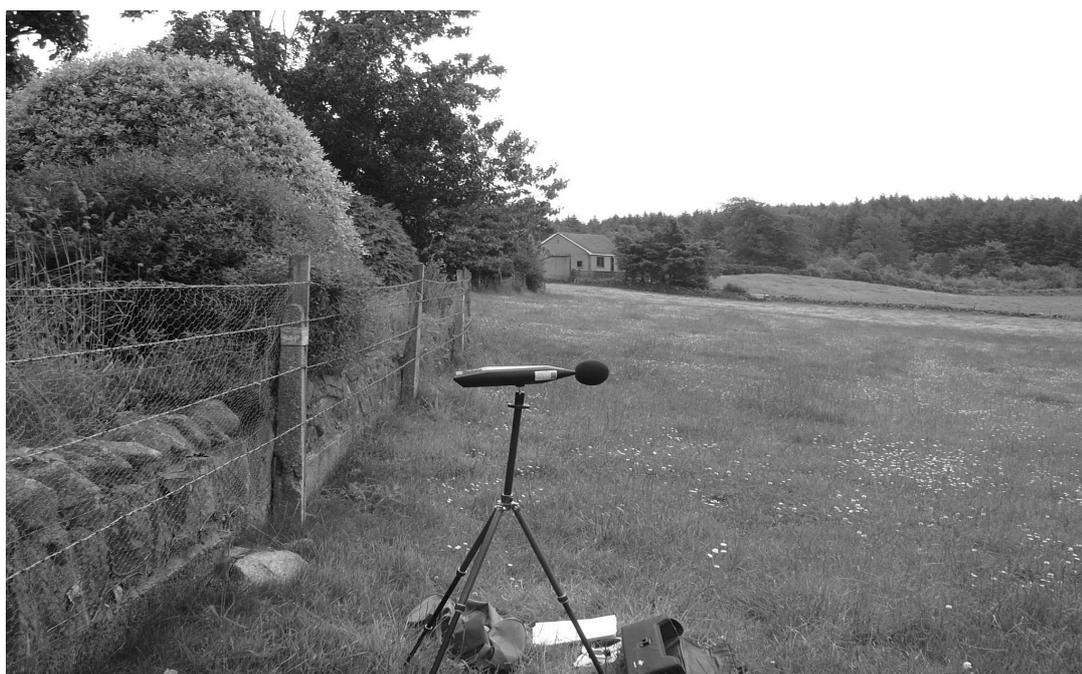
**Figure 7 – Measurement Location 7**

**Location 7 Craiglug:** The measurement location was 1m from the west facing boundary wall of the property, the façade of the house was a further 15m behind the boundary wall. The sound level meter was located 1.2m above the ground, in façade conditions. The monitoring equipment was calibrated both before and after the measurement period using an acoustic calibrator, which has itself been calibrated against a reference set traceable to National and International Standards. There was no shift in the observed calibration level.

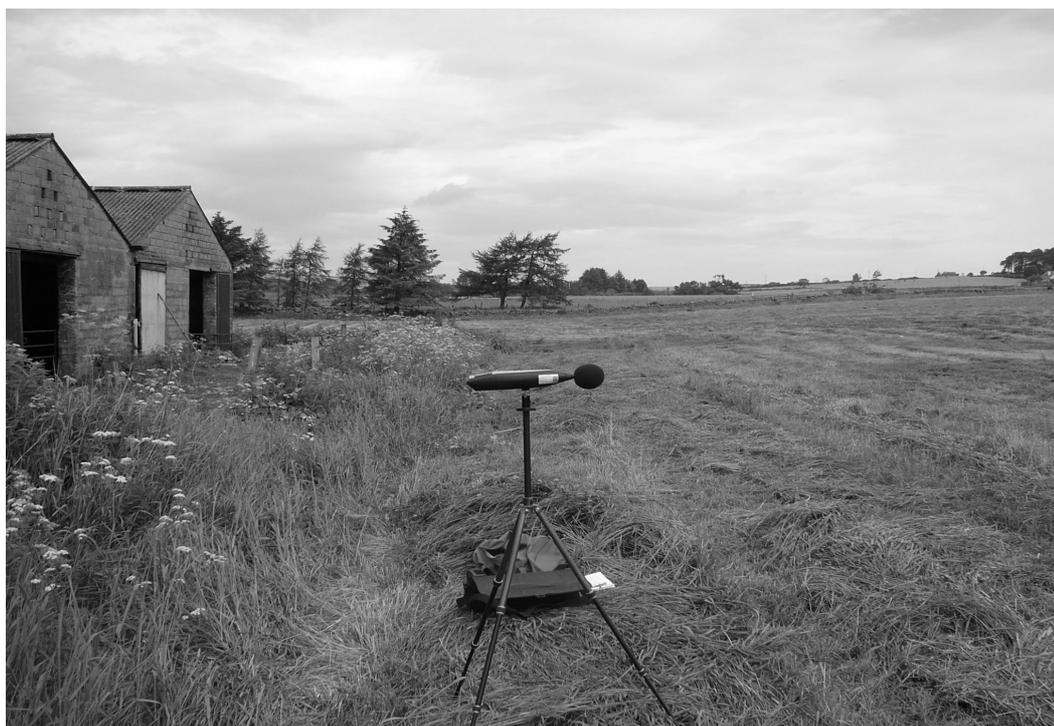
**Figure 8 – Measurement Location 8**

**Location 8 Gairn Farm:** The measurement location was 3.5m from the east facing wall of the property. The sound level meter was located 1.2m above the ground in free field conditions. The monitoring equipment was calibrated both before and after the measurement period using an acoustic calibrator, which has itself been calibrated against a reference set traceable to National and International Standards. There was no shift in the observed calibration level.

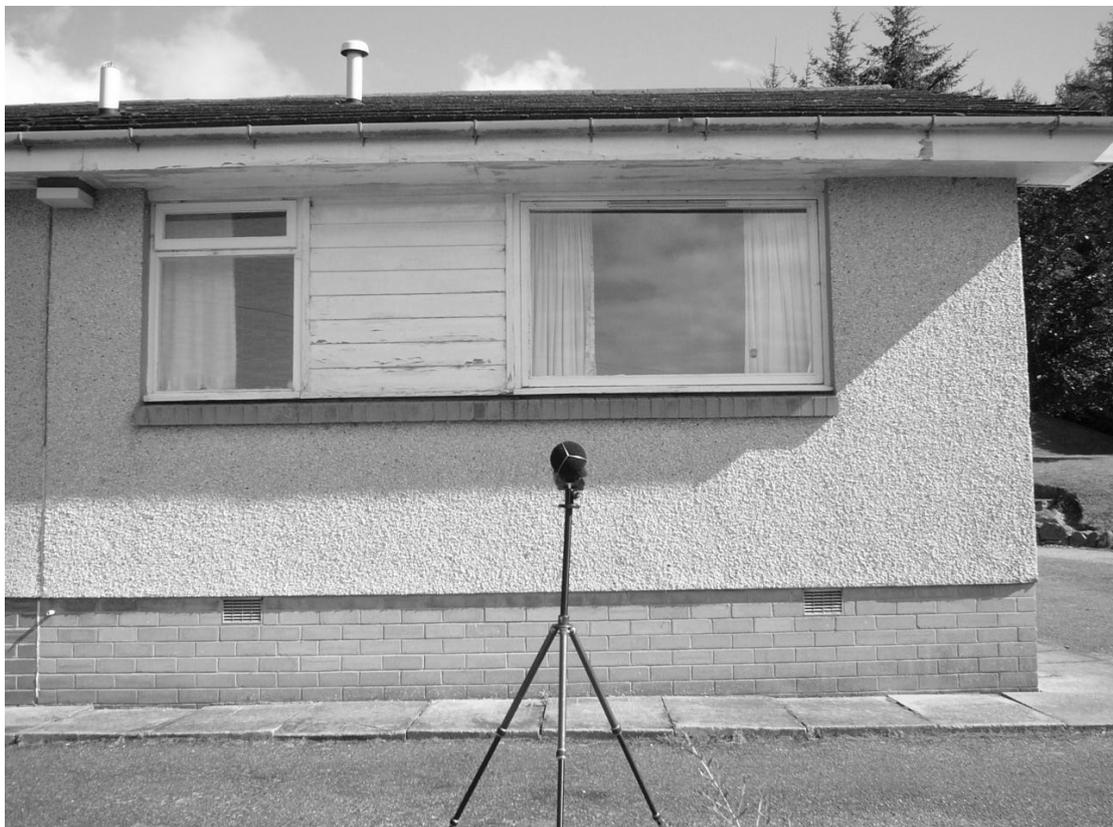
**Figure 9 – Measurement Location 9**

**Location 9 Broomhill:** The measurement location was 3.5m from the west facing windows of the property. The sound level meter was located 1.2m above the ground in free field conditions. The monitoring equipment was calibrated both before and after the measurement period using an acoustic calibrator, which has itself been calibrated against a reference set traceable to National and International Standards. There was no shift in the observed calibration level.

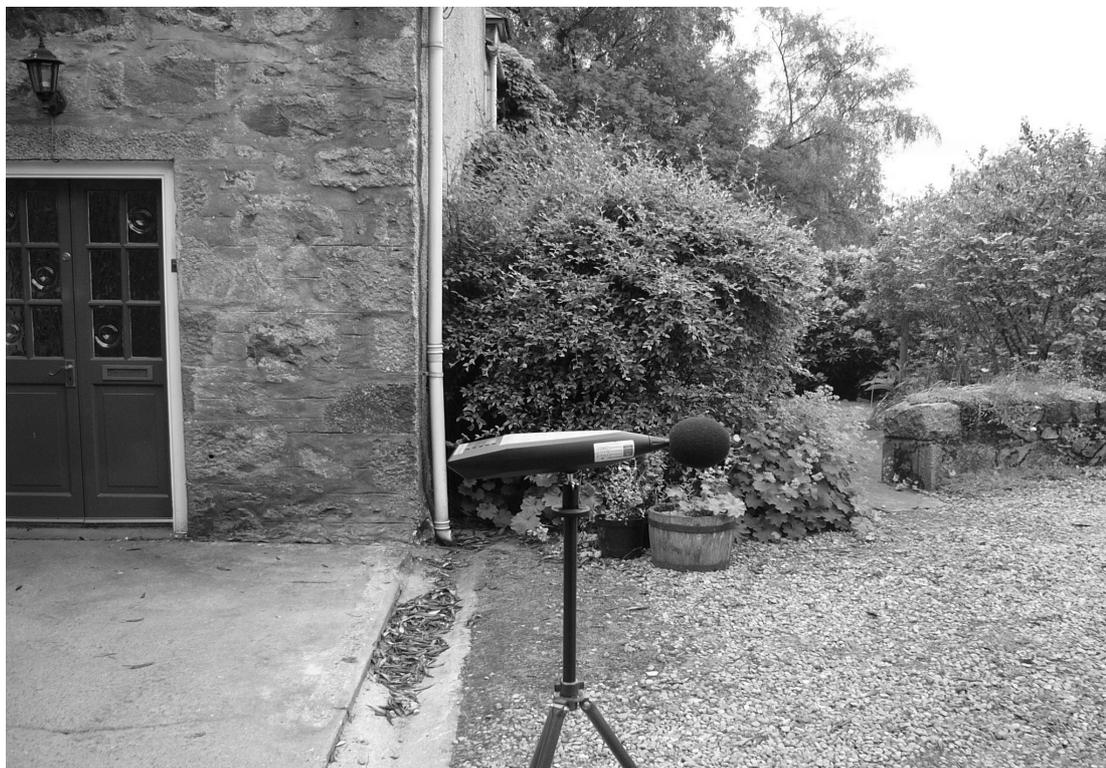
**Figure 10 – Measurement Location 10**

**Location 10 Ardnamoine:** The measurement location was 3.5m from the west facing window of the property. The sound level meter was located 1.2m above the ground in free field conditions. The monitoring equipment was calibrated both before and after the measurement period using an acoustic calibrator, which has itself been calibrated against a reference set traceable to National and International Standards. There was no shift in the observed calibration level.

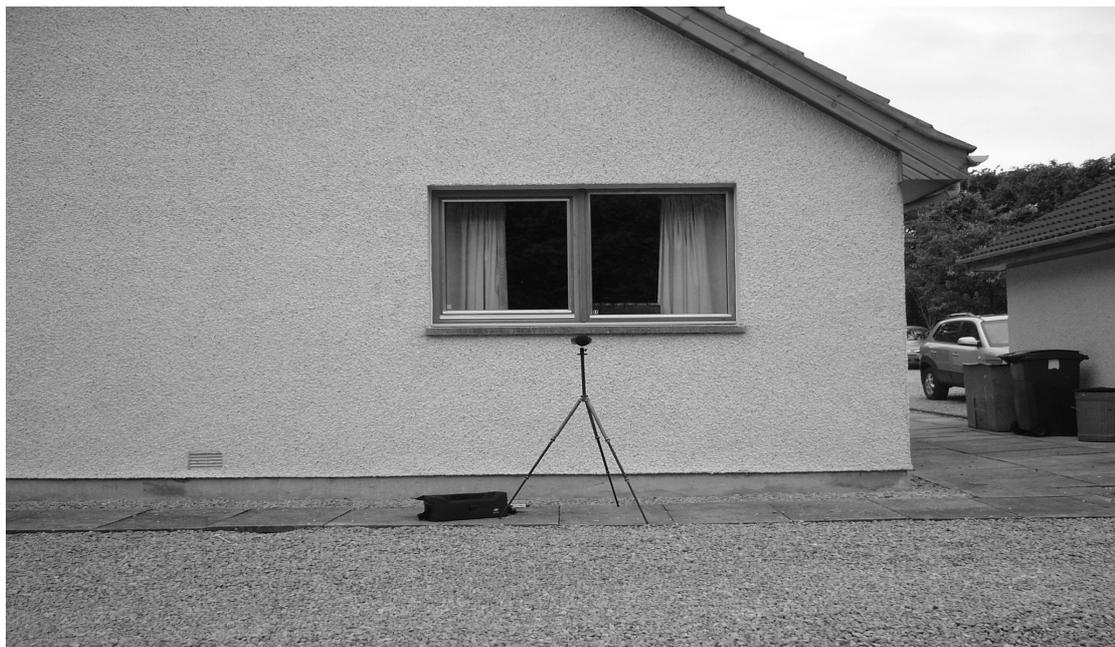
**Figure 11 – Measurement Location 11**

**Location 11 Gairn Park:** There is an access road to other properties situated directly north of the property. The measurement location was 1m from the east facing window of the property. The sound level meter was located 1.2m above the ground at 1m from the façade. The monitoring equipment was calibrated both before and after the measurement period using an acoustic calibrator, which has itself been calibrated against a reference set traceable to National and International Standards. There was no shift in the observed calibration level.

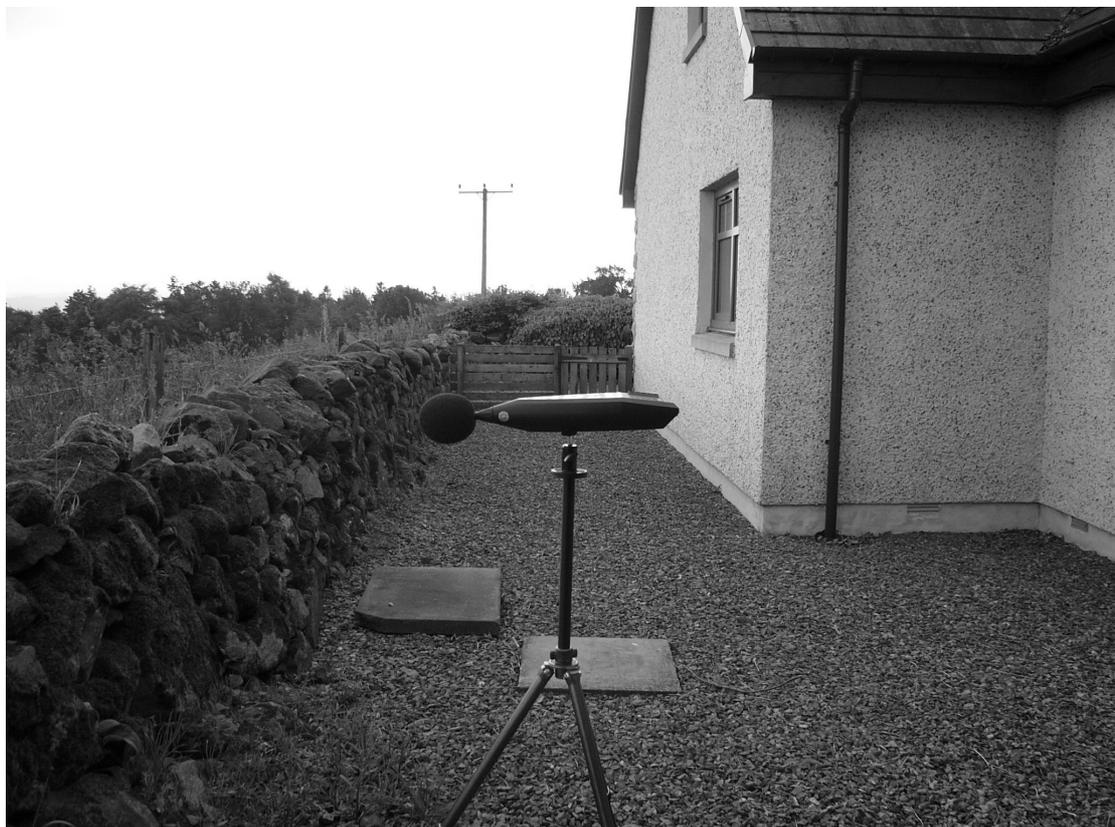
**Figure 12 – Measurement Location 12**

**Location 12 Beanshill Lodge:** The measurement location was 3.5m from the east facing window of the property. The sound level meter was located 1.2m above the ground in free field conditions. The monitoring equipment was calibrated both before and after the measurement period using an acoustic calibrator, which has itself been calibrated against a reference set traceable to National and International Standards. There was no shift in the observed calibration level.

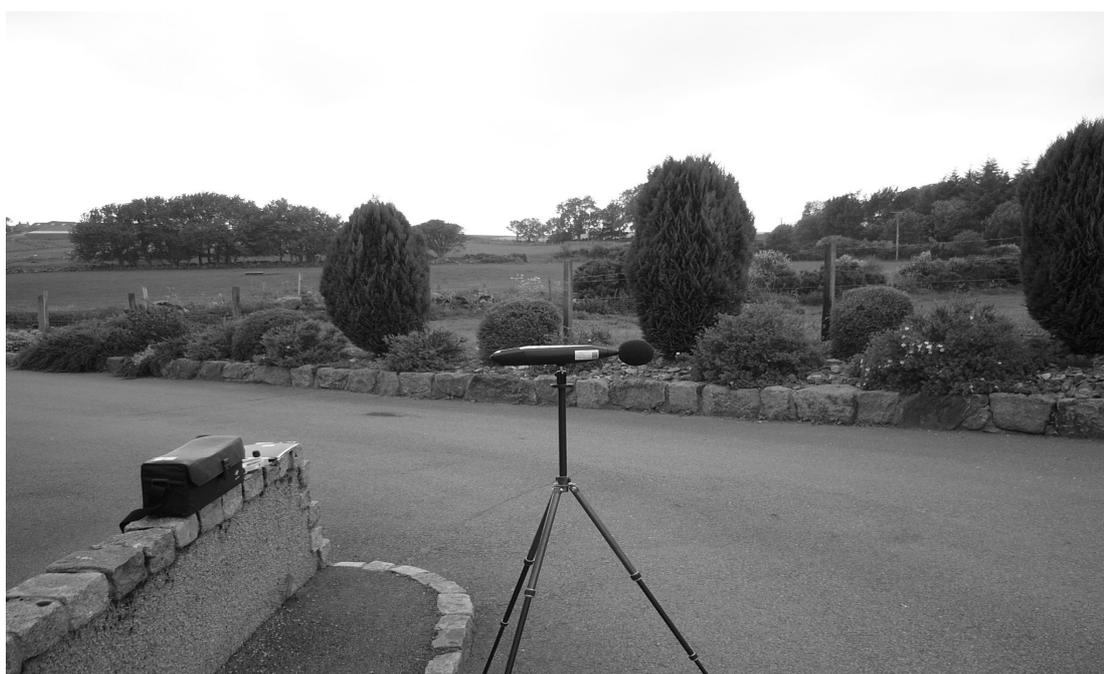
**Figure 13 – Measurement Location 13**

**Location 13 Hill Farm:** There is an access road to other properties situated directly north west of the property boundary. The measurement location was 8m from the south west facing windows of the property. The sound level meter was located 1.2m above the ground in free field conditions. The monitoring equipment was calibrated both before and after the measurement period using an acoustic calibrator, which has itself been calibrated against a reference set traceable to National and International Standards. There was no shift in the observed calibration level.

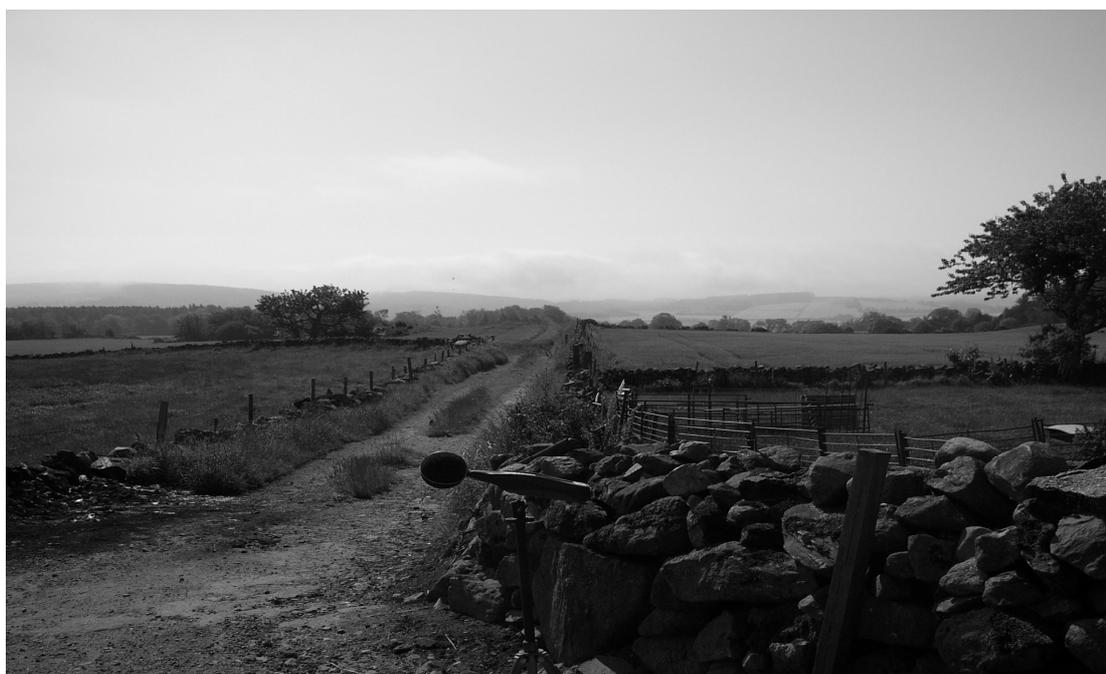
**Figure 14 – Measurement Location 14**

**Location 14 Neather Beanshill Farm:** The measurement location was 55m from the east facing windows of the property. The sound level meter was located 1.2m above the ground in free field conditions. The monitoring equipment was calibrated both before and after the measurement period using an acoustic calibrator, which has itself been calibrated against a reference set traceable to National and International Standards. There was no shift in the observed calibration level.

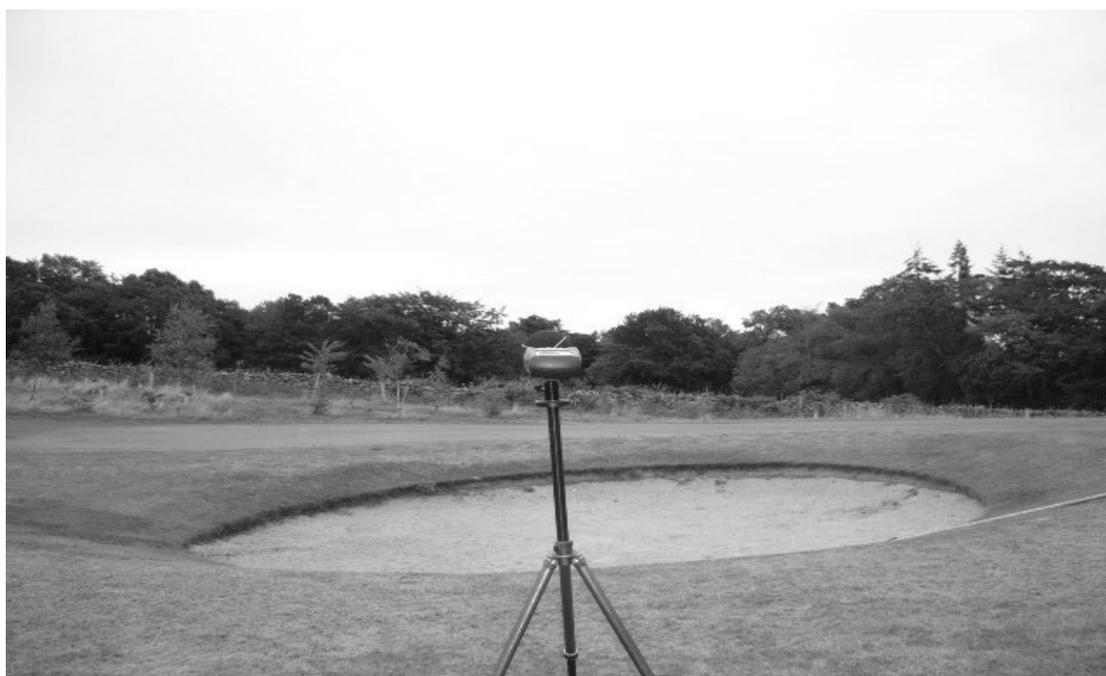
**Figure 15 – Measurement Location 15**

**Location 15 Golf Course:** The measurement location was approximately 45m from the eastern edge of the golf course boundary, which was 3.5m from the western edge of the bunker on the 7<sup>th</sup> hole. The sound level meter was located 1.2m above the ground in free field conditions. The monitoring equipment was calibrated both before and after the measurement period using an acoustic calibrator, which has itself been calibrated against a reference set traceable to National and International Standards. There was no shift in the observed calibration level.

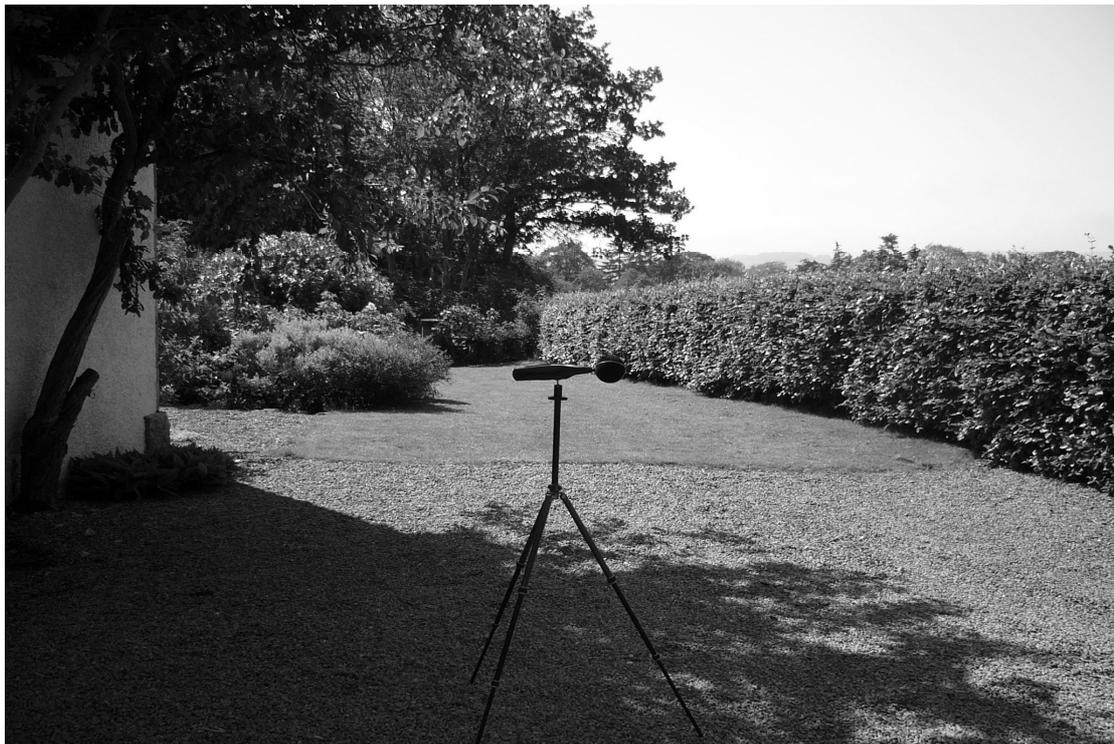
**Figure 16 – Measurement Location 16**

**Location 16 Croft House:** Culter House Road is situated directly south of the property boundary. The measurement location was 3.5m from the east facing door of the property. The sound level meter was located 1.2m above the ground in free field conditions. The monitoring equipment was calibrated both before and after the measurement period using an acoustic calibrator, which has itself been calibrated against a reference set traceable to National and International Standards. There was no shift in the observed calibration level.

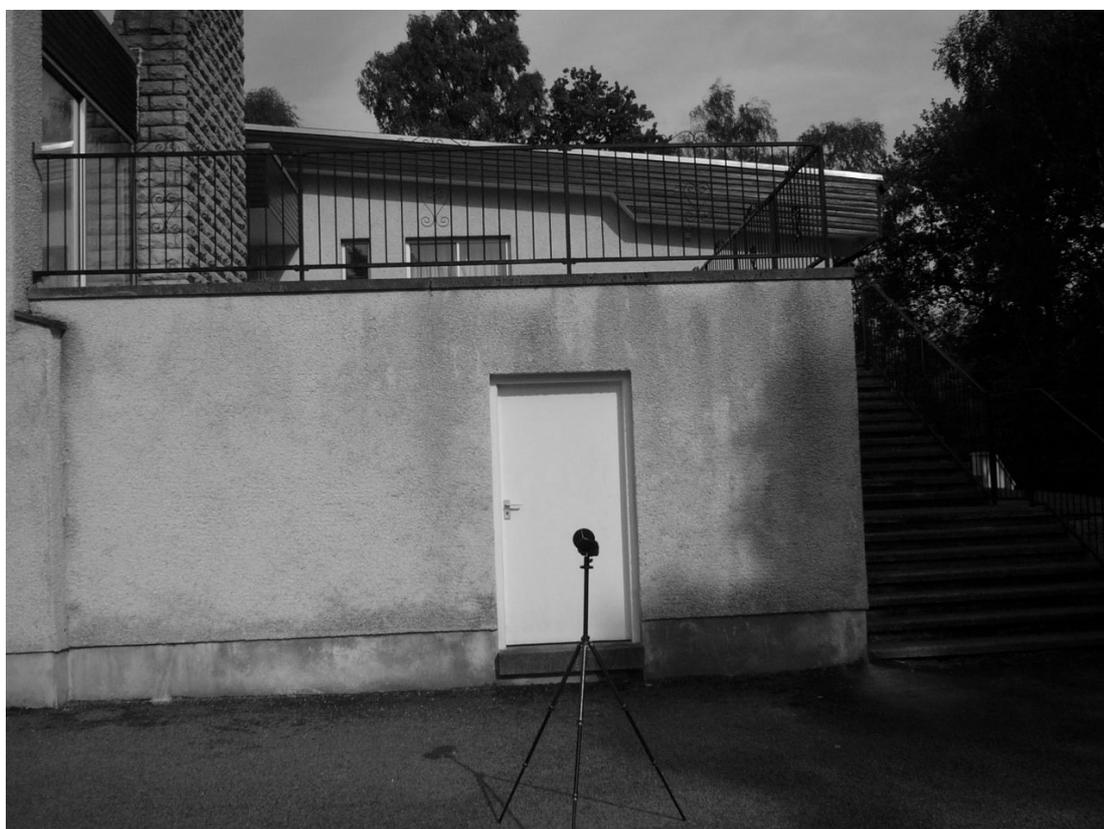
**Figure 17 – Measurement Location 17**

**Location 17 69B Culter House Road:** The measurement location was 3.5m from the western facing door of the property. The sound level meter was located 1.2m above the ground in free field conditions. The monitoring equipment was calibrated both before and after the measurement period using an acoustic calibrator, which has itself been calibrated against a reference set traceable to National and International Standards. There was no shift in the observed calibration level.

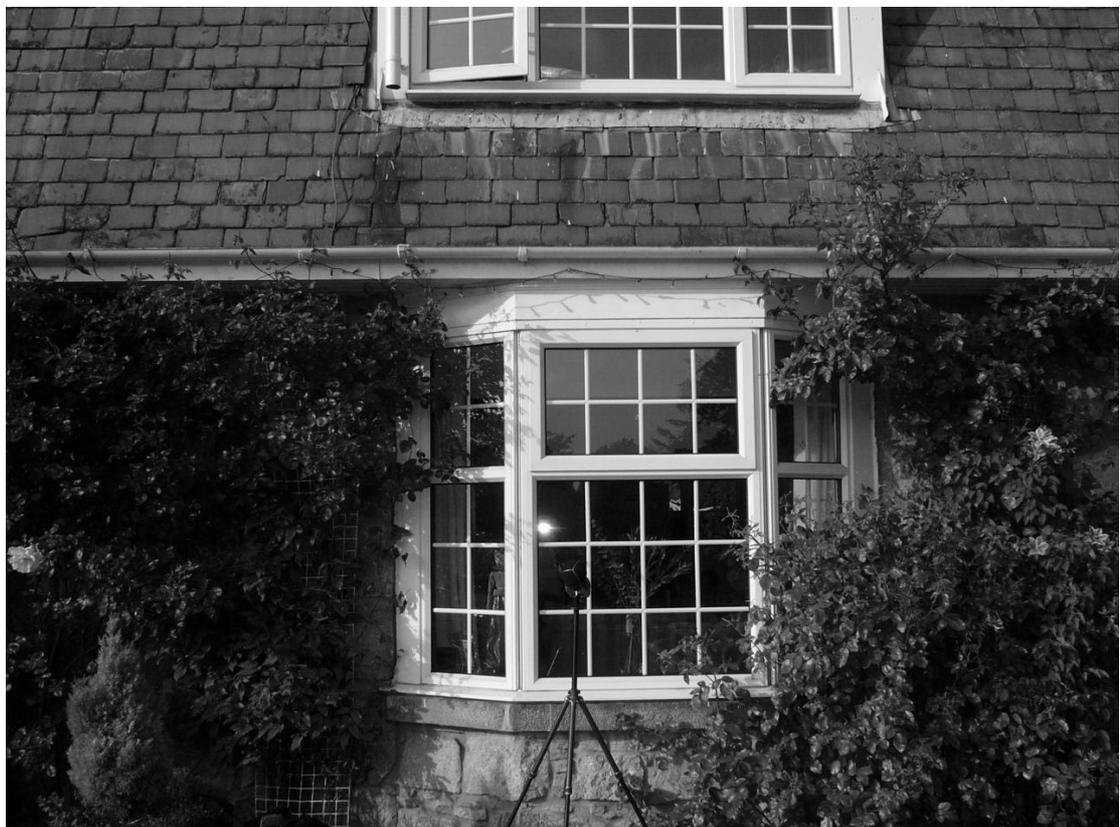
**Figure 18 – Measurement Location 18**

**Location 18 East Lodge:** The measurement location was 1m from the south facing windows and doors of the property. The sound level meter was located 1.2m above the ground in façade conditions. The monitoring equipment was calibrated both before and after the measurement period using an acoustic calibrator, which has itself been calibrated against a reference set traceable to National and International Standards. There was no shift in the observed calibration level.

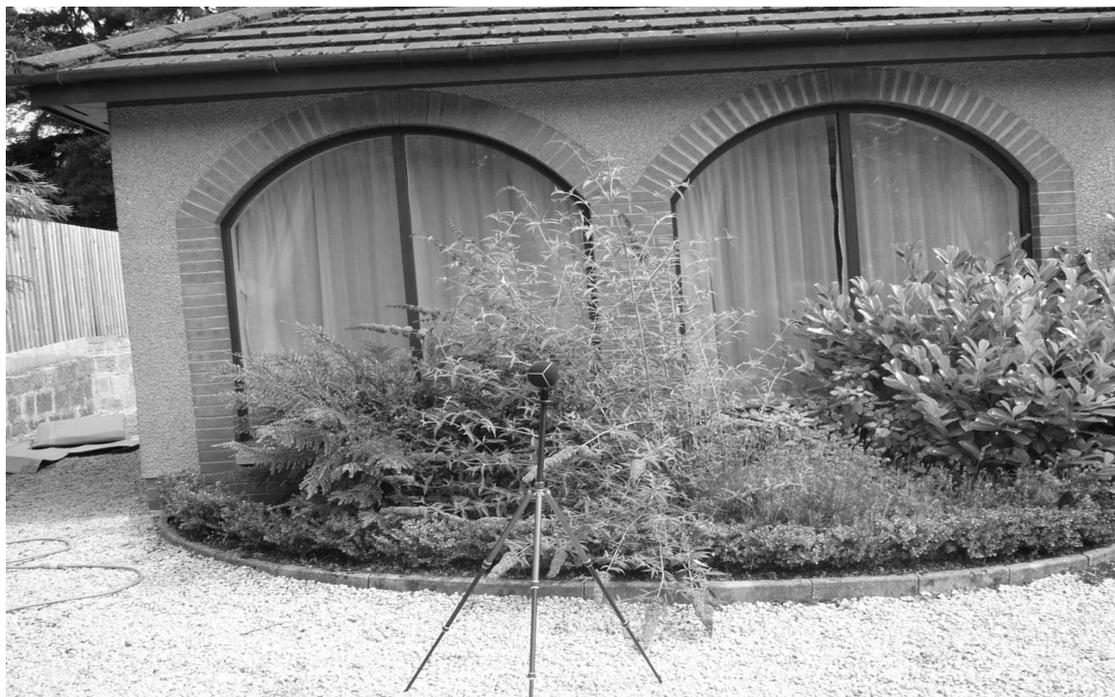
**Figure 19 – Measurement Location 19**

**Location 19 The Stables:** The measurement location was 3.5m from the west facing windows of the property. The sound level meter was located 1.2m above the ground in free field conditions. The monitoring equipment was calibrated both before and after the measurement period using an acoustic calibrator, which has itself been calibrated against a reference set traceable to National and International Standards. There was no shift in the observed calibration level.

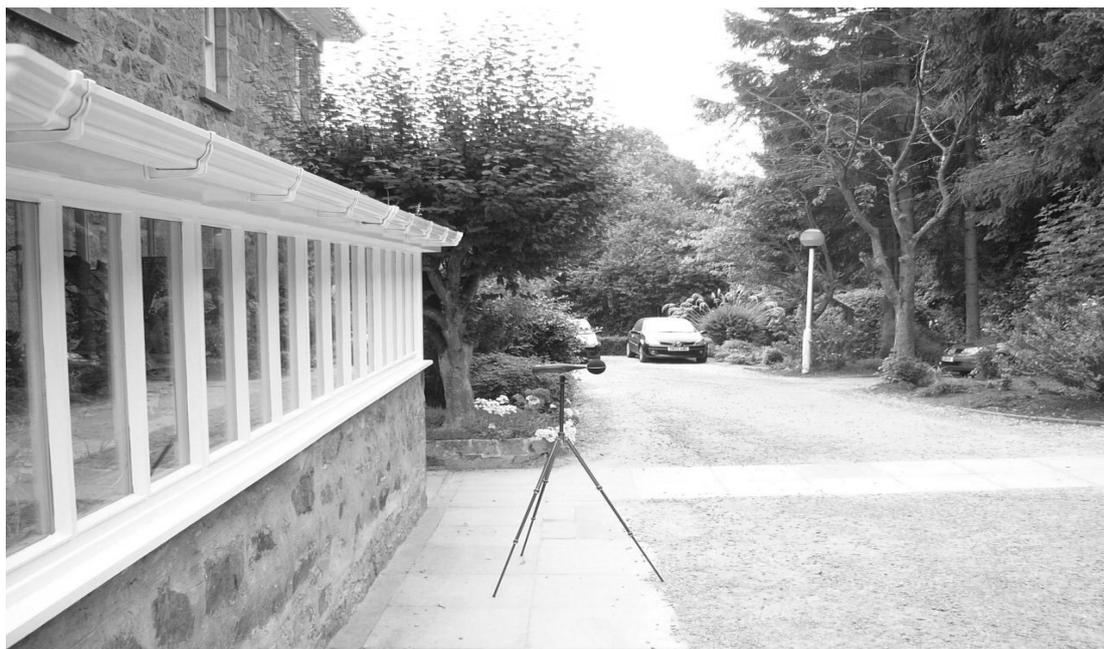
**Figure 20 – Measurement Location 20**

**Location 20 Hawkhill House Residential Nursing Home:** Culter House Road is situated to the north of the property. The measurement location was 1m from the west facing conservatory of the property. The sound level meter was located 1.2m above the ground in façade conditions. The monitoring equipment was calibrated both before and after the measurement period using an acoustic calibrator, which has itself been calibrated against a reference set traceable to National and International Standards. There was no shift in the observed calibration level.

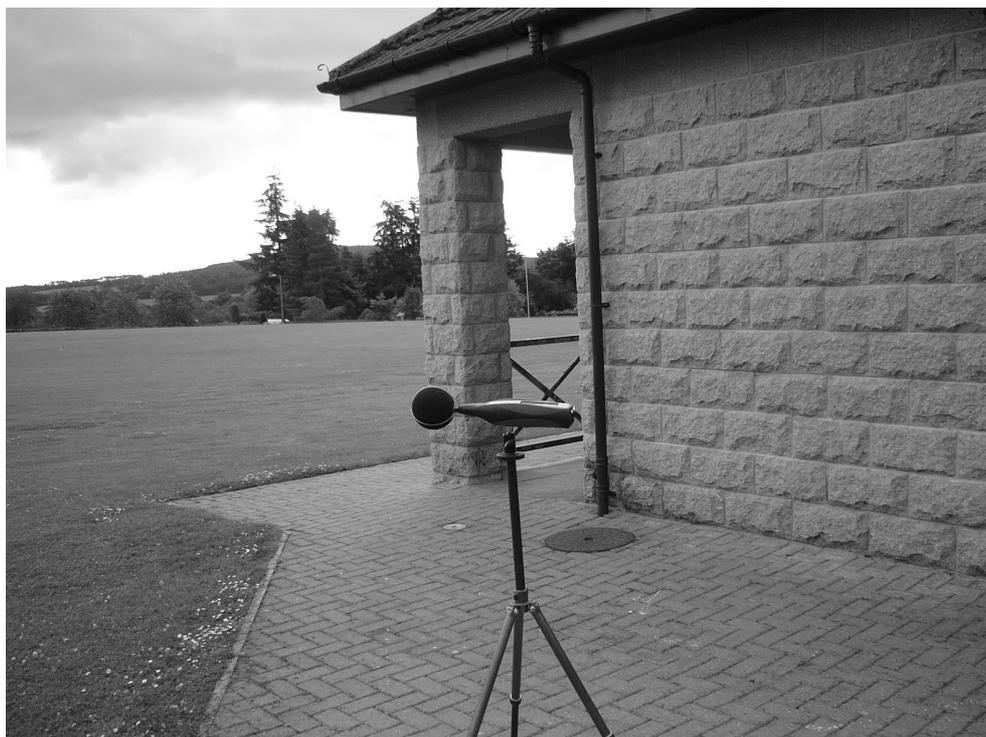
**Figure 22 – Measurement Location 22**

**Location 22 Pavilion:** The pavilion is located within Milltimber Playing Fields. The measurement location was 3.5m from the east facing windows of the property. The sound level meter was located 1.2m above the ground in free field conditions. The monitoring equipment was calibrated both before and after the measurement period using an acoustic calibrator, which has itself been calibrated against a reference set traceable to National and International Standards. There was no shift in the observed calibration level.

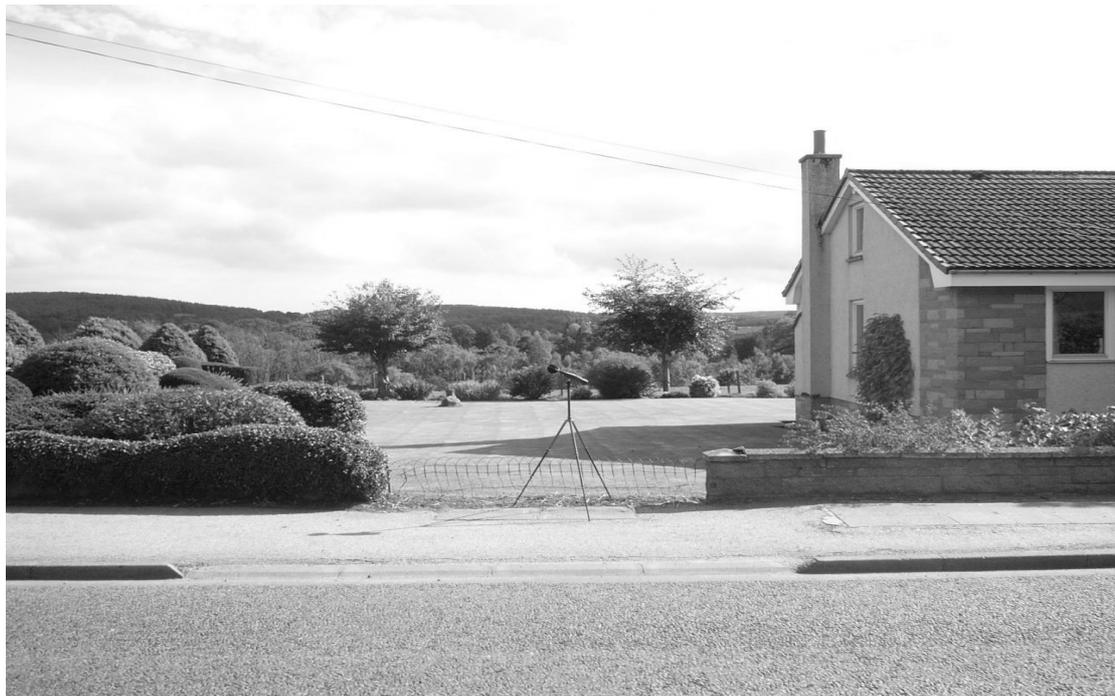
**Figure 23 – Measurement Location 23**

**Location 23 381 North Deeside Road:** The measurement location was 2.4m from the kerb of the A93 facing north. This position is 7.5m from the nearest build line of the property. The sound level meter was located 1.2m above the ground in free field conditions. The monitoring equipment was calibrated both before and after the measurement period using an acoustic calibrator, which has itself been calibrated against a reference set traceable to National and International Standards. There was no shift in the observed calibration level.

The dominant noise source at this location, at the time of measurement, was road traffic noise from the A93.

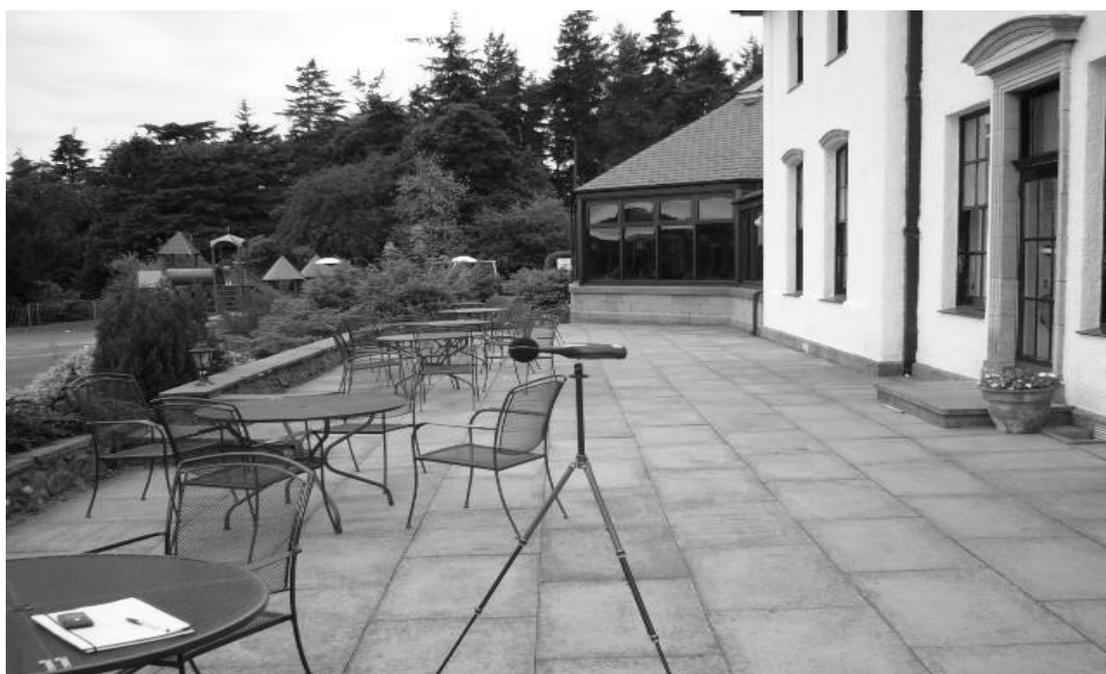
**Figure 24 – Measurement Location 24**

**Location 24 Kippie Lodge, Aberdeen Petroleum Club:** The measurement location was 3.5m from the south facing windows of the property. The sound level meter was placed here to restrict noise from the kitchen extractor fan, near the main property entrance, situated to the east, affecting the noise levels during measurement. The sound level meter was located 1.2m above the ground in free field conditions. The monitoring equipment was calibrated both before and after the measurement period using an acoustic calibrator, which has itself been calibrated against a reference set traceable to National and International Standards. There was no shift in the observed calibration level.
