**Aberdeen Western Peripheral Route**  
**Environmental Statement Appendices 2007**  
**Part C: Southern Leg**  
**Appendix 30.2 – Ambient Noise Data**

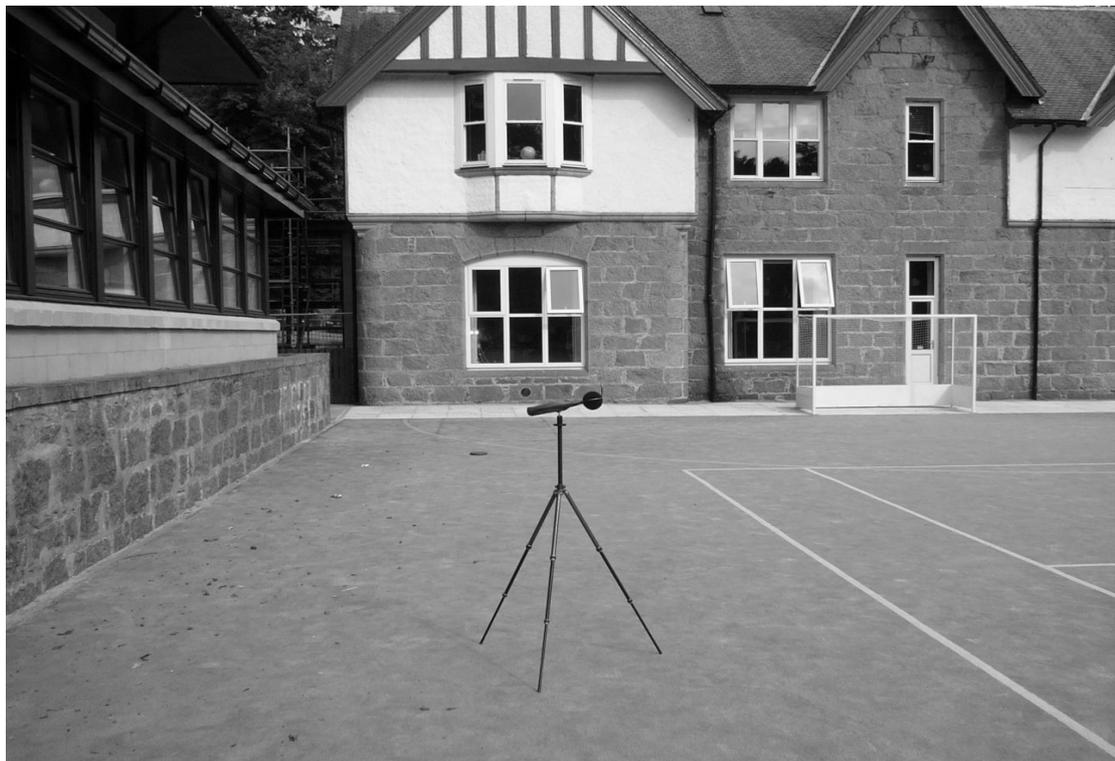
**Figure 25 – Measurement Location 25**

**Location 25 International School of Aberdeen:** The measurement location was 3.5m from the south facing windows of the property. The measurement location was on a playing field that is used frequently by children during break and lunch times. The sound level meter was located 1.2m above the ground in free field conditions. The monitoring equipment was calibrated both before and after the measurement period using an acoustic calibrator, which has itself been calibrated against a reference set traceable to National and International Standards. There was no shift in the observed calibration level.

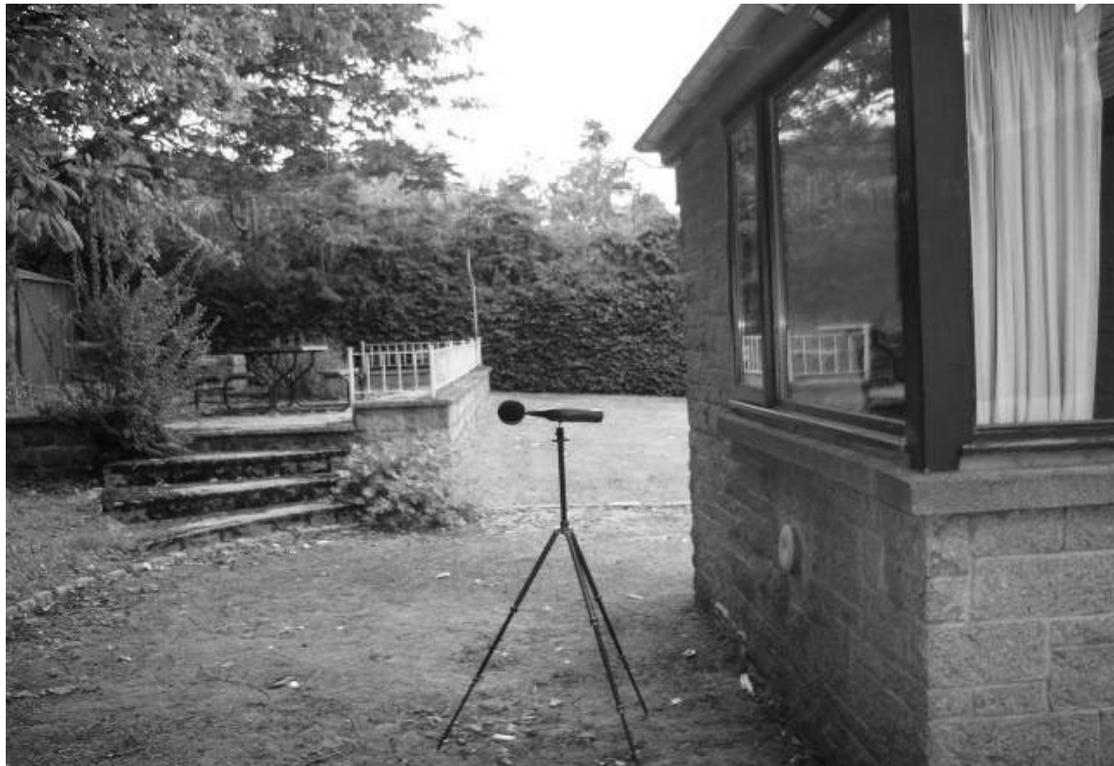
**Figure 26– Measurement Location 26**

**Location 26 1 Milltimber Brae East:** The measurement location was 1m from the north facing windows of the property. The sound level meter was located 1.2m above the ground and 1m from the façade. The monitoring equipment was calibrated both before and after the measurement period using an acoustic calibrator, which has itself been calibrated against a reference set traceable to National and International Standards. There was no shift in the observed calibration level.

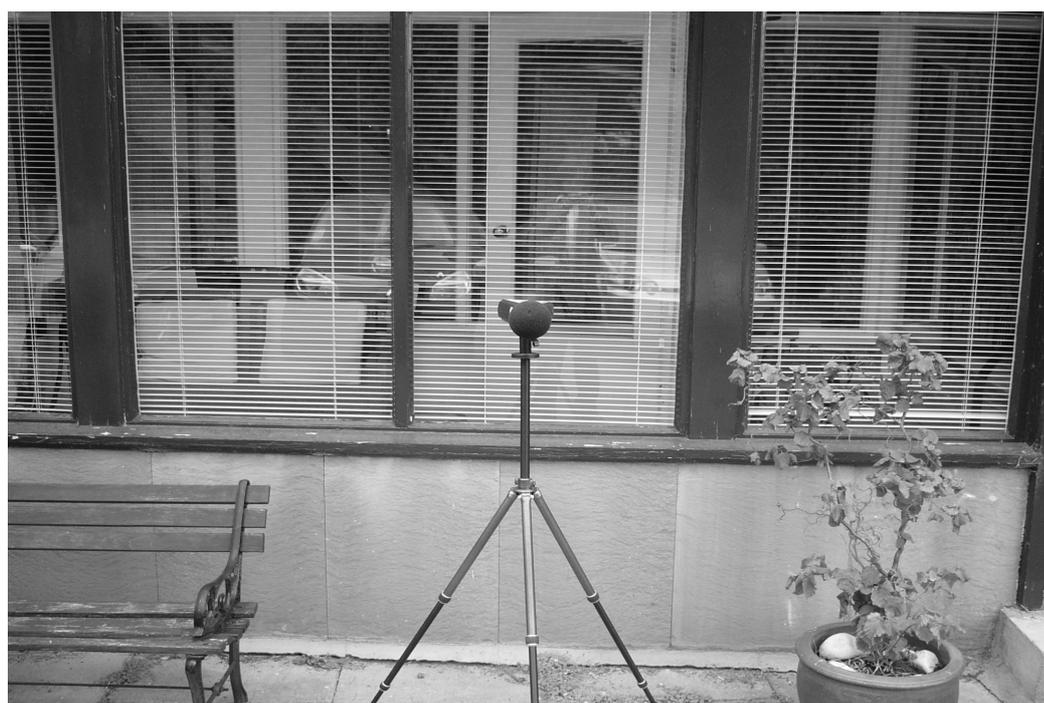
**Figure 27 – Measurement Location 27**

**Location 27 The Siding:** Station Road is situated directly north of the property boundary. The measurement location was 1m from the west facing windows of the property. The sound level meter was located 1.2m above the ground and 1m from the façade. The monitoring equipment was calibrated both before and after the measurement period using an acoustic calibrator, which has itself been calibrated against a reference set traceable to National and International Standards. There was no shift in the observed calibration level.

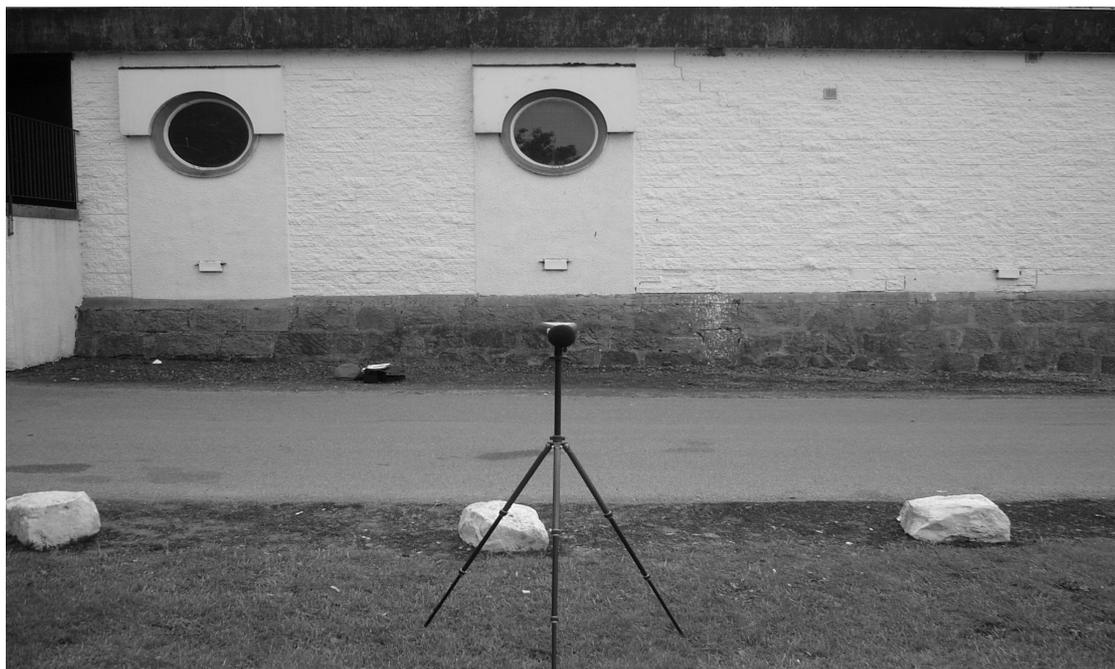
**Figure 30 – Measurement Location 30**

**Location 30 Old Mill Inn:** The measurement location was 10m from the east facing windows of the property. The sound level meter was located 1.2m above the ground in free field conditions. The monitoring equipment was calibrated both before and after the measurement period using an acoustic calibrator, which has itself been calibrated against a reference set traceable to National and International Standards. There was no shift in the observed calibration level.

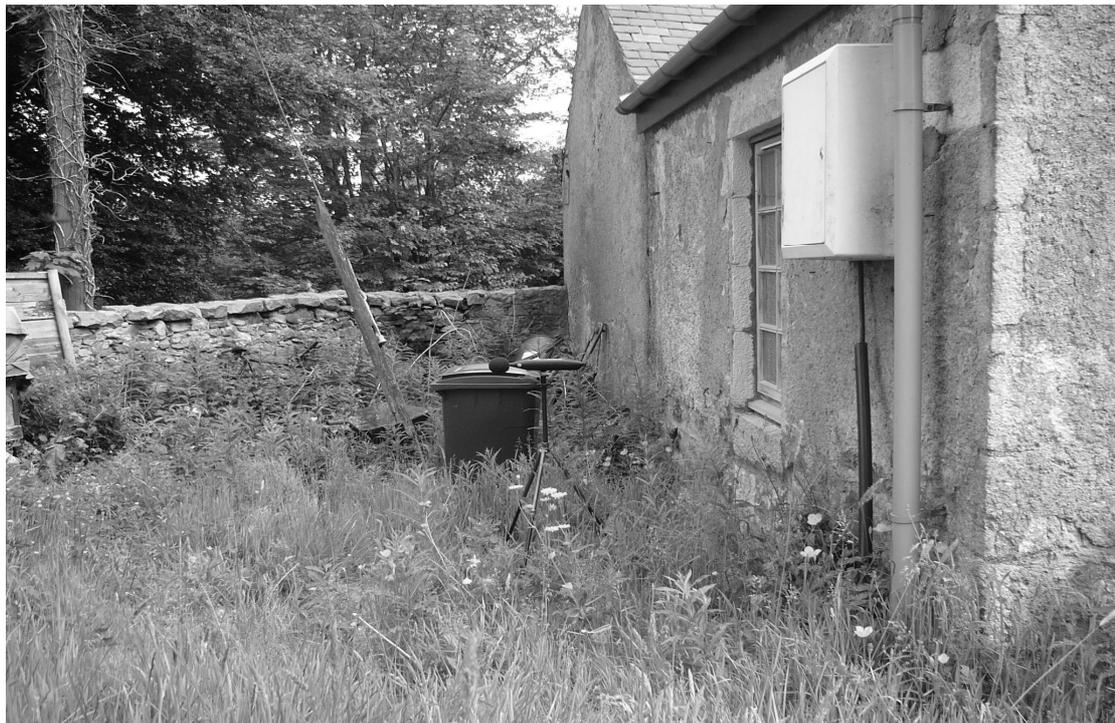
**Figure 31 – Measurement Location 31**

**Location 31 North Lodge:** The B9077 is located directly north of the property boundary. The measurement location was 1m from the north facing window of the property. The sound level meter was located 1.2m above the ground and 1m from the facade. The monitoring equipment was calibrated both before and after the measurement period using an acoustic calibrator, which has itself been calibrated against a reference set traceable to National and International Standards. There was no shift in the observed calibration level.

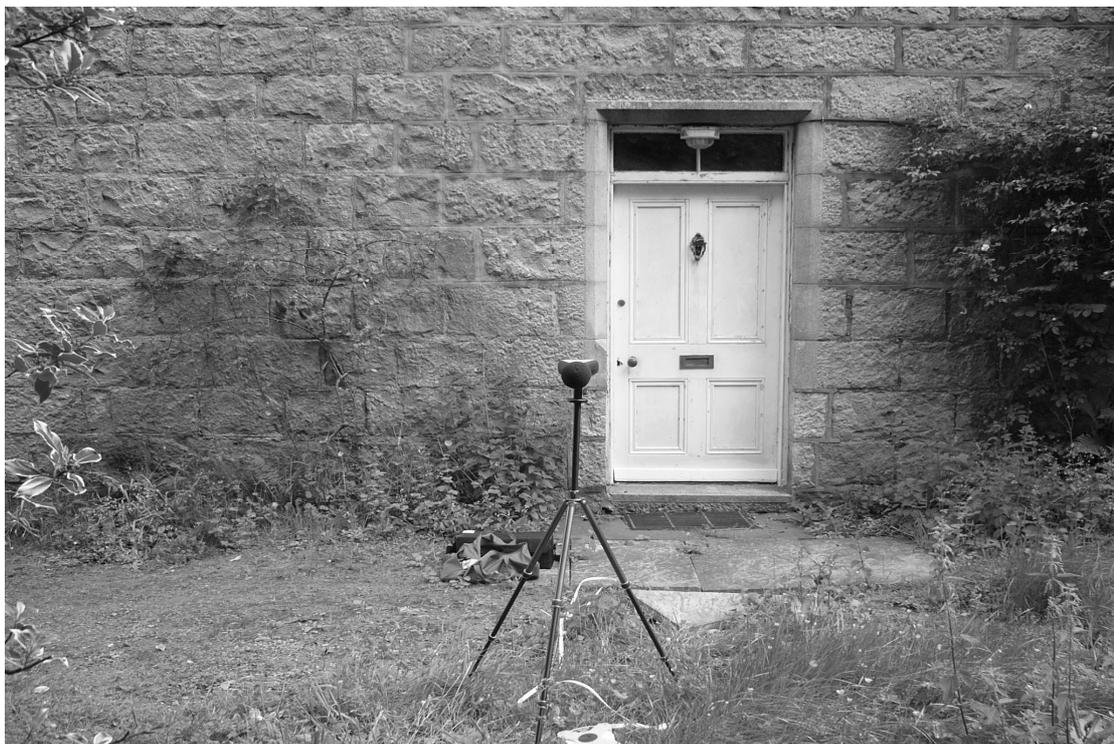
**Figure 32 – Measurement Location 32**

**Location 32 Kingcausie House:** The measurement location was 3.5m from the east facing windows of the property. The sound level meter was located 1.2m above the ground in free field conditions. The monitoring equipment was calibrated both before and after the measurement period using an acoustic calibrator, which has itself been calibrated against a reference set traceable to National and International Standards. There was no shift in the observed calibration level.

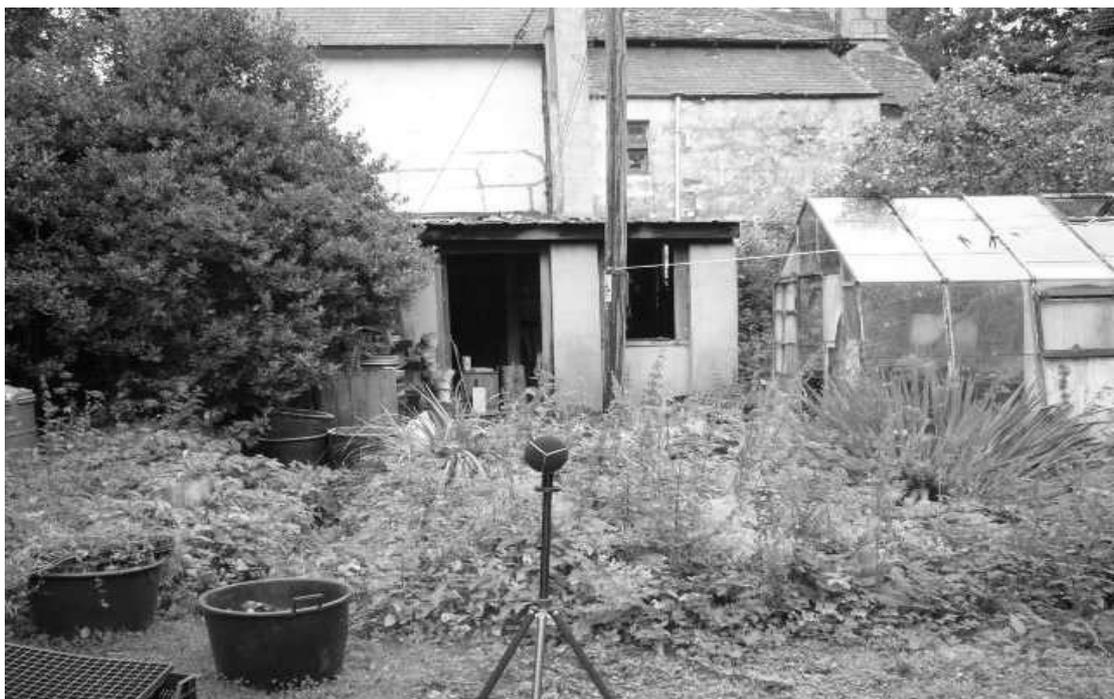
**Figure 33/34 – Measurement Location 33/34**

**Location 33/34 Eastland Cottage/House:** The measurement location was 9.3m from the east facing doors and windows of the property. The sound level meter was located 1.2m above the ground in free field conditions. The monitoring equipment was calibrated both before and after the measurement period using an acoustic calibrator, which has itself been calibrated against a reference set traceable to National and International Standards. There was no shift in the observed calibration level.

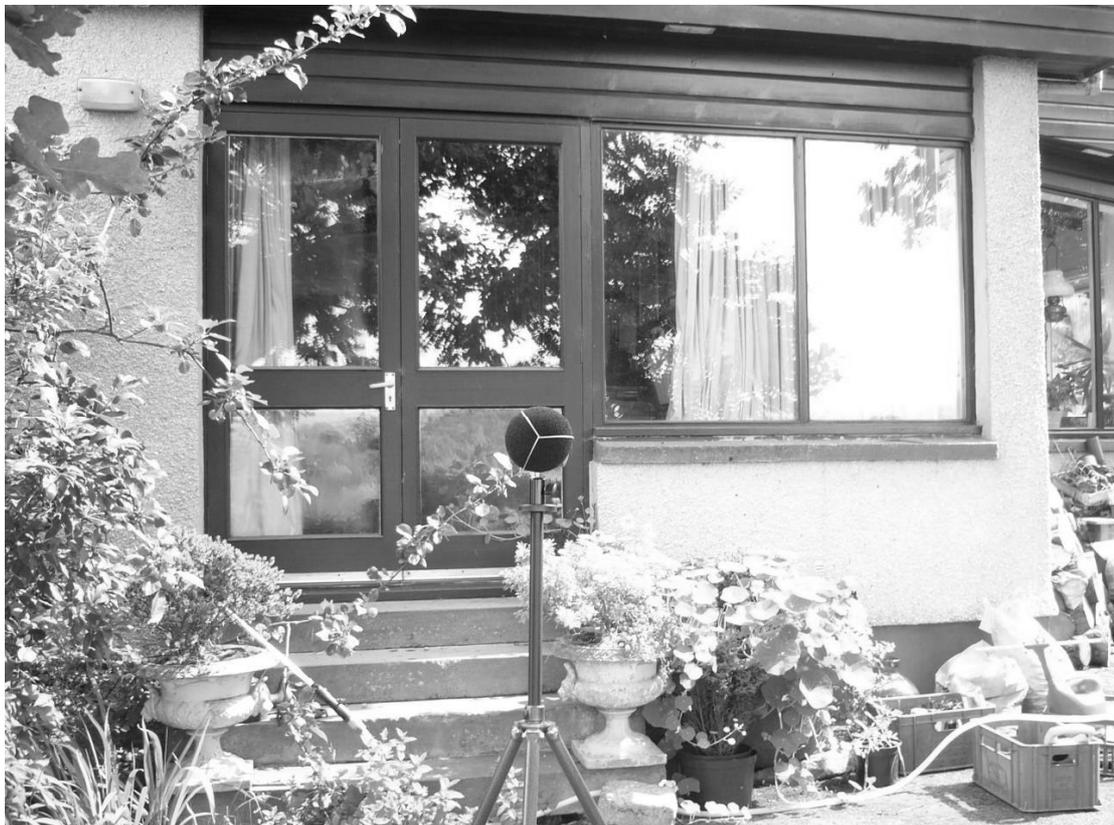
**Figure 36 – Measurement Location 36**

**Location 36 Tarns:** The measurement location was 6.7m from the east facing window of the property. The sound level meter was located 1.2m above the ground in free field conditions. The monitoring equipment was calibrated both before and after the measurement period using an acoustic calibrator, which has itself been calibrated against a reference set traceable to National and International Standards. There was no shift in the observed calibration level.

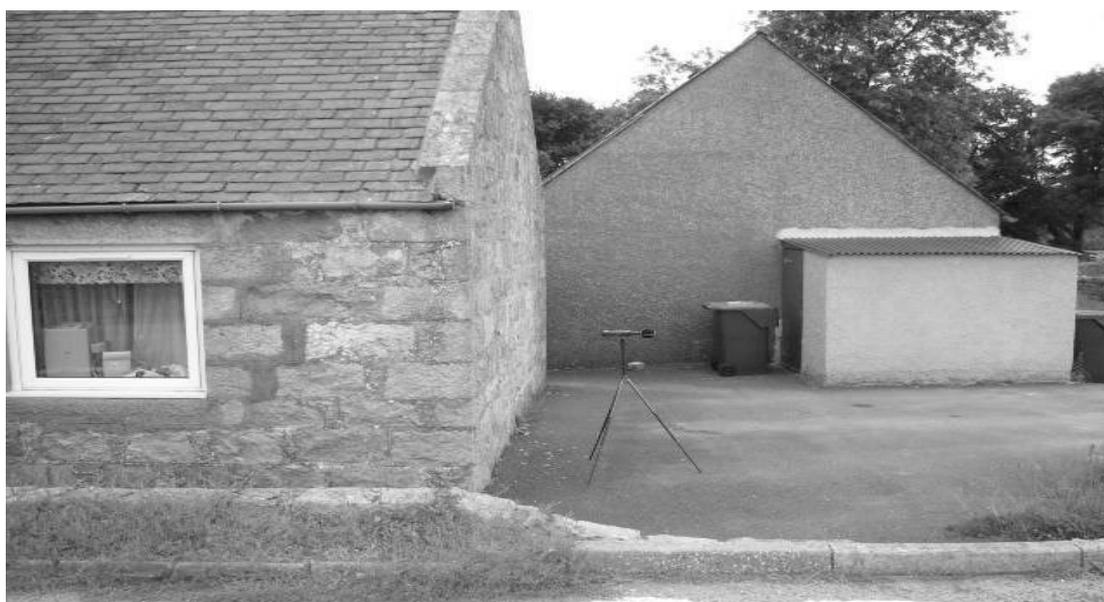
**Figure 37 – Measurement Location 37**

**Location 37 Burnhead Cottage:** There is an access road, to other properties in the area, located 5.7m to the north of the property boundary. There is second access road, to other properties in the area, located 3.5m to the east of the property boundary. The measurement location was 1m from the north facing wall of the property. The sound level meter was located 1.2m above the ground in façade conditions. The monitoring equipment was calibrated both before and after the measurement period using an acoustic calibrator, which has itself been calibrated against a reference set traceable to National and International Standards. There was no shift in the observed calibration level.

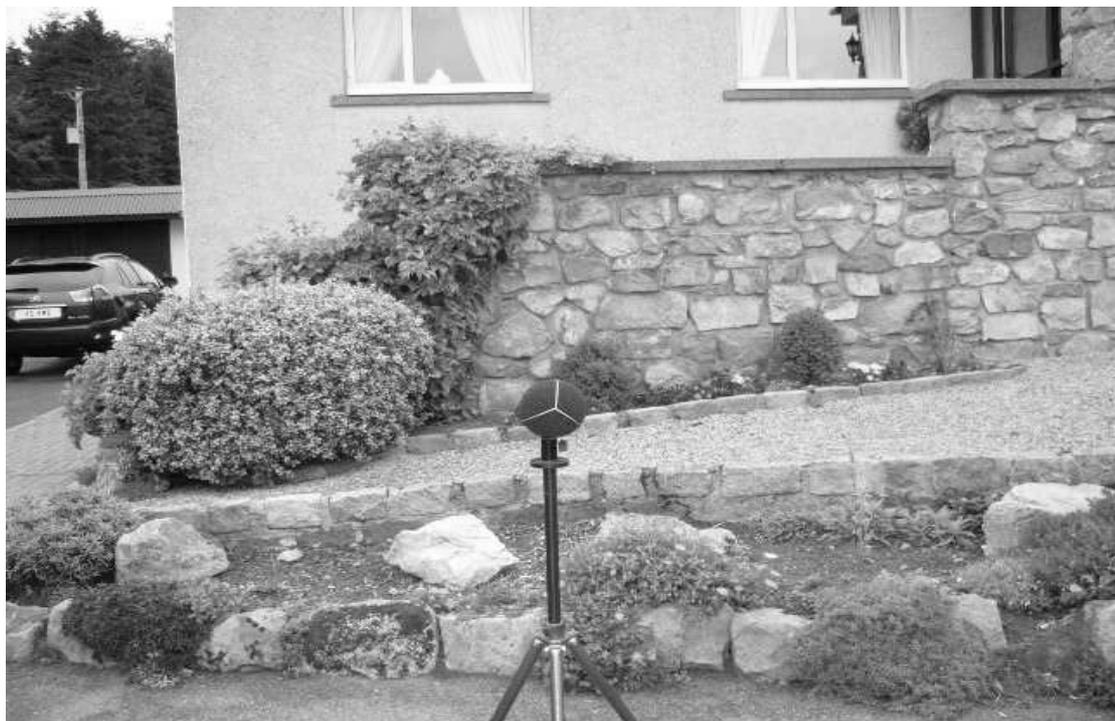
**Figure 38 – Measurement Location 38**

**Location 38 Kemehe:** The measurement location was 7.7m from the south facing windows of the property. The sound level meter was located 1.2m above the ground in free field conditions. The monitoring equipment was calibrated both before and after the measurement period using an acoustic calibrator, which has itself been calibrated against a reference set traceable to National and International Standards. There was no shift in the observed calibration level.

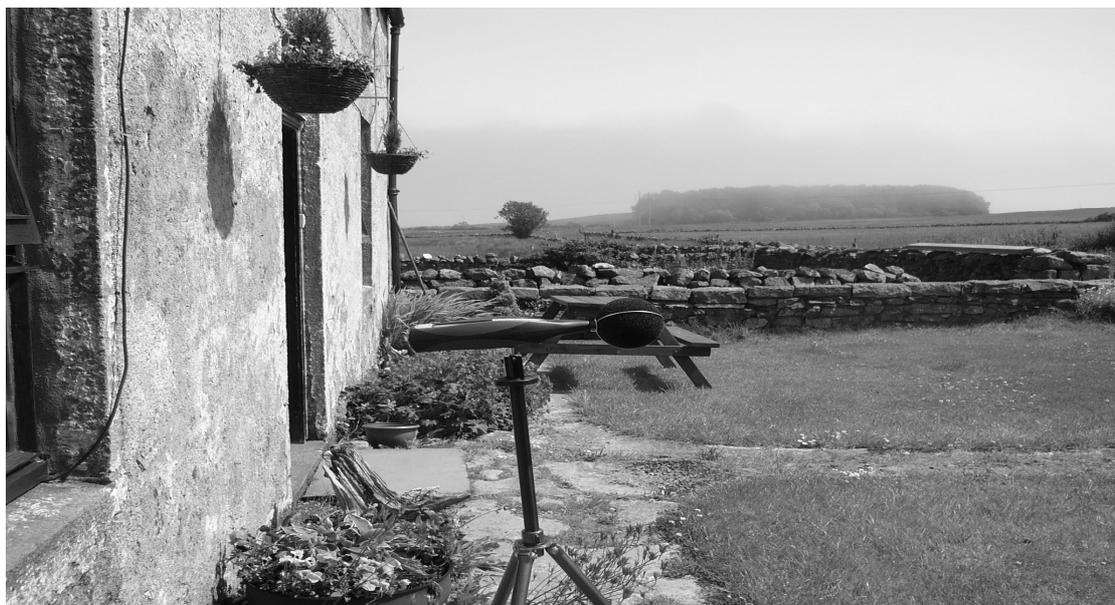
**Figure 40 – Measurement Location 40**

**Location 40 Newlands Farm:** The measurement location was 1m from the south facing window of the property. The sound level meter was located 1.2m above the ground in façade conditions. The monitoring equipment was calibrated both before and after the measurement period using an acoustic calibrator, which has itself been calibrated against a reference set traceable to National and International Standards. There was no shift in the observed calibration level.

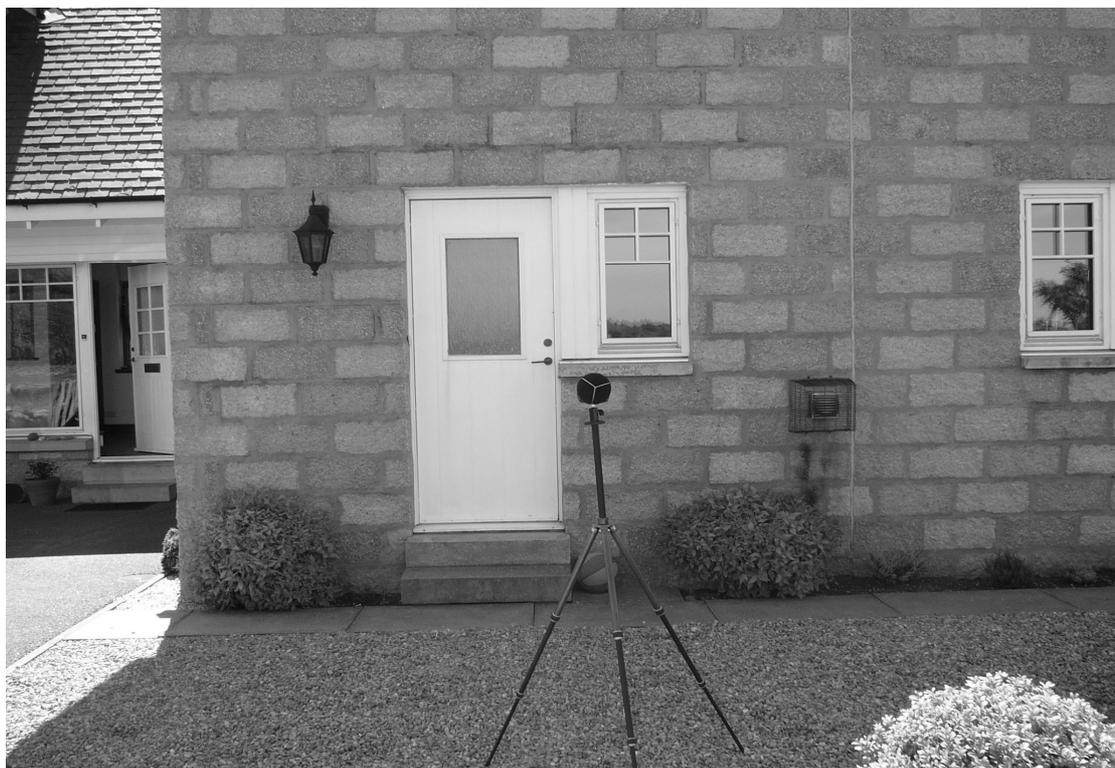
**Figure 41 – Measurement Location 41**

**Location 41 Grianan:** The measurement location was 3.5m from the east facing door and window of the property. The sound level meter was located 1.2m above the ground in free field conditions. The monitoring equipment was calibrated both before and after the measurement period using an acoustic calibrator, which has itself been calibrated against a reference set traceable to National and International Standards. There was no shift in the observed calibration level.

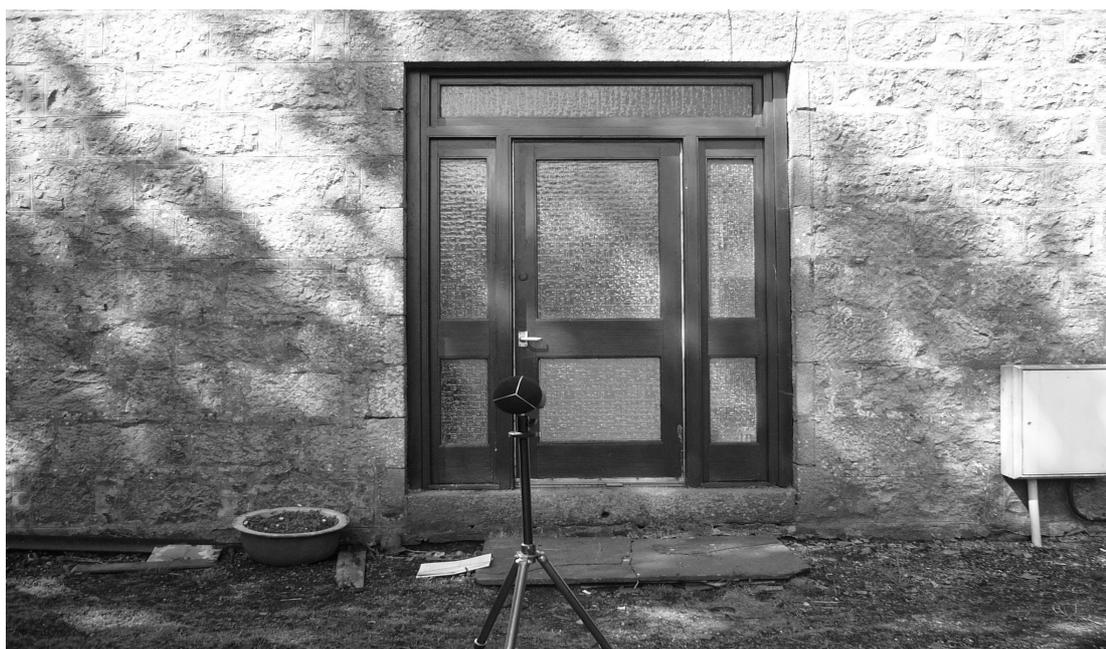
**Figure 42 – Measurement Location 42**

**Location 42 Bishopston Farm:** The measurement location was 3.5m from the east facing door of the property. The microphone was placed here as there were no windows or doors on the north facing wall of the property. The sound level meter was located 1.2m above the ground in free field conditions. The monitoring equipment was calibrated both before and after the measurement period using an acoustic calibrator, which has itself been calibrated against a reference set traceable to National and International Standards. There was no shift in the observed calibration level.

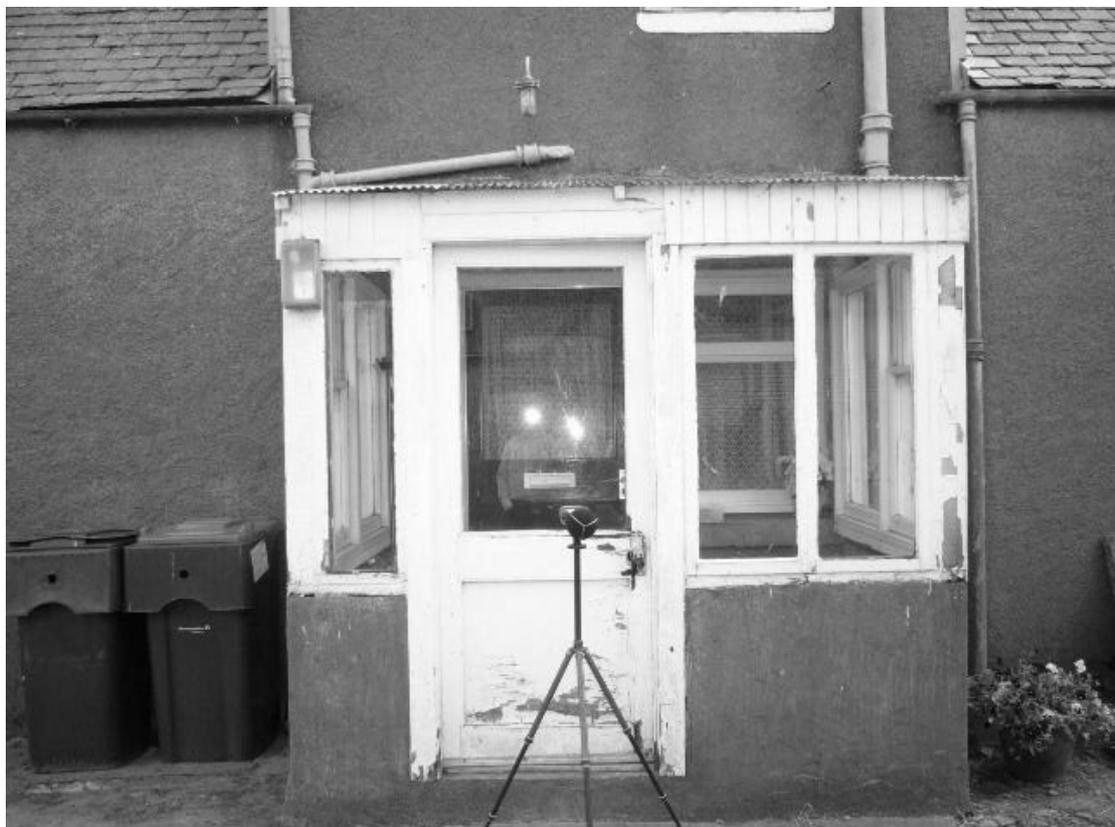
**Figure 43 – Measurement Location 43**

**Location 43 Little Bishopston:** The measurement location was 1m from the north facing porch door of the property. The microphone was placed here as there was no access available to the south side of the property. The sound level meter was located 1.2m above the ground in free field conditions. The monitoring equipment was calibrated both before and after the measurement period using an acoustic calibrator, which has itself been calibrated against a reference set traceable to National and International Standards. There was no shift in the observed calibration level.

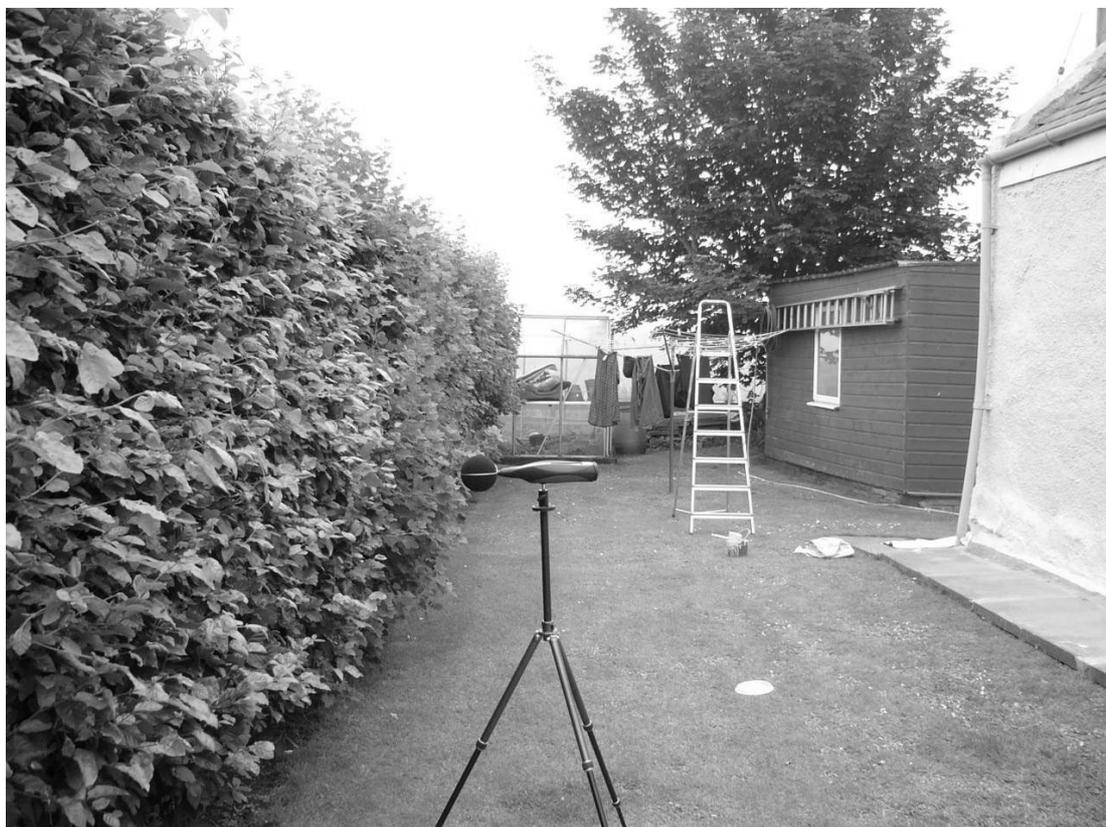
**Figure 44 – Measurement Location 44**

**Location 44 Midfield Cottage:** The measurement location was 3.5m from the north facing window of the property. The sound level meter was located 1.2m above the ground in free field conditions. The monitoring equipment was calibrated both before and after the measurement period using an acoustic calibrator, which has itself been calibrated against a reference set traceable to National and International Standards. There was no shift in the observed calibration level.

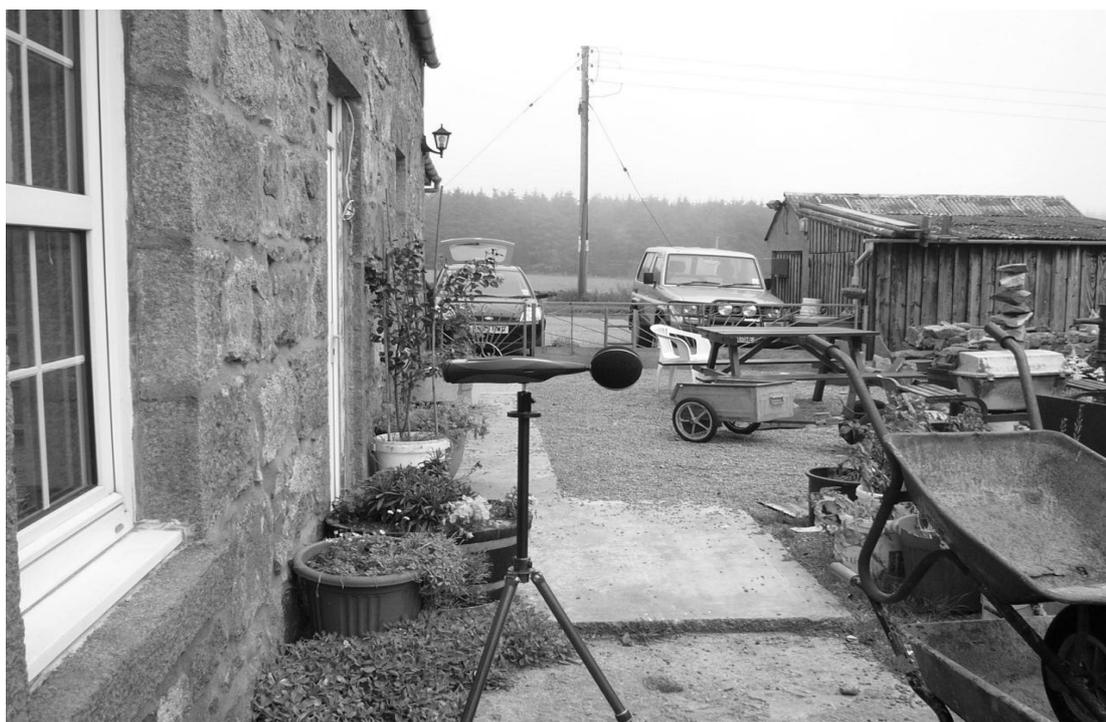
**Figure 45 – Measurement Location 45**

**Location 45 Haremass Cottage:** The measurement location was 1m from the south facing window of the property. This location was chosen as there was no access available to the north side of the property and there were no windows present on the east facing wall. The sound level meter was located 1.2m above the ground in free field conditions. The monitoring equipment was calibrated both before and after the measurement period using an acoustic calibrator, which has itself been calibrated against a reference set traceable to National and International Standards. There was no shift in the observed calibration level.

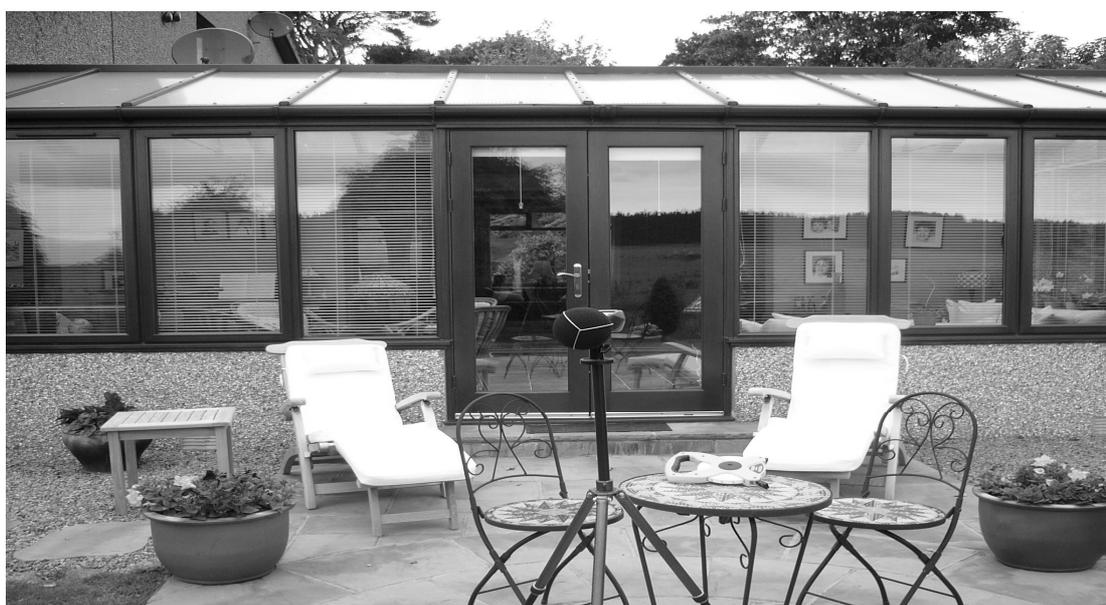
**Figure 46/47 – Measurement Location 46/47**

**Location 46/ 47 The Beaches/Duffshill:** To the west of the property there is an access road to other properties in the area. The measurement location was 4.3m from the south facing conservatory of The Beaches property. Duffshill is located approx 100m away to the south of The Beaches. The road will be passing directly through the middle of the land between the properties and as they are positioned on the same elevation, one measurement was taken for both properties. The sound level meter was located 1.2m above the ground in free field conditions. The monitoring equipment was calibrated both before and after the measurement period using an acoustic calibrator, which has itself been calibrated against a reference set traceable to National and International Standards. There was no shift in the observed calibration level.

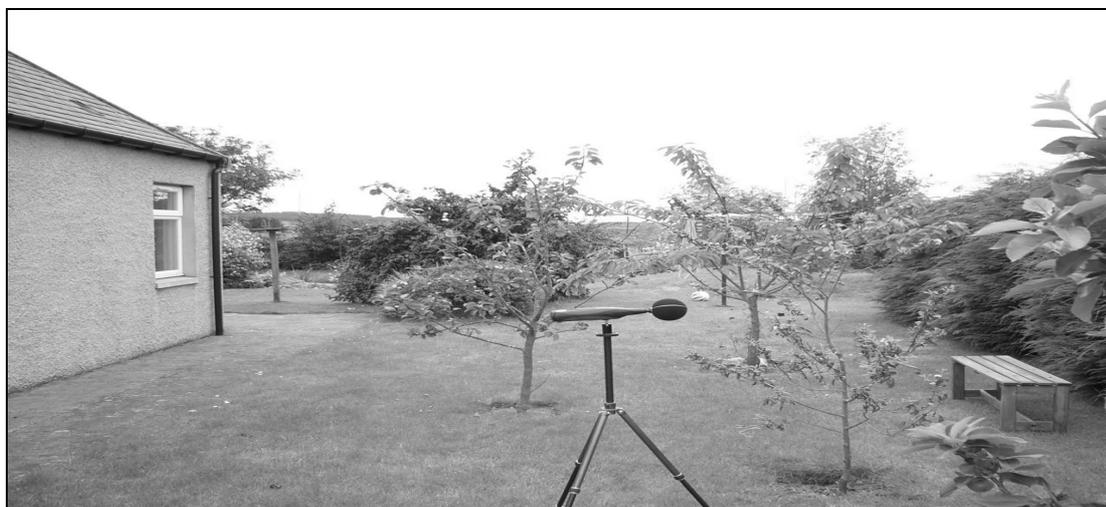
**Figure 48 – Measurement Location 48**

**Location 48 Turnamiddle House:** The measurement location was in the rear garden, 3.5m from the north facing entrance of the property. The sound level meter was located 1.2m above the ground in free field conditions. The monitoring equipment was calibrated both before and after the measurement period using an acoustic calibrator, which has itself been calibrated against a reference set traceable to National and International Standards. There was no shift in the observed calibration level.

It should be noted that Turnamiddle Cottage is situated to the north of this property and could act as an acoustic barrier for Turnamiddle House, in relation to the potential road traffic noise from the proposed AWPR.

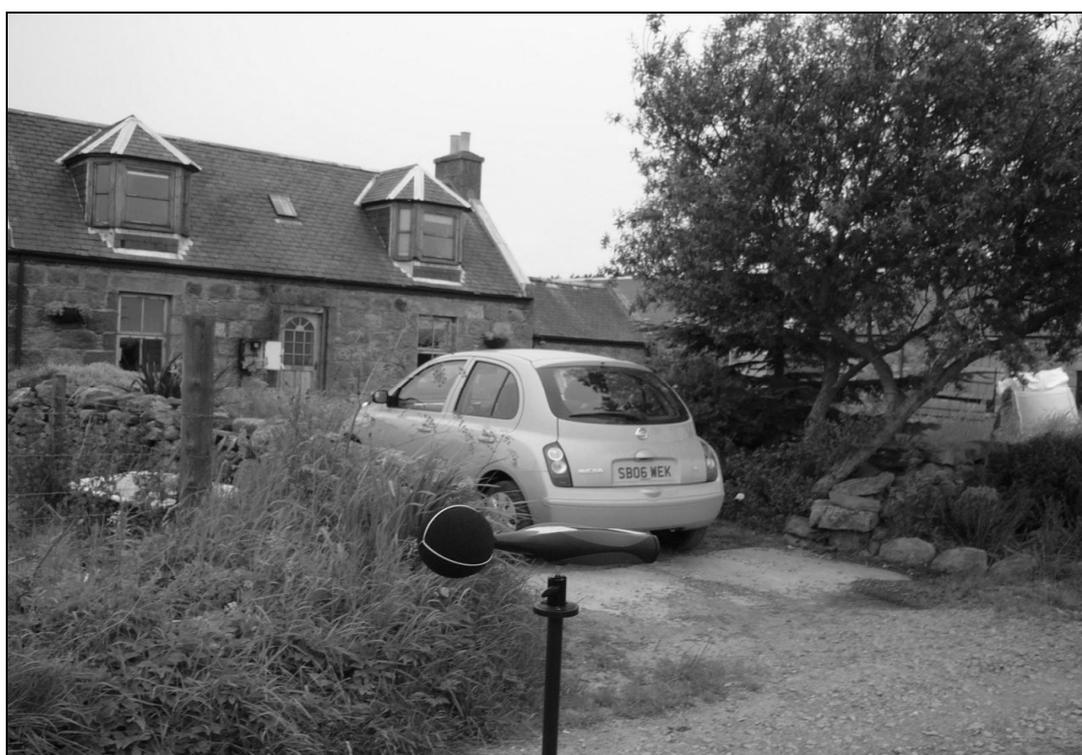
**Figure 49 – Measurement Location 49**

**Location 49 Whistlebrae Farmhouse:** The measurement location was on the access road, in front of the property, situated directly to the east of the property boundary. The sound level meter was located 1.2m above the ground in free field conditions. The monitoring equipment was calibrated both before and after the measurement period using an acoustic calibrator, which has itself been calibrated against a reference set traceable to National and International Standards. There was no shift in the observed calibration level.

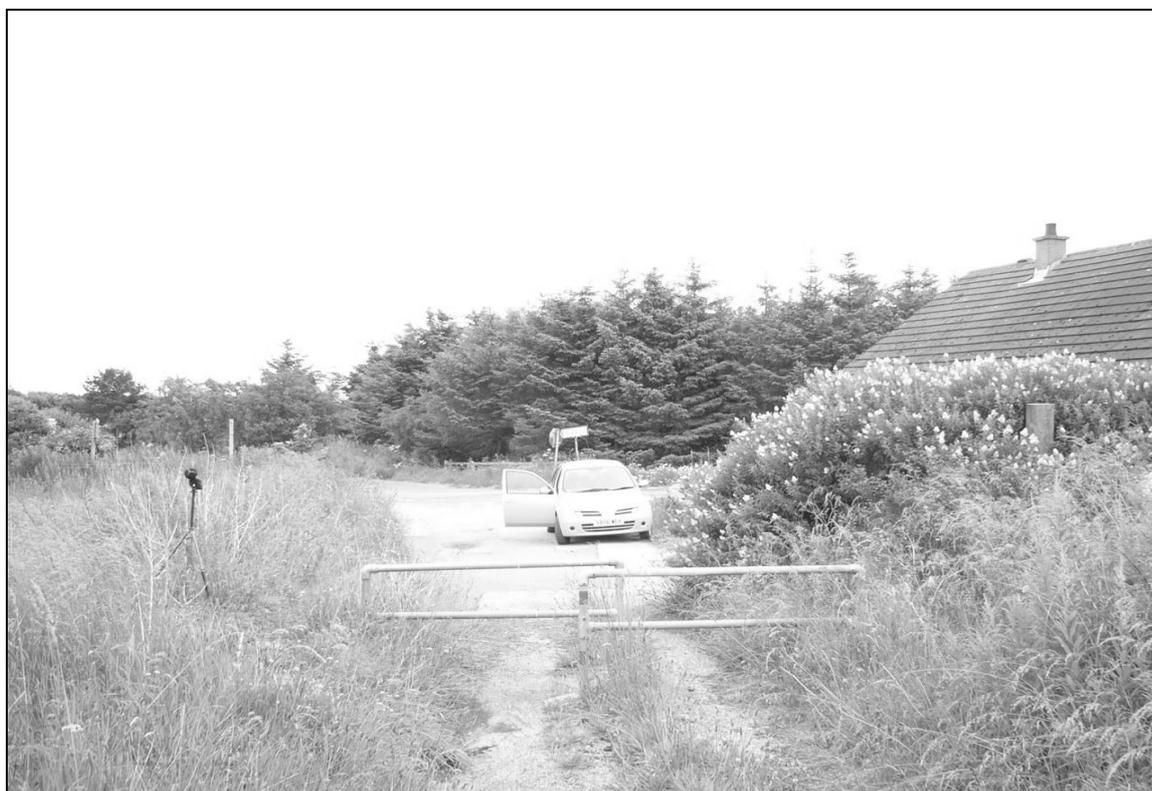
**Figure 50 – Measurement Location 50**

**Location 50 The Clachan:** The measurement location was approximately 16m to the north and 2m to the west of the property. The sound level meter was located 1.2m above the ground in free field conditions. The monitoring equipment was calibrated both before and after the measurement period using an acoustic calibrator, which has itself been calibrated against a reference set traceable to National and International Standards. There was no shift in the observed calibration level.

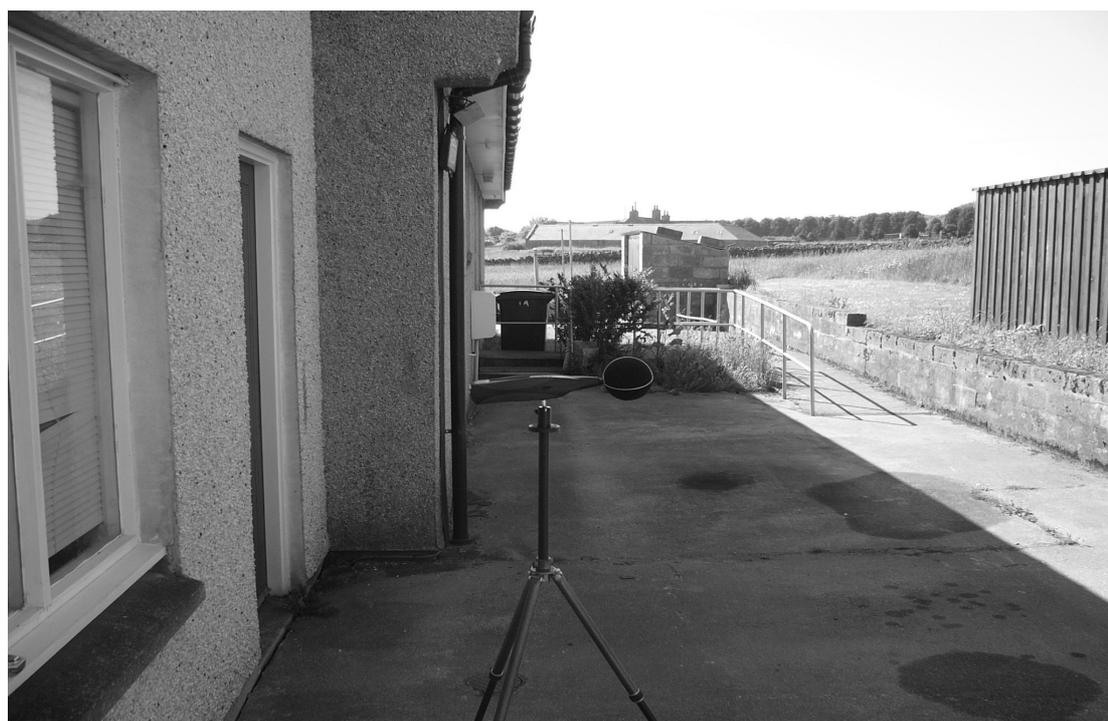
**Figure 51 – Measurement Location 51**

**Location 51 Novara:** The measurement location was 1m from the west facing window of the property. The sound level meter was located 1.2m above the ground in façade conditions. The monitoring equipment was calibrated both before and after the measurement period using an acoustic calibrator, which has itself been calibrated against a reference set traceable to National and International Standards. There was no shift in the observed calibration level.

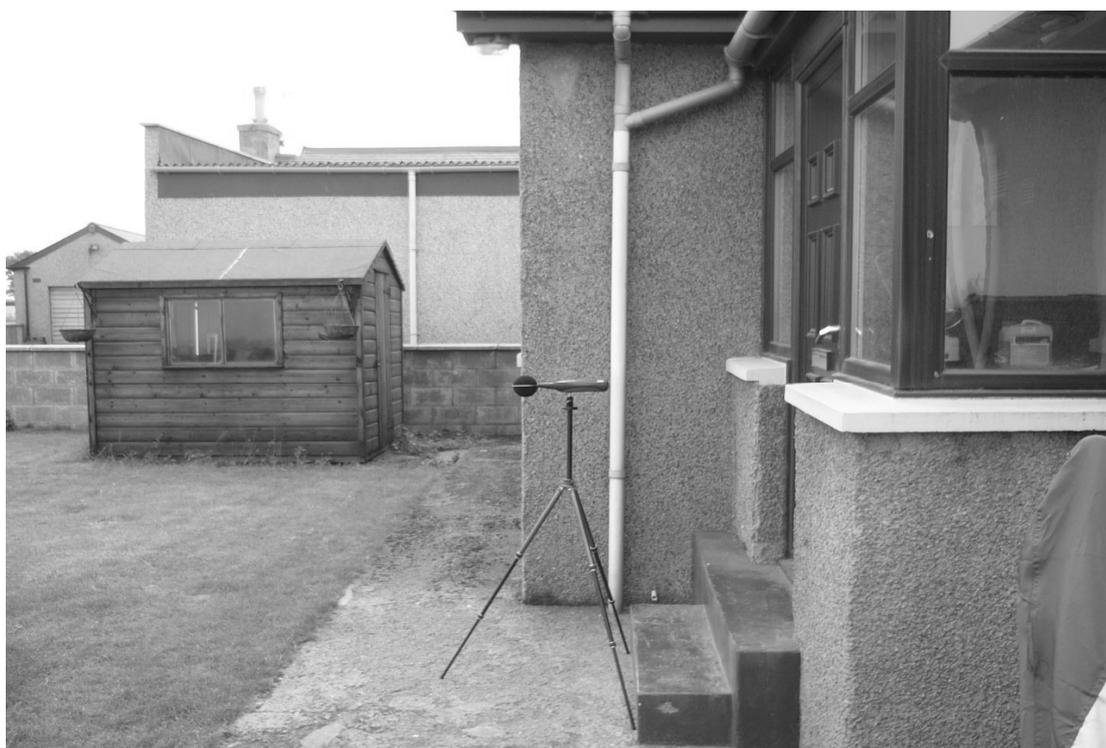
**Figure 52 – Measurement Location 52**

**Location 52 Brae View:** The measurement location was 1m from the north facing door of the property. The sound level meter was located 1.2m above the ground in façade conditions. The monitoring equipment was calibrated both before and after the measurement period using an acoustic calibrator, which has itself been calibrated against a reference set traceable to National and International Standards. There was no shift in the observed calibration level.

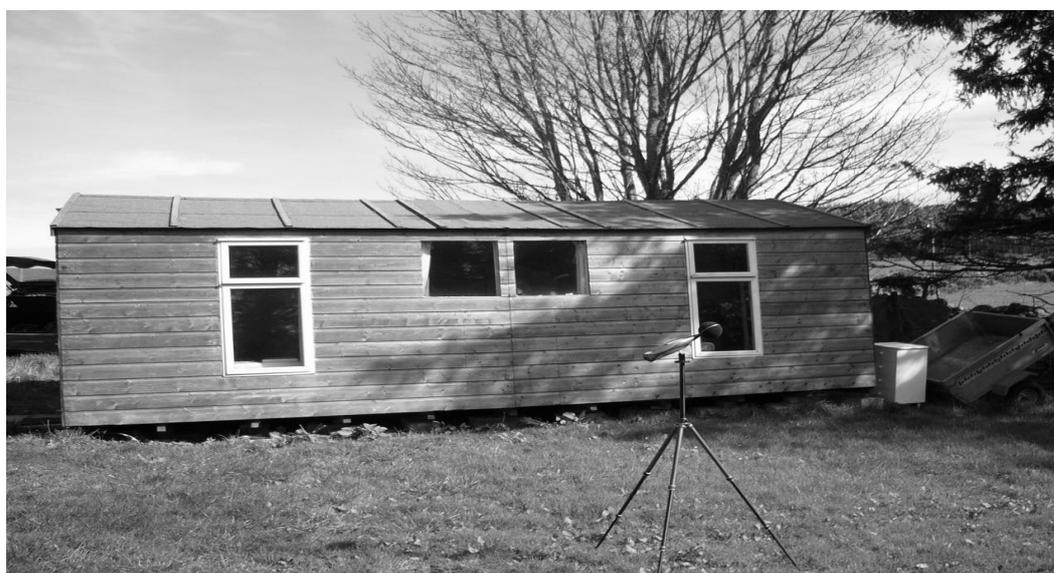
**Figure 70 – Measurement Location 70**

**Location 70 Mossie of Auchlea:** The measurement location was 3.5m from the south west facing window of the studio. This location was chosen as it is a very noise sensitive area. There are also no other windows on the studio building. The sound level meter was located 1.2m above the ground in free field conditions. The monitoring equipment was calibrated both before and after the measurement period using an acoustic calibrator, which has itself been calibrated against a reference set traceable to National and International Standards. There was no shift in the observed calibration level.

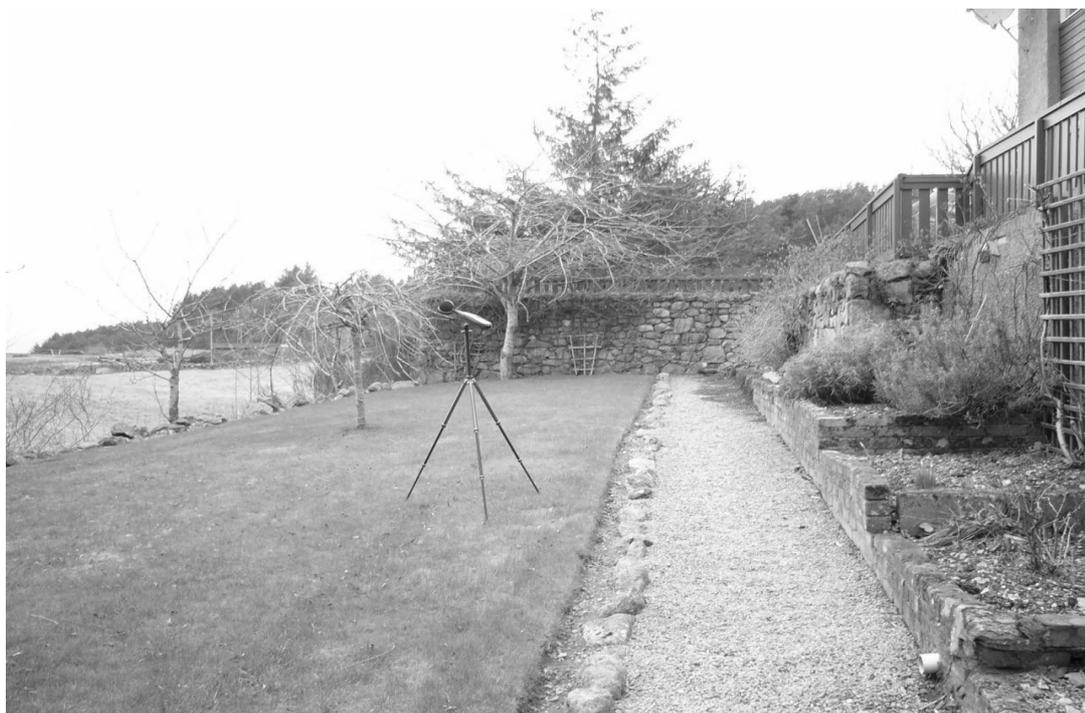
**Figure 72 – Measurement Location 72**

**Location 72 Silverburn House:** There is an access road to other properties in front of the house which extends along the north western boundary of the property. The measurement location was 3.5m from the wall at the edge of the patio, which was 3.5m from the south east facing property wall. The sound level meter was located 1.2m above the ground in free field conditions. The monitoring equipment was calibrated both before and after the measurement period using an acoustic calibrator, which has itself been calibrated against a reference set traceable to National and International Standards. There was no shift in the observed calibration level.
