**Aberdeen Western Peripheral Route**  
**Environmental Statement Appendices 2007**  
**Part C: Southern Leg**  
**Appendix 30.2 – Ambient Noise Data**

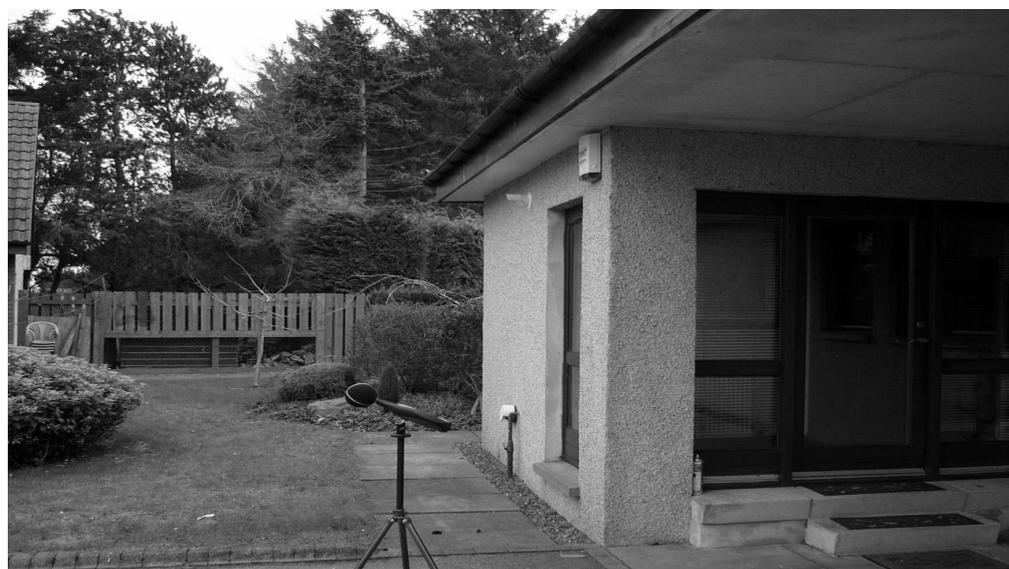
**Figure 73 – Measurement Location 73**

**Location 73 Glencairn:** There is an access road, to other properties, directly north of the property. The measurement location was 3.5m from the north facing windows of the property. The sound level meter was located 1.2m above the ground in free field conditions. The monitoring equipment was calibrated both before and after the measurement period using an acoustic calibrator, which has itself been calibrated against a reference set traceable to National and International Standards. There was no shift in the observed calibration level.

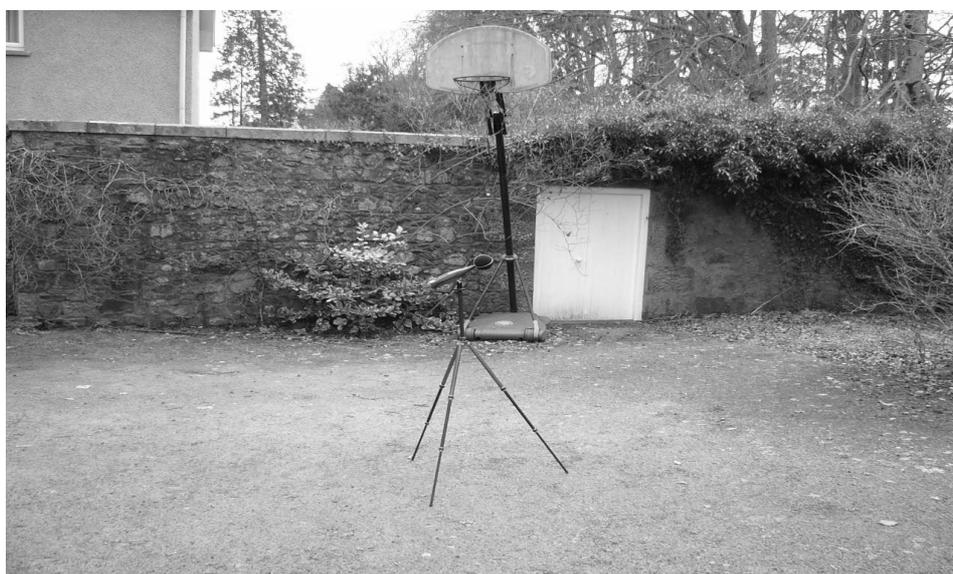
**Figure 74 – Measurement Location 74**

**Location 74 47 Culterhouse Road:** Culterhouse Road is situated directly north of the property. The measurement location was 10m from west facing wall of the property. The sound level meter was located 1.2m above the ground in free field conditions. The monitoring equipment was calibrated both before and after the measurement period using an acoustic calibrator, which has itself been calibrated against a reference set traceable to National and International Standards. There was no shift in the observed calibration level.

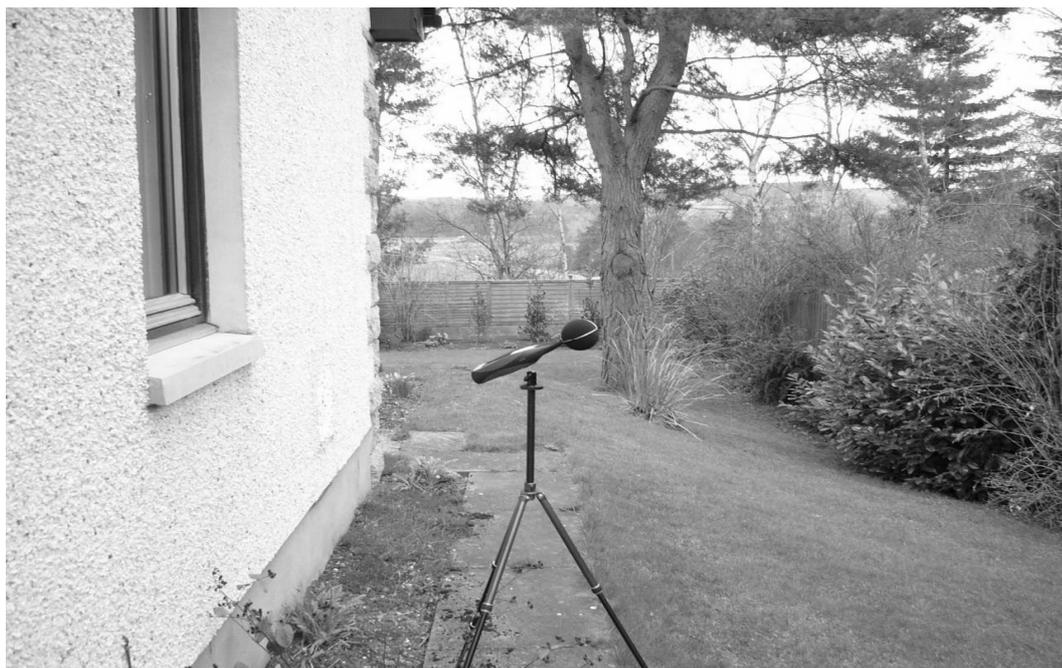
**Figure 75 – Measurement Location 75**

**Location 75 Holly House:** Station Road lies directly north of the property. The measurement location was 1m from the west facing wall of the property. The sound level meter was located 1.2m above the ground in façade conditions. The position was sheltered by mature trees and bushes surrounding the property; therefore there was no wind present at the time of measurement. The monitoring equipment was calibrated both before and after the measurement period using an acoustic calibrator, which has itself been calibrated against a reference set traceable to National and International Standards. There was no shift in the observed calibration level.

The dominant noise of this location, at the time of measurement, was birdsong. Distant road traffic noise from the B979, situated to the west, also affected the noise climate.

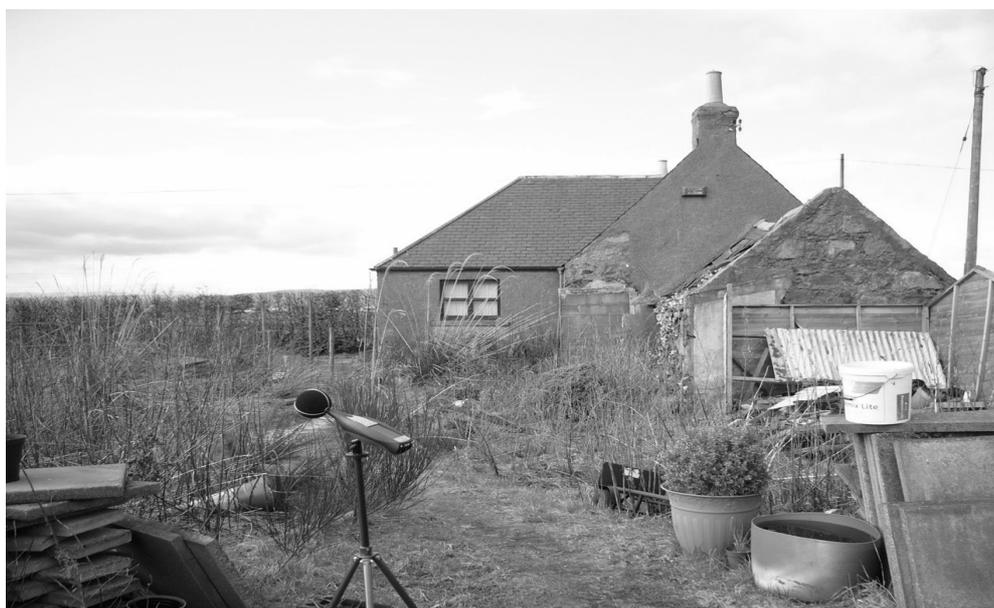
**Figure 76 – Measurement Location 76**

**Location 76 Fairview, West Hatton:** There is a lane passing in front of the property to the south, giving access to other properties, the A994 lies to the south, in the distance. The measurement location was 18m from the north facing window on the grounds of the property. The sound level meter was located 1.2m above the ground in free field conditions. The monitoring equipment was calibrated both before and after the measurement period using an acoustic calibrator, which has itself been calibrated against a reference set traceable to National and International Standards. There was no shift in the observed calibration level.

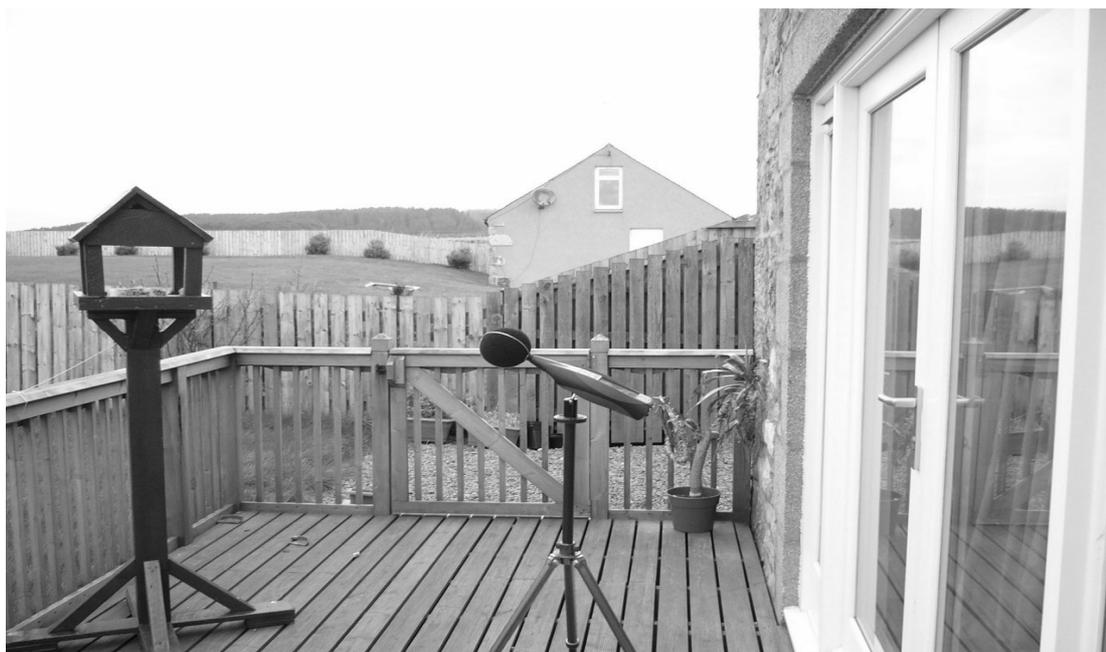
**Figure 77 – Measurement Location 77**

**Location 77 4 Hare Moss House:** There is an access road to the area situated directly to the east of the property. The measurement location was 1m from the west facing patio doors of the property. The sound level meter was located 1.2m above the ground in façade conditions. The monitoring equipment was calibrated both before and after the measurement period using an acoustic calibrator, which has itself been calibrated against a reference set traceable to National and International Standards. There was no shift in the observed calibration level.
