Aberdeen Western Peripheral Route
Environmental Statement Appendices 2007
Part D: Fastlink
Appendix 45.2 – Ambient Noise Measurement Data

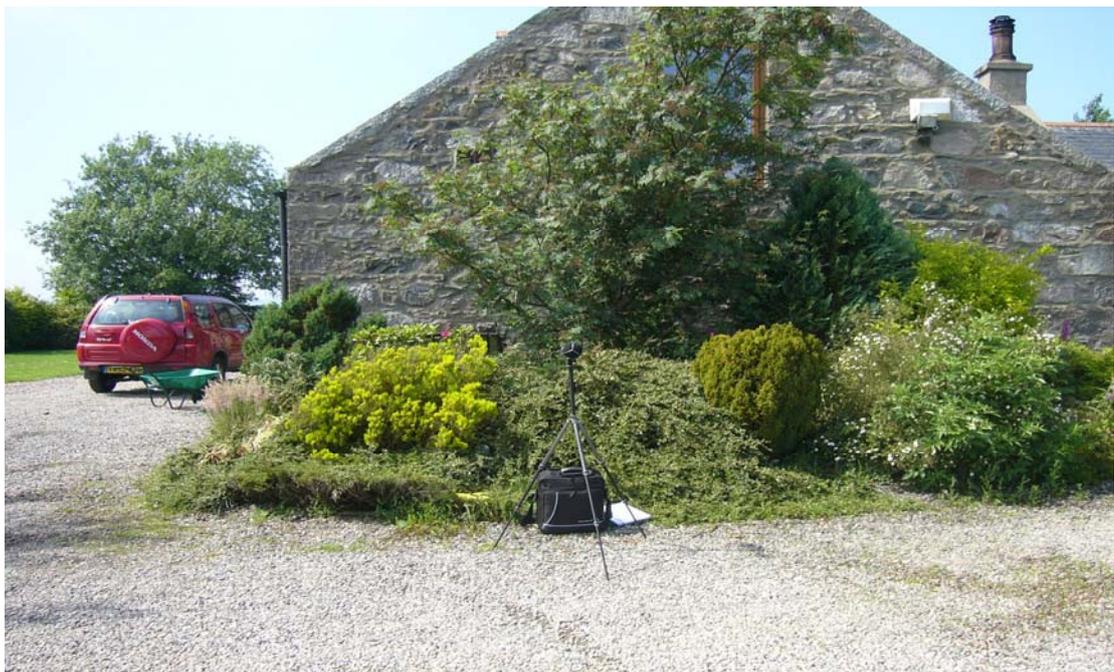
Figure 35 – Measurement Location 35

Location 35 Blakiewell Mill: The measurement location was 6.7m from the east facing window of the property. The sound level meter was located 1.2m above the ground in free field conditions. The monitoring equipment was calibrated both before and after the measurement period using an acoustic calibrator, which has itself been calibrated against a reference set traceable to National and International Standards. There was no shift in the observed calibration level.

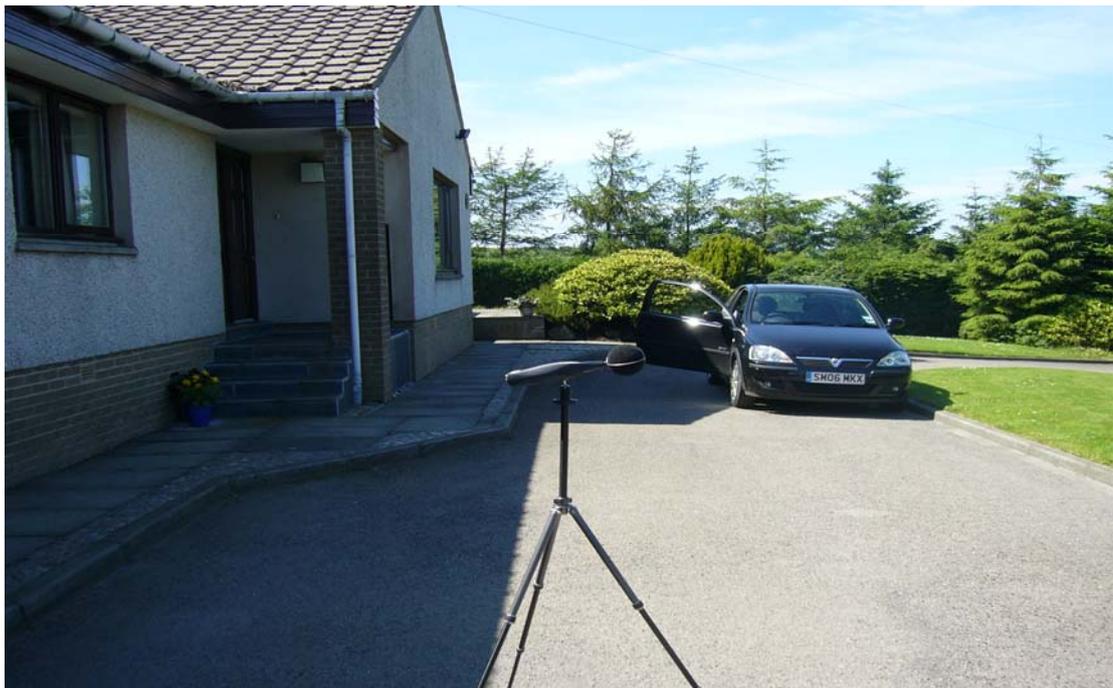
Figure 53 – Measurement Location 53

Location 53 Greens of Crynoch: There is an access road to other properties in the area, situated directly north of the property boundary. The measurement location was 3.5m from the north facing window of the property. This location was chosen due to no windows or doors being present on the east facing wall. The sound level meter was located 1.2m above the ground in free field conditions. The monitoring equipment was calibrated both before and after the measurement period using an acoustic calibrator, which has itself been calibrated against a reference set traceable to National and International Standards. There was no shift in the observed calibration level.

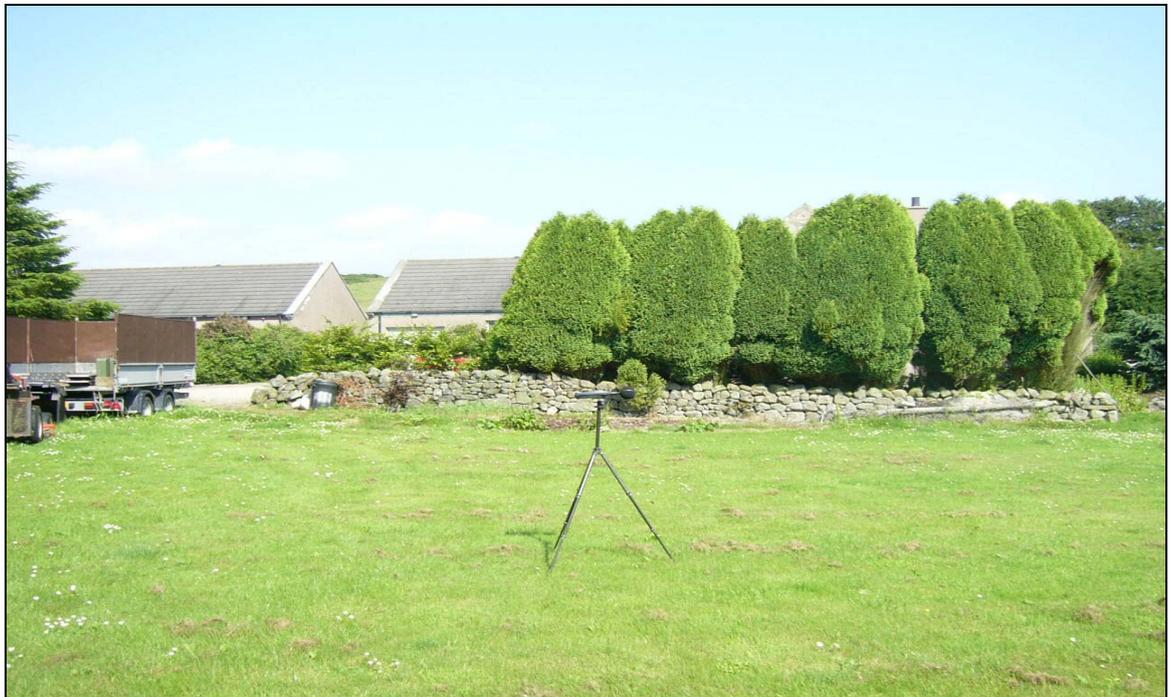
Figure 54/55: Measurement Location 54/55

Location 54/55 Crossley: The measurement location was 5m from the east facing windows of the property. The sound level meter was located 1.2m above the ground in free field conditions. The monitoring equipment was calibrated both before and after the measurement period using an acoustic calibrator, which has itself been calibrated against a reference set traceable to National and International Standards. There was no shift in the observed calibration level.

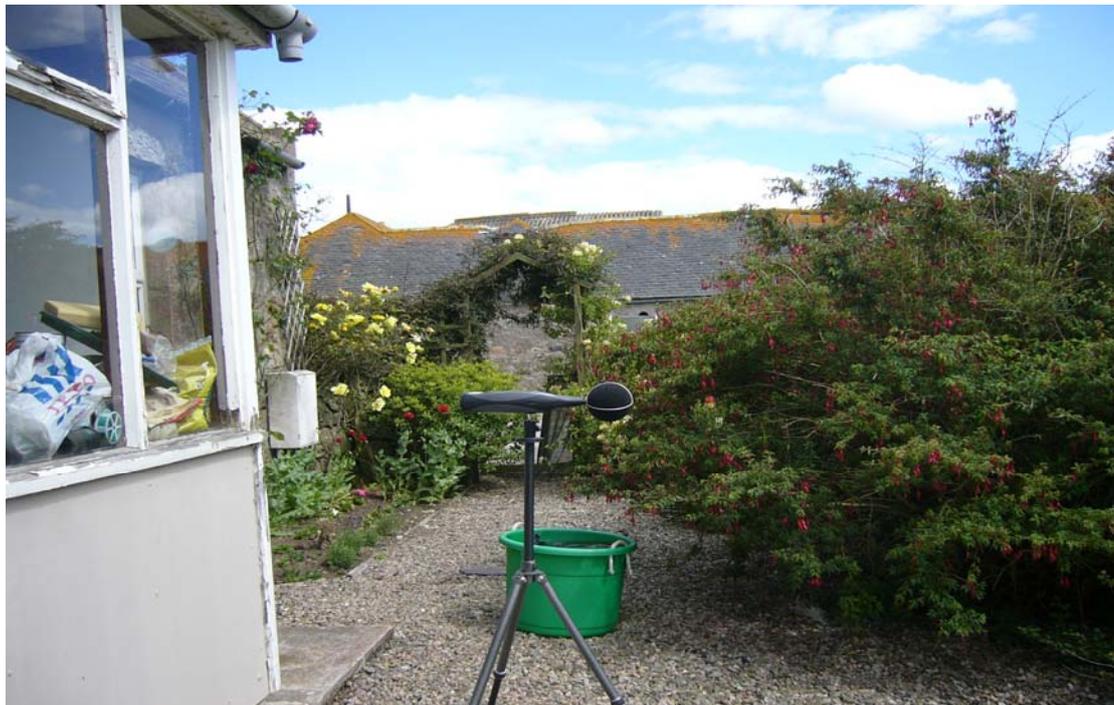
Figure 56 – Measurement Location 56

Location 56 North Rothnick: The measurement location was 1m from the south facing window of the property. This location was chosen due to no windows or doors being present on the east facing wall. The sound level meter was located 1.2m above the ground in façade conditions. The monitoring equipment was calibrated both before and after the measurement period using an acoustic calibrator, which has itself been calibrated against a reference set traceable to National and International Standards. There was no shift in the observed calibration level.

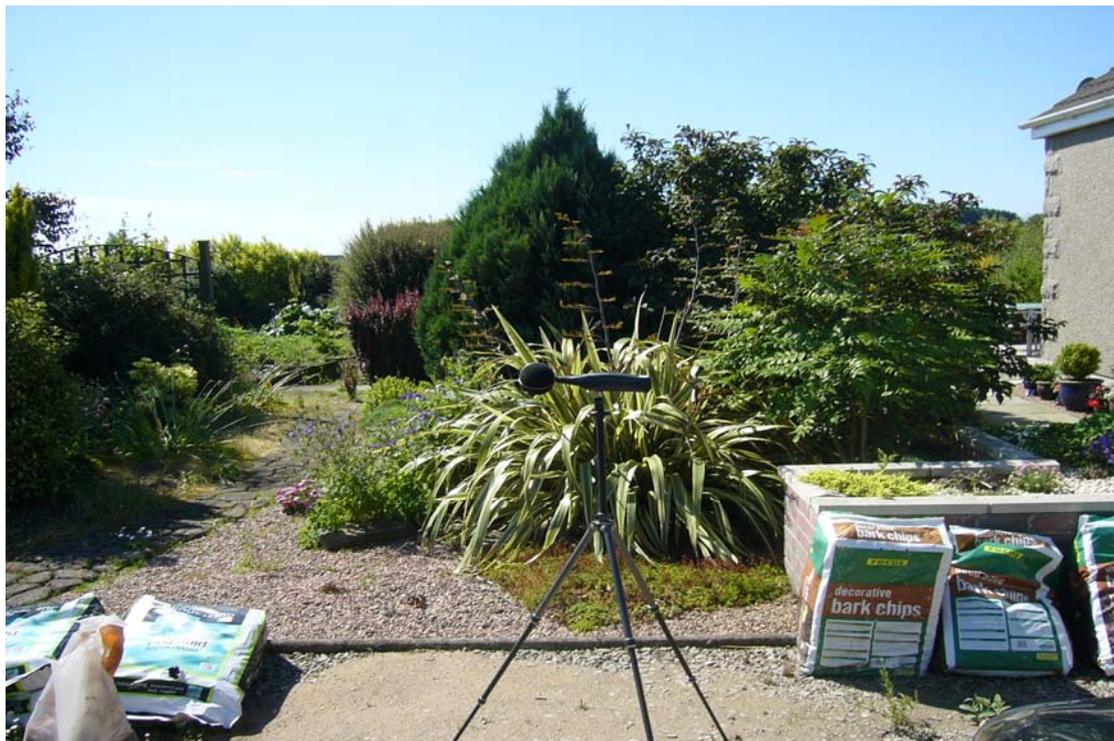
Figure 57 – Measurement Location 57

Location 57 Meadowbank: There is an access road to other properties in the area directly to the north of the property boundary. The measurement location was 4.7m from the east facing window of the property. The sound level meter was located 1.2m above the ground in free field conditions. The monitoring equipment was calibrated both before and after the measurement period using an acoustic calibrator, which has itself been calibrated against a reference set traceable to National and International Standards. There was no shift in the observed calibration level.

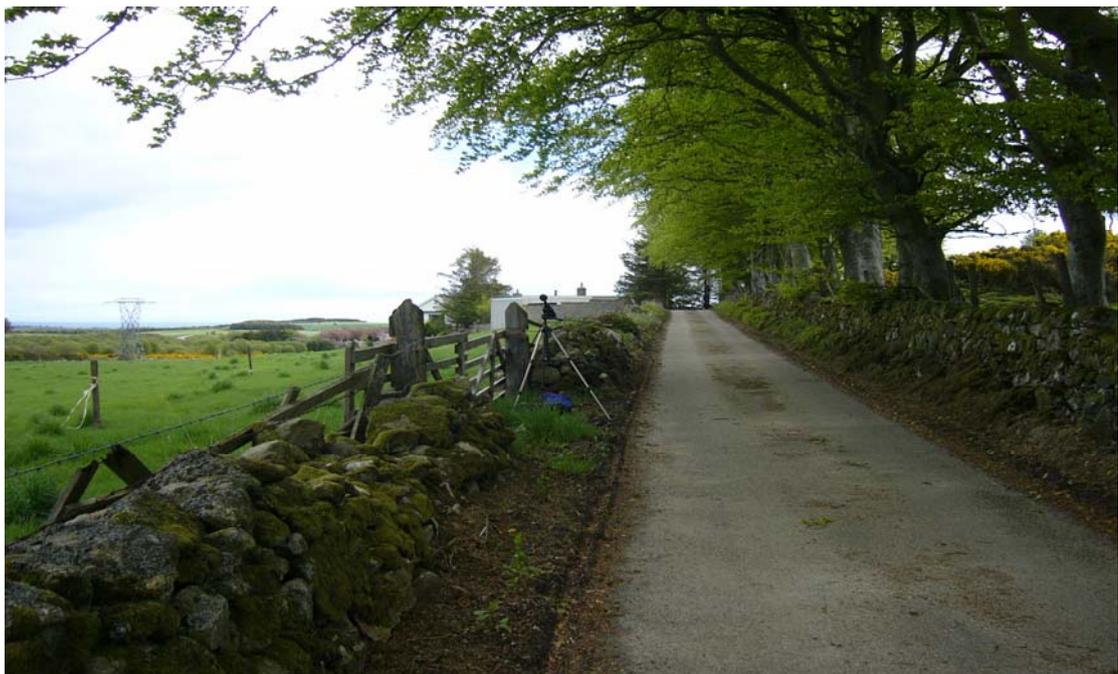
Figure 58: Location 58

Location 58 North Cookney Croft: The measurement location was approximately 2m from the property boundary wall facing south. The sound level meter was located 1.2m above the ground in free field conditions. The monitoring equipment was calibrated both before and after the measurement period using an acoustic calibrator, which has itself been calibrated against a reference set traceable to National and International Standards. There was no shift in the observed calibration level.

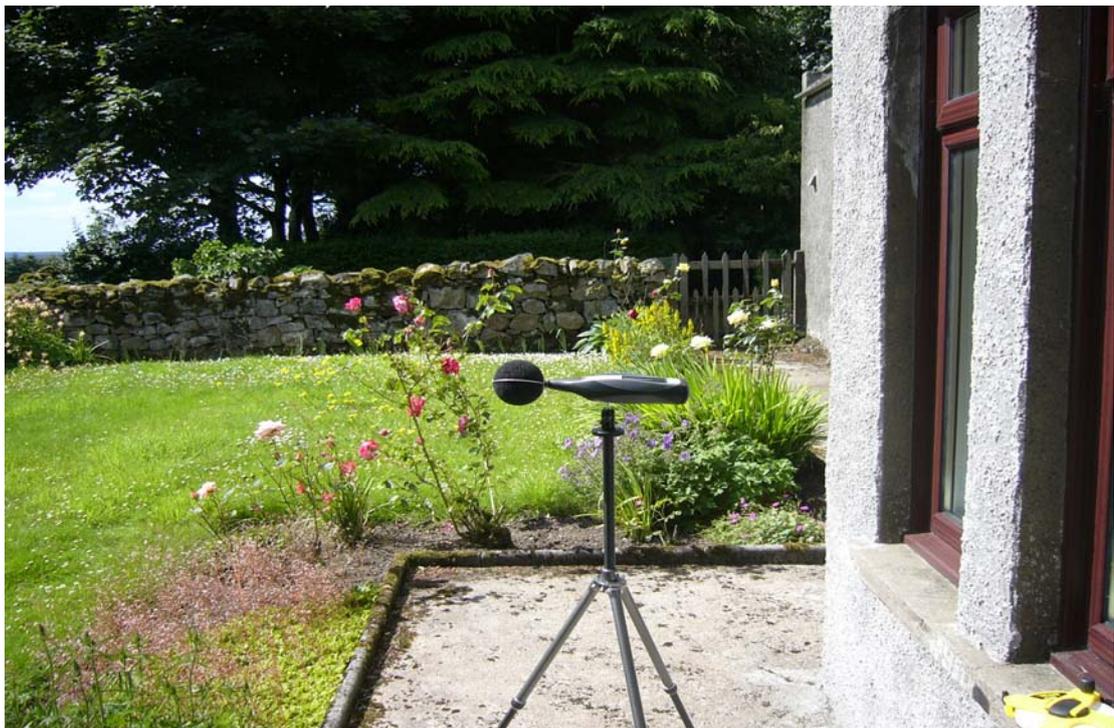
Figure 59 – Measurement Location 59

Location 59 Mains of Cookney: The measurement location was 4.3m from the south east facing window of the property. The sound level meter was located 1.2m above the ground in free field conditions. The monitoring equipment was calibrated both before and after the measurement period using an acoustic calibrator, which has itself been calibrated against a reference set traceable to National and International Standards. There was no shift in the observed calibration level.

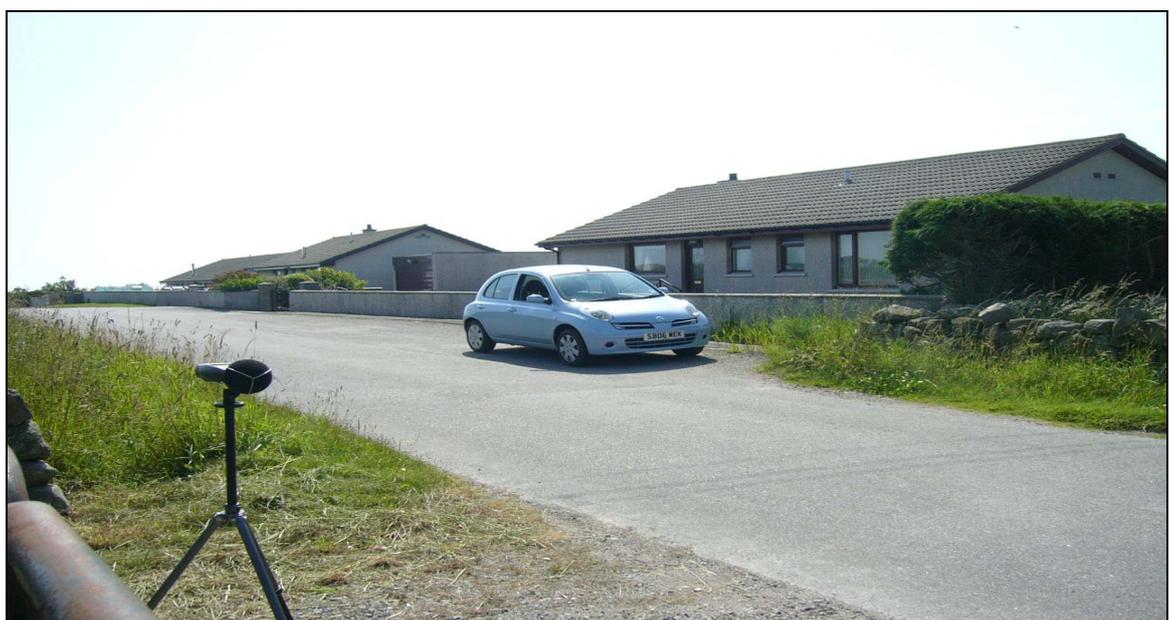
Figure 55: Measurement Location at Gowanlea

Location 60 Gowanlea: The measurement location was across the road from the property, approximately 2.2m from the roadside, facing west. The sound level meter was located 1.2m above the ground in free field conditions. The monitoring equipment was calibrated both before and after the measurement period using an acoustic calibrator, which has itself been calibrated against a reference set traceable to National and International Standards. There was no shift in the observed calibration level.

The property of Gowanlea, shown below in Figure 60, is at a further distance from the road than the microphone was positioned during the measurement period. Therefore a distance correction has been applied to any vehicles passing during the measurement period.

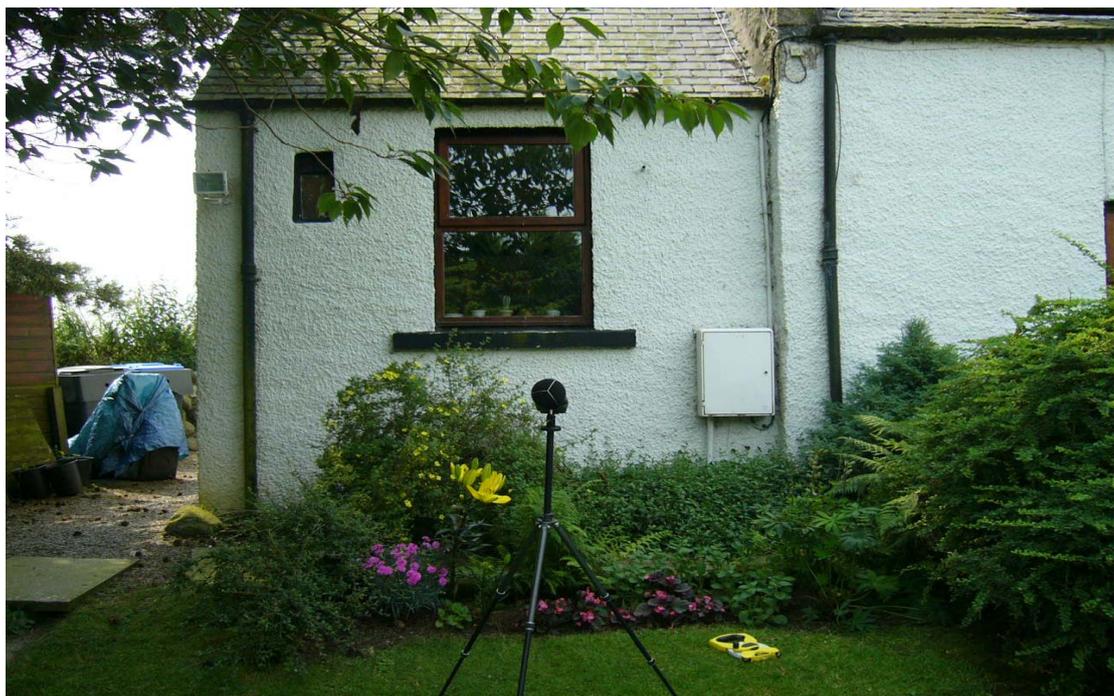
Figure 61 – Measurement Location 61

Location 61 Elrick Cottar House: There is an access lane to farmland passing in front of the property to the north. The measurement location was 3.5m from the north facing window of the property. This location was chosen due to no windows or doors being present on the east facing wall of the property. The sound level meter was located 1.2m above the ground in free field conditions. The monitoring equipment was calibrated both before and after the measurement period using an acoustic calibrator, which has itself been calibrated against a reference set traceable to National and International Standards. There was no shift in the observed calibration level.

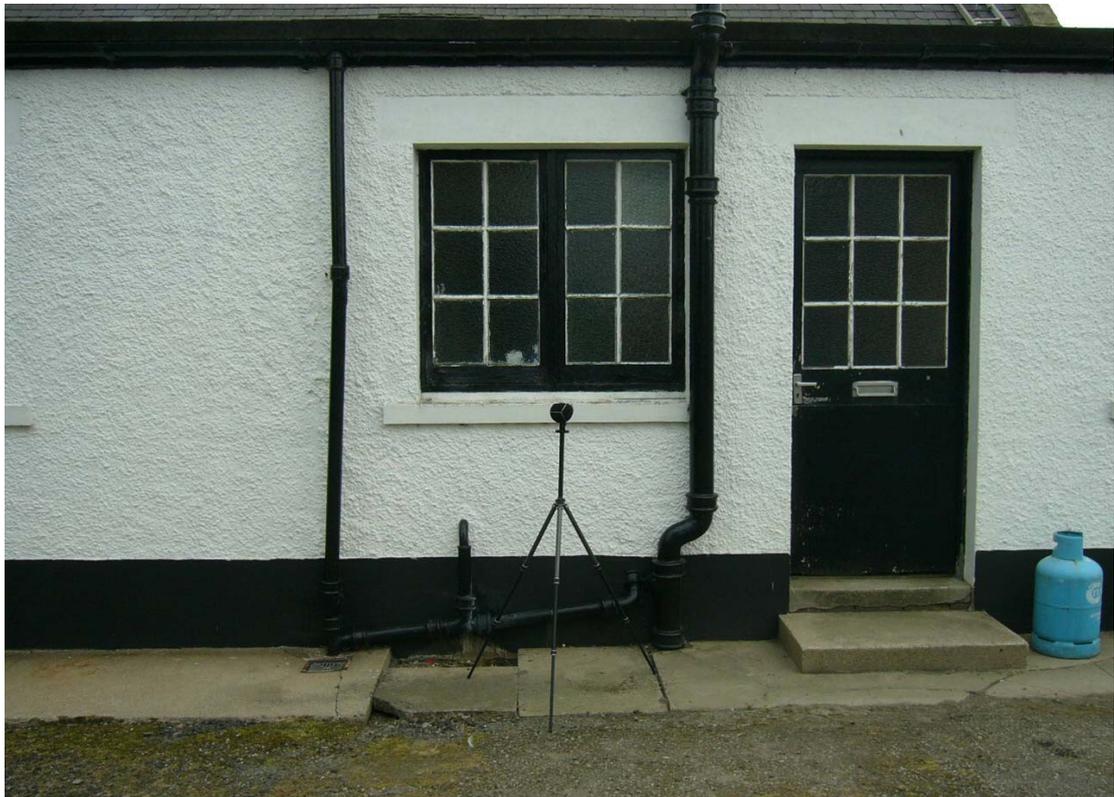
Figure 62 – Measurement Location 62

Location 62 Burnside Farm: The measurement location was 1m from the west facing window of the property. The sound level meter was located 1.2m above the ground in façade conditions. The monitoring equipment was calibrated both before and after the measurement period using an acoustic calibrator, which has itself been calibrated against a reference set traceable to National and International Standards. There was no shift in the observed calibration level.

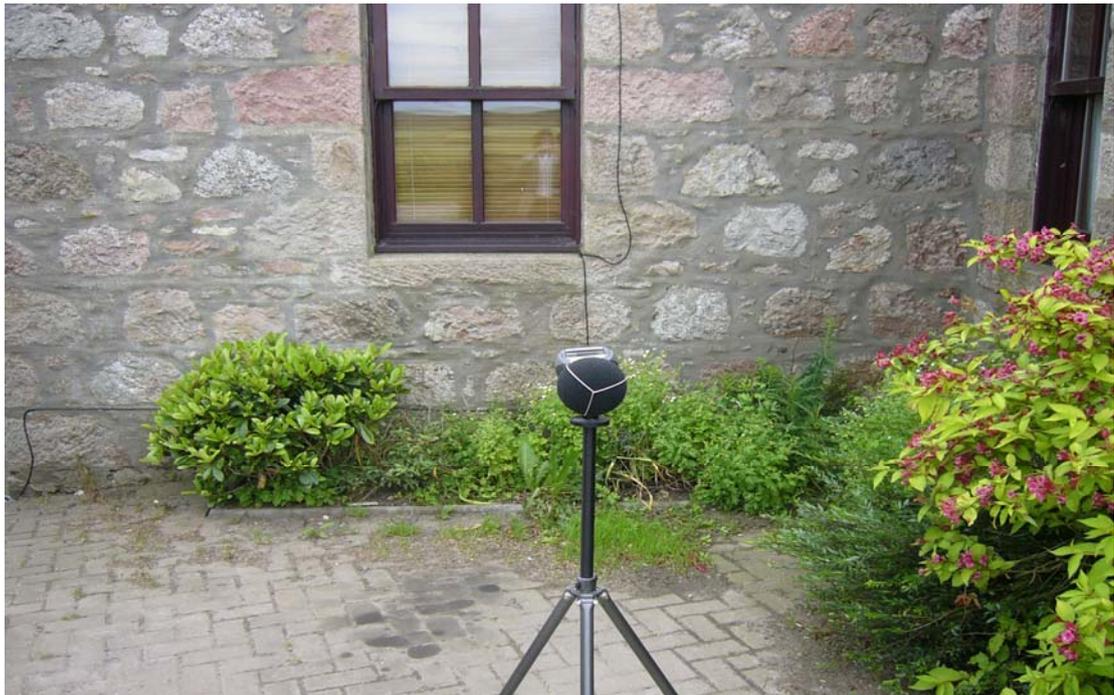
Figure 64 – Measurement Location 64

Location 64 Broomhill Cottage: There is an access road to other properties in the area situated directly to west of the property boundary. The measurement location was 3.5m from the west facing window of the property. The sound level meter was located 1.2m above the ground in free field conditions. The monitoring equipment was calibrated both before and after the measurement period using an acoustic calibrator, which has itself been calibrated against a reference set traceable to National and International Standards. There was no shift in the observed calibration level.

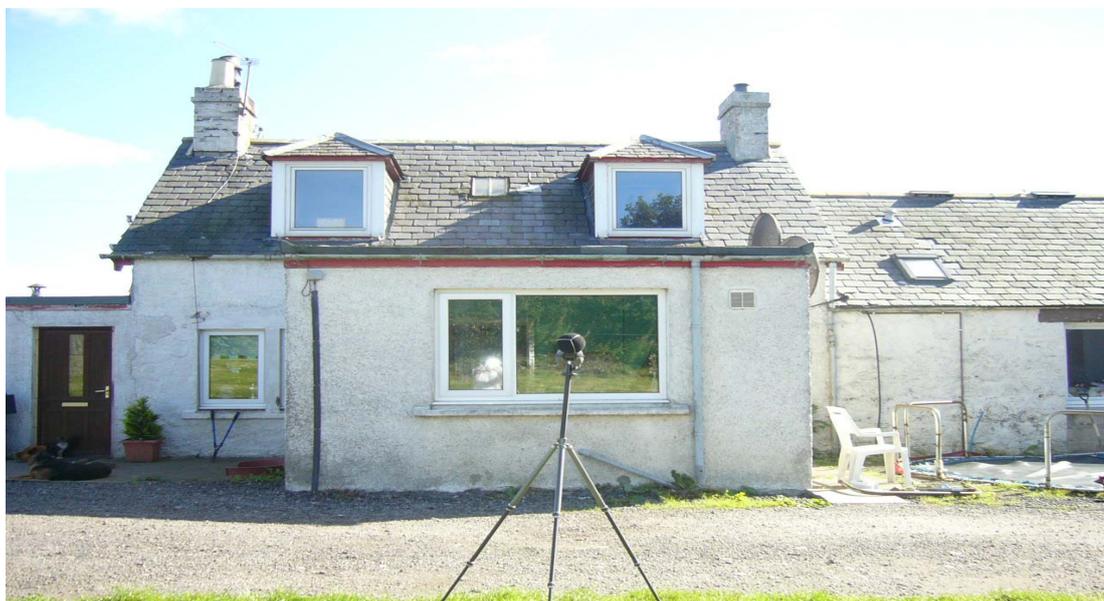
Figure 65 – Measurement Location 65

Location 65 Fishermyme: There is an access road to the B979 directly to the north of the property boundary. The measurement location was 5m from the west facing windows of the property. This location was chosen due to no windows or doors being present on the east facing wall of the property. The sound level meter was located 1.2m above the ground in free field conditions. The monitoring equipment was calibrated both before and after the measurement period using an acoustic calibrator, which has itself been calibrated against a reference set traceable to National and International Standards. There was no shift in the observed calibration level.

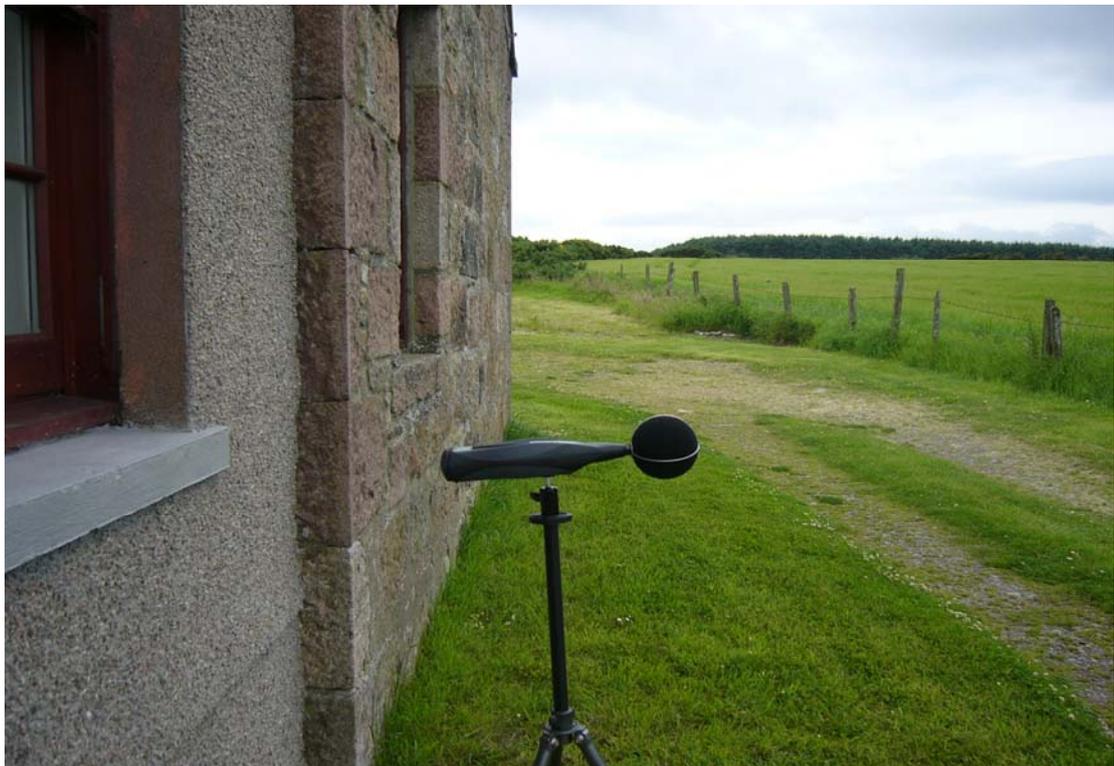
Figure 66 – Measurement Location 66

Location 66 Kempstone Hill: The measurement location was 1m from the west facing window of the property. The sound level meter was located 1.2m above the ground in façade conditions. The monitoring equipment was calibrated both before and after the measurement period using an acoustic calibrator, which has itself been calibrated against a reference set traceable to National and International Standards. There was no shift in the observed calibration level.

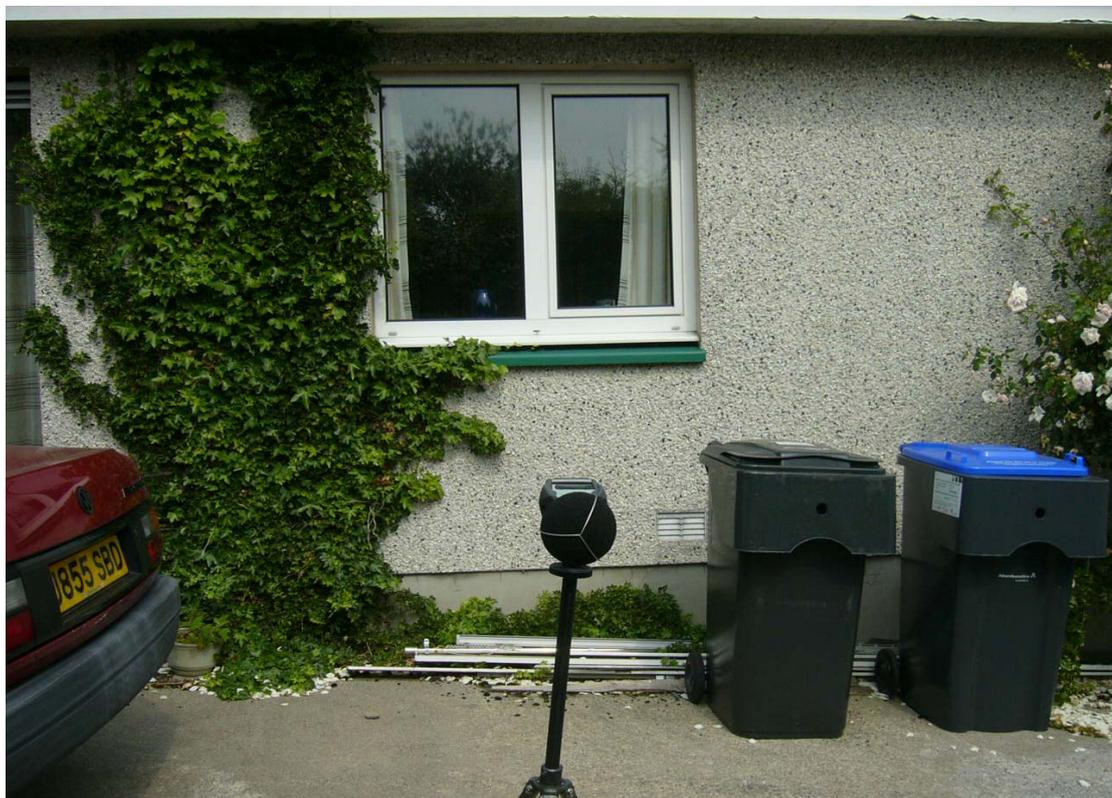
Figure 67 – Measurement Location 67

Location 67 Ardchoille: The measurement location was 3.5m from the west facing window of the property. The sound level meter was located 1.2m above the ground in free field conditions. The monitoring equipment was calibrated both before and after the measurement period using an acoustic calibrator, which has itself been calibrated against a reference set traceable to National and International Standards. There was no shift in the observed calibration level.

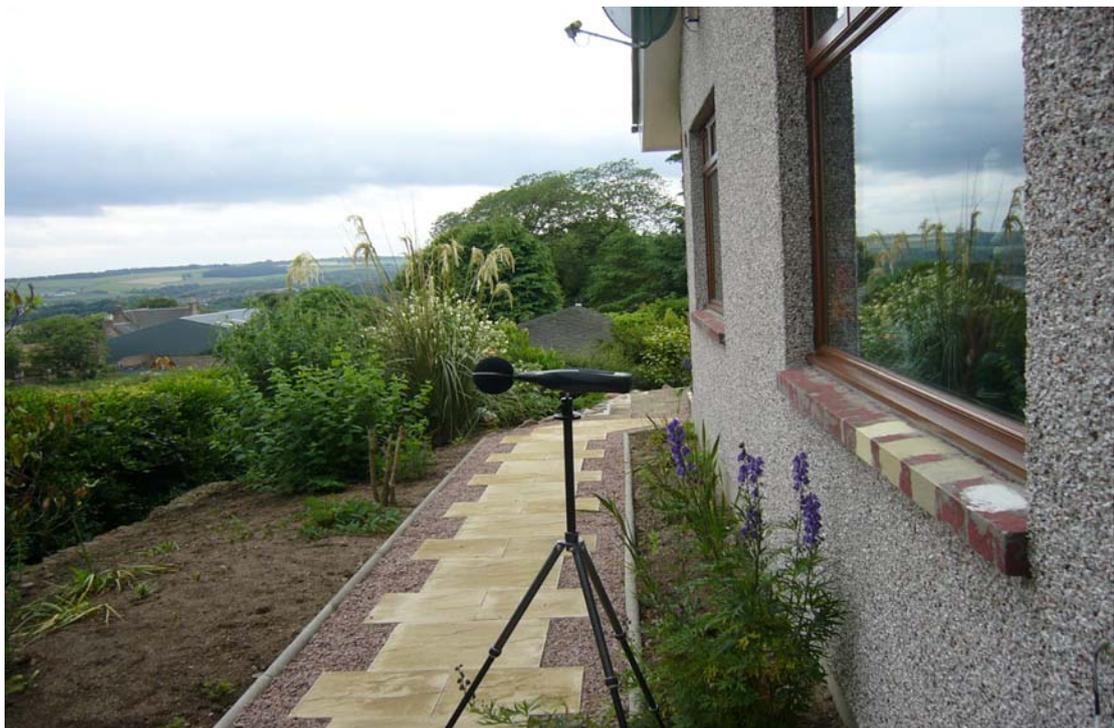
Figure 68 – Measurement Location 68

Location 68 Bayview Ury: The measurement location was 1m from the east facing window of the property. The sound level meter was located 1.2m above the ground in façade conditions. The monitoring equipment was calibrated both before and after the measurement period using an acoustic calibrator, which has itself been calibrated against a reference set traceable to National and International Standards. There was no shift in the observed calibration level.

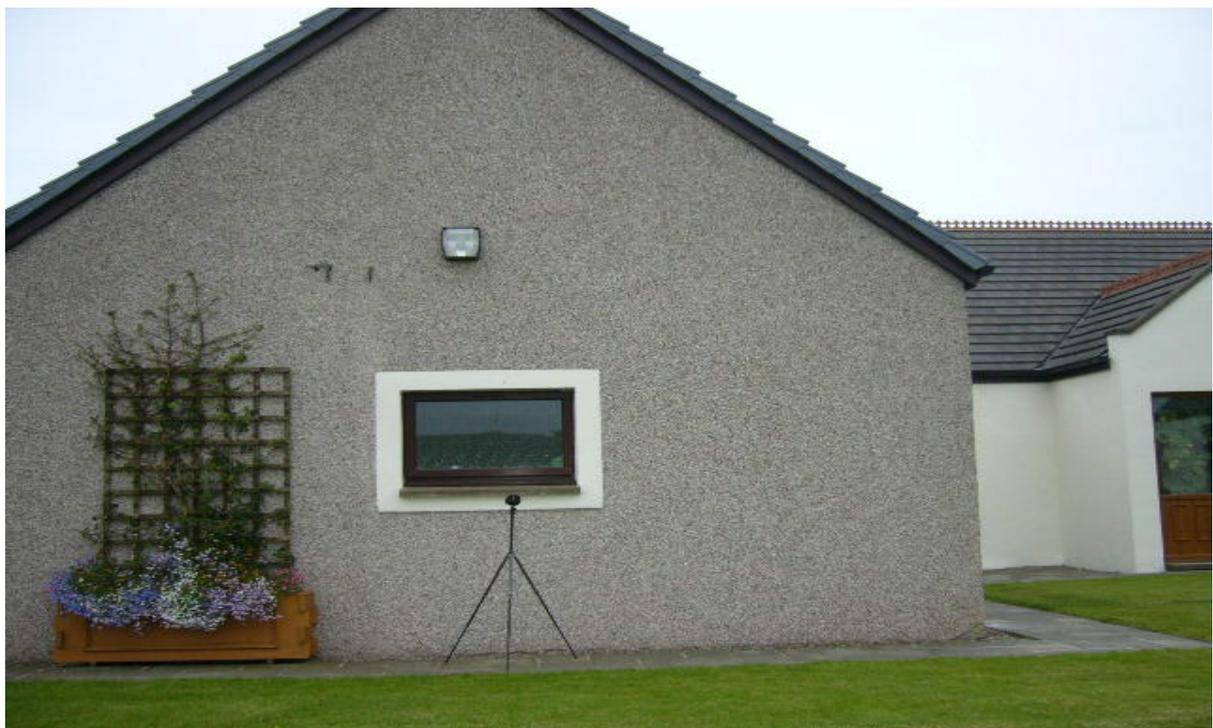
Figure 69 – Measurement Location 69

Location 69 Megray House: The measurement location was 1m from the west facing window of the property. The sound level meter was located 1.2m above the ground in façade conditions. The monitoring equipment was calibrated both before and after the measurement period using an acoustic calibrator, which has itself been calibrated against a reference set traceable to National and International Standards. There was no shift in the observed calibration level.

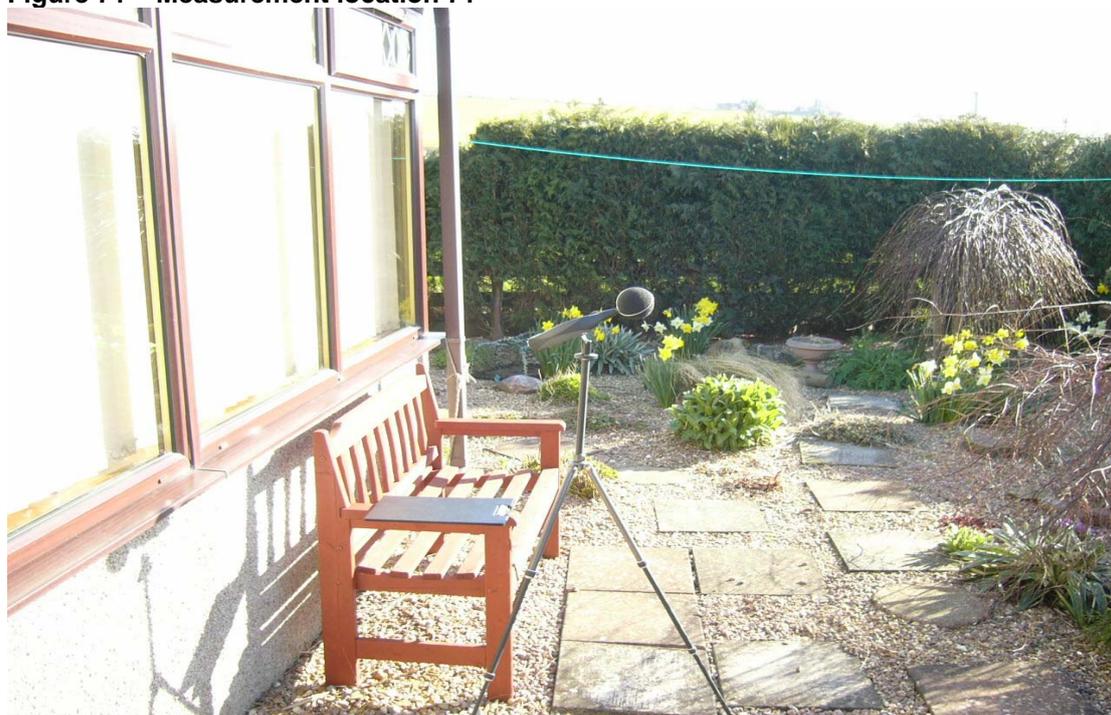
Figure 71 – Measurement location 71

Location 71 3 Mains of Ury: Partially shielded by vegetation, the A90 is situated approximately 20m to the south of the property boundary. The measurement location was 1m from the south facing conservatory windows of the property. The sound level meter was located 1.2m above the ground in façade conditions. The monitoring equipment was calibrated both before and after the measurement period using an acoustic calibrator, which has itself been calibrated against a reference set traceable to National and International Standards. There was no shift in the observed calibration level.

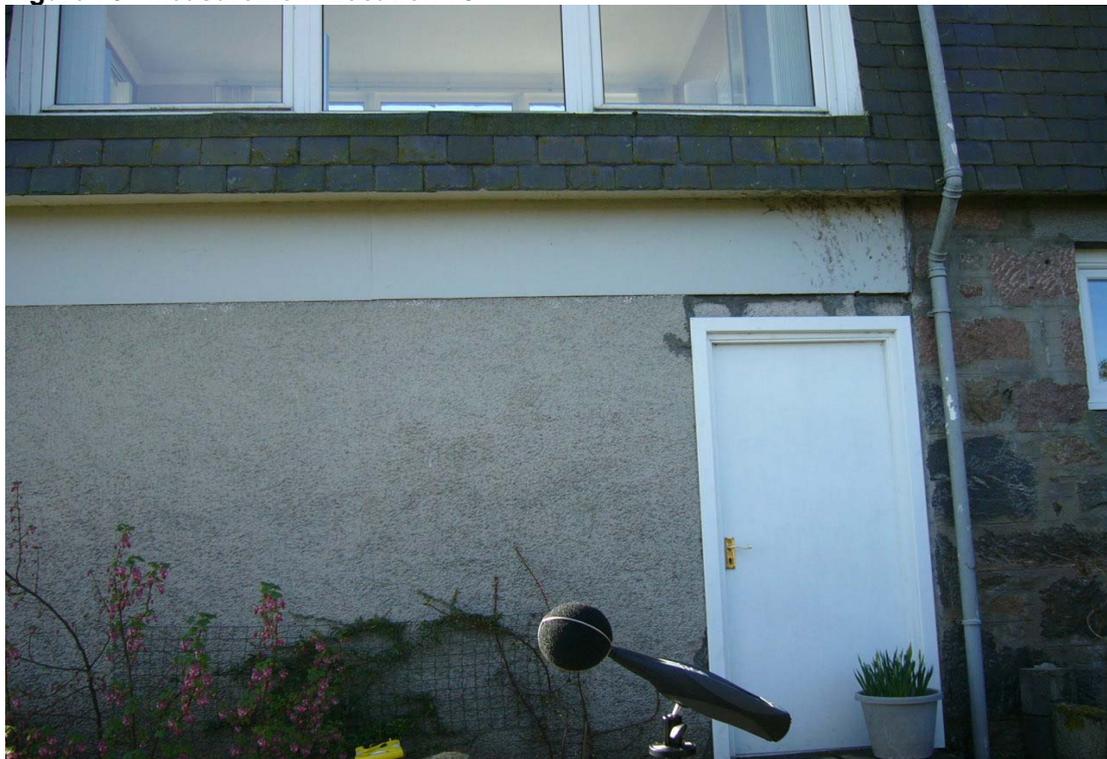
Figure 78 –Measurement Location 78

New Location 78 Foresters Croft: The measurement location was 3.5m from the north facing door of the property. The sound level meter was located 1.2m above the ground in free field conditions. The monitoring equipment was calibrated both before and after the measurement period using an acoustic calibrator, which has itself been calibrated against a reference set traceable to National and International Standards. There was no shift in the observed calibration level.

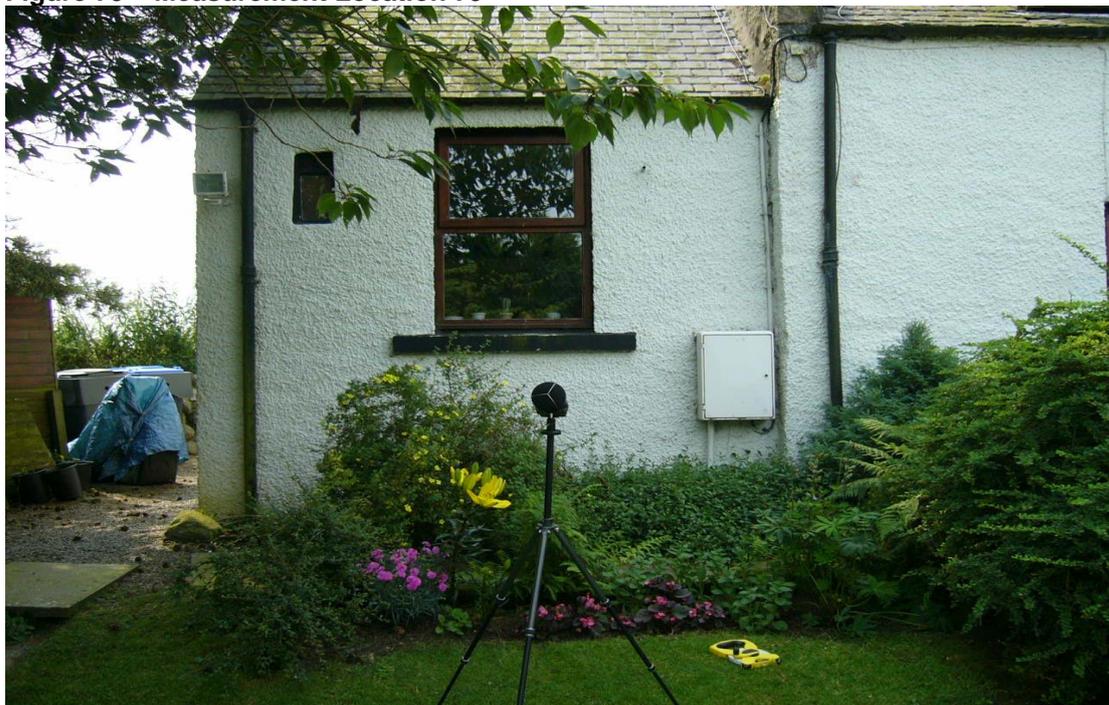
Figure 79 – Measurement Location 79

New Location 79 Curlews Cottage: The measurement location was 8.8m from the north facing window of the property. The sound level meter was located 1.2m above the ground in free field conditions. The monitoring equipment was calibrated both before and after the measurement period using an acoustic calibrator, which has itself been calibrated against a reference set traceable to National and International Standards. There was no shift in the observed calibration level.
