Project **FORTH REPLACEMENT CROSSING**

**AIR QUALITY MONITORING REPORT  
FEBRUARY 2017**

Made by Steven Westwater	Checked By: David Clark
Initials: SWR	Initials: David Clark
Document number <b>REP-00314</b>	Rev <b>00</b>

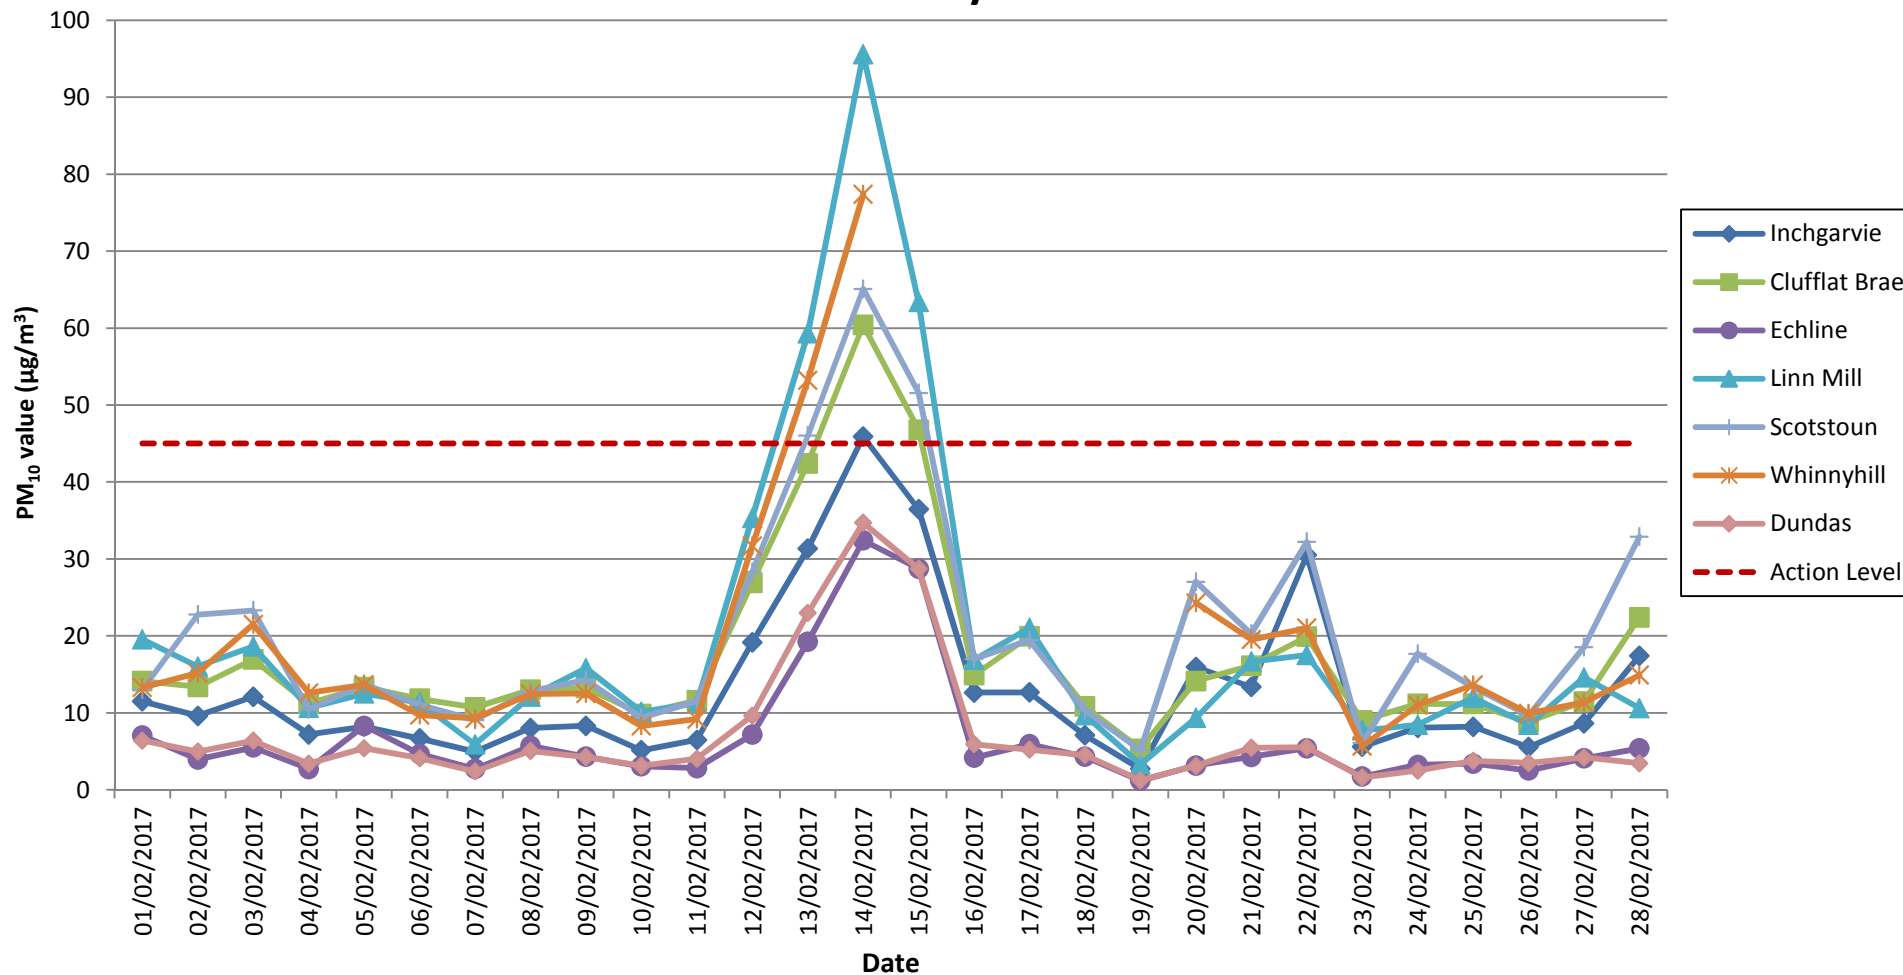
## Particulate Matter (PM10) Results for all Monitoring Locations

**Note:** There is no data at the Whinnyhill monitor between 15/02/2017 and 19/02/2017 due to a electrical problem at the monitor.

3.1.1. Light scatter results for February 2017 have been presented in a monthly chart; this can be found in Appendix A. Results show that the

PM<sub>10</sub> levels follow a similar pattern and were below threshold levels throughout the month with the exception of the 13<sup>th</sup> - 15<sup>th</sup> February, where some monitors showed an exceedance. As all monitors recorded a significant increase over this time period it is concluded that these exceedances were caused by regional air quality.

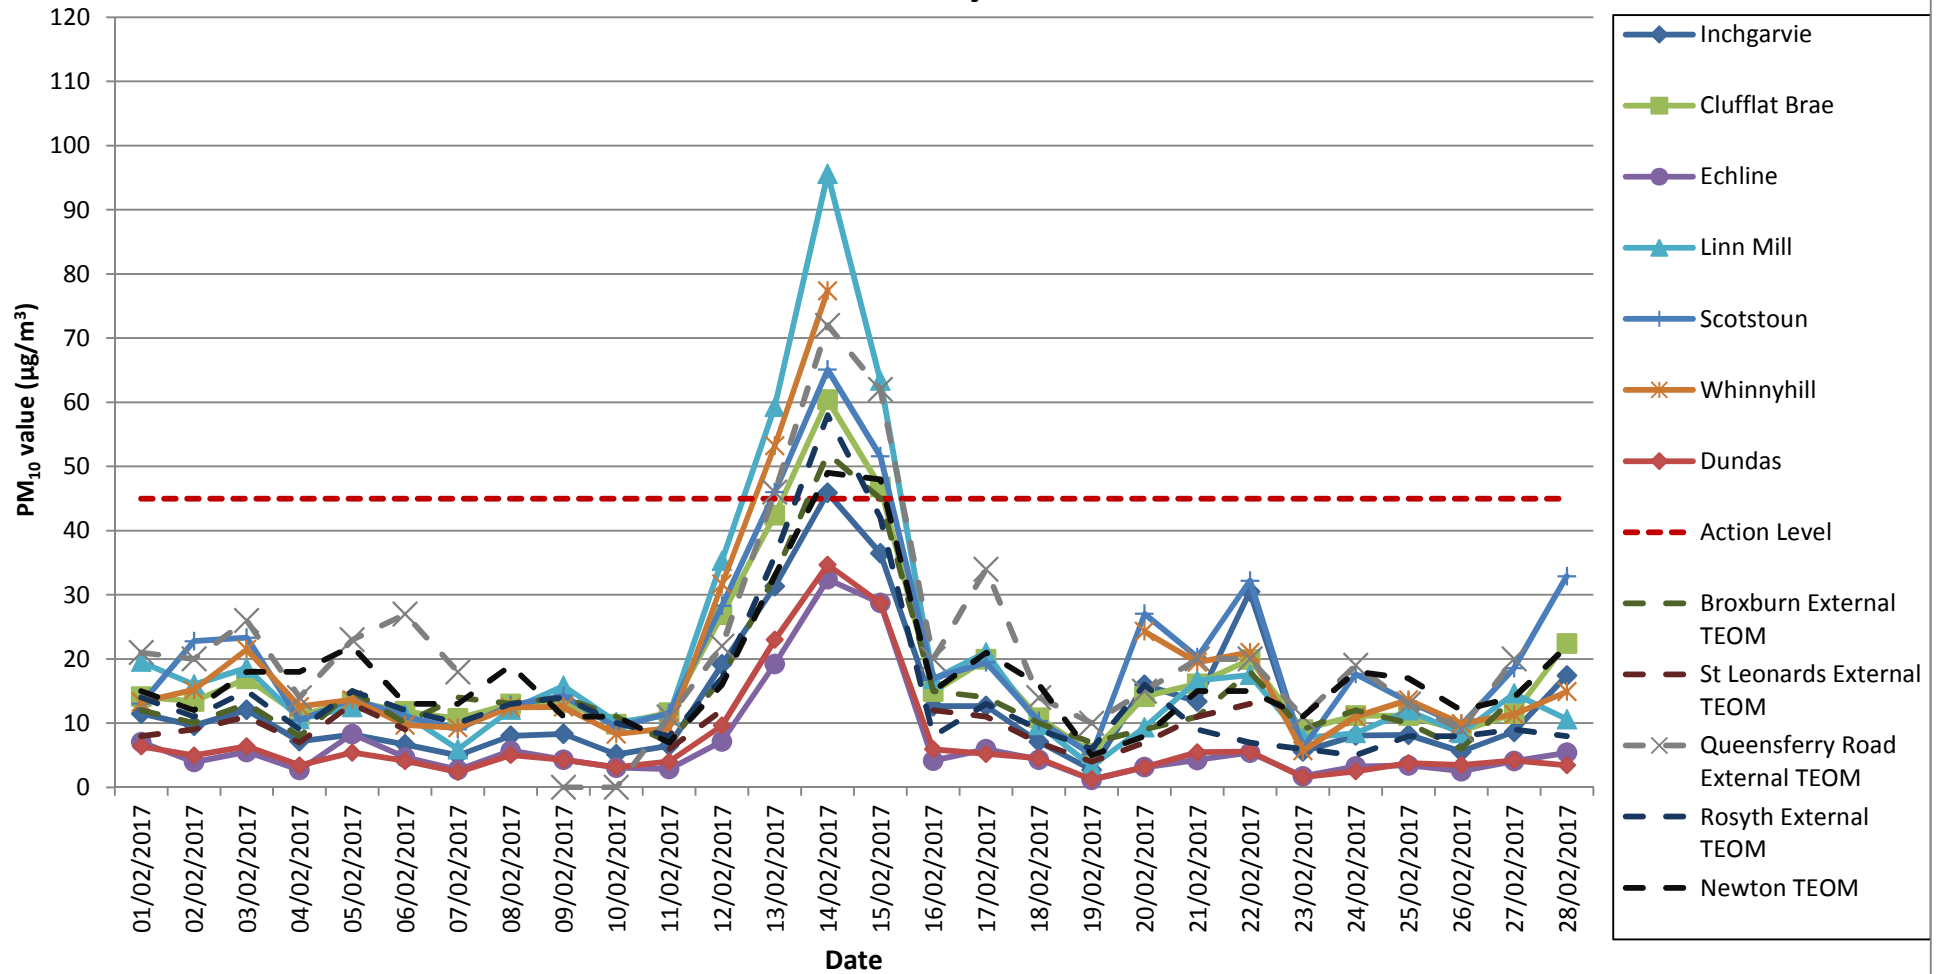
## Air Quality Monitoring: Particulate Matter (PM10) Results for all Monitoring Locations, including TEOM data February 2017

**Note:** There is no data at the Whinnyhill monitor between 15/02/2017 and 19/02/2017 due to a electrical problem at the monitor.

- 3.1.2.** The PM<sub>10</sub> results have also been compared to the daily mean results obtained from the TEOM air quality monitoring stations located in Newton, Rosyth, and Broxburn, and from the TEOM FDMS station located at Queensferry Road and St Leonards, Edinburgh (an urban background site). The TEOM at Newton was installed by West Lothian Council, facilitated by FCBC, during January 2012. The comparison between the light scatter and TEOM results demonstrates that both sets of results generally follow the same pattern throughout the month, including during the time period of the exceedances noted in 3.1.1.

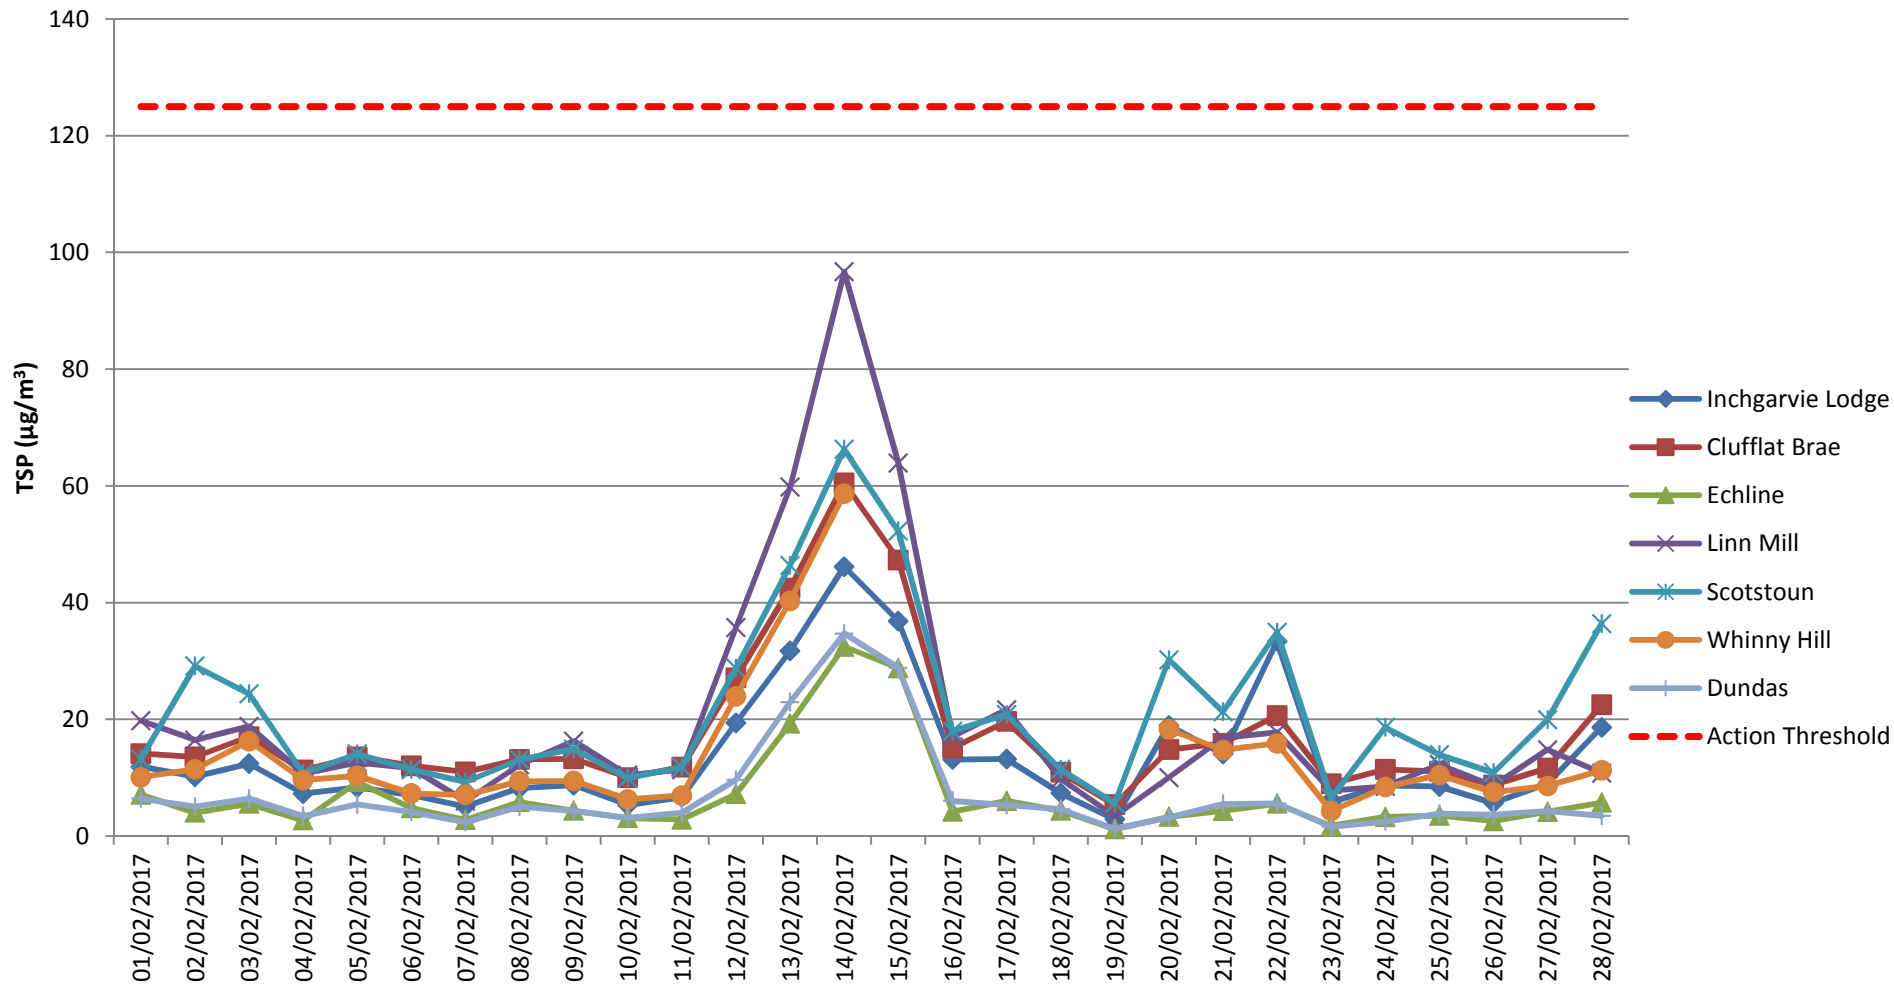
## Total Suspended Particles (TSP) Results February 2017

**Note:** There is no data at the Whinnyhill monitor between 15/02/2017 and 19/02/2017 due to a electrical problem at the monitor.

- 3.2.1.** The TSP results for February 2017 have been presented in a monthly chart; this can be found in Appendix B. The TSP levels at monitoring locations during February were found to be generally low and all within the threshold. All locations across the site were found to follow a similar pattern (similar to that observed for PM<sub>10</sub> levels), including an increase between 13<sup>th</sup> – 15<sup>th</sup> February. As with PM<sub>10</sub> it is considered that the TSP levels across site were influenced by regional changes in TSP levels.

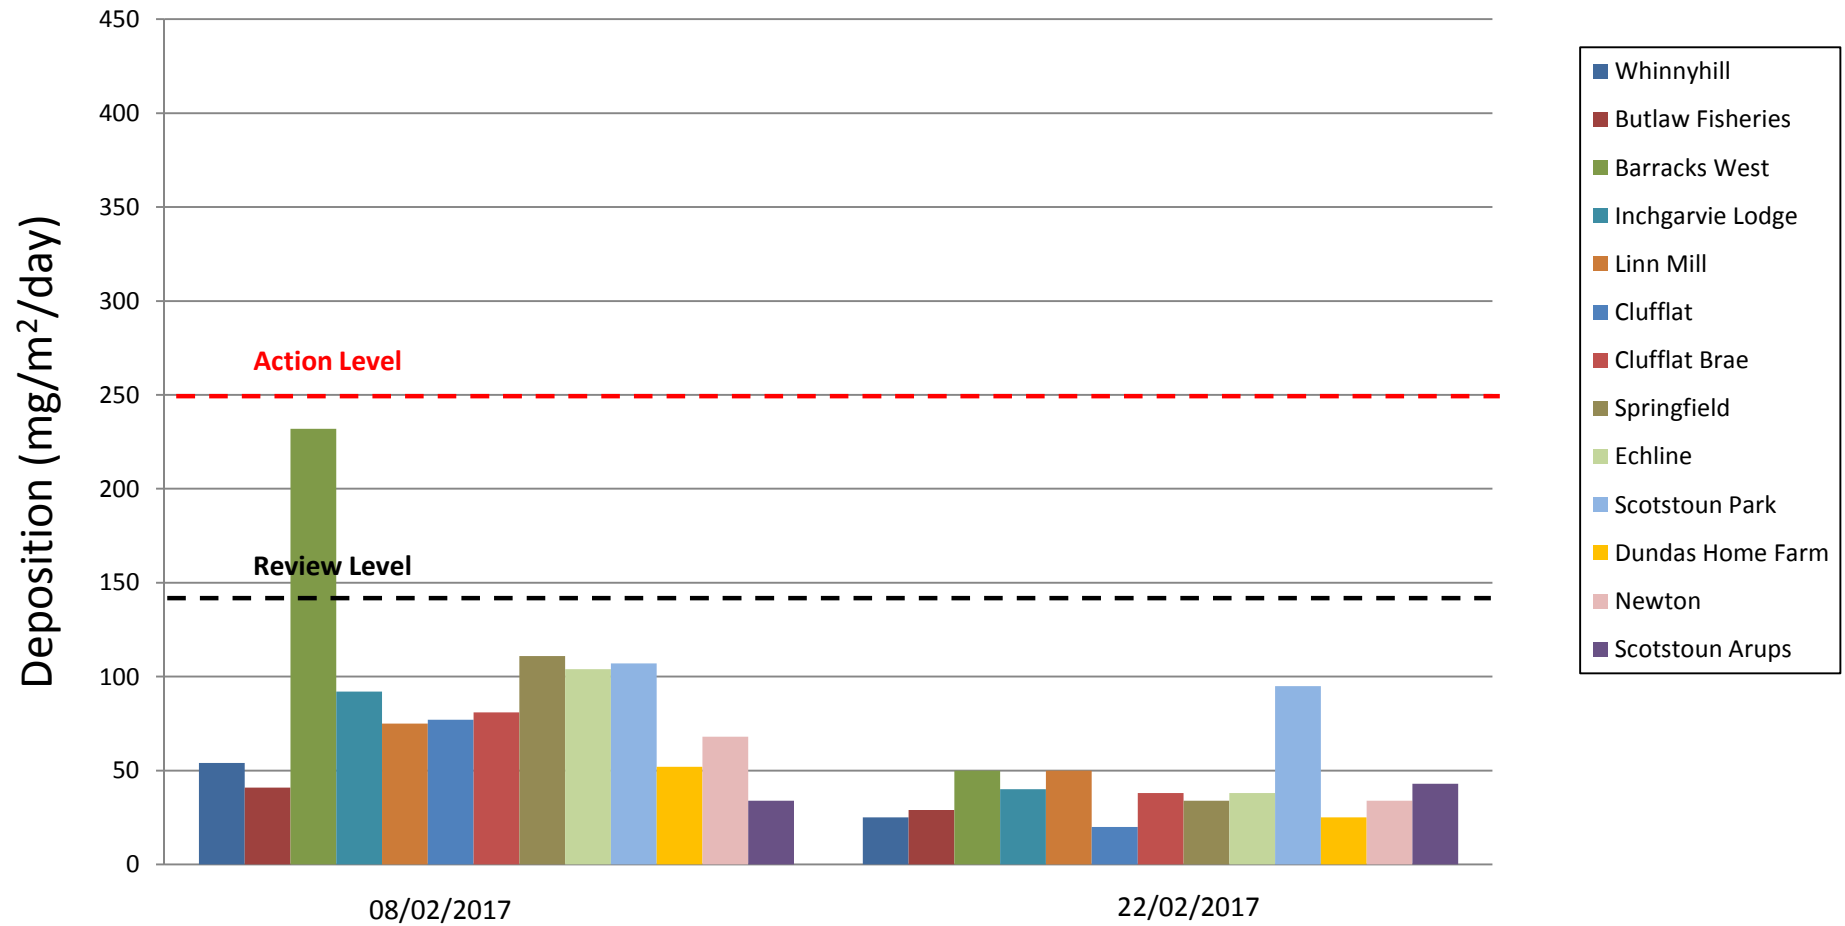
# Frisbee Dust Deposition Results: February 2017

- 3.3.1.** The Frisbee dust deposition results for February 2017 have been presented in a chart and can be found in Appendix C. Two collections were made in February; these occurred on the 8<sup>th</sup> and 22<sup>nd</sup> February 2017.

- 3.3.2.** The site action level for the dust deposition rate has been set at 250 mg/m<sup>2</sup>/day. Exceedances of this level are treated as a potential incident and a review of the works in the vicinity of the site is instigated. A lower site review level has been set at 140 mg/m<sup>2</sup>/day. Where concentrations exceed the lower review threshold the site works are reviewed to ensure good practice is implemented; it is essentially a warning that additional controls may be required.

- 3.3.3.** During February there was one exceedance of the site review and no exceedances of the action level. The Barracks West monitor recorded an exceedance of the review level for the period ending 8<sup>th</sup> February. This is considered likely to have been caused by concrete finishing work, which included sanding, on Pier S6 on 6<sup>th</sup> February 2017. The monitor is located on site in close proximity to Pier S6. The dust is considered to be very localised and there is no indication from the other monitors nearby to indicate that dust from this activity had migrated off-site.
