Project **FORTH REPLACEMENT CROSSING**

**AIR QUALITY MONITORING REPORT
MARCH 2017**

Document number	Rev
REP-00317	00

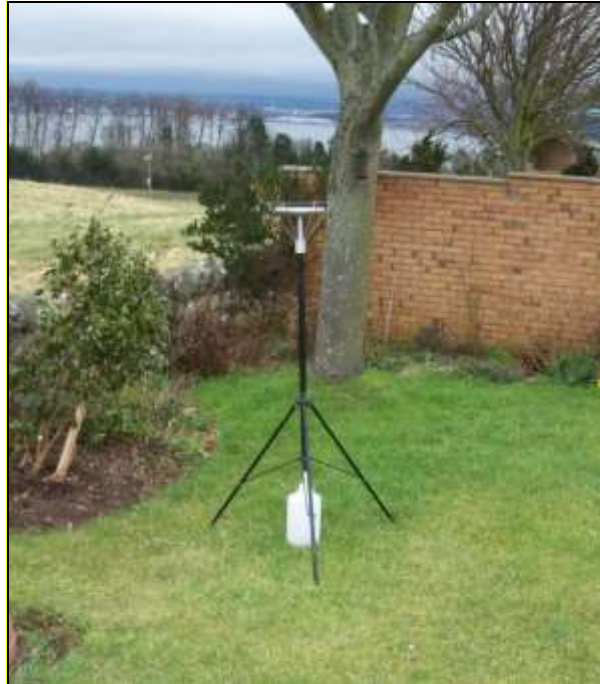
Figure 1: Example of an Installed Frisbee Gauge Meter

2.1. Air quality is being monitored on site using both automatic light scatter dust meters and Frisbee gauge dust deposition monitoring. Twelve Frisbee gauges are currently set up at sensitive locations across the site to measure dust deposition rates (Figure 1). Seven automatic light scatter meters have also been installed at various sensitive locations to measure real time particulate matter (PM₁₀) concentrations and the Total Suspended Particle (TSP) concentrations (Figure 2). These meters are calibrated annually. Table 1 lists the air quality monitoring equipment present at each monitoring location, including the date it was installed.

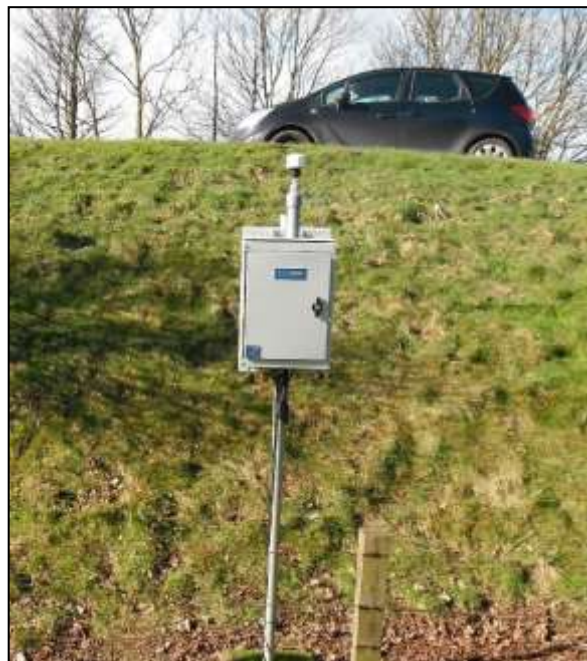
Figure 2: Example of an installed Automatic Light Scatter Dust Meter

2.2. Light scatter type monitoring equipment have been selected as a site monitoring tool to create a live network which assesses the levels of fugitive particulate matter, principally airborne dust. These monitors require less space, maintenance and power than other real time monitors such as a Tapered Element Oscillating Microbalance (TEOM) which is used and designed to measure particulate levels to exceedingly high standards, including measuring long-term compliance to statutory limits. Light scatter meters are more practicable to deploy. However, the meters do generally record levels higher than those measured by the TEOM. The meters can also be affected by atmospheric moisture content which further increases reported levels. Accordingly, any elevations of statutory limits should be treated as precautionary exceedances. The monitors are reliable for on-site monitoring and the establishment of action thresholds to ensure unforeseen activities generating significant dust are identified and suitably controlled. Light scatter meters are becoming the construction and waste industries norm for particulate dust monitoring.
