Project **FORTH REPLACEMENT CROSSING**

**AIR QUALITY MONITORING REPORT
JANUARY 2016**

Document number	Rev
REP-00310	00

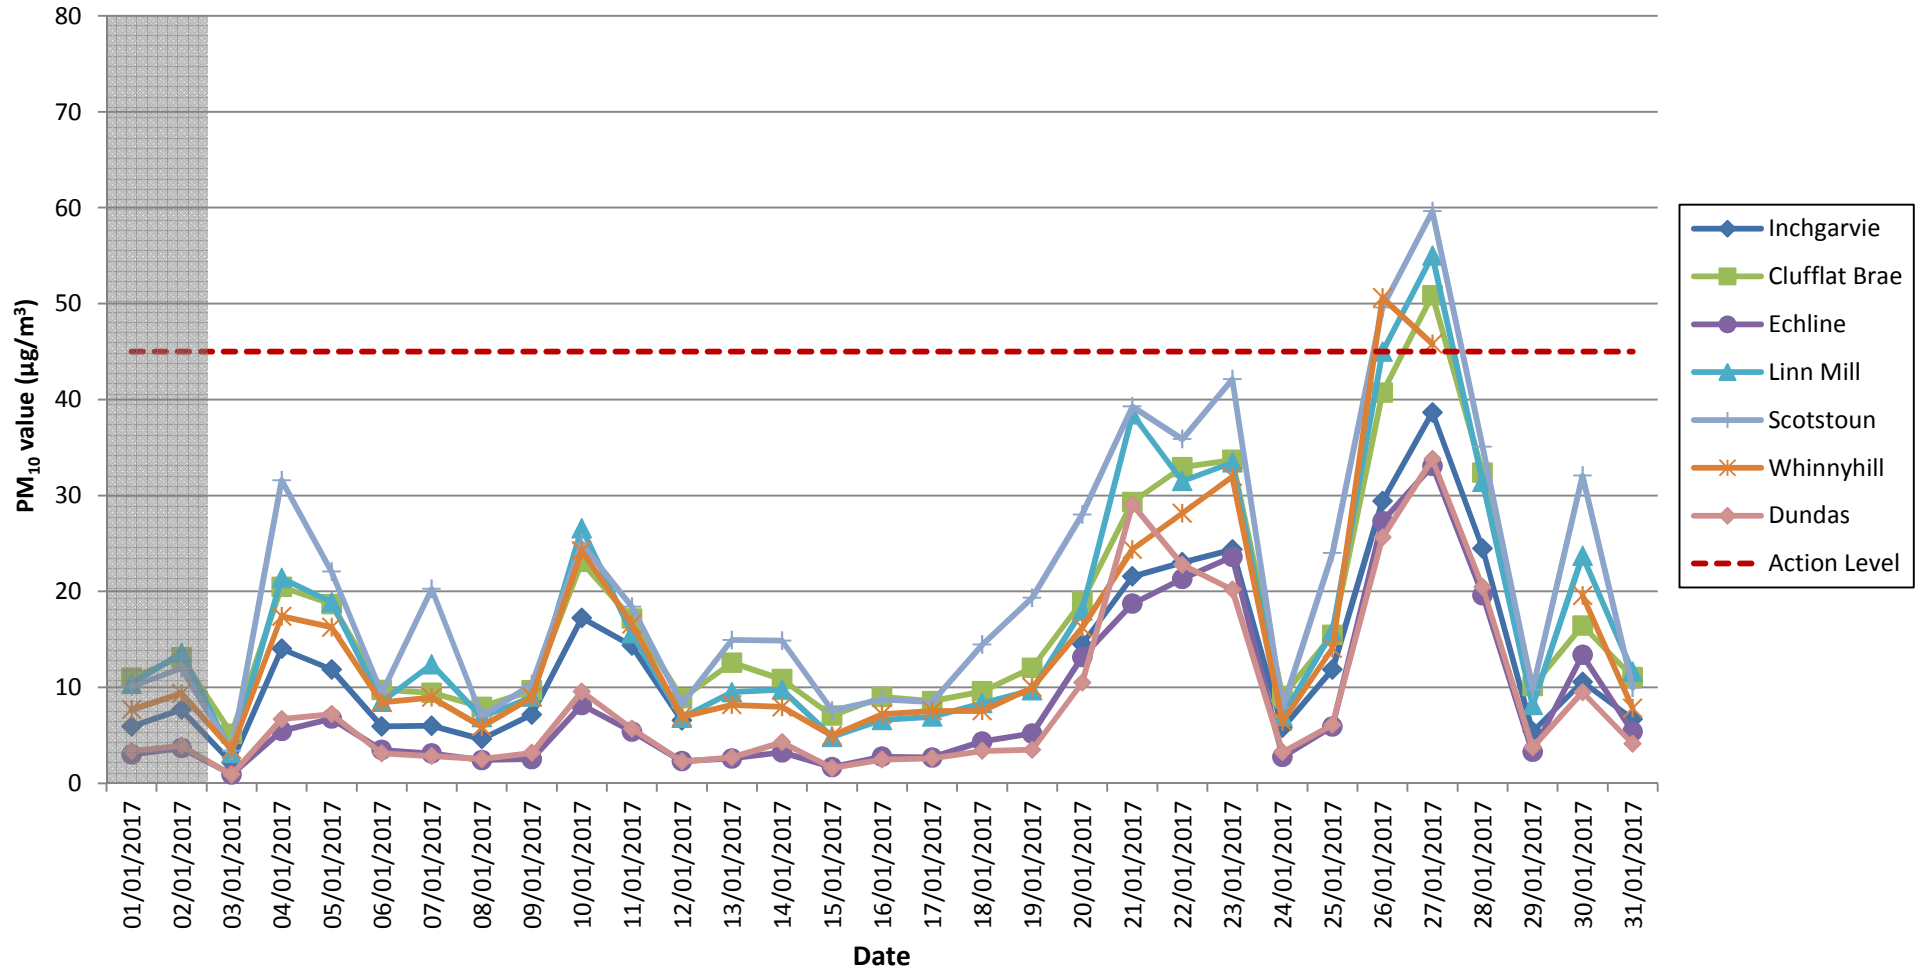
Particulate Matter (PM10) Results for all Monitoring Locations

Note: Data missing from Inchgarvie between 13th-19th January and from Whinnyhill on the 28th and 29th January due to electrical faults.

3.1.1. Light scatter results for January 2017 have been presented in a monthly chart; this can be found in Appendix A. Results show that the PM₁₀

levels follow a similar pattern and were below threshold levels throughout the month with the exception of the 26th - 27th January, where some monitors showed an exceedance. As all monitors recorded an increase over this time period it is concluded that these exceedances were caused by regional air quality.

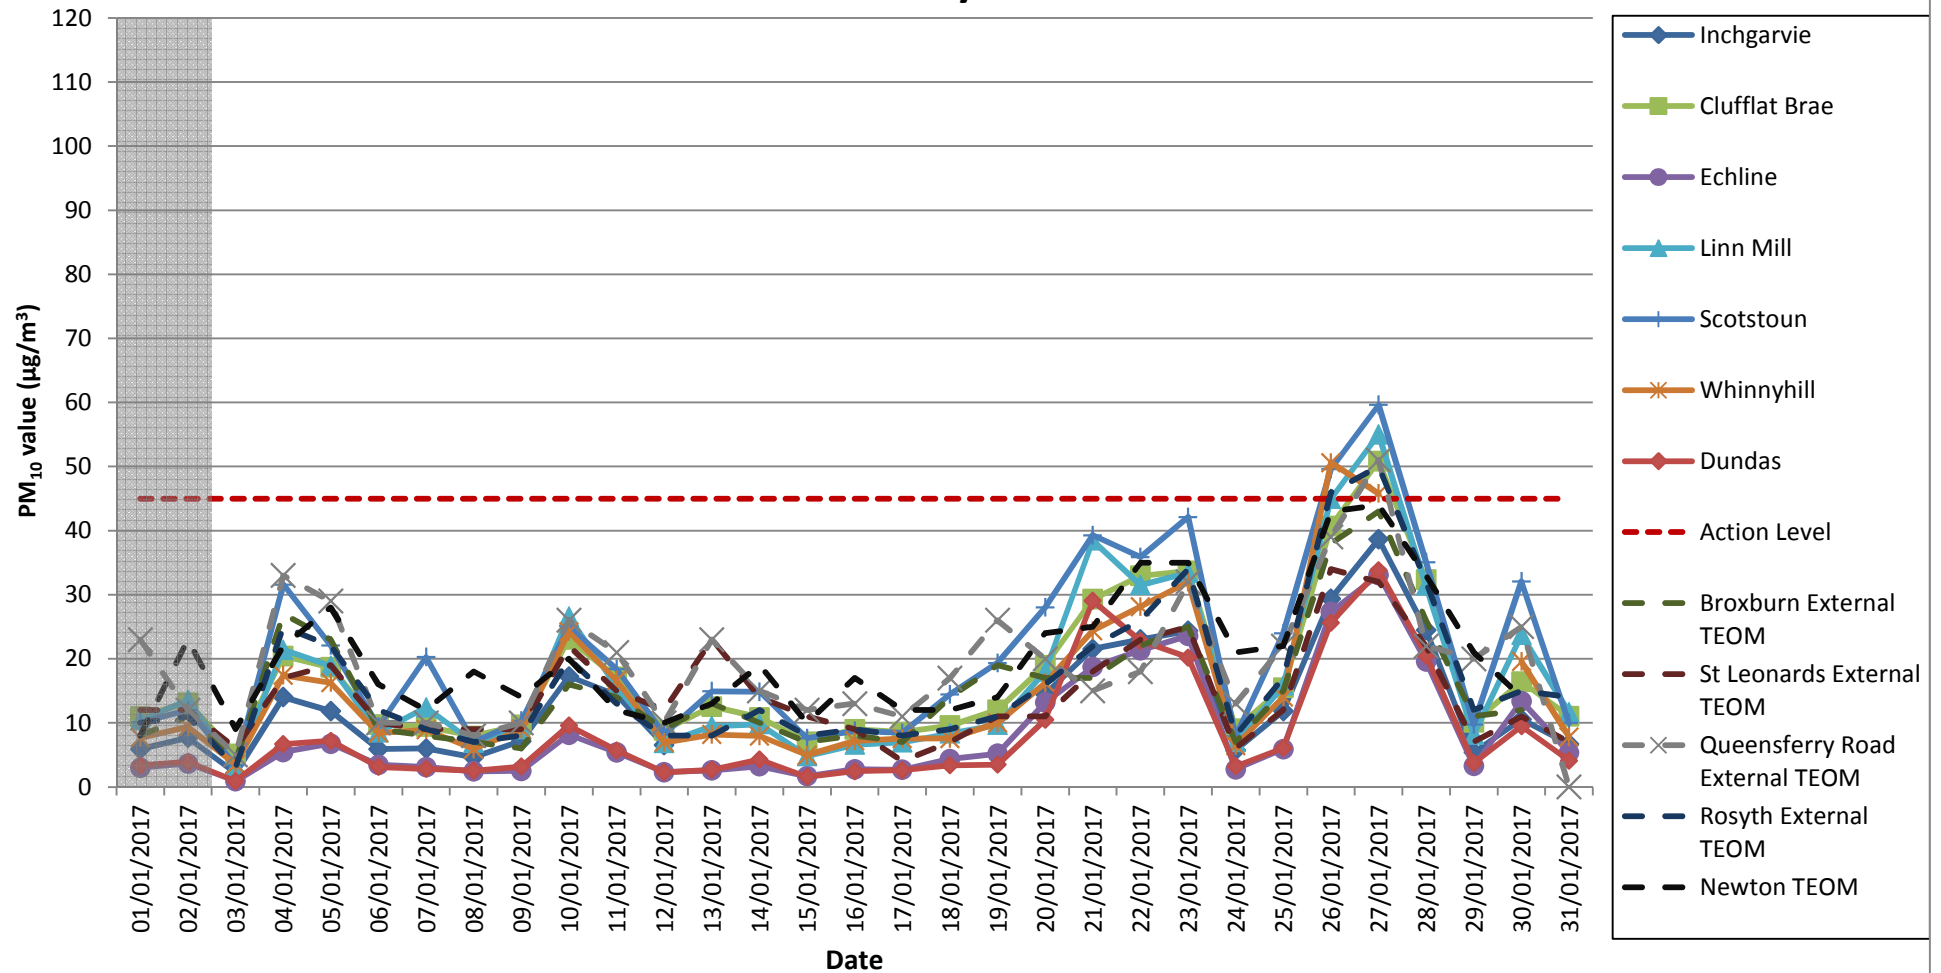
Air Quality Monitoring: Particulate Matter (PM10) Results for all Monitoring Locations, including TEOM data January 2017

Note: Data missing from Inchgarvie between 13th-19th January and from Whinnyhill on the 28th and 29th January due to electrical faults.

- 3.1.2.** The PM₁₀ results have also been compared to the daily mean results obtained from the TEOM air quality monitoring stations located in Newton, Rosyth, and Broxburn, and from the TEOM FDMS station located at Queensferry Road and St Leonards, Edinburgh (an urban background site). The TEOM at Newton was installed by West Lothian Council, facilitated by FCBC, during January 2012. The comparison between the light scatter and TEOM results demonstrates that both sets of results generally follow the same pattern throughout the month, including during the time period of the exceedances noted in 3.1.1.

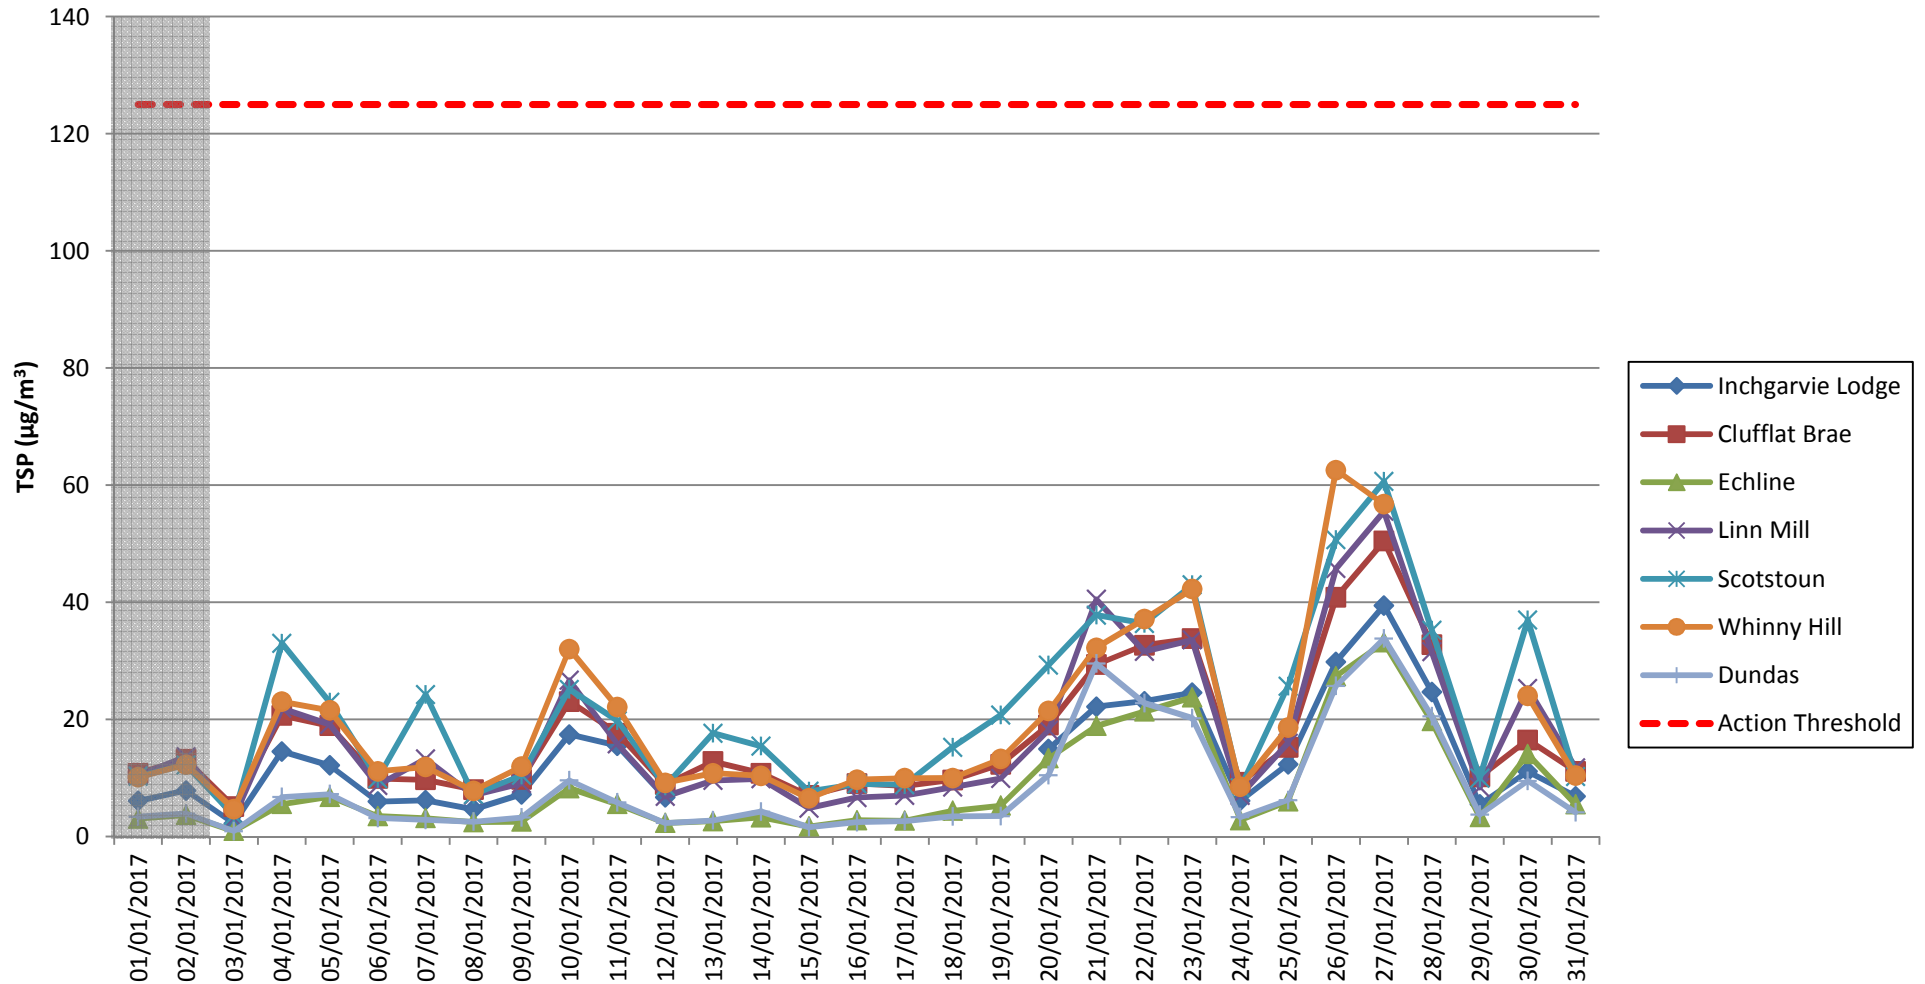
Total Suspended Particles (TSP) Results January 2017

Note: Data missing from Inchgarvie between 13th-19th January and from Whinnyhill on the 28th and 29th January due to electrical faults.

- 3.2.1.** The TSP results for January 2017 have been presented in a monthly chart; this can be found in Appendix B. The TSP levels at monitoring locations during January were found to be low and all within the threshold. All locations across the site were found to follow a similar pattern (similar to that observed for PM₁₀ levels). As with PM₁₀ it is considered that the TSP levels across site were influenced by regional changes in TSP levels.

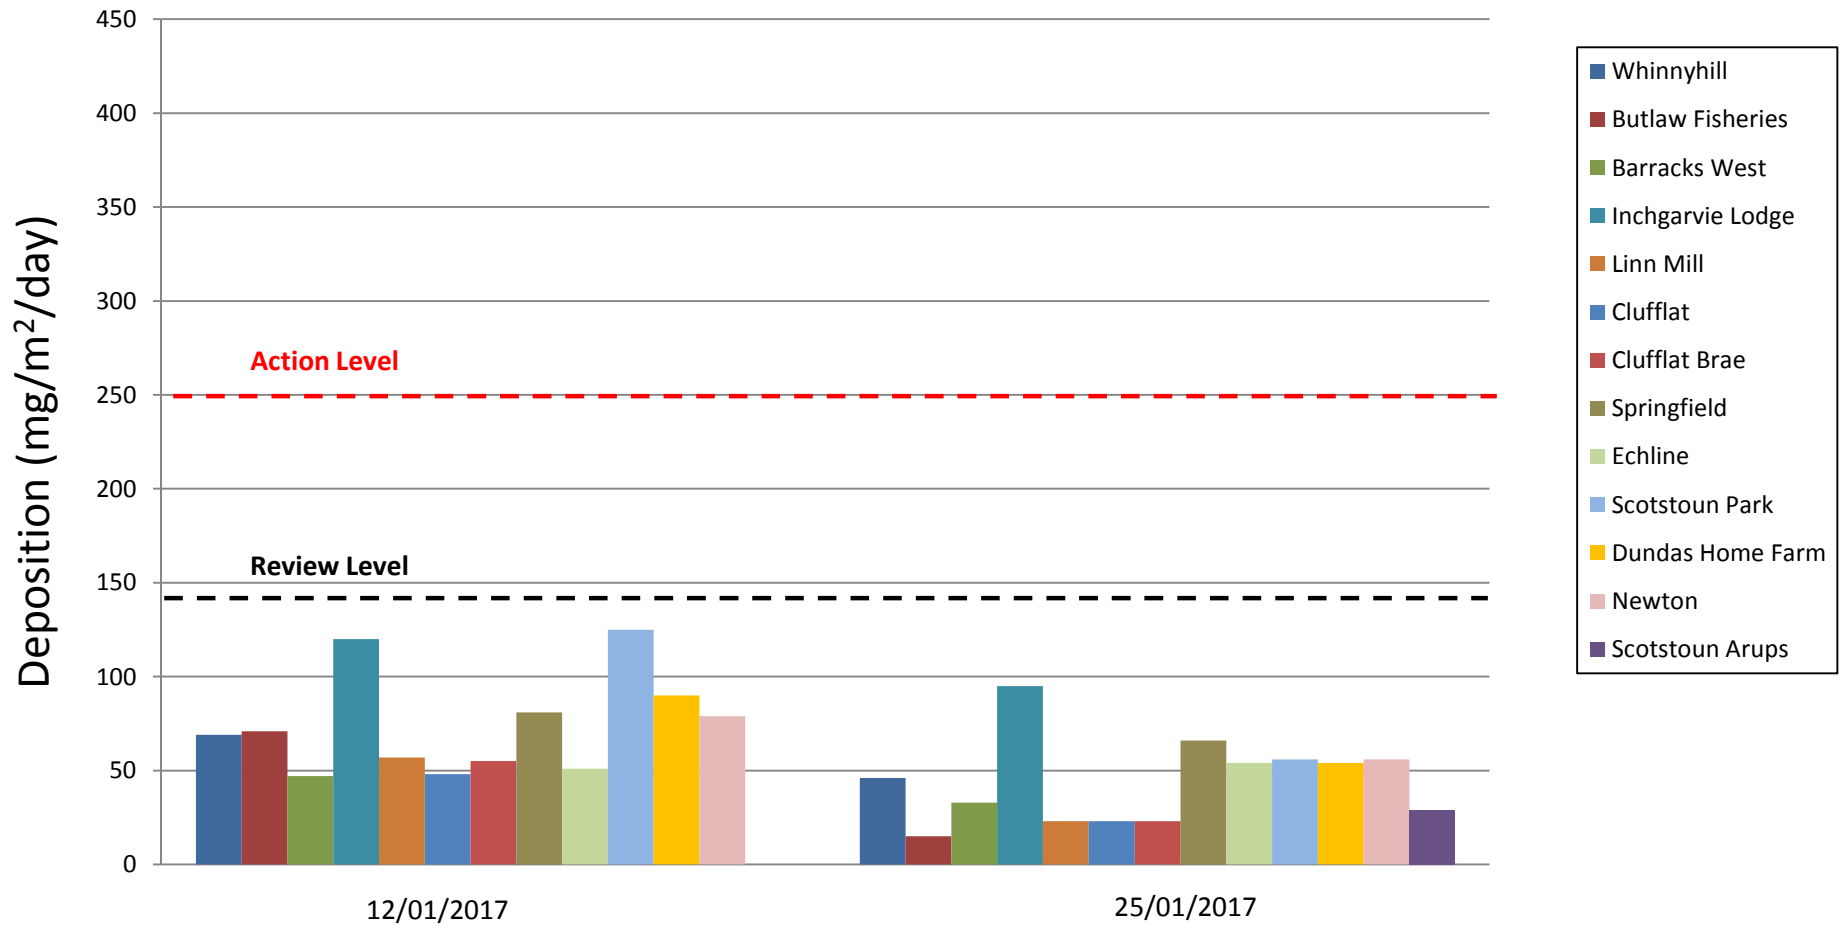
Frisbee Dust Deposition Results: January 2017

Note: Data missing from Scotstoun Arups on the 12/01/2017 as frisbee had been blown over in high winds.

- 3.3.1.** The Frisbee dust deposition results for January 2017 have been presented in a chart and can be found in Appendix C. Two collections were made in January; these occurred on the 12th and 25th January 2017.

- 3.3.2.** The site action level for the dust deposition rate has been set at 250 mg/m²/day. Exceedances of this level are treated as a potential incident and a review of the works in the vicinity of the site is instigated. A lower site review level has been set at 140 mg/m²/day. Where concentrations exceed the lower review threshold the site works are reviewed to ensure good practice is implemented; it is essentially a warning that additional controls may be required.
- 3.3.3.** During January there were no exceedances of either the site review or action levels.
