Project **FORTH REPLACEMENT CROSSING**

**AIR QUALITY MONITORING REPORT
APRIL 2017**

Document number	Rev
REP-00320	00

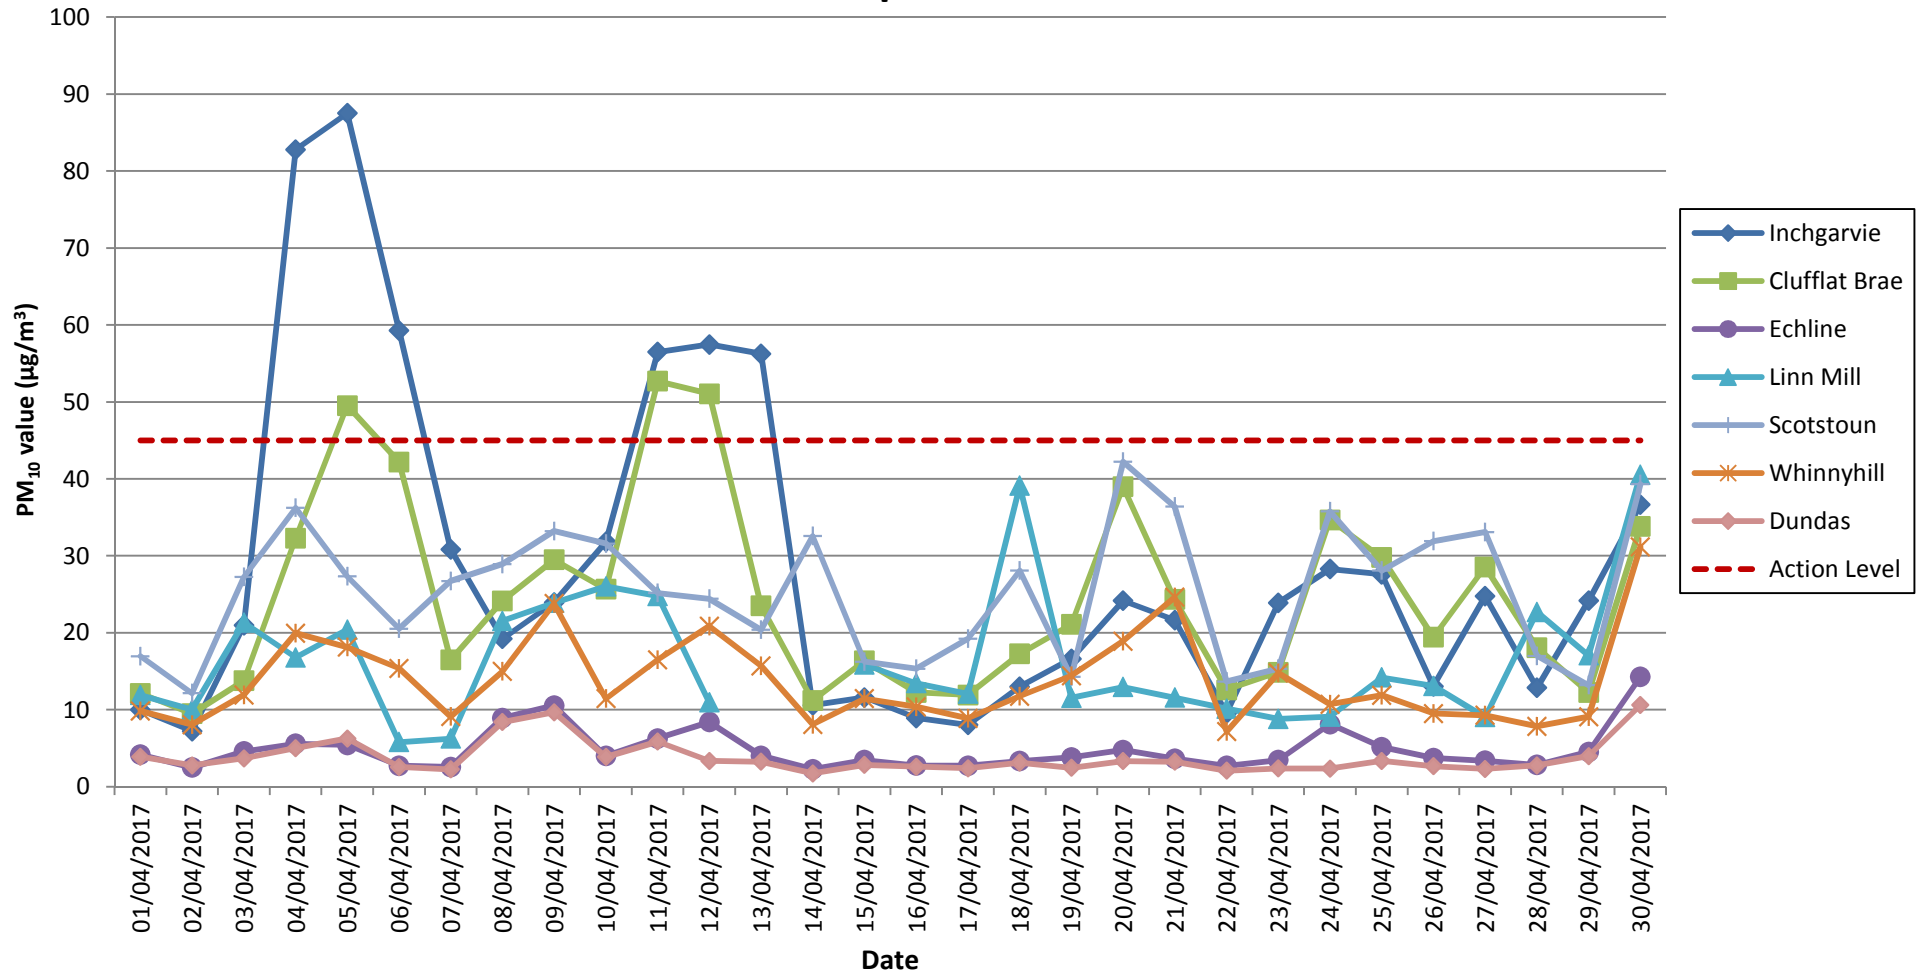
Particulate Matter (PM10) Results for all Monitoring Locations

3.1.1. Light scatter results for April 2017 have been presented in a monthly chart; this can be found in Appendix A. Results show that the PM₁₀ levels generally follow a similar pattern with a few notable exceptions. Inchgarvie and Clufflat Brae show two periods of higher results in the first two weeks of April with exceedances for Inchgarvie on 4 – 6 April and again on 11 -13 April. Clufflat Brae had exceedances on 5 April and 11 – 12 April. Higher levels of PM₁₀ were also obtained at Clufflat Brae and Scotstoun on 20 and 24 April although below the threshold levels on these dates. It is considered likely that the exceedances at

Inchgarvie and Clufflat were due to site activities and very dry conditions. Action was taken to manage the situation and the site team increased bowser movement and decreased site traffic in the area. The lower PM_{10} results in the second half of the month indicate some success with these mitigation measures. The environmental team continue to monitor the area.

Note: There is no data at the the Linn Mill monitor between 13/04/2017 and 14/04/2017 due to a electrical problem at the monitor.

- 3.4.3.** As noted in 3.1.1 there were exceedances registered during the month at Inchgarvie and Clufflat. These incidents were investigated by the environmental team. Site teams were instructed to increase dust suppression and reduce vehicle movement.

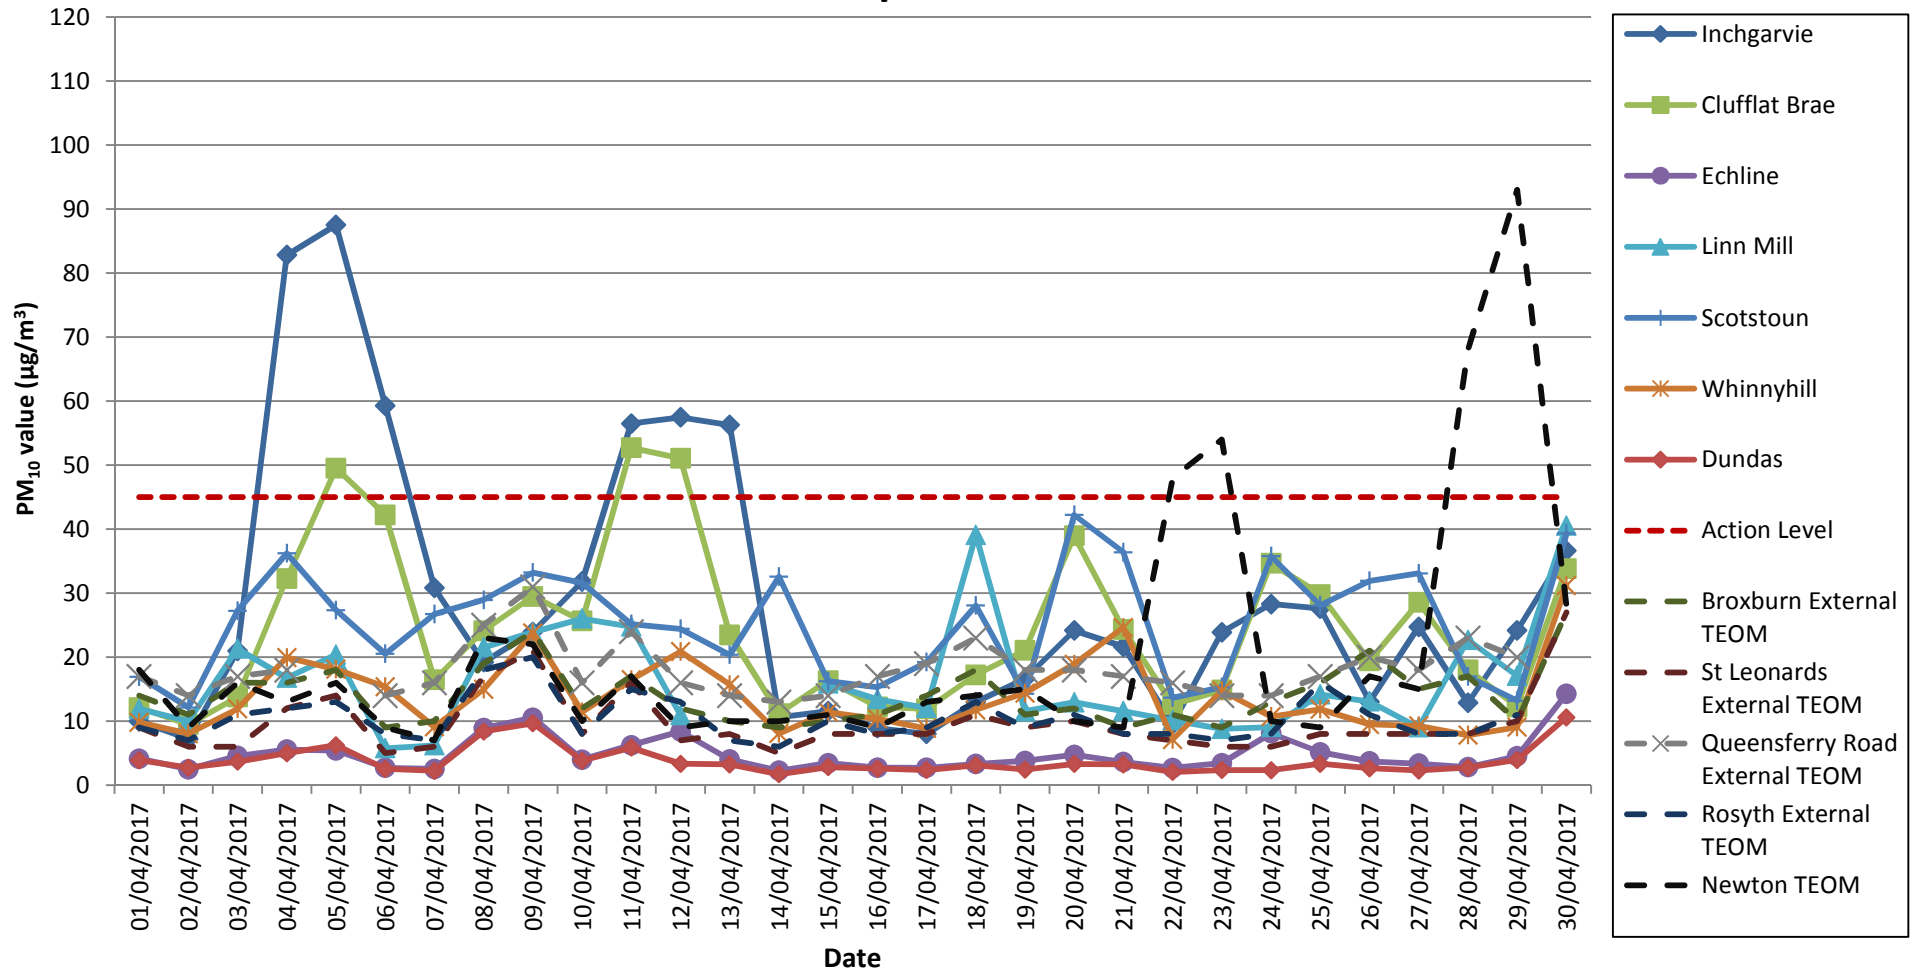
Air Quality Monitoring: Particulate Matter (PM10) Results for all Monitoring Locations, including TEOM data April 2017

- 3.1.2.** The PM_{10} results have also been compared to the daily mean results obtained from the TEOM air quality monitoring stations located in Newton, Rosyth, and Broxburn, and from the TEOM FDMS station located at Queensferry Road and St Leonards, Edinburgh (an urban background site). The TEOM at Newton was installed by West Lothian Council, facilitated by FCBC, during January 2012. The comparison between the light scatter and TEOM results demonstrates that both sets of results generally follow the same pattern throughout the month, with the exception of the elevated results noted in 3.1.1 where these locations showed significantly higher results than the TEOM levels.

Note: There is no data at the the Linn Mill monitor between 13/04/2017 and 14/04/2017 due to a electrical problem at the monitor.

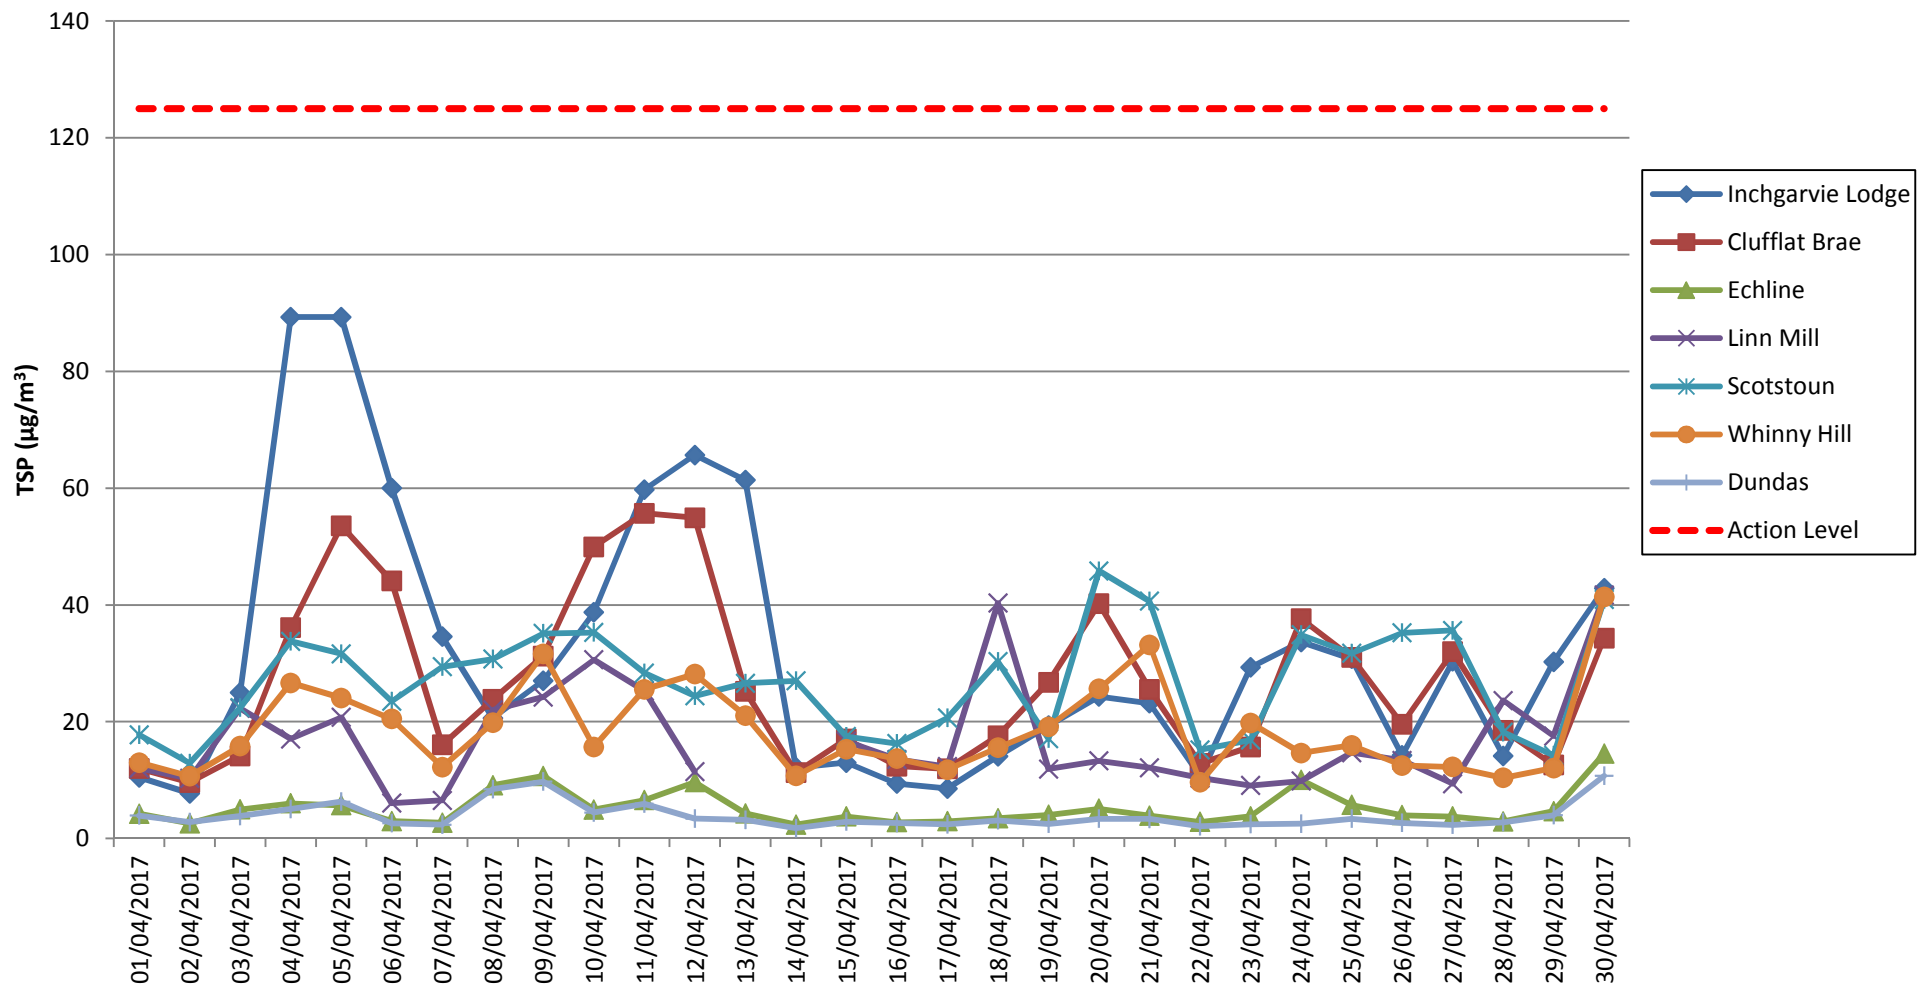
Total Suspended Particles (TSP) Results April 2017

- 3.2.1.** The TSP results for April 2017 have been presented in a monthly chart; this can be found in Appendix B. The TSP levels at monitoring locations during April were found to be generally low and all within the threshold. All locations across the site were found to follow a similar pattern to that observed for PM_{10} levels, with the most notable increase occurring at Inchgarvie and Clufflat Brae in the first half of the month, corresponding to the high PM_{10} levels noted in 3.1.1.

Note: There is no data at the the Linn Mill monitor between 13/04/2017 and 14/04/2017 due to a electrical problem at the monitor.

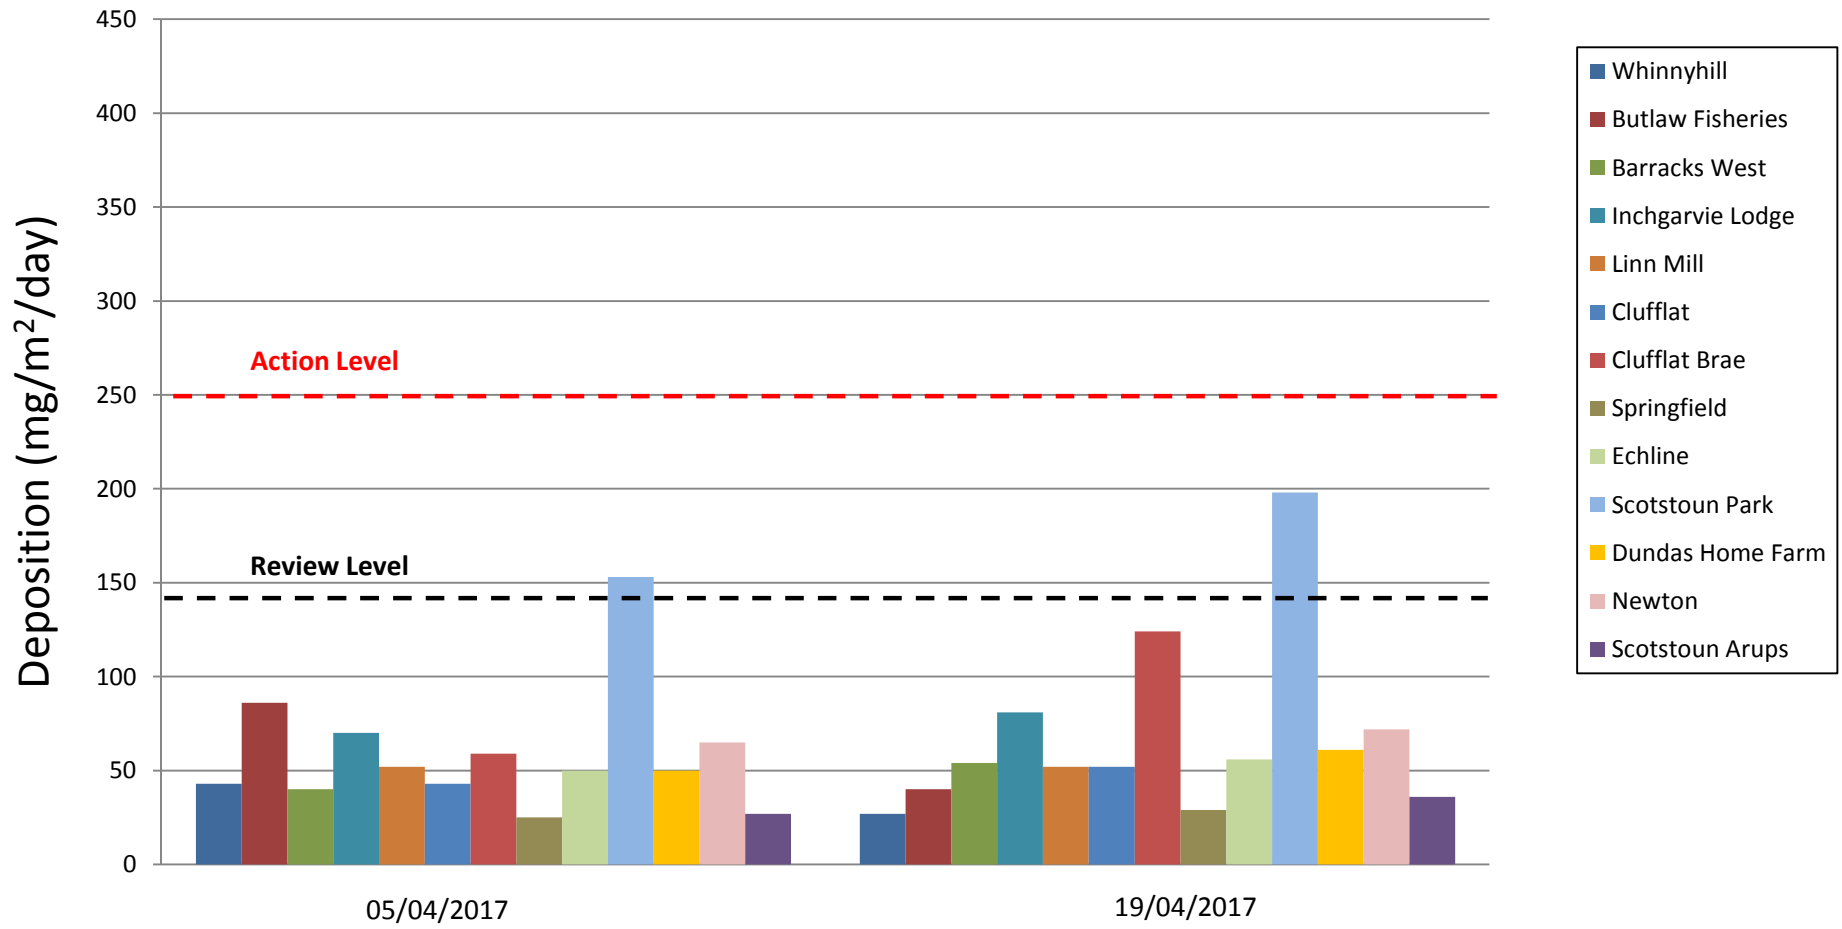
Frisbee Dust Deposition Results: April 2017

- 3.3.1.** The Frisbee dust deposition results for April 2017 have been presented in a chart and can be found in Appendix C. Two collections were made in April; these occurred on the 5th and 19th April 2017.

- 3.3.2.** The site action level for the dust deposition rate has been set at 250 mg/m²/day. Exceedances of this level are treated as a potential incident and a review of the works in the vicinity of the site is instigated. A lower site review level has been set at 140 mg/m²/day. Where concentrations exceed the lower review threshold the site works are reviewed to ensure good practice is implemented; it is essentially a warning that additional controls may be required.

- 3.3.3.** During April there were exceedances of the site review level at Scotstoun Park for both monitoring periods. With regards to the exceedances at Scotstoun Park, the temporary Frisbee at Scotstoun Arups, which is located closer to the FCBC works, indicates a significantly lower result than for the permanent Frisbee during this period. This suggests that the higher results obtained at the permanent monitoring location are not entirely due to FCBC activities. In addition, there were limited project related activities being undertaken in this area during April which would give rise to dust. The roads in this area are substantially complete with only tidying / reinstatement works and minor access road improvements occurring. As noted in previous reports, other construction work (not project related) is ongoing in the Scotstoun area. However, FCBC will continue to monitor Forth Replacement Crossing construction closely as works progress and provide mitigation as necessary.
