Project **FORTH REPLACEMENT CROSSING**

**AIR QUALITY MONITORING REPORT
JULY 2017**

Document number	Rev
REP-00339	00

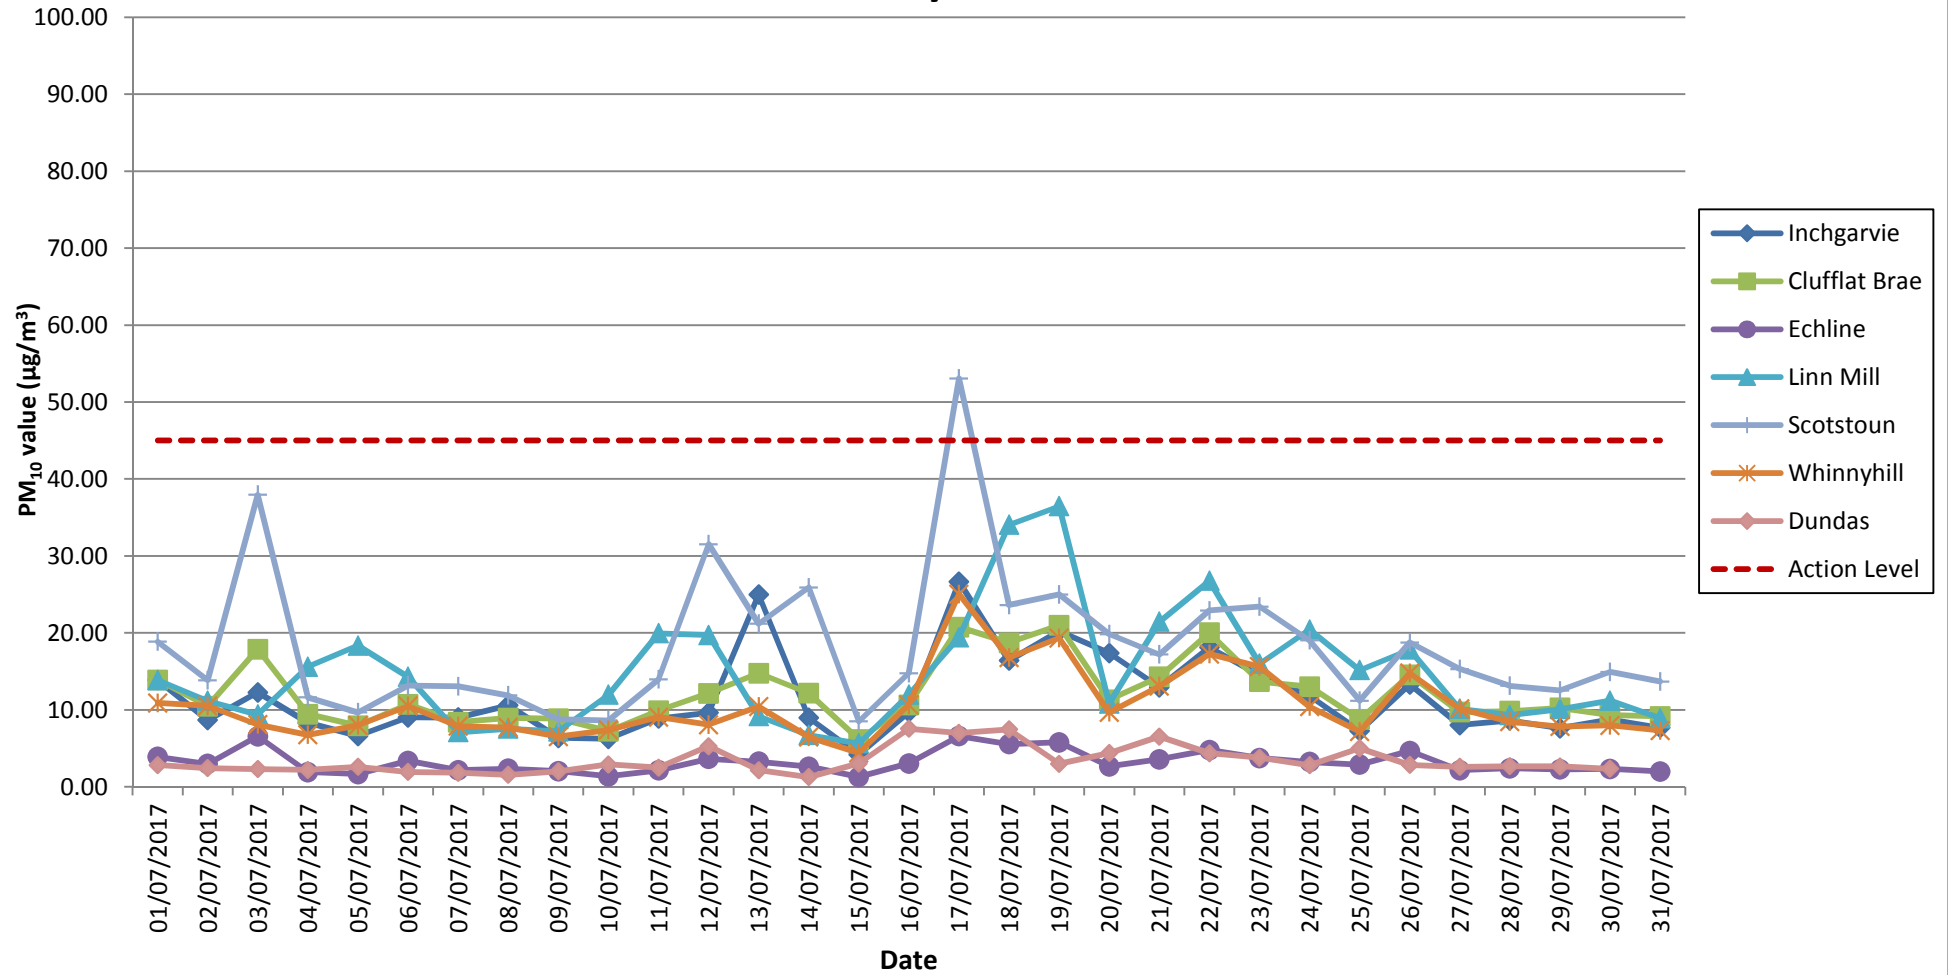
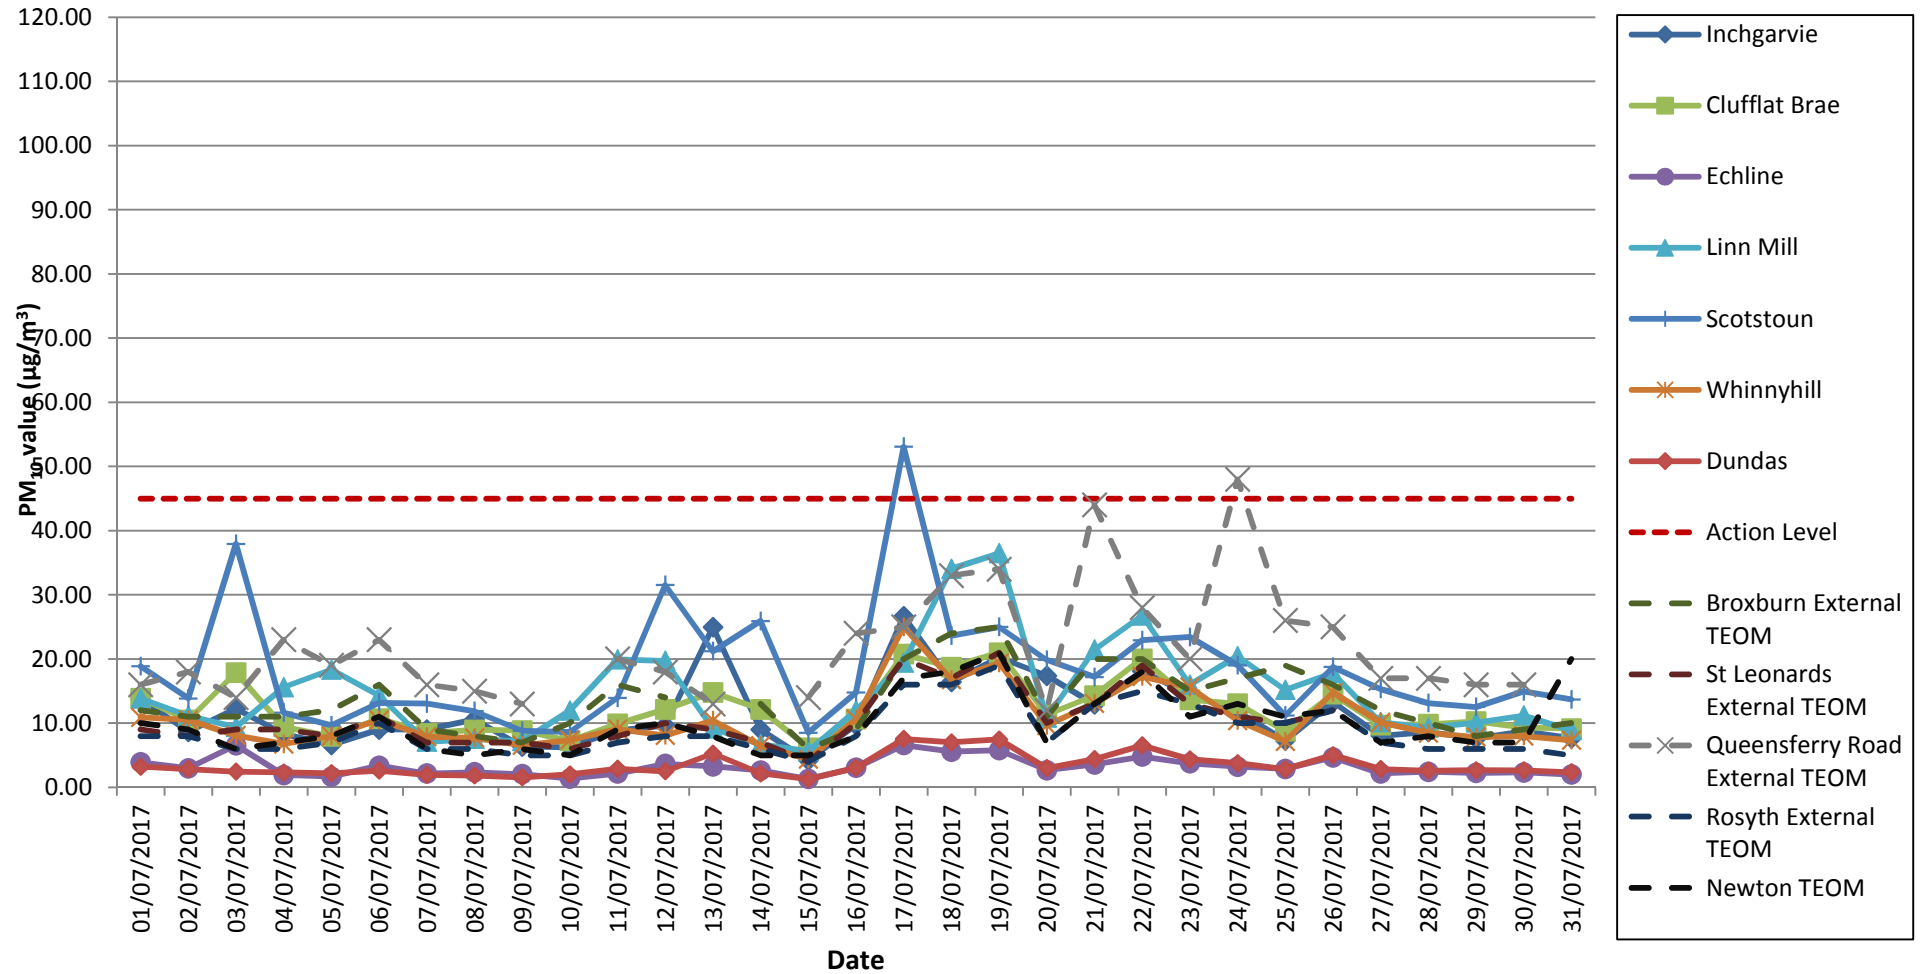
APPENDIX A: LIGHT SCATTER METER RESULTS

3.1.1. Light scatter results for July 2017 have been presented in a monthly chart; this can be found in Appendix A. Results show that the PM₁₀ levels generally follow a similar pattern throughout the month with the exception of an exceedance that is recorded at Scotstoun on the 17th July. At the time of this exceedance there were no project related activities being undertaken in this area which would give rise to dust, FRC construction works now being complete in this area.

3.1.2. There were also higher results recorded at Scotstoun on the 3rd, 12th and 14th July, although none of these resulted in an exceedance of the action level.

Air Quality Monitoring: Particulate Matter (PM10) Results for all Monitoring Locations, including TEOM data JULY 2017

3.1.3. The PM₁₀ results have also been compared to the daily mean results obtained from the TEOM air quality monitoring stations located in Newton, Rosyth, and Broxburn, and from the TEOM FDMS station located at Queensferry Road and St Leonards, Edinburgh (an urban background site). The TEOM at Newton was installed by West Lothian Council, facilitated by FCBC, during January 2012. The comparison between the light scatter and TEOM results demonstrates that both sets

of results generally follow the same pattern throughout the month, with the exception of the results recorded at Scotstoun noted in 3.1.1 and 3.1.2 where PM_{10} levels were higher than the TEOM levels.

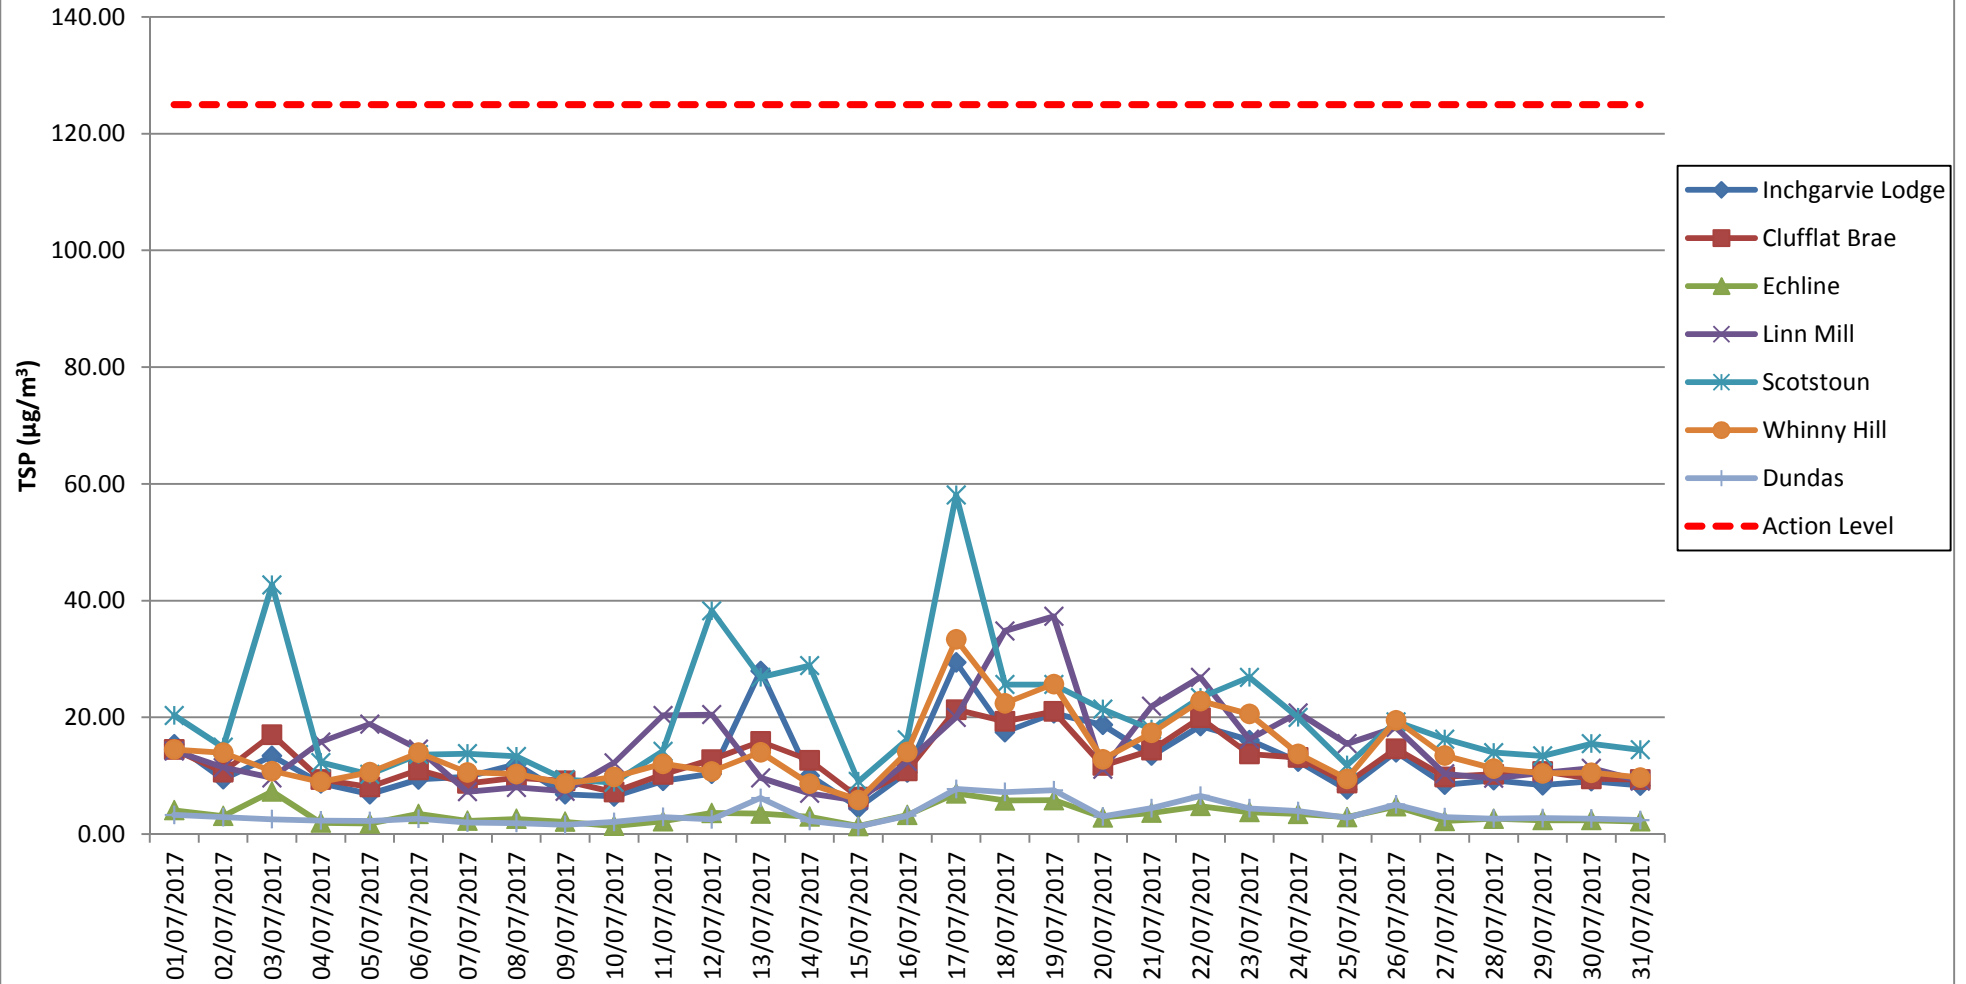
APPENDIX B: TOTAL SUSPENDED PARTICLES

3.2.1. The TSP results for July 2017 have been presented in a monthly chart; this can be found in Appendix B. The TSP levels at monitoring locations during July were found to be generally low and all within the threshold level. All locations across the site were found to follow a similar pattern to that observed for PM_{10} levels, as described in 3.1.1 and 3.1.2.

Total Suspended Particles (TSP) Results July 2017

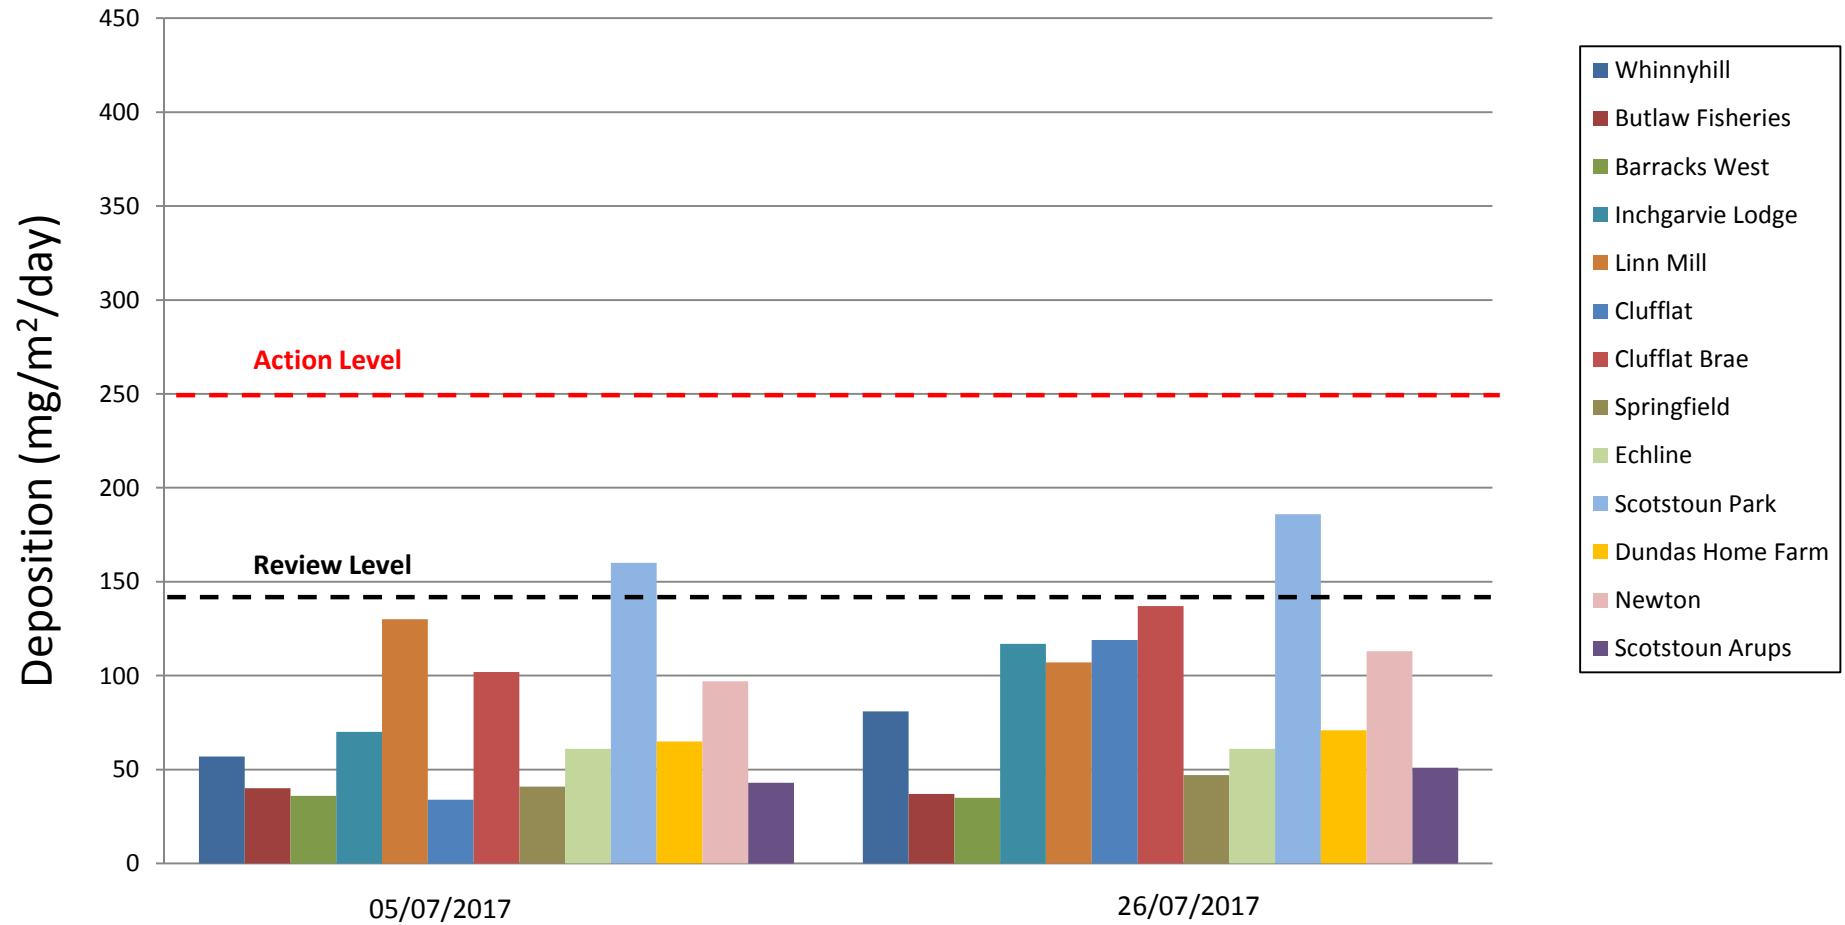
APPENDIX C: FRISBEE GAUGE RESULTS

3.3.1. The Frisbee dust deposition results for July 2017 have been presented in a chart and can be found in Appendix C. Two collections were made in July; these occurred on the 5th and 26th July 2017. Please note that due to an error with the courier collecting the samples there was a three week period between collections rather than a two week period.

3.3.2. The site action level for the dust deposition rate has been set at 250 $mg/m^2/day$. Exceedances of this level are treated as a potential incident and a review of the works in the vicinity of the site is instigated. A lower site review level has been set at 140 $mg/m^2/day$. Where concentrations exceed the lower review threshold the site works are reviewed to ensure good practice is implemented; it is essentially a warning that additional controls may be required.

3.3.3. During July there were exceedances of the site review level at Scotstoun Park for both monitoring periods. With regards to these exceedances, the temporary Frisbee at Scotstoun Arups, which is located closer to the FCBC works area, indicates a significantly lower result than for the permanent Frisbee during this period. In addition, there were no project related activities being undertaken in this area during July which would give rise to dust. This suggests that the higher

results obtained at the permanent monitoring location are not due to FCBC activities.

Frisbee Dust Deposition Results: July 2017
