Project **FORTH REPLACEMENT CROSSING**

**AIR QUALITY MONITORING REPORT
SEPTEMBER 2017**

00	12/10/2017	First revision	SWR	DCK	DCK
Rev	Rev. Date	Purpose of revision	Made	Checked	Reviewed
Document status					
FOR REVIEW					
Made by Steven Westwater			Checked By: David Clark		
Initials: SWR			Initials: David Clark		
Document number					Rev
REP-00346					00

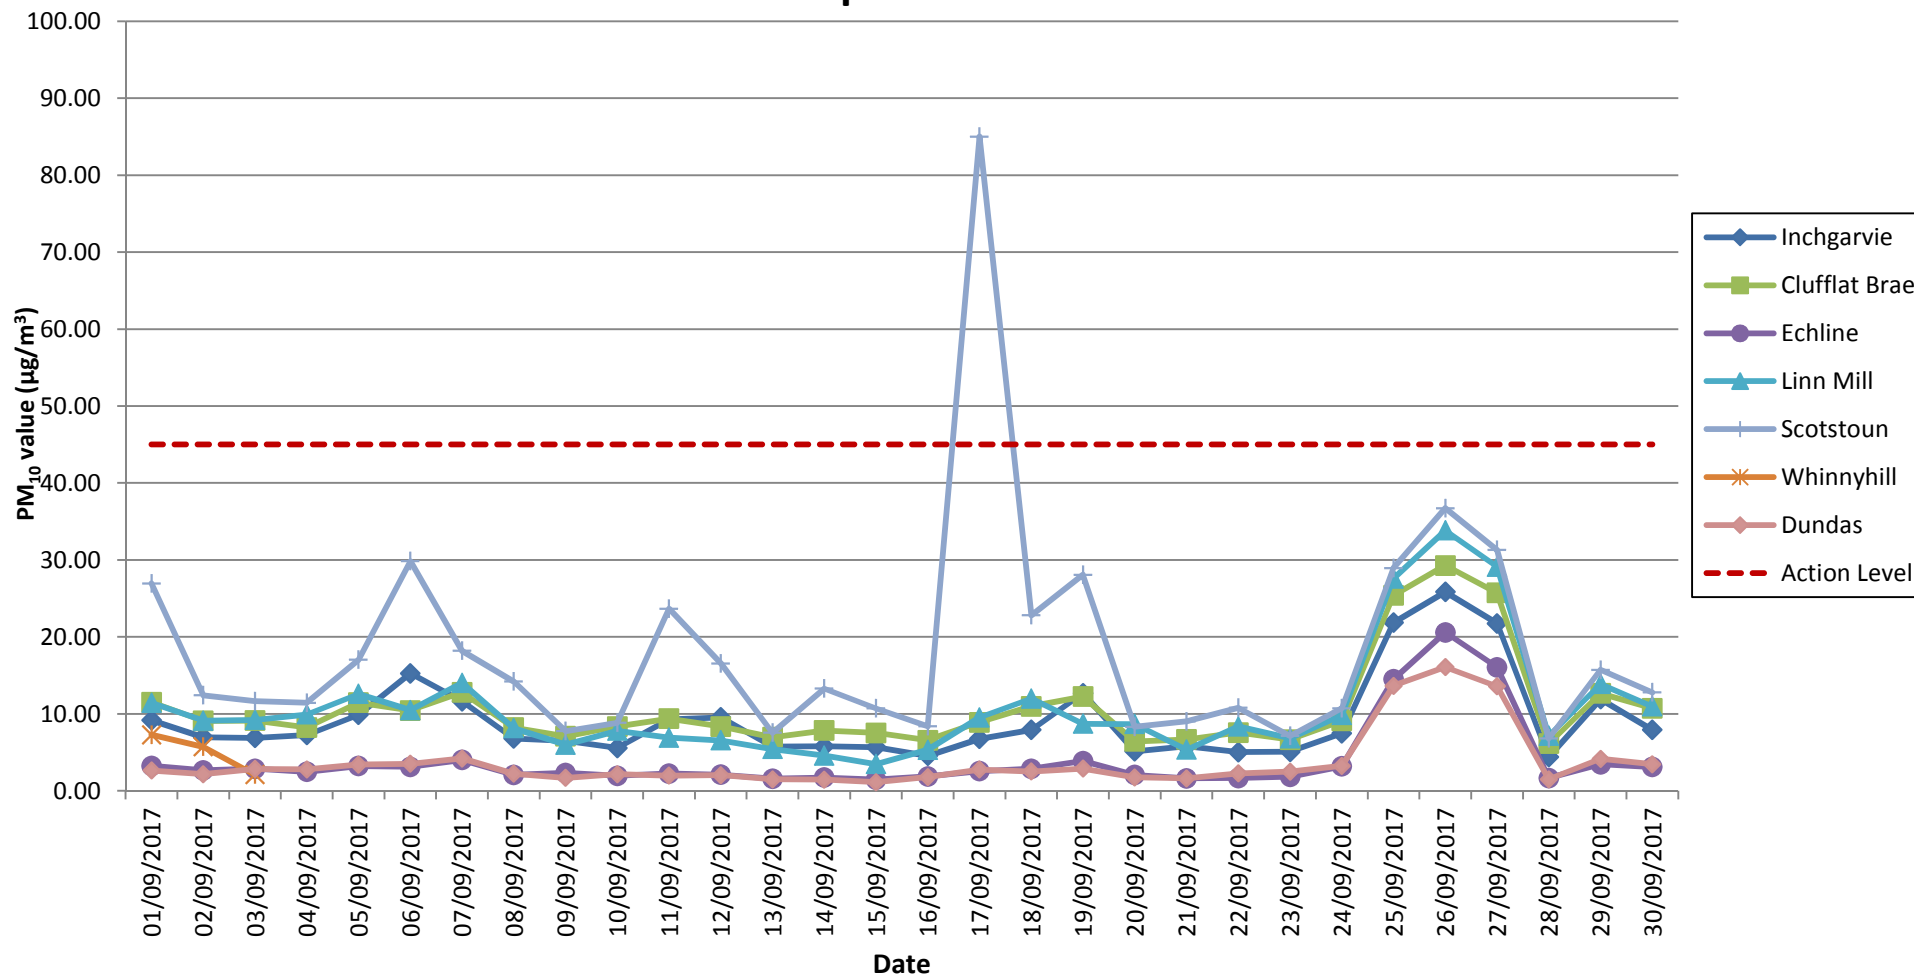
Particulate Matter (PM10) Results for all Monitoring Locations

Note: There is no data at the the Whinnyhill monitor between 04/09/2017 and 30/09/2017 due to a electrical problem with the monitor. Probable erroneous reading at Scotstoun on 17 September.

3.1.1. Light scatter meter results for September 2017 have been presented in a monthly chart; this can be found in Appendix A. Results for the month are generally low and all are below the action level with the exception of Scotstoun on the 17th September. This is considered to be an erroneous result as the instrument indicates a PM₁₀ spike of 4819µg/m³ between 17:15 and 17:30. This exceedance occurred on a Sunday and no FCBC activities were undertaken on that day. PM₁₀ levels generally follow a similar pattern throughout the month with the exception of the higher results recorded at Scotstoun on the 1st, 6th, 11th, 17th and 19th September. It should be noted that another construction site (not FRC project related) is located closer to the monitor.

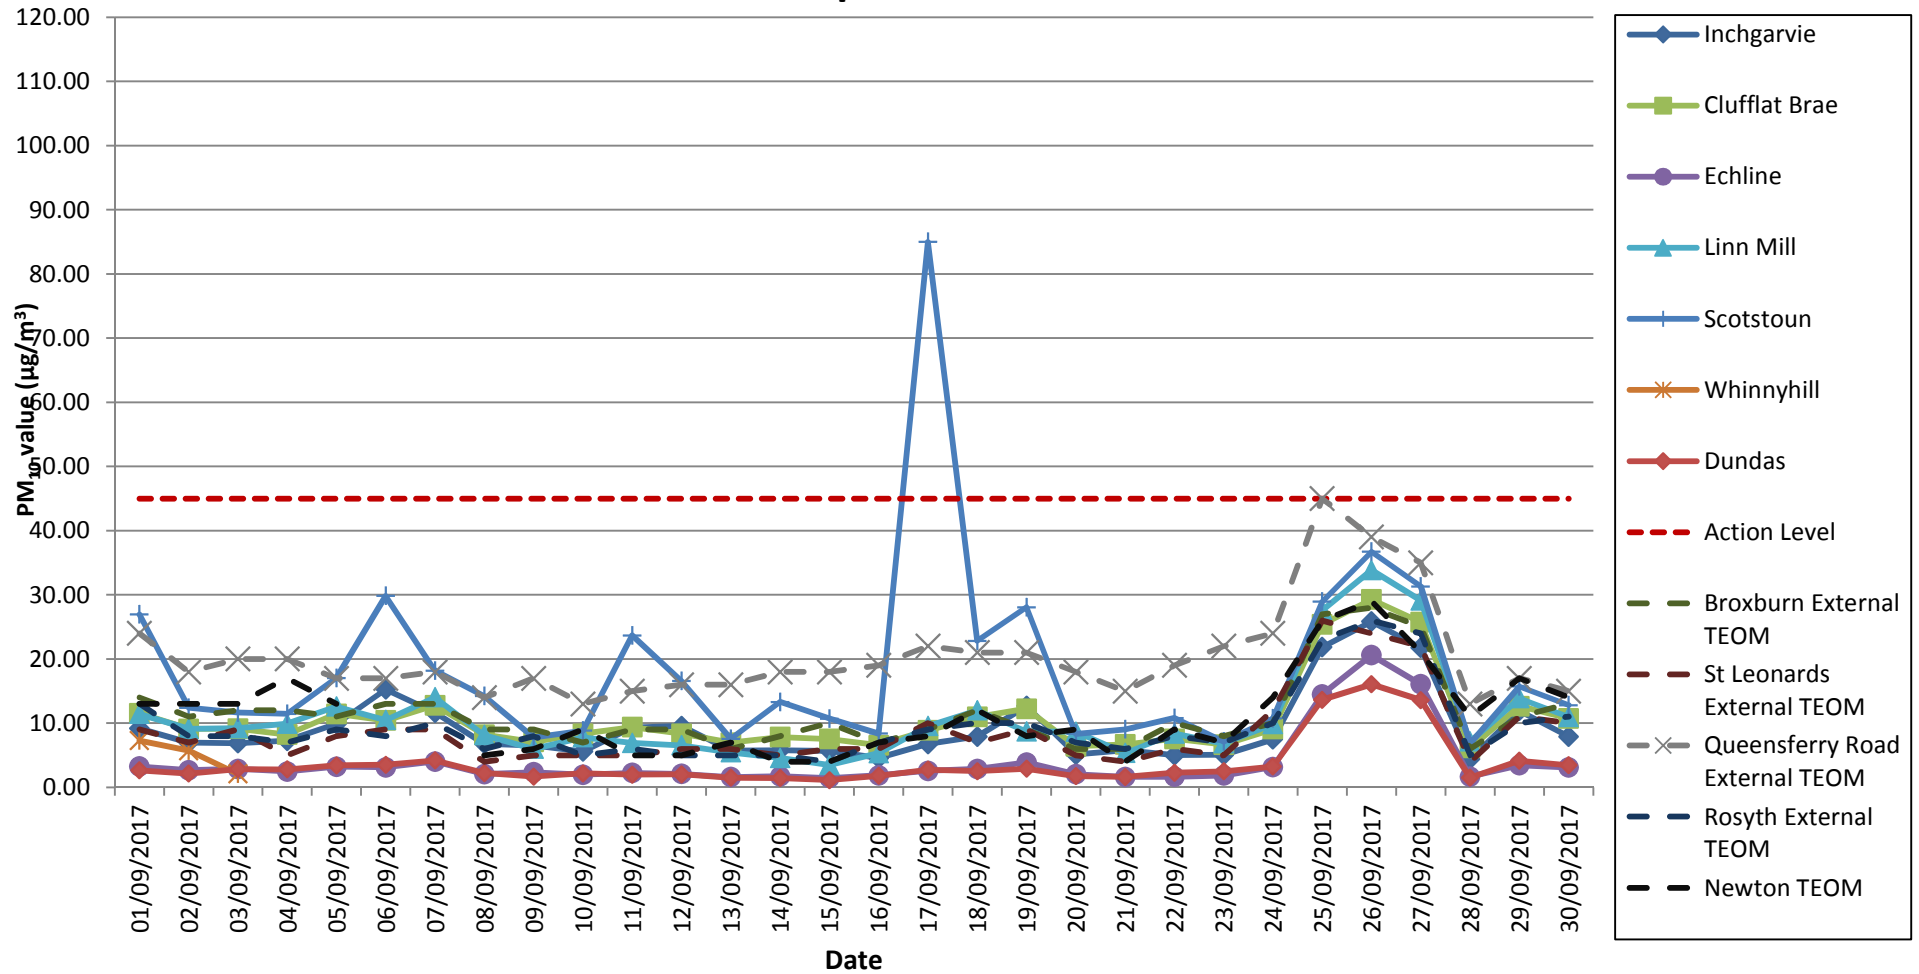
Air Quality Monitoring: Particulate Matter (PM10) Results for all Monitoring Locations, including TEOM data September 2017

Note: There is no data at the the Whinnyhill monitor between 04/09/2017 and 30/09/2017 due to a electrical problem with the monitor.
Probable erroneous reading at Scotstoun on 17 September.

3.1.2. The PM₁₀ results have also been compared to the daily mean results obtained from the TEOM air quality monitoring stations located in Newton, Rosyth, and Broxburn, and from the TEOM FDMS station located at Queensferry Road and St Leonards, Edinburgh (an urban background site). The TEOM at Newton was installed by West Lothian Council, facilitated by FCBC, during January 2012. The comparison between the light scatter and TEOM results demonstrates that both sets of results generally follow the same pattern throughout the month, with

the exception of the results recorded at Scotstoun on 6th, 11th, 17th and 19th September.

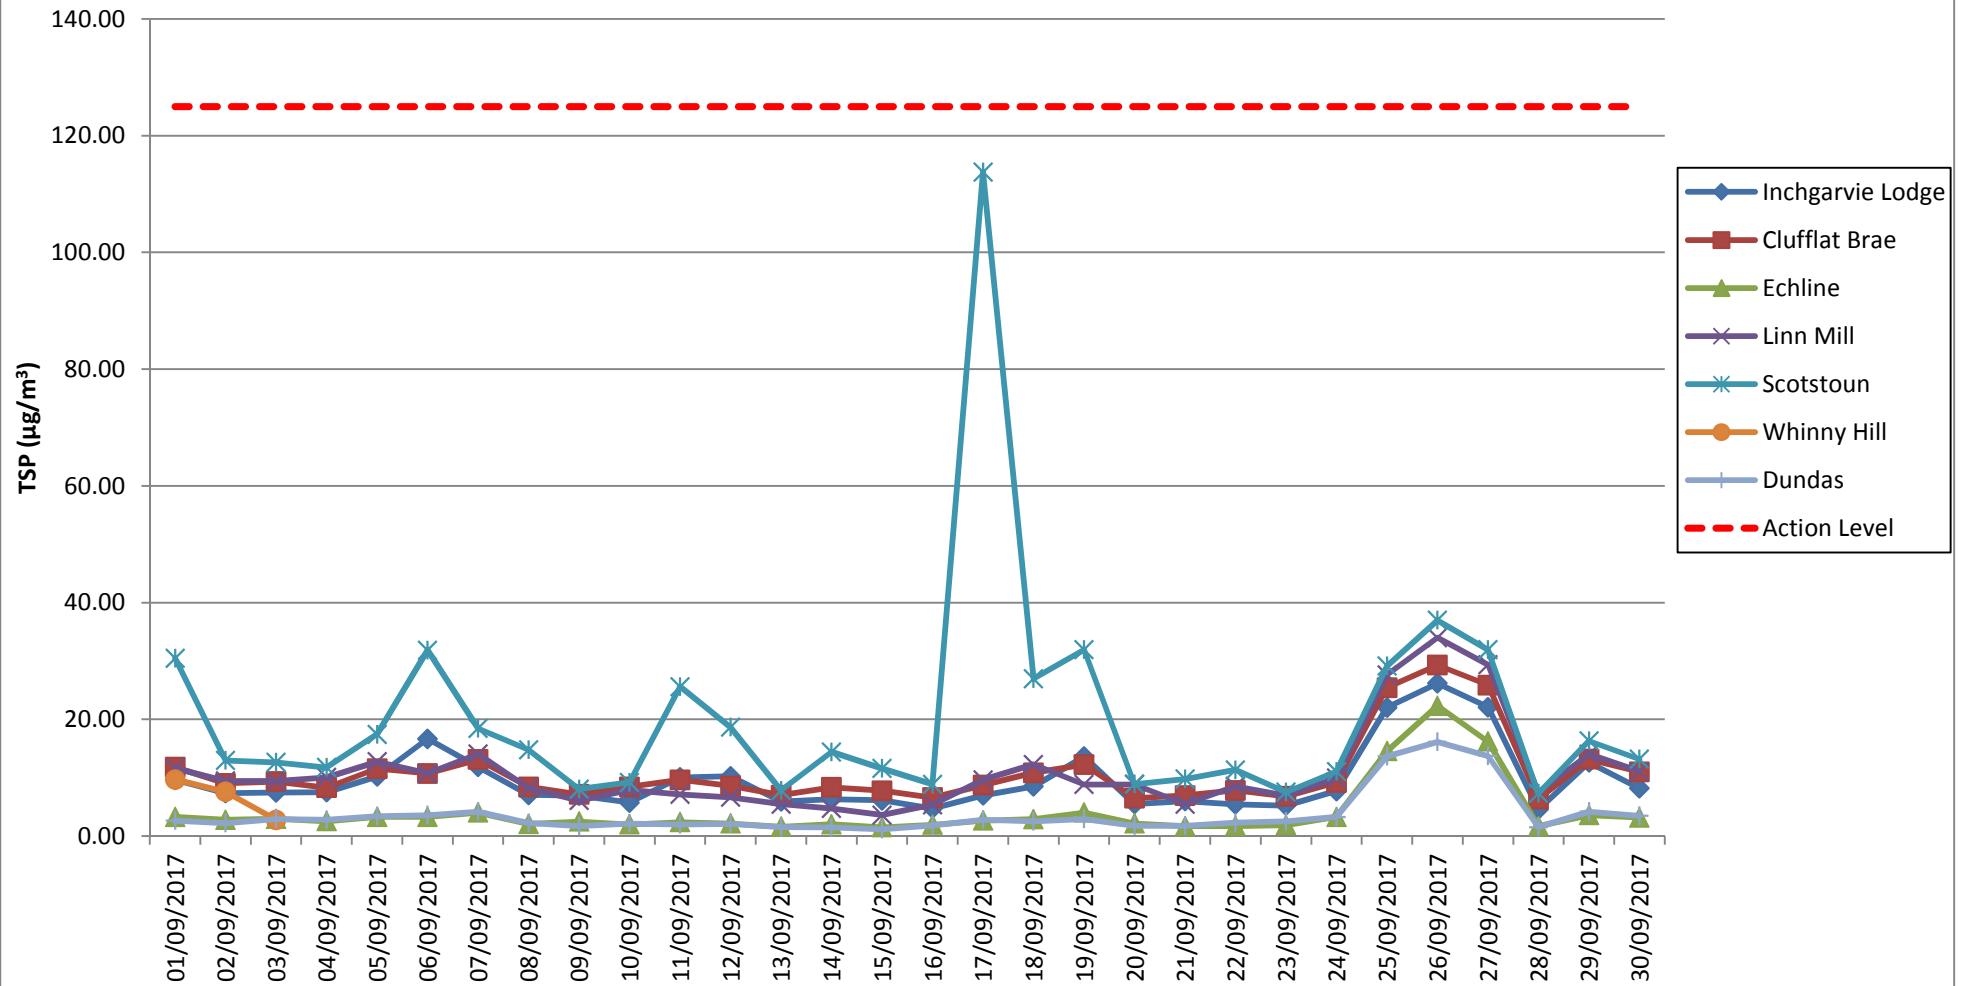
Total Suspended Particles (TSP) Results September 2017

Note: There is no data at the the Whinnyhill monitor between 04/09/2017 and 30/09/2017 due to a electrical problem with the monitor. Probable erroneous reading at Scotstoun on 17 September.

3.2.1. The TSP results for September 2017 have been presented in a monthly chart; this can be found in Appendix B. The TSP levels at monitoring locations during September were found to be generally low, with the exception of Scotstoun on the 17th September. However, all results were within the threshold level. All locations across the site were found to follow a similar pattern to that observed for PM₁₀ levels, as described in 3.1.1.
