Project **FORTH REPLACEMENT CROSSING**

**AIR QUALITY MONITORING REPORT
OCTOBER 2017**

Made by Steven Westwater	Checked By: Tom Shaw
Initials: SWR	Initials: TSW
Document number REP-00348	Rev 00

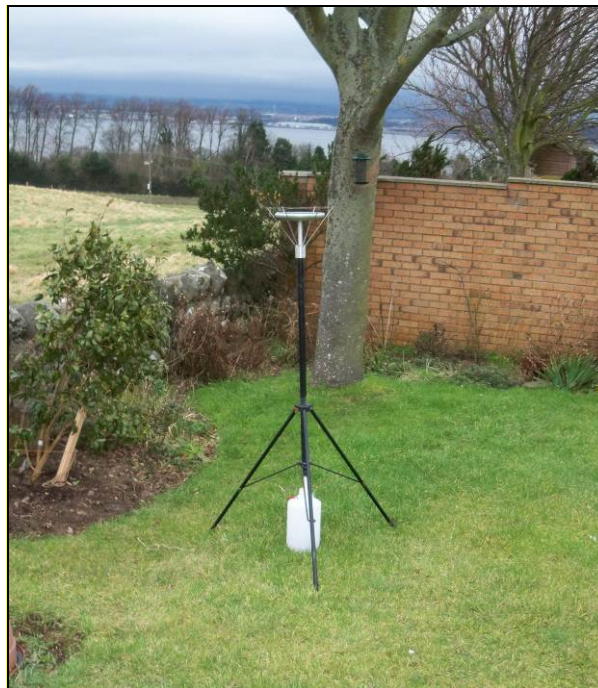
Figure 1: Example of an Installed Frisbee Gauge Meter

2.1. Air quality is being monitored on site using both automatic light scatter dust meters and Frisbee gauge dust deposition monitoring. Four Frisbee gauges are currently set up at sensitive locations across the site to measure dust deposition rates (Figure 1). Seven automatic light scatter meters are installed at various sensitive locations to measure real time particulate matter (PM₁₀) concentrations and the Total Suspended Particle (TSP) concentrations (Figure 2). These meters are calibrated annually. Table 1 lists the air quality monitoring equipment present at each monitoring location, including the date it was installed.

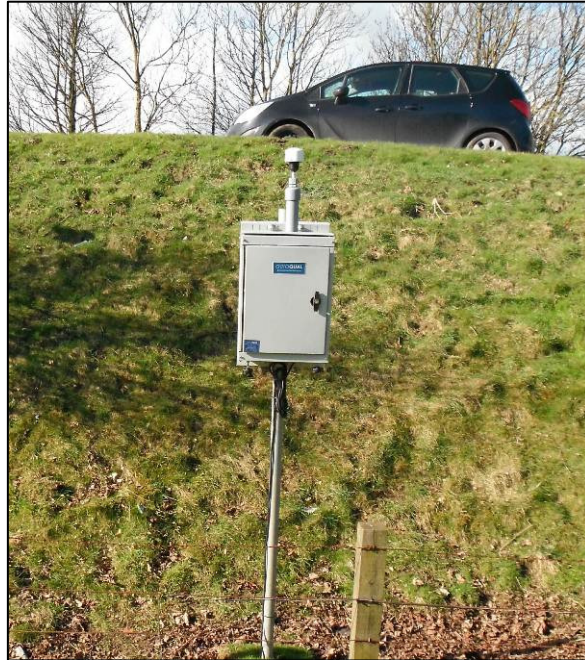
Figure 2: Example of an installed Automatic Light Scatter Dust Meter

2.2. Light scatter type monitoring equipment have been selected as a site monitoring tool to create a live network which assesses the levels of fugitive particulate matter, principally airborne dust. These monitors require less space, maintenance and power than other real time monitors such as a Tapered Element Oscillating Microbalance (TEOM) which is used and designed to measure particulate levels to exceedingly high standards, including measuring long-term compliance to statutory limits. Light scatter meters are more practicable to deploy. However, the meters do generally record levels higher than those measured by the TEOM. The meters can also be affected by atmospheric moisture content which further increases reported levels. Accordingly, any elevations of statutory limits should be treated as precautionary exceedances. The monitors are reliable for on-site monitoring and the establishment of action thresholds to ensure unforeseen activities generating significant dust are identified and suitably controlled. Light scatter meters are becoming the construction and waste industries norm for particulate dust monitoring.

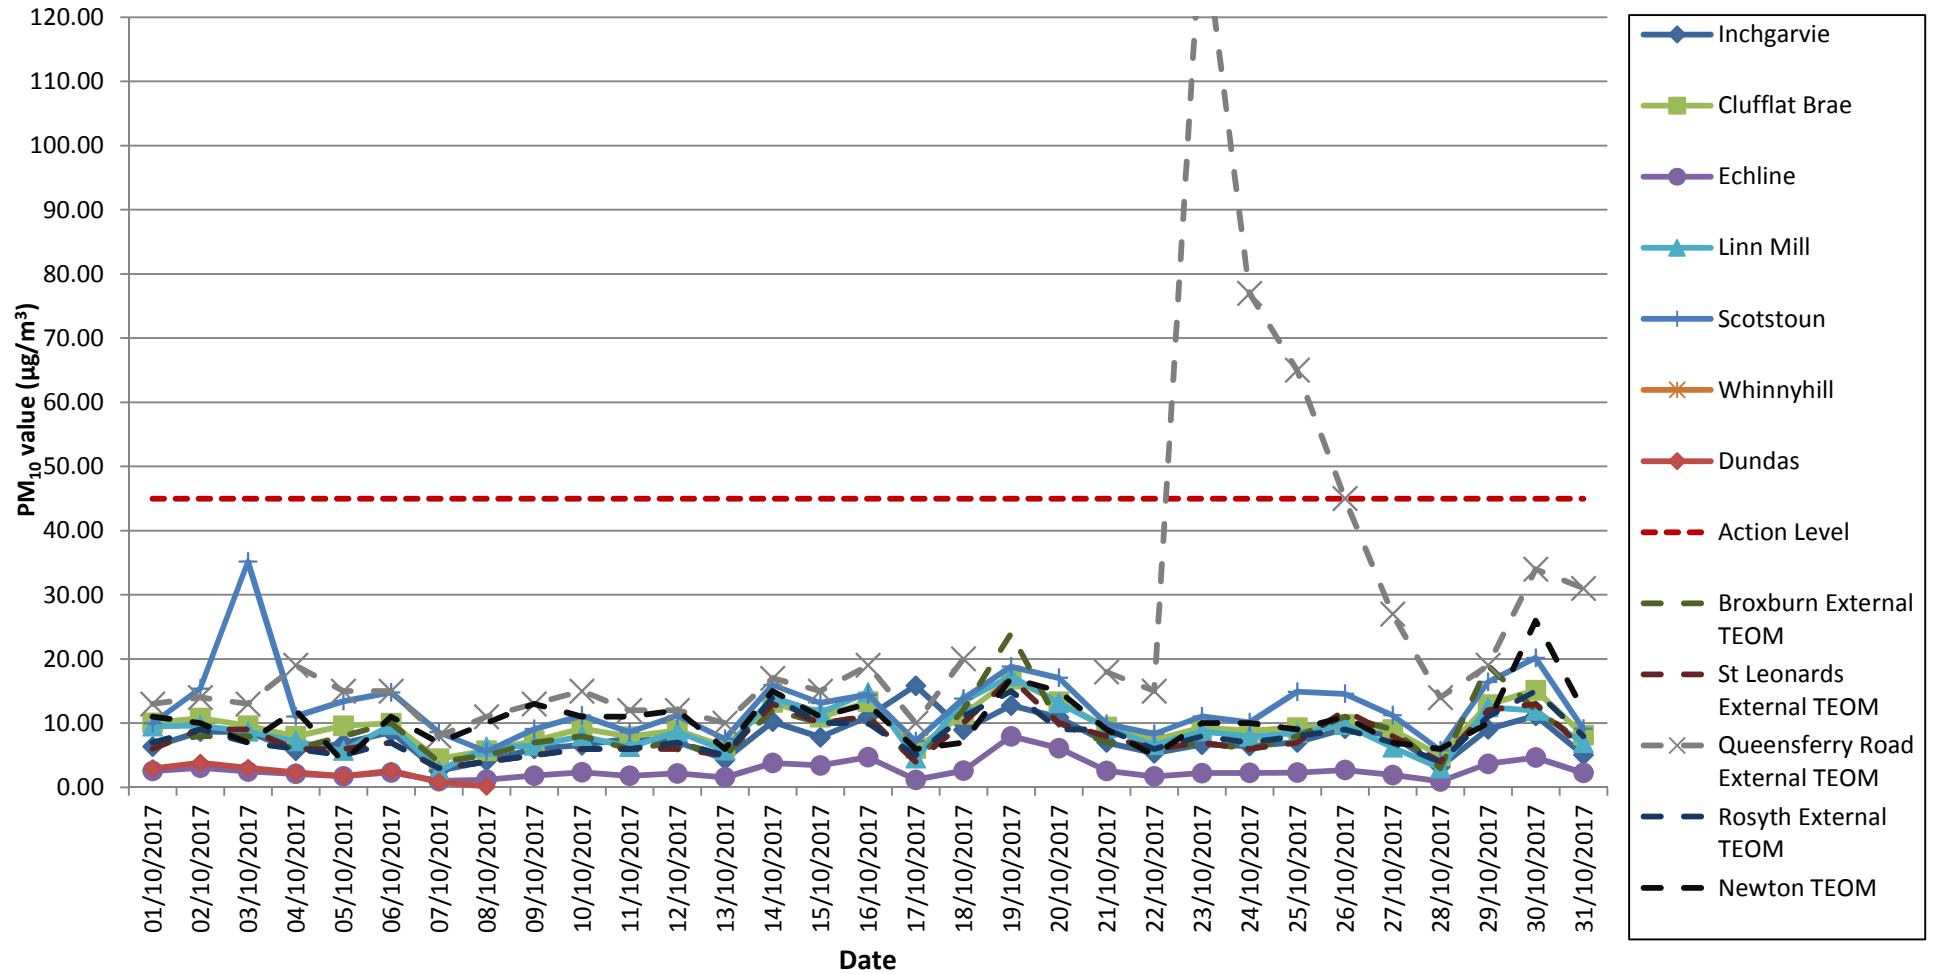
Air Quality Monitoring: Particulate Matter (PM10) Results for all Monitoring Locations, including TEOM data October 2017

Note: There is no data at the Whinnyhill monitor due to an electrical problem with the monitor. There was no data between the 9/10/2017 and 31/10/2017 at Dundas due to an electrical fault with the monitor

3.1.2. The PM_{10} results have also been compared to the daily mean results obtained from the TEOM air quality monitoring stations located in Newton, Rosyth, and Broxburn, and from the TEOM FDMS station located at Queensferry Road and St Leonards, Edinburgh (an urban background site). The TEOM at Newton was installed by West Lothian Council, facilitated by FCBC, during January 2012. The comparison between the light scatter and TEOM results demonstrates that both sets of results generally follow the same pattern throughout the month, with the exception of the result recorded at Scotstoun on 3rd October.
