# Appendix 15.1

## Cultural Heritage Desk Based Survey

1.1.1 This report presents the results of a cultural heritage desk based survey undertaken to inform **Chapter 15** of the Design Manual for Roads and Bridges (DMRB) Stage 3 Environmental Impact Assessment (EIA) for Project 8 – Dalwhinnie to Crubenmore. The aim of this report is to collate and assess existing information on the cultural heritage baseline of the study area and set this information out in its context. The archaeological and historical background has therefore used the known archaeology of a wider area within the Highlands to place the study area within context. This report has also been prepared to describe the value of the cultural heritage assets.

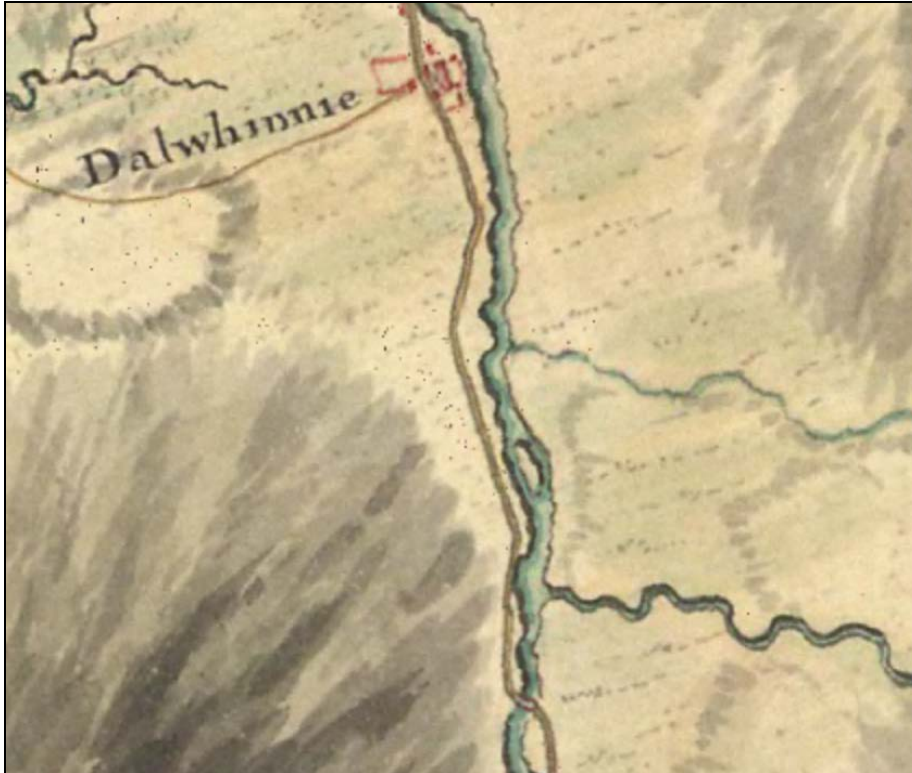
Figure 6.1.1: Roy Highlands 1747-52: Wade Bridge and Dalwhinnie  
(National Library of Scotland. Available at: <http://maps.nls.uk/>)

- 6.1.3 Wade Bridge can be seen at the bottom of the map, with the settlement of Dalwhinnie towards the top of the map. There is no evidence of any settlements elsewhere.

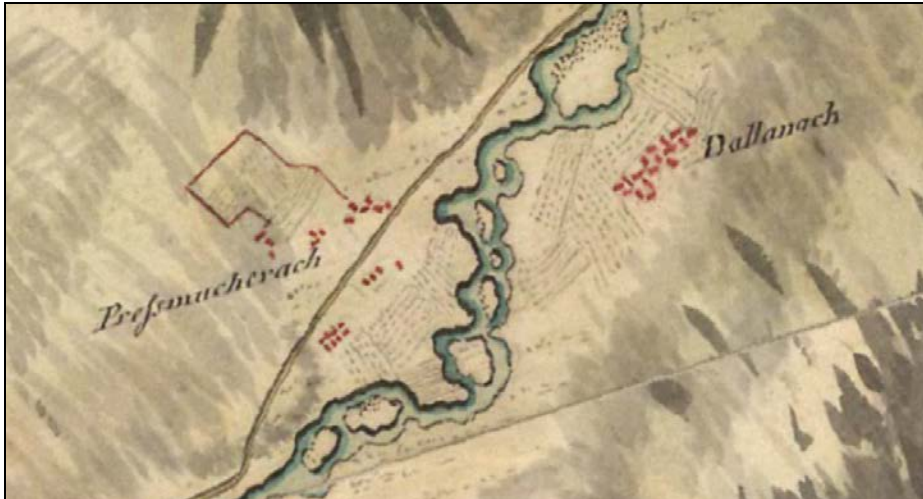
Figure 6.1.2: Roy Highlands 1747-52: Presmucharach and Dallarach  
(National Library of Scotland. Available at: <http://maps.nls.uk/>)

6.1.4 The settlements of Presmucharach and Dallarach are shown. Dallarach lies close to the existing A9.

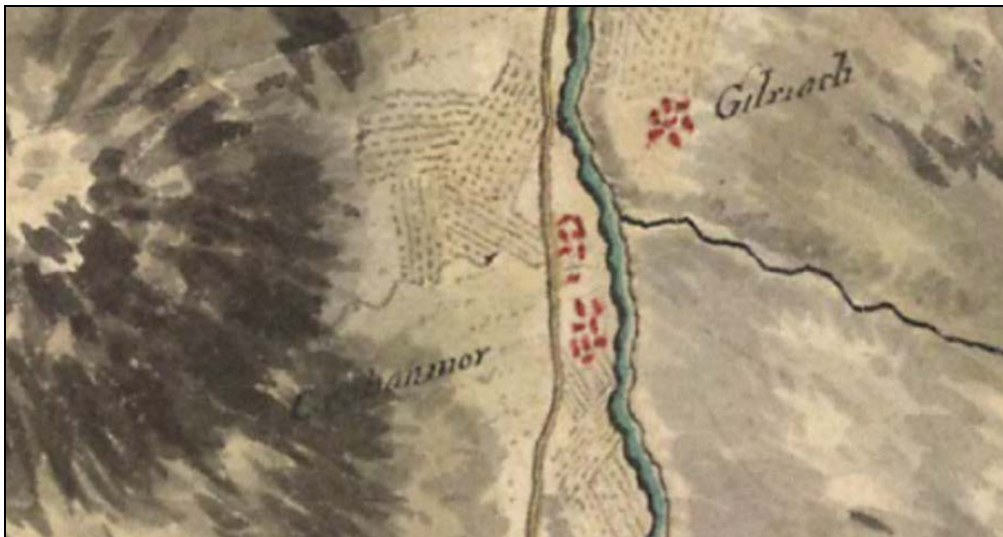
Figure 6.1.3: Roy Highlands 1747-52: Crubanmore  
(National Library of Scotland. Available at: <http://maps.nls.uk/>)

6.1.5 The settlement of Crubanmore (Crubenmore) can be seen to the west of the River Truim. A small settlement, Gilriach is to the east of the river. Gilriach does not appear on later maps, but likely lies close to the existing A9.

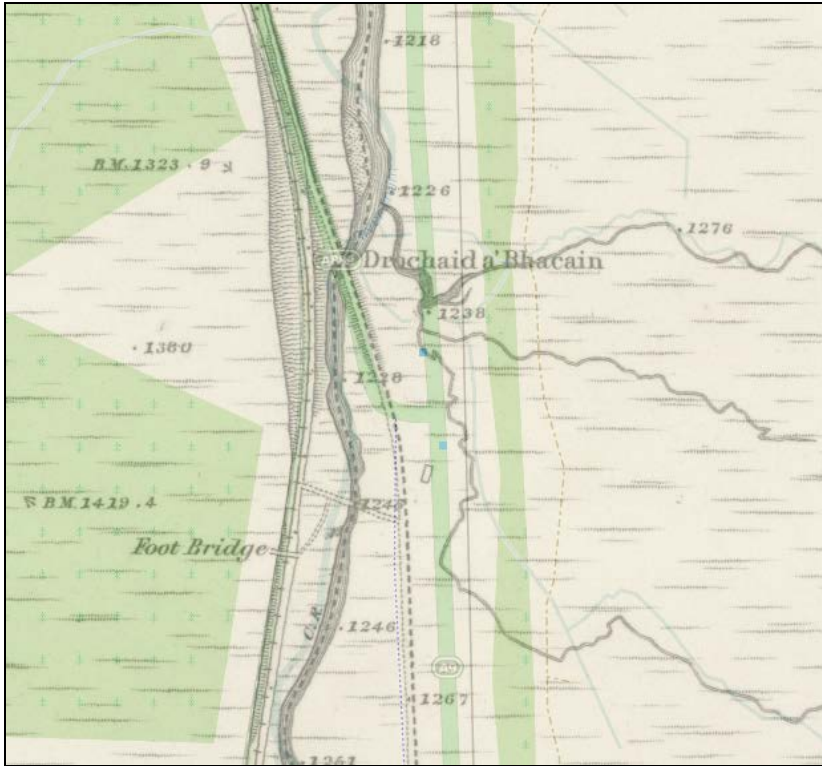
Figure 6.1.4: OS 6" 1843-1882: Wade Bridge  
 (National Library of Scotland. Available at: <http://maps.nls.uk/>)

6.1.6 Wade Bridge can be seen crossing the River Truim at the bottom of the map. The existing A9 and A889, and the Highland Mainline railway can be seen.

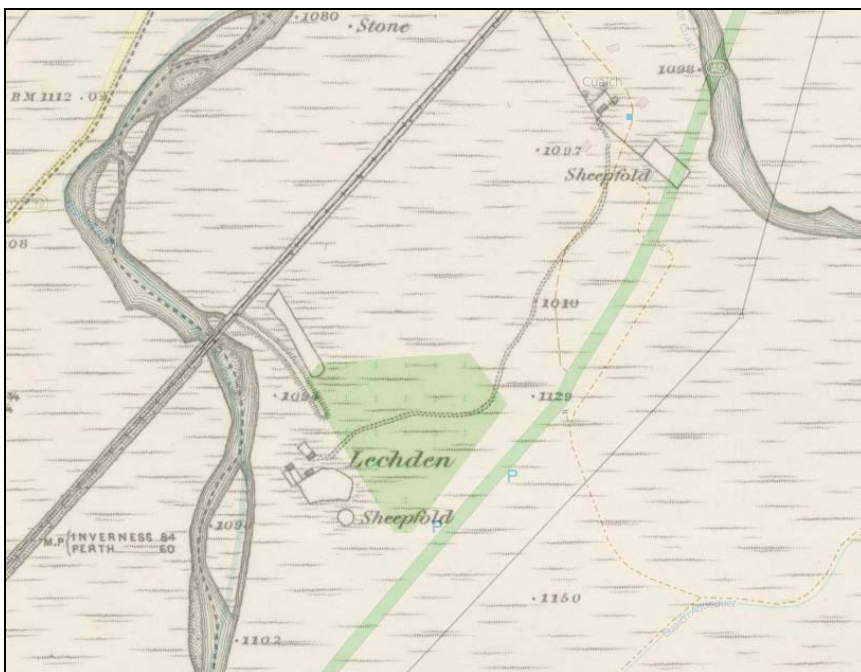
Figure 6.1.5: OS 6" 1843-1882: Lechden  
 (National Library of Scotland. Available at: <http://maps.nls.uk/>)

6.1.7 The small farmstead at Lechden and associated sheepfolds are shown close to, and on, the line of the existing A9.

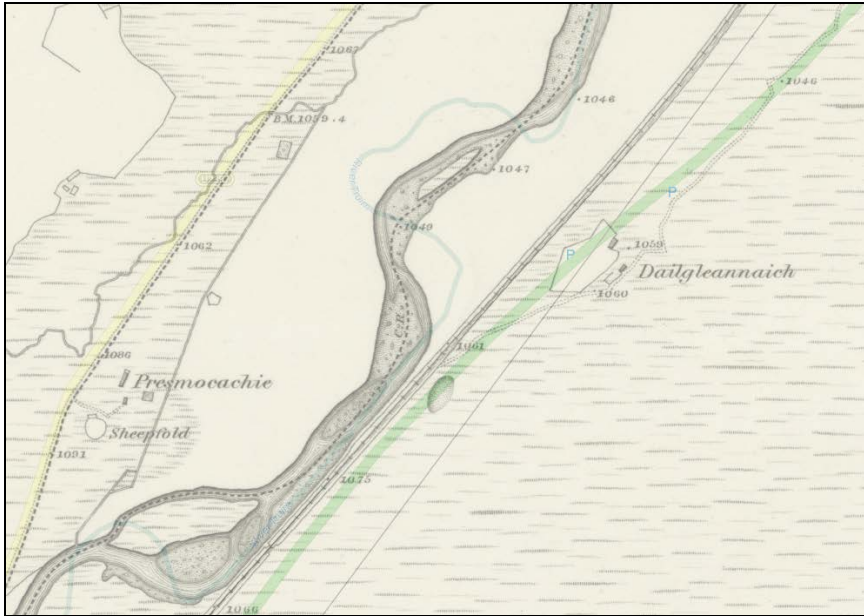
Figure 6.1.6: OS 6" 1843-1882: Dailgleannich (Dallanach) (National Library of Scotland. Available at: <http://maps.nls.uk/>)

6.1.8 The existing A9 can be seen to pass through the farmstead of Dailgleannich (Dallanach). A small quarry is to the south of Dallanach, and the line of General Wade’s road runs to the north-east through Dallanach.

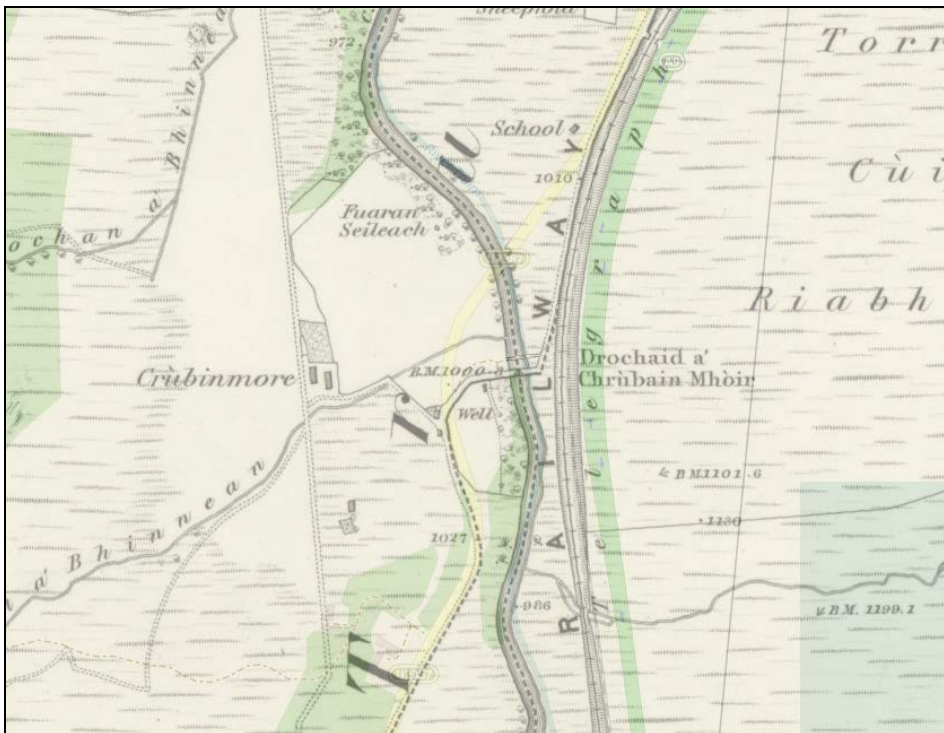
Figure 6.1.7: OS 6" 1843-1882: Crubinmore (Crubenmore) and Drochaid a' Chrubain Mhoir (Crubenmore Bridge) (National Library of Scotland. Available at: <http://maps.nls.uk/>)

- 6.1.9 Crubenmore Bridge is shown crossing the River Truim. The settlement of Crubinmore is shown as two houses with associated field system.

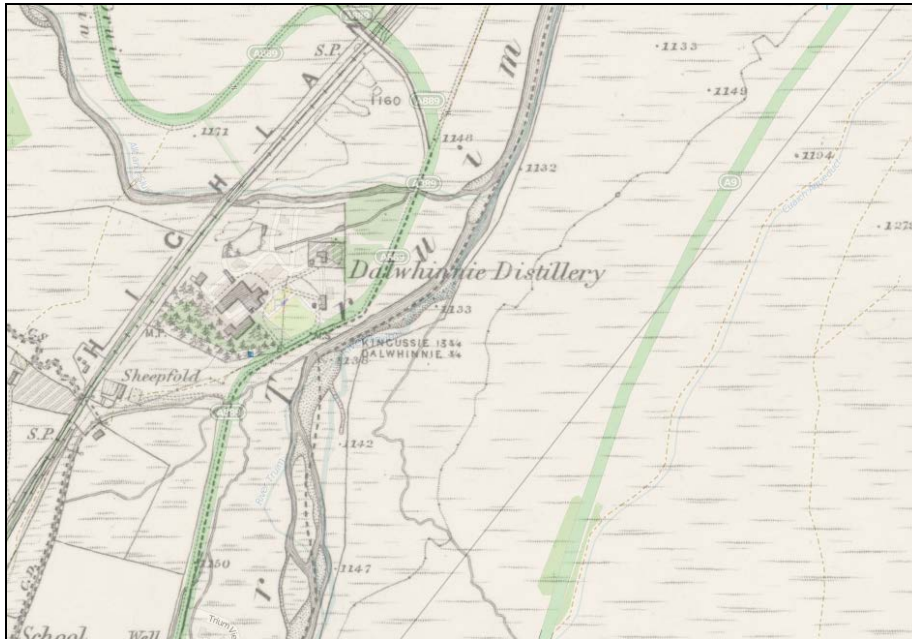
Figure 6.1.8: OS 6" 1888 – 1913: Dalwhinnie Distillery  
(National Library of Scotland. Available at: <http://maps.nls.uk/>)

- 6.1.10 The Speyside Distillery, opened in 1897 and closed in 1898. It re-opened as Dalwhinnie Distillery in 1905.

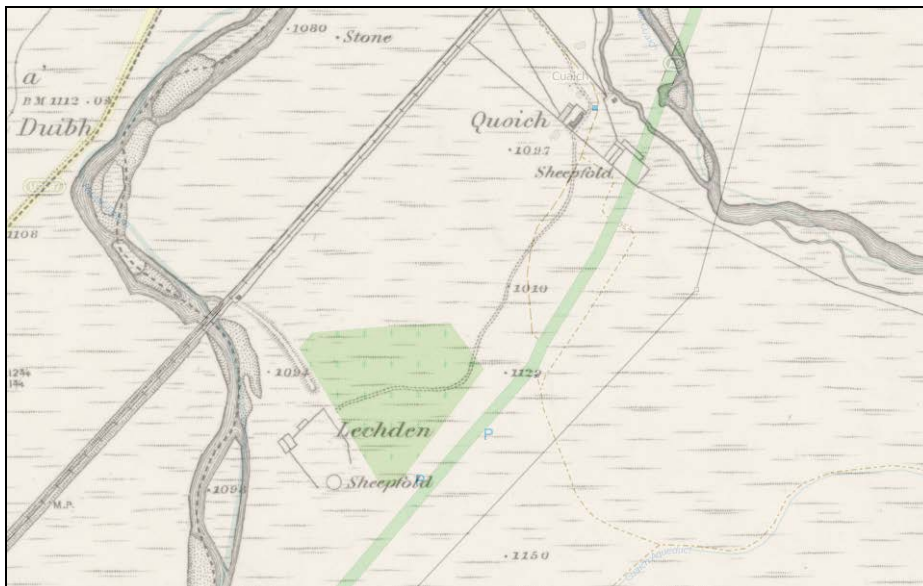
Figure 6.1.9: OS 6" 1888 – 1913: Lechden  
(National Library of Scotland. Available at: <http://maps.nls.uk/>)

- 6.1.11 Lechden farmstead and Quoich (Cuaich) farmsteads and sheepfolds are shown close to, and on the line of the existing A9.

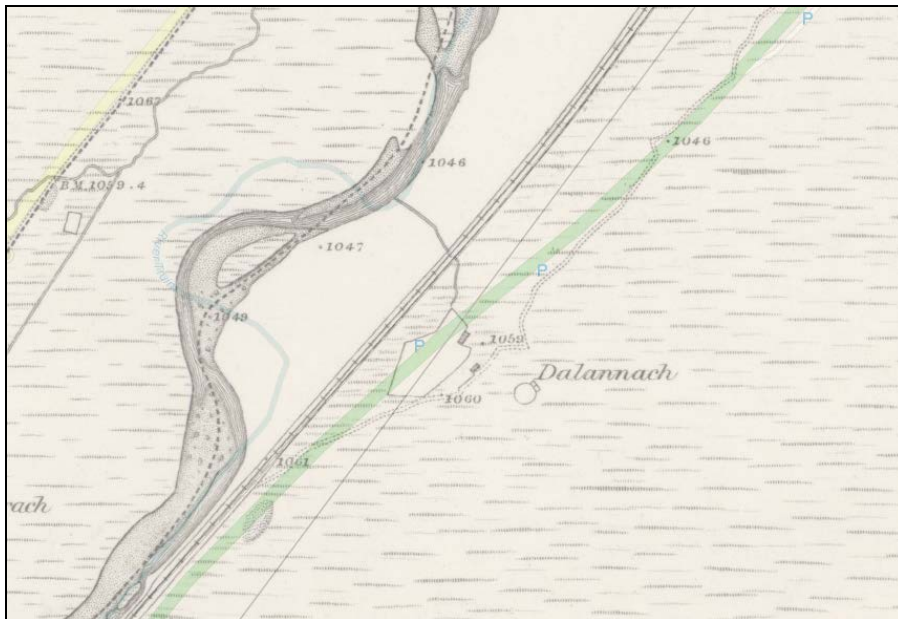
Figure 6.1.10: OS 6" 1888 – 1913: Dallenach  
(National Library of Scotland. Available at: <http://maps.nls.uk/>)

6.1.12 A small quarry can be seen at the bottom of the map; Dallenach farmstead has reduced in size since the previous OS map. Part of General Wade’s Road is located just to the south of the existing A9.

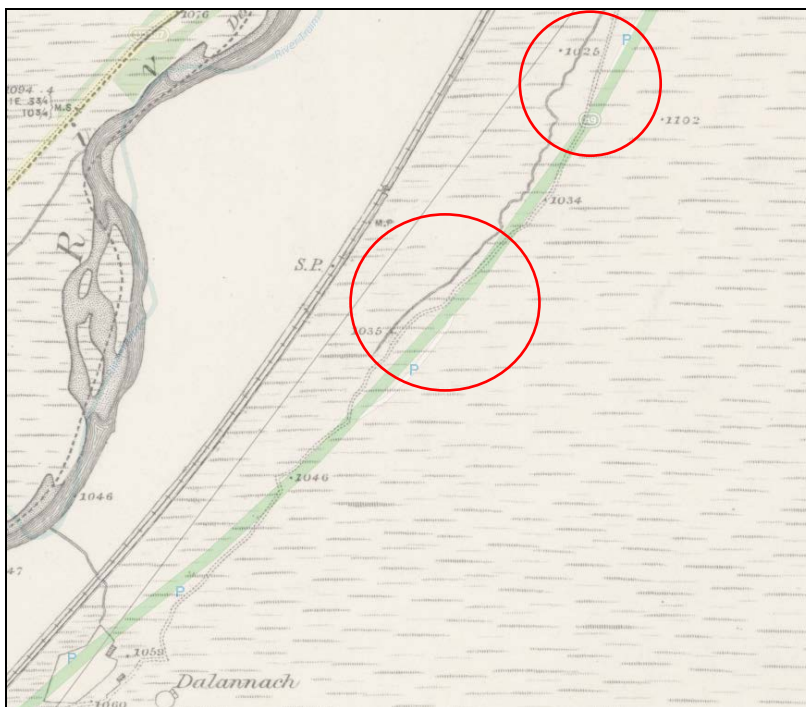
Figure 6.1.11: OS 6" 1888 – 1913: Wade’s Military Road to the NE of Dallenach  
(National Library of Scotland. Available at: <http://maps.nls.uk/>)

6.1.13 Sections of General Wade’s Military Road can be seen to the north of the existing A9. It is possible that buried remains could survive within areas not disturbed by the existing A9 construction.
