Project **FORTH REPLACEMENT CROSSING**

**AIR QUALITY MONITORING REPORT
DECEMBER 2017**

REP-00350

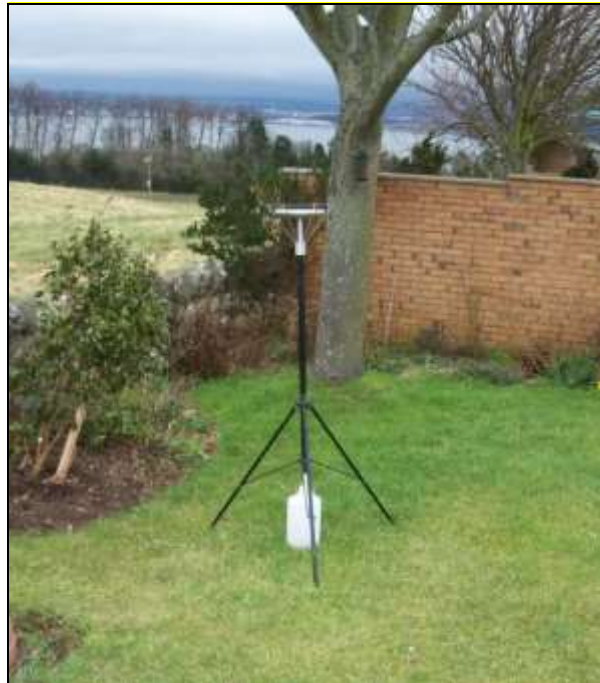
Figure 1: Example of an Installed Frisbee Gauge Meter

2.1. Air quality is being monitored on site using both automatic light scatter dust meters and Frisbee gauge dust deposition monitoring. Four Frisbee gauges are currently set up at sensitive locations across the site to measure dust deposition rates (Figure 1). Three automatic light scatter meters are installed at sensitive locations near the south abutment of the Queensferry Crossing to measure real time particulate matter (PM₁₀) concentrations and the Total Suspended Particle (TSP) concentrations (Figure 2). These meters are calibrated annually. Table 1 lists the air quality monitoring equipment present at each monitoring location, including the date it was installed.

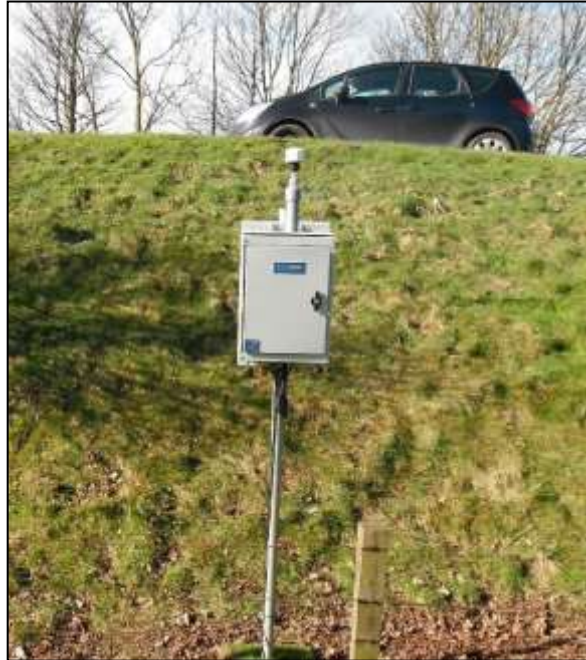
Figure 2: Example of an installed Automatic Light Scatter Dust Meter

2.2. Light scatter type monitoring equipment have been selected as a site monitoring tool to create a live network which assesses the levels of fugitive particulate matter, principally airborne dust. These monitors require less space, maintenance and power than other real time monitors such as a Tapered Element Oscillating Microbalance (TEOM) which is used and designed to measure particulate levels to exceedingly high standards, including measuring long-term compliance to statutory limits. Light scatter meters are more practicable to deploy. However, the meters do generally record levels higher than those measured by the TEOM. The meters can also be affected by atmospheric moisture content which further increases reported levels. Accordingly, any elevations of statutory limits should be treated as precautionary exceedances. The monitors are reliable for on-site monitoring and the establishment of action thresholds to ensure unforeseen activities generating significant dust are identified and suitably controlled. Light scatter meters are becoming the construction and waste industries norm for particulate dust monitoring.
