Project **FORTH REPLACEMENT CROSSING**

**AIR QUALITY MONITORING REPORT
JANUARY 2018**

Document number	Rev
REP-00351	00

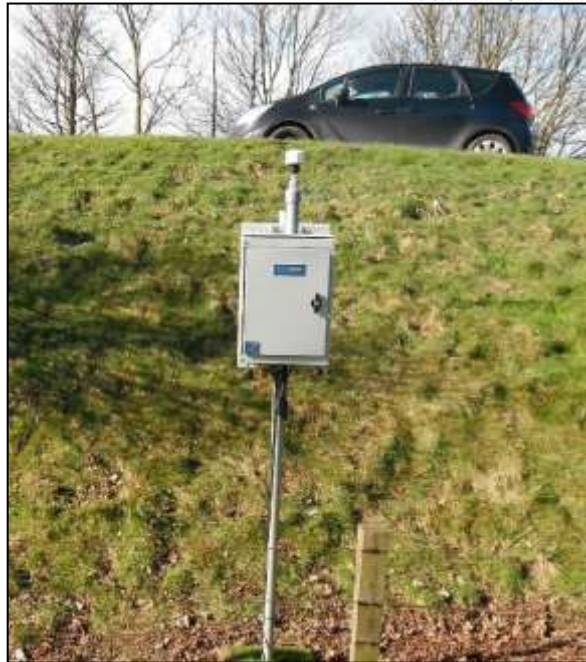
Figure 2: Example of an installed Automatic Light Scatter Dust Meter
